NYC Department of Education
Building Condition Assessment Survey 2023 - 2024

Architectural Inspection

Asset: P.S. 84 - QUEENS, 22-45 41 STREET, New York, 11105

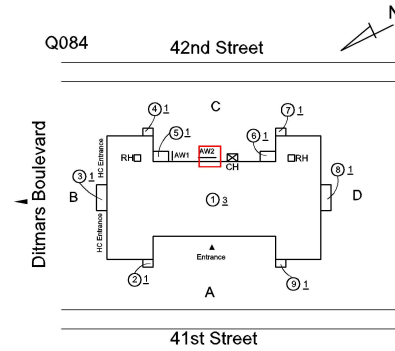
Roof Plan reference

Question	Response
Architectural	
EXTERIOR	Inspected
AREAWAY	Inspected
Instance on AW1 - AW2	Inspected
Instance Condition	3 - Fair
Instance Quantity	2
Instance Quantity Uom	EACH
Deficiency	AREAWAY SLAB: CRACKS AND SPALLING

10
S.F.
REPLACE
PRIORITY 4
LEVEL 2

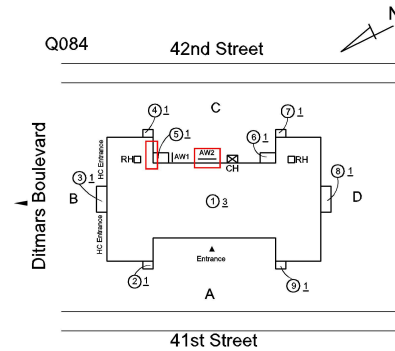
Roof Plan reference

AREAWAY WALLS: CRACKS AND SPALLING

40
S.F.
REPLACE
PRIORITY 4
LEVEL 2

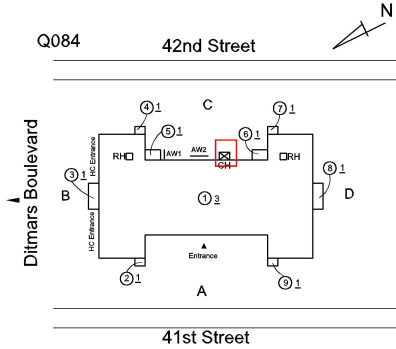
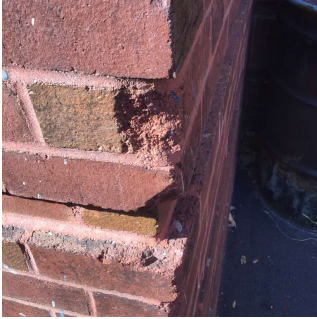
Violations	AW2 No violations recorded.
AWNINGS AND CANOPIES	Does not Exist
CHIMNEY	Inspected
Material Type(s)	Masonry
Condition	3 - Fair
Deficiency	BRICK: MINOR CRACKS AND SPALLING
Roof Plan reference

Deficiency Quantity	30
Quantity Uom	S.F.
Potential Action	RESTITCH
Urgency of Action	PRIORITY 3
Purpose of Action	LEVEL 2
Deficiency Photo1

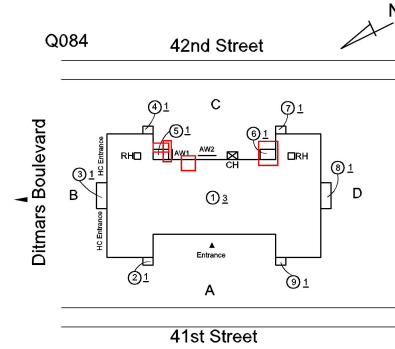
Roof Plan reference

Violations	CH No violations recorded.
COPING	Inspected
Condition	3 - Fair
Deficiency	CAST STONE: DETERIORATED TRANSVERSE JOINTS

30
L.F.
MAINTENANCE
PRIORITY 3
LEVEL 2

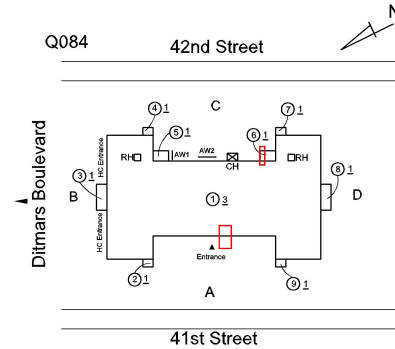
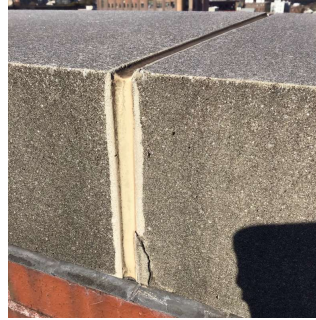
Roof 1

CAST STONE: CRACKED/BROKEN PIECES

20
L.F.
REPLACE-IN-KIND
PRIORITY 4
LEVEL 2

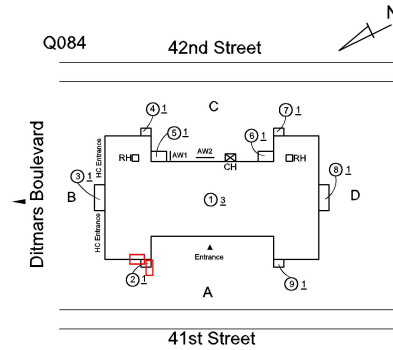
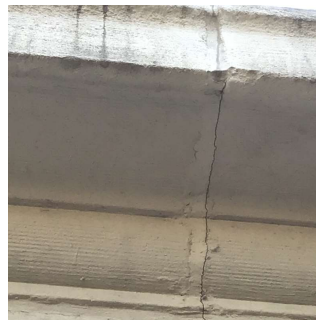
Facade A

STONE: MAJOR CRACKS, SPALLING

20

REPLACE

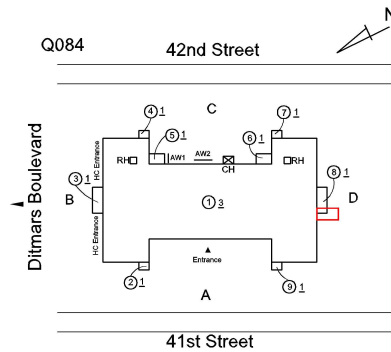
Roof Plan reference

METAL: AIR/WATER INFILTRATION, DETERIORATED JOINTS WITH DAMAGED CAULKING

10
L.F.
MAINTENANCE
PRIORITY 3
LEVEL 2

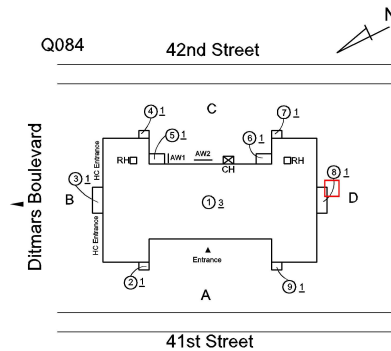
Roof Plan reference

METAL: DETERIORATED DOOR AND FRAME - MAJOR DETERIORATION

1
EACH
REPLACE
PRIORITY 4
LEVEL 2

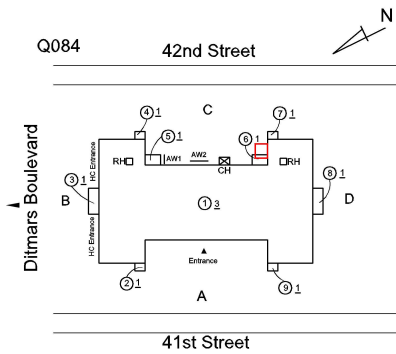
Violations	Facade D No violations recorded.
Deficiency	METAL: DETERIORATED DOOR - MAJOR DETERIORATION
Roof Plan reference

Deficiency Quantity	1
Quantity Uom	EACH
Potential Action	REPLACE
Urgency of Action	PRIORITY 4
Purpose of Action	LEVEL 2
Deficiency Photo1

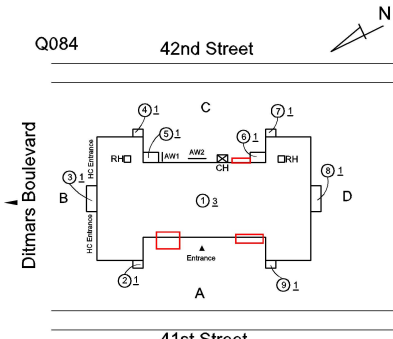
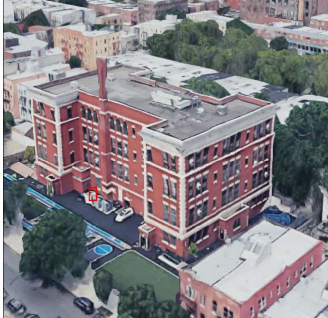
Question	Response
EXTERIOR	
EXTERIOR WALLS	Inspected
Material Type(s)	Masonry
Replacement Quantity	30,000
Replacement Uom	S.F.
Instance on All Facades	Inspected
Instance Condition	4 - Between Fair and Poor
Instance Quantity	30,000
Instance Quantity Uom	S.F.
Deficiency	BRICK: DETERIORATED JOINTS
Roof Plan reference

Deficiency Quantity	60
Quantity Uom	S.F.
Potential Action	REPOINT
Urgency of Action	PRIORITY 3
Purpose of Action	LEVEL 2
Deficiency Photo1

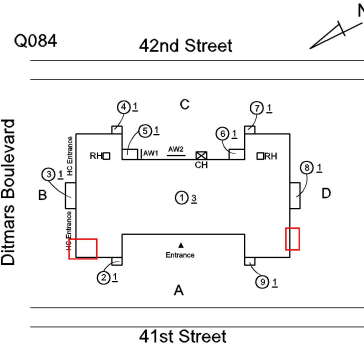
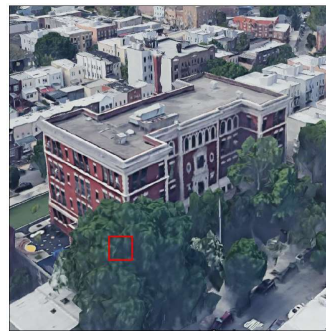
Violations	Facade C No violations recorded.
Deficiency	STUCCO CEMENT SURFACE: CRACKS, SPALLING

40

REPLACE

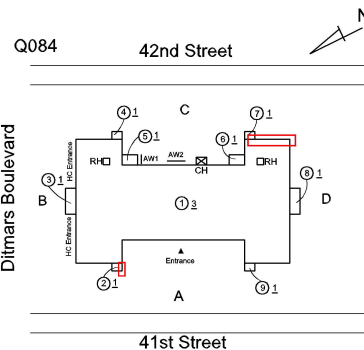
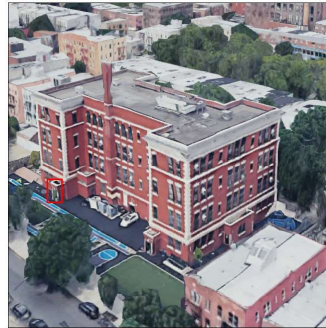
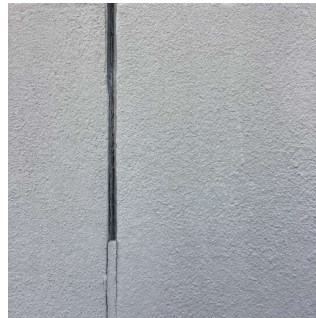
Facade A

STONE: DETERIORATED JOINTS

50

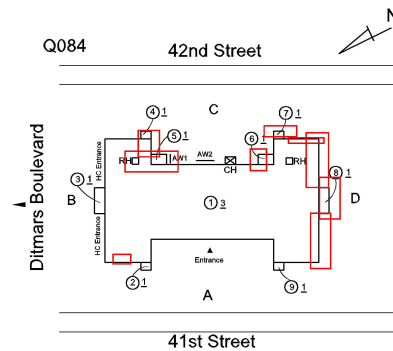
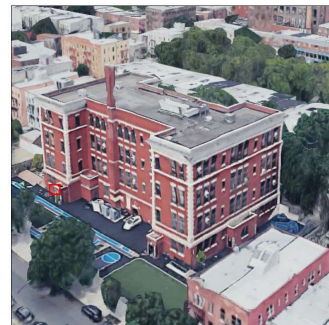
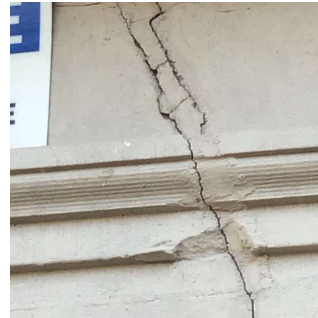
Facade A

STONE: CHIPPED/SPALLED/BROKEN PIECES - MAJOR

200

REPLACE

PRIORITY 4
LEVEL 2

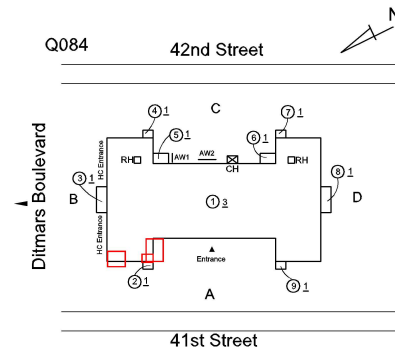
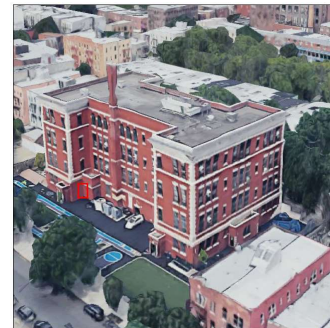
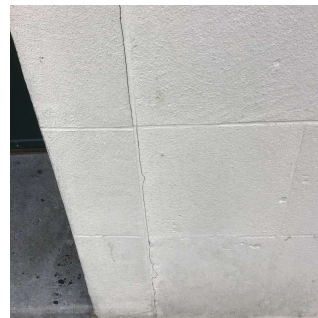
Facade A

STONE: CHIPPED/SPALLED/BROKEN PIECES - MINOR

50

REPAIR

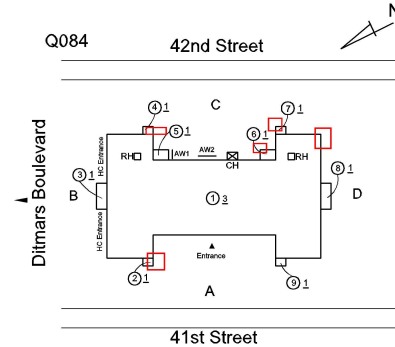
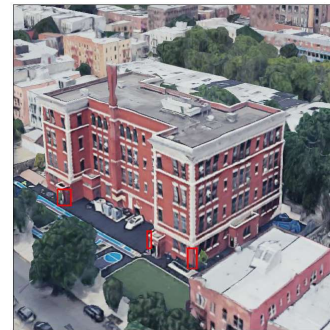
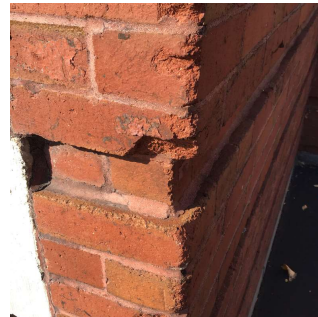
Facade C

BRICK: CRACKS/DISPLACED/SPALLED BRICK AT BUILDING CORNERS

50

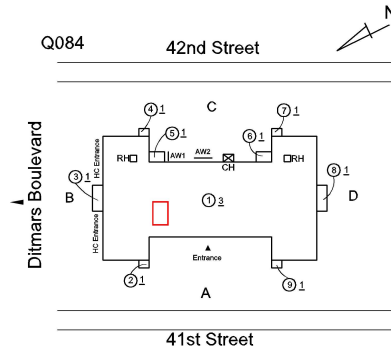
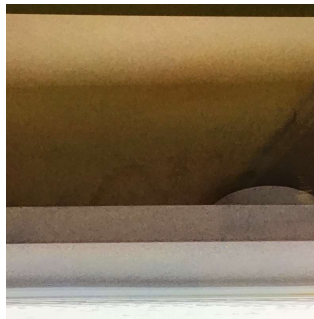
Do solar panels exist on these roofs?	No
Is/Are the roof(s) suitable for Solar Panel installation?	Yes
Installation Year	1986
Source of Installation	Custodial Staff
Deficiency	BUILT-UP: ROOFING: MAJOR ACTIVE ROOF LEAKS IN INSTRUCTIONAL SPACE

100
S.F.
REPLACE ROOFING WITHOUT MAJOR EQUIPMENT
REMOVAL
PRIORITY 5
LEVEL 2

Roof 1 - Multipurpose Room - 3 rd Floor near windows left side
No violations recorded.

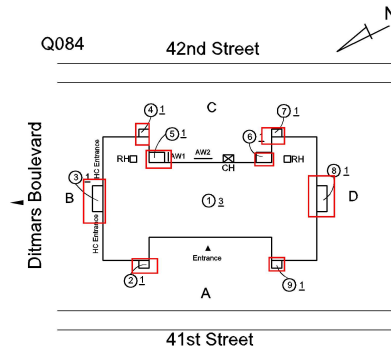
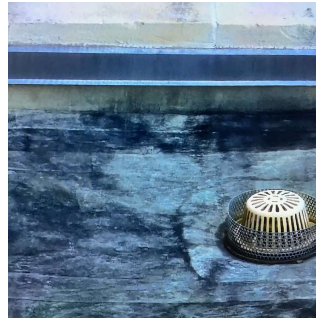
Roof 9

BUILT-UP: ROOFING: LOSS OF GRAVEL

300
S.F.
INSTALL NEW GRAVEL
PRIORITY 3
LEVEL 2

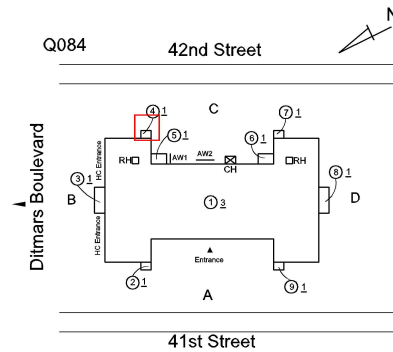
DETERIORATED

1

REPLACE

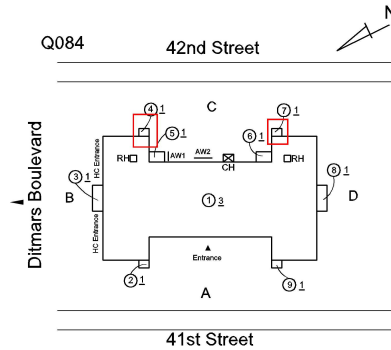
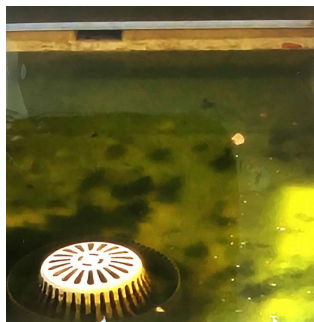
Roof 4
 No violations recorded.

2
 EACH
 MAINTENANCE
 PRIORITY 5
 LEVEL 2

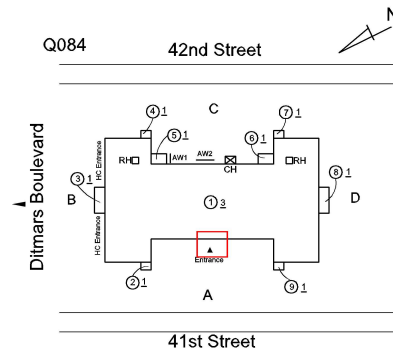
Specialties	Inspected
BULKHEAD/PENTHOUSE	Does not Exist
CUPOLA/ SPIRES/ TOWERS	Does not Exist
DORMER	Does not Exist
DUNNAGE STEEL	Inspected
Condition	2 - Between Good and Fair
Deficiency	No deficiencies recorded
SKYLIGHT/ROOF VENT	Does not Exist
ROOF/GRAVITY TANK	Does not Exist
STAIRS/RAMPS: EXTERIOR	Inspected
BUILDING CHEEK/FLANK WALLS	Inspected
Condition	3 - Fair
Deficiency	CAST IN PLACE CONCRETE: CRACKS/SPALLING - MAJOR

15
S.F.
REPLACE
PRIORITY 4
LEVEL 2

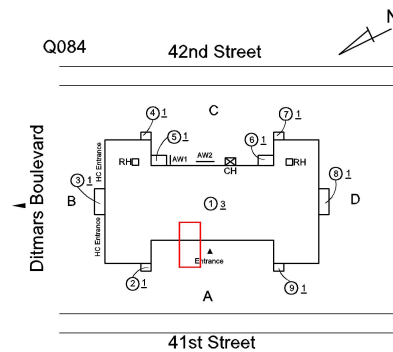
CAST IN PLACE CONCRETE: CRACKS/SPALLING - MINOR

10
S.F.
REPAIR
PRIORITY 3
LEVEL 2

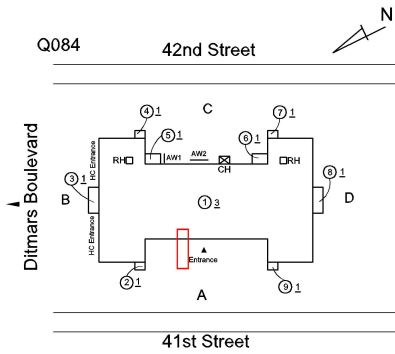
Violations	Facade A No violations recorded.
Deficiency	STONE: CRACKS/SPALLING - MINOR
Roof Plan reference

Deficiency Quantity	10
Quantity Uom	S.F.
Potential Action	REPAIR
Urgency of Action	PRIORITY 3
Purpose of Action	LEVEL 2
Deficiency Photo1

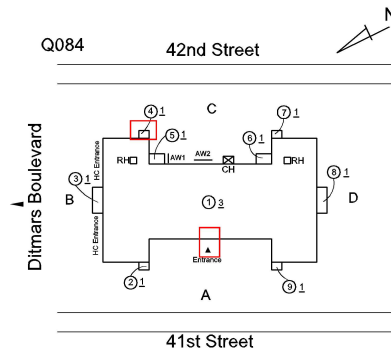
Violations	Facade A No violations recorded.
RAILINGS	Inspected
Condition	2 - Between Good and Fair
Deficiency	No deficiencies recorded
STAIRS/RAMPS	Inspected
Condition	4 - Between Fair and Poor
Deficiency	CONCRETE: WORN-OUT TREAD/RISER/NOSING

20
S.F.
REPLACE
PRIORITY 4
LEVEL 2

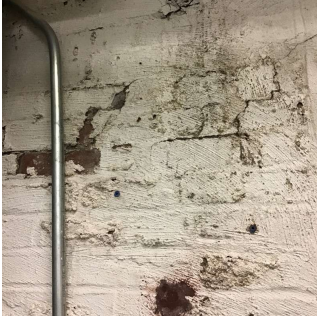
Basement - Multipurpose Room
Violations	No violations recorded.
Deficiency	BRICK: WATER INFILTRATION IN ELECTRICAL PANEL ROOM

Deficiency Location/Instance	Basement - Electrical Panel Room
Deficiency Quantity	100
Quantity Uom	S.F.

Question	Response
INTERIOR	
STRUCTURAL	
FOUNDATION WALLS	
Potential Action	INSTALL WATERPROOFING
Urgency of Action	PRIORITY 5
Purpose of Action	LEVEL 6
Deficiency Photo1

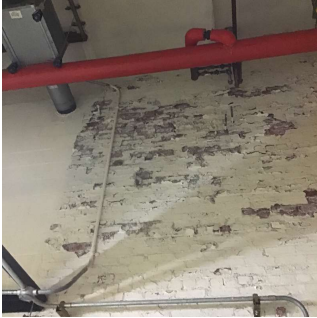
Basement - Gas Meter Room
Violations	35665549L
Deficiency	BRICK: CRACKED/SPALLED
Deficiency Location/Instance	Basement - Electrical Room
Deficiency Quantity	10
Quantity Uom	S.F.
Potential Action	RESTITCH
Urgency of Action	PRIORITY 3
Purpose of Action	LEVEL 5

Basement - Electrical Panel Room
Violations	35665549L
Deficiency	BRICK: WATER INFILTRATION IN NON- INSTRUCTIONAL SPACE
Deficiency Location/Instance	Basement - Gas Meter Room
Deficiency Quantity	100
Quantity Uom	S.F.
Potential Action	INSTALL WATERPROOFING
Urgency of Action	PRIORITY 5
Purpose of Action	LEVEL 5
Deficiency Photo1

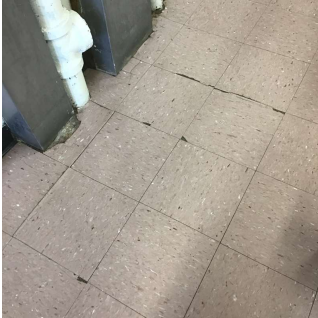
Question	Response
INTERIOR	
CAFETERIA	
Floor Finish	
Condition	2 - Between Good and Fair
Deficiency	VINYL TILES: BROKEN/DETERIORATED/MISSING TILES
Deficiency Location/Instance	Near Windows, center, Stairs.
Deficiency Quantity	40
Quantity Uom	S.F.
Potential Action	REPLACE
Urgency of Action	PRIORITY 3
Purpose of Action	LEVEL 2
Deficiency Photo1

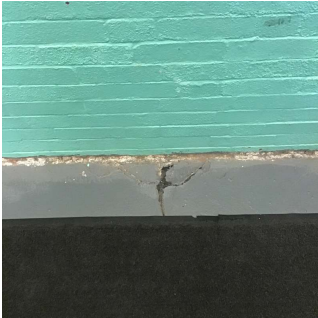
Violations	Near Windows No violations recorded.
Deficiency	ROLLED ASPHALT: CRACKS
Deficiency Location/Instance	Exit 9 Vestibule
Deficiency Quantity	10
Quantity Uom	S.F.
Potential Action	REPLACE
Urgency of Action	PRIORITY 3
Purpose of Action	LEVEL 2
Deficiency Photo1

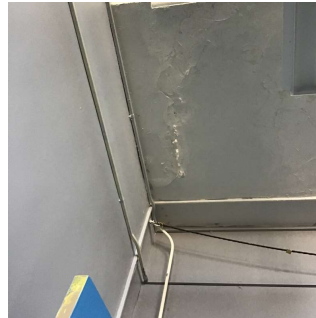
Room 209

PLASTER: CRACKS/SPALLING

REPLACE

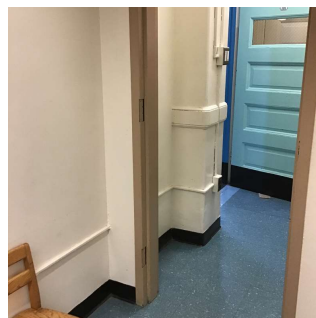
METAL: MISSING DOOR

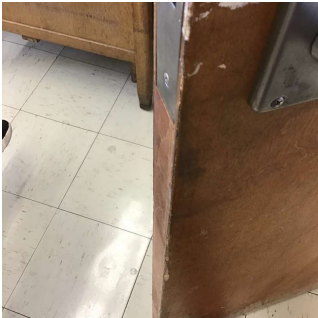
Question	Response
INTERIOR	
CLASSROOMS/CORRIDORS/ADMIN SPACES	
Door(s)	
Violations	Room 101B No violations recorded.
Deficiency	WOOD: DETERIORATED DOOR
Deficiency Location/Instance	Rooms 150, 204, 250, 309, 310, and others.
Deficiency Quantity	12
Quantity Uom	EACH
Potential Action	MAINTENANCE
Urgency of Action	PRIORITY 3
Purpose of Action	LEVEL 2
Deficiency Photo1

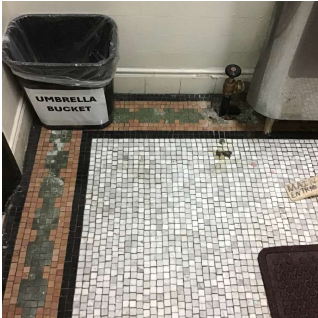
Violations	Room 309 No violations recorded.
Floor Finish	Inspected
Condition	3 - Fair
Deficiency	CERAMIC TILE: BROKEN/MISSING TILES
Deficiency Location/Instance	Main Entrance
Deficiency Quantity	10
Quantity Uom	S.F.
Potential Action	REPLACE
Urgency of Action	PRIORITY 3
Purpose of Action	LEVEL 2
Deficiency Photo1

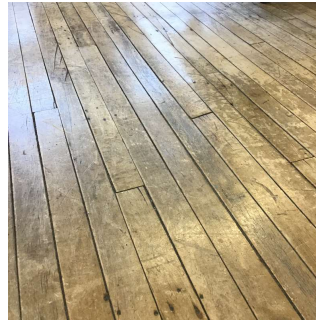
Violations	Main Entrance No violations recorded.
Deficiency	WOOD: DAMAGED/DETERIORATED
Deficiency Location/Instance	Room 302
Deficiency Quantity	100
Quantity Uom	S.F.
Potential Action	REPLACE
Urgency of Action	PRIORITY 3
Purpose of Action	LEVEL 2

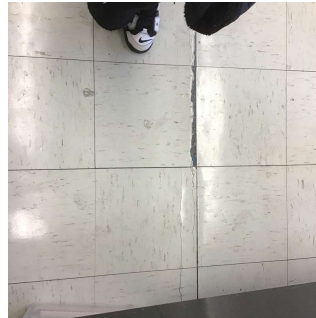
Room 309

VINYL TILES: DETERIORATED SUBSTRATE

REPLACE

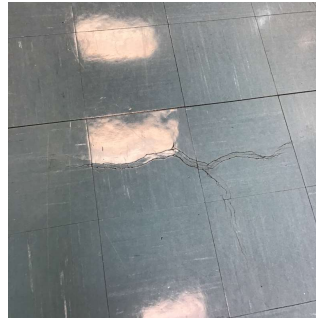
Near Main Entrance

VINYL TILES: BROKEN/DETERIORATED/MISSING TILES

REPLACE

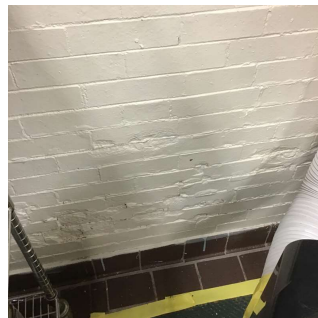
Instance on Basement	Inspected
Condition	2 - Between Good and Fair
Deficiency	BRICK: CRACKS/SPALLING
Deficiency Location/Instance	Storage-Office Area
Deficiency Quantity	10
Quantity Uom	S.F.
Potential Action	REPLACE
Urgency of Action	PRIORITY 3
Purpose of Action	LEVEL 2
Deficiency Photo1

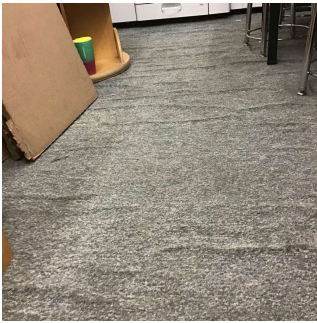
Question	Response
INTERIOR	
LIBRARY	
Door(s)	Entrance
Violations	No violations recorded.
Floor Finish	
Instance on Room 109	Inspected
Condition	4 - Between Fair and Poor
Deficiency	CARPET: WORN/DETERIORATED
Deficiency Location/Instance	Near librarian Desk
Deficiency Quantity	100
Quantity Uom	S.F.
Potential Action	REPLACE
Urgency of Action	PRIORITY 5
Purpose of Action	LEVEL 6
Deficiency Photo1

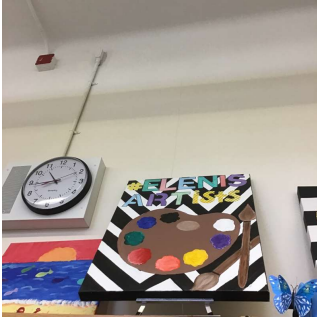
Violations	Near librarian Desk No violations recorded.
Walls	
Instance on Room 109	Inspected
Condition	2 - Between Good and Fair
Deficiency	PLASTER: CRACKS/SPALLING
Deficiency Location/Instance	Near Entrance
Deficiency Quantity	10
Quantity Uom	S.F.
Potential Action	REPLACE
Urgency of Action	PRIORITY 3
Purpose of Action	LEVEL 2
Deficiency Photo1

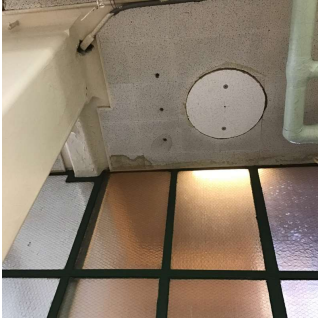
Near Windows
Violations	No violations recorded.
Instance on Basement	Inspected
Condition	2 - Between Good and Fair
Deficiency	ACOUSTIC TILES ON PLASTER: DAMAGED/MISSING
Deficiency Location/Instance	Near Exit 4, Windows

Deficiency Quantity	20
Quantity Uom	S.F.
Potential Action	REPLACE

Question	Response
INTERIOR	
MULTI-PURPOSE ROOM	
Ceiling	
Urgency of Action	PRIORITY 3
Purpose of Action	LEVEL 2
Deficiency Photo1

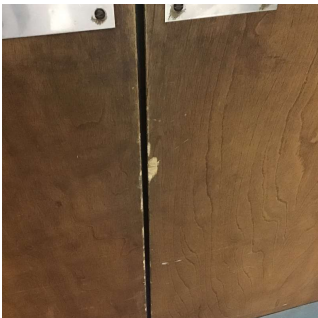
Violations	Near Exit 4 No violations recorded.
Door(s)	
Instance on Basement	Inspected
Condition	4 - Between Fair and Poor
Deficiency	WOOD: DETERIORATED DOOR
Deficiency Location/Instance	Exit 5 Vestibule
Deficiency Quantity	2
Quantity Uom	EACH
Potential Action	MAINTENANCE
Urgency of Action	PRIORITY 3
Purpose of Action	LEVEL 2
Deficiency Photo1

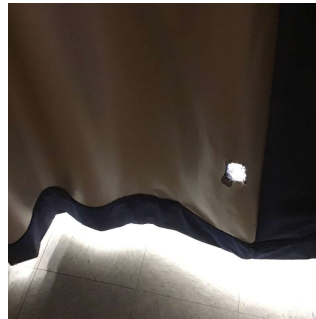
Instance on 3rd Floor	Inspected
Condition	3 - Fair
Deficiency	WORN/DETERIORATED
Deficiency Location/Instance	Main Left Side
Deficiency Quantity	100
Quantity Uom	S.F.
Potential Action	REPLACE
Urgency of Action	PRIORITY 3
Purpose of Action	LEVEL 2
Deficiency Photo1

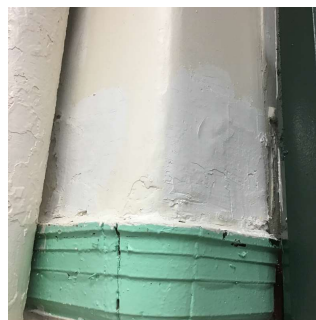
Instance on Basement	Inspected
Condition	2 - Between Good and Fair
Deficiency	PLASTER: CRACKS/SPALLING - ACTIVE LEAK
Deficiency Location/Instance	Near Stair D
Deficiency Quantity	10
Quantity Uom	S.F.
Potential Action	REPLACE
Urgency of Action	PRIORITY 5
Purpose of Action	LEVEL 2
Deficiency Photo1

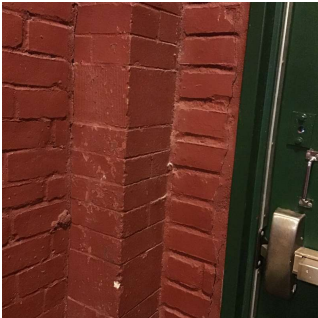
Question	Response
INTERIOR	
MULTI-PURPOSE ROOM	
Walls	
Violations	No violations recorded.
Deficiency	BRICK: CRACKS/SPALLING
Deficiency Location/Instance	Exit 5 Vestibule
Deficiency Quantity	20
Quantity Uom	S.F.
Potential Action	REPLACE
Urgency of Action	PRIORITY 3
Purpose of Action	LEVEL 2
Deficiency Photo1

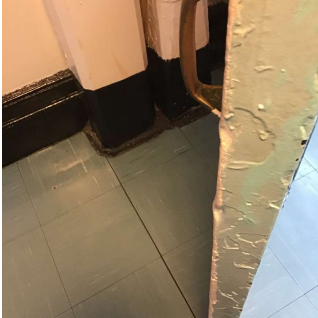
Question	Response
INTERIOR	
MULTI-PURPOSE ROOM	
Walls	
Purpose of Action	LEVEL 2
Deficiency Photo1	 
Violations	Near Drinking Fountain No violations recorded.
Window Curtains/Shades/Blinds	
Instance on 3rd Floor	Inspected
Condition	2 - Between Good and Fair
Deficiency	No deficiencies recorded
Instance on Basement	Does not Exist
SCIENCE DEMO ROOM	Does not Exist
SCIENCE LAB	Does not Exist
SCIENCE PREP ROOM	Does not Exist
SHOWER ROOM	Does not Exist
STAIRS/RAMPS: INTERIOR	
Do Letter Stair Signs Exist?	Inspected Yes
Ceiling	
Condition	Inspected 2 - Between Good and Fair
Deficiency	PLASTER: CRACKS/SPALLING
Deficiency Location/Instance	Stair C/2
Deficiency Quantity	10
Quantity Uom	S.F.
Potential Action	REPLACE
Urgency of Action	PRIORITY 3
Purpose of Action	LEVEL 2
Deficiency Photo1	 
Violations	Stair C/2 No violations recorded.
Door(s)	
Condition	Inspected 5 - Poor
Deficiency	METAL CLAD WOOD: DETERIORATED DOOR

Question	Response
INTERIOR	
STAIRS/RAMPS: INTERIOR	
Door(s)	
Deficiency Location/Instance	Stairs A/1, B/2, 3, C/1
Deficiency Quantity	4
Quantity Uom	EACH
Potential Action	MAINTENANCE
Urgency of Action	PRIORITY 3
Purpose of Action	LEVEL 2
Deficiency Photo1

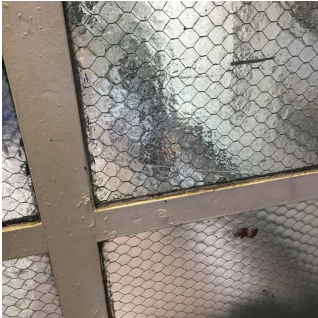
Stair C/1
Violations	No violations recorded.
Partition	Inspected
Condition	2 - Between Good and Fair
Deficiency	GLASS PANEL: DAMAGED/DETERIORATED
Deficiency Location/Instance	Stairs B/Basement, C/Basement
Deficiency Quantity	20
Quantity Uom	S.F.
Potential Action	REPLACE
Urgency of Action	PRIORITY 3
Purpose of Action	LEVEL 2
Deficiency Photo1

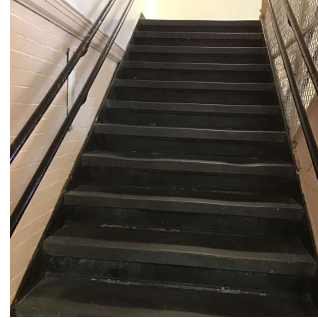
Stair B/Basement
Violations	No violations recorded.
Railings	Inspected
Condition	2 - Between Good and Fair
Deficiency	No deficiencies recorded
Stairs and Landings	Inspected
Condition	5 - Poor
Deficiency	STONE: WORN-OUT TREAD/NOSINGS
Deficiency Location/Instance	Stairs A/Basement, B/Basement, D/Basement, 1
Deficiency Quantity	520

Quantity Uom	S.F.
Potential Action	REPLACE

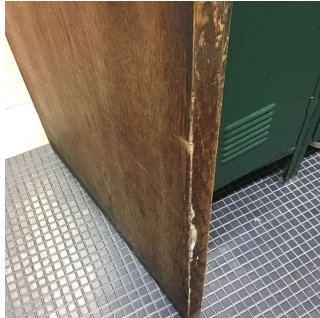
Question	Response
INTERIOR	
TOILET ROOMS - STAFF	Inspected
Ceiling	Inspected
Condition	2 - Between Good and Fair
Deficiency	No deficiencies recorded
Door(s)	Inspected
Condition	5 - Poor
Deficiency	WOOD: DETERIORATED DOOR
Deficiency Location/Instance	Room 250A, Kitchen Locker Room, 1st Floor
Deficiency Quantity	3
Quantity Uom	EACH
Potential Action	MAINTENANCE
Urgency of Action	PRIORITY 3
Purpose of Action	LEVEL 2
Deficiency Photo1

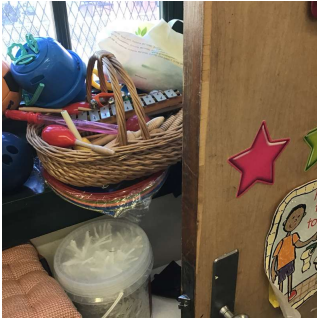
Violations	Kitchen Locker Room No violations recorded.
TOILET ROOMS - STUDENTS	
Ceiling	Inspected
Condition	2 - Between Good and Fair
Deficiency	No deficiencies recorded
Door(s)	Inspected
Condition	5 - Poor
Deficiency	WOOD: DETERIORATED DOOR
Deficiency Location/Instance	Room 112A, Boys - 2nd Floor, Girls - 2nd Floor,
Deficiency Quantity	3
Quantity Uom	EACH
Potential Action	MAINTENANCE
Urgency of Action	PRIORITY 3
Purpose of Action	LEVEL 2
Deficiency Photo1

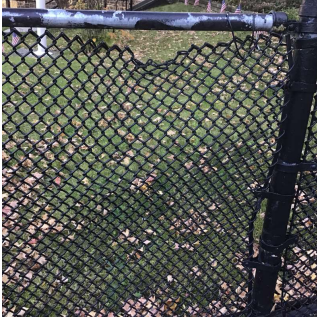
42nd Street
Violations	No violations recorded.
Deficiency	CHAIN LINK: DAMAGED/DETERIORATED
Deficiency Location/Instance	Near Exit 1, 42nd Street.
Deficiency Quantity	350
Quantity Uom	S.F.
Potential Action	REPLACE
Urgency of Action	PRIORITY 3
Purpose of Action	LEVEL 2
Deficiency Photo1

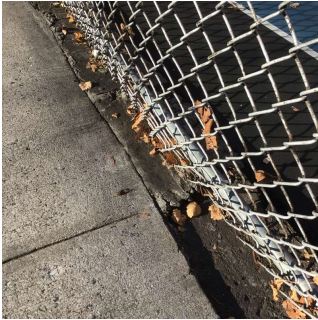
Near Exit 1
Violations	No violations recorded.
Deficiency	CONCRETE CURB: DAMAGED/DETERIORATED
Deficiency Location/Instance	42nd Street
Deficiency Quantity	50
Quantity Uom	S.F.
Potential Action	REPLACE
Urgency of Action	PRIORITY 3
Purpose of Action	LEVEL 2

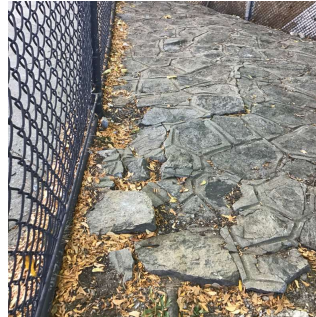
Near Exit 8

Deficiency

CRACKS - MAJOR

REPLACE

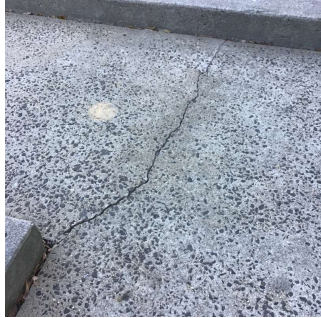
Near Exit 1
Violations	No violations recorded.
Pavers	Does not Exist
DOT Sidewalk	Inspected
Asphalt	Does not Exist
Concrete	Inspected
Condition	4 - Between Fair and Poor
Deficiency	HEAVING
Deficiency Location/Instance	42nd Street
Deficiency Quantity	50
Quantity Uom	S.F.
Potential Action	REPLACE
Urgency of Action	PRIORITY 5
Purpose of Action	LEVEL 6
Deficiency Photo1

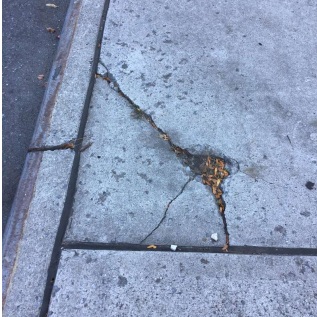
41st Street
Violations	No violations recorded.
Deficiency	DAMAGED CURBS
Deficiency Location/Instance	42nd Street
Deficiency Quantity	25
Quantity Uom	L.F.
Potential Action	REPLACE
Urgency of Action	PRIORITY 3
Purpose of Action	LEVEL 2
Deficiency Photo1

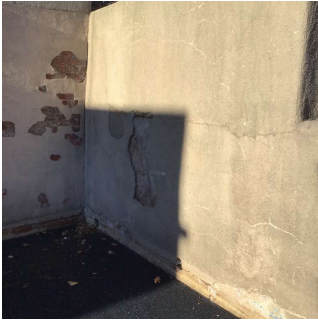
Violations	Near Playground North No violations recorded.
Deficiency	STONE: CRACKS/SPALLING - MAJOR
Deficiency Location/Instance	Near 41st Street, 42nd Street, Playground North, South, Exit 9
Deficiency Quantity	100
Quantity Uom	S.F.
Potential Action	REPLACE
Urgency of Action	PRIORITY 3
Purpose of Action	LEVEL 2
Deficiency Photo1

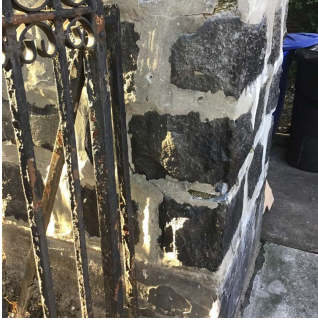
41st Street
Violations	No violations recorded.
STAIRS/RAMPS: EXTERIOR	
	Inspected
Railings	Inspected
Condition	2 - Between Good and Fair
Deficiency	No deficiencies recorded
Site Cheek/flank Walls	Inspected
Condition	2 - Between Good and Fair
Deficiency	CAST IN PLACE CONCRETE: CRACKS/SPALLING - MAJOR
Deficiency Location/Instance	Near Exit 2
Deficiency Quantity	10
Quantity Uom	S.F.
Potential Action	REPLACE
Urgency of Action	PRIORITY 3
Purpose of Action	LEVEL 2
Deficiency Photo1

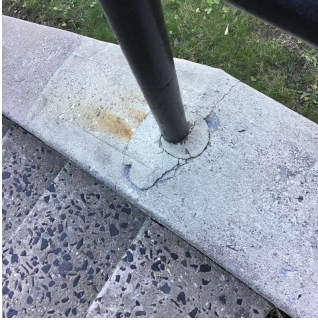
Near Exit 2
Violations	No violations recorded.
Stairs/ramps	Inspected
Condition	3 - Fair
Deficiency	CAST IN PLACE CONCRETE: CRACKS/SPALLING - MAJOR
Deficiency Location/Instance	Near Exits 2, 8, Playground South.
Deficiency Quantity	60
Quantity Uom	S.F.
Potential Action	REPLACE
Urgency of Action	PRIORITY 3
Purpose of Action	LEVEL 2
