**NYC Department of Education**  
**Building Condition Assessment Survey 2023 - 2024**

Architectural Inspection

**Asset:** P.S. 85 - QUEENS, 23-70 31 STREET, New York, 11105

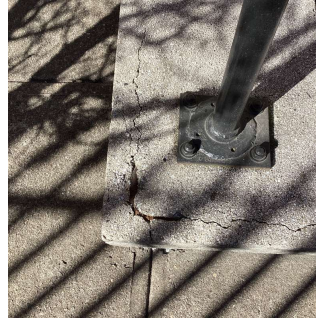
Facade A - AW6

Question	Response
<b>Architectural</b>	
<b>EXTERIOR</b>	Inspected
<b>AREAWAY</b>	Inspected
Instance on AW1-AW7	Inspected
Instance Condition	3 - Fair
Instance Quantity	7
Instance Quantity Uom	EACH
Deficiency	AREAWAY WALLS: CRACKS AND SPALLING
Roof Plan reference	Q085
Deficiency Quantity	20
Quantity Uom	S.F.
Potential Action	REPLACE
Urgency of Action	PRIORITY 4
Purpose of Action	LEVEL 2

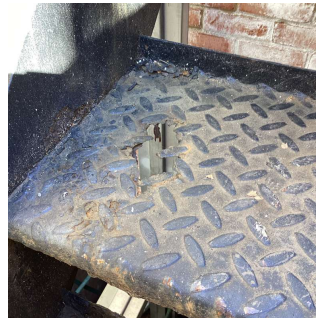
Facade A - AW7

AREAWAY STAIRS: DETERIORATED  
TREADS/RISERS/NOSINGS

10  
S.F.  
REPLACE  
PRIORITY 4  
LEVEL 2

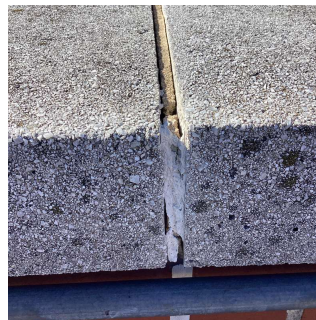
Roof 1

CAST STONE: DETERIORATED TRANSVERSE JOINTS

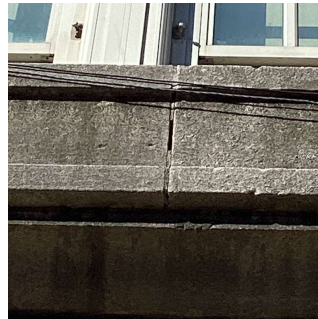
Facade A

STONE: DETERIORATED JOINTS

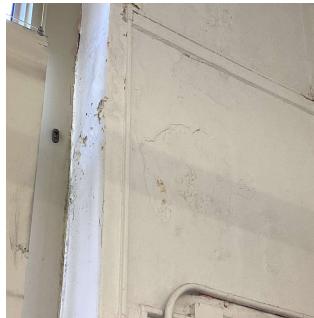
BRICK: WATER INFILTRATION IN INSTRUCTIONAL SPACE

Facade E - Room 304 (shown), Facade E - Room 306, Stair C/3,  
Facade A - Rooms 303, 307, 309, Facade L - Room 312 (similar)

REPAIR

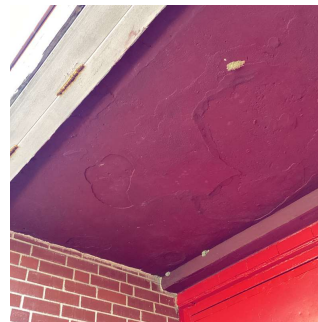
Facade G

Deficiency Quantity	30
Quantity Uom	S.F.
Potential Action	MAINTENANCE
Urgency of Action	PRIORITY 1
Purpose of Action	LEVEL 1
Deficiency Photo1	No photo recorded
Violations	No violations recorded.
<b>EXTERIOR SOFFITS</b>	
Condition	Inspected
Deficiency	2 - Between Good and Fair
	CONCRETE: MINOR CRACKS/SPALLING

REPAIR

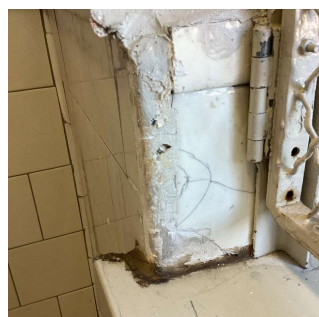
BULKHEAD/PENTHOUSE WALLS/INTERIOR: GLAZED BLOCK CRACKS/SPALLING

Question	Response
<b>EXTERIOR</b>	
<b>ROOF</b>	
<b>Specialties</b>	
<b>BULKHEAD/PENTHOUSE</b>	
Quantity Uom	S.F.
Potential Action	REPLACE
Urgency of Action	PRIORITY 3
Purpose of Action	LEVEL 2
Deficiency Photo1

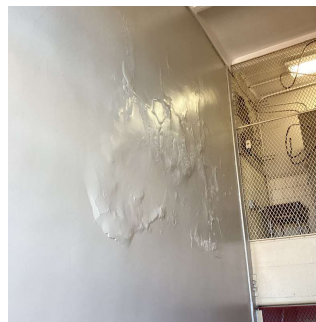
Violations	Roof 1 - Bulkhead 1 No violations recorded.
Deficiency	BULKHEAD/PENTHOUSE WALLS/EXTERIOR: WATER INFILTRATION

100  
 S.F.  
 REPAIR  
 PRIORITY 5  
 LEVEL 2

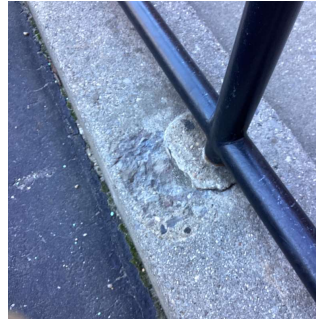
Facade E

CAST IN PLACE CONCRETE: CRACKS/SPALLING - MINOR

S.F.  
 REPAIR  
 PRIORITY 3  
 LEVEL 2

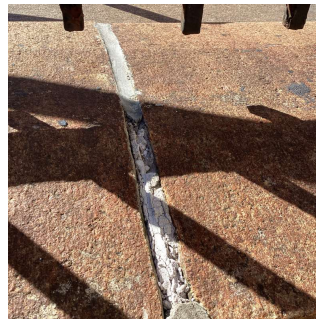
Facade A

STONE: DETERIORATED JOINTS AT COPING STONES

10  
 L.F.  
 MAINTENANCE  
 PRIORITY 3  
 LEVEL 2

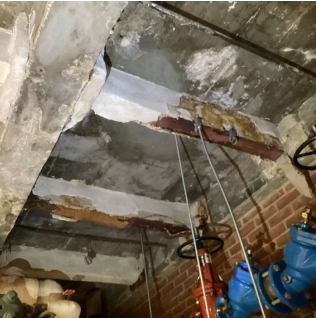
Deficiency Quantity	220
Quantity Uom	EACH
Potential Action	REPLACE BALANCES
Urgency of Action	PRIORITY 3
Purpose of Action	LEVEL 2
Deficiency Photo1	No photo recorded
Violations	No violations recorded.
<b>INTERIOR</b>	Inspected
<b>POOLS</b>	Does not Exist
<b>STRUCTURAL</b>	Inspected
<b>COLUMNS/BEAMS/BEARING WALLS</b>	Inspected
Condition	3 - Fair
Deficiency	STEEL COLUMNS/BEAMS: DETERIORATED CONCRETE FIREPROOFING
Deficiency Location/Instance	Sub-Basement - Boiler Room, Shop
Deficiency Quantity	30
Quantity Uom	S.F.
Potential Action	REPLACE
Urgency of Action	PRIORITY 3
Purpose of Action	LEVEL 5
Deficiency Photo1

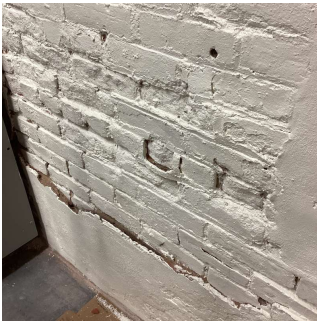
Question	Response
<b>INTERIOR</b>	
<b>STRUCTURAL</b>	
<b>FLOOR STRUCTURE</b>	
Deficiency Photo1	 
Violations	Sub-Basement - Shop No violations recorded.
<b>FOUNDATION WALLS</b>	
Material Type(s)	Inspected Concrete, Masonry
Condition	4 - Between Fair and Poor
Deficiency	BRICK: WATER INFILTRATION IN NON- INSTRUCTIONAL SPACE
Deficiency Location/Instance	Sub-Basement - Storage Area
Deficiency Quantity	100
Quantity Uom	S.F.
Potential Action	INSTALL WATERPROOFING
Urgency of Action	PRIORITY 5
Purpose of Action	LEVEL 5
Deficiency Photo1	 
Violations	Sub-Basement - Storage Area No violations recorded.
Deficiency	BRICK: CRACKED/SPALLED
Deficiency Location/Instance	Sub-Basement - Electrical Panel Room
Deficiency Quantity	30
Quantity Uom	S.F.
Potential Action	RESTITCH
Urgency of Action	PRIORITY 4
Purpose of Action	LEVEL 5

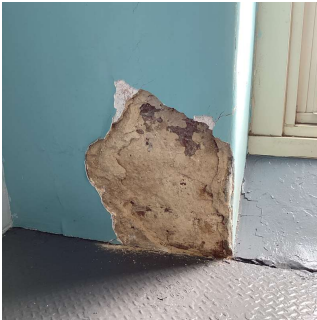
Sub-Basement - Electrical Panel Room
Violations	No violations recorded.
Deficiency	CONCRETE: WATER INFILTRATION IN NON- INSTRUCTIONAL SPACE
Deficiency Location/Instance	Sub-Basement - Staff Area
Deficiency Quantity	100
Quantity Uom	S.F.
Potential Action	INSTALL WATERPROOFING
Urgency of Action	PRIORITY 5
Purpose of Action	LEVEL 5
Deficiency Photo1

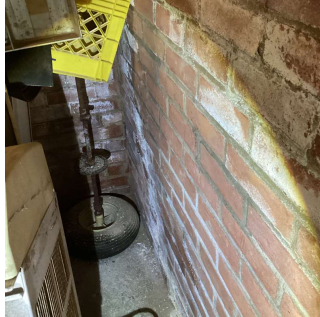
Sub-Basement - Staff Area
Violations	No violations recorded.
<b>ROOF STRUCTURE</b>	Inspected
Condition	2 - Between Good and Fair
Deficiency	No deficiencies recorded
<b>VAULTS-BUNKERS</b>	Inspected
<b>Foundation Walls</b>	Inspected
Condition	4 - Between Fair and Poor
Deficiency	WATER INFILTRATION IN NON- INSTRUCTIONAL SPACE
Deficiency Location/Instance	Sub-Basement - Vault
Deficiency Quantity	100
Quantity Uom	S.F.
Potential Action	INSTALL WATERPROOFING
Urgency of Action	PRIORITY 5

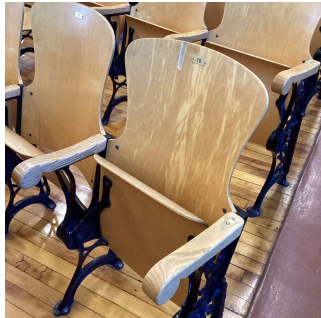
Violations	Sub-Basement - Vault No violations recorded.
<b>Slab Structure</b>	Inspected
Condition	2 - Between Good and Fair
Deficiency	No deficiencies recorded
<b>Vault/Ash Hoist Doors and Framing</b>	Does not Exist
<b>AUDITORIUM</b>	
Instance on 2nd Floor (395 Seats)	Inspected
<b>Ceiling</b>	
Instance on 2nd Floor (395 Seats)	Inspected
Condition	2 - Between Good and Fair
Deficiency	No deficiencies recorded
<b>Door(s)</b>	
Instance on 2nd Floor (395 Seats)	Inspected
Condition	2 - Between Good and Fair
Deficiency	No deficiencies recorded
<b>Fixed H/C Lift</b>	
Instance on 2nd Floor (395 Seats)	Does not Exist
<b>Fixed Seating</b>	
Instance on 2nd Floor (395 Seats)	Inspected
Condition	2 - Between Good and Fair
Deficiency	DAMAGED/BROKEN/INOPERABLE
Deficiency Location/Instance	Seat G/18
Deficiency Quantity	1

Quantity Uom	EACH
Potential Action	REPLACE
Urgency of Action	PRIORITY 3
Purpose of Action	LEVEL 2
Deficiency Photo1

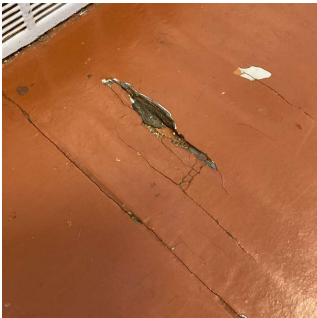
Question	Response
<b>INTERIOR</b>	
<b>AUDITORIUM</b>	
<b>Fixed Seating</b>	
	Seat G/18
Violations	No violations recorded.
<b>Floor Finish</b>	
Instance on 2nd Floor (395 Seats)	Inspected
Condition	2 - Between Good and Fair
Deficiency	SHEET VINYL: DETERIORATED SUBSTRATE
Deficiency Location/Instance	Near Seats A/15, Q/101, Windows
Deficiency Quantity	90
Quantity Uom	S.F.
Potential Action	REPLACE
Urgency of Action	PRIORITY 3
Purpose of Action	LEVEL 2
Deficiency Photo1

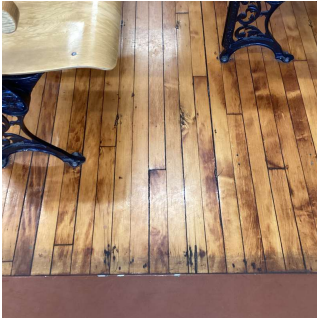
Near Seat C/107
Violations	No violations recorded.
<b>Sliding-folding Partition</b>	
Instance on 2nd Floor (395 Seats)	Does not Exist
<b>Stage</b>	
Instance on 2nd Floor (395 Seats)	Inspected

Near Windows
Violations	No violations recorded.
Deficiency	WOOD: DAMAGED/DETERIORATED
Deficiency Location/Instance	Near Seats C/107, F/101, N/102
Deficiency Quantity	60
Quantity Uom	S.F.
Potential Action	REPLACE
Urgency of Action	PRIORITY 3
Purpose of Action	LEVEL 2
Deficiency Photo1

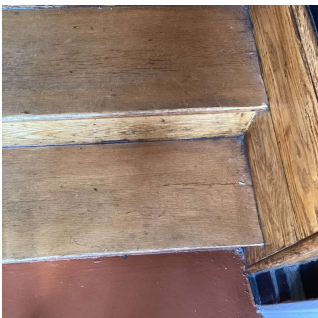
Question	Response
<b>INTERIOR</b>	
<b>AUDITORIUM</b>	
<b>Stage</b>	
<b>Stage</b>	
Instance on 2nd Floor (395 Seats)	Inspected
Condition	2 - Between Good and Fair
Deficiency	DAMAGED STEPS
Deficiency Location/Instance	Right and Left Side
Deficiency Quantity	10
Quantity Uom	S.F.
Potential Action	REPLACE
Urgency of Action	PRIORITY 3
Purpose of Action	LEVEL 2
Deficiency Photo1

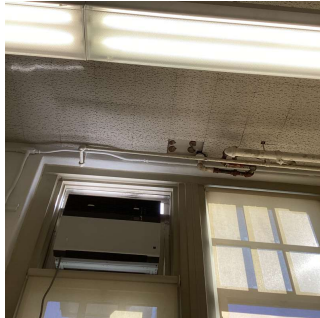
Room 109
Violations	No violations recorded.
Deficiency	PLASTER: CRACKS/SPALLING
Deficiency Location/Instance	Rooms 150, 310, 311
Deficiency Quantity	30
Quantity Uom	S.F.
Potential Action	REPLACE
Urgency of Action	PRIORITY 3
Purpose of Action	LEVEL 2

Room 212
Violations	No violations recorded.
Deficiency	ACOUSTIC TILES ON PLASTER: DAMAGED/MISSING
Deficiency Location/Instance	Room 109
Deficiency Quantity	10
Quantity Uom	S.F.
Potential Action	REPLACE
Urgency of Action	PRIORITY 3
Purpose of Action	LEVEL 2
Deficiency Photo1

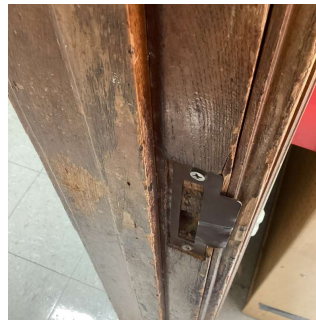
Room 109

WOOD: DETERIORATED DOOR AND FRAME

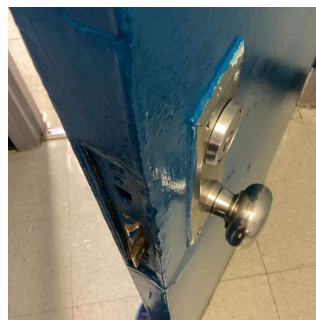
METAL CLAD WOOD: DETERIORATED DOOR

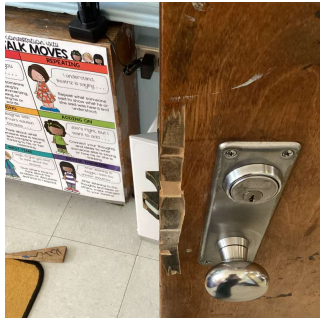
Question	Response
<b>INTERIOR</b>	
<b>CLASSROOMS/CORRIDORS/ADMIN SPACES</b>	
<b>Door(s)</b>	Inspected
	Room 202
Violations	No violations recorded.
Deficiency	WOOD: DETERIORATED DOOR
Deficiency Location/Instance	Rooms 209, 311
Deficiency Quantity	12
Quantity Uom	EACH
Potential Action	MAINTENANCE
Urgency of Action	PRIORITY 3
Purpose of Action	LEVEL 2
Deficiency Photo1

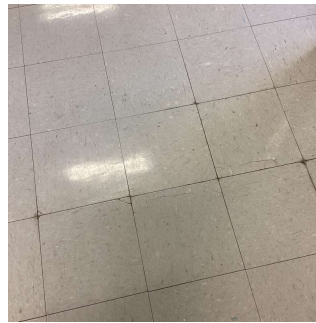
Corridor near Room 104

Room 312
Violations	No violations recorded.
Deficiency	VINYL TILES: BROKEN/DETERIORATED/MISSING TILES
Deficiency Location/Instance	Rooms 104, 304, 308, 309, Corridor near Room 104, and others.

Deficiency Quantity	600
Quantity Uom	S.F.
Potential Action	REPLACE
Urgency of Action	PRIORITY 3
Purpose of Action	LEVEL 2

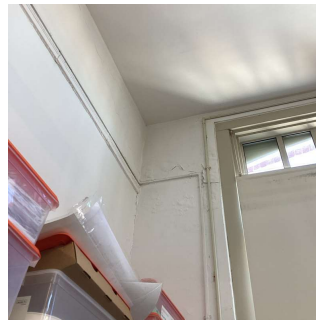
Room 311

PLASTER: CRACKS/SPALLING - ACTIVE LEAK

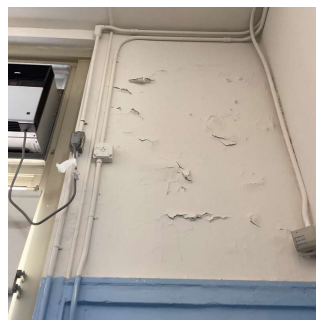
PLASTER: CRACKS/SPALLING - ACTIVE LEAK

Question	Response
<b>INTERIOR</b>	
<b>CLASSROOMS/CORRIDORS/ADMIN SPACES</b>	
<b>Walls</b>	
Violations	Room 312 35671727X
Deficiency	CERAMIC TILE: BROKEN/ MISSING
Deficiency Location/Instance	Exit 7, Corridor near Room 304
Deficiency Quantity	20
Quantity Uom	S.F.
Potential Action	REPLACE
Urgency of Action	PRIORITY 3
Purpose of Action	LEVEL 2
Deficiency Photo1	 
Violations	Exit 7 No violations recorded.
Deficiency	PLASTER: CRACKS/SPALLING
Deficiency Location/Instance	Rooms 106, 201, 212, Corridor near Rooms 203, 204, and others.
Deficiency Quantity	100
Quantity Uom	S.F.
Potential Action	REPLACE
Urgency of Action	PRIORITY 3
Purpose of Action	LEVEL 2
Deficiency Photo1	 
Violations	Room 201 No violations recorded.
<b>Specialties</b>	Does not Exist
<b>GYMNASIUM</b>	Inspected
Instance on Basement	Inspected
<b>Ceiling</b>	
Instance on Basement	Inspected
Condition	2 - Between Good and Fair
Deficiency	PLASTER: CRACKS/SPALLING
Deficiency Location/Instance	Near Storage Room

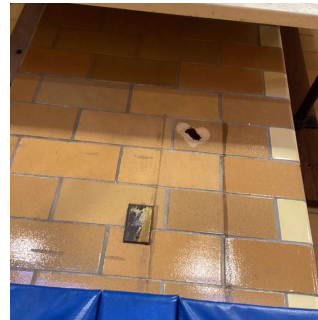
Near Windows

GLAZED BLOCK: CRACKS/SPALLING

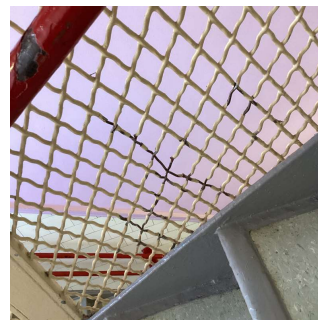
DETERIORATED/TORN-OUT/MISSING

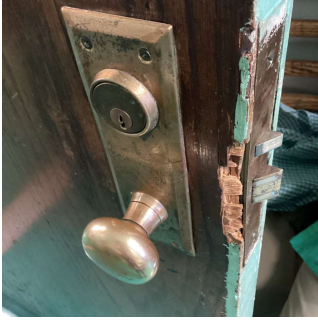
Question	Response
<b>INTERIOR</b>	
<b>INTERIOR GUARDS</b>	Inspected
	Stair B/1
Violations	No violations recorded.
<b>KITCHEN</b>	Inspected
Instance on Basement	Inspected
<b>Ceiling</b>	
Instance on Basement	Inspected
Condition	2 - Between Good and Fair
Deficiency	PLASTER: CRACKS/SPALLING
Deficiency Location/Instance	Locker Room - Cafeteria
Deficiency Quantity	30
Quantity Uom	S.F.
Potential Action	REPLACE
Urgency of Action	PRIORITY 3
Purpose of Action	LEVEL 2
Deficiency Photo1	No photo recorded
Violations	No violations recorded.
<b>Door(s)</b>	
Instance on Basement	Inspected
Condition	4 - Between Fair and Poor
Deficiency	WOOD: DETERIORATED DOOR
Deficiency Location/Instance	Locker Room - Cafeteria
Deficiency Quantity	1
Quantity Uom	EACH
Potential Action	MAINTENANCE
Urgency of Action	PRIORITY 3
Purpose of Action	LEVEL 2
Deficiency Photo1

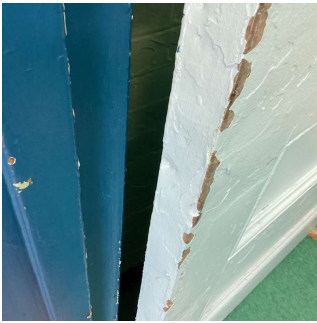
Locker Room - Cafeteria
Violations	No violations recorded.
Deficiency	METAL CLAD WOOD: DETERIORATED DOOR

Deficiency Location/Instance	Entrance
Deficiency Quantity	1
Quantity Uom	EACH
Potential Action	MAINTENANCE
Urgency of Action	PRIORITY 3
Purpose of Action	LEVEL 2

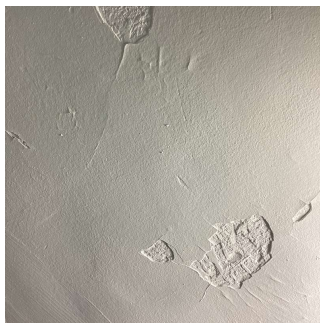
Question	Response
<b>INTERIOR</b>	
<b>KITCHEN</b>	
<b>Walls</b>	
Deficiency Photo1	 
Violations	Near Windows No violations recorded.
<b>LIBRARY</b>	Does not Exist
<b>LOCKER ROOM</b>	Does not Exist
<b>MULTI-PURPOSE ROOM</b>	Does not Exist
<b>SCIENCE DEMO ROOM</b>	Does not Exist
<b>SCIENCE LAB</b>	Does not Exist
<b>SCIENCE PREP ROOM</b>	Does not Exist
<b>SHOWER ROOM</b>	Does not Exist
<b>STAIRS/RAMPS: INTERIOR</b>	Inspected
Do Letter Stair Signs Exist?	Yes
<b>Ceiling</b>	Inspected
Condition	2 - Between Good and Fair
Deficiency	PLASTER: CRACKS/SPALLING
Deficiency Location/Instance	Stair D/2
Deficiency Quantity	10
Quantity Uom	S.F.
Potential Action	REPLACE
Urgency of Action	PRIORITY 3
Purpose of Action	LEVEL 2
Deficiency Photo1

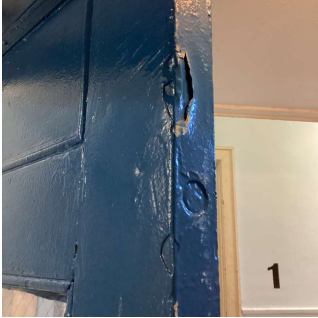
Stair A/1
Violations	No violations recorded.
Deficiency	WOOD: DETERIORATED DOOR
Deficiency Location/Instance	Stairs A/Basement, D/Basement
Deficiency Quantity	3
Quantity Uom	EACH
Potential Action	MAINTENANCE
Urgency of Action	PRIORITY 3
Purpose of Action	LEVEL 2
Deficiency Photo1

Violations	Stair D/2 No violations recorded.
<b>Door(s)</b>	Inspected
Condition	5 - Poor
Deficiency	METAL CLAD WOOD: DETERIORATED DOOR
Deficiency Location/Instance	Stairs A/1, 2, B/1, C/2, D/2, and others.

Question	Response
<b>INTERIOR</b>	
<b>STAIRS/RAMPS: INTERIOR</b>	
<b>Door(s)</b>	
Potential Action	MAINTENANCE
Urgency of Action	PRIORITY 3
Purpose of Action	LEVEL 2
Deficiency Photo1

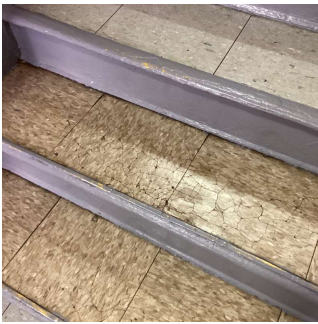
Question	Response
<b>INTERIOR</b>	
<b>STAIRS/RAMPS: INTERIOR</b>	
<b>Stairs and Landings</b>	
Deficiency Photo1	 
Violations	Stair C/Basement No violations recorded.
Deficiency	VINYL TILES: BROKEN/DETERIORATED/MISSING TILES
Deficiency Location/Instance	Stairs A/1, B/Basement, C/Basement, 1, D/Basement-vestibule Exits 6, and others.
Deficiency Quantity	400
Quantity Uom	S.F.
Potential Action	REPLACE
Urgency of Action	PRIORITY 3
Purpose of Action	LEVEL 2
Deficiency Photo1

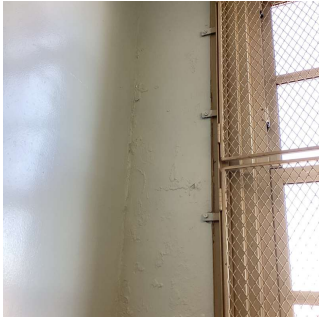
Question	Response
<b>INTERIOR</b>	
<b>STAIRS/RAMPS: INTERIOR</b>	
<b>Walls</b>	
Purpose of Action	LEVEL 2
Deficiency Photo1	 
Violations	Stair D- Vestibule Exit 6
Violations	No violations recorded.
Deficiency	PLASTER: CRACKS/SPALLING - ACTIVE LEAK
Deficiency Location/Instance	Stairs A/Basement, 3
Deficiency Quantity	30
Quantity Uom	S.F.
Potential Action	REPLACE
Urgency of Action	PRIORITY 5
Purpose of Action	LEVEL 2
Deficiency Photo1

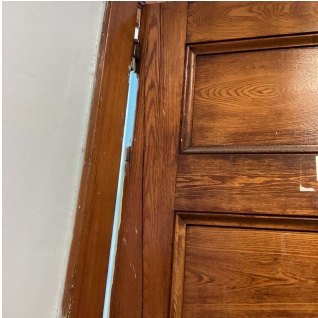
Question	Response
<b>INTERIOR</b>	
<b>STAIRS/RAMPS: INTERIOR</b>	Inspected
<b>Walls</b>	Inspected
Violations	No violations recorded.
<b>TOILET ROOMS - STAFF</b>	Inspected
<b>Ceiling</b>	Inspected
Condition	2 - Between Good and Fair
Deficiency	No deficiencies recorded
<b>Door(s)</b>	Inspected
Condition	5 - Poor
Deficiency	WOOD: DETERIORATED DOOR
Deficiency Location/Instance	Staff - 2nd Floor , Staff - 3rd Floor, inside Principal Office, Staff - Inside General Office
Deficiency Quantity	3
Quantity Uom	EACH
Potential Action	MAINTENANCE
Urgency of Action	PRIORITY 3
Purpose of Action	LEVEL 2
Deficiency Photo1

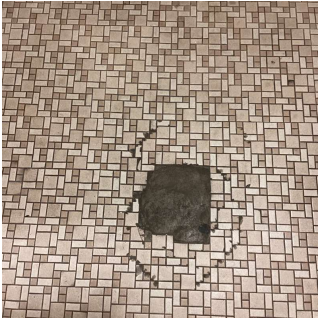
Violations	Staff - 2nd Floor No violations recorded.
<b>Floor Finish</b>	Inspected
Condition	3 - Fair
Deficiency	CERAMIC TILE: BROKEN/MISSING TILES
Deficiency Location/Instance	Room 161A
Deficiency Quantity	20
Quantity Uom	S.F.
Potential Action	REPLACE
Urgency of Action	PRIORITY 3
Purpose of Action	LEVEL 2
Deficiency Photo1

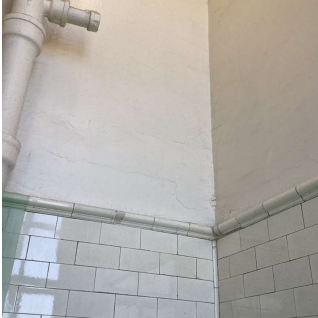
Question	Response
<b>INTERIOR</b>	
<b>TOILET ROOMS - STAFF</b>	Inspected
<b>Walls</b>	Inspected
Condition	2 - Between Good and Fair
Deficiency	PLASTER: CRACKS/SPALLING
Deficiency Location/Instance	Room 112B, Staff - 2nd Floor, Staff - 3rd Floor, Kitchen - Cafeteria
Deficiency Quantity	40
Quantity Uom	S.F.
Potential Action	REPLACE
Urgency of Action	PRIORITY 3
Purpose of Action	LEVEL 2
Deficiency Photo1

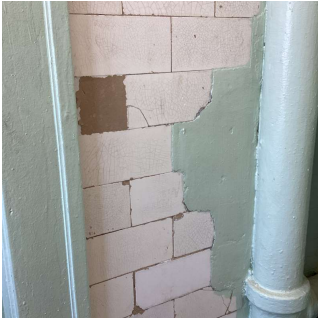
Staff - 3rd Floor
Violations	No violations recorded.
Deficiency	CERAMIC TILE: BROKEN/ MISSING
Deficiency Location/Instance	Staff - 3rd Floor
Deficiency Quantity	10
Quantity Uom	S.F.
Potential Action	REPLACE
Urgency of Action	PRIORITY 3
Purpose of Action	LEVEL 2
Deficiency Photo1

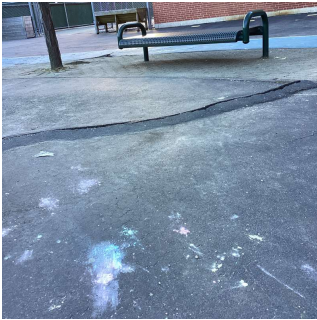
Question	Response
<b>SITE</b>	
<b>FENCES</b>	
Deficiency Photo1	 
Violations	Near Exit 3 No violations recorded.
<b>IRRIGATION SYSTEM</b>	Does not Exist
<b>PAVING</b>	Inspected
<b>Student Non-Use</b>	Inspected
Gravel Exists?	No
<b>Asphalt</b>	Does not Exist
<b>Concrete</b>	Inspected
Condition	2 - Between Good and Fair
Deficiency	No deficiencies recorded
<b>Pavers</b>	Does not Exist
<b>Student Use</b>	Inspected
Gravel Exists?	No
<b>Asphalt</b>	Inspected
Condition	4 - Between Fair and Poor
Deficiency	CRACKS - MAJOR
Deficiency Location/Instance	Near center
Deficiency Quantity	40
Quantity Uom	S.F.
Potential Action	REPLACE
Urgency of Action	PRIORITY 5
Purpose of Action	LEVEL 6
Deficiency Photo1

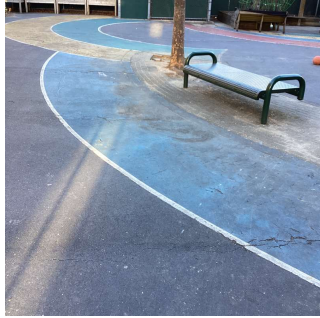
Violations	Near center No violations recorded.
Deficiency	CRACKS - MAJOR
Deficiency Location/Instance	Near Entrance, Exits 3, 4
Deficiency Quantity	4,000
Quantity Uom	S.F.
Potential Action	REPLACE

Question	Response
<b>SITE</b>	
<b>PAVING</b>	
<b>Student Use</b>	
<b>Asphalt</b>	
Urgency of Action	PRIORITY 3
Purpose of Action	LEVEL 2
Deficiency Photo1

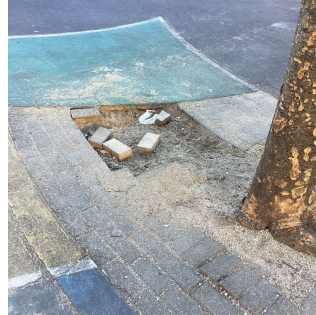
Violations	Near Entrance No violations recorded.
Deficiency	DAMAGED/MISSING
Deficiency Location/Instance	Near Entrance
Deficiency Quantity	10
Quantity Uom	S.F.
Potential Action	REPLACE
Urgency of Action	PRIORITY 5
Purpose of Action	LEVEL 6

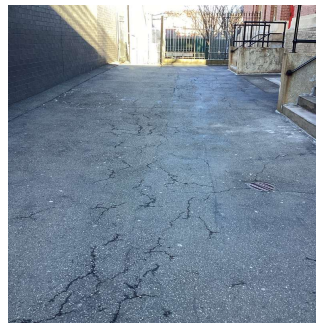
Near Exit 6

CRACKS - MAJOR

REPLACE

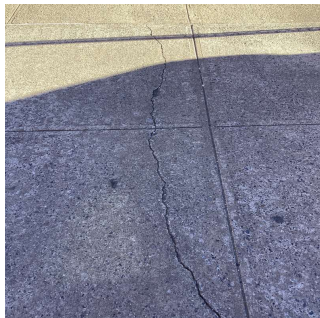
Question	Response
<b>SITE</b>	
<b>PAVING</b>	
<b>Site Sidewalks &amp; Walkways</b>	
<b>Concrete</b>	
Deficiency Photo1	 
	31st Street
Violations	No violations recorded.
<b>Pavers</b>	Does not Exist
<b>DOT Sidewalk</b>	Inspected
<b>Asphalt</b>	Does not Exist
<b>Concrete</b>	Inspected
Condition	3 - Fair
Deficiency	DAMAGED/DETERIORATED/MISSING SECTIONS
Deficiency Location/Instance	31st Street
Deficiency Quantity	250
Quantity Uom	S.F.
Potential Action	REPLACE
Urgency of Action	PRIORITY 3
Purpose of Action	LEVEL 2
Deficiency Photo1

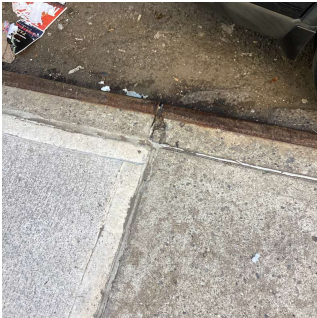
31st Street
Violations	No violations recorded.
Deficiency	DAMAGED CURBS
Deficiency Location/Instance	31st Street
Deficiency Quantity	10
Quantity Uom	L.F.
Potential Action	REPLACE
Urgency of Action	PRIORITY 3
Purpose of Action	LEVEL 2

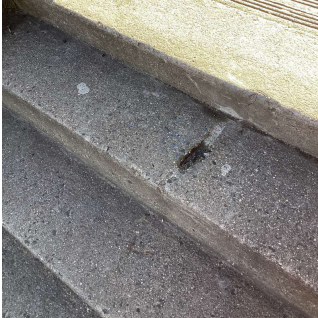
Question	Response
<b>SITE</b>	
<b>STAIRS/RAMPS: EXTERIOR</b>	
<b>Stairs/ramps</b>	
Deficiency	CAST IN PLACE CONCRETE: CRACKS/SPALLING - MAJOR
Deficiency Location/Instance	Near Exit 5
Deficiency Quantity	10
Quantity Uom	S.F.
Potential Action	REPLACE
Urgency of Action	PRIORITY 3
Purpose of Action	LEVEL 2
Deficiency Photo1
