**NYC Department of Education**  
**Building Condition Assessment Survey 2023 - 2024**

Architectural Inspection

**Asset:** P.S. 87 - QUEENS, 67-54 80 STREET, New York, 11379

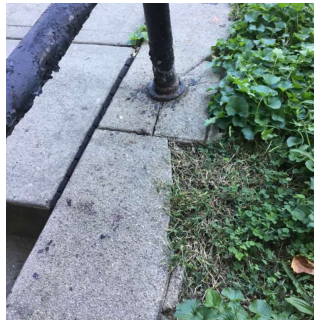
AW1  
 No violations recorded.

**AREAWAY WALLS: CRACKS AND SPALLING**

20  
 S.F.  
 REPLACE  
 PRIORITY 4  
 LEVEL 2

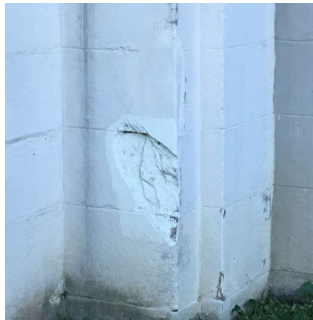
Facade B

STONE: CHIPPED/SPALLED/BROKEN PIECES - MAJOR

REPLACE

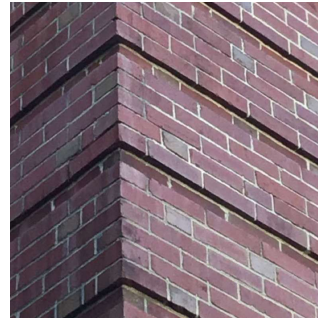
Facade A

**BRICK: DETERIORATED JOINTS**

PRIORITY 3  
LEVEL 2

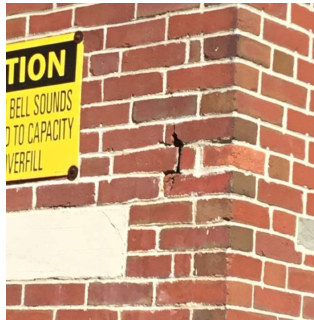
Facade F

**BRICK: MAJOR / THRU CRACKS**

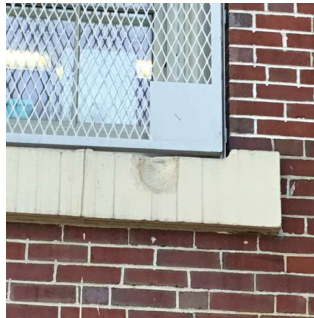
Facade F

**BRICK: DETERIORATED MASONRY SILLS - MAJOR**

REMOVE AND REPLACE

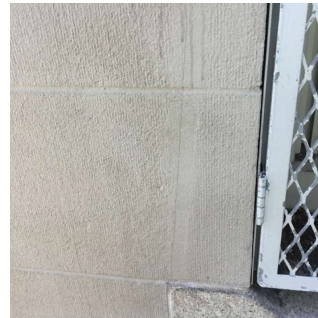
Facade B

**STONE: CHIPPED/SPALLED/BROKEN PIECES - MINOR**

REPAIR

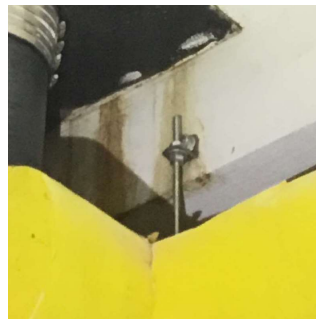
Roof 12 - Gas Meter Room, Sub-Basement Corridor, Boiler Room  
No violations recorded.

Deficiency	CONCRETE: MAJOR ACTIVE PLAZA DECK LEAKS IN NON-INSTRUCTIONAL SPACE
------------	--

Deficiency Quantity	300
Quantity Uom	S.F.
Potential Action	REPLACE
Urgency of Action	PRIORITY 5
Purpose of Action	LEVEL 2
Deficiency Photo1

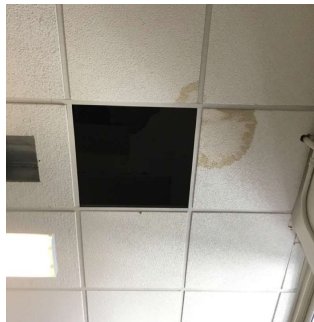
Roof 3 - Room 316

Deficiency	IRMA: ROOFING: MAJOR ACTIVE ROOF LEAKS IN INSTRUCTIONAL SPACE
------------	---

Deficiency Quantity	100
Quantity Uom	S.F.

Potential Action	REPLACE ROOFING WITHOUT MAJOR EQUIPMENT REMOVAL
------------------	---

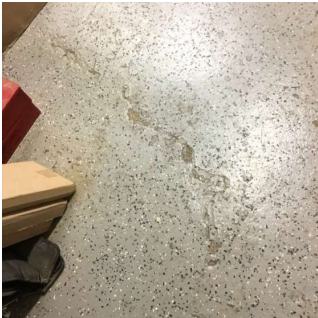
Question	Response
<b>INTERIOR</b>	
<b>STRUCTURAL</b>	
<b>FLOOR STRUCTURE</b>	
Violations	Boiler Room No violations recorded.
Deficiency	CONCRETE: CRACKS/SPALLED/REINFORCEMENT EXPOSED
Deficiency Location/Instance	Basement - Custodian Shop
Deficiency Quantity	25
Quantity Uom	S.F.
Potential Action	REPAIR
Urgency of Action	PRIORITY 3
Purpose of Action	LEVEL 5
Deficiency Photo1

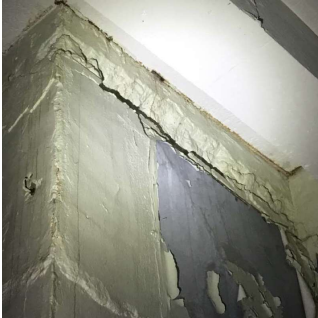
Violations	Custodian Shop No violations recorded.
<b>FOUNDATION WALLS</b>	
Material Type(s)	Inspected Concrete, Masonry
Condition	4 - Between Fair and Poor
Deficiency	CONCRETE: CRACKED/SPALLED/REINFORCEMENT EXPOSED
Deficiency Location/Instance	SubBasement - Storage Area
Deficiency Quantity	40
Quantity Uom	S.F.
Potential Action	REPAIR
Urgency of Action	PRIORITY 4
Purpose of Action	LEVEL 5
Deficiency Photo1

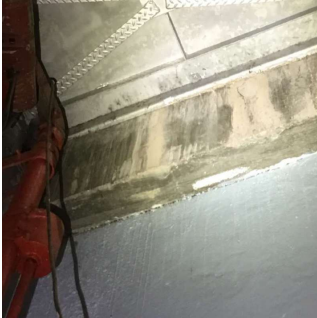
Deficiency	<b>WATER INFILTRATION</b>
Deficiency Location/Instance	Vault
Deficiency Quantity	10
Quantity Uom	S.F.

Question	Response
<b>INTERIOR</b>	
<b>STRUCTURAL</b>	
<b>VAULTS-BUNKERS</b>	
<b>Vault/Ash Hoist Doors and Framing</b>	
Potential Action	REPAIR
Urgency of Action	PRIORITY 5
Purpose of Action	LEVEL 2
Deficiency Photo1

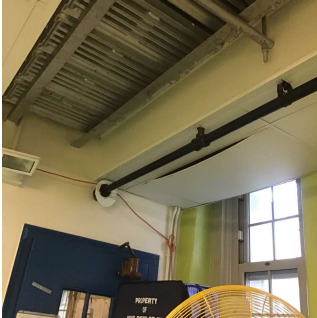
Violations	Vault No violations recorded.
<b>AUDITORIUM</b>	Does not Exist
<b>CAFETERIA</b>	Inspected
Instance on Basement (1000Sf)	Inspected
<b>Ceiling</b>	
Instance on Basement (1000Sf)	Inspected
Condition	2 - Between Good and Fair
Deficiency	ACOUSTIC TILES: DAMAGED/MISSING
Deficiency Location/Instance	Near Serving Area
Deficiency Quantity	10
Quantity Uom	S.F.
Potential Action	REPLACE
Urgency of Action	PRIORITY 3
Purpose of Action	LEVEL 2
Deficiency Photo1

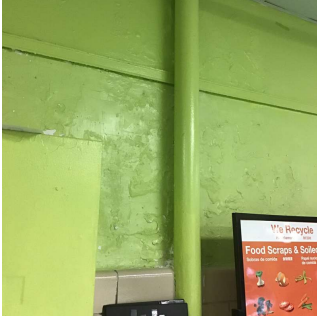
Question	Response
<b>INTERIOR</b>	
<b>CAFETERIA</b>	
<b>Door(s)</b>	
Urgency of Action	PRIORITY 3
Purpose of Action	LEVEL 2
Deficiency Photo1	 
	Near Kitchen
Violations	No violations recorded.
<b>Fixed Equipment</b>	
Instance on Basement (1000Sf)	Does not Exist
<b>Floor Finish</b>	
Instance on Basement (1000Sf)	Inspected
Condition	4 - Between Fair and Poor
Deficiency	VINYL TILES: BROKEN/DETERIORATED/MISSING TILES
Deficiency Location/Instance	Near Windows, Entrances, Center.
Deficiency Quantity	100
Quantity Uom	S.F.
Potential Action	REPLACE
Urgency of Action	PRIORITY 3
Purpose of Action	LEVEL 2
Deficiency Photo1	 
	Near Windows
Violations	No violations recorded.
<b>Sliding-folding Partition</b>	
Instance on Basement (1000Sf)	Does not Exist
<b>Stage</b>	
Instance on Basement (1000Sf)	Does not Exist
<b>Walls</b>	
Instance on Basement (1000Sf)	Inspected
Condition	3 - Fair
Deficiency	PLASTER: CRACKS/SPALLING - ACTIVE LEAK
Deficiency Location/Instance	Near Windows

Deficiency Quantity	40
Quantity Uom	S.F.

Question	Response
<b>INTERIOR</b>	
<b>CAFETERIA</b>	
<b>Walls</b>	
Potential Action	REPLACE
Urgency of Action	PRIORITY 5
Purpose of Action	LEVEL 2
Deficiency Photo1

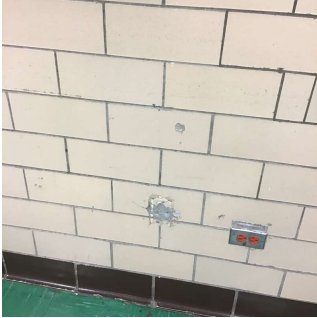
Near Windows
Violations	No violations recorded.
Deficiency	GLAZED BLOCK: CRACKS/SPALLING
Deficiency Location/Instance	Near Serving Area
Deficiency Quantity	10
Quantity Uom	S.F.
Potential Action	REPLACE
Urgency of Action	PRIORITY 3
Purpose of Action	LEVEL 2
Deficiency Photo1

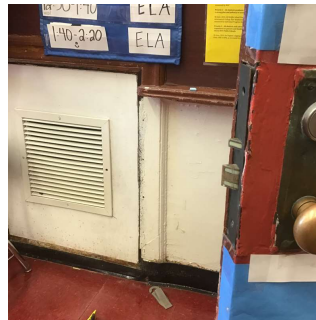
Room 311

METAL CLAD WOOD: DETERIORATED DOOR

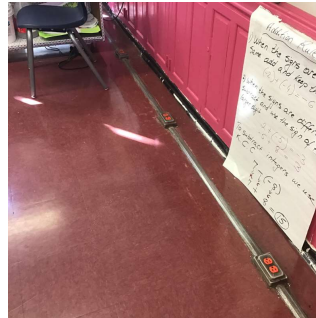
Room 303

VINYL TILES: TRIPPING HAZARD - ELECTRICAL OUTLET

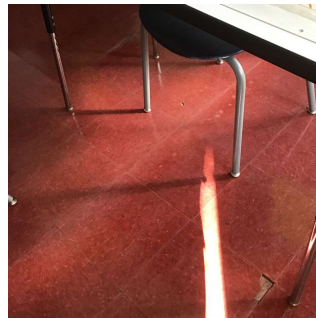
Room 310

VINYL TILES: BROKEN/DETERIORATED/MISSING TILES

REPLACE

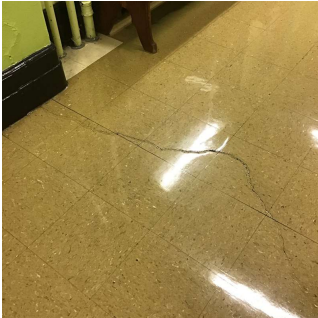
Question	Response
<b>INTERIOR</b>	
<b>CLASSROOMS/CORRIDORS/ADMIN SPACES</b>	
<b>Floor Finish</b>	
Deficiency	VINYL TILES: DETERIORATED SUBSTRATE
Deficiency Location/Instance	Rooms 121, 311, Corridor near Room 102, 108, 204, and others.
Deficiency Quantity	550
Quantity Uom	S.F.
Potential Action	REPLACE
Urgency of Action	PRIORITY 3
Purpose of Action	LEVEL 2
Deficiency Photo1

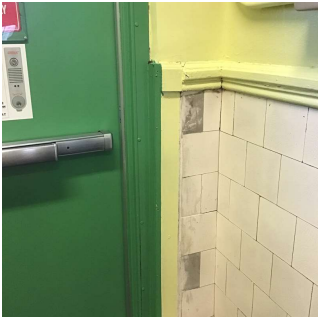
Corridor near Room 108
Violations	No violations recorded.
<b>Walls</b>	
Condition	Inspected
Condition	2 - Between Good and Fair
Deficiency	CERAMIC TILE: BROKEN/ MISSING
Deficiency Location/Instance	Vestibule Exit 7/8
Deficiency Quantity	10
Quantity Uom	S.F.
Potential Action	REPLACE
Urgency of Action	PRIORITY 3
Purpose of Action	LEVEL 2
Deficiency Photo1

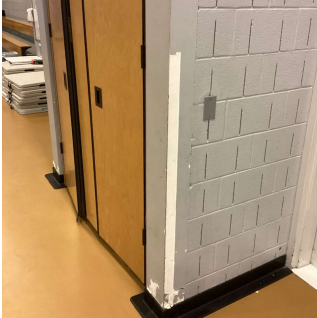
Question	Response
<b>INTERIOR</b>	
<b>GYMNASIUM</b>	
<b>Seating</b>	
Instance on Basement	Inspected
Condition	2 - Between Good and Fair
Deficiency	No deficiencies recorded
<b>Sliding-folding Partition</b>	
Instance on Basement	Inspected
Condition	2 - Between Good and Fair
Deficiency	No deficiencies recorded
<b>Stage</b>	
Instance on Basement	Does not Exist
<b>Walls</b>	
Instance on Basement	Inspected
Condition	2 - Between Good and Fair
Deficiency	GYP SUM BOARD: DETERIORATED
Deficiency Location/Instance	Near Sliding Folding Partition Enclosure
Deficiency Quantity	10
Quantity Uom	S.F.
Potential Action	REPLACE
Urgency of Action	PRIORITY 3
Purpose of Action	LEVEL 2
Deficiency Photo1

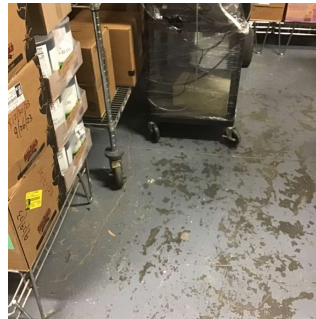
Condition	4 - Between Fair and Poor
-----------	---------------------------

Deficiency CONCRETE: CRACKS

Deficiency Location/Instance Room B8

Potential Action REPLACE

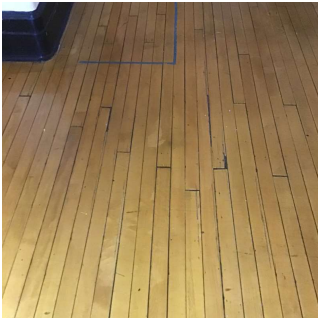
Question	Response
<b>INTERIOR</b>	
<b>MULTI-PURPOSE ROOM</b>	
<b>Floor Finish</b>	
Deficiency Quantity	500
Quantity Uom	S.F.
Potential Action	REPLACE
Urgency of Action	PRIORITY 3
Purpose of Action	LEVEL 2
Deficiency Photo1

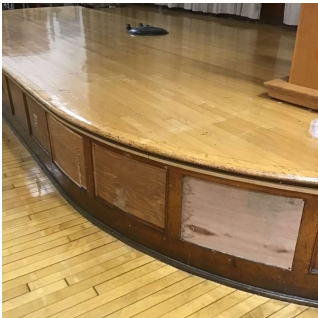
Main entrance near Stair EF
Violations	No violations recorded.
<b>Sliding-folding Partition</b>	
Instance on 3rd Floor	Does not Exist
<b>Stage</b>	
Instance on 3rd Floor	Inspected
<b>Stage</b>	Inspected
Instance on 3rd Floor	Inspected
Condition	2 - Between Good and Fair
Deficiency	DAMAGED FASCIA
Deficiency Location/Instance	Left Side
Deficiency Quantity	10
Quantity Uom	S.F.
Potential Action	REPLACE
Urgency of Action	PRIORITY 3
Purpose of Action	LEVEL 2
Deficiency Photo1

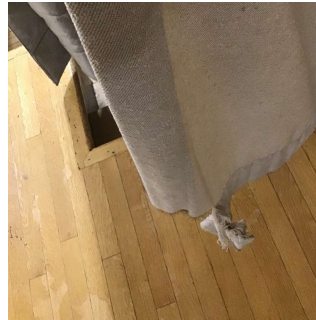
Instance on 3rd Floor	Inspected
Condition	3 - Fair
Deficiency	WORN/DETERIORATED
Deficiency Location/Instance	Back Curtain Right Side
Deficiency Quantity	100
Quantity Uom	S.F.
Potential Action	REPLACE
Urgency of Action	PRIORITY 3
Purpose of Action	LEVEL 2
Deficiency Photo1

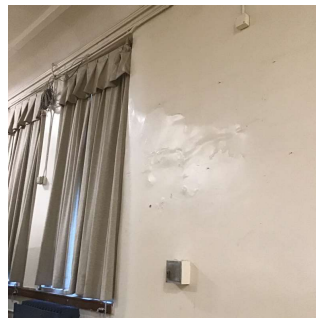
Instance on 3rd Floor	Inspected
Condition	2 - Between Good and Fair
Deficiency	PLASTER: CRACKS/SPALLING - ACTIVE LEAK
Deficiency Location/Instance	Near Windows close to Stair EF
Deficiency Quantity	30
Quantity Uom	S.F.
Potential Action	REPLACE
Urgency of Action	PRIORITY 5
Purpose of Action	LEVEL 2
Deficiency Photo1

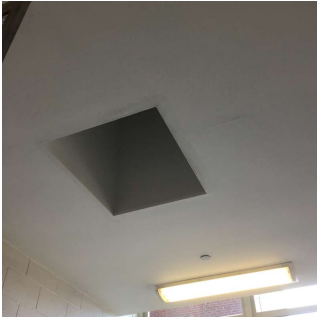
Question	Response
<b>INTERIOR</b>	
<b>MULTI-PURPOSE ROOM</b>	
<b>Walls</b>	
Violations	Near Windows close to Stair EF No violations recorded.
<b>Window Curtains/Shades/Blinds</b>	
Instance on 3rd Floor	Inspected
Condition	2 - Between Good and Fair
Deficiency	No deficiencies recorded
<b>SCIENCE DEMO ROOM</b>	
Does not Exist	
<b>SCIENCE LAB</b>	
Inspected	
Instance on Room 315	Inspected
Alternative use	No
<b>Fixed Equipment</b>	
Instance on Room 315	Inspected
Condition	2 - Between Good and Fair
Deficiency	No deficiencies recorded
<b>SCIENCE PREP ROOM</b>	
Inspected	
Instance on Room 316	Inspected
Alternative use	No
<b>Fixed Equipment</b>	
Instance on Room 316	Inspected
Condition	2 - Between Good and Fair
Deficiency	No deficiencies recorded
<b>SHOWER ROOM</b>	
Does not Exist	
<b>STAIRS/RAMPS: INTERIOR</b>	
Inspected	
Do Letter Stair Signs Exist?	Partially
<b>Ceiling</b>	
Condition	2 - Between Good and Fair
Deficiency	GYPSON BOARD: DAMAGED/DETERIORATED

Deficiency Location/Instance	Stair J/Basement, 1
Deficiency Quantity	20
Quantity Uom	S.F.
Potential Action	REPLACE
Urgency of Action	PRIORITY 3
Purpose of Action	LEVEL 2
Deficiency Photo1

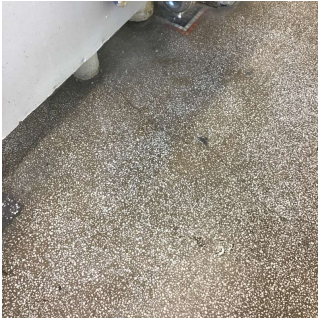
Question	Response
<b>INTERIOR</b>	
<b>TOILET ROOMS - STAFF</b>	
<b>Door(s)</b>	Inspected
	Room 306
Violations	No violations recorded.
<b>Floor Finish</b>	Inspected
Condition	5 - Poor
Deficiency	TERRAZZO: CRACKS
Deficiency Location/Instance	Rooms 206, 215, 306, 314, 314
Deficiency Quantity	70
Quantity Uom	S.F.
Potential Action	REPLACE
Urgency of Action	PRIORITY 3
Purpose of Action	LEVEL 2
Deficiency Photo1

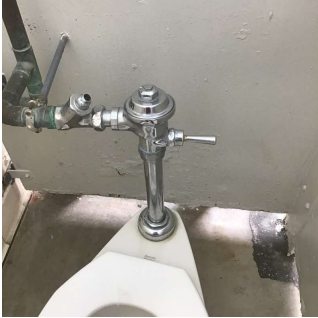
Room 314
Violations	No violations recorded.
<b>Stalls</b>	Inspected
Condition	5 - Poor
Deficiency	RUST - MAJOR
Deficiency Location/Instance	Rooms 306, 314
Deficiency Quantity	2
Quantity Uom	EACH
Potential Action	REPLACE
Urgency of Action	PRIORITY 3
Purpose of Action	LEVEL 2
Deficiency Photo1

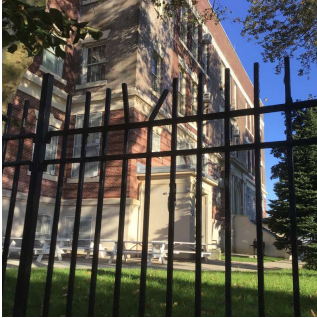
Question	Response
<b>SITE</b>	
<b>Drainage System for Soil</b>	Inspected
<b>Catch Basins/Manhole - Surrounded by Soil</b>	Inspected
Condition	2 - Between Good and Fair
Deficiency	No deficiencies recorded
<b>Culverts - Soil Covering</b>	Does not Exist
<b>DRINKING FOUNTAINS</b>	Does not Exist
<b>FENCES</b>	Inspected
Condition	4 - Between Fair and Poor
Deficiency	WROUGHT IRON: DAMAGED/DETERIORATED
Deficiency Location/Instance	68 Avenue, 80th Avenue.
Deficiency Quantity	280
Quantity Uom	S.F.
Potential Action	REPLACE
Urgency of Action	PRIORITY 3
Purpose of Action	LEVEL 2
Deficiency Photo1

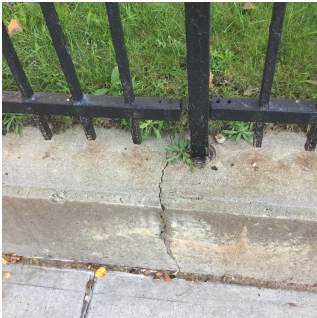
Violations	68 Avenue No violations recorded.
Deficiency	CONCRETE CURB: DAMAGED/DETERIORATED
Deficiency Location/Instance	67th Drive, 68th Avenue, 80th Street, schoolyard.
Deficiency Quantity	220
Quantity Uom	S.F.
Potential Action	REPLACE
Urgency of Action	PRIORITY 3
Purpose of Action	LEVEL 2
Deficiency Photo1

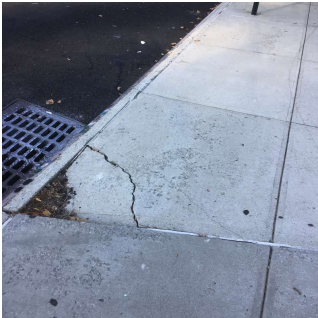
Violations	Near Exit 5 No violations recorded.
<b>Pavers</b>	Does not Exist
<b>DOT Sidewalk</b>	Inspected
<b>Asphalt</b>	Does not Exist
<b>Concrete</b>	Inspected
Condition	3 - Fair
Deficiency	DAMAGED/DETERIORATED/MISSING SECTIONS
Deficiency Location/Instance	67th Drive, 68th Avenue, 80th Street.
Deficiency Quantity	300
Quantity Uom	S.F.
Potential Action	REPLACE
Urgency of Action	PRIORITY 3
Purpose of Action	LEVEL 2
Deficiency Photo1

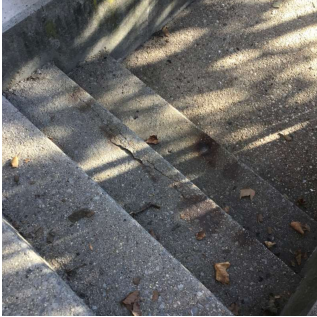
Question	Response
<b>SITE</b>	
<b>STAIRS/RAMPS: EXTERIOR</b>	
<b>Railings</b>	
Purpose of Action	LEVEL 6
Deficiency Photo1

Stair 80th Street
Violations	No violations recorded.
<b>Site Cheek/flank Walls</b>	
Condition	Inspected
Deficiency	2 - Between Good and Fair
	No deficiencies recorded
<b>Stairs/ramps</b>	
Condition	Inspected
Deficiency	2 - Between Good and Fair
Deficiency Location/Instance	STONE: CRACKS/SPALLING 67 Drive lateral Stair near Exit 10, 68 Avenue Lateral Stair Near Exit 5.
Deficiency Quantity	20
Quantity Uom	S.F.
Potential Action	REPLACE
Urgency of Action	PRIORITY 3
Purpose of Action	LEVEL 2
Deficiency Photo1

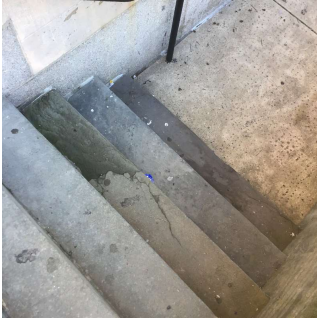
67 Drive lateral Stair near Exit 10
Violations	No violations recorded.
Deficiency	CAST IN PLACE CONCRETE: CRACKS/SPALLING - MAJOR
Deficiency Location/Instance	Near Entrance to exit 5 and 10
Deficiency Quantity	20
Quantity Uom	S.F.
Potential Action	REPLACE
Urgency of Action	PRIORITY 3
