NYC Department of Education
Building Condition Assessment Survey 2023 - 2024

Architectural Inspection

Asset: P.S. 88 - QUEENS, 60-85 CATALPA AVENUE, New York, 11385

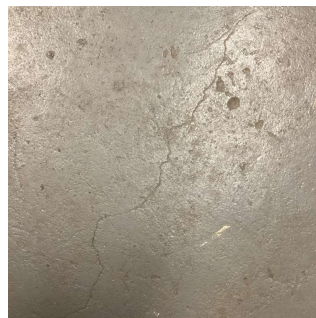
Ground Floor - Water Main

CONCRETE: CRACKS/SPALLED/REINFORCEMENT EXPOSED

REPAIR
