NYC Department of Education
Building Condition Assessment Survey 2023 - 2024

Architectural Inspection

Q093

Asset: I.S. 93 - QUEENS, 66-56 FOREST AVENUE, New York, 11385

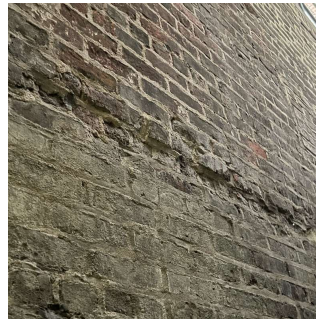
AW1

AREAWAY WALLS: CRACKS AND SPALLING

REPLACE

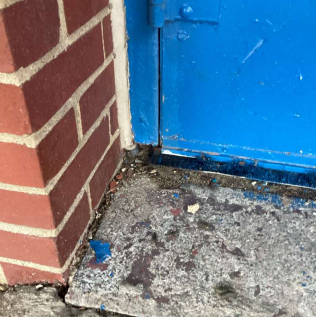
Question	Response
EXTERIOR	
CHIMNEY	Inspected
Material Type(s)	Masonry
Condition	2 - Between Good and Fair
Deficiency	No deficiencies recorded
COPING	Under Construction
CORNICE	Inspected
Condition	2 - Between Good and Fair
Deficiency	No deficiencies recorded
DOORS	Inspected
DOORS AND FRAMES	Inspected
Condition	3 - Fair
Deficiency	METAL CLAD: DETERIORATED DOOR AND FRAME - MAJOR DETERIORATION
Roof Plan reference	<p>Q093</p>

<p>Facade G</p> <p>No violations recorded.</p>
Deficiency Quantity	1
Quantity Uom	EACH
Potential Action	REPLACE
Urgency of Action	PRIORITY 4
Purpose of Action	LEVEL 2
Deficiency Photo1

<p>1 EACH REPLACE PRIORITY 4 LEVEL 2</p>

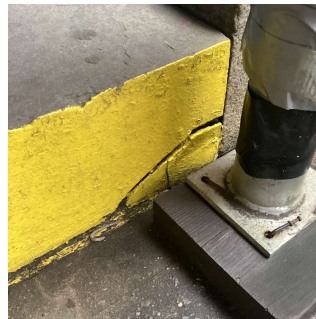
Facade A
 No violations recorded.

STONE: CRACKS/SPALLING - MAJOR

10
 S.F.
 REPLACE
 PRIORITY 4
 LEVEL 2

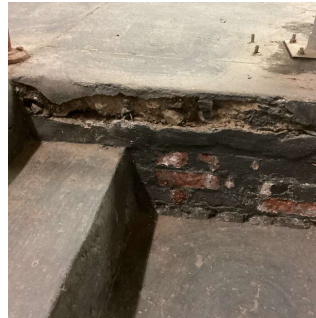
Basement - Water Main

CONCRETE: CRACKS/SPALLED/REINFORCEMENT EXPOSED

REPAIR

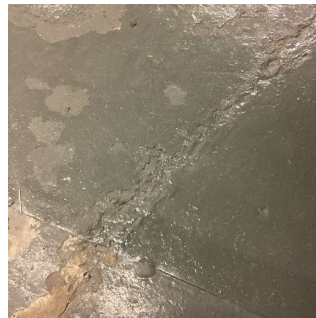
Basement - Custodians Shop Area

CONCRETE SLAB ON GRADE: THRU CRACKS

REPAIR

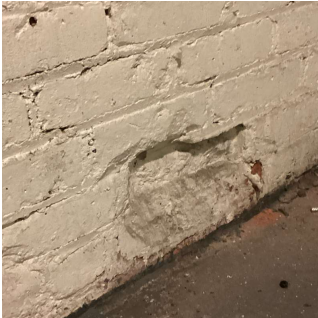
Question	Response
INTERIOR	
STRUCTURAL	
FLOOR STRUCTURE	Inspected
Violations	No violations recorded.
FOUNDATION WALLS	Inspected
Material Type(s)	Concrete, Masonry
Condition	3 - Fair
Deficiency	BRICK: CRACKED/SPALLED
Deficiency Location/Instance	Basement - Electrical Panel Room, behind Boilers
Deficiency Quantity	40
Quantity Uom	S.F.
Potential Action	RESTITCH
Urgency of Action	PRIORITY 4
Purpose of Action	LEVEL 5
Deficiency Photo1

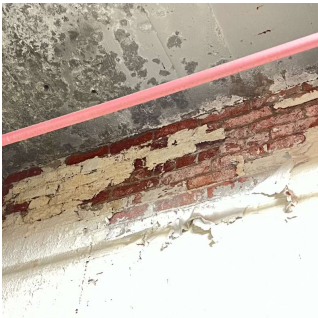
Violations	Basement - Electrical Panel Room No violations recorded.
Deficiency	BRICK: CRACKED/SPALLED
Deficiency Location/Instance	Basement - Water Main, West Fan Room, Boiler Room
Deficiency Quantity	100
Quantity Uom	S.F.
Potential Action	RESTITCH
Urgency of Action	PRIORITY 3
Purpose of Action	LEVEL 5
Deficiency Photo1

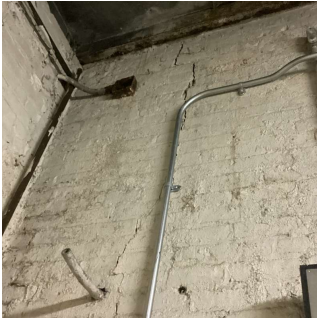
Question	Response
INTERIOR	
STRUCTURAL	
ROOF STRUCTURE	
Potential Action	REPAIR
Urgency of Action	PRIORITY 3
Purpose of Action	LEVEL 5
Deficiency Photo1	 
	Roof 1 - BH1
Violations	No violations recorded.
VAULTS-BUNKERS	Inspected
Foundation Walls	Inspected
Condition	3 - Fair
Deficiency	CRACKS, SPALLING
Deficiency Location/Instance	Vault at Exit 2, Old sidewalk Elevator
Deficiency Quantity	40
Quantity Uom	S.F.
Potential Action	REPAIR
Urgency of Action	PRIORITY 4
Purpose of Action	LEVEL 5
Deficiency Photo1

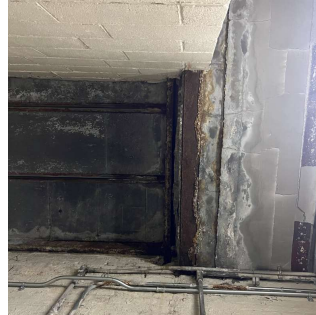
Vault at Exit 2
Violations	No violations recorded.
Slab Structure	Inspected
Condition	4 - Between Fair and Poor
Deficiency	CONCRETE: WATER INFILTRATION IN NON- INSTRUCTIONAL SPACE
Deficiency Location/Instance	Vault at Exit 2, Old Sidewalk Elevator
Deficiency Quantity	100
Quantity Uom	S.F.
Potential Action	INSTALL WATERPROOFING
Urgency of Action	PRIORITY 5
Purpose of Action	LEVEL 5

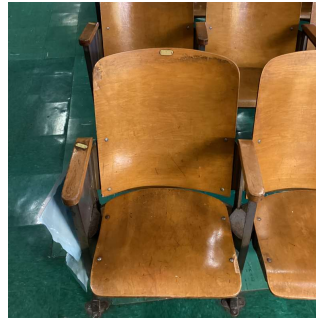
Seat A/1

DAMAGED/BROKEN/INOPERABLE

REPLACE

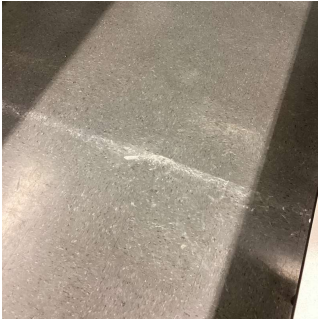
Question	Response
INTERIOR	
CAFETERIA	
Ceiling	
Violations	No violations recorded.
Door(s)	
Instance on 1st Floor	Inspected
Condition	2 - Between Good and Fair
Deficiency	No deficiencies recorded
Fixed Equipment	
Instance on 1st Floor	Does not Exist
Floor Finish	
Instance on 1st Floor	Inspected
Condition	2 - Between Good and Fair
Deficiency	VINYL TILES: BROKEN/DETERIORATED/MISSING TILES
Deficiency Location/Instance	Left Side
Deficiency Quantity	10
Quantity Uom	S.F.
Potential Action	REPLACE
Urgency of Action	PRIORITY 3
Purpose of Action	LEVEL 2
Deficiency Photo1

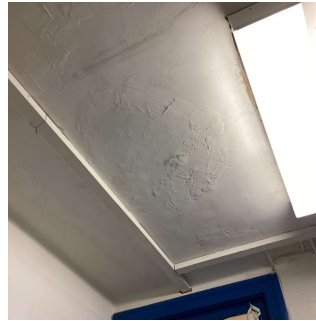
Question	Response
INTERIOR	
CAFETERIA	
Walls	
Deficiency Photo1	 
Violations	Left Side No violations recorded.
Window Curtains/Shades/Blinds	
Instance on 1st Floor	Does not Exist
CLASSROOMS/CORRIDORS/ADMIN SPACES	
Ceiling	Inspected
Condition	2 - Between Good and Fair
Deficiency	ACOUSTIC TILES: DAMAGED/MISSING
Deficiency Location/Instance	Corridor near Stair P/1, R/1, Near Exit 7, Rooms 250, 350 and others
Deficiency Quantity	200
Quantity Uom	S.F.
Potential Action	REPLACE
Urgency of Action	PRIORITY 3
Purpose of Action	LEVEL 2
Deficiency Photo1	 
Violations	Corridor near Stair P/1 No violations recorded.
Deficiency	PLASTER: CRACKS/SPALLING
Deficiency Location/Instance	Corridor near Room 320
Deficiency Quantity	20
Quantity Uom	S.F.
Potential Action	REPLACE
Urgency of Action	PRIORITY 3
Purpose of Action	LEVEL 2

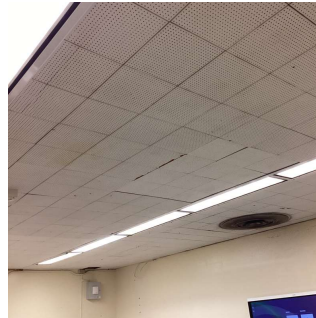
Room 115

ACOUSTIC TILES ON PLASTER: DAMAGED/MISSING

REPLACE

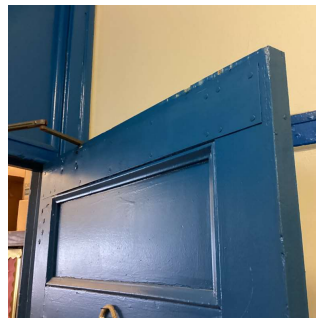
WOOD: DETERIORATED DOOR

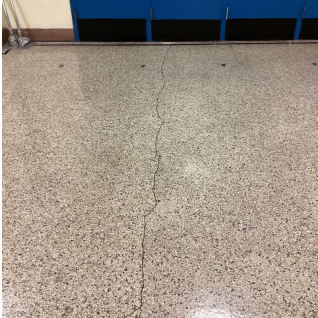
Question	Response
INTERIOR	
CLASSROOMS/CORRIDORS/ADMIN SPACES	
Door(s)	Inspected
	Room 304
Violations	No violations recorded.
Floor Finish	Inspected
Condition	3 - Fair
Deficiency	TERRAZZO: CRACKS
Deficiency Location/Instance	Corridor near Auditorium, Main Entrance Lobby, Main Entrance Vestibule, Exit 12
Deficiency Quantity	80
Quantity Uom	S.F.
Potential Action	REPLACE
Urgency of Action	PRIORITY 3
Purpose of Action	LEVEL 2
Deficiency Photo1

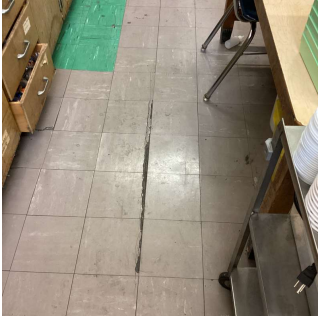
Violations	Corridor near Auditorium No violations recorded.
Deficiency	VINYL TILES: DETERIORATED SUBSTRATE
Deficiency Location/Instance	Rooms 416, 402, 306, Corridor near Rooms 520, 409 and others
Deficiency Quantity	1,600
Quantity Uom	S.F.
Potential Action	REPLACE
Urgency of Action	PRIORITY 3
Purpose of Action	LEVEL 2
Deficiency Photo1

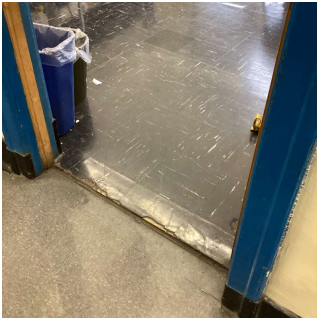
Violations	Room 416 No violations recorded.
Deficiency	VINYL TILES: BROKEN/DETERIORATED/MISSING TILES
Deficiency Location/Instance	Rooms 520, 503, 416, 409, 402 and others

Deficiency Quantity	1,200
Quantity Uom	S.F.
Potential Action	REPLACE
Urgency of Action	PRIORITY 3

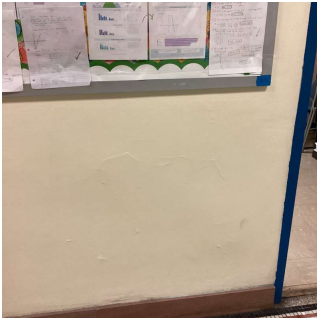
Violations	Room 503 No violations recorded.
Walls	Inspected
Condition	2 - Between Good and Fair
Deficiency	PLASTER: CRACKS/SPALLING
Deficiency Location/Instance	Corridor near Rooms 209, 122B, Main Entrance Lobby, Main Entrance Vestibule, Room 201 and others
Deficiency Quantity	150
Quantity Uom	S.F.
Potential Action	REPLACE
Urgency of Action	PRIORITY 3
Purpose of Action	LEVEL 2
Deficiency Photo1

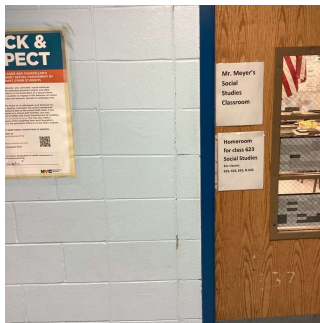
Violations	Corridor near Room 209 No violations recorded.
Deficiency	MASONRY: CRACKS/SPALLING
Deficiency Location/Instance	Corridor near Room 153
Deficiency Quantity	20
Quantity Uom	S.F.
Potential Action	REPLACE
Urgency of Action	PRIORITY 3
Purpose of Action	LEVEL 2

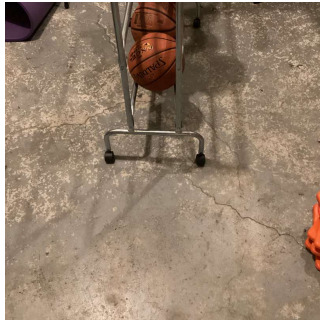
No	Potential Falling Debris	Severely damaged plaster ceiling is a potential safety hazard.	INTERIOR GYMNASIUM Ceiling	Room 125J	Timothy Moran	Fireman

Question	Response
INTERIOR	
GYMNASIUM	
Ceiling	
Deficiency Photo1	 
Violations	Near Room 125K No violations recorded.
Door(s)	
Instance on 2nd Floor	Inspected
Condition	2 - Between Good and Fair
Deficiency	No deficiencies recorded
Fixed Equipment	
Instance on 2nd Floor	Inspected
Condition	2 - Between Good and Fair
Deficiency	No deficiencies recorded
Floor Finish	
Instance on 2nd Floor	Inspected
Condition	2 - Between Good and Fair
Deficiency	CONCRETE: CRACKS
Deficiency Location/Instance	Room 125J
Deficiency Quantity	25
Quantity Uom	S.F.
Potential Action	REPLACE
Urgency of Action	PRIORITY 3
Purpose of Action	LEVEL 2
Deficiency Photo1

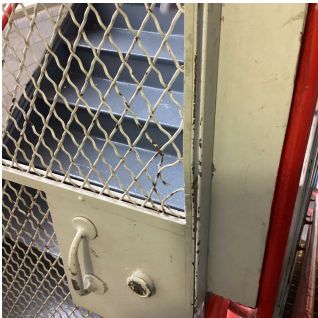
Question	Response
INTERIOR	
INTERIOR GUARDS	Inspected
Condition	2 - Between Good and Fair
Deficiency	DETERIORATED/TORN-OUT/MISSING
Deficiency Location/Instance	Stair KL/Bulkhead
Deficiency Quantity	20
Quantity Uom	S.F.
Potential Action	REPLACE
Urgency of Action	PRIORITY 3
Purpose of Action	LEVEL 2
Deficiency Photo1

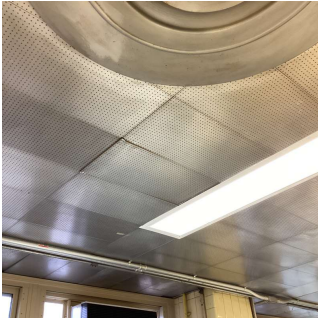
Violations	Near Freezers No violations recorded.
Door(s)	Inspected
Instance on 1st Floor	Inspected
Condition	4 - Between Fair and Poor
Deficiency	METAL: DETERIORATED DOOR AND FRAME

Violations	Stair KL/Bulkhead No violations recorded.
KITCHEN	Inspected
Instance on 1st Floor	Inspected
Ceiling	Inspected
Instance on 1st Floor	Inspected
Condition	2 - Between Good and Fair
Deficiency	METAL PAN: DAMAGED/MISSING
Deficiency Location/Instance	Near Freezers, Serving area, Right Side
Deficiency Quantity	30
Quantity Uom	S.F.
Potential Action	REPLACE
Urgency of Action	PRIORITY 3
Purpose of Action	LEVEL 2
Deficiency Photo1

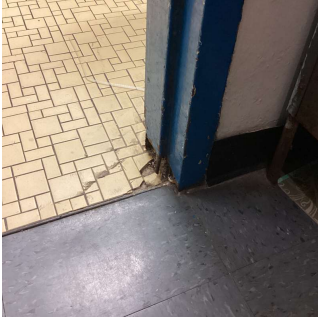
Deficiency Location/Instance	Room 120D, Mop Room
Deficiency Quantity	2

Question	Response
INTERIOR	
KITCHEN	
Door(s)	
Quantity Uom	EACH
Potential Action	MAINTENANCE
Urgency of Action	PRIORITY 3
Purpose of Action	LEVEL 2
Deficiency Photo1

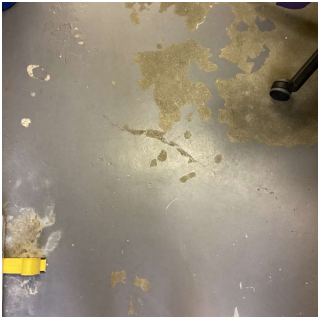
Room 120D
Violations	No violations recorded.
Floor Finish	
Instance on 1st Floor	Inspected
Condition	4 - Between Fair and Poor
Deficiency	CONCRETE: CRACKS
Deficiency Location/Instance	Rooms 120B, 120C
Deficiency Quantity	50
Quantity Uom	S.F.
Potential Action	REPLACE
Urgency of Action	PRIORITY 3
Purpose of Action	LEVEL 2
Deficiency Photo1

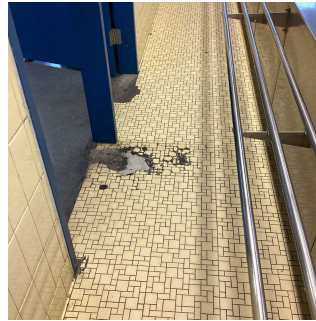
Serving area

Room 120B
Violations	No violations recorded.
Deficiency	CERAMIC TILE: BROKEN/MISSING TILES
Deficiency Location/Instance	Serving area, Prep Area, Near Freezers, near Room 120B, prep area and others
Deficiency Quantity	50
Quantity Uom	S.F.
Potential Action	REPLACE
Urgency of Action	PRIORITY 3
Purpose of Action	LEVEL 2

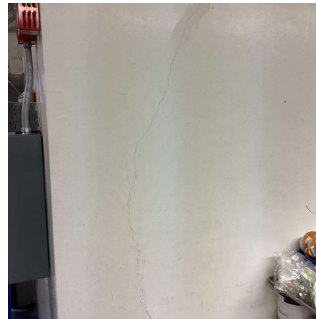
Room 120B

Instance on 1st Floor	Inspected
Condition	3 - Fair
Deficiency	PLASTER: CRACKS/SPALLING
Deficiency Location/Instance	Rooms 120B, 120C, 120D
Deficiency Quantity	60
Quantity Uom	S.F.
Potential Action	REPLACE
Urgency of Action	PRIORITY 3
Purpose of Action	LEVEL 2
Deficiency Photo1

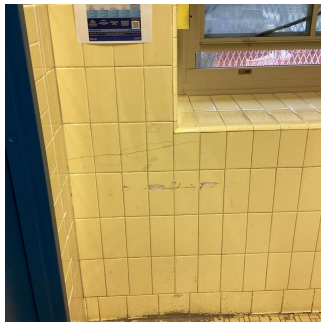
Deficiency	CERAMIC TILE: BROKEN/ MISSING
Deficiency Location/Instance	Serving area, near Rooms 120B, 120C, 120D
Deficiency Quantity	40
Quantity Uom	S.F.
Potential Action	REPLACE
Urgency of Action	PRIORITY 3
Purpose of Action	LEVEL 2

Violations	Serving area No violations recorded.
LIBRARY	Inspected
Instance on Room 405	Inspected
Built-in Furnishing	
Instance on Room 405	Inspected
Condition	2 - Between Good and Fair
Deficiency	SINK/STORAGE CABINET - DAMAGED/DETERIORATED
Deficiency Location/Instance	Inside Room 405A
Deficiency Quantity	10
Quantity Uom	L.F.
Potential Action	REPLACE
Urgency of Action	PRIORITY 3
Purpose of Action	LEVEL 2
Deficiency Photo1

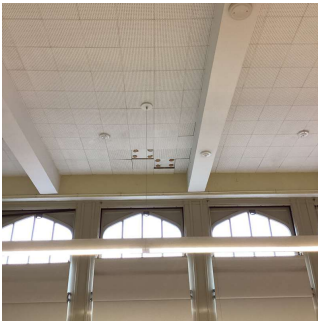
Violations	Inside Room 405A No violations recorded.
Ceiling	
Instance on Room 405	Inspected
Condition	2 - Between Good and Fair
Deficiency	ACOUSTIC TILES ON PLASTER: DAMAGED/MISSING
Deficiency Location/Instance	Near Windows
Deficiency Quantity	30
Quantity Uom	S.F.
Potential Action	REPLACE
Urgency of Action	PRIORITY 3
Purpose of Action	LEVEL 2

Violations	Near Windows No violations recorded.
Door(s)	
Instance on Room 405	Inspected
Condition	2 - Between Good and Fair
Deficiency	No deficiencies recorded
Floor Finish	
Instance on Room 405	Inspected
Condition	2 - Between Good and Fair
Deficiency	WOOD: DAMAGED/DETERIORATED
Deficiency Location/Instance	Center, near Circulation Desk, Room 405A
Deficiency Quantity	30
Quantity Uom	S.F.
Potential Action	REPLACE
Urgency of Action	PRIORITY 3
Purpose of Action	LEVEL 2
Deficiency Photo1

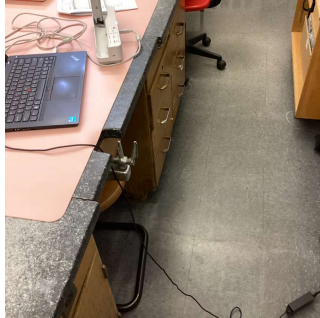
Question	Response
INTERIOR	
LIBRARY	
Walls	
Deficiency Photo1	 
Violations	Near Windows No violations recorded.
LOCKER ROOM	
Instance on 2nd Floor - Boys	Inspected Inaccessible
Instance on 2nd Floor - Girls (870 Lockers)	Inaccessible
MULTI-PURPOSE ROOM	
Does not Exist	
SCIENCE DEMO ROOM	
Instance on Rooms 514, 518, 418, 414	Inspected
Alternative use	No
Instance on Room 250,350	Inspected
Alternative use	No
Instance on Room 150	Inspected
Alternative use	No
Fixed Equipment	
Instance on Room 150	Inspected
Condition	3 - Fair
Deficiency	CABINETS: MISSING/DAMAGED
Deficiency Location/Instance	Room 150
Deficiency Quantity	10
Quantity Uom	L.F.
Potential Action	REPLACE
Urgency of Action	PRIORITY 3
Purpose of Action	LEVEL 2
Deficiency Photo1	 
Violations	Room 150 No violations recorded.
Instance on Rooms 514, 518, 418, 414	Inspected
Condition	5 - Poor
Deficiency	DEMO TABLE: DAMAGED/DETERIORATED

Question	Response
INTERIOR	
SCIENCE DEMO ROOM	
Fixed Equipment	
Deficiency Location/Instance	Rooms 514, 518, 418, 414
Deficiency Quantity	4
Quantity Uom	EACH
Potential Action	REPLACE
Urgency of Action	PRIORITY 3
Purpose of Action	LEVEL 2
Deficiency Photo1

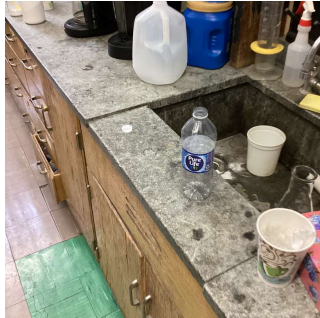
Room 516
Violations	No violations recorded.
SHOWER ROOM	Inspected
Instance on 2nd Floor - Boys	Inaccessible
Instance on 2nd Floor - Girls	Inaccessible
STAIRS/RAMPS: INTERIOR	Inspected
Do Letter Stair Signs Exist?	Yes

Room 514
Violations	No violations recorded.
SCIENCE LAB	Does not Exist
SCIENCE PREP ROOM	Inspected
Instance on Rooms 416, 516	Inspected
Alternative use	No
Fixed Equipment	
Instance on Rooms 416, 516	Inspected
Condition	5 - Poor
Deficiency	DEMO TABLE: DAMAGED/DETERIORATED
Deficiency Location/Instance	Rooms 416, 516
Deficiency Quantity	2
Quantity Uom	EACH
Potential Action	REPLACE
Urgency of Action	PRIORITY 3
Purpose of Action	LEVEL 2
Deficiency Photo1

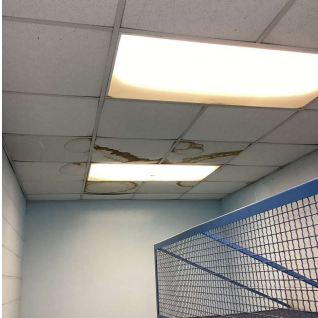
Question	Response
INTERIOR	
STAIRS/RAMPS: INTERIOR	
Ceiling	Inspected
Condition	2 - Between Good and Fair
Deficiency	ACOUSTIC TILES: DAMAGED/MISSING
Deficiency Location/Instance	Stairs R/3, S/2, O/2
Deficiency Quantity	60
Quantity Uom	S.F.
Potential Action	REPLACE
Urgency of Action	PRIORITY 3
Purpose of Action	LEVEL 2
Deficiency Photo1

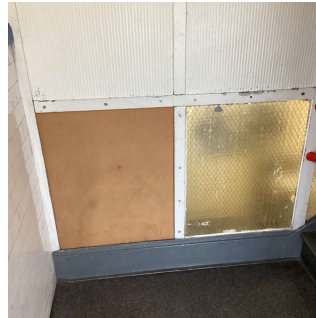
Stair KL/4

GLASS PANEL: DAMAGED/DETERIORATED

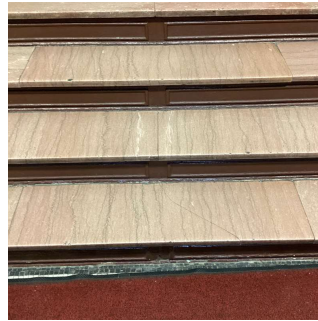
Main Entrance Lobby

STONE: BROKEN/MISSING

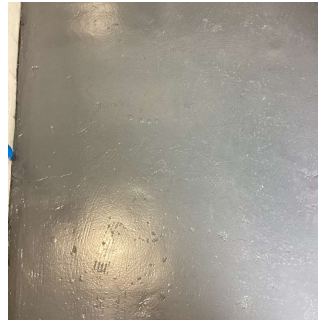
Stair KL/Bulkhead

CONCRETE: CRACKS/SPALLING - MAJOR

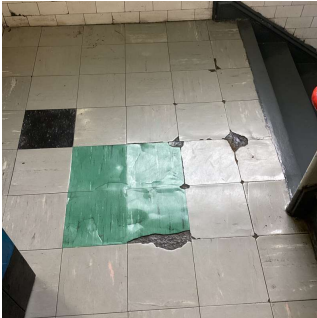
Stair GH/3
Violations	No violations recorded.
Deficiency	TERRAZZO: CRACKS
Deficiency Location/Instance	Stairs A/1, T/1
Deficiency Quantity	20
Quantity Uom	S.F.
Potential Action	REPLACE
Urgency of Action	PRIORITY 3
Purpose of Action	LEVEL 2
Deficiency Photo1

Question	Response
INTERIOR	
STAIRS/RAMPS: INTERIOR	
Stairs and Landings	
Deficiency	VINYL TILES: BROKEN/DETERIORATED/MISSING TILES
Deficiency Location/Instance	Stairs A/1, I/3 J/3, KL/3, T/1 and others
Deficiency Quantity	700
Quantity Uom	S.F.
Potential Action	REPLACE
Urgency of Action	PRIORITY 3
Purpose of Action	LEVEL 2
Deficiency Photo1

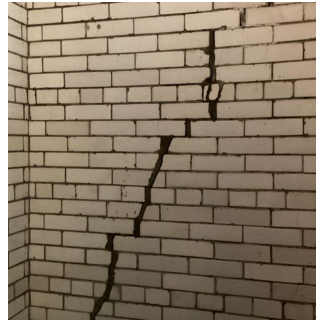
Stair T/1
Violations	No violations recorded.
Walls	Inspected
Condition	2 - Between Good and Fair
Deficiency	BRICK: CRACKS/SPALLING
Deficiency Location/Instance	Stair KL/1 Vestibule
Deficiency Quantity	20
Quantity Uom	S.F.
Potential Action	REPLACE
Urgency of Action	PRIORITY 3
Purpose of Action	LEVEL 2

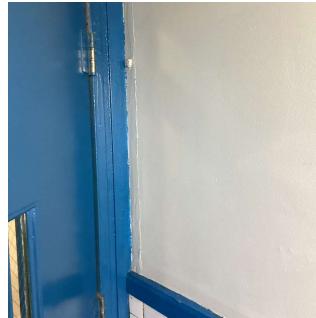
Stair GH/4

PLASTER: CRACKS/SPALLING

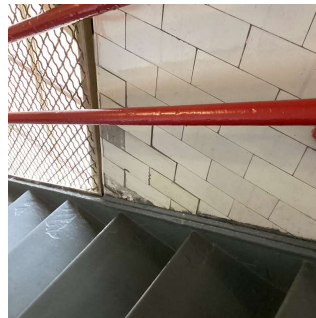
Stair KL/5

CERAMIC TILE: BROKEN/ MISSING

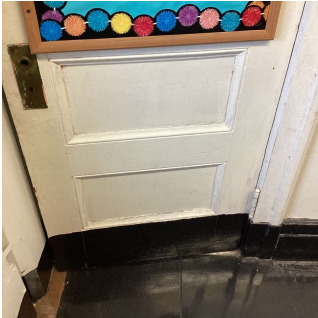
Question	Response
INTERIOR	
TOILET ROOMS - STAFF	Inspected
Ceiling	Inspected
Condition	2 - Between Good and Fair
Deficiency	No deficiencies recorded
Door(s)	Inspected
Condition	5 - Poor
Deficiency	WOOD: DETERIORATED DOOR
Deficiency Location/Instance	Rooms 402A, 105B
Deficiency Quantity	2
Quantity Uom	EACH
Potential Action	MAINTENANCE
Urgency of Action	PRIORITY 3
Purpose of Action	LEVEL 2
Deficiency Photo1

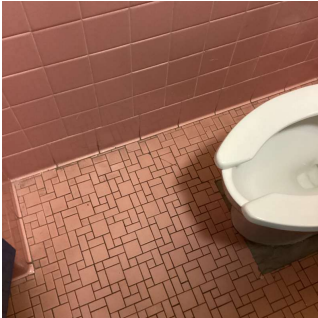
Room 402A	
Violations	No violations recorded.
Floor Finish	Inspected
Condition	3 - Fair
Deficiency	CERAMIC TILE: DETERIORATED SUBSTRATE
Deficiency Location/Instance	Inside Room 120D, Room 105B
Deficiency Quantity	20
Quantity Uom	S.F.
Potential Action	REPLACE
Urgency of Action	PRIORITY 3
Purpose of Action	LEVEL 2
Deficiency Photo1

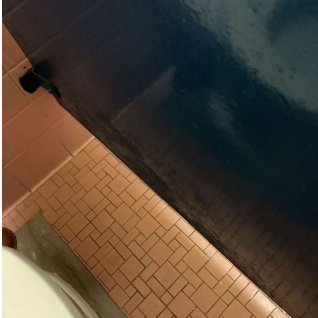
Inside Room 120D	
Violations	No violations recorded.
Stalls	Inspected
Condition	5 - Poor
Deficiency	RUST - MAJOR
Deficiency Location/Instance	Inside Room 120D, Room 105B
Deficiency Quantity	2

Question	Response
INTERIOR	
TOILET ROOMS - STAFF	
Stalls	
Quantity Uom	EACH
Potential Action	REPLACE
Urgency of Action	PRIORITY 3
Purpose of Action	LEVEL 2
Deficiency Photo1

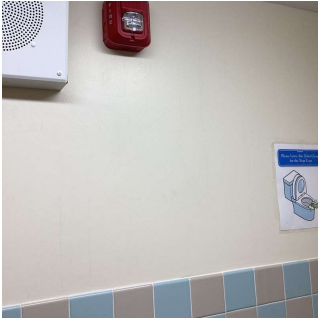
Violations	Inside Room 120D No violations recorded.
Walls	Inspected
Condition	2 - Between Good and Fair
Deficiency	GYPSUM BOARD: DETERIORATED
Deficiency Location/Instance	Room 110A
Deficiency Quantity	10
Quantity Uom	S.F.
Potential Action	REPLACE
Urgency of Action	PRIORITY 3
Purpose of Action	LEVEL 2
Deficiency Photo1

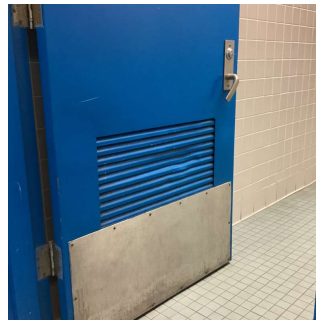
Room 354

METAL: DAMAGED LOUVER

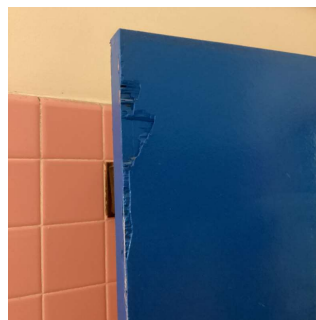
WOOD: DETERIORATED DOOR

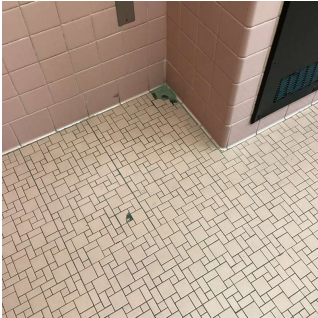
Question	Response
INTERIOR	
TOILET ROOMS - STUDENTS	
Door(s)	Inspected Room 306
Violations	No violations recorded.
Floor Finish	Inspected
Condition	2 - Between Good and Fair
Deficiency	CERAMIC TILE: BROKEN/MISSING TILES
Deficiency Location/Instance	Rooms 512, 506, 306, 118, 116 and others
Deficiency Quantity	60
Quantity Uom	S.F.
Potential Action	REPLACE
Urgency of Action	PRIORITY 3
Purpose of Action	LEVEL 2
Deficiency Photo1

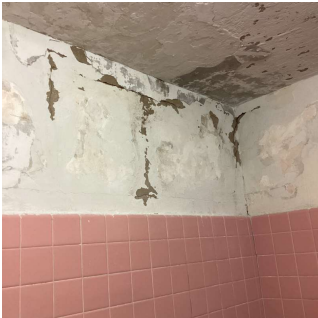
Question	Response
INTERIOR	
TOILET ROOMS - STUDENTS	
Walls	
Quantity Uom	S.F.
Potential Action	REPLACE
Urgency of Action	PRIORITY 3
Purpose of Action	LEVEL 2
Deficiency Photo1	 
	Room 506
Violations	No violations recorded.
Deficiency	PLASTER: CRACKS/SPALLING
Deficiency Location/Instance	Room 125C
Deficiency Quantity	20
Quantity Uom	S.F.
Potential Action	REPLACE
Urgency of Action	PRIORITY 3
Purpose of Action	LEVEL 2
Deficiency Photo1

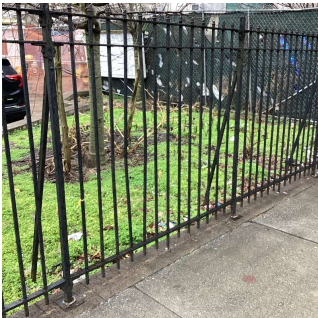
Question	Response
SITE	
FENCES	Inspected
Condition	4 - Between Fair and Poor
Deficiency	WROUGHT IRON: DAMAGED/DETERIORATED
Deficiency Location/Instance	Woodbine Street, Forest Avenue
Deficiency Quantity	480
Quantity Uom	S.F.
Potential Action	REPLACE
Urgency of Action	PRIORITY 3
Purpose of Action	LEVEL 2
Deficiency Photo1

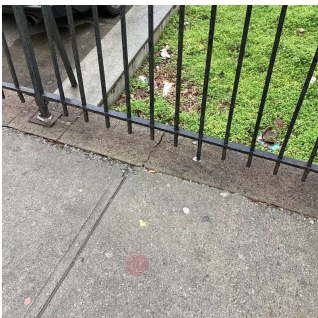
Violations	Woodbine Street No violations recorded.
Deficiency	CONCRETE CURB: DAMAGED/DETERIORATED
Deficiency Location/Instance	Woodbine Street, Forest Avenue
Deficiency Quantity	40
Quantity Uom	S.F.
Potential Action	REPLACE
Urgency of Action	PRIORITY 3
Purpose of Action	LEVEL 2
Deficiency Photo1

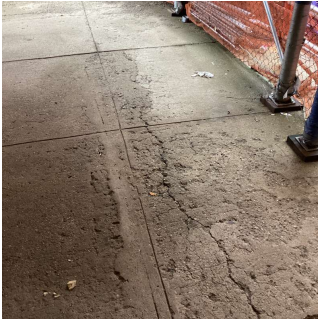
Violations	Near Exit 7 No violations recorded.
Deficiency	CRACKS - MAJOR
Deficiency Location/Instance	Exits 12, 7, 5, 4, 1 and others
Deficiency Quantity	575
Quantity Uom	S.F.
Potential Action	REPLACE
Urgency of Action	PRIORITY 3
Purpose of Action	LEVEL 2
Deficiency Photo1

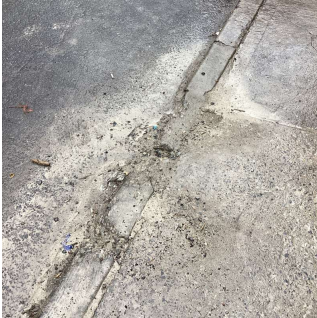
Violations	Exit 4 No violations recorded.
Pavers	Does not Exist
DOT Sidewalk	Inspected
Asphalt	Does not Exist
Concrete	Inspected
Condition	4 - Between Fair and Poor
Deficiency	DAMAGED CURBS
Deficiency Location/Instance	Woodbine Street, forest Avenue, Madison Street, Fairview Avenue

Question	Response
SITE	
PAVING	
DOT Sidewalk	
Concrete	
Deficiency Quantity	80
Quantity Uom	L.F.
Potential Action	REPLACE
Urgency of Action	PRIORITY 3
Purpose of Action	LEVEL 2
Deficiency Photo1

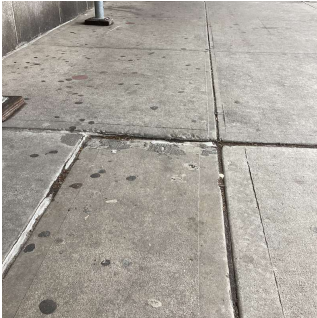
Woodbine Street
Violations	No violations recorded.
Deficiency	HEAVING
Deficiency Location/Instance	Madison Street, woodbine Street
Deficiency Quantity	75
Quantity Uom	S.F.
Potential Action	REPLACE
Urgency of Action	PRIORITY 3
Purpose of Action	LEVEL 2
Deficiency Photo1

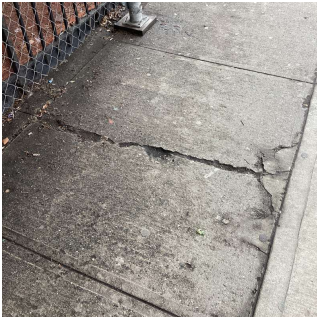
Madison Street
Violations	No violations recorded.
Deficiency	DAMAGED/DETERIORATED/MISSING SECTIONS
Deficiency Location/Instance	Woodbine Street, forest Avenue, Madison Street, Fairview Avenue
Deficiency Quantity	825
Quantity Uom	S.F.
Potential Action	REPLACE
Urgency of Action	PRIORITY 3
Purpose of Action	LEVEL 2

Question	Response
SITE	
PAVING	
DOT Sidewalk	
Concrete	
Deficiency Photo1

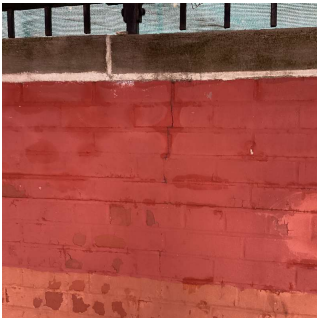
Violations	Forest Avenue No violations recorded.
Pavers	Does not Exist
PLAYGROUNDS	Does not Exist
PLAYING SURFACE	Does not Exist
RETAINING WALLS	Inspected
Are there any Retaining Walls 6' OR higher facing public street/sidewalk?	Yes
Condition	2 - Between Good and Fair
Deficiency	BRICK: CRACKS/SPALLING - MAJOR
Deficiency Location/Instance	Madison Street
Deficiency Quantity	20
Quantity Uom	S.F.
Potential Action	REPLACE
Urgency of Action	PRIORITY 3
Purpose of Action	LEVEL 2
Deficiency Photo1
