NYC Department of Education
Building Condition Assessment Survey 2023 - 2024

Architectural Inspection

Asset: P.S. 95 - QUEENS, 179-01 90TH AVENUE, New York, 11432

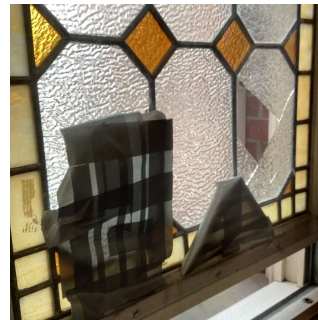
Facade F - Auditorium

Question	Response
EXTERIOR	
WINDOWS	
EXTERIOR GUARDS	
Elevation	 
Deficiency Quantity	20
Quantity Uom	S.F.
Potential Action	REPLACE
Urgency of Action	PRIORITY 4
Purpose of Action	LEVEL 2
Deficiency Photo1	 
Violations	Facade H No violations recorded.
LINTELS	Inspected
Condition	2 - Between Good and Fair
Deficiency	No deficiencies recorded
WINDOWS	Inspected
Material Type(s)	Aluminum, Solid Wood
Instance on Aluminum - Double Hung: All Facades	Inspected
Instance Condition	3 - Fair
Instance Quantity	14,600
Instance Quantity Uom	S.F.
Are these windows insulated	No
Installation Year	1999
Source of Installation	Custodial Staff
Deficiency	No deficiencies recorded
Instance on Wood: Facade F - 2nd Floor Auditorium	Inspected
Instance Condition	3 - Fair
Instance Quantity	400
Instance Quantity Uom	S.F.
Are these windows insulated	No
Installation Year	1990
Source of Installation	Custodial Staff
Deficiency	WOOD: BROKEN PANE
