NYC Department of Education
Building Condition Assessment Survey 2023 - 2024

Architectural Inspection

Q096

Asset: P.S. 96 - QUEENS, 130-01 ROCKAWAY BLVD, New York, 11420

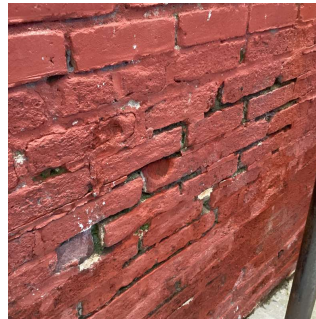
Facade E - AW1

AREAWAY WALLS: DETERIORATED JOINTS

REPAIR

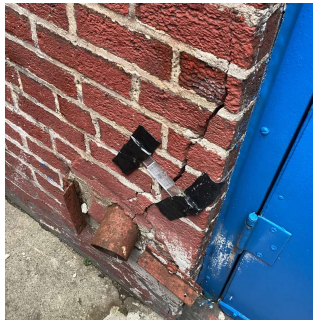
Facade E

BRICK: MAJOR / THRU CRACKS

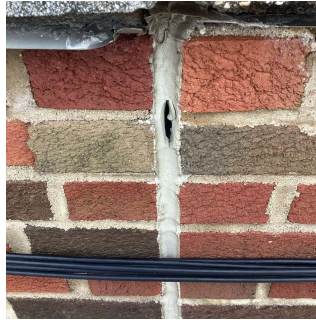
Roof 1
No violations recorded.

Question	Response
EXTERIOR	
EXTERIOR WALLS	
Urgency of Action	PRIORITY 3
Purpose of Action	LEVEL 2
Deficiency Photo1	 
	Facade B
Violations	No violations recorded.
EXTERIOR SOFFITS	Does not Exist
LOADING DOCK	Does not Exist
LOUVER	Inspected
Condition	2 - Between Good and Fair
Deficiency	No deficiencies recorded
PARAPETS	Inspected
Material Type(s)	Masonry
Replacement Quantity	6,000
Replacement Uom	C.F.
Instance on All Facades	Inspected
Instance Condition	3 - Fair
Instance Quantity	6,000
Instance Quantity Uom	C.F.
Deficiency	BRICK: EFFLORESCENCE
Roof Plan reference	 
Deficiency Quantity	50
Quantity Uom	S.F.
Potential Action	MAINTENANCE
Urgency of Action	PRIORITY 1
Purpose of Action	LEVEL 1
Deficiency Photo1	No photo recorded
Violations	No violations recorded.
Deficiency	BRICK: DETERIORATED CONTROL/EXPANSION JOINT

10
L.F.
MAINTENANCE
PRIORITY 3
LEVEL 2

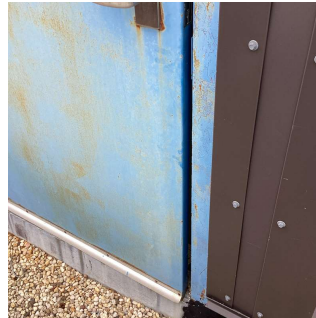
BULKHEAD/PENTHOUSE DOORS: DETERIORATED DOOR AND FRAME

Roof 1 - Bulkhead - door does not close

1
EACH
REPLACE DOOR AND FRAME
PRIORITY 4
LEVEL 2

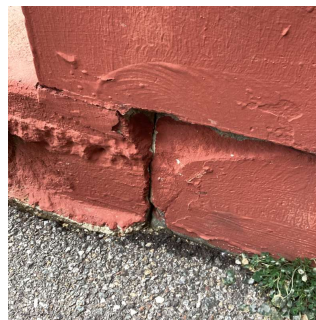
Facade E

STONE: CRACKS/SPALLING - MAJOR

REPLACE

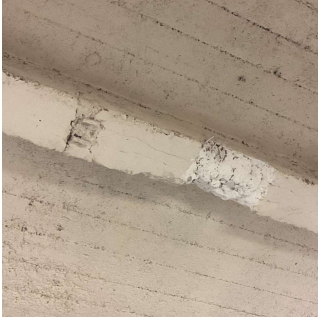
Question	Response
EXTERIOR	
WINDOWS	
WINDOWS	Inspected
Material Type(s)	Aluminum
Instance on Aluminum - Double Hung: All Facades	Inspected
Instance Condition	2 - Between Good and Fair
Instance Quantity	5,600
Instance Quantity Uom	S.F.
Are these windows insulated	Yes
Installation Year	2011
Source of Installation	Custodial Staff
Deficiency	No deficiencies recorded
INTERIOR	Inspected
POOLS	Does not Exist
STRUCTURAL	Inspected
COLUMNS/BEAMS/BEARING WALLS	Inspected
Condition	3 - Fair
Deficiency	STEEL COLUMNS/BEAMS: DETERIORATED CONCRETE FIREPROOFING
Deficiency Location/Instance	Basement - Oil Tank Room
Deficiency Quantity	20
Quantity Uom	S.F.
Potential Action	REPLACE
Urgency of Action	PRIORITY 3
Purpose of Action	LEVEL 5
Deficiency Photo1

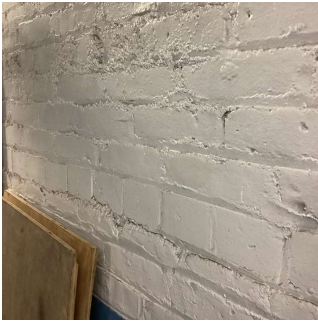
Question	Response
INTERIOR	
STRUCTURAL	
COLUMNS/BEAMS/BEARING WALLS	
Deficiency Photo1	 
Violations	Basement - Boiler Room No violations recorded.
FLOOR STRUCTURE	Inspected
Condition	2 - Between Good and Fair
Deficiency	No deficiencies recorded
FOUNDATION WALLS	Inspected
Material Type(s)	Masonry
Condition	4 - Between Fair and Poor
Deficiency	BRICK: WATER INFILTRATION IN NON- INSTRUCTIONAL SPACE
Deficiency Location/Instance	Basement - Boiler Room
Deficiency Quantity	100
Quantity Uom	S.F.
Potential Action	INSTALL WATERPROOFING
Urgency of Action	PRIORITY 5
Purpose of Action	LEVEL 5
Deficiency Photo1	 
Violations	Basement - Boiler Room No violations recorded.
Deficiency	BRICK: CRACKED/SPALLED
Deficiency Location/Instance	Basement - Boiler Room
Deficiency Quantity	300
Quantity Uom	S.F.
Potential Action	RESTITCH
Urgency of Action	PRIORITY 3
Purpose of Action	LEVEL 5

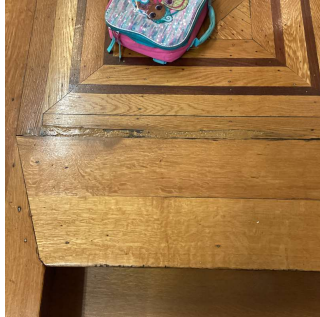
Question	Response
INTERIOR	
AUDITORIUM	
Stage	
Stage	
Deficiency Photo1

Near Steps Left Side
Violations	No violations recorded.
Stage Curtain Rigging	Inspected
Instance on 1st Floor (400 Seats)	Inspected
Condition	2 - Between Good and Fair
Deficiency	No deficiencies recorded
Stage Curtains	Inspected
Instance on 1st Floor (400 Seats)	Inspected
Condition	2 - Between Good and Fair
Deficiency	No deficiencies recorded
Walls	
Instance on 1st Floor (400 Seats)	Inspected
Condition	2 - Between Good and Fair
Deficiency	PLASTER: CRACKS/SPALLING
Deficiency Location/Instance	Near Windows
Deficiency Quantity	10
Quantity Uom	S.F.
Potential Action	REPLACE
Urgency of Action	PRIORITY 3
Purpose of Action	LEVEL 2
Deficiency Photo1

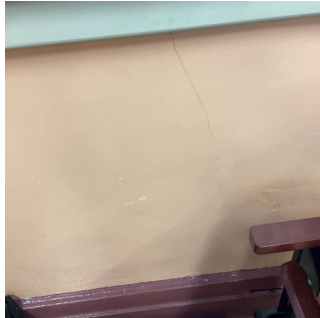
Near Windows
Violations	No violations recorded.
Window Curtains/Shades/Blinds	
Instance on 1st Floor (400 Seats)	Inspected
Condition	2 - Between Good and Fair
Deficiency	No deficiencies recorded
CAFETERIA	Inspected

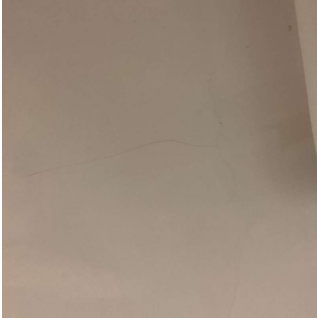
Question	Response
INTERIOR	
CAFETERIA	
Ceiling	
Instance on Basement (1600SF)	Inspected
Condition	2 - Between Good and Fair
Deficiency	PLASTER: CRACKS/SPALLING
Deficiency Location/Instance	Near center
Deficiency Quantity	10
Quantity Uom	S.F.
Potential Action	REPLACE
Urgency of Action	PRIORITY 3
Purpose of Action	LEVEL 2
Deficiency Photo1

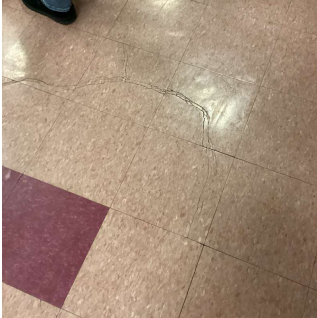
Question	Response
INTERIOR	
CAFETERIA	
Floor Finish	
Condition	3 - Fair
Deficiency	VINYL TILES: BROKEN/DETERIORATED/MISSING TILES
Deficiency Location/Instance	Near center, Stairs, Windows, toilet Room
Deficiency Quantity	100
Quantity Uom	S.F.
Potential Action	REPLACE
Urgency of Action	PRIORITY 3
Purpose of Action	LEVEL 2
Deficiency Photo1

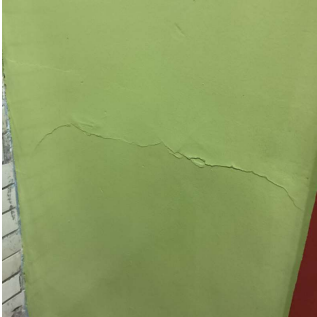
Violations	Near center No violations recorded.
Sliding-folding Partition	
Instance on Basement (1600SF)	Does not Exist
Stage	
Instance on Basement (1600SF)	Does not Exist
Walls	
Instance on Basement (1600SF)	Inspected
Condition	2 - Between Good and Fair
Deficiency	PLASTER: CRACKS/SPALLING
Deficiency Location/Instance	Near center
Deficiency Quantity	10
Quantity Uom	S.F.
Potential Action	REPLACE
Urgency of Action	PRIORITY 3
Purpose of Action	LEVEL 2
Deficiency Photo1

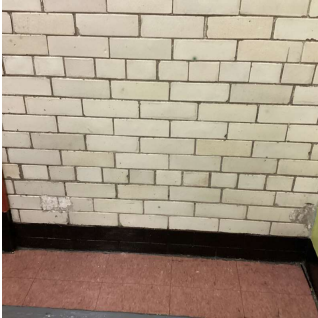
Violations	Near center No violations recorded.
Deficiency	BRICK: CRACKS/SPALLING
Deficiency Location/Instance	Near Entrance, Center

Deficiency Quantity	20

Question	Response
INTERIOR	
CAFETERIA	
Walls	
Quantity Uom	S.F.
Potential Action	REPLACE
Urgency of Action	PRIORITY 3
Purpose of Action	LEVEL 2
Deficiency Photo1

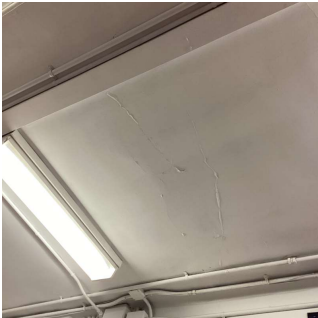
Near center
Violations	No violations recorded.
Window Curtains/Shades/Blinds	
Instance on Basement (1600SF)	Does not Exist
CLASSROOMS/CORRIDORS/ADMIN SPACES	
Ceiling	
Condition	2 - Between Good and Fair
Deficiency	PLASTER: CRACKS/SPALLING
Deficiency Location/Instance	Main Entrance
Deficiency Quantity	10
Quantity Uom	S.F.
Potential Action	REPLACE
Urgency of Action	PRIORITY 3
Purpose of Action	LEVEL 2
Deficiency Photo1

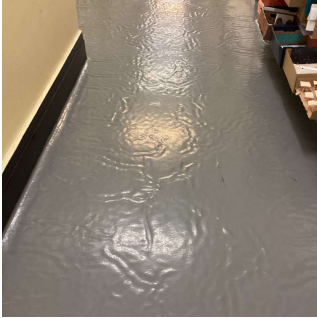
Question	Response
INTERIOR	
CLASSROOMS/CORRIDORS/ADMIN SPACES	
Floor Finish	Inspected
Condition	5 - Poor
Deficiency	ROLLED ASPHALT: CRACKS
Deficiency Location/Instance	Hallway 2nd Floor, 3rd Floor
Deficiency Quantity	2,000
Quantity Uom	S.F.
Potential Action	REPLACE
Urgency of Action	PRIORITY 3
Purpose of Action	LEVEL 2
Deficiency Photo1

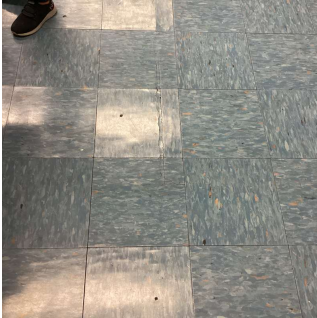
Violations	Hallway 2nd Floor No violations recorded.
Deficiency	VINYL TILES: DETERIORATED SUBSTRATE
Deficiency Location/Instance	Rooms 103, 202, 203, 204, Corridor near Room 103, and others.
Deficiency Quantity	300
Quantity Uom	S.F.
Potential Action	REPLACE
Urgency of Action	PRIORITY 3
Purpose of Action	LEVEL 2
Deficiency Photo1

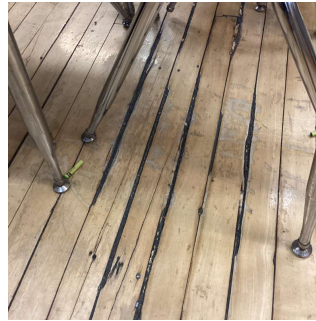
Room 306

Violations	Room 202 No violations recorded.
Deficiency	WOOD: DAMAGED/DETERIORATED
Deficiency Location/Instance	Rooms 302, 304, 305, 306
Deficiency Quantity	1,200
Quantity Uom	S.F.
Potential Action	REPLACE
Urgency of Action	PRIORITY 3
Purpose of Action	LEVEL 2

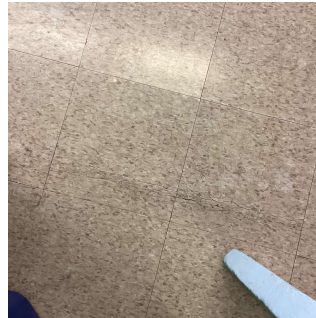
Room 301

VINYL TILES: BROKEN/DETERIORATED/MISSING TILES

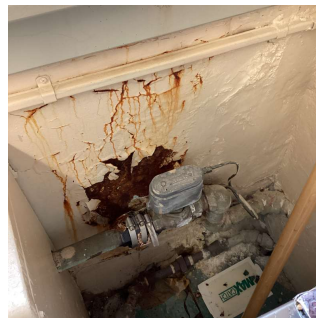
PLASTER: CRACKS/SPALLING - ACTIVE LEAK

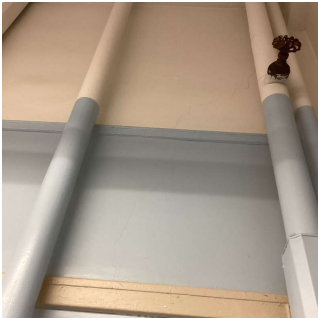
Question	Response
INTERIOR	
CLASSROOMS/CORRIDORS/ADMIN SPACES	
Walls	
Violations	Room 353 No violations recorded.
Deficiency	PLASTER: CRACKS/SPALLING
Deficiency Location/Instance	Rooms 103, 104, 202, 205
Deficiency Quantity	50
Quantity Uom	S.F.
Potential Action	REPLACE
Urgency of Action	PRIORITY 3
Purpose of Action	LEVEL 2
Deficiency Photo1

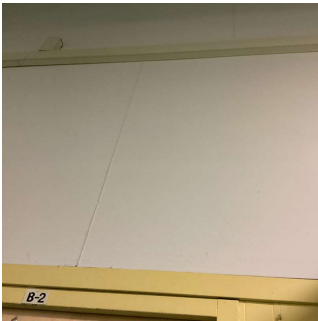
Violations	Room 202 No violations recorded.
Deficiency	GYPSUM BOARD: DETERIORATED
Deficiency Location/Instance	Corridor near Room B2
Deficiency Quantity	10
Quantity Uom	S.F.
Potential Action	REPLACE
Urgency of Action	PRIORITY 3
Purpose of Action	LEVEL 2
Deficiency Photo1

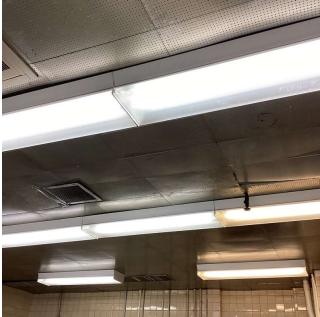
Question	Response
INTERIOR	
KITCHEN	Inspected
Instance on Basement	Inspected
Ceiling	
Instance on Basement	Inspected
Condition	2 - Between Good and Fair
Deficiency	METAL PAN: DAMAGED/MISSING
Deficiency Location/Instance	Near Entrance, Center
Deficiency Quantity	20
Quantity Uom	S.F.
Potential Action	REPLACE
Urgency of Action	PRIORITY 3
Purpose of Action	LEVEL 2
Deficiency Photo1

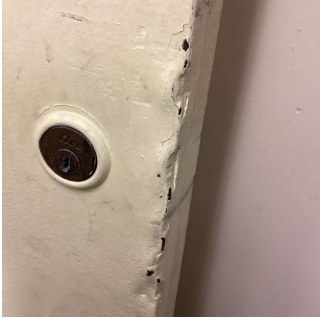
Near center
Violations	No violations recorded.
Door(s)	
Instance on Basement	Inspected
Condition	3 - Fair
Deficiency	METAL: DETERIORATED DOOR
Deficiency Location/Instance	Storage Room
Deficiency Quantity	1
Quantity Uom	EACH
Potential Action	MAINTENANCE
Urgency of Action	PRIORITY 3
Purpose of Action	LEVEL 2
Deficiency Photo1

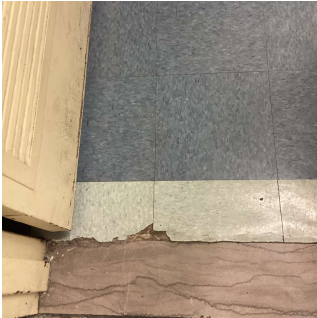
Storage Room
Violations	No violations recorded.
Floor Finish	
Instance on Basement	Inspected
Condition	2 - Between Good and Fair
Deficiency	VINYL TILES: BROKEN/DETERIORATED/MISSING TILES
Deficiency Location/Instance	Storage Room

Question	Response
INTERIOR	
KITCHEN	
Floor Finish	
Deficiency Quantity	10
Quantity Uom	S.F.
Potential Action	REPLACE
Urgency of Action	PRIORITY 3
Purpose of Action	LEVEL 2
Deficiency Photo1

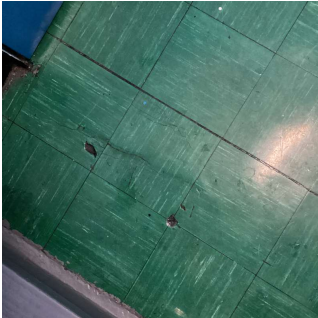
Question	Response
INTERIOR	
STAIRS/RAMPS: INTERIOR	
Railings	Inspected
Condition	2 - Between Good and Fair
Deficiency	No deficiencies recorded
Stairs and Landings	Inspected
Condition	3 - Fair
Deficiency	VINYL TILES: BROKEN/DETERIORATED/MISSING TILES
Deficiency Location/Instance	Stair B/Basement, 1
Deficiency Quantity	40
Quantity Uom	S.F.
Potential Action	REPLACE
Urgency of Action	PRIORITY 3
Purpose of Action	LEVEL 2
Deficiency Photo1

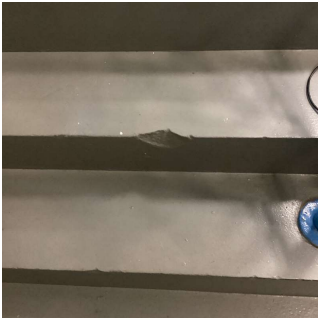
Stair B/Basement
Violations	No violations recorded.
Deficiency	CONCRETE: CRACKS/SPALLING - MAJOR
Deficiency Location/Instance	Near Exit F
Deficiency Quantity	10
Quantity Uom	S.F.
Potential Action	REPLACE
Urgency of Action	PRIORITY 3
Purpose of Action	LEVEL 2
Deficiency Photo1

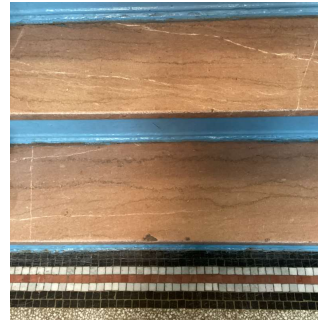
Near Exit F
Violations	No violations recorded.
Deficiency	STONE: BROKEN/MISSING
Deficiency Location/Instance	Main Entrance
Deficiency Quantity	20
Quantity Uom	S.F.
Potential Action	REPLACE
Urgency of Action	PRIORITY 3

Purpose of Action	LEVEL 2

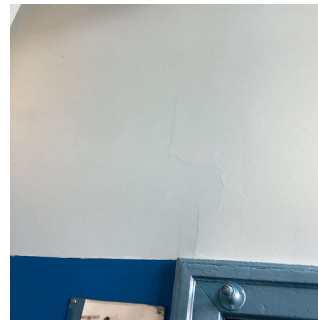
Stair B/3

PLASTER: CRACKS/SPALLING

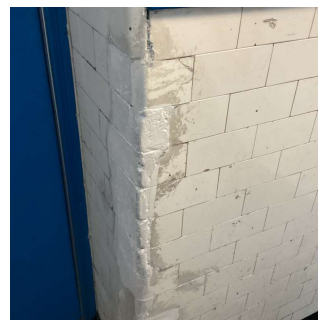
CERAMIC TILE: BROKEN/ MISSING

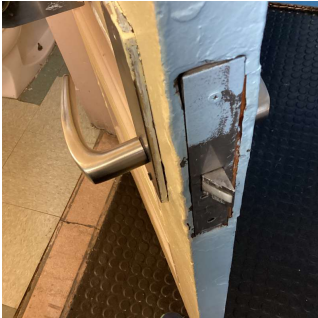
Question	Response
INTERIOR	
STAIRS/RAMPS: INTERIOR	Inspected
Walls	Inspected
Violations	Stair B/Basement No violations recorded.
TOILET ROOMS - STAFF	Inspected
Ceiling	Inspected
Condition	2 - Between Good and Fair
Deficiency	No deficiencies recorded
Door(s)	Inspected
Condition	5 - Poor
Deficiency	METAL CLAD WOOD: DETERIORATED DOOR
Deficiency Location/Instance	Staff 1st Floor, 2nd Floor
Deficiency Quantity	2
Quantity Uom	EACH
Potential Action	MAINTENANCE
Urgency of Action	PRIORITY 3
Purpose of Action	LEVEL 2
Deficiency Photo1

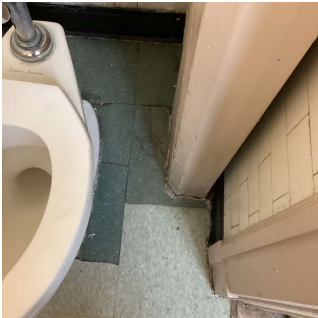
Violations	Staff 2nd Floor No violations recorded.
Floor Finish	Inspected
Condition	3 - Fair
Deficiency	VINYL TILES: BROKEN/DETERIORATED/MISSING TILES
Deficiency Location/Instance	Staff 2nd Floor
Deficiency Quantity	10
Quantity Uom	S.F.
Potential Action	REPLACE
Urgency of Action	PRIORITY 3
Purpose of Action	LEVEL 2
Deficiency Photo1

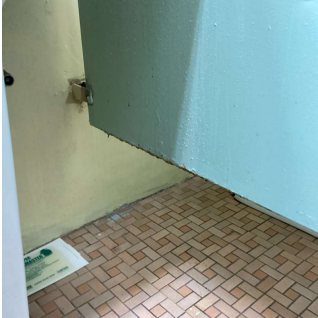
Question	Response
INTERIOR	
TOILET ROOMS - STAFF	Inspected
Stalls	
Condition	5 - Poor
Deficiency	RUST - MAJOR
Deficiency Location/Instance	Kitchen Locker Room inside Cafeteria
Deficiency Quantity	1
Quantity Uom	EACH
Potential Action	REPLACE
Urgency of Action	PRIORITY 3
Purpose of Action	LEVEL 2
Deficiency Photo1

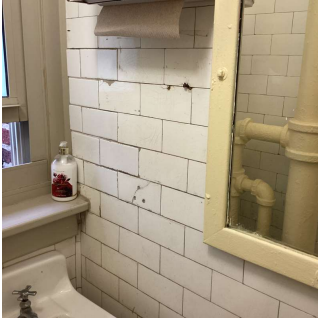
Violations	Kitchen Locker Room inside Cafeteria No violations recorded.
Walls	Inspected
Condition	2 - Between Good and Fair
Deficiency	CERAMIC TILE: BROKEN/ MISSING
Deficiency Location/Instance	Staff 1st Floor, 2nd Floor, 3rd Floor, principal Office
Deficiency Quantity	30
Quantity Uom	S.F.
Potential Action	REPLACE
Urgency of Action	PRIORITY 3
Purpose of Action	LEVEL 2
Deficiency Photo1

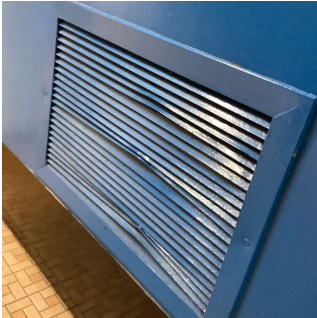
Violations	Staff 3rd Floor No violations recorded.
TOILET ROOMS - STUDENTS	Inspected
Ceiling	Inspected
Condition	2 - Between Good and Fair
Deficiency	No deficiencies recorded
Door(s)	Inspected
Condition	5 - Poor
Deficiency	WOOD: DAMAGED LOUVER

Deficiency Location/Instance	Girls- Cafeteria

Question	Response
INTERIOR	
TOILET ROOMS - STUDENTS	
Door(s)	
Deficiency Quantity	1
Quantity Uom	EACH
Potential Action	MAINTENANCE
Urgency of Action	PRIORITY 3
Purpose of Action	LEVEL 2
Deficiency Photo1

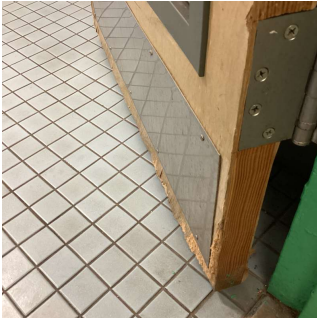
Girls- Cafeteria
Violations	No violations recorded.
Deficiency	WOOD: DETERIORATED DOOR
Deficiency Location/Instance	Room 104, Girls 3rd Floor, Boys 3rd Floor, Boys - Cafeteria
Deficiency Quantity	4
Quantity Uom	EACH
Potential Action	MAINTENANCE
Urgency of Action	PRIORITY 3
Purpose of Action	LEVEL 2
Deficiency Photo1

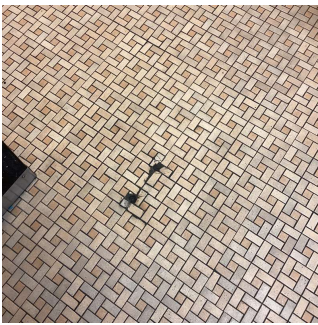
Boys 3rd Floor
Violations	No violations recorded.
Floor Finish	Inspected
Condition	2 - Between Good and Fair
Deficiency	CERAMIC TILE: BROKEN/MISSING TILES
Deficiency Location/Instance	Girls- Cafeteria
Deficiency Quantity	10
Quantity Uom	S.F.
Potential Action	REPLACE
Urgency of Action	PRIORITY 3
Purpose of Action	LEVEL 2

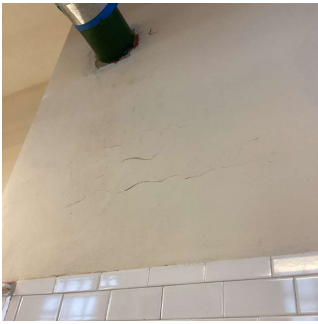
Violations	Girls- Cafeteria No violations recorded.
Stalls	Inspected
Condition	2 - Between Good and Fair
Deficiency	No deficiencies recorded
Walls	Inspected
Condition	2 - Between Good and Fair
Deficiency	PLASTER: CRACKS/SPALLING
Deficiency Location/Instance	Girls - Cafeteria
Deficiency Quantity	30
Quantity Uom	S.F.
Potential Action	REPLACE
Urgency of Action	PRIORITY 3
Purpose of Action	LEVEL 2
Deficiency Photo1

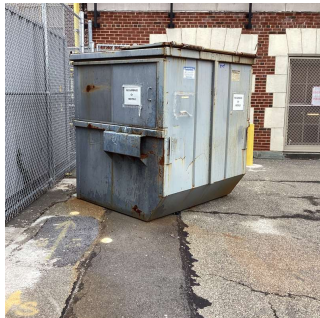
Violations	Parking Area No violations recorded.
Deficiency	CONTAINER DAMAGED
Deficiency Location/Instance	Parking Area
Deficiency Quantity	4
Quantity Uom	EACH
Potential Action	REPLACE
Urgency of Action	PRIORITY 3
Purpose of Action	LEVEL 2
Deficiency Photo1

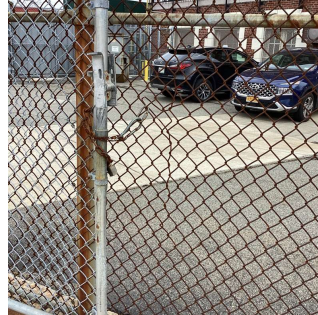
Violations	Parking Area No violations recorded.
Drainage System for Asphalt	Inspected
Catch Basins/Manhole - Surrounded by asphalt	Inspected
Condition	2 - Between Good and Fair
Deficiency	No deficiencies recorded
Culverts - Asphalt Covering	Does not Exist
Drainage System for Concrete	Inspected
Catch Basins/Manhole - Surrounded by concrete	Inspected
Condition	2 - Between Good and Fair
Deficiency	No deficiencies recorded
Culverts - Concrete Covering	Does not Exist
Drainage System for Soil	Does not Exist
DRINKING FOUNTAINS	Does not Exist
FENCES	Inspected
Condition	4 - Between Fair and Poor
Deficiency	CHAIN LINK: DAMAGED/DETERIORATED

Deficiency Location/Instance	130th Street
Deficiency Quantity	50
Quantity Uom	S.F.

REPLACE
PRIORITY 3
LEVEL 2

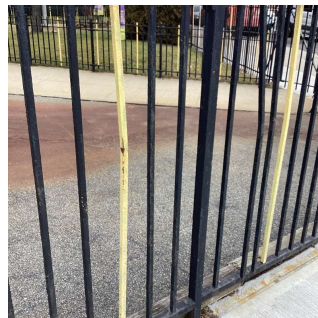
WROUGHT IRON: DAMAGED/DETERIORATED
130th Street, Rockaway Boulevard
160
S.F.
REPLACE
PRIORITY 3
LEVEL 2

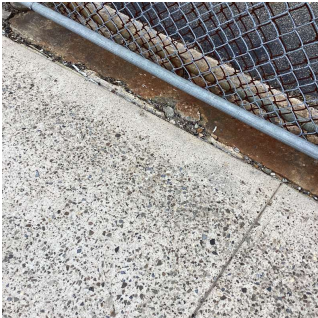
Question	Response
SITE	
FENCES	
Violations	130th Street No violations recorded.
Deficiency	CONCRETE CURB: DAMAGED/DETERIORATED
Deficiency Location/Instance	130th Street, Rockaway Boulevard
Deficiency Quantity	180
Quantity Uom	S.F.
Potential Action	REPLACE
Urgency of Action	PRIORITY 3
Purpose of Action	LEVEL 2
Deficiency Photo1

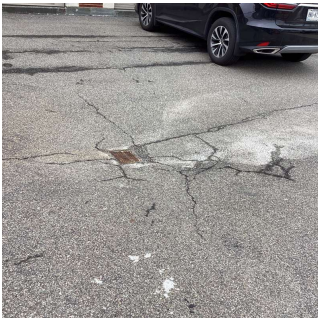
Violations	130th Street No violations recorded.
IRRIGATION SYSTEM	Does not Exist
PAVING	Inspected
Student Non-Use	Inspected
Gravel Exists?	No
Asphalt	Inspected
Condition	3 - Fair
Deficiency	CRACKS - MAJOR
Deficiency Location/Instance	Parking Area
Deficiency Quantity	400
Quantity Uom	S.F.
Potential Action	REPLACE
Urgency of Action	PRIORITY 3
Purpose of Action	LEVEL 2
Deficiency Photo1

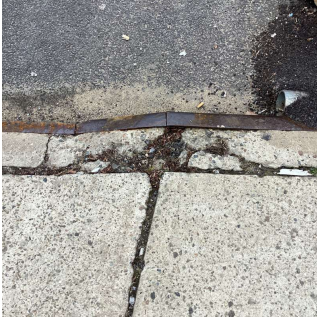
Question	Response
SITE	
PAVING	
DOT Sidewalk	
Concrete	
Condition	4 - Between Fair and Poor
Deficiency	DAMAGED CURBS
Deficiency Location/Instance	130th Street, Rockaway Boulevard, Lincoln Street
Deficiency Quantity	150
Quantity Uom	L.F.
Potential Action	REPLACE
Urgency of Action	PRIORITY 3
Purpose of Action	LEVEL 2
Deficiency Photo1

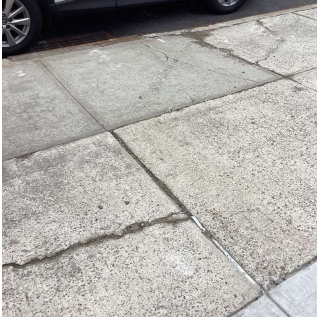
130th Street
Violations	No violations recorded.
Deficiency	DAMAGED/DETERIORATED/MISSING SECTIONS
Deficiency Location/Instance	130th Street, Rockaway Boulevard, Lincoln Street
Deficiency Quantity	700
Quantity Uom	S.F.
Potential Action	REPLACE
Urgency of Action	PRIORITY 3
Purpose of Action	LEVEL 2
Deficiency Photo1

130th Street
Violations	No violations recorded.
Pavers	Does not Exist
PLAYGROUNDS	Does not Exist
PLAYING SURFACE	Does not Exist
RETAINING WALLS	Does not Exist
SEATING	Inspected
Benches	Inspected
Concrete	Does not Exist
Metal/Wood/Plastic	Inspected
