NYC Department of Education
Building Condition Assessment Survey 2023 - 2024

Architectural Inspection

Asset: P.S. 101 - QUEENS, 2 RUSSELL PLACE, New York, 11375

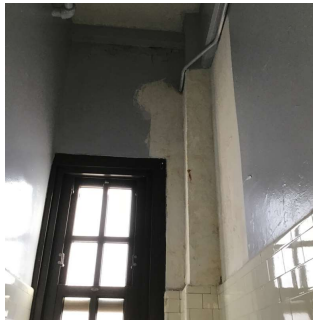
Facade F - 1st Floor Women Toilet Room

Material Type(s)	Inspected Masonry
Replacement Quantity	27,000
Replacement Uom	S.F.
Instance on All Facades	Inspected
Instance Condition	3 - Fair
Instance Quantity	27,000
Instance Quantity Uom	S.F.
Deficiency	BRICK: WATER INFILTRATION IN INSTRUCTIONAL SPACE
Roof Plan reference

REPAIR

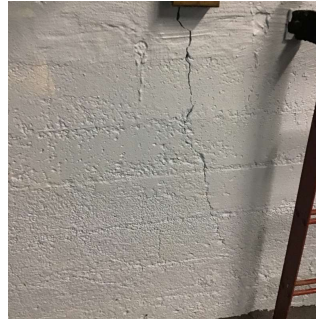
Basement - Fan Area

CONCRETE: CRACKED/SPALLED/REINFORCEMENT EXPOSED

REPAIR
