**NYC Department of Education**  
**Building Condition Assessment Survey 2023 - 2024**

Architectural Inspection

**Asset:** P.S./I.S. 102 - QUEENS, 55-24 VAN HORN STREET, New York, 11373

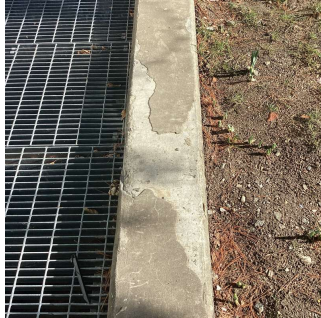
Question	Response
<b>Architectural</b>	
<b>EXTERIOR</b>	Inspected
<b>AREAWAY</b>	Inspected
Instance on AW1-AW3	Inspected
Instance Condition	2 - Between Good and Fair
Instance Quantity	3
Instance Quantity Uom	EACH
Deficiency	AREAWAY WALLS: CRACKS AND SPALLING
Roof Plan reference	Q102
Deficiency Quantity	20
Quantity Uom	S.F.

Question	Response
<b>EXTERIOR</b>	
<b>AREAWAY</b>	
Potential Action	REPAIR
Urgency of Action	PRIORITY 3
Purpose of Action	LEVEL 2
Deficiency Photo1

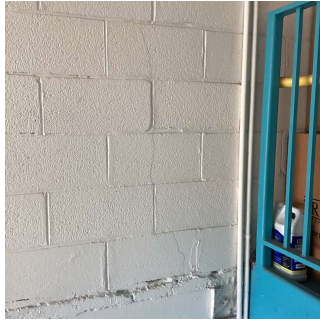
Question	Response
<b>EXTERIOR</b>	
<b>ROOF</b>	
<b>Specialties</b>	
<b>BULKHEAD/PENTHOUSE</b>	
Urgency of Action	PRIORITY 3
Purpose of Action	LEVEL 2
Deficiency Photo1

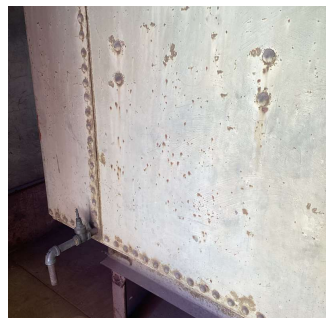
Question	Response
<b>EXTERIOR</b>	
<b>ROOF</b>	
<b>Specialties</b>	
<b>SKYLIGHT/ROOF VENT</b>	Inspected
Condition	2 - Between Good and Fair
Deficiency	No deficiencies recorded
<b>ROOF/GRAVITY TANK</b>	Inspected
Condition	3 - Fair
Deficiency	TANK: NOT IN USE - MINOR DETERIORATION
Roof Plan reference	<p>Q102</p>

Deficiency Quantity	1
Quantity Uom	EACH
Potential Action	NO ACTION
Urgency of Action	PRIORITY 1
Purpose of Action	LEVEL 1
Deficiency Photo1

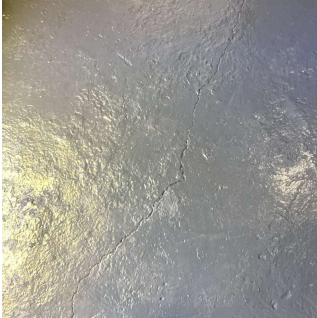
Violations	Basement - Fire Pump Room No violations recorded.
Deficiency	CONCRETE: CRACKS/SPALLED/REINFORCEMENT EXPOSED
Deficiency Location/Instance	PH, Basement - Gas Meter Room
Deficiency Quantity	60
Quantity Uom	S.F.
Potential Action	REPAIR
Urgency of Action	PRIORITY 3
Purpose of Action	LEVEL 5
Deficiency Photo1

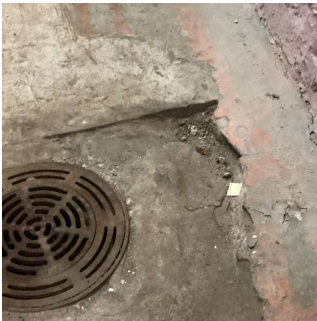
Violations	PH No violations recorded.
Deficiency	CONCRETE SLAB ON GRADE: THRU CRACKS
Deficiency Location/Instance	Basement - Boiler Room, Crawlspace, Fire Pump Room
Deficiency Quantity	60
Quantity Uom	S.F.
Potential Action	REPLACE

Urgency of Action	PRIORITY 4
Purpose of Action	LEVEL 5

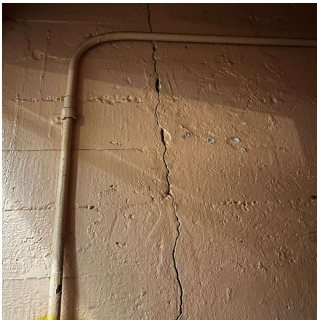
Violations	Basement - Fire Pump Room No violations recorded.
<b>FOUNDATION WALLS</b>	
Material Type(s)	Inspected Concrete, Masonry
Condition	3 - Fair
Deficiency	CONCRETE: CRACKED/SPALLED/REINFORCEMENT EXPOSED
Deficiency Location/Instance	Basement - Boiler Room
Deficiency Quantity	40
Quantity Uom	S.F.
Potential Action	REPAIR
Urgency of Action	PRIORITY 4
Purpose of Action	LEVEL 5
Deficiency Photo1

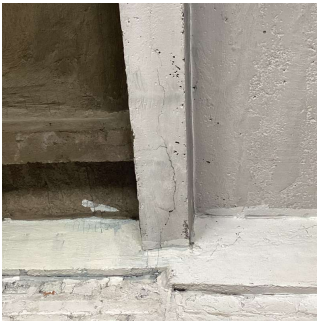
Violations	Basement - Boiler Room No violations recorded.
<b>ROOF STRUCTURE</b>	
Condition	Inspected 3 - Fair
Deficiency	CONCRETE COLUMNS AND BEAMS: CRACKED/SPALLED/REINFORCEMENT EXPOSED
Deficiency Location/Instance	PH
Deficiency Quantity	10
Quantity Uom	S.F.
Potential Action	REPAIR
Urgency of Action	PRIORITY 3
Purpose of Action	LEVEL 5

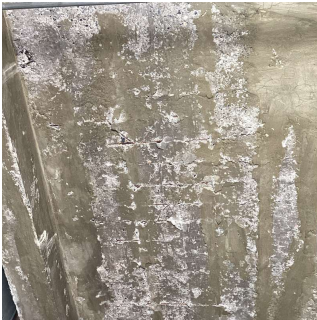
Violations	PH No violations recorded.
Deficiency	CONCRETE: CRACKED/SPALLED/REINFORCEMENT EXPOSED
Deficiency Location/Instance	PH
Deficiency Quantity	20
Quantity Uom	S.F.
Potential Action	REPAIR
Urgency of Action	PRIORITY 3
Purpose of Action	LEVEL 5
Deficiency Photo1

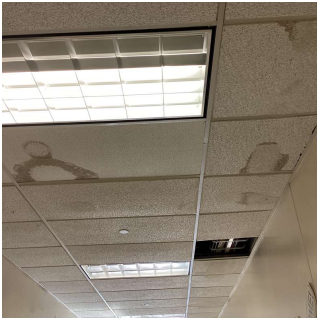
Violations	Corridor near Room 403 No violations recorded.

Violations	Near Entrance No violations recorded.
<b>Window Curtains/Shades/Blinds</b>	
Instance on Basement	Does not Exist
<b>CLASSROOMS/CORRIDORS/ADMIN SPACES</b>	
<b>Ceiling</b>	
Condition	Inspected
Condition	2 - Between Good and Fair
Deficiency	ACOUSTIC TILES: DAMAGED/MISSING - ACTIVE LEAK
Deficiency Location/Instance	Corridor near Rooms 403, 408
Deficiency Quantity	40
Quantity Uom	S.F.
Potential Action	REPLACE
Urgency of Action	PRIORITY 5
Purpose of Action	LEVEL 2
Deficiency Photo1

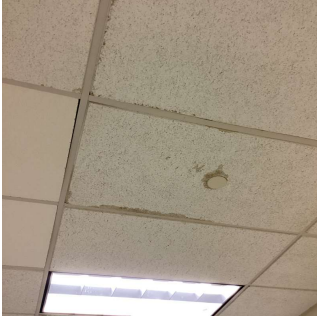
Deficiency	ACOUSTIC TILES: DAMAGED/MISSING
Deficiency Location/Instance	Corridor near Rooms 411, 108, 008, Rooms 405, 401 and others
Deficiency Quantity	220
Quantity Uom	S.F.

Question	Response
<b>INTERIOR</b>	
<b>CLASSROOMS/CORRIDORS/ADMIN SPACES</b>	
<b>Ceiling</b>	
Potential Action	REPLACE
Urgency of Action	PRIORITY 3
Purpose of Action	LEVEL 2
Deficiency Photo1

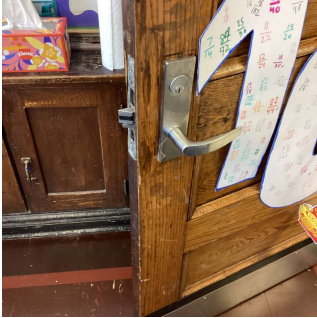
Corridor near Room 008
Violations	No violations recorded.
<b>Door(s)</b>	Inspected
Condition	5 - Poor
Deficiency	WOOD: DETERIORATED DOOR
Deficiency Location/Instance	Rooms 329, 325, 323, 321, 221 and others
Deficiency Quantity	11
Quantity Uom	EACH
Potential Action	MAINTENANCE
Urgency of Action	PRIORITY 3
Purpose of Action	LEVEL 2
Deficiency Photo1

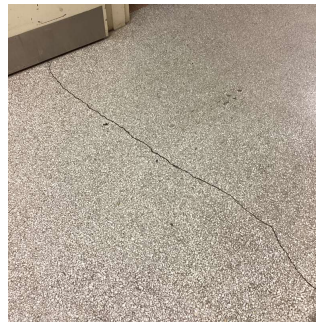
Corridor near Room 225B

Room 323
Violations	No violations recorded.
<b>Floor Finish</b>	Inspected
Condition	3 - Fair
Deficiency	TERRAZZO: CRACKS
Deficiency Location/Instance	Corridor near Rooms 225A, 225B
Deficiency Quantity	40
Quantity Uom	S.F.
Potential Action	REPLACE
Urgency of Action	PRIORITY 3
Purpose of Action	LEVEL 2

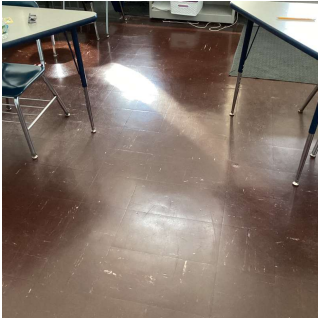
Question	Response
<b>INTERIOR</b>	
<b>CLASSROOMS/CORRIDORS/ADMIN SPACES</b>	
<b>Floor Finish</b>	
Deficiency	VINYL TILES: BROKEN/DETERIORATED/MISSING TILES
Deficiency Location/Instance	Rooms 344, 336, 329, 323, 321 and others
Deficiency Quantity	2,200
Quantity Uom	S.F.
Potential Action	REPLACE
Urgency of Action	PRIORITY 3
Purpose of Action	LEVEL 2
Deficiency Photo1

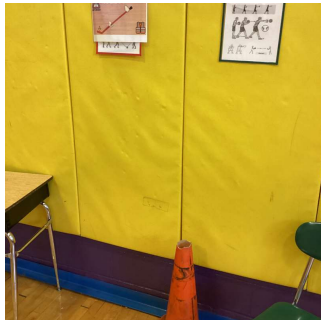
Question	Response
<b>INTERIOR</b>	
<b>GYMNASIUM</b>	
<b>Seating</b>	
Instance on Basement	Inspected
Condition	2 - Between Good and Fair
Deficiency	No deficiencies recorded
<b>Sliding-folding Partition</b>	
Instance on Basement	Inspected
Condition	2 - Between Good and Fair
Deficiency	No deficiencies recorded
<b>Stage</b>	
Instance on Basement	Does not Exist
<b>Walls</b>	
Instance on Basement	Inspected
Condition	2 - Between Good and Fair
Deficiency	WALL PADDING: DETERIORATED
Deficiency Location/Instance	Left Side
Deficiency Quantity	20
Quantity Uom	S.F.
Potential Action	REPLACE
Urgency of Action	PRIORITY 3
Purpose of Action	LEVEL 2
Deficiency Photo1

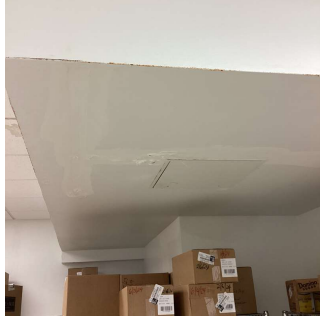
Instance on Basement	Inspected
Condition	2 - Between Good and Fair
Deficiency	No deficiencies recorded
<b>KITCHEN</b>	
Instance on Basement	Inspected
<b>Ceiling</b>	
Instance on Basement	Inspected
Condition	3 - Fair
Deficiency	GYPSUM BOARD: DAMAGED/DETERIORATED
Deficiency Location/Instance	Room 003F
Deficiency Quantity	20
Quantity Uom	S.F.

Question	Response
<b>INTERIOR</b>	
<b>KITCHEN</b>	
<b>Ceiling</b>	
Potential Action	REPLACE
Urgency of Action	PRIORITY 3
Purpose of Action	LEVEL 2
Deficiency Photo1

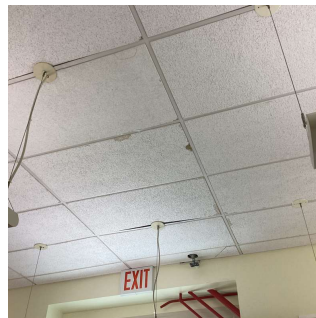
Condition	2 - Between Good and Fair
Deficiency	GYPSON BOARD: DAMAGED/DETERIORATED
Deficiency Location/Instance	Center
Deficiency Quantity	10
Quantity Uom	S.F.
Potential Action	REPLACE
Urgency of Action	PRIORITY 3
Purpose of Action	LEVEL 2

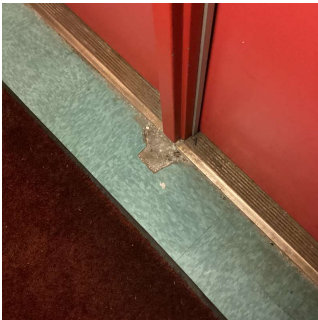
Question	Response
<b>INTERIOR</b>	
<b>STAIRS/RAMPS: INTERIOR</b>	
<b>Partition</b>	Does not Exist
<b>Railings</b>	Inspected
Condition	2 - Between Good and Fair
Deficiency	No deficiencies recorded
<b>Stairs and Landings</b>	Inspected
Condition	2 - Between Good and Fair
Deficiency	VINYL TILES: BROKEN/DETERIORATED/MISSING TILES
Deficiency Location/Instance	Stair G/1 Vestibule
Deficiency Quantity	10
Quantity Uom	S.F.
Potential Action	REPLACE
Urgency of Action	PRIORITY 3
Purpose of Action	LEVEL 2
Deficiency Photo1

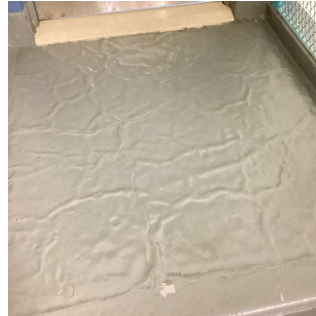
Stair G/3  
No violations recorded.

ROLLED ASPHALT: CRACKS

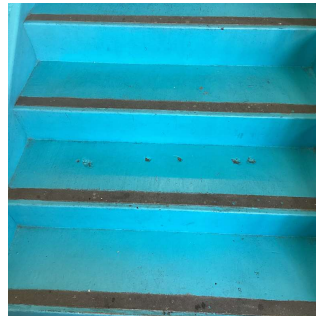
Stair A/3

CONCRETE: CRACKS/SPALLING - MAJOR

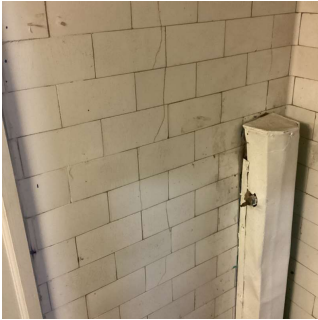
Question	Response
<b>INTERIOR</b>	
<b>STAIRS/RAMPS: INTERIOR</b>	
<b>Stairs and Landings</b>	Inspected
Violations	No violations recorded.
<b>Walls</b>	Inspected
Condition	2 - Between Good and Fair
Deficiency	CERAMIC TILE: BROKEN/ MISSING
Deficiency Location/Instance	Stairs E/1 Vestibule, G/1 Vestibule
Deficiency Quantity	20
Quantity Uom	S.F.
Potential Action	REPLACE
Urgency of Action	PRIORITY 3
Purpose of Action	LEVEL 2
Deficiency Photo1

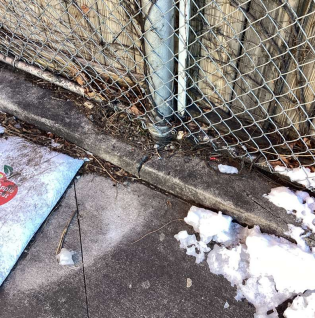
<b>Culverts - Soil Covering</b>	Does not Exist
<b>DRINKING FOUNTAINS</b>	Does not Exist
<b>FENCES</b>	Inspected
Condition	3 - Fair
Deficiency	CONCRETE CURB: DAMAGED/DETERIORATED
Deficiency Location/Instance	Schoolyard
Deficiency Quantity	40
Quantity Uom	S.F.
Potential Action	REPLACE
Urgency of Action	PRIORITY 3
Purpose of Action	LEVEL 2

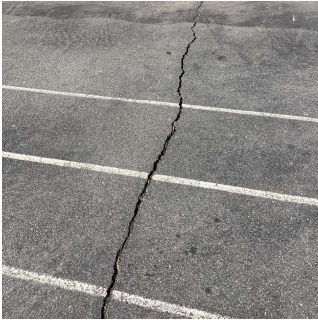
Question	Response
<b>SITE</b>	
<b>IRRIGATION SYSTEM</b>	Does not Exist
<b>PAVING</b>	Inspected
<b>Student Non-Use</b>	Inspected
Gravel Exists?	No
<b>Asphalt</b>	Inspected
Condition	1 - Good
Deficiency	No deficiencies recorded
<b>Concrete</b>	Does not Exist
<b>Pavers</b>	Does not Exist
<b>Student Use</b>	Inspected
Gravel Exists?	No
<b>Asphalt</b>	Inspected
Condition	4 - Between Fair and Poor
Deficiency	CRACKS - MAJOR
Deficiency Location/Instance	Schoolyard
Deficiency Quantity	1,200
Quantity Uom	S.F.
Potential Action	REPLACE
Urgency of Action	PRIORITY 3
Purpose of Action	LEVEL 2
Deficiency Photo1

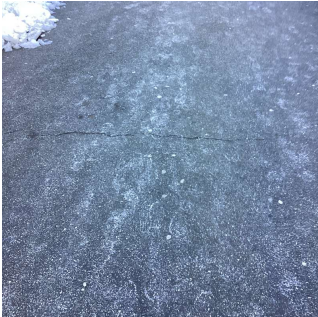
Deficiency	CRACKS - MAJOR
Deficiency Location/Instance	Exit 3
Deficiency Quantity	50
Quantity Uom	S.F.
Potential Action	REPLACE
Urgency of Action	PRIORITY 3
Purpose of Action	LEVEL 2

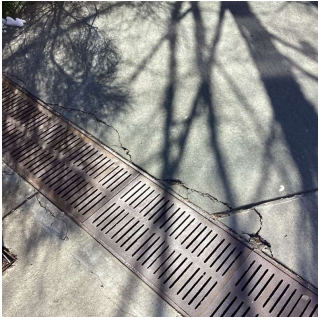
Violations	Exit 3 No violations recorded.
<b>Concrete</b>	Inspected
Condition	3 - Fair
Deficiency	CRACKS - MAJOR
Deficiency Location/Instance	Van Horn Street, Exits 9, 2
Deficiency Quantity	200
Quantity Uom	S.F.
Potential Action	REPLACE
Urgency of Action	PRIORITY 3
Purpose of Action	LEVEL 2
Deficiency Photo1

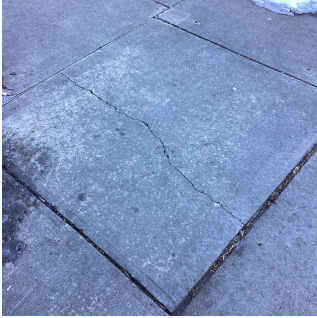
Violations	Van Horn Street No violations recorded.
<b>Pavers</b>	Does not Exist
<b>DOT Sidewalk</b>	Inspected
<b>Asphalt</b>	Does not Exist
<b>Concrete</b>	Inspected
Condition	4 - Between Fair and Poor
Deficiency	DAMAGED/DETERIORATED/MISSING SECTIONS
Deficiency Location/Instance	Van Horn Street
Deficiency Quantity	675
Quantity Uom	S.F.
Potential Action	REPLACE
Urgency of Action	PRIORITY 3
Purpose of Action	LEVEL 2

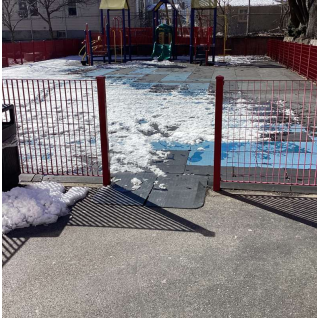
Violations	Van Horn Street No violations recorded.
<b>Pavers</b>	Does not Exist
<b>PLAYGROUNDS</b>	Inspected
Instance on West side of Schoolyard	Inspected
Instance on East side of Schoolyard	Inspected
<b>Benches</b>	
Instance on West side of Schoolyard	Does not Exist
Instance on East side of Schoolyard	Does not Exist
<b>Fence</b>	
Instance on West side of Schoolyard	Inspected
Condition	2 - Between Good and Fair
Deficiency	ALUMINUM: DAMAGED/DETERIORATED
Deficiency Location/Instance	Main Entrance
Deficiency Quantity	40
Quantity Uom	S.F.
Potential Action	REPLACE
Urgency of Action	PRIORITY 3
Purpose of Action	LEVEL 2
Deficiency Photo1

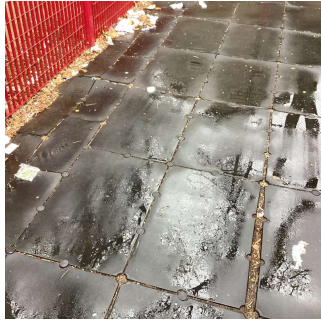
Question	Response
<b>SITE</b>	
<b>PLAYGROUNDS</b>	
<b>Play Equipment</b>	
Deficiency	No deficiencies recorded
Instance on East side of Schoolyard	Inspected
Condition	2 - Between Good and Fair
Deficiency	No deficiencies recorded
<b>Safety Surfacing</b>	
Instance on West side of Schoolyard	Inspected
Condition	3 - Fair
Deficiency	DETERIORATED/MISSING
Deficiency Location/Instance	Entrance Ramp, Center, Rear
Deficiency Quantity	50
Quantity Uom	S.F.
Potential Action	REPLACE
Urgency of Action	PRIORITY 3
Purpose of Action	LEVEL 2
Deficiency Photo1

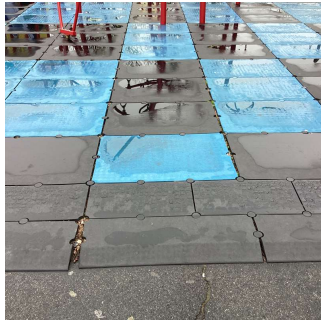
Rear
Violations	No violations recorded.
Instance on East side of Schoolyard	Inspected
Condition	3 - Fair
Deficiency	DETERIORATED/MISSING
Deficiency Location/Instance	East Side, West Side
Deficiency Quantity	50
Quantity Uom	S.F.
Potential Action	MAINTENANCE
Urgency of Action	PRIORITY 3
Purpose of Action	LEVEL 2
Deficiency Photo1

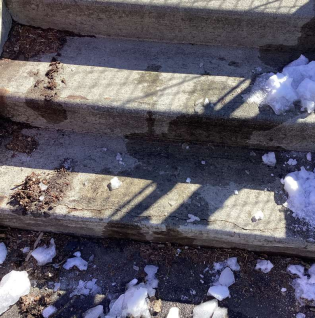
Violations	Schoolyard No violations recorded.
<b>Stairs/ramps</b>	
Condition	Inspected
Deficiency	2 - Between Good and Fair
Deficiency Location/Instance	CAST IN PLACE CONCRETE: CRACKS/SPALLING - MAJOR
Deficiency Location/Instance	Schoolyard
Deficiency Quantity	40
Quantity Uom	S.F.
Potential Action	REPLACE
Urgency of Action	PRIORITY 3
Purpose of Action	LEVEL 2
Deficiency Photo1
