NYC Department of Education
Building Condition Assessment Survey 2023 - 2024

Architectural Inspection

Asset: P.S. 108 - QUEENS, 108-10 109 AVENUE, New York, 11420

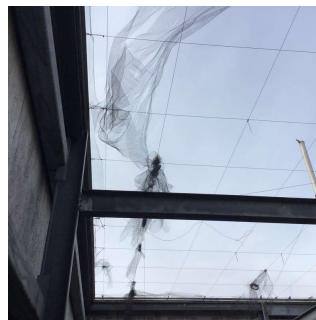
Roof 6

Deficiency	MESH: DETERIORATED
------------	--------------------

REPLACE

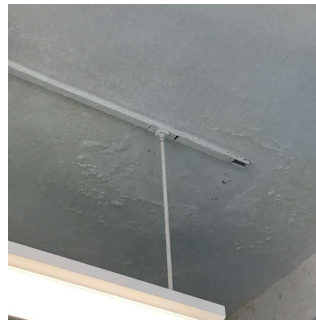
Roof 1 - Room 556

Deficiency MODIFIED BITUMEN: ROOFING: MAJOR ACTIVE ROOF LEAKS IN INSTRUCTIONAL SPACE

REPLACE ROOFING WITHOUT MAJOR EQUIPMENT REMOVAL

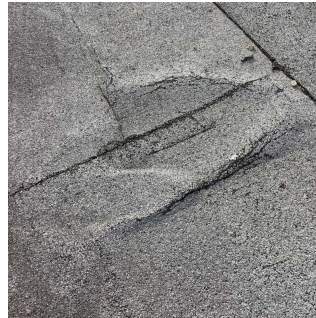
Roof 6

MODIFIED BITUMEN: ROOFING: DELAMINATION

100
S.F.
REPLACE ROOFING WITHOUT MAJOR EQUIPMENT
REMOVAL
PRIORITY 4
LEVEL 2

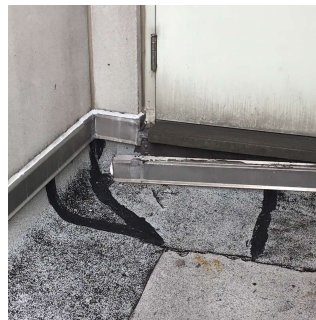
Roof 6

MODIFIED BITUMEN: FLASHING: CAP FLASHING DAMAGED

REPLACE

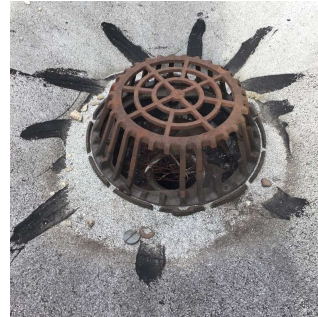
Roof 6
No violations recorded.

DETERIORATED

3
EACH
REPLACE
PRIORITY 4
LEVEL 2

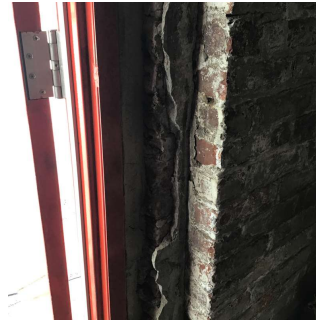
Roof 1 - Tank Room

BULKHEAD/PENTHOUSE WALLS/INTERIOR: BRICK
CRACKS/SPALLING

20
S.F.
REPLACE
PRIORITY 3
LEVEL 2

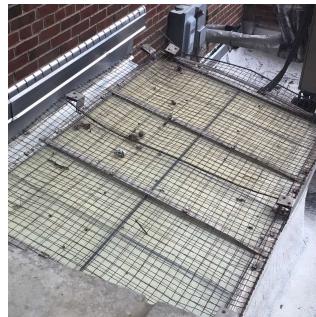
Roof 9

DAMAGED GUARDS

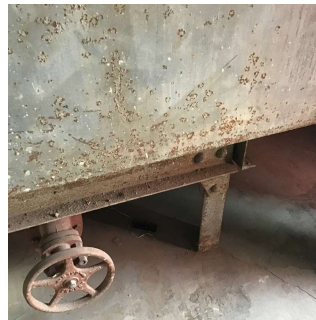
Roof 1 - Tank Room

TANK: NOT IN USE - MINOR DETERIORATION

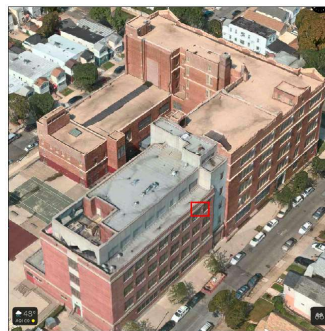
100
L.F.
REPLACE TRIM, SILLS OR WEATHERSTRIPPING
PRIORITY 5
LEVEL 2

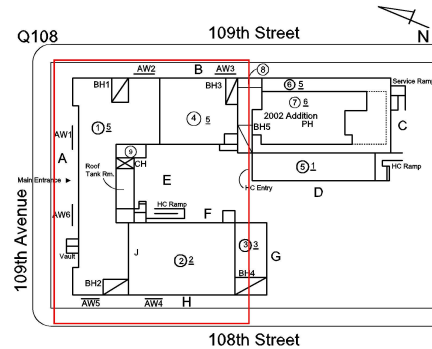
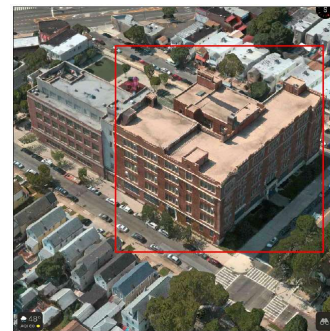
ALUMINUM - DOUBLE HUNG: BROKEN PANE

40

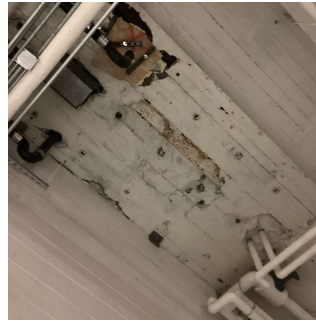
Storage Room

METAL DECK AND CONCRETE: DETERIORATED

REPAIR

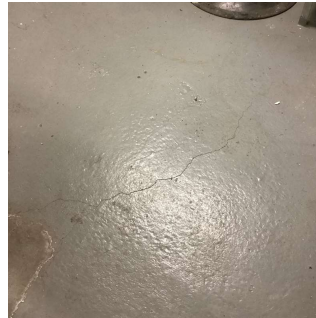
Chiller Room 546

METAL DECK AND CONCRETE: DETERIORATED

REPAIR

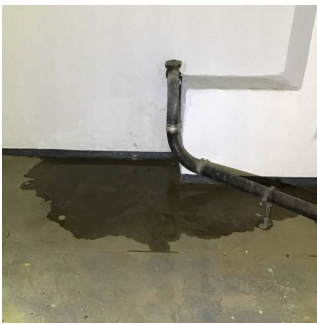
Question	Response
INTERIOR	
STRUCTURAL	
FOUNDATION WALLS	
Deficiency Photo1

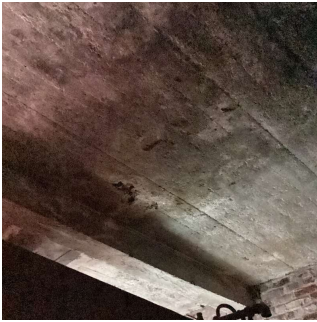
Violations	Sub-Basement - Boiler Room No violations recorded.
ROOF STRUCTURE	
Condition	Inspected 2 - Between Good and Fair
Deficiency	CONCRETE: CRACKED/SPALLED/REINFORCEMENT EXPOSED
Deficiency Location/Instance	PH1
Deficiency Quantity	20
Quantity Uom	S.F.
Potential Action	REPAIR
Urgency of Action	PRIORITY 3
Purpose of Action	LEVEL 5
Deficiency Photo1

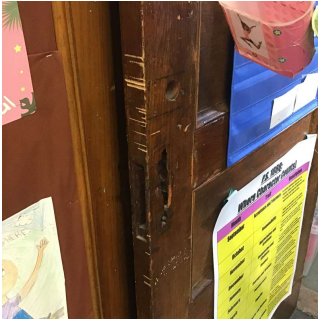
Question	Response
INTERIOR	
AUDITORIUM	
Ceiling	
Deficiency	No deficiencies recorded
Door(s)	
Instance on 2nd Floor (720 Seats)	Inspected
Condition	5 - Poor
Deficiency	WOOD: DETERIORATED DOOR
Deficiency Location/Instance	Rear Right and Left of Stage, Room 258
Deficiency Quantity	3
Quantity Uom	EACH
Potential Action	MAINTENANCE
Urgency of Action	PRIORITY 3
Purpose of Action	LEVEL 2
Deficiency Photo1

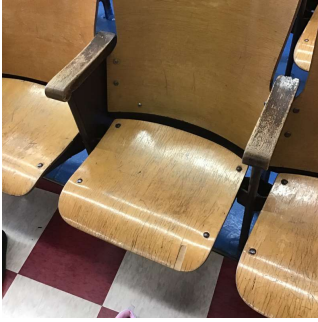
Rear Right of Stage
Violations	No violations recorded.
Fixed H/C Lift	
Instance on 2nd Floor (720 Seats)	Does not Exist
Fixed Seating	
Instance on 2nd Floor (720 Seats)	Inspected
Condition	5 - Poor
Deficiency	DAMAGED/BROKEN/INOPERABLE
Deficiency Location/Instance	Seat A/8,14,16, B/14,16 and others
Deficiency Quantity	73
Quantity Uom	EACH
Potential Action	REPLACE
Urgency of Action	PRIORITY 3
Purpose of Action	LEVEL 2
Deficiency Photo1

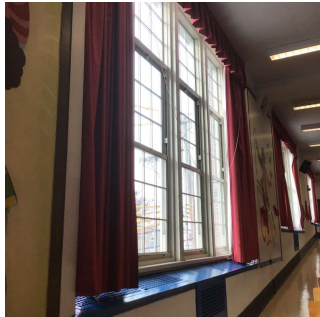
Question	Response
INTERIOR	
AUDITORIUM	
Stage	
Stage Curtain Rigging	Inspected
Condition	2 - Between Good and Fair
Deficiency	No deficiencies recorded
Stage Curtains	Inspected
Instance on 2nd Floor (720 Seats)	Inspected
Condition	2 - Between Good and Fair
Deficiency	No deficiencies recorded
Walls	
Instance on 2nd Floor (720 Seats)	Inspected
Condition	2 - Between Good and Fair
Deficiency	No deficiencies recorded
Window Curtains/Shades/Blinds	
Instance on 2nd Floor (720 Seats)	Inspected
Condition	5 - Poor
Deficiency	INOPERABLE CURTAINS
Deficiency Location/Instance	All 6 Windows
Deficiency Quantity	6
Quantity Uom	EACH
Potential Action	MAINTENANCE
Urgency of Action	PRIORITY 3
Purpose of Action	LEVEL 2
Deficiency Photo1

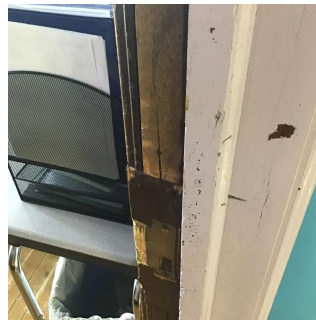
Room 407

WOOD: DETERIORATED DOOR AND FRAME

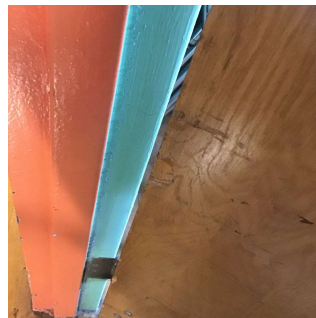
WOOD: DETERIORATED DOOR

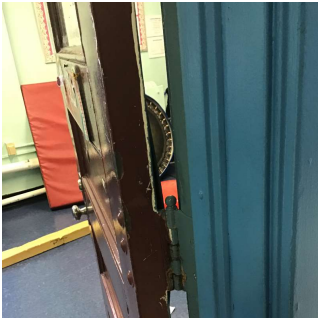
Question	Response
INTERIOR	
CLASSROOMS/CORRIDORS/ADMIN SPACES	
Door(s)	
Violations	Room 502 No violations recorded.
Deficiency	METAL CLAD WOOD: DETERIORATED DOOR
Deficiency Location/Instance	Room 455, Corridor near Room 410
Deficiency Quantity	2
Quantity Uom	EACH
Potential Action	MAINTENANCE
Urgency of Action	PRIORITY 3
Purpose of Action	LEVEL 2
Deficiency Photo1

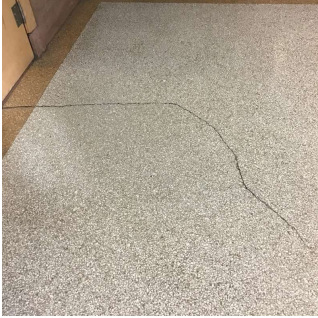
Violations	Room 445 No violations recorded.
Floor Finish	Inspected
Condition	2 - Between Good and Fair
Deficiency	TERRAZZO: CRACKS
Deficiency Location/Instance	Main Lobby, Main Vestibule, Corridor near room 211, 212, 213 and others
Deficiency Quantity	100
Quantity Uom	S.F.
Potential Action	REPLACE
Urgency of Action	PRIORITY 3
Purpose of Action	LEVEL 2
Deficiency Photo1

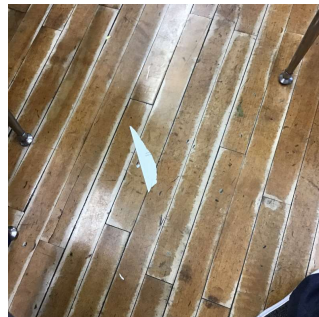
Violations	Main Lobby No violations recorded.
Deficiency	WOOD: DETERIORATED SUBSTRATE
Deficiency Location/Instance	Room 510
Deficiency Quantity	15
Quantity Uom	S.F.
Potential Action	REPLACE

Question	Response
INTERIOR	
CLASSROOMS/CORRIDORS/ADMIN SPACES	
Floor Finish	
Purpose of Action	LEVEL 2
Deficiency Photo1

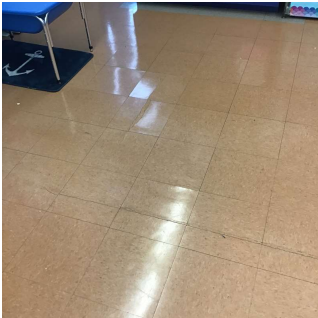
Question	Response
INTERIOR	
CLASSROOMS/CORRIDORS/ADMIN SPACES	
Floor Finish	
Violations	No violations recorded.
Deficiency	VINYL TILES: DETERIORATED SUBSTRATE
Deficiency Location/Instance	Rooms 201, 318, 412, 504, Corridor Near room 543, and others
Deficiency Quantity	300
Quantity Uom	S.F.
Potential Action	REPLACE
Urgency of Action	PRIORITY 3
Purpose of Action	LEVEL 2
Deficiency Photo1

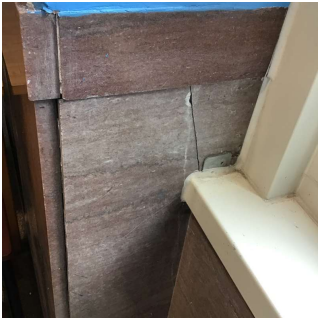
Violations	Room 201 No violations recorded.
Walls	Inspected
Condition	2 - Between Good and Fair
Deficiency	STONE: CRACKS/SPALLING
Deficiency Location/Instance	Corridor near Auditorium
Deficiency Quantity	20
Quantity Uom	S.F.
Potential Action	REPLACE
Urgency of Action	PRIORITY 3
Purpose of Action	LEVEL 2
Deficiency Photo1

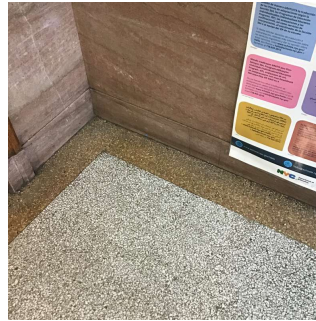
Corridor near room 164

Violations	Main Entrance Vestibule No violations recorded.
Deficiency	STONE MOLDINGS: CRACKS/SPALLING
Deficiency Location/Instance	Corridor near room 164, Main Entrance Vestibule
Deficiency Quantity	15
Quantity Uom	L.F.

Potential Action	REPLACE
Urgency of Action	PRIORITY 3
Purpose of Action	LEVEL 2

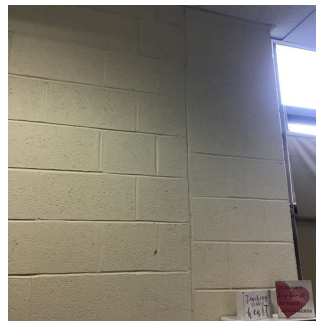
Room 414

MASONRY: CRACKS/SPALLING

REPLACE

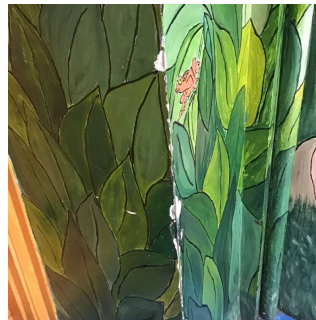
Near Stair C/4

PLASTER: CRACKS/SPALLING

REPLACE

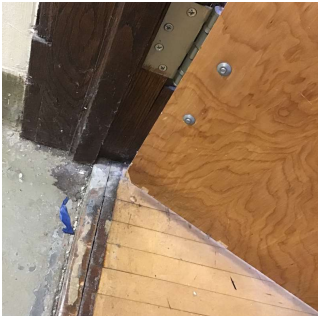
Question	Response
INTERIOR	
CLASSROOMS/CORRIDORS/ADMIN SPACES	
Specialties	Inspected
Classroom Locker(s)	Inspected
Condition	2 - Between Good and Fair
Deficiency	No deficiencies recorded
Fixed Seating	Does not Exist
GYMNASIUM	
Instance on Basement	Inspected
Ceiling	
Instance on Basement	Inspected
Condition	2 - Between Good and Fair
Deficiency	No deficiencies recorded
Door(s)	
Instance on Basement	Inspected
Condition	5 - Poor
Deficiency	METAL CLAD WOOD: DETERIORATED DOOR
Deficiency Location/Instance	Near room 168
Deficiency Quantity	2
Quantity Uom	EACH
Potential Action	MAINTENANCE
Urgency of Action	PRIORITY 3
Purpose of Action	LEVEL 2
Deficiency Photo1	 
	Near room 168
Violations	No violations recorded.
Deficiency	WOOD: DETERIORATED DOOR
Deficiency Location/Instance	Storage Room
Deficiency Quantity	1
Quantity Uom	EACH
Potential Action	MAINTENANCE
Urgency of Action	PRIORITY 3
Purpose of Action	LEVEL 2
Deficiency Photo1

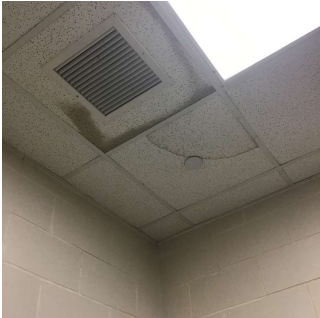
Violations	Gymnasium No violations recorded.
KITCHEN	Inspected
Instance on 1st Floor	Inspected
Ceiling	
Instance on 1st Floor	Inspected
Condition	2 - Between Good and Fair
Deficiency	ACOUSTIC TILES: DAMAGED/MISSING
Deficiency Location/Instance	Rooms 152, 164
Deficiency Quantity	25
Quantity Uom	S.F.
Potential Action	REPLACE
Urgency of Action	PRIORITY 3
Purpose of Action	LEVEL 2
Deficiency Photo1

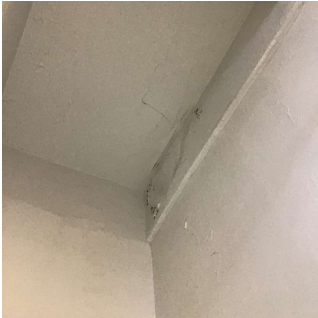
Question	Response
INTERIOR	
MULTI-PURPOSE ROOM	
Walls	
Instance on 1st Floor	Inspected
Condition	2 - Between Good and Fair
Deficiency	No deficiencies recorded
Window Curtains/Shades/Blinds	
Instance on 1st Floor	Does not Exist
SCIENCE DEMO ROOM	
Does not Exist	
SCIENCE LAB	
Does not Exist	
SCIENCE PREP ROOM	
Does not Exist	
SHOWER ROOM	
Does not Exist	
STAIRS/RAMPS: INTERIOR	
Inspected	
Do Letter Stair Signs Exist?	Partially
Ceiling	
Inspected	
Condition	2 - Between Good and Fair
Deficiency	PLASTER: CRACKS/SPALLING
Deficiency Location/Instance	Stair H/4
Deficiency Quantity	20
Quantity Uom	S.F.
Potential Action	REPLACE
Urgency of Action	PRIORITY 3
Purpose of Action	LEVEL 2
Deficiency Photo1

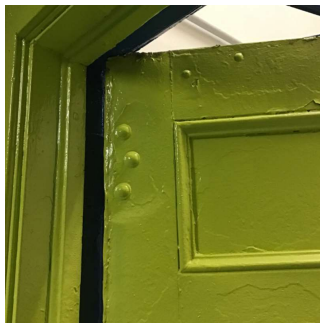
Stair H/4
Violations	No violations recorded.
Door(s)	
Inspected	
Condition	3 - Fair
Deficiency	METAL CLAD WOOD: DETERIORATED DOOR
Deficiency Location/Instance	Stair C/4,3,2 Stair F/1 (Door Left of Auditorium Stage)
Deficiency Quantity	4

Quantity Uom	EACH
Potential Action	MAINTENANCE
Urgency of Action	PRIORITY 3
Purpose of Action	LEVEL 2

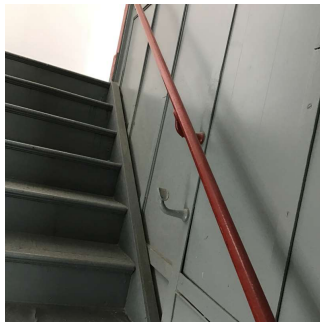
Violations	Stair C/4 No violations recorded.
Partition	Inspected
Condition	2 - Between Good and Fair
Deficiency	No deficiencies recorded
Railings	Inspected
Condition	3 - Fair
Deficiency	METAL: MISSING
Deficiency Location/Instance	Stair H/Bulkhead
Deficiency Quantity	13
Quantity Uom	L.F.
Potential Action	REPLACE
Urgency of Action	PRIORITY 5
Purpose of Action	LEVEL 6
Deficiency Photo1

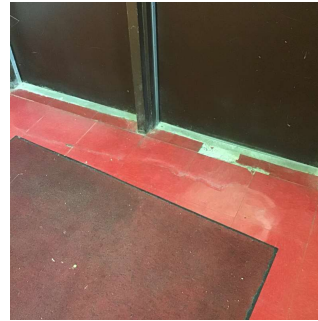
Violations	Stair H/Bulkhead No violations recorded.
Stairs and Landings	Inspected
Condition	5 - Poor
Deficiency	SHEET VINYL: DETERIORATED SUBSTRATE
Deficiency Location/Instance	Stair G/Basement
Deficiency Quantity	20
Quantity Uom	S.F.
Potential Action	REPLACE
Urgency of Action	PRIORITY 3
Purpose of Action	LEVEL 2

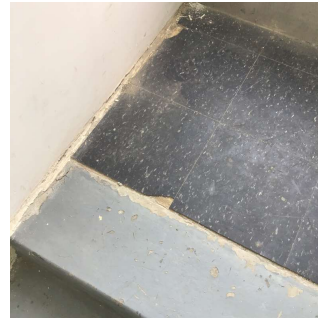
Stair H/5

VINYL TILES: BROKEN/DETERIORATED/MISSING TILES

REPLACE

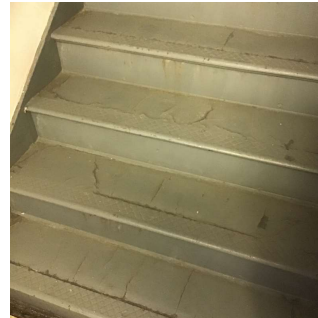
Stair H/5

ROLLED ASPHALT: CRACKS

REPLACE

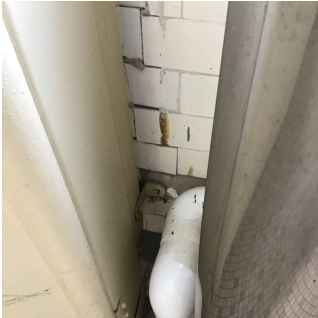
Question	Response
INTERIOR	
TOILET ROOMS - STAFF	Inspected
Stalls	Inspected
	Room 456
Violations	No violations recorded.
Walls	Inspected
Condition	2 - Between Good and Fair
Deficiency	CERAMIC TILE: BROKEN/ MISSING
Deficiency Location/Instance	Rooms 557, 360, 456,541
Deficiency Quantity	30
Quantity Uom	S.F.
Potential Action	REPLACE
Urgency of Action	PRIORITY 3
Purpose of Action	LEVEL 2
Deficiency Photo1

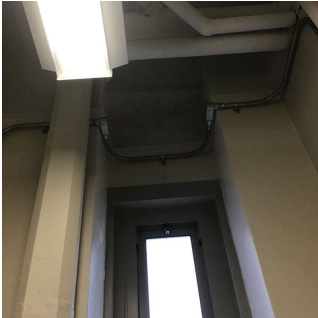
Room 557
Violations	No violations recorded.
Deficiency	PLASTER: CRACKS/SPALLING
Deficiency Location/Instance	Rooms 164
Deficiency Quantity	30
Quantity Uom	S.F.
Potential Action	REPLACE
Urgency of Action	PRIORITY 3
Purpose of Action	LEVEL 2
Deficiency Photo1

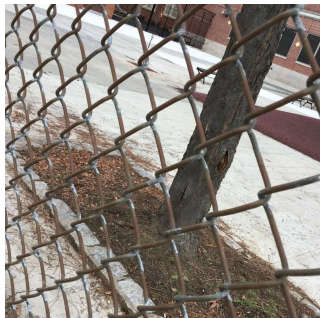
Question	Response
SITE	
DRINKING FOUNTAINS	Inspected
Condition	2 - Between Good and Fair
Deficiency	No deficiencies recorded
FENCES	Inspected
Condition	4 - Between Fair and Poor
Deficiency	CHAIN LINK: RUST - MAJOR
Deficiency Location/Instance	Schoolyard
Deficiency Quantity	2,400
Quantity Uom	S.F.
Potential Action	REPLACE
Urgency of Action	PRIORITY 3
Purpose of Action	LEVEL 2
Deficiency Photo1

Schoolyard
Violations	No violations recorded.
Deficiency	CONCRETE CURB: DAMAGED/DETERIORATED
Deficiency Location/Instance	108th Street
Deficiency Quantity	50
Quantity Uom	S.F.
Potential Action	REPLACE
Urgency of Action	PRIORITY 3
Purpose of Action	LEVEL 2
Deficiency Photo1

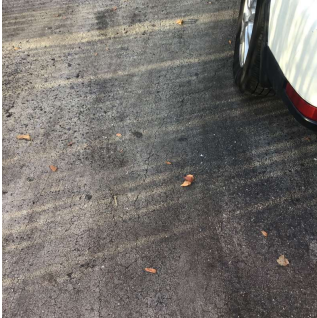
108th Street
Violations	No violations recorded.
IRRIGATION SYSTEM	Does not Exist
PAVING	Inspected
Student Non-Use	Inspected
Gravel Exists?	No
Asphalt	Does not Exist
Concrete	Inspected
Condition	3 - Fair
Deficiency	CRACKS - MAJOR

Question	Response
SITE	
PAVING	
Student Non-Use	
Concrete	
Deficiency Location/Instance	109th Street
Deficiency Quantity	60
Quantity Uom	S.F.
Potential Action	REPLACE
Urgency of Action	PRIORITY 3
Purpose of Action	LEVEL 2
Deficiency Photo1

Violations	109th Street No violations recorded.
Pavers	Does not Exist
Student Use	Inspected
Gravel Exists?	No
Asphalt	Inspected
Condition	1 - Good
Deficiency	No deficiencies recorded
Concrete	Inspected
Condition	3 - Fair
Deficiency	CRACKS - MAJOR
Deficiency Location/Instance	Schoolyard
Deficiency Quantity	425
Quantity Uom	S.F.
Potential Action	REPLACE
Urgency of Action	PRIORITY 3
Purpose of Action	LEVEL 2
Deficiency Photo1

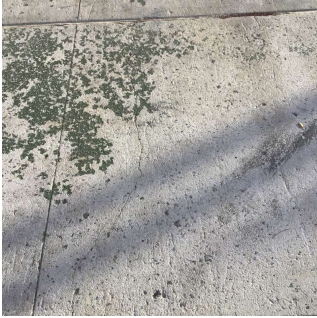
Violations	Schoolyard No violations recorded.
Pavers	Does not Exist
Site Sidewalks & Walkways	Inspected
Asphalt	Does not Exist

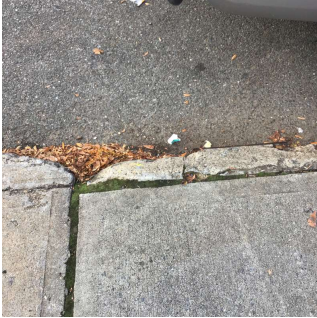
Question	Response
SITE	
PAVING	
Site Sidewalks & Walkways	
Concrete	Inspected
Condition	2 - Between Good and Fair
Deficiency	No deficiencies recorded
Pavers	Does not Exist
DOT Sidewalk	Inspected
Asphalt	Does not Exist
Concrete	Inspected
Condition	4 - Between Fair and Poor
Deficiency	DAMAGED/DETERIORATED/MISSING SECTIONS
Deficiency Location/Instance	108th Street, 109th Street, 109th Avenue
Deficiency Quantity	625
Quantity Uom	S.F.
Potential Action	REPLACE
Urgency of Action	PRIORITY 3
Purpose of Action	LEVEL 2
Deficiency Photo1	 
	108th Street
Violations	No violations recorded.
Deficiency	DAMAGED CURBS
Deficiency Location/Instance	108th Street, 109th Street, 109th Avenue
Deficiency Quantity	100
Quantity Uom	L.F.
Potential Action	REPLACE
Urgency of Action	PRIORITY 3
Purpose of Action	LEVEL 2
Deficiency Photo1

108th Street
Violations	No violations recorded.
Deficiency	HEAVING
Deficiency Location/Instance	108th Street
Deficiency Quantity	25

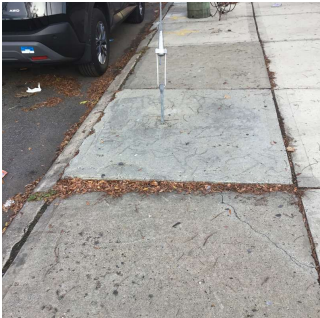
Question	Response
SITE	
PAVING	
DOT Sidewalk	
Concrete	
Quantity Uom	S.F.
Potential Action	REPLACE
Urgency of Action	PRIORITY 3
Purpose of Action	LEVEL 2
Deficiency Photo1

Violations	108th Street No violations recorded.
Pavers	Does not Exist
PLAYGROUNDS	Inspected
Instance on Schoolyard- South	Inspected
Instance on Schoolyard-North	Inspected
Benches	
Instance on Schoolyard- South	Does not Exist
Instance on Schoolyard-North	Does not Exist
Fence	
Instance on Schoolyard-North	Does not Exist
Instance on Schoolyard- South	Does not Exist
Pavement	
Instance on Schoolyard- South	Does not Exist
Instance on Schoolyard-North	Does not Exist
Play Equipment	
Instance on Schoolyard-North	Inspected
Condition	2 - Between Good and Fair
Deficiency	No deficiencies recorded
Instance on Schoolyard- South	Inspected
Condition	2 - Between Good and Fair
Deficiency	No deficiencies recorded
Safety Surfacing	
Instance on Schoolyard-North	Inspected

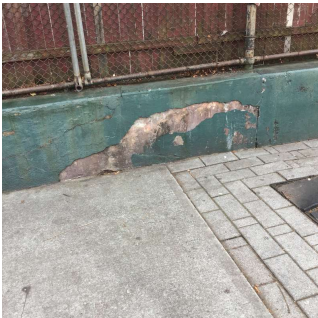
Question	Response
SITE	
SITE WALLS (NOT RETAINING WALLS)	Inspected
Condition	3 - Fair
Deficiency	CAST IN PLACE CONCRETE: CRACKS/SPALLING - MAJOR
Deficiency Location/Instance	Rear Schoolyard
Deficiency Quantity	120
Quantity Uom	S.F.
Potential Action	REPLACE
Urgency of Action	PRIORITY 3
Purpose of Action	LEVEL 2
Deficiency Photo1

Violations	Rear Schoolyard No violations recorded.
STAIRS/RAMPS: EXTERIOR	Inspected
Railings	Does not Exist
Site Cheek/flank Walls	Does not Exist
Stairs/ramps	Inspected
Condition	2 - Between Good and Fair
Deficiency	CAST IN PLACE CONCRETE: CRACKS/SPALLING - MAJOR
Deficiency Location/Instance	Rear Schoolyard
Deficiency Quantity	20
Quantity Uom	S.F.
Potential Action	REPLACE
Urgency of Action	PRIORITY 3
Purpose of Action	LEVEL 2
Deficiency Photo1
