**NYC Department of Education**  
**Building Condition Assessment Survey 2023 - 2024**

Architectural Inspection

**Asset:** I.S. 109 - QUEENS, 213-10 92 AVENUE, New York, 11428

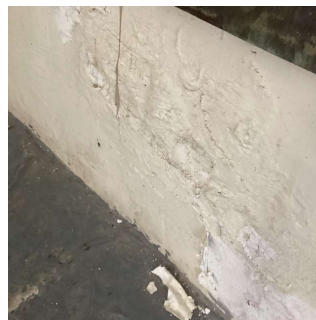
Roof 1 - Bulkhead 1

Violations	No violations recorded.
Deficiency	BULKHEAD/PENTHOUSE WALLS/INTERIOR: PLASTER CRACKS/SPALLING

40  
S.F.  
REPLACE  
PRIORITY 3  
LEVEL 2

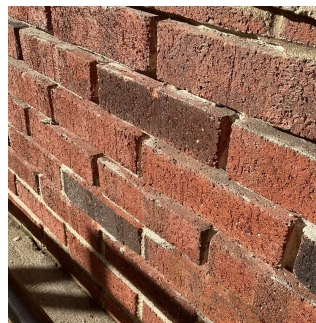
Facade C

**BRICK: DETERIORATED JOINTS**

50

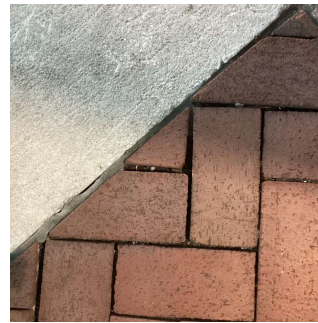
Facade A

**BRICK: DETERIORATED JOINTS**

10  
S.F.  
REPOINT  
PRIORITY 4  
LEVEL 2

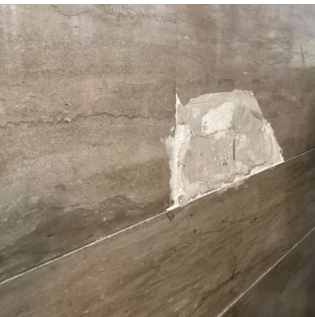
Question	Response
<b>INTERIOR</b>	
<b>AUDITORIUM</b>	
<b>Walls</b>	
Purpose of Action	LEVEL 2
Deficiency Photo1

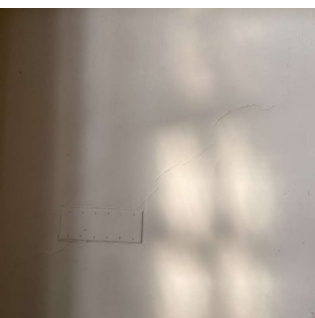
<p data-bbox="917 661 1230 745">Near Windows No violations recorded.</p>
Violations	No violations recorded.
Deficiency	PLASTER: CRACKS/SPALLING
Deficiency Location/Instance	Near Entrance, Windows
Deficiency Quantity	50
Quantity Uom	S.F.
Potential Action	REPLACE
Urgency of Action	PRIORITY 3
Purpose of Action	LEVEL 2
Deficiency Photo1

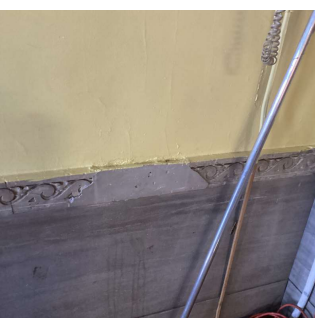
<p data-bbox="917 1963 1230 2001">Near Windows</p>

<p data-bbox="917 1312 1230 1323">Near Entrance</p>
Violations	No violations recorded.
Deficiency	STONE MOLDINGS: CRACKS/SPALLING
Deficiency Location/Instance	Near Windows
Deficiency Quantity	30
Quantity Uom	L.F.
Potential Action	REPLACE
Urgency of Action	PRIORITY 3
Purpose of Action	LEVEL 2
Deficiency Photo1

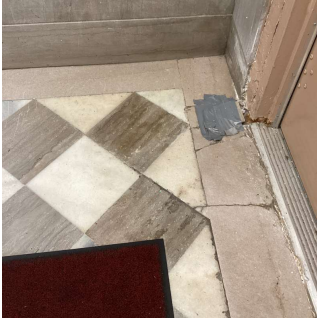
Question	Response
<b>INTERIOR</b>	
<b>CLASSROOMS/CORRIDORS/ADMIN SPACES</b>	
<b>Floor Finish</b>	
Violations	Room 514 35663190P
Deficiency	STONE: BROKEN/MISSING TILES
Deficiency Location/Instance	Main Entrance, Exit 6 - Vestibule
Deficiency Quantity	20
Quantity Uom	S.F.
Potential Action	REPLACE
Urgency of Action	PRIORITY 3
Purpose of Action	LEVEL 2
Deficiency Photo1

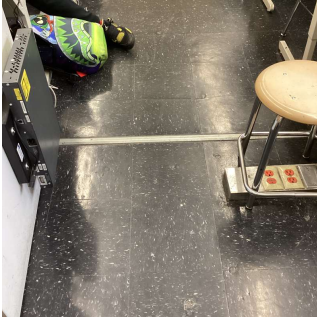
Violations	Exit 6 - Vestibule No violations recorded.
Deficiency	VINYL TILES: TRIPPING HAZARD - ELECTRICAL OUTLET
Deficiency Location/Instance	Room 402
Deficiency Quantity	10
Quantity Uom	S.F.
Potential Action	REMOVE
Urgency of Action	PRIORITY 5
Purpose of Action	LEVEL 6
Deficiency Photo1

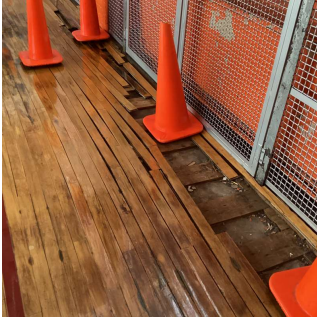
Yes	Tripping Hazard	Severely Heaving wood Floor is a tripping hazard Condition.	INTERIOR   GYMNASIUM   Floor Finish	Near Windows left Side	Carlton Worrie	Cleaner

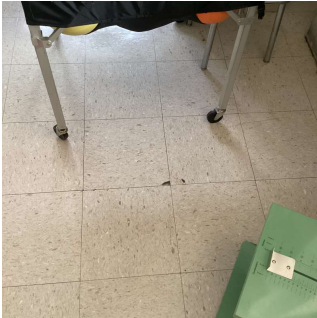
Violations	Near Windows No violations recorded.
Instance on 5th Floor	Inspected
Condition	2 - Between Good and Fair
Deficiency	VINYL TILES: BROKEN/DETERIORATED/MISSING TILES
Deficiency Location/Instance	Office
Deficiency Quantity	10
Quantity Uom	S.F.
Potential Action	REPLACE
Urgency of Action	PRIORITY 3
Purpose of Action	LEVEL 2
Deficiency Photo1

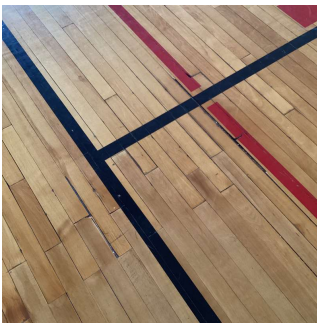
Violations	Office No violations recorded.
Deficiency	WOOD: DAMAGED/DETERIORATED
Deficiency Location/Instance	Near Entrance, Storage Room
Deficiency Quantity	50
Quantity Uom	S.F.
Potential Action	REPLACE
Urgency of Action	PRIORITY 3
Purpose of Action	LEVEL 2

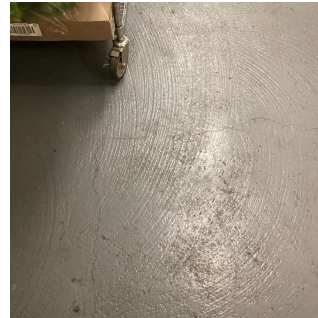
Storage Room

CERAMIC TILE: BROKEN/MISSING TILES

REPLACE

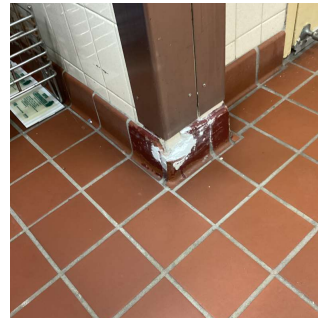
Near Entrance

CERAMIC TILE: BROKEN/ MISSING

REPLACE

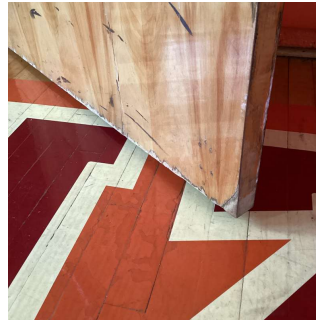
Deficiency Location/Instance	Entrance
Deficiency Quantity	1
Quantity Uom	EACH
Potential Action	MAINTENANCE
Urgency of Action	PRIORITY 3
Purpose of Action	LEVEL 2

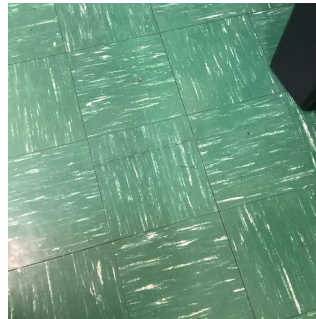
Instance on 5th Floor - Girls (420 Lockers)	Inspected
Condition	2 - Between Good and Fair
Deficiency	VINYL TILES: BROKEN/DETERIORATED/MISSING TILES
Deficiency Location/Instance	Near Entrance
Deficiency Quantity	10
Quantity Uom	S.F.
Potential Action	REPLACE
Urgency of Action	PRIORITY 3
Purpose of Action	LEVEL 2
Deficiency Photo1

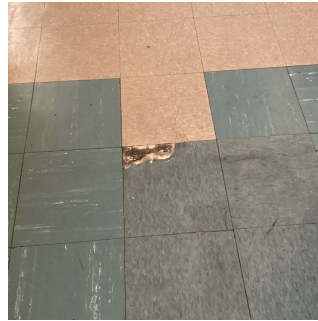
Near Toilet Room

Instance on 3rd Floor - Boys (88 Lockers)	Inspected
Condition	3 - Fair
Deficiency	VINYL TILES: BROKEN/DETERIORATED/MISSING TILES
Deficiency Location/Instance	Near Toilet Room, Center, Windows
Deficiency Quantity	100
Quantity Uom	S.F.
Potential Action	REPLACE
Urgency of Action	PRIORITY 3
Purpose of Action	LEVEL 2

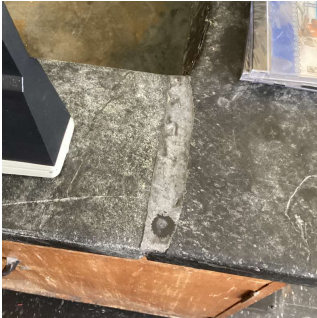
Question	Response
<b>INTERIOR</b>	
<b>SCIENCE PREP ROOM</b>	
Instance on Room 403	Inspected
Alternative use	No
<b>Fixed Equipment</b>	
Instance on Room 403	Inspected
Condition	5 - Poor
Deficiency	DEMO TABLE: DAMAGED/DETERIORATED
Deficiency Location/Instance	Room 403
Deficiency Quantity	1
Quantity Uom	EACH
Potential Action	REPLACE
Urgency of Action	PRIORITY 3
Purpose of Action	LEVEL 2
Deficiency Photo1

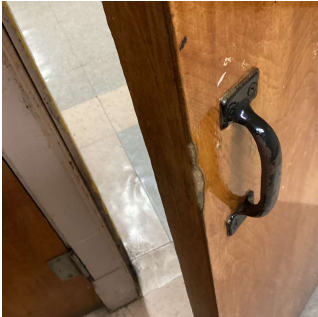
Question	Response
<b>INTERIOR</b>	
<b>STAIRS/RAMPS: INTERIOR</b>	
<b>Ceiling</b>	Inspected
Violations	No violations recorded.
<b>Door(s)</b>	Inspected
Condition	3 - Fair
Deficiency	WOOD: DETERIORATED DOOR
Deficiency Location/Instance	Exit 4 Vestibule
Deficiency Quantity	2
Quantity Uom	EACH
Potential Action	MAINTENANCE
Urgency of Action	PRIORITY 3
Purpose of Action	LEVEL 2
Deficiency Photo1

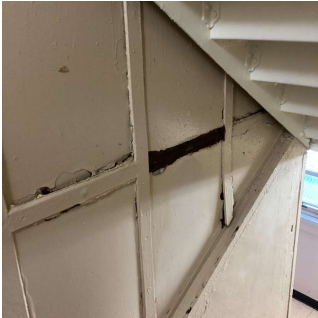
Violations	Exit 4 Vestibule No violations recorded.
<b>Partition</b>	Inspected
Condition	3 - Fair
Deficiency	METAL FRAME: DAMAGED/DETERIORATED
Deficiency Location/Instance	Stair CD/1, EF/ 2, GH/1, 2, 3, and others.
Deficiency Quantity	100
Quantity Uom	L.F.
Potential Action	REPLACE
Urgency of Action	PRIORITY 3
Purpose of Action	LEVEL 2
Deficiency Photo1

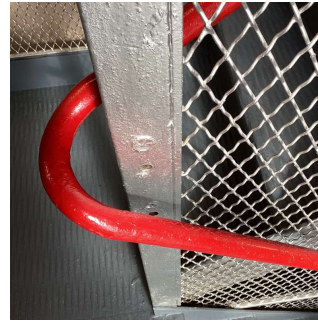
Violations	Stair GH/3 No violations recorded.
<b>Railings</b>	
Condition	Inspected 5 - Poor
Deficiency	METAL: BROKEN BRACKET
Deficiency Location/Instance	Stair I/Bulkhead
Deficiency Quantity	1
Quantity Uom	EACH
Potential Action	REPLACE
Urgency of Action	PRIORITY 3
Purpose of Action	LEVEL 2

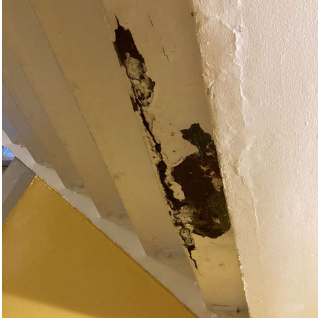
Question	Response
<b>INTERIOR</b>	
<b>STAIRS/RAMPS: INTERIOR</b>	
<b>Stairs and Landings</b>	
Violations	Stair CD/1 35655477M
Deficiency	METAL: RUST - MAJOR
Deficiency Location/Instance	Stairs CD/1, 2, 3, 4, 5, EF/ Bulkhead, 3, GH/1, 3
Deficiency Quantity	80
Quantity Uom	S.F.
Potential Action	REPLACE
Urgency of Action	PRIORITY 5
Purpose of Action	LEVEL 6
Deficiency Photo1

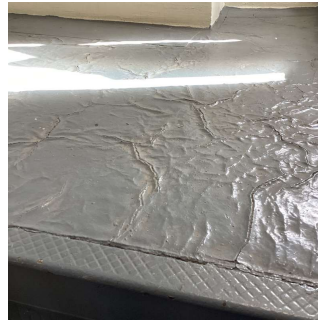
Violations	Exit 6 - Vestibule No violations recorded.
Deficiency	ROLLED ASPHALT: DETERIORATED SUBSTRATE
Deficiency Location/Instance	Stair EF/Bulkhead
Deficiency Quantity	300
Quantity Uom	S.F.
Potential Action	REPLACE
Urgency of Action	PRIORITY 3
Purpose of Action	LEVEL 2

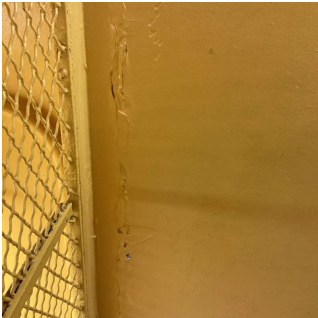
Question	Response
<b>INTERIOR</b>	
<b>STAIRS/RAMPS: INTERIOR</b>	
<b>Walls</b>	
Violations	Exit 2 - Vestibule No violations recorded.
Deficiency	PLASTER: CRACKS/SPALLING
Deficiency Location/Instance	Stairs EF/3, CD/Exit 2 - Vestibule, GH/3, 5, I/4, and others.
Deficiency Quantity	120
Quantity Uom	S.F.
Potential Action	REPLACE
Urgency of Action	PRIORITY 3
Purpose of Action	LEVEL 2
Deficiency Photo1

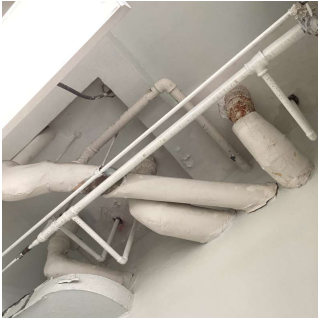
Violations	Stair GH/3 No violations recorded.
<b>TOILET ROOMS - STAFF</b>	
<b>Ceiling</b>	Inspected
Condition	2 - Between Good and Fair
Deficiency	PLASTER: CRACKS/SPALLING
Deficiency Location/Instance	Room 260
Deficiency Quantity	10
Quantity Uom	S.F.
Potential Action	REPLACE
Urgency of Action	PRIORITY 3
Purpose of Action	LEVEL 2
Deficiency Photo1

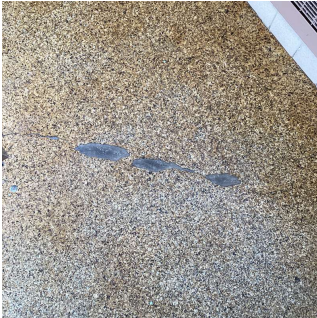
Room 351A
Violations	No violations recorded.
<b>Floor Finish</b>	Inspected
Condition	3 - Fair
Deficiency	CONCRETE: CRACKS
Deficiency Location/Instance	Near Entrance
Deficiency Quantity	10
Quantity Uom	S.F.
Potential Action	REPLACE
Urgency of Action	PRIORITY 3
Purpose of Action	LEVEL 2
Deficiency Photo1

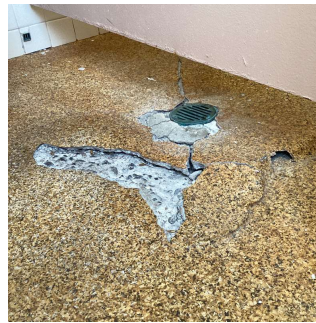
Kitchen
Violations	No violations recorded.
Deficiency	CONCRETE: CRACKS
Deficiency Location/Instance	Kitchen
Deficiency Quantity	10
Quantity Uom	S.F.
Potential Action	REPLACE
Urgency of Action	PRIORITY 5
Purpose of Action	LEVEL 6

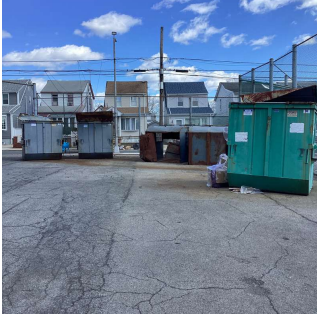
Question	Response
<b>SITE</b>	
<b>CONTAINERIZATION</b>	
Condition	5 - Poor
Deficiency	FENCING MISSING
Deficiency Location/Instance	Near Schoolyard
Deficiency Quantity	1,050
Quantity Uom	S.F.
Potential Action	INSTALL NEW
Urgency of Action	PRIORITY 3
Purpose of Action	LEVEL 2
Deficiency Photo1

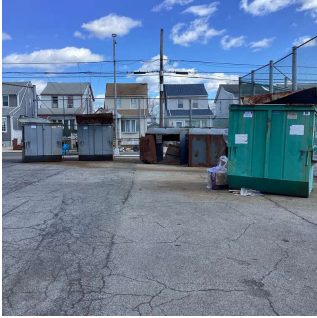
Violations	Near Schoolyard No violations recorded.
Deficiency	CONTAINER DAMAGED
Deficiency Location/Instance	Near Schoolyard
Deficiency Quantity	6
Quantity Uom	EACH
Potential Action	REPLACE
Urgency of Action	PRIORITY 3
Purpose of Action	LEVEL 2
Deficiency Photo1

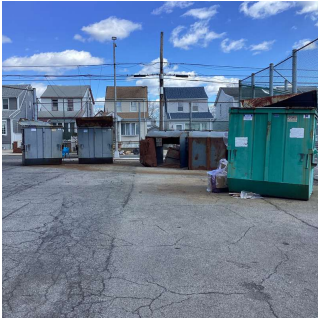
Violations	Near Schoolyard No violations recorded.
Deficiency	CONCRETE PAD MISSING
Deficiency Location/Instance	Near Schoolyard
Deficiency Quantity	600
Quantity Uom	S.F.
Potential Action	INSTALL NEW
Urgency of Action	PRIORITY 3
Purpose of Action	LEVEL 2

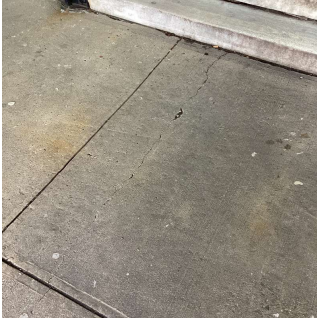
Question	Response
<b>SITE</b>	
<b>PAVING</b>	
<b>Site Sidewalks &amp; Walkways</b>	
<b>Concrete</b>	
Deficiency Location/Instance	92nd Avenue, Near Exits 3, 4
Deficiency Quantity	375
Quantity Uom	S.F.
Potential Action	REPLACE
Urgency of Action	PRIORITY 3
Purpose of Action	LEVEL 2
Deficiency Photo1

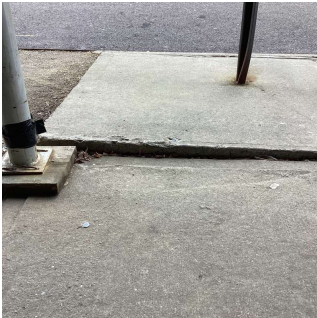
Violations	92nd Avenue No violations recorded.
<b>Pavers</b>	Does not Exist
<b>DOT Sidewalk</b>	Inspected
<b>Asphalt</b>	Does not Exist
<b>Concrete</b>	Inspected
Condition	4 - Between Fair and Poor
Deficiency	HEAVING
Deficiency Location/Instance	92nd Avenue
Deficiency Quantity	50
Quantity Uom	S.F.
Potential Action	REPLACE
Urgency of Action	PRIORITY 3
Purpose of Action	LEVEL 2
Deficiency Photo1

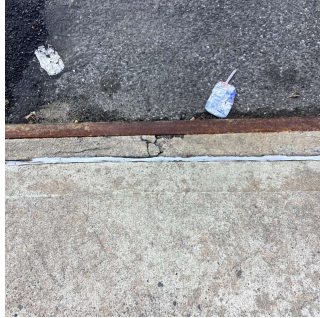
Violations	92nd Avenue No violations recorded.
Deficiency	DAMAGED CURBS
Deficiency Location/Instance	92nd Avenue, 93rd Avenue, 213rd Avenue, 214th Street
Deficiency Quantity	180
Quantity Uom	L.F.
Potential Action	REPLACE
Urgency of Action	PRIORITY 3
