NYC Department of Education
Building Condition Assessment Survey 2023 - 2024

Architectural Inspection

Q111

Asset: P.S. 111 - QUEENS, 37-15 13 STREET, New York, 11101

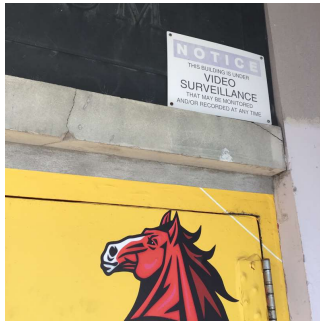
Violations	Facade A - Main Entrance No violations recorded.
DOOR HARDWARE	Inspected
Condition	3 - Fair
Deficiency	No deficiencies recorded
LINTELS	Inspected
Condition	3 - Fair
Deficiency	STONE: CHIPPED/SPALLED/BROKEN PIECES
Roof Plan reference	Q111
Deficiency Quantity	10
Quantity Uom	S.F.
Potential Action	REPLACE
Urgency of Action	PRIORITY 4
Purpose of Action	LEVEL 2
Deficiency Photo1

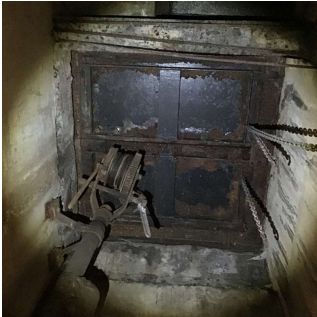
Violations	Basement - Ash Hoist Vault No violations recorded.
Deficiency	WATER INFILTRATION
Deficiency Location/Instance	Basement - Ash Hoist Vault
Deficiency Quantity	10
Quantity Uom	S.F.
Potential Action	REPAIR
Urgency of Action	PRIORITY 5
Purpose of Action	LEVEL 2
Deficiency Photo1

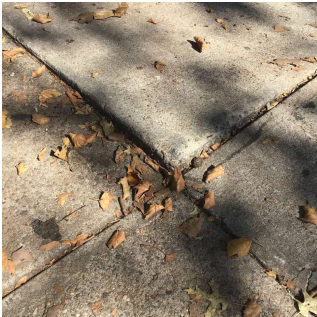
14th Street
Violations	No violations recorded.
Deficiency	DAMAGED/DETERIORATED/MISSING SECTIONS
Deficiency Location/Instance	13th Street, 14th Street, 37th Avenue
Deficiency Quantity	2,600
Quantity Uom	S.F.
Potential Action	REPLACE
Urgency of Action	PRIORITY 3
Purpose of Action	LEVEL 2
Deficiency Photo1

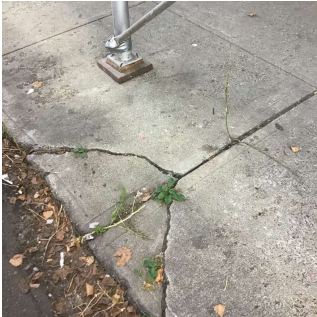
No	Tripping Hazard	Severely heaving DOT Sidewalk is a potential tripping hazard.	SITE PAVING DOT Sidewalk Concrete	13th Street, 14th Street.	Michael Mistretta	Fireman

13th Street
Violations	No violations recorded.
Deficiency	HEAVING
Deficiency Location/Instance	13th Street, 14th Street.
Deficiency Quantity	75
Quantity Uom	S.F.
Potential Action	REPLACE
Urgency of Action	PRIORITY 5
Purpose of Action	LEVEL 6
Deficiency Photo1	 
	13th Street

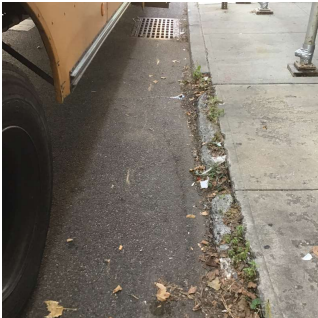
Question	Response
SITE	
PAVING	
DOT Sidewalk	
Concrete	
Violations	No violations recorded.
Deficiency	DAMAGED CURBS
Deficiency Location/Instance	13th Street, 14th Street, 37th Avenue
Deficiency Quantity	570
Quantity Uom	L.F.
Potential Action	REPLACE
Urgency of Action	PRIORITY 3
Purpose of Action	LEVEL 2
Deficiency Photo1

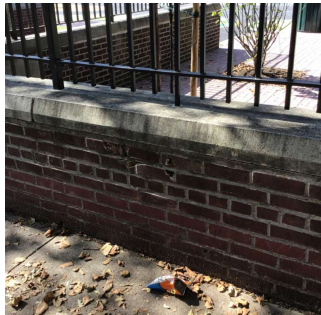
Violations	14th Street No violations recorded.
Deficiency	BRICK: CRACKS/SPALLING - MINOR
Deficiency Location/Instance	14th Street
Deficiency Quantity	50
Quantity Uom	S.F.
Potential Action	REPAIR
Urgency of Action	PRIORITY 3
Purpose of Action	LEVEL 2
Deficiency Photo1
