NYC Department of Education
Building Condition Assessment Survey 2023 - 2024

Architectural Inspection

Asset: P.S. 112 - QUEENS, 25-05 37 AVENUE, New York, 11101

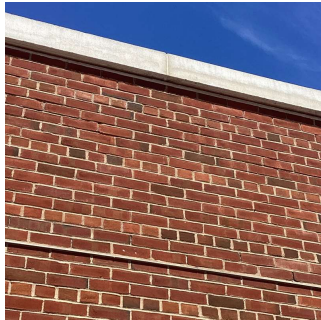
Question	Response
EXTERIOR	
PARAPETS	
Instance Condition	3 - Fair
Instance Quantity	8,500
Instance Quantity Uom	C.F.
Deficiency	BRICK: DETERIORATED JOINTS
Roof Plan reference	Q112
Deficiency Quantity	20
Quantity Uom	S.F.
Potential Action	REPOINT
Urgency of Action	PRIORITY 3
Purpose of Action	LEVEL 2
Deficiency Photo1

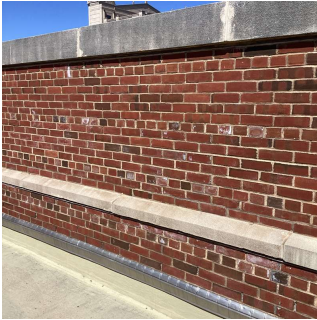
Violations	Roof 7 - Facade B No violations recorded.
PLAZA DECK	Does not Exist
ROOF	Inspected
Roofing	Inspected
Replacement Quantity	27,000
Replacement Uom	S.F.
ROOF HATCH/SMOKE HATCH	Does not Exist
LEADERS, GUTTERS, DOWNSPOUTS, SCUPPERS	Inspected
Condition	2 - Between Good and Fair
Deficiency	No deficiencies recorded
ROOF BARRIER/FENCE	Inspected
Condition	1 - Good
Deficiency	No deficiencies recorded
ROOF CAGE	Does not Exist
ROOFING	Inspected
Instance on Modified Bitumen: Roofs 1 - 5	Inspected
Instance Condition	1 - Good
Instance Photo	 
	Roof 1
Instance Quantity	26,000
Instance Quantity Uom	S.F.
Does the roof have major mechanical equipment sitting on Dunnage Steel less than 18" above the Roofing?	No
Does this roof instance have a Sustainable Roof System?	Yes
Sustainable Roof Type	White Roof
Sustainable Roof Location (Roof Number)	Roofs 1 - 5
Do solar panels exist on these roofs?	No

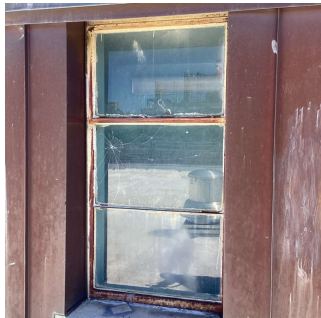
Violations	PH No violations recorded.
Deficiency	BULKHEAD/PENTHOUSE WINDOWS: DAMAGED, DETERIORATED WINDOWS
Roof Plan reference	Q112  
Deficiency Quantity	30
Quantity Uom	S.F.
Potential Action	REPLACE
Urgency of Action	PRIORITY 4
Purpose of Action	LEVEL 2
Deficiency Photo1

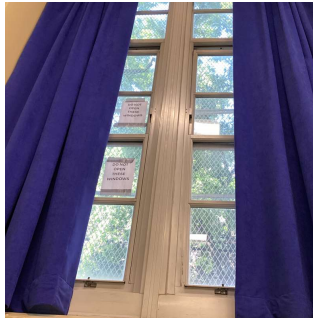
Facade A - Auditorium
No violations recorded.

Question	Response
EXTERIOR	
WINDOWS	
EXTERIOR GUARDS	
Elevation	 
Deficiency Quantity	150
Quantity Uom	S.F.
Potential Action	REPLACE
Urgency of Action	PRIORITY 4
Purpose of Action	LEVEL 2
Deficiency Photo1	 
Violations	Facade G No violations recorded.
LINTELS	Inspected
Condition	2 - Between Good and Fair
Deficiency	No deficiencies recorded
WINDOWS	Inspected
Material Type(s)	Aluminum, Steel
Instance on Aluminum - Double Hung: All Facades	Inspected
Instance Condition	3 - Fair
Instance Quantity	9,400
Instance Quantity Uom	S.F.
Are these windows insulated	No
Installation Year	1996
Source of Installation	Custodial Staff
Deficiency	ALUMINUM - DOUBLE HUNG: INOPERABLE BALANCE

10
EACH
REPLACE BALANCES
PRIORITY 3
LEVEL 2

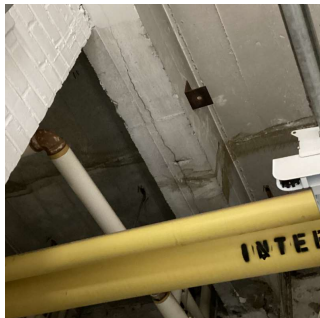
Violations	Room B7 No violations recorded.
Deficiency	STEEL COLUMNS/BEAMS: DETERIORATED CONCRETE FIREPROOFING
Deficiency Location/Instance	Basement - Shop Room
Deficiency Quantity	20
Quantity Uom	S.F.
Potential Action	REPLACE
Urgency of Action	PRIORITY 3
Purpose of Action	LEVEL 5
Deficiency Photo1

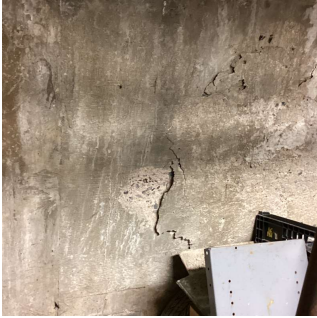
Question	Response
INTERIOR	
STRUCTURAL	
FOUNDATION WALLS	Inspected
Material Type(s)	Concrete
Condition	3 - Fair
Deficiency	CONCRETE: CRACKED/SPALLED/REINFORCEMENT EXPOSED
Deficiency Location/Instance	Basement - Room B7
Deficiency Quantity	20
Quantity Uom	S.F.
Potential Action	REPAIR
Urgency of Action	PRIORITY 3
Purpose of Action	LEVEL 5
Deficiency Photo1

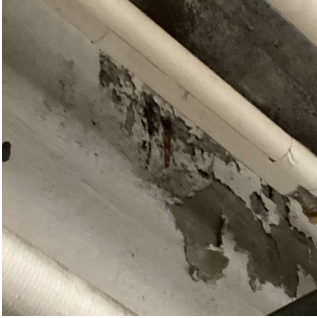
Violations	Room B7 No violations recorded.
Deficiency	CONCRETE: CRACKED/SPALLED/REINFORCEMENT EXPOSED
Deficiency Location/Instance	Basement - Shop Room
Deficiency Quantity	10
Quantity Uom	S.F.
Potential Action	REPAIR
Urgency of Action	PRIORITY 4
Purpose of Action	LEVEL 5
Deficiency Photo1

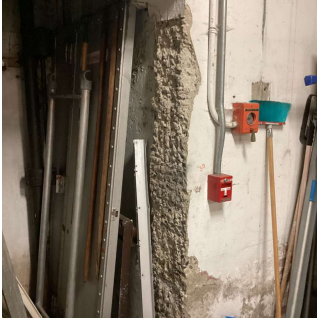
Violations	Shop Room No violations recorded.
ROOF STRUCTURE	Inspected
Condition	2 - Between Good and Fair
Deficiency	No deficiencies recorded
VAULTS-BUNKERS	Inspected
Foundation Walls	Inspected
Condition	2 - Between Good and Fair
Deficiency	CRACKS, SPALLING
Deficiency Location/Instance	Basement - Ash Hoist Vault

Question	Response
INTERIOR	
STRUCTURAL	
VAULTS-BUNKERS	
Foundation Walls	
Deficiency Quantity	20
Quantity Uom	S.F.
Potential Action	REPAIR
Urgency of Action	PRIORITY 3
Purpose of Action	LEVEL 5
Deficiency Photo1

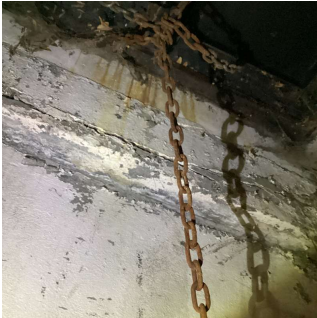
Violations	Ash Hoist Vault No violations recorded.
Slab Structure	
Condition	Inspected
Deficiency	3 - Fair
Deficiency	STEEL COLUMNS/BEAMS: DETERIORATED CONCRETE FIREPROOFING
Deficiency Location/Instance	Basement - Ash Hoist Vault
Deficiency Quantity	20
Quantity Uom	S.F.
Potential Action	REPAIR
Urgency of Action	PRIORITY 4
Purpose of Action	LEVEL 5
Deficiency Photo1

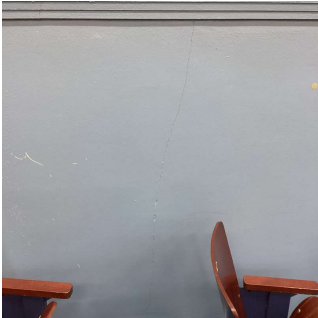
Question	Response
INTERIOR	
AUDITORIUM	
Stage	
Stage Curtain Rigging	Inspected
Instance on 1st Floor (395 Seats)	Inspected
Condition	2 - Between Good and Fair
Deficiency	No deficiencies recorded
Stage Curtains	Inspected
Instance on 1st Floor (395 Seats)	Inspected
Condition	2 - Between Good and Fair
Deficiency	No deficiencies recorded
Walls	
Instance on 1st Floor (395 Seats)	Inspected
Condition	2 - Between Good and Fair
Deficiency	PLASTER: CRACKS/SPALLING
Deficiency Location/Instance	Right and Left Side
Deficiency Quantity	40
Quantity Uom	S.F.
Potential Action	REPLACE
Urgency of Action	PRIORITY 3
Purpose of Action	LEVEL 2
Deficiency Photo1

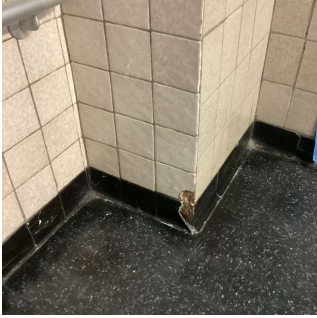
Question	Response
INTERIOR	
CLASSROOMS/CORRIDORS/ADMIN SPACES	
Floor Finish	Inspected
Violations	No violations recorded.
Walls	Inspected
Condition	2 - Between Good and Fair
Deficiency	GLAZED BLOCK: CRACKS/SPALLING
Deficiency Location/Instance	Main Entrance Lobby, Corridor near Rooms 105, 113, by Elevator/3rd Floor, Exit 8 - Vestibule and others
Deficiency Quantity	120
Quantity Uom	S.F.
Potential Action	REPLACE
Urgency of Action	PRIORITY 3
Purpose of Action	LEVEL 2
Deficiency Photo1

Violations	Corridor near Elevator/3rd Floor No violations recorded.
Deficiency	PLASTER: CRACKS/SPALLING
Deficiency Location/Instance	Room 403, Corridor near Room 120, by Star A/3
Deficiency Quantity	30
Quantity Uom	S.F.
Potential Action	REPLACE
Urgency of Action	PRIORITY 3
Purpose of Action	LEVEL 2
Deficiency Photo1

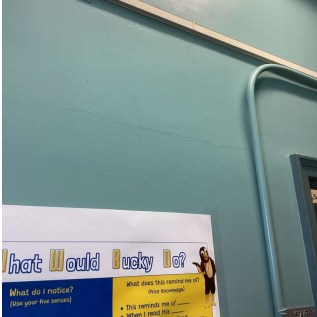
Violations	Room 403 No violations recorded.
Specialties	Does not Exist
GYMNASIUM	
Instance on 3rd Floor	Inspected

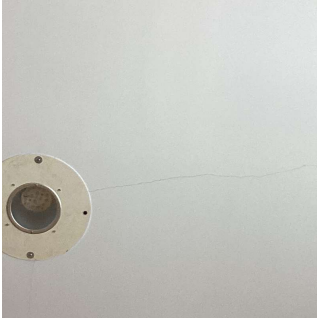
Ceiling	Inspected
Instance on 3rd Floor	Inspected
Condition	2 - Between Good and Fair
Deficiency	GYPSUM BOARD: DAMAGED/DETERIORATED

Question	Response
INTERIOR	
GYMNASIUM	
Ceiling	
Deficiency Location/Instance	Near Left Side Windows, Left Side
Deficiency Quantity	60
Quantity Uom	S.F.
Potential Action	REPLACE
Urgency of Action	PRIORITY 3
Purpose of Action	LEVEL 2
Deficiency Photo1

Near Left Side Windows
Violations	No violations recorded.
Door(s)	
Instance on 3rd Floor	Inspected
Condition	5 - Poor
Deficiency	WOOD: DETERIORATED DOOR
Deficiency Location/Instance	Storage Room(2x), Rooms 359, 356
Deficiency Quantity	4
Quantity Uom	EACH
Potential Action	MAINTENANCE
Urgency of Action	PRIORITY 3
Purpose of Action	LEVEL 2
Deficiency Photo1

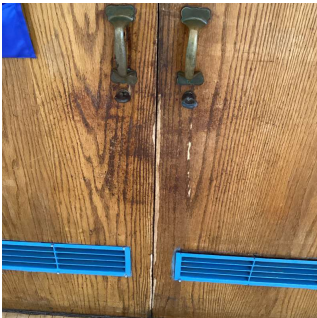
Storage Room
Violations	No violations recorded.
Fixed Equipment	
Instance on 3rd Floor	Inspected
Condition	1 - Good
Deficiency	No deficiencies recorded
Floor Finish	
Instance on 3rd Floor	Inspected
Condition	2 - Between Good and Fair
Deficiency	WOOD: DAMAGED/DETERIORATED
Deficiency Location/Instance	Near Left Side Main Entrance

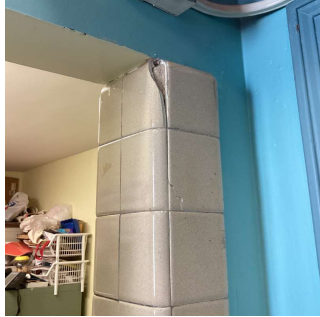
Question	Response
INTERIOR	
GYMNASIUM	
Floor Finish	
Deficiency Quantity	10
Quantity Uom	S.F.
Potential Action	REPLACE
Urgency of Action	PRIORITY 3
Purpose of Action	LEVEL 2
Deficiency Photo1	 
	Near Left Side Main Entrance
Violations	No violations recorded.
Deficiency	VINYL TILES: DETERIORATED SUBSTRATE
Deficiency Location/Instance	Room 339
Deficiency Quantity	10
Quantity Uom	S.F.
Potential Action	REPLACE
Urgency of Action	PRIORITY 3
Purpose of Action	LEVEL 2
Deficiency Photo1	 
	Room 339
Violations	No violations recorded.
Seating	
Instance on 3rd Floor	Inspected
Condition	2 - Between Good and Fair
Deficiency	No deficiencies recorded
Sliding-folding Partition	
Instance on 3rd Floor	Does not Exist
Stage	
Instance on 3rd Floor	Does not Exist
Walls	
Instance on 3rd Floor	Inspected
Condition	2 - Between Good and Fair
Deficiency	CERAMIC TILE: BROKEN/ MISSING
Deficiency Location/Instance	Room 359

Question	Response
INTERIOR	
GYMNASIUM	
Walls	
Deficiency Quantity	10
Quantity Uom	S.F.
Potential Action	REPLACE
Urgency of Action	PRIORITY 3
Purpose of Action	LEVEL 2
Deficiency Photo1

Room 359
Violations	No violations recorded.
Deficiency	PLASTER: CRACKS/SPALLING
Deficiency Location/Instance	Room 359
Deficiency Quantity	20
Quantity Uom	S.F.
Potential Action	REPLACE
Urgency of Action	PRIORITY 3
Purpose of Action	LEVEL 2
Deficiency Photo1

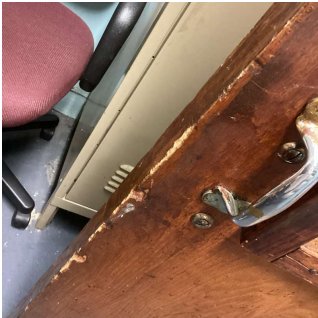
Question	Response
INTERIOR	
GYMNASIUM	
Walls	
Deficiency Photo1	 
	Near Main Entrance
Violations	No violations recorded.
Window Curtains/Shades/Blinds	
Instance on 3rd Floor	Does not Exist
INTERIOR DOOR HARDWARE	
Condition	Inspected
Deficiency	3 - Fair
	No deficiencies recorded
INTERIOR GUARDS	
Condition	Inspected
Deficiency	3 - Fair
Deficiency	DETERIORATED/TORN-OUT/MISSING
Deficiency Location/Instance	Stairs C/Bulkhead, D/1, E/1
Deficiency Quantity	60
Quantity Uom	S.F.
Potential Action	REPLACE
Urgency of Action	PRIORITY 3
Purpose of Action	LEVEL 2
Deficiency Photo1	 
	Stair E/1
Violations	No violations recorded.
KITCHEN	
Instance on 1st Floor	Inspected
Instance on 1st Floor	Inspected
Ceiling	
Instance on 1st Floor	Inspected
Condition	2 - Between Good and Fair
Deficiency	No deficiencies recorded
Door(s)	
Instance on 1st Floor	Inspected
Condition	5 - Poor
Deficiency	WOOD: DETERIORATED DOOR
Deficiency Location/Instance	Storage Room, Office Room(2x)

Question	Response
INTERIOR	
KITCHEN	
Door(s)	
Deficiency Quantity	3
Quantity Uom	EACH
Potential Action	MAINTENANCE
Urgency of Action	PRIORITY 3
Purpose of Action	LEVEL 2
Deficiency Photo1

Storage Room
Violations	No violations recorded.
Floor Finish	
Instance on 1st Floor	Inspected
Condition	3 - Fair
Deficiency	CONCRETE: CRACKS
Deficiency Location/Instance	Storage Room, Office Room
Deficiency Quantity	70
Quantity Uom	S.F.
Potential Action	REPLACE
Urgency of Action	PRIORITY 3
Purpose of Action	LEVEL 2
Deficiency Photo1

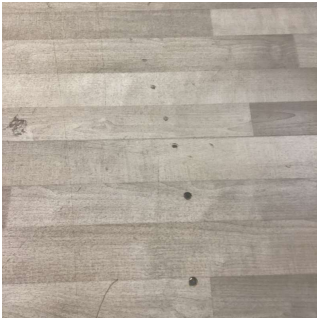
Question	Response
INTERIOR	
KITCHEN	
Walls	
Deficiency Photo1	 
Violations	Near Sink No violations recorded.
LIBRARY	
Instance on Room 219	Inspected
Built-in Furnishing	Inspected
Instance on Room 219	Inspected
Condition	2 - Between Good and Fair
Deficiency	No deficiencies recorded
Ceiling	
Instance on Room 219	Inspected
Condition	2 - Between Good and Fair
Deficiency	No deficiencies recorded
Door(s)	
Instance on Room 219	Inspected
Condition	3 - Fair
Deficiency	WOOD: DETERIORATED DOOR
Deficiency Location/Instance	Storage Room
Deficiency Quantity	1
Quantity Uom	EACH
Potential Action	MAINTENANCE
Urgency of Action	PRIORITY 3
Purpose of Action	LEVEL 2
Deficiency Photo1	 
Violations	Storage Room No violations recorded.
Floor Finish	
Instance on Room 219	Inspected
Condition	2 - Between Good and Fair
Deficiency	VINYL TILES: BROKEN/DETERIORATED/MISSING TILES
Deficiency Location/Instance	Near Windows

Question	Response
INTERIOR	
LIBRARY	
Floor Finish	
Deficiency Quantity	10
Quantity Uom	S.F.
Potential Action	REPLACE
Urgency of Action	PRIORITY 3
Purpose of Action	LEVEL 2
Deficiency Photo1

Near Windows
Violations	No violations recorded.
Deficiency	CONCRETE: CRACKS
Deficiency Location/Instance	Storage Room
Deficiency Quantity	25
Quantity Uom	S.F.
Potential Action	REPLACE
Urgency of Action	PRIORITY 3
Purpose of Action	LEVEL 2
Deficiency Photo1

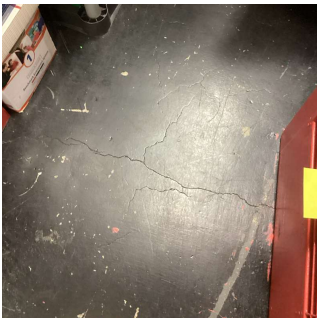
Storage Room
Violations	No violations recorded.
Walls	
Instance on Room 219	Inspected
Condition	2 - Between Good and Fair
Deficiency	No deficiencies recorded
LOCKER ROOM	Does not Exist
MULTI-PURPOSE ROOM	Does not Exist
SCIENCE DEMO ROOM	Does not Exist
SCIENCE LAB	Does not Exist
SCIENCE PREP ROOM	Does not Exist
SHOWER ROOM	Inspected
Instance on 4th Floor	Inaccessible
STAIRS/RAMPS: INTERIOR	Inspected

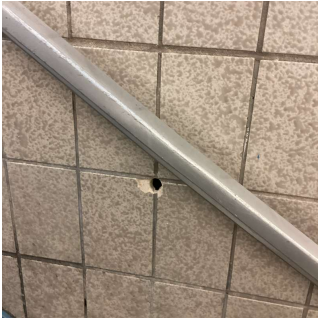
Question	Response
INTERIOR	
STAIRS/RAMPS: INTERIOR	
Do Letter Stair Signs Exist?	Yes
Ceiling	Inspected
Condition	2 - Between Good and Fair
Deficiency	No deficiencies recorded
Door(s)	Inspected
Condition	2 - Between Good and Fair
Deficiency	No deficiencies recorded
Partition	Does not Exist
Railings	Inspected
Condition	3 - Fair
Deficiency	METAL: BROKEN BRACKET
Deficiency Location/Instance	Stair C/1
Deficiency Quantity	1
Quantity Uom	EACH
Potential Action	REPLACE
Urgency of Action	PRIORITY 3
Purpose of Action	LEVEL 2
Deficiency Photo1

Violations	Stair C/1 No violations recorded.
Stairs and Landings	Inspected
Condition	2 - Between Good and Fair
Deficiency	VINYL TILES: BROKEN/DETERIORATED/MISSING TILES
Deficiency Location/Instance	Stair E/3
Deficiency Quantity	10
Quantity Uom	S.F.
Potential Action	REPLACE
Urgency of Action	PRIORITY 3
Purpose of Action	LEVEL 2
Deficiency Photo1

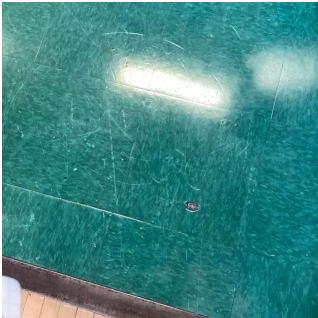
Violations	Stair E/3 No violations recorded.

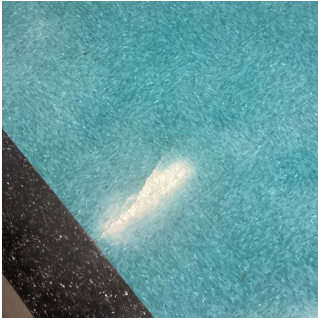
Question	Response
INTERIOR	
STAIRS/RAMPS: INTERIOR	
Stairs and Landings	
Deficiency	VINYL TILES: DETERIORATED SUBSTRATE
Deficiency Location/Instance	Stairs A/1, E/4
Deficiency Quantity	20
Quantity Uom	S.F.
Potential Action	REPLACE
Urgency of Action	PRIORITY 3
Purpose of Action	LEVEL 2
Deficiency Photo1

Violations	Stair A/1 No violations recorded.
Deficiency	STONE: BROKEN/MISSING
Deficiency Location/Instance	Stair A/1
Deficiency Quantity	10
Quantity Uom	S.F.
Potential Action	REPLACE
Urgency of Action	PRIORITY 3
Purpose of Action	LEVEL 2
Deficiency Photo1

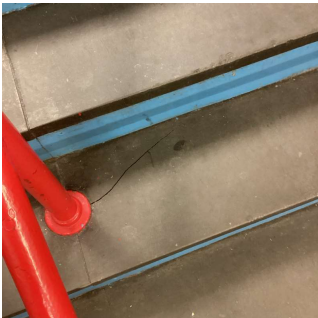
Violations	Stair A/1 No violations recorded.
Walls	Inspected
Condition	2 - Between Good and Fair
Deficiency	PLASTER: CRACKS/SPALLING
Deficiency Location/Instance	Stairs A/1, 2, 3, C/1, 3 and others
Deficiency Quantity	60
Quantity Uom	S.F.
Potential Action	REPLACE
Urgency of Action	PRIORITY 3
Purpose of Action	LEVEL 2

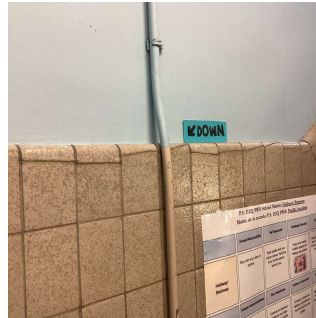
Stair A/1

GLAZED BLOCK: CRACKS/SPALLING

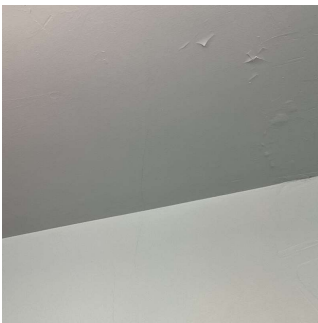
Question	Response
INTERIOR	
TOILET ROOMS - STAFF	
Ceiling	Inspected
Deficiency Photo1

Violations	In Room 359 No violations recorded.
Door(s)	Inspected
Condition	5 - Poor
Deficiency	WOOD: DETERIORATED DOOR
Deficiency Location/Instance	In Rooms 221, 321, 359, 356, 402 and others
Deficiency Quantity	7
Quantity Uom	EACH
Potential Action	MAINTENANCE
Urgency of Action	PRIORITY 3
Purpose of Action	LEVEL 2
Deficiency Photo1

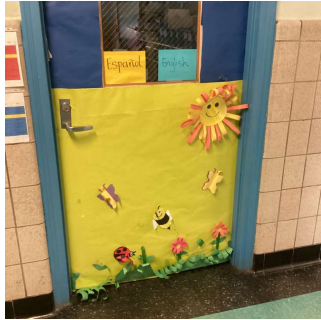
Question	Response
INTERIOR	
TOILET ROOMS - STUDENTS	
Walls	
Deficiency Photo1	 
Violations	Room 204 No violations recorded.
LIFE SAFETY	Inspected
F.D. HOLDING AREA	Inspected
Condition	5 - Poor
Deficiency	HOLDING AREAS NOT IDENTIFIED
Deficiency Location/Instance	Facades B - Rooms 111, 211, 311
Deficiency Quantity	3
Quantity Uom	EACH
Potential Action	PROVIDE IDENTIFICATION ON EXTERIOR SIDE OF WINDOW
Urgency of Action	PRIORITY 5
Purpose of Action	LEVEL 2
Deficiency Photo1	 
Violations	Facade B - Room 211 No violations recorded.
Deficiency	HOLDING AREAS NOT IDENTIFIED
Deficiency Location/Instance	Room 111
Deficiency Quantity	1
Quantity Uom	EACH
Potential Action	PROVIDE IDENTIFICATION AT DOOR
Urgency of Action	PRIORITY 5
Purpose of Action	LEVEL 2

Room 111
Violations	No violations recorded.
STEEL STAIRS	Does not Exist
SITE	Inspected
CONTAINERIZATION	Does not Exist
Drainage System for Asphalt	Inspected
Catch Basins/Manhole - Surrounded by asphalt	Inspected
Condition	2 - Between Good and Fair
Deficiency	No deficiencies recorded
Culverts - Asphalt Covering	Does not Exist
Drainage System for Concrete	Inspected
Catch Basins/Manhole - Surrounded by concrete	Inspected
Condition	5 - Poor
Deficiency	BLOCKED
Deficiency Location/Instance	Near Playground
Deficiency Quantity	1
Quantity Uom	EACH
Potential Action	MAINTENANCE
Urgency of Action	PRIORITY 3
Purpose of Action	LEVEL 2
Deficiency Photo1	No photo recorded
Violations	No violations recorded.
Culverts - Concrete Covering	Does not Exist
Drainage System for Soil	Inspected
Catch Basins/Manhole - Surrounded by Soil	Inspected
Condition	2 - Between Good and Fair

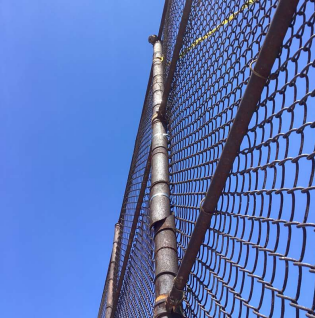
Deficiency	No deficiencies recorded
Culverts - Soil Covering	Does not Exist
DRINKING FOUNTAINS	Does not Exist
FENCES	Inspected
Condition	4 - Between Fair and Poor
Deficiency	CHAIN LINK: DAMAGED POST/RAIL
Deficiency Location/Instance	Near Playground
Deficiency Quantity	10
Quantity Uom	L.F.
Potential Action	REPLACE
Urgency of Action	PRIORITY 5
Purpose of Action	LEVEL 6

Violations	Near Playground No violations recorded.
Deficiency	CHAIN LINK: DAMAGED/DETERIORATED
Deficiency Location/Instance	Near NYC Park, by Schoolyard
Deficiency Quantity	200
Quantity Uom	S.F.
Potential Action	REPLACE
Urgency of Action	PRIORITY 3
Purpose of Action	LEVEL 2
Deficiency Photo1

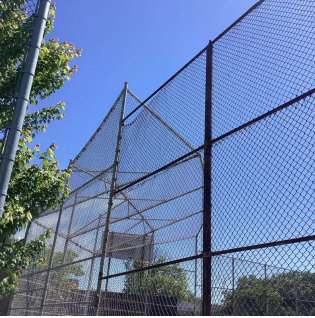
Violations	By Schoolyard No violations recorded.
Deficiency	CHAIN LINK: DAMAGED POST/RAIL
Deficiency Location/Instance	Near NYC Park
Deficiency Quantity	30
Quantity Uom	L.F.
Potential Action	REPLACE
Urgency of Action	PRIORITY 3
Purpose of Action	LEVEL 2
Deficiency Photo1

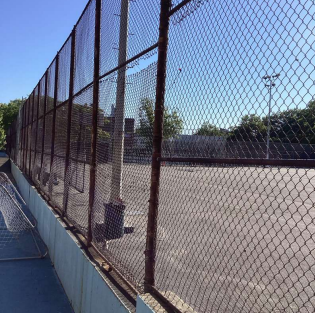
Violations	Near NYC Park No violations recorded.
Deficiency	CHAIN LINK: RUST - MAJOR

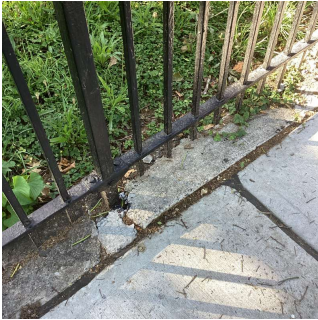
Question	Response
SITE	
FENCES	
Deficiency Location/Instance	Crescent Street, near Playground, by NYC Park
Deficiency Quantity	2,500
Quantity Uom	S.F.
Potential Action	REPLACE
Urgency of Action	PRIORITY 3
Purpose of Action	LEVEL 2
Deficiency Photo1	 
Violations	Crescent Street No violations recorded.
Deficiency	WROUGHT IRON: DAMAGED/DETERIORATED
Deficiency Location/Instance	Crescent Street, 37th Avenue
Deficiency Quantity	120
Quantity Uom	S.F.
Potential Action	REPLACE
Urgency of Action	PRIORITY 3
Purpose of Action	LEVEL 2
Deficiency Photo1	 
Violations	Crescent Street No violations recorded.
Deficiency	CONCRETE CURB: DAMAGED/DETERIORATED
Deficiency Location/Instance	Crescent Street, 37th Avenue, near Playground
Deficiency Quantity	160
Quantity Uom	S.F.
Potential Action	REPLACE
Urgency of Action	PRIORITY 3
Purpose of Action	LEVEL 2

Violations	Crescent Street No violations recorded.
IRRIGATION SYSTEM	Does not Exist
PAVING	Inspected
Student Non-Use	Inspected
Gravel Exists?	No
Asphalt	Does not Exist
Concrete	Inspected
Condition	3 - Fair
Deficiency	DAMAGED/DETERIORATED/MISSING SECTIONS
Deficiency Location/Instance	Crescent Street
Deficiency Quantity	50
Quantity Uom	S.F.
Potential Action	REPLACE
Urgency of Action	PRIORITY 3
Purpose of Action	LEVEL 2
Deficiency Photo1	 
Violations	Crescent Street No violations recorded.
Pavers	Does not Exist
Student Use	Inspected
Gravel Exists?	No
Asphalt	Inspected
Condition	2 - Between Good and Fair
Deficiency	CRACKS - MAJOR
Deficiency Location/Instance	Near Playground, by Soccer Goal
Deficiency Quantity	30
Quantity Uom	S.F.
Potential Action	REPLACE
Urgency of Action	PRIORITY 3

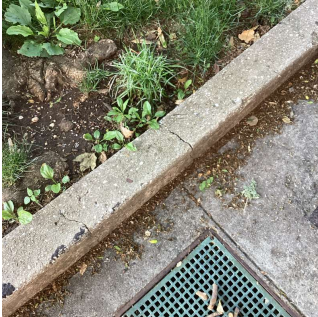
Question	Response
SITE	
PAVING	
Site Sidewalks & Walkways	
Concrete	
Deficiency Photo1

Violations	37th Avenue No violations recorded.
Deficiency	DAMAGED/DETERIORATED/MISSING SECTIONS
Deficiency Location/Instance	Crescent Street, 37th Avenue, near Exits 10, 11
Deficiency Quantity	125
Quantity Uom	S.F.
Potential Action	REPLACE
Urgency of Action	PRIORITY 3
Purpose of Action	LEVEL 2
Deficiency Photo1	 
Violations	37th Avenue No violations recorded.
Pavers	Does not Exist
DOT Sidewalk	Inspected
Asphalt	Does not Exist
Concrete	Inspected
Condition	3 - Fair
Deficiency	DAMAGED/DETERIORATED/MISSING SECTIONS
Deficiency Location/Instance	37th Avenue
Deficiency Quantity	75
Quantity Uom	S.F.
Potential Action	REPLACE
Urgency of Action	PRIORITY 3
Purpose of Action	LEVEL 2

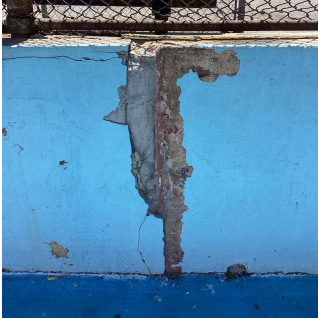
Question	Response
SITE	
PLAYGROUNDS	Inspected
Unpaved Area	
Instance on Schoolyard	Does not Exist
PLAYING SURFACE	Does not Exist
RETAINING WALLS	Inspected
Are there any Retaining Walls 6' OR higher facing public street/sidewalk?	No
Condition	3 - Fair
Deficiency	CAST IN PLACE CONCRETE: CRACKS/SPALLING - MAJOR
Deficiency Location/Instance	Near Playground, by NYC Park, close to Soccer Goal
Deficiency Quantity	120
Quantity Uom	S.F.
Potential Action	REPLACE
Urgency of Action	PRIORITY 3
Purpose of Action	LEVEL 2
Deficiency Photo1

Close to Soccer Goal	
Violations	No violations recorded.
SEATING	Inspected
Benches	Inspected
Concrete	Does not Exist
Metal/Wood/Plastic	Inspected
Condition	2 - Between Good and Fair
Deficiency	No deficiencies recorded
Bleachers	Does not Exist
SITE WALLS (NOT RETAINING WALLS)	Does not Exist
STAIRS/RAMPS: EXTERIOR	Inspected
Railings	Inspected
Condition	2 - Between Good and Fair
Deficiency	No deficiencies recorded

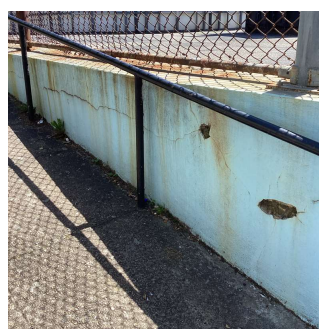
Site Cheek/flank Walls	Inspected
Condition	2 - Between Good and Fair
Deficiency	CAST IN PLACE CONCRETE: CRACKS/SPALLING - MAJOR
Deficiency Location/Instance	Ramp near NYC Park
Deficiency Quantity	30
Quantity Uom	S.F.
Potential Action	REPLACE
Urgency of Action	PRIORITY 3
Purpose of Action	LEVEL 2

Violations	<p>Ramp near NYC Park No violations recorded.</p>
Stairs/ramps	Inspected
Condition	3 - Fair
Deficiency	CAST IN PLACE CONCRETE: CRACKS/SPALLING - MAJOR
Deficiency Location/Instance	Stair near NYC Park, Ramp near NYC Park
Deficiency Quantity	200
Quantity Uom	S.F.
Potential Action	REPLACE
Urgency of Action	PRIORITY 3
Purpose of Action	LEVEL 2
Deficiency Photo1

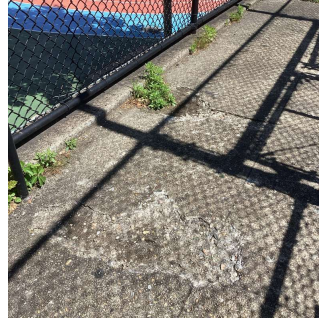
Violations	<p>Ramp near NYC Park No violations recorded.</p>
ARTWORK	Does not Exist
