NYC Department of Education
Building Condition Assessment Survey 2023 - 2024

Architectural Inspection

Asset: P.S. 116 - QUEENS, 107-25 WREN PLACE, New York, 11433

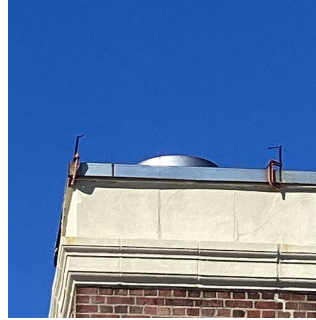
Roof 1

Deficiency Quantity	25
Quantity Uom	L.F.
Potential Action	REPLACE
Urgency of Action	PRIORITY 5
Purpose of Action	LEVEL 6

CHIMNEY

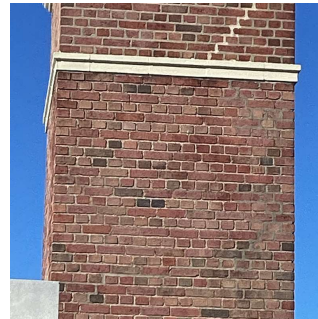
Roof 1

BRICK: DETERIORATED JOINTS

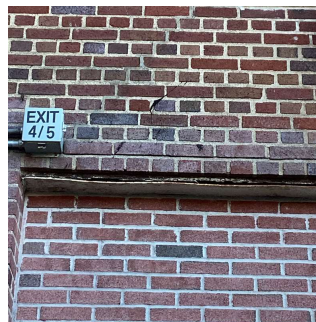
Facade C

STEEL: MAJOR RUSTING

REPLACE

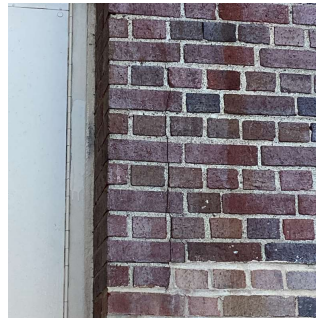
Violations	Facade C - Room 507 (shown), Facade B - Room 507 (similar) No violations recorded.
Deficiency	BRICK: MINOR CRACKS AND SPALLING

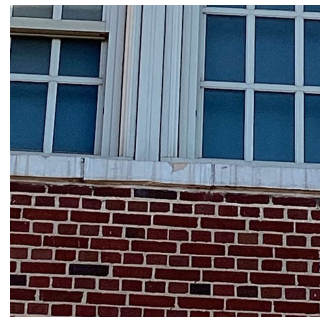
Facade A

BRICK: DETERIORATED MASONRY SILLS - MINOR

REPAIR

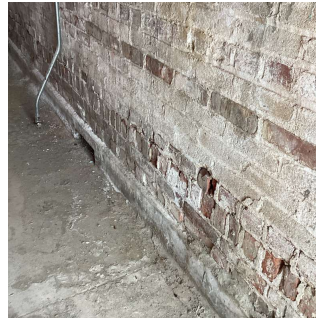
Roof 1 - Tank Room

BULKHEAD/PENTHOUSE	Inspected
Condition	3 - Fair
Deficiency	BULKHEAD/PENTHOUSE WALLS/INTERIOR: BRICK CRACKS/SPALLING

Deficiency Quantity	30
Quantity Uom	S.F.
Potential Action	REPLACE
Urgency of Action	PRIORITY 3
Purpose of Action	LEVEL 2

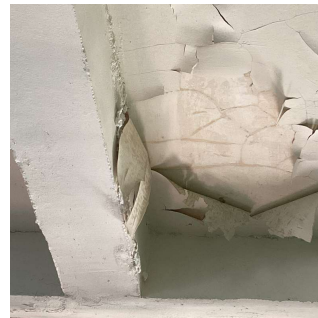
Roof 1 - Bulkhead

**BULKHEAD/PENTHOUSE CEILING: PLASTER
DAMAGED/DETERIORATED**

30
 S.F.
 REPLACE
 PRIORITY 3
 LEVEL 2

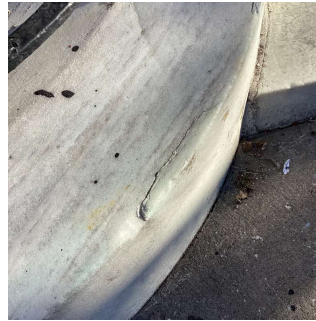
Facade A

STONE: CRACKS/SPALLING - MINOR

10
 S.F.
 REPAIR
 PRIORITY 3
 LEVEL 2

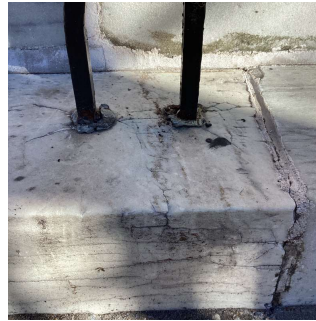
Facade A

STONE: CRACKS/SPALLING - MINOR

20
S.F.
REPAIR
PRIORITY 3
LEVEL 2

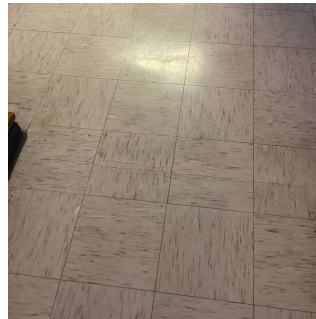
Near Entrance

Instance on 1st Floor (680 Seats)	Inspected
Condition	3 - Fair
Deficiency	VINYL TILES: BROKEN/DETERIORATED/MISSING TILES
Deficiency Location/Instance	Near Entrance, Seat C/1, Windows
Deficiency Quantity	30
Quantity Uom	S.F.
Potential Action	REPLACE
Urgency of Action	PRIORITY 3
Purpose of Action	LEVEL 2
Deficiency Photo1

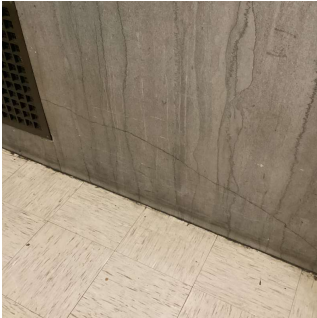
Question	Response
INTERIOR	
AUDITORIUM	
Stage	
Stage	
Deficiency Photo1	 
Violations	Near Steps Left Side No violations recorded.
Stage Curtain Rigging	Inspected
Instance on 1st Floor (680 Seats)	Inspected
Condition	2 - Between Good and Fair
Deficiency	No deficiencies recorded
Stage Curtains	Inspected
Instance on 1st Floor (680 Seats)	Inspected
Condition	2 - Between Good and Fair
Deficiency	No deficiencies recorded
Walls	
Instance on 1st Floor (680 Seats)	Inspected
Condition	2 - Between Good and Fair
Deficiency	STONE: CRACKS/SPALLING
Deficiency Location/Instance	Near Stage Right
Deficiency Quantity	20
Quantity Uom	S.F.
Potential Action	REPLACE
Urgency of Action	PRIORITY 3
Purpose of Action	LEVEL 2
Deficiency Photo1

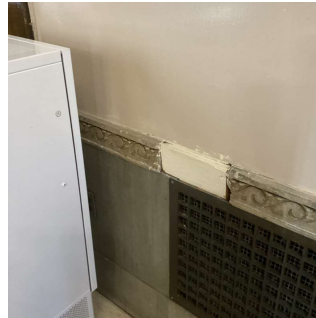
Violations	Near Stage Right No violations recorded.
Deficiency	STONE MOLDINGS: CRACKS/SPALLING
Deficiency Location/Instance	Near Entrance
Deficiency Quantity	10
Quantity Uom	L.F.
Potential Action	REPLACE

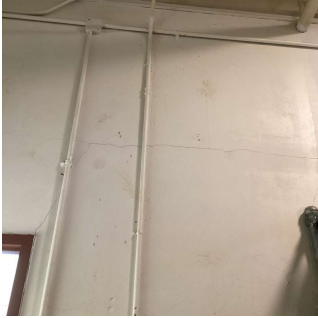
Question	Response
INTERIOR	
CAFETERIA	
Floor Finish	
Violations	Near Stair BC No violations recorded.
Sliding-folding Partition	
Instance on 1st Floor (6000 SF)	Does not Exist
Stage	
Instance on 1st Floor (6000 SF)	Does not Exist
Walls	
Instance on 1st Floor (6000 SF)	Inspected
Condition	2 - Between Good and Fair
Deficiency	PLASTER: CRACKS/SPALLING
Deficiency Location/Instance	Near Boys toilet Room
Deficiency Quantity	30
Quantity Uom	S.F.
Potential Action	REPLACE
Urgency of Action	PRIORITY 3
Purpose of Action	LEVEL 2
Deficiency Photo1

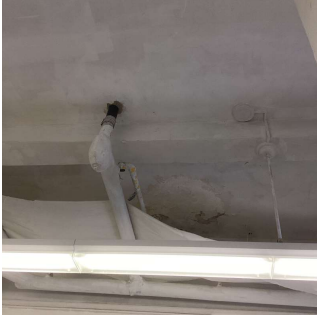
Question	Response
INTERIOR	
CAFETERIA	Inspected
Window Curtains/Shades/Blinds	
Instance on 1st Floor (6000 SF)	Does not Exist
CLASSROOMS/CORRIDORS/ADMIN SPACES	
Ceiling	Inspected
Condition	2 - Between Good and Fair
Deficiency	PLASTER: CRACKS/SPALLING
Deficiency Location/Instance	Room 263
Deficiency Quantity	50
Quantity Uom	S.F.
Potential Action	REPLACE
Urgency of Action	PRIORITY 3
Purpose of Action	LEVEL 2
Deficiency Photo1

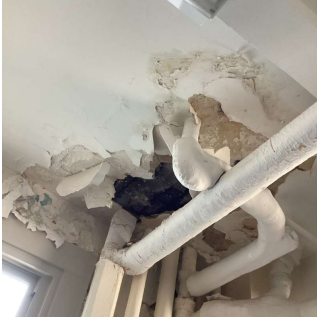
Violations	Room 263 No violations recorded.
Deficiency	PLASTER: CRACKS/SPALLING - ACTIVE LEAK
Deficiency Location/Instance	Room 216
Deficiency Quantity	40
Quantity Uom	S.F.
Potential Action	REPLACE
Urgency of Action	PRIORITY 5
Purpose of Action	LEVEL 2
Deficiency Photo1

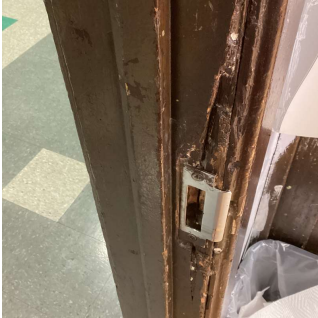
Violations	Room 216 No violations recorded.
Door(s)	Inspected
Condition	5 - Poor
Deficiency	WOOD: DETERIORATED DOOR AND FRAME
Deficiency Location/Instance	Rooms 416, 513
Deficiency Quantity	2
Quantity Uom	EACH
Potential Action	MAINTENANCE

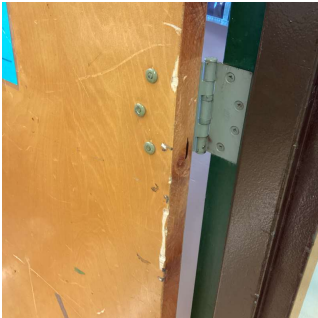
Room 416
Violations	No violations recorded.
Deficiency	WOOD: DETERIORATED DOOR
Deficiency Location/Instance	Rooms 208, 411, 417, 507, 519, and others
Deficiency Quantity	17
Quantity Uom	EACH
Potential Action	MAINTENANCE
Urgency of Action	PRIORITY 3
Purpose of Action	LEVEL 2
Deficiency Photo1

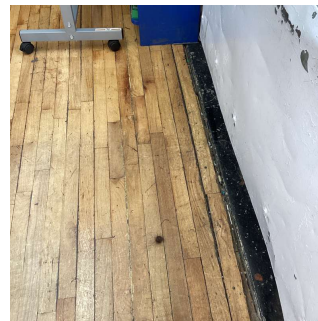
Room 512

WOOD: DAMAGED/DETERIORATED

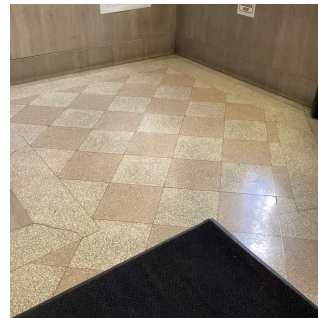
Lobby Main Entrance

TERRAZZO: CRACKS

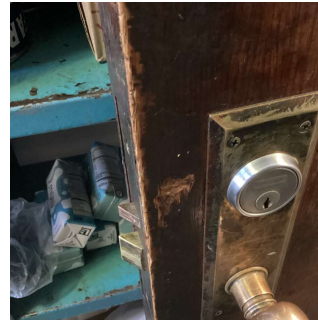
Violations	Entrance No violations recorded.
Deficiency	WOOD: DETERIORATED DOOR
Deficiency Location/Instance	Storage Room
Deficiency Quantity	1
Quantity Uom	EACH
Potential Action	MAINTENANCE
Urgency of Action	PRIORITY 3
Purpose of Action	LEVEL 2

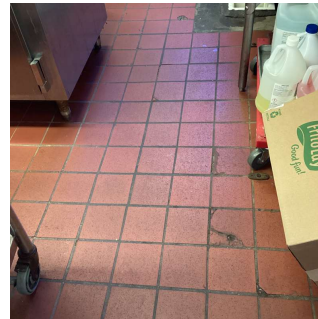
Near center

CERAMIC TILE: BROKEN/MISSING TILES

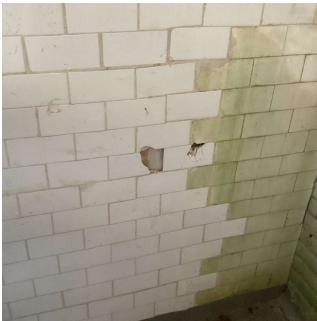
Deficiency	CERAMIC TILE: BROKEN/ MISSING
Deficiency Location/Instance	Near Windows
Deficiency Quantity	10
Quantity Uom	S.F.
Potential Action	REPLACE
Urgency of Action	PRIORITY 3
Purpose of Action	LEVEL 2

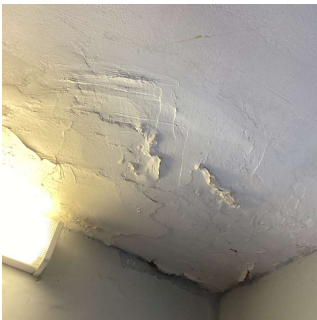
Violations	Near Windows No violations recorded.
STAIRS/RAMPS: INTERIOR	
Do Letter Stair Signs Exist?	Inspected Yes
Ceiling	
Condition	Inspected 2 - Between Good and Fair
Deficiency	PLASTER: CRACKS/SPALLING
Deficiency Location/Instance	Stairs BC/3, 4, DE/4, G/2, 4, and others
Deficiency Quantity	40
Quantity Uom	S.F.
Potential Action	REPLACE
Urgency of Action	PRIORITY 3
Purpose of Action	LEVEL 2
Deficiency Photo1

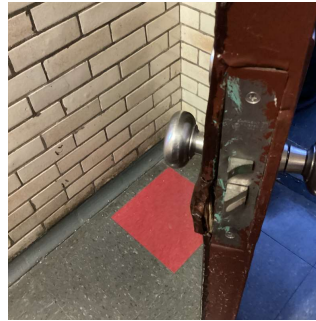
Stair G/Vestibule

Violations	Stair G/4 No violations recorded.
Door(s)	
Condition	Inspected 4 - Between Fair and Poor
Deficiency	METAL CLAD WOOD: DETERIORATED DOOR
Deficiency Location/Instance	Stairs BC/1,2, G/Vestibule Exit 6
Deficiency Quantity	4
Quantity Uom	EACH
Potential Action	MAINTENANCE
Urgency of Action	PRIORITY 3
Purpose of Action	LEVEL 2

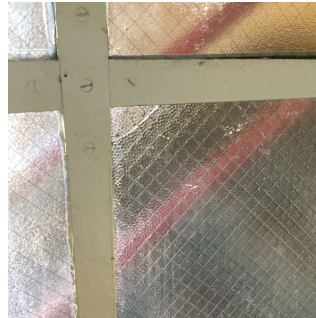
Stair BC/4

GLASS PANEL: DAMAGED/DETERIORATED

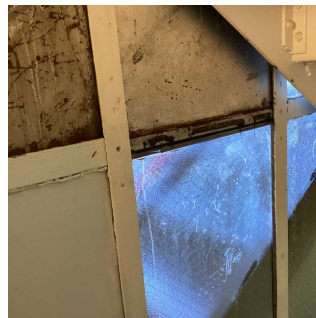
METAL FRAME: DAMAGED/DETERIORATED

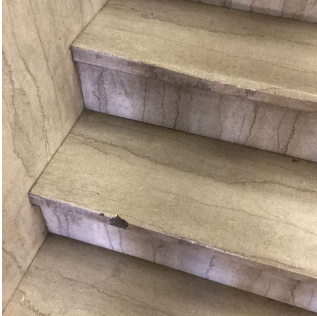
Violations	Stair G/1 No violations recorded.
Deficiency	STONE: BROKEN/MISSING
Deficiency Location/Instance	Lobby Main Entrance, Exit 8
Deficiency Quantity	30
Quantity Uom	S.F.
Potential Action	REPLACE
Urgency of Action	PRIORITY 3
Purpose of Action	LEVEL 2
Deficiency Photo1

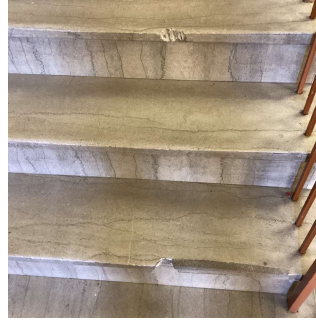
Violations	Lobby Main Entrance No violations recorded.
Deficiency	STONE: BROKEN/MISSING
Deficiency Location/Instance	Lobby Main Entrance

Potential Action	REPLACE
Urgency of Action	PRIORITY 5
Purpose of Action	LEVEL 6
Deficiency Photo1

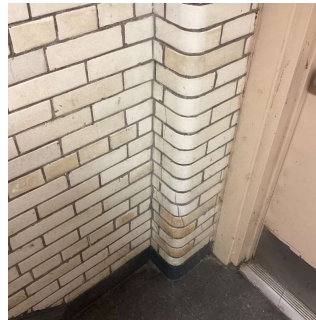
Deficiency	BRICK: CRACKS/SPALLING
Deficiency Location/Instance	Stair DE/1
Deficiency Quantity	10
Quantity Uom	S.F.
Potential Action	REPLACE
Urgency of Action	PRIORITY 3
Purpose of Action	LEVEL 2
Deficiency Photo1

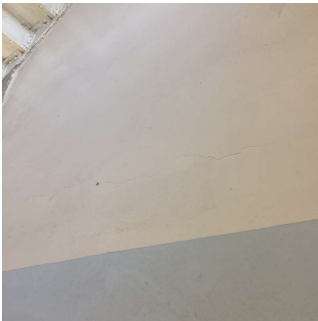
Deficiency	PLASTER: CRACKS/SPALLING
Deficiency Location/Instance	Stairs BC/1, DE/1, G/3, 4
Deficiency Quantity	100
Quantity Uom	S.F.
Potential Action	REPLACE
Urgency of Action	PRIORITY 3
Purpose of Action	LEVEL 2

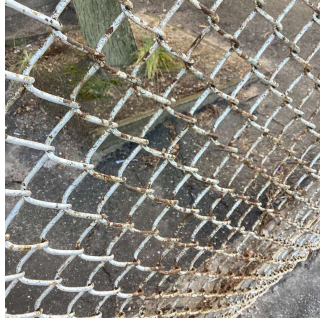
Deficiency	CHAIN LINK: RUST - MAJOR
Deficiency Location/Instance	Fern Place, Rex Road, Wren Place, polhemus Avenue

Question	Response
SITE	
FENCES	
Deficiency Quantity	4,500
Quantity Uom	S.F.
Potential Action	REPLACE
Urgency of Action	PRIORITY 3
Purpose of Action	LEVEL 2
Deficiency Photo1

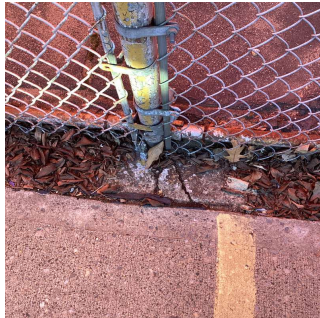
Violations	Fern Place No violations recorded.
Deficiency	CONCRETE CURB: DAMAGED/DETERIORATED
Deficiency Location/Instance	Fern Place, Rex Road, Wren Place
Deficiency Quantity	200
Quantity Uom	S.F.
Potential Action	REPLACE
Urgency of Action	PRIORITY 3
Purpose of Action	LEVEL 2
Deficiency Photo1

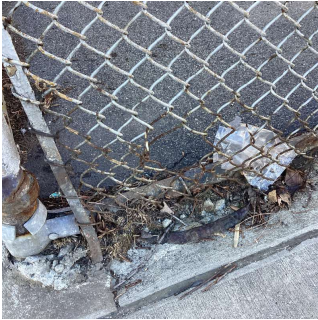
Violations	Rex road No violations recorded.
Deficiency	CHAIN LINK: DAMAGED/DETERIORATED
Deficiency Location/Instance	Fern Place, Rex Road, Wren Place
Deficiency Quantity	550
Quantity Uom	S.F.
Potential Action	REPLACE
Urgency of Action	PRIORITY 3
Purpose of Action	LEVEL 2

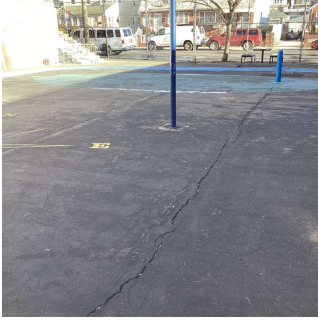
Violations	Fern Place No violations recorded.
IRRIGATION SYSTEM	Does not Exist
PAVING	Inspected
Student Non-Use	Inspected
Gravel Exists?	No
Asphalt	Inaccessible
Concrete	Does not Exist
Pavers	Does not Exist
Student Use	Inspected
Gravel Exists?	No
Asphalt	Inspected
Condition	4 - Between Fair and Poor
Deficiency	CRACKS - MAJOR
Deficiency Location/Instance	Near TCU, Exit 2/3, Polhemus Avenue, Fern Place.
Deficiency Quantity	600
Quantity Uom	S.F.
Potential Action	REPLACE
Urgency of Action	PRIORITY 3
Purpose of Action	LEVEL 2
Deficiency Photo1

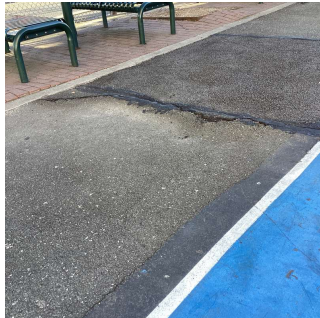
Violations	Near TCU No violations recorded.
Deficiency	CRACKS - MAJOR
Deficiency Location/Instance	Schoolyard near T6
Deficiency Quantity	40
Quantity Uom	S.F.
Potential Action	REPLACE
Urgency of Action	PRIORITY 5
Purpose of Action	LEVEL 6

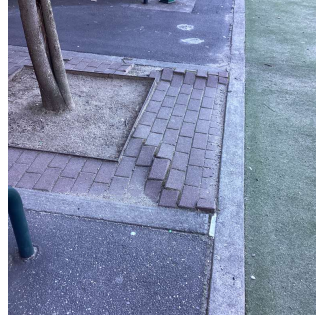
Near Exit 2/3

CRACKS - MAJOR

REPLACE

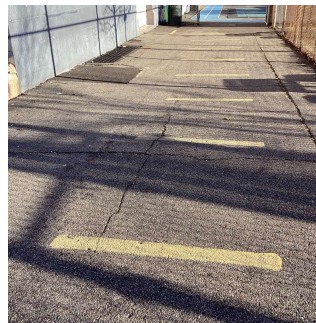
Near Exit 8

CRACKS - MAJOR

REPLACE

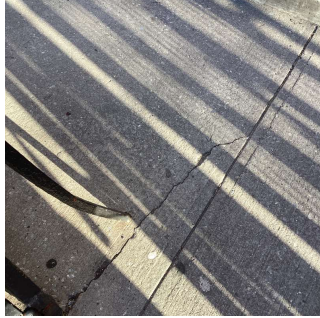
Near Exit 1
Violations	No violations recorded.
Pavers	Does not Exist
DOT Sidewalk	Inspected
Asphalt	Does not Exist
Concrete	Inspected
Condition	4 - Between Fair and Poor
Deficiency	DAMAGED/DETERIORATED/MISSING SECTIONS
Deficiency Location/Instance	Fern Place, Wren Place, Rex road, Polhemus Avenue
Deficiency Quantity	1,400
Quantity Uom	S.F.
Potential Action	REPLACE
Urgency of Action	PRIORITY 3
Purpose of Action	LEVEL 2
Deficiency Photo1

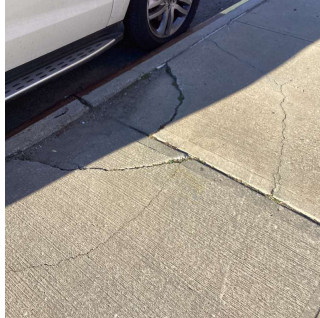
Wren Place
Violations	No violations recorded.
Deficiency	DAMAGED CURBS
Deficiency Location/Instance	Rex road, Fern Place, Wren Place, Polhemus Avenue
Deficiency Quantity	300
Quantity Uom	L.F.
Potential Action	REPLACE
Urgency of Action	PRIORITY 3
Purpose of Action	LEVEL 2
