NYC Department of Education
Building Condition Assessment Survey 2023 - 2024

Architectural Inspection

Asset: I.S. 119 - QUEENS, 74-01 78 AVENUE, New York, 11385

Inspection Id	Inspection Type	Time In	Last Edited
SA : Q119	Architectural - Senior	2023-12-07 8:28 AM	2024-02-13 3:24 PM
AA : Q119	Architectural - Associate	2023-12-07 7:31 AM	2024-02-16 1:59 PM

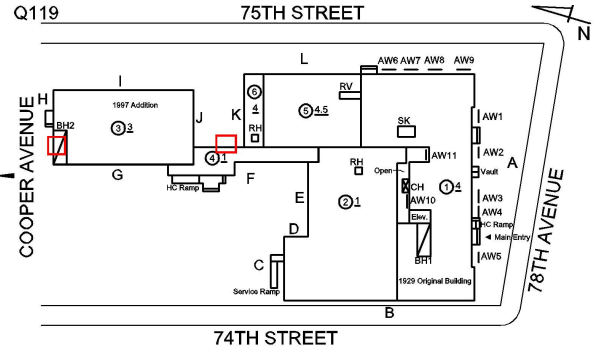
METAL: DETERIORATED DOOR - MINOR DETERIORATION

4
EACH
MAINTENANCE
PRIORITY 3
LEVEL 2

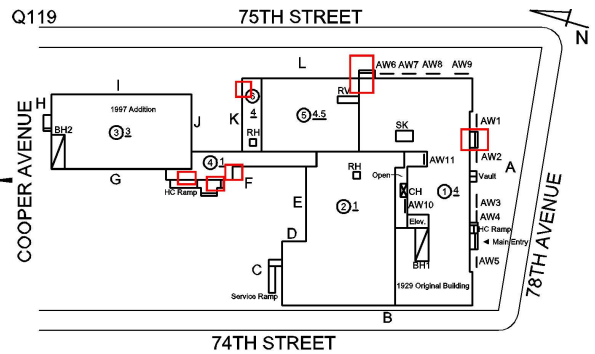
METAL: DETERIORATED DOOR AND FRAME - MINOR DETERIORATION

10
EACH
MAINTENANCE
PRIORITY 3
LEVEL 2

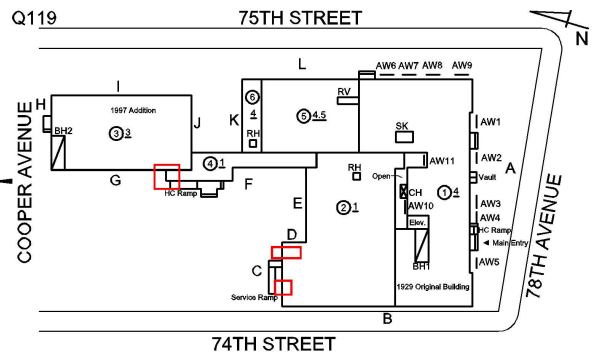
METAL: DETERIORATED DOOR AND FRAME - MAJOR DETERIORATION

3
EACH
REPLACE
PRIORITY 4
LEVEL 2

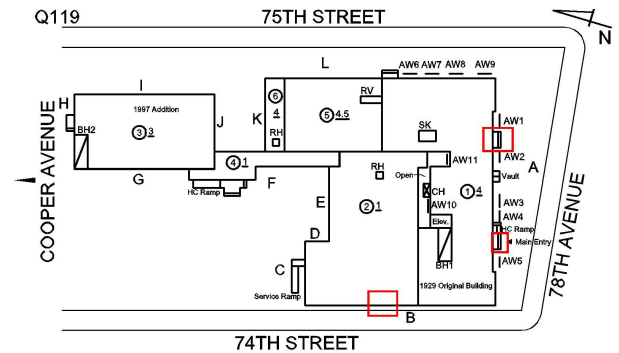
METAL: BROKEN GLASS

90

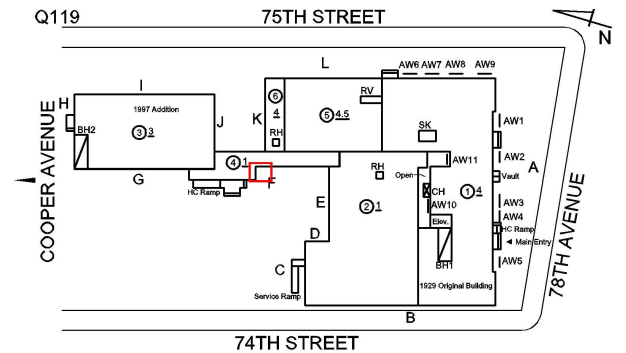
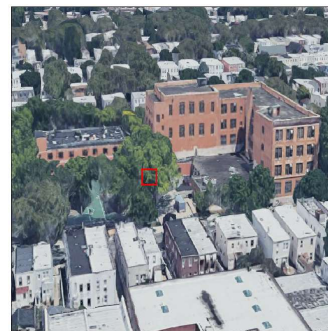
Condition	3 - Fair
-----------	----------

Deficiency	BROKEN/ DENTED BLADES
------------	-----------------------

REPLACE

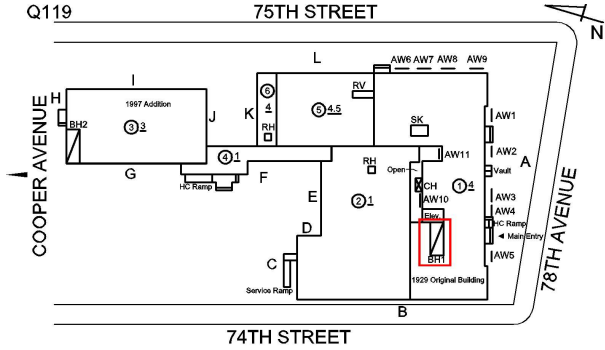
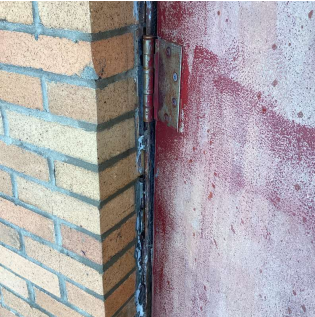
Question	Response
EXTERIOR	
ROOF	
Specialties	Inspected
BULKHEAD/PENTHOUSE	Inspected
Condition	3 - Fair
Deficiency	BULKHEAD/PENTHOUSE DOORS: AIR/WATER INFILTRATION WITH DAMAGED CAULKING
Roof Plan reference

Deficiency Quantity	10
Quantity Uom	L.F.
Potential Action	MAINTENANCE
Urgency of Action	PRIORITY 3
Purpose of Action	LEVEL 2
Deficiency Photo1

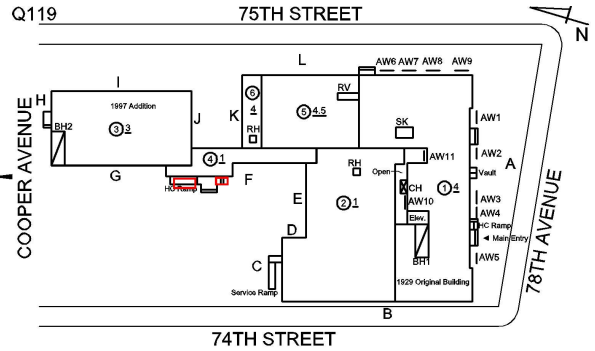
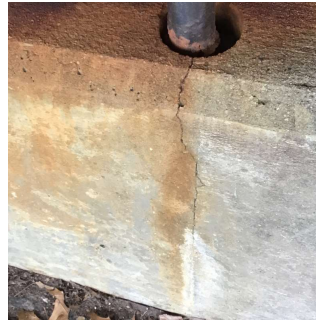
Facade G

Inspected
 Condition 5 - Poor

CAST IN PLACE CONCRETE: CRACKS/SPALLING - MINOR

REPAIR

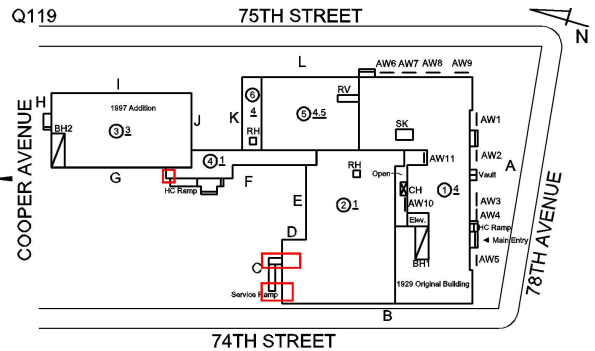
CAST IN PLACE CONCRETE: CRACKS/SPALLING - MAJOR

REPLACE

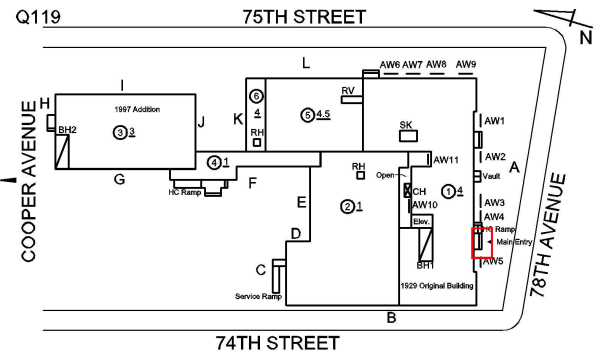
STONE: CRACKS/SPALLING - MAJOR

REPLACE

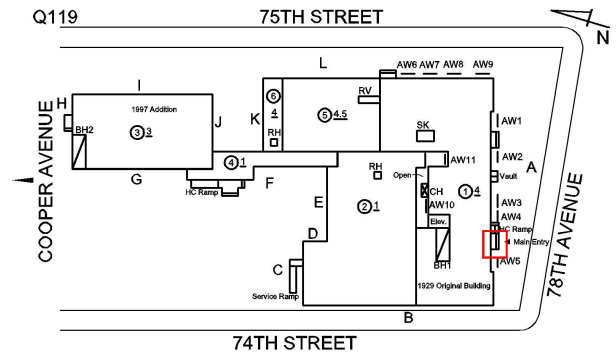
STONE: DETERIORATED JOINTS

30
S.F.
REPOINT
PRIORITY 3
LEVEL 2

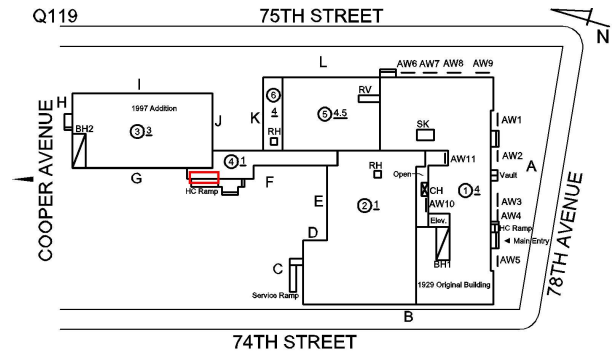
MISSING RAILING

15
L.F.
REPLACE
PRIORITY 5
LEVEL 6

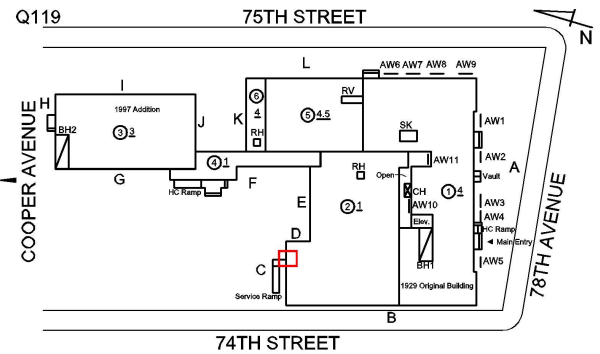
BROKEN BRACKET

REPLACE

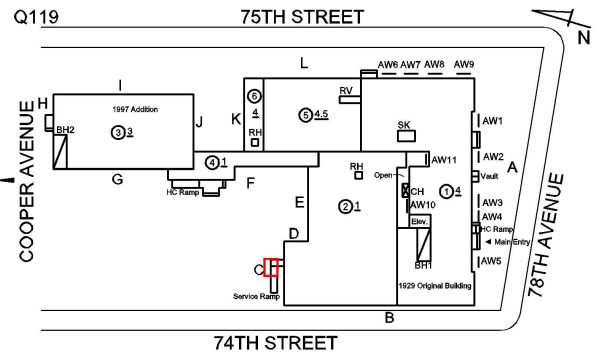
DAMAGED

RAILINGS

10
 L.F.
 REPLACE
 PRIORITY 4
 LEVEL 2

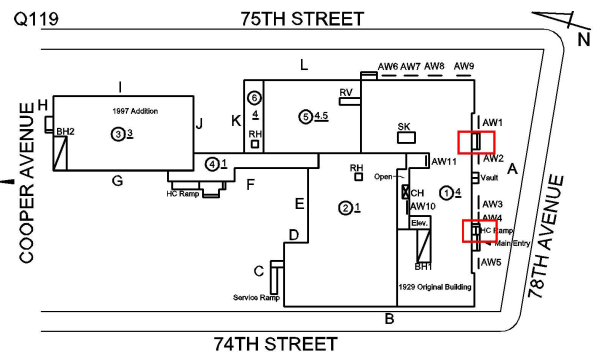
RUST - MAJOR

25
 L.F.
 REPLACE
 PRIORITY 4
 LEVEL 2

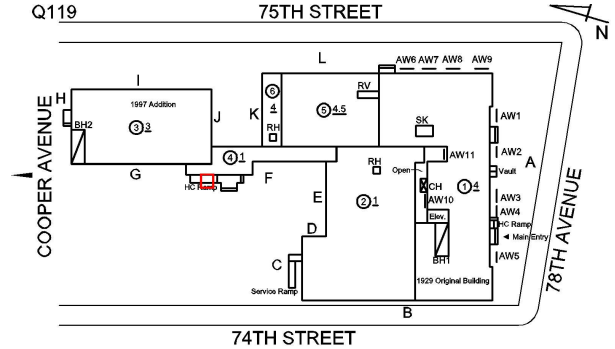
Violations	Facade A No violations recorded.
STAIRS/RAMPS	Inspected
Condition	5 - Poor
Deficiency	CONCRETE: CRACKS/SPALLING - MINOR
Roof Plan reference	Q119 75TH STREET

Deficiency Quantity	10
Quantity Uom	S.F.
Potential Action	REPAIR
Urgency of Action	PRIORITY 3
Purpose of Action	LEVEL 2
Deficiency Photo1

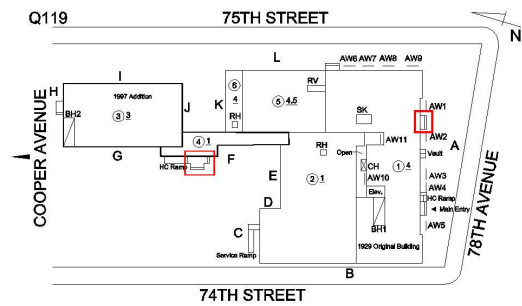
CONCRETE: WORN-OUT TREAD/RISER/NOSING

25
 S.F.
 REPLACE
 PRIORITY 4
 LEVEL 2

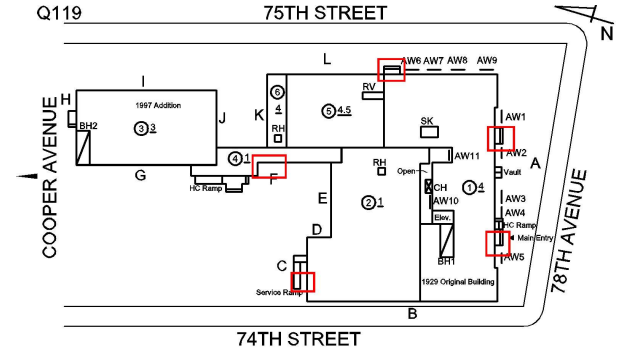
CONCRETE: CRACKS/SPALLING - MAJOR

REPLACE

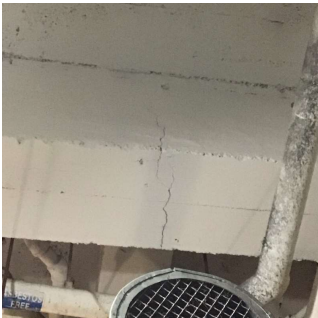
Question	Response
EXTERIOR	Inspected
WINDOWS	
WINDOWS	
Instance on Aluminum - Double Hung: All Facades	Under Construction
Instance Quantity	12,000
Instance Quantity Uom	S.F.
INTERIOR	Inspected
POOLS	Does not Exist
STRUCTURAL	Inspected
COLUMNS/BEAMS/BEARING WALLS	Inspected
Condition	3 - Fair
Deficiency	STEEL COLUMNS/BEAMS: DETERIORATED CONCRETE FIREPROOFING
Deficiency Location/Instance	Basement - Elevator Machine Room, Room B5, Gas Meter Room, Boiler Room
Deficiency Quantity	60
Quantity Uom	S.F.
Potential Action	REPLACE
Urgency of Action	PRIORITY 3
Purpose of Action	LEVEL 5
Deficiency Photo1

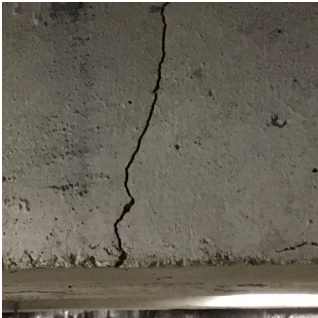
Violations	Basement - Gas Meter Room No violations recorded.
Deficiency	STEEL COLUMNS/BEAMS: DETERIORATED CONCRETE FIREPROOFING
Deficiency Location/Instance	Basement - Crawlspace
Deficiency Quantity	50
Quantity Uom	S.F.
Potential Action	REPLACE
Urgency of Action	PRIORITY 4
Purpose of Action	LEVEL 5
Deficiency Photo1

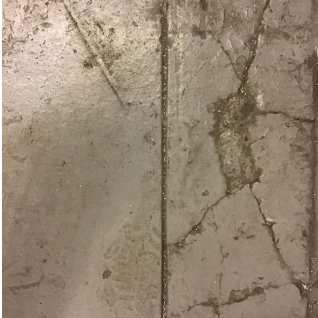
Question	Response
INTERIOR	Inspected
STRUCTURAL	
FLOOR STRUCTURE	Inspected
Condition	3 - Fair
Deficiency	CONCRETE SLAB ON GRADE: THRU CRACKS
Deficiency Location/Instance	Basement - Boiler Room, Mechanical Equipment Room, Crawlspace
Deficiency Quantity	50
Quantity Uom	S.F.
Potential Action	REPAIR
Urgency of Action	PRIORITY 3
Purpose of Action	LEVEL 5
Deficiency Photo1

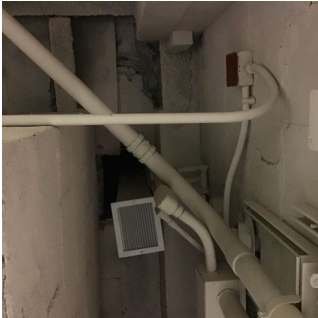
Violations	Basement - Boiler Room No violations recorded.
Deficiency	CONCRETE: CRACKS/SPALLED/REINFORCEMENT EXPOSED
Deficiency Location/Instance	Basement - Elevator Machine Room, Boiler Room
Deficiency Quantity	50
Quantity Uom	S.F.
Potential Action	REPAIR
Urgency of Action	PRIORITY 3
Purpose of Action	LEVEL 5
Deficiency Photo1

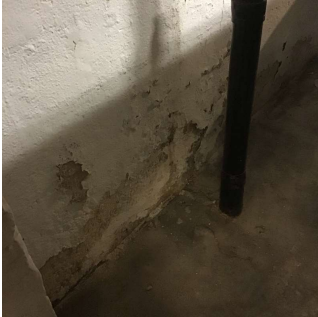
Violations	Basement - Elevator Machine Room No violations recorded.
FOUNDATION WALLS	Inspected
Material Type(s)	Concrete
Condition	4 - Between Fair and Poor
Deficiency	CONCRETE: WATER INFILTRATION IN NON- INSTRUCTIONAL SPACE

Deficiency Location/Instance	Basement - Boiler Room
Deficiency Quantity	100
Quantity Uom	S.F.
Potential Action	INSTALL WATERPROOFING
Urgency of Action	PRIORITY 5

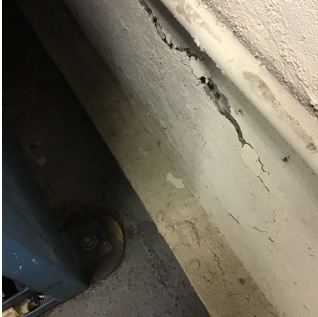
Basement - Boiler Room
Violations	No violations recorded.
Deficiency	CONCRETE: CRACKED/SPALLED/REINFORCEMENT EXPOSED
Deficiency Location/Instance	Basement - Elevator Machine Room, Boiler Room, Storage Room, Mechanical Room, Rooms B5 and B7
Deficiency Quantity	100
Quantity Uom	S.F.
Potential Action	REPAIR
Urgency of Action	PRIORITY 4
Purpose of Action	LEVEL 5
Deficiency Photo1

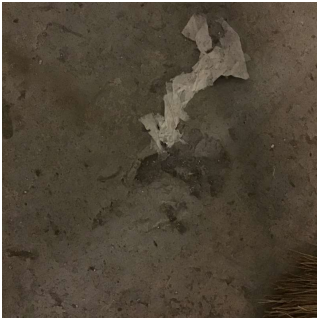
Violations	Basement- Vault No violations recorded.
Slab Structure	Inspected
Condition	3 - Fair
Deficiency	CONCRETE SLAB ON GRADE: THRU CRACKS
Deficiency Location/Instance	Basement - Vault
Deficiency Quantity	25
Quantity Uom	S.F.
Potential Action	REPAIR
Urgency of Action	PRIORITY 3
Purpose of Action	LEVEL 5
Deficiency Photo1

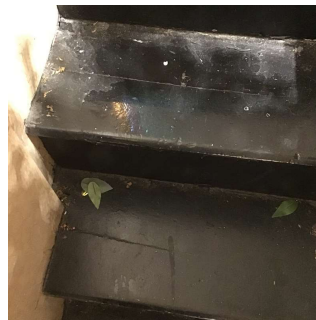
Right Side

Deficiency	DAMAGED STEPS
------------	---------------

Deficiency Location/Instance	Right and Left Side
------------------------------	---------------------

Potential Action	REPLACE
------------------	---------

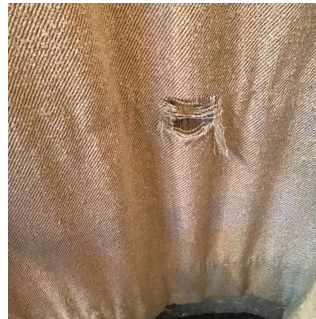
Deficiency	WORN/DETERIORATED
------------	-------------------

Deficiency Location/Instance	Lateral Right side
------------------------------	--------------------

Potential Action	REPLACE
------------------	---------

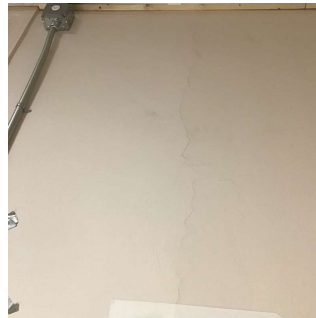
Deficiency	PLASTER: CRACKS/SPALLING
------------	--------------------------

Deficiency Location/Instance	Near Entrance
------------------------------	---------------

Potential Action	REPLACE
------------------	---------

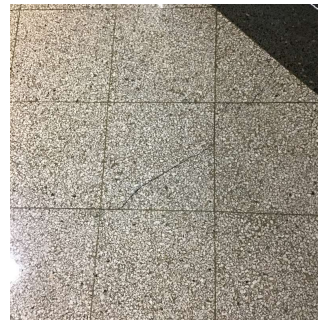
Near Auditorium

TERRAZZO: CRACKS

REPLACE

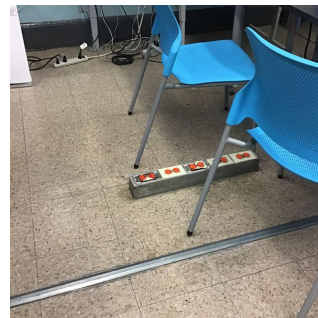
VINYL TILES: TRIPPING HAZARD - ELECTRICAL OUTLET

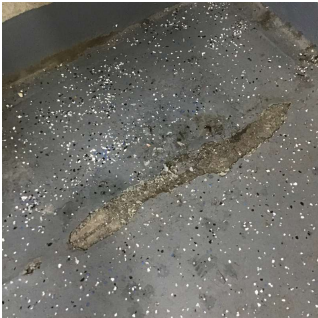
Question	Response
INTERIOR	
CLASSROOMS/CORRIDORS/ADMIN SPACES	
Floor Finish	Inspected
	Room 309
Violations	No violations recorded.
Deficiency	ROLLED ASPHALT: CRACKS
Deficiency Location/Instance	Corridor near Rooms 319, 412, 421
Deficiency Quantity	20
Quantity Uom	S.F.
Potential Action	REPLACE
Urgency of Action	PRIORITY 3
Purpose of Action	LEVEL 2
Deficiency Photo1

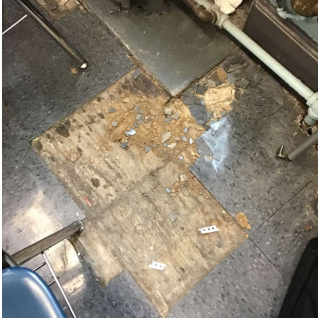
Corridor near Room 421
Violations	No violations recorded.
Deficiency	VINYL TILES: DETERIORATED SUBSTRATE
Deficiency Location/Instance	Rooms M301, 401, 402, Corridor near Rooms M302, M303, and others.
Deficiency Quantity	100
Quantity Uom	S.F.
Potential Action	REPLACE
Urgency of Action	PRIORITY 3
Purpose of Action	LEVEL 2
Deficiency Photo1

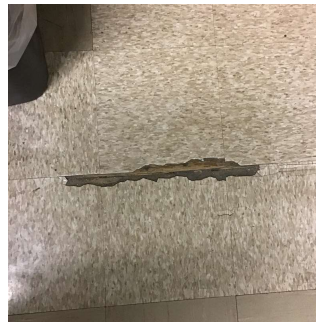
Room 103

Room 402
Violations	No violations recorded.
Deficiency	VINYL TILES: BROKEN/DETERIORATED/MISSING TILES
Deficiency Location/Instance	Rooms 103, 305, 401, 414, Corridor near Room M303, and others.
Deficiency Quantity	500

Quantity Uom	S.F.
Potential Action	REPLACE
Urgency of Action	PRIORITY 3
Purpose of Action	LEVEL 2

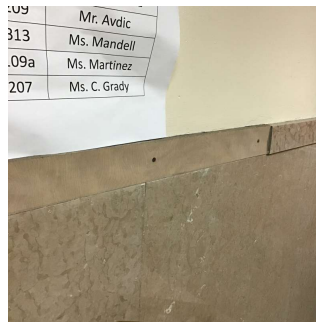
Vestibule - Exit 1/2

STONE MOLDINGS: CRACKS/SPALLING

REPLACE

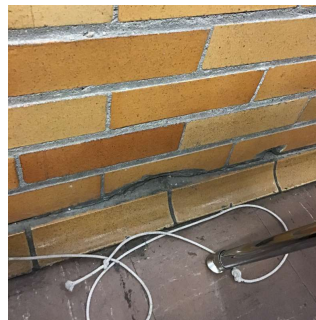
BRICK: CRACKS/SPALLING

REPLACE

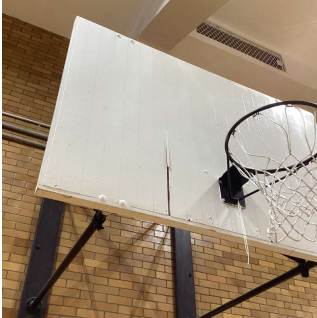
Instance on 3rd Floor	Inspected
Condition	5 - Poor
Deficiency	DAMAGED/MISSING
Deficiency Location/Instance	Near Room 300C
Deficiency Quantity	1

Question	Response
INTERIOR	
GYMNASIUM	
Fixed Equipment	
Quantity Uom	EACH
Potential Action	REPLACE
Urgency of Action	PRIORITY 3
Purpose of Action	LEVEL 2
Deficiency Photo1

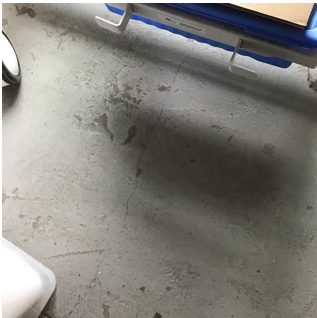
Near Room 300C
Violations	No violations recorded.
Floor Finish	
Instance on 3rd Floor	Inspected
Condition	2 - Between Good and Fair
Deficiency	CONCRETE: CRACKS
Deficiency Location/Instance	Storage Room
Deficiency Quantity	10
Quantity Uom	S.F.
Potential Action	REPLACE
Urgency of Action	PRIORITY 3
Purpose of Action	LEVEL 2
Deficiency Photo1

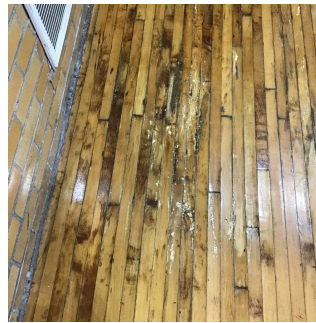
Storage Room
Violations	No violations recorded.
Instance on 4th Floor	Inspected
Condition	2 - Between Good and Fair
Deficiency	WOOD: DAMAGED/DETERIORATED
Deficiency Location/Instance	Near Windows
Deficiency Quantity	50
Quantity Uom	S.F.
Potential Action	REPLACE
Urgency of Action	PRIORITY 3
Purpose of Action	LEVEL 2

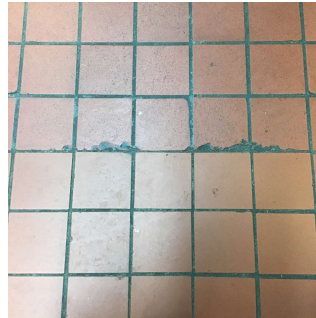
Near Serving Area

QUARRY TILE: BROKEN/MISSING TILES

REPLACE

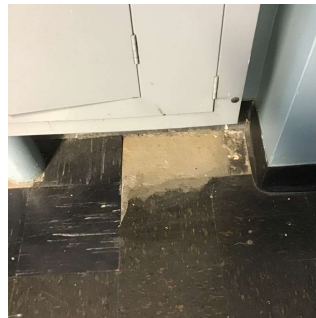
Office/Staff Lounge

VINYL TILES: BROKEN/DETERIORATED/MISSING TILES

REPLACE

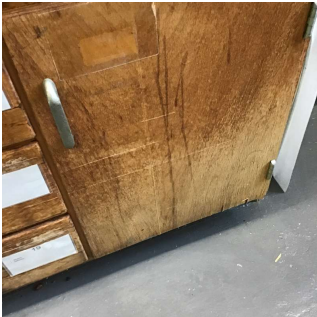
Violations	Room 415 No violations recorded.
SCIENCE LAB	Does not Exist
SCIENCE PREP ROOM	Inspected
Instance on Room 411	Inspected
Alternative use	No
Instance on Room M302	Inspected
Alternative use	Yes
Fixed Equipment	
Instance on Room 411	Inspected
Condition	3 - Fair
Deficiency	CABINETS: MISSING/DAMAGED
Deficiency Location/Instance	Room 411
Deficiency Quantity	10
Quantity Uom	L.F.
Potential Action	REPLACE
Urgency of Action	PRIORITY 3
Purpose of Action	LEVEL 2
Deficiency Photo1

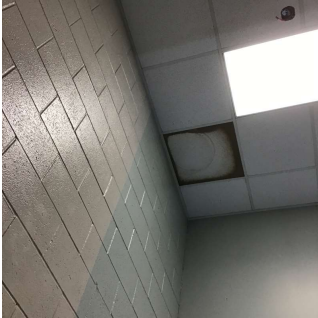
Question	Response
INTERIOR	
STAIRS/RAMPS: INTERIOR	
Do Letter Stair Signs Exist?	Yes
Ceiling	Inspected
Condition	2 - Between Good and Fair
Deficiency	ACOUSTIC TILES: DAMAGED/MISSING
Deficiency Location/Instance	Stairs A/1, 3, B/1, 3
Deficiency Quantity	100
Quantity Uom	S.F.
Potential Action	REPLACE
Urgency of Action	PRIORITY 3
Purpose of Action	LEVEL 2
Deficiency Photo1

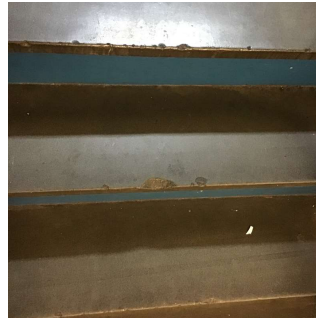
Corridor near Room 119B

STONE: BROKEN/MISSING

REPLACE

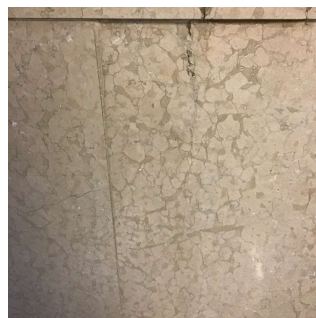
STONE: CRACKS/SPALLING

REPLACE

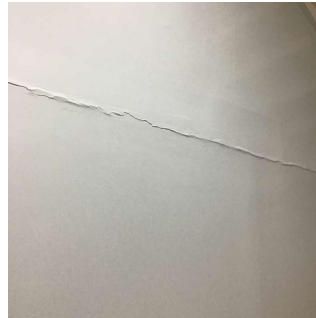
Stair A/2

GYPSUM BOARD: DETERIORATED

REPLACE

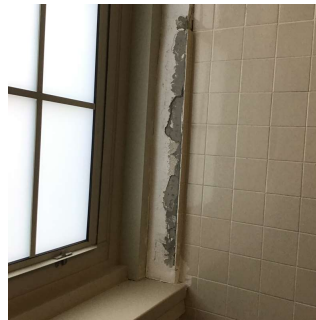
Room 312

PLASTER: CRACKS/SPALLING

REPLACE

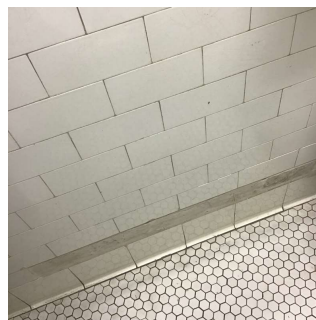
CERAMIC TILE: BROKEN/ MISSING

REPLACE

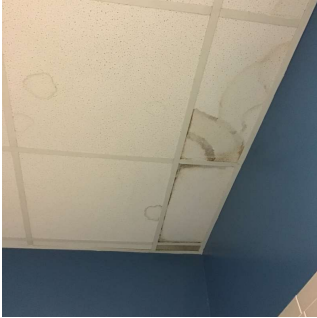
Question	Response
INTERIOR	
TOILET ROOMS - STAFF	Inspected
Walls	Inspected
	Room 206
Violations	No violations recorded.
TOILET ROOMS - STUDENTS	Inspected
Ceiling	Inspected
Condition	3 - Fair
Deficiency	ACOUSTIC TILES: DAMAGED/MISSING
Deficiency Location/Instance	Rooms M110, M206, M209, M307, M310
Deficiency Quantity	120
Quantity Uom	S.F.
Potential Action	REPLACE
Urgency of Action	PRIORITY 3
Purpose of Action	LEVEL 2
Deficiency Photo1

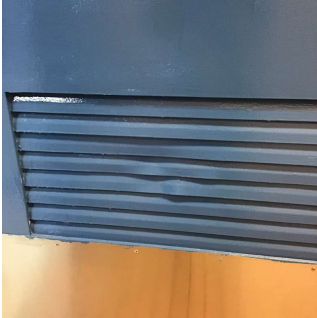
Violations	Room M209 No violations recorded.
Door(s)	Inspected
Condition	3 - Fair
Deficiency	METAL: DAMAGED LOUVER
Deficiency Location/Instance	Room M110
Deficiency Quantity	1
Quantity Uom	EACH
Potential Action	MAINTENANCE
Urgency of Action	PRIORITY 3
Purpose of Action	LEVEL 2
Deficiency Photo1

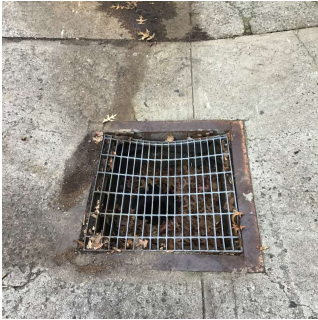
Violations	Near Playground No violations recorded.

Question	Response
INTERIOR	
TOILET ROOMS - STUDENTS	Inspected
Stalls	Inspected
Condition	2 - Between Good and Fair
Deficiency	No deficiencies recorded
Walls	Inspected
Condition	2 - Between Good and Fair
Deficiency	No deficiencies recorded
LIFE SAFETY	Inspected
F.D. HOLDING AREA	Does not Exist
STEEL STAIRS	Does not Exist
SITE	Inspected
CONTAINERIZATION	Does not Exist
Drainage System for Asphalt	Inspected
Catch Basins/Manhole - Surrounded by asphalt	Inspected
Condition	2 - Between Good and Fair
Deficiency	No deficiencies recorded
Culverts - Asphalt Covering	Does not Exist
Drainage System for Concrete	Inspected
Catch Basins/Manhole - Surrounded by concrete	Inspected
Condition	3 - Fair
Deficiency	DAMAGED COVER
Deficiency Location/Instance	Near Playground
Deficiency Quantity	1
Quantity Uom	EACH
Potential Action	REPLACE
Urgency of Action	PRIORITY 3
Purpose of Action	LEVEL 2
Deficiency Photo1

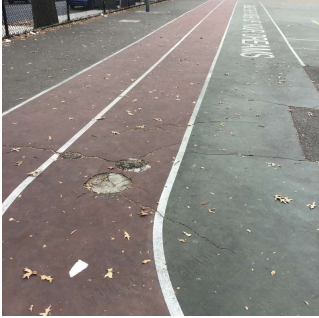
Question	Response
SITE	
PAVING	
Student Non-Use	Inspected
Asphalt	Inaccessible
Concrete	Inaccessible
Pavers	Does not Exist
Student Use	Inspected
Gravel Exists?	No
Asphalt	Inspected
Condition	4 - Between Fair and Poor
Deficiency	CRACKS - MAJOR
Deficiency Location/Instance	Near Entrance
Deficiency Quantity	1,200
Quantity Uom	S.F.
Potential Action	REPLACE
Urgency of Action	PRIORITY 3
Purpose of Action	LEVEL 2
Deficiency Photo1

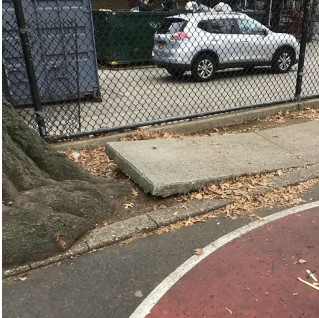
Violations	Near Entrance No violations recorded.
Concrete	Inspected
Condition	4 - Between Fair and Poor
Deficiency	DAMAGED/DETERIORATED/MISSING SECTIONS
Deficiency Location/Instance	Near Schoolyard Entrance
Deficiency Quantity	25
Quantity Uom	S.F.
Potential Action	REPLACE
Urgency of Action	PRIORITY 5
Purpose of Action	LEVEL 6
Deficiency Photo1

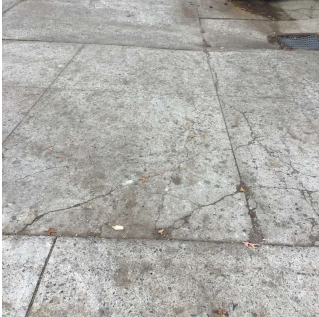
Violations	Near Schoolyard Entrance No violations recorded.
Deficiency	DAMAGED/DETERIORATED/MISSING SECTIONS
Deficiency Location/Instance	Near Playground

Question	Response
SITE	
PAVING	
Student Use	Inspected
Concrete	
Deficiency Quantity	550
Quantity Uom	S.F.
Potential Action	REPLACE
Urgency of Action	PRIORITY 3
Purpose of Action	LEVEL 2
Deficiency Photo1

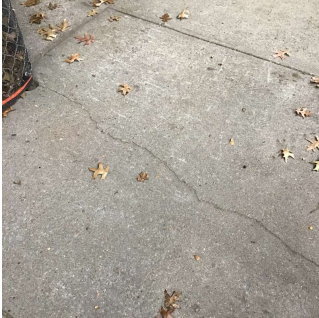
Near Exit 7
Violations	No violations recorded.
Pavers	Inaccessible
DOT Sidewalk	Inspected
Asphalt	Does not Exist
Concrete	Inspected
Condition	4 - Between Fair and Poor

Near Playground
Violations	No violations recorded.
Pavers	Does not Exist
Site Sidewalks & Walkways	Inspected
Asphalt	Inspected
Condition	2 - Between Good and Fair
Deficiency	No deficiencies recorded
Concrete	Inspected
Condition	3 - Fair
Deficiency	DAMAGED/DETERIORATED/MISSING SECTIONS
Deficiency Location/Instance	Near Exits 3, 7
Deficiency Quantity	75
Quantity Uom	S.F.
Potential Action	REPLACE
Urgency of Action	PRIORITY 3
Purpose of Action	LEVEL 2
Deficiency Photo1

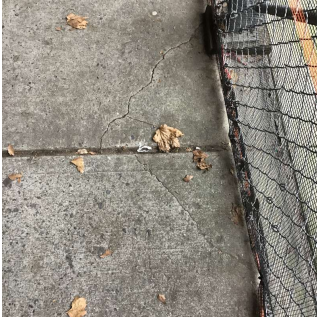
Question	Response
SITE	
PAVING	
DOT Sidewalk	
Concrete	
Deficiency	DAMAGED/DETERIORATED/MISSING SECTIONS
Deficiency Location/Instance	74th Street, 75th Street, 78th Avenue
Deficiency Quantity	725
Quantity Uom	S.F.
Potential Action	REPLACE
Urgency of Action	PRIORITY 3
Purpose of Action	LEVEL 2
Deficiency Photo1
