NYC Department of Education
Building Condition Assessment Survey 2023 - 2024

Architectural Inspection

Q120

Asset: P.S. 120 - QUEENS, 58-01 136 STREET, New York, 11355

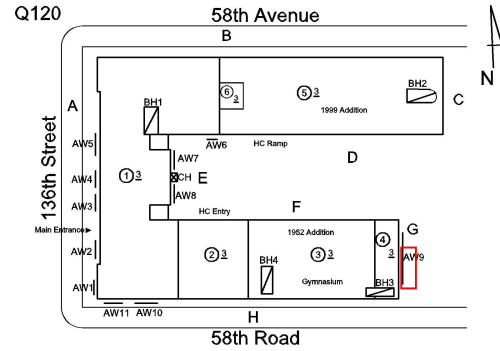
Roof Plan reference

Question	Response
Architectural	
EXTERIOR	Inspected
AREAWAY	Inspected
Instance on AW1-AW8, AW10, AW11	Inaccessible
Instance Quantity	10
Instance Quantity Uom	EACH
Instance on AW9	Inspected
Instance Condition	3 - Fair
Instance Quantity	1
Instance Quantity Uom	EACH
Deficiency	AREAWAY WALLS: CRACKS AND SPALLING

AREAWAY

25
S.F.
REPLACE
PRIORITY 4
LEVEL 2

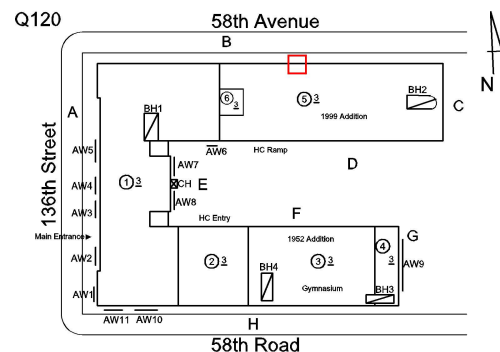
Roof Plan reference

METAL: DETERIORATED DOOR AND FRAME - MAJOR DETERIORATION

2
EACH
REPLACE
PRIORITY 4

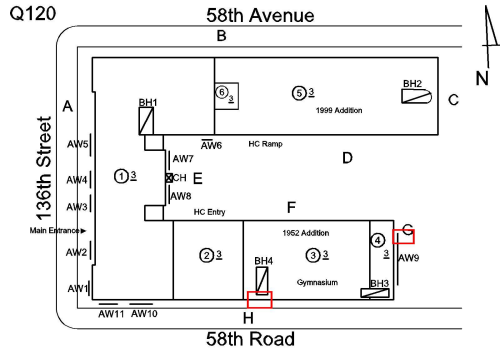
Violations	Facade B - Exit 3 No violations recorded.
Deficiency	METAL CLAD: DETERIORATED DOOR - MAJOR DETERIORATION
Roof Plan reference	Q120

Deficiency Quantity	4
Quantity Uom	EACH
Potential Action	REPLACE
Urgency of Action	PRIORITY 4
Purpose of Action	LEVEL 2
Deficiency Photo1

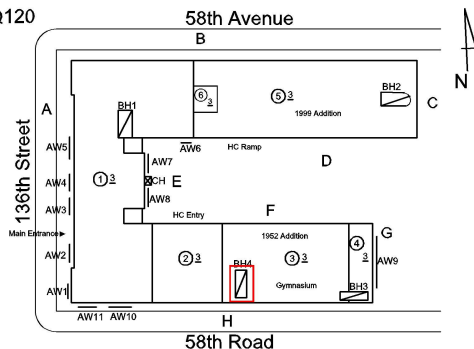
Condition	3 - Fair
Deficiency	BULKHEAD/PENTHOUSE WALLS/INTERIOR: PLASTER CRACKS/SPALLING
Roof Plan reference	Q120

Question	Response
EXTERIOR	
ROOF	Inspected
Specialties	
BULKHEAD/PENTHOUSE	
Deficiency Quantity	80
Quantity Uom	S.F.
Potential Action	REPLACE
Urgency of Action	PRIORITY 3
Purpose of Action	LEVEL 2
Deficiency Photo1

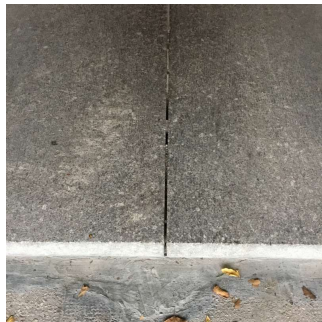
Violations	Facade H No violations recorded.
Deficiency	CONCRETE: CRACKS/SPALLING - MINOR

Question	Response
EXTERIOR	
ROOF	Inspected
Specialties	
DUNNAGE STEEL	Does not Exist
SKYLIGHT/ROOF VENT	Does not Exist
ROOF/GRAVITY TANK	Does not Exist
STAIRS/RAMPS: EXTERIOR	Inspected
BUILDING CHEEK/FLANK WALLS	Inspected
Condition	2 - Between Good and Fair
Deficiency	No deficiencies recorded
RAILINGS	Inspected
Condition	2 - Between Good and Fair
Deficiency	No deficiencies recorded
STAIRS/RAMPS	Inspected
Condition	3 - Fair
Deficiency	STONE: DETERIORATED JOINTS
Roof Plan reference	Q120
Deficiency Quantity	10
Quantity Uom	L.F.
Potential Action	REPOINT
Urgency of Action	PRIORITY 4
Purpose of Action	LEVEL 2
Deficiency Photo1

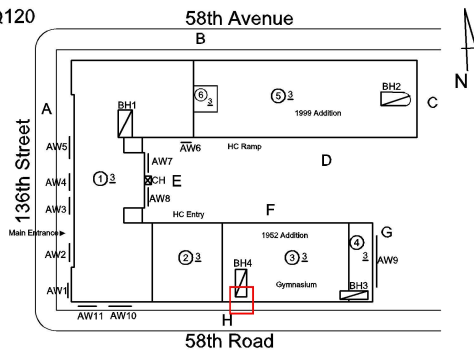
Facade H

CONCRETE: CRACKS/SPALLING - MINOR

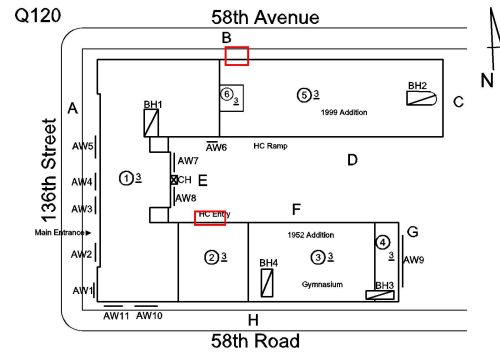
Roof Plan reference

STAIRS/RAMPS

20
S.F.
REPAIR
PRIORITY 3
LEVEL 2

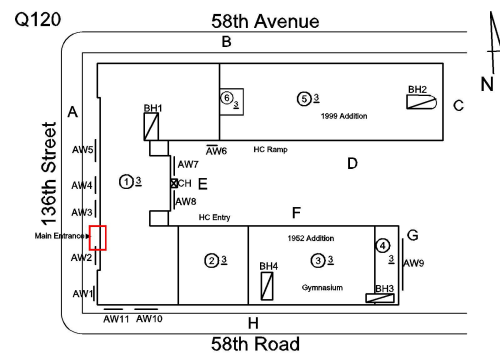
Roof Plan reference

STONE: DETERIORATED JOINTS

10
L.F.
REPOINT
PRIORITY 3
LEVEL 2

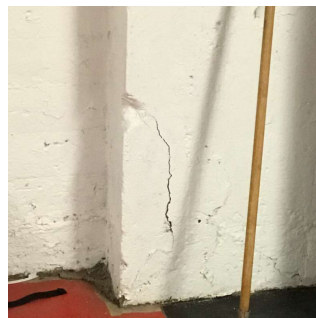
STEEL COLUMNS/BEAMS: DETERIORATED CONCRETE
FIREPROOFING

REPLACE

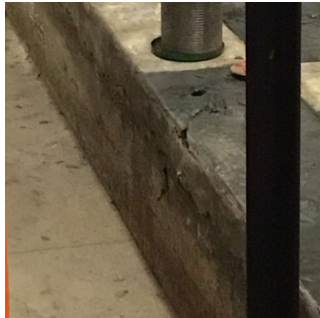
Basement Storage Area (Boiler Room similar)
Violations	No violations recorded.
Deficiency	CONCRETE SLAB ON GRADE: THRU CRACKS
Deficiency Location/Instance	Basement
Deficiency Quantity	30
Quantity Uom	S.F.
Potential Action	REPLACE
Urgency of Action	PRIORITY 4
Purpose of Action	LEVEL 5
Deficiency Photo1

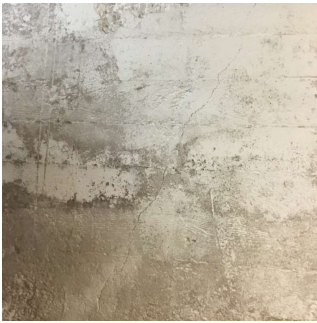
Basement Storage Area
Violations	No violations recorded.
Deficiency	CONCRETE: CRACKED/SPALLED/REINFORCEMENT EXPOSED
Deficiency Location/Instance	Basement
Deficiency Quantity	120
Quantity Uom	S.F.
Potential Action	REPAIR
Urgency of Action	PRIORITY 4
Purpose of Action	LEVEL 5
Deficiency Photo1

Boiler Room
Violations	No violations recorded.
FOUNDATION WALLS	
Material Type(s)	Inspected Concrete
Condition	4 - Between Fair and Poor
Deficiency	CONCRETE: CRACKED/SPALLED/REINFORCEMENT EXPOSED
Deficiency Location/Instance	Basement
Deficiency Quantity	70
Quantity Uom	S.F.
Potential Action	REPAIR
Urgency of Action	PRIORITY 3
Purpose of Action	LEVEL 5

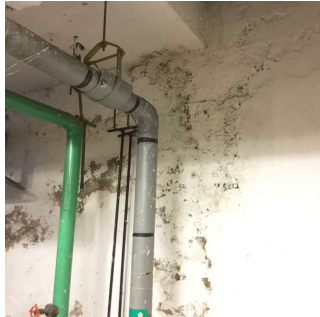
Question	Response
INTERIOR	
STRUCTURAL	
VAULTS-BUNKERS	
Foundation Walls	
Deficiency Photo1	 
Violations	Vault at Boiler Room No violations recorded.
Deficiency	WATER INFILTRATION IN NON- INSTRUCTIONAL SPACE
Deficiency Location/Instance	Vault at Boiler Room
Deficiency Quantity	200
Quantity Uom	S.F.
Potential Action	INSTALL WATERPROOFING
Urgency of Action	PRIORITY 5
Purpose of Action	LEVEL 5
Deficiency Photo1

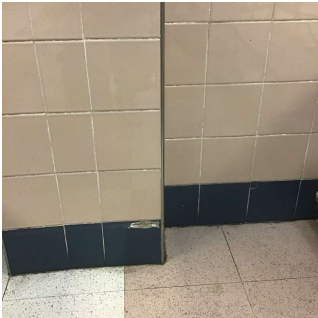
Question	Response
INTERIOR	
CAFETERIA	
Ceiling	
Deficiency Photo1	 
Violations	Near Entrance No violations recorded.
Door(s)	
Instance on 1st Floor	Inspected
Condition	2 - Between Good and Fair
Deficiency	No deficiencies recorded
Fixed Equipment	
Instance on 1st Floor	Does not Exist
Floor Finish	
Instance on 1st Floor	Inspected
Condition	2 - Between Good and Fair
Deficiency	VINYL TILES: DETERIORATED SUBSTRATE
Deficiency Location/Instance	Near Exit 5, Entrance Stair A/1
Deficiency Quantity	30
Quantity Uom	S.F.
Potential Action	REPLACE
Urgency of Action	PRIORITY 3
Purpose of Action	LEVEL 2
Deficiency Photo1	 
Violations	Near Exit 5 No violations recorded.
Sliding-folding Partition	
Instance on 1st Floor	Does not Exist
Stage	
Instance on 1st Floor	Does not Exist
Walls	
Instance on 1st Floor	Inspected
Condition	2 - Between Good and Fair
Deficiency	CERAMIC TILE: BROKEN/ MISSING
Deficiency Location/Instance	Near Windows

Question	Response
INTERIOR	
CAFETERIA	
Walls	
Deficiency Quantity	10
Quantity Uom	S.F.
Potential Action	REPLACE
Urgency of Action	PRIORITY 3
Purpose of Action	LEVEL 2
Deficiency Photo1

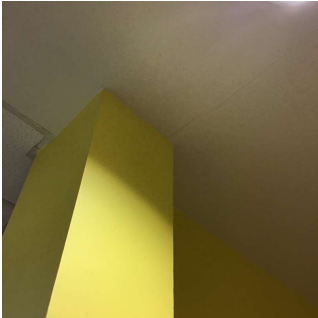
Corridor near Room Girls/3rd Floor Elevator
Violations	No violations recorded.
Deficiency	ACOUSTIC TILES: DAMAGED/MISSING
Deficiency Location/Instance	Rooms 204 304, 304A, 311,343, and others.
Deficiency Quantity	180
Quantity Uom	S.F.
Potential Action	REPLACE
Urgency of Action	PRIORITY 3

Near Windows
Violations	No violations recorded.
Window Curtains/Shades/Blinds	
Instance on 1st Floor	Does not Exist
CLASSROOMS/CORRIDORS/ADMIN SPACES	
Ceiling	
Condition	2 - Between Good and Fair
Deficiency	GYPSUM BOARD: DAMAGED/DETERIORATED
Deficiency Location/Instance	Corridor near Room Girls/3rd Floor Elevator
Deficiency Quantity	10
Quantity Uom	S.F.
Potential Action	REPLACE
Urgency of Action	PRIORITY 3
Purpose of Action	LEVEL 2
Deficiency Photo1

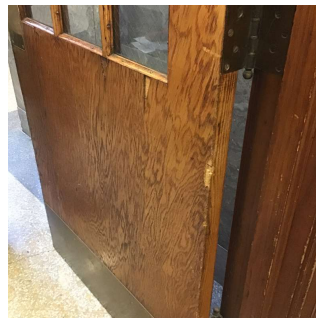
WOOD: DETERIORATED DOOR

Question	Response
INTERIOR	
CLASSROOMS/CORRIDORS/ADMIN SPACES	
Door(s)	Inspected
Violations	Corridor near Exit 1 No violations recorded.
Floor Finish	Inspected
Condition	2 - Between Good and Fair
Deficiency	SHEET VINYL: BROKEN/DETERIORATED
Deficiency Location/Instance	Room 311
Deficiency Quantity	150
Quantity Uom	S.F.
Potential Action	REPLACE
Urgency of Action	PRIORITY 3
Purpose of Action	LEVEL 2
Deficiency Photo1

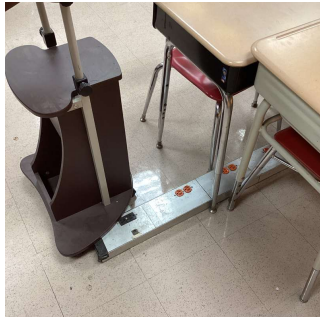
Violations	Room 240 No violations recorded.
Deficiency	TERRAZZO: CRACKS
Deficiency Location/Instance	Corridor near Exit 1, Rooms 107, 110 111.
Deficiency Quantity	50
Quantity Uom	S.F.
Potential Action	REPLACE
Urgency of Action	PRIORITY 3

Violations	Room 311 No violations recorded.
Deficiency	VINYL TILES: TRIPPING HAZARD - ELECTRICAL OUTLET
Deficiency Location/Instance	Room 240
Deficiency Quantity	10
Quantity Uom	S.F.
Potential Action	REMOVE
Urgency of Action	PRIORITY 5
Purpose of Action	LEVEL 6
Deficiency Photo1

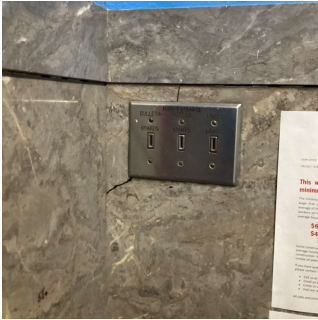
Violations	Main Entrance Vestibule No violations recorded.
Deficiency	STONE MOLDINGS: CRACKS/SPALLING
Deficiency Location/Instance	Main Entrance Vestibule
Deficiency Quantity	10
Quantity Uom	L.F.
Potential Action	REPLACE
Urgency of Action	PRIORITY 3
Purpose of Action	LEVEL 2
Deficiency Photo1

Question	Response
INTERIOR	
CLASSROOMS/CORRIDORS/ADMIN SPACES	
Floor Finish	Inspected
Violations	No violations recorded.
Walls	Inspected
Condition	2 - Between Good and Fair
Deficiency	STONE: CRACKS/SPALLING
Deficiency Location/Instance	Main Entrance Vestibule
Deficiency Quantity	20
Quantity Uom	S.F.
Potential Action	REPLACE
Urgency of Action	PRIORITY 3
Purpose of Action	LEVEL 2
Deficiency Photo1

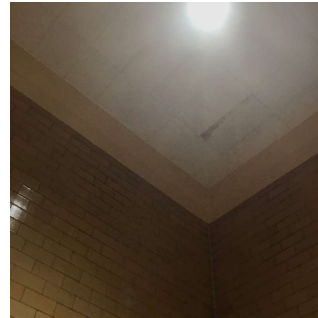
Near Door Stair I

METAL PAN: DAMAGED/MISSING

REPLACE

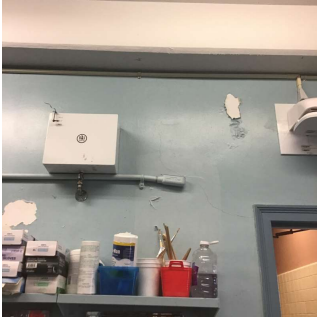
Question	Response
INTERIOR	
LOCKER ROOM	
Floor Finish	
Deficiency	No deficiencies recorded
Locker Room Lockers	
Instance on 3rd Floor (16 Lockers)	Inspected
Condition	2 - Between Good and Fair
Deficiency	No deficiencies recorded
Walls	
Instance on 3rd Floor (16 Lockers)	Inspected
Condition	2 - Between Good and Fair
Deficiency	PLASTER: CRACKS/SPALLING
Deficiency Location/Instance	Near Toilet Room
Deficiency Quantity	20
Quantity Uom	S.F.
Potential Action	REPLACE
Urgency of Action	PRIORITY 3
Purpose of Action	LEVEL 2
Deficiency Photo1

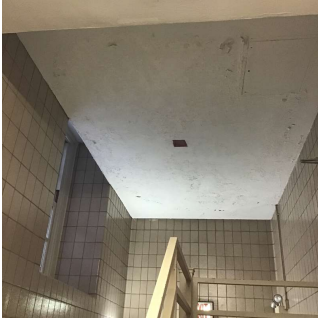
Instance on 3rd Floor	Inaccessible
Instance on 3rd Floor - Mezzanine	Inaccessible
STAIRS/RAMPS: INTERIOR	
Do Letter Stair Signs Exist?	Partially
Ceiling	
Condition	2 - Between Good and Fair
Deficiency	PLASTER: CRACKS/SPALLING
Deficiency Location/Instance	Stairs EF/1, J/1
Deficiency Quantity	160

Question	Response
INTERIOR	
STAIRS/RAMPS: INTERIOR	
Ceiling	
Quantity Uom	S.F.
Potential Action	REPLACE
Urgency of Action	PRIORITY 3
Purpose of Action	LEVEL 2
Deficiency Photo1

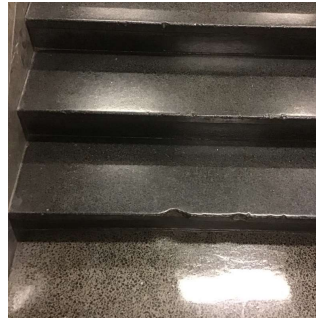
Priority Condition Exist Last Year?	Priority Category	Condition Description	Component Affected	Location Description	Person(s) Notified	Person(s) Title	PhotoImage
Yes	Tripping Hazard	Severely Damage Stair tread is a potential tripping hazard.	INTERIOR STAIRS/RAMP S: INTERIOR Stairs and Landings	Stair I/Exit 9, Corridor near Room 106	Edgar Cruzeta	Fireman

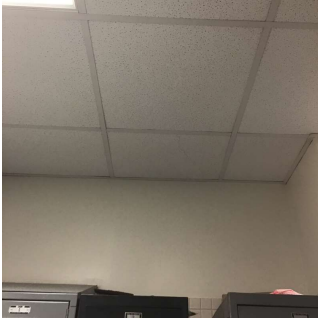
Violations	Kitchen Mens Locker Room No violations recorded.
Deficiency	PLASTER: CRACKS/SPALLING
Deficiency Location/Instance	Inside Office Gymnasium Toilet
Deficiency Quantity	20
Quantity Uom	S.F.
Potential Action	REPLACE
Urgency of Action	PRIORITY 3
Purpose of Action	LEVEL 2
Deficiency Photo1

Question	Response
INTERIOR	
TOILET ROOMS - STAFF	Inspected
Ceiling	Inspected
Condition	3 - Fair
Deficiency	ACOUSTIC TILES: DAMAGED/MISSING
Deficiency Location/Instance	Kitchen Mens Locker Room
Deficiency Quantity	10
Quantity Uom	S.F.
Potential Action	REPLACE
Urgency of Action	PRIORITY 3
Purpose of Action	LEVEL 2
Deficiency Photo1

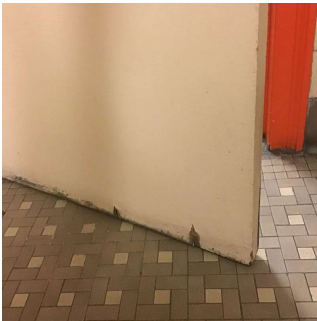
Violations	Inside Office Gymnasium Toilet No violations recorded.
Door(s)	Inspected
Condition	5 - Poor
Deficiency	WOOD: DETERIORATED DOOR
Deficiency Location/Instance	Rooms 106, 216, 316,
Deficiency Quantity	3
Quantity Uom	EACH
Potential Action	MAINTENANCE
Urgency of Action	PRIORITY 3
Purpose of Action	LEVEL 2

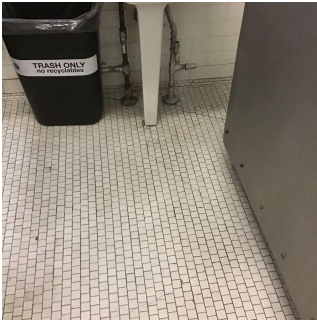
Violations	Room 106 No violations recorded.
Floor Finish	Inspected
Condition	3 - Fair
Deficiency	CERAMIC TILE: BROKEN/MISSING TILES
Deficiency Location/Instance	Rooms 106, 216, 316, Inside Principal Office.
Deficiency Quantity	40
Quantity Uom	S.F.
Potential Action	REPLACE
Urgency of Action	PRIORITY 3
Purpose of Action	LEVEL 2
Deficiency Photo1

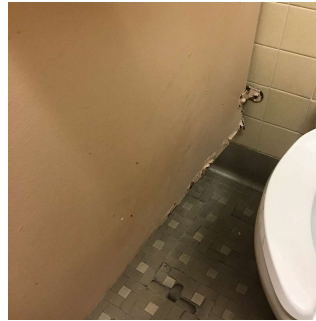
Room 106

Violations	Room 316 No violations recorded.
Stalls	Inspected
Condition	5 - Poor
Deficiency	RUST - MAJOR
Deficiency Location/Instance	Rooms 102, 106, 216, 316
Deficiency Quantity	4
Quantity Uom	EACH
Potential Action	REPLACE
Urgency of Action	PRIORITY 3
Purpose of Action	LEVEL 2

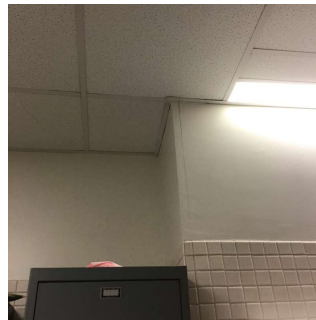
Kitchen Mens Locker Room

GYP SUM BOARD: DETERIORATED

REPLACE

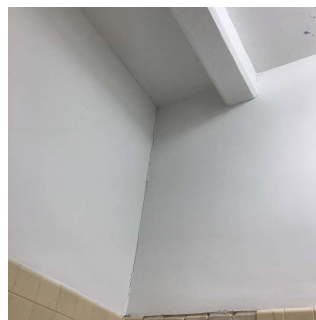
PLASTER: CRACKS/SPALLING

REPLACE

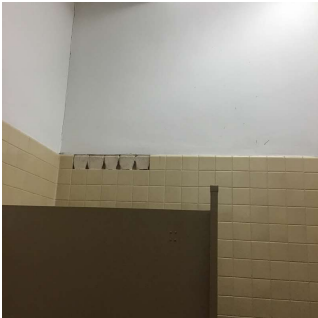
Question	Response
INTERIOR	
TOILET ROOMS - STAFF	
Walls	
Violations	Toilet Room (Antique Mezzanine Locker Room) No violations recorded.
Deficiency	CERAMIC TILE: BROKEN/ MISSING
Deficiency Location/Instance	Rooms 216, 316 Toilet Room (Antique Mezzanine Locker Room)
Deficiency Quantity	30
Quantity Uom	S.F.
Potential Action	REPLACE
Urgency of Action	PRIORITY 3
Purpose of Action	LEVEL 2
Deficiency Photo1

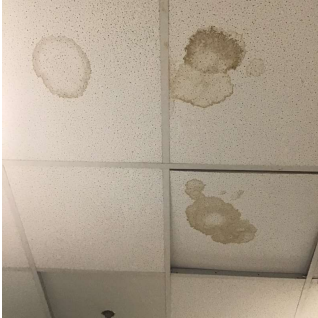
Violations	Girls/Next to Cafeteria No violations recorded.

Violations	Toilet Room (Antique Mezzanine Locker Room) No violations recorded.
TOILET ROOMS - STUDENTS	
Ceiling	Inspected
Condition	2 - Between Good and Fair
Deficiency	ACOUSTIC TILES: DAMAGED/MISSING
Deficiency Location/Instance	Girls/Next to Cafeteria, Boys /3rd Floor elevator, Boys/2nd Floor Elevator, Girls/3rd Floor Elevator
Deficiency Quantity	60
Quantity Uom	S.F.
Potential Action	REPLACE
Urgency of Action	PRIORITY 3
Purpose of Action	LEVEL 2
Deficiency Photo1

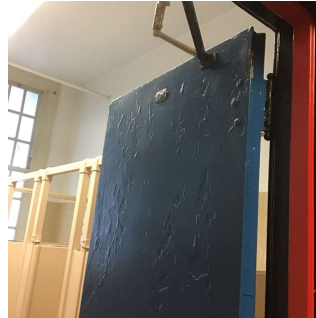
Door(s)	Inspected
Condition	5 - Poor
Deficiency	METAL: DETERIORATED DOOR
Deficiency Location/Instance	Room 219
Deficiency Quantity	1

Quantity Uom	EACH
Potential Action	MAINTENANCE
Urgency of Action	PRIORITY 3
Purpose of Action	LEVEL 2
Deficiency Photo1

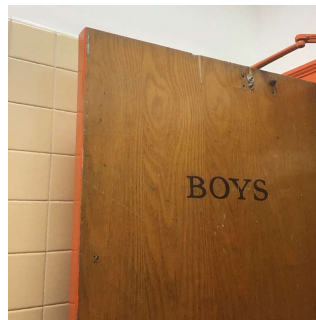
Room 308

Deficiency	WOOD: DETERIORATED DOOR
Deficiency Location/Instance	Rooms 127, 131, 208, 308, 320
Deficiency Quantity	5
Quantity Uom	EACH
Potential Action	MAINTENANCE
Urgency of Action	PRIORITY 3
Purpose of Action	LEVEL 2
Deficiency Photo1

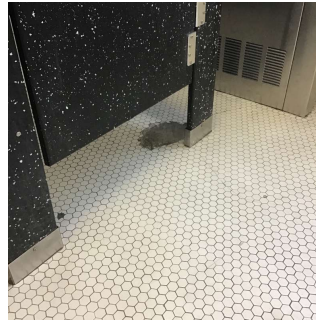
Room 131

Deficiency	CERAMIC TILE: BROKEN/MISSING TILES
Deficiency Location/Instance	Rooms 127, 131, 208, 308, 320, and others .
Deficiency Quantity	70
Quantity Uom	S.F.
Potential Action	REPLACE
Urgency of Action	PRIORITY 3
Purpose of Action	LEVEL 2

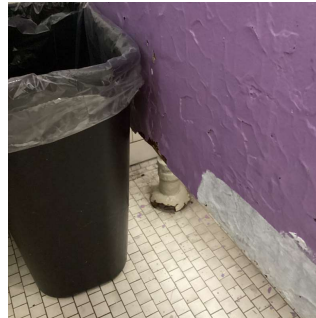
Room 320

RUST - MAJOR

REPLACE

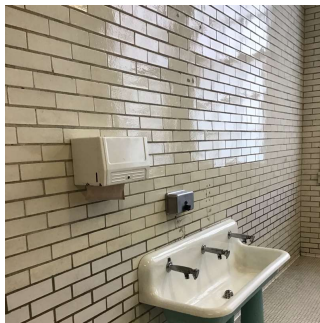
BRICK: CRACKS/SPALLING

REPLACE

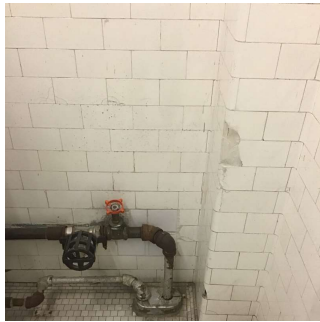
Room 127
Violations	No violations recorded.
Deficiency	CERAMIC TILE: BROKEN/ MISSING
Deficiency Location/Instance	Rooms 127, 208, 308, 320, Boys/ 3rd Floor elevator.
Deficiency Quantity	60
Quantity Uom	S.F.
Potential Action	REPLACE
Urgency of Action	PRIORITY 3
Purpose of Action	LEVEL 2
Deficiency Photo1

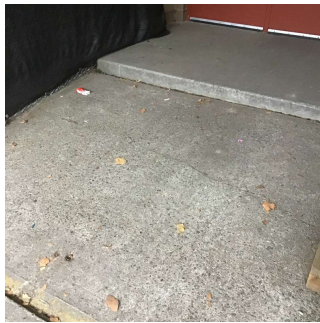
Question	Response
SITE	
Drainage System for Soil	Inspected
Culverts - Soil Covering	Does not Exist
DRINKING FOUNTAINS	Inspected
Condition	1 - Good
Deficiency	No deficiencies recorded
FENCES	Inaccessible
IRRIGATION SYSTEM	Does not Exist
PAVING	Inspected
Student Non-Use	Inspected
Gravel Exists?	No
Asphalt	Inaccessible
Concrete	Inaccessible
Pavers	Does not Exist
Student Use	Inspected
Gravel Exists?	No
Asphalt	Inaccessible
Concrete	Inaccessible
Pavers	Inaccessible
Site Sidewalks & Walkways	Inspected
Asphalt	Does not Exist
Concrete	Inspected
Condition	3 - Fair
Deficiency	CRACKS - MAJOR
Deficiency Location/Instance	Near Exit 3
Deficiency Quantity	50
Quantity Uom	S.F.
Potential Action	REPLACE
Urgency of Action	PRIORITY 3
Purpose of Action	LEVEL 2
Deficiency Photo1

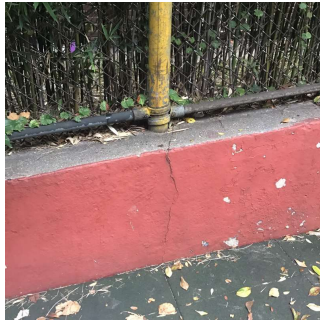
Near Exit 4
Violations	No violations recorded.
SEATING	Inspected
Benches	Inspected

Question	Response
SITE	
PLAYGROUNDS	
Play Equipment	
Instance on Schoolyard	Inspected
Condition	2 - Between Good and Fair
Deficiency	No deficiencies recorded
Safety Surfacing	
Instance on Schoolyard	Inspected
Condition	2 - Between Good and Fair
Deficiency	No deficiencies recorded
Unpaved Area	
Instance on Schoolyard	Does not Exist
PLAYING SURFACE	Inspected
Playing Field	Inspected
Instance on Courtyard	Inaccessible
Instance on Schoolyard	Inaccessible
Running Track	Does not Exist
RETAINING WALLS	Inspected
Are there any Retaining Walls 6' OR higher facing public street/sidewalk?	No
Condition	2 - Between Good and Fair
Deficiency	CAST IN PLACE CONCRETE: CRACKS/SPALLING - MAJOR
Deficiency Location/Instance	Near Exit 4
Deficiency Quantity	10
Quantity Uom	S.F.
Potential Action	REPLACE
Urgency of Action	PRIORITY 3
Purpose of Action	LEVEL 2
Deficiency Photo1
