NYC Department of Education
Building Condition Assessment Survey 2023 - 2024

Architectural Inspection

Asset: P.S. 121 - QUEENS, 126-10 109 AVENUE, New York, 11420

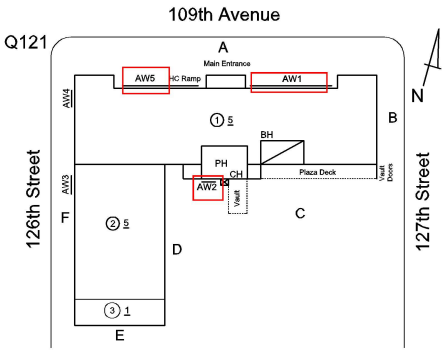
Question	Response
EXTERIOR	
AREAWAY	
Instance Quantity	3
Instance Quantity Uom	EACH
Deficiency	AREAWAY GRATINGS: MAJOR RUSTING / OR BROKEN
Roof Plan reference

Deficiency Quantity	100
Quantity Uom	S.F.
Potential Action	REPLACE
Urgency of Action	PRIORITY 4
Purpose of Action	LEVEL 2
Deficiency Photo1

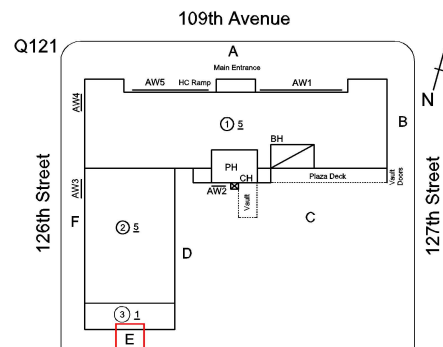
METAL CLAD: DETERIORATED DOOR AND FRAME - MAJOR DETERIORATION

Question	Response
EXTERIOR	
DOORS	
DOORS AND FRAMES	
Potential Action	REPLACE
Urgency of Action	PRIORITY 4
Purpose of Action	LEVEL 2
Deficiency Photo1	 
Violations	Facade E No violations recorded.
DOOR HARDWARE	Inspected
Condition	3 - Fair
Deficiency	No deficiencies recorded
LINTELS	Inspected
Condition	2 - Between Good and Fair
Deficiency	No deficiencies recorded
TRANSOM/SIDE LIGHT	Inspected
Condition	2 - Between Good and Fair
Deficiency	No deficiencies recorded
EXTERIOR WALLS	Inspected
Material Type(s)	Masonry
Replacement Quantity	45,000
Replacement Uom	S.F.
Instance on All Facades	Inspected
Instance Condition	3 - Fair
Instance Quantity	45,000
Instance Quantity Uom	S.F.
Deficiency	BRICK: WATER INFILTRATION IN INSTRUCTIONAL SPACE
Roof Plan reference

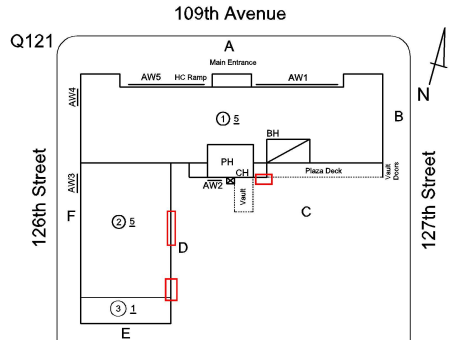
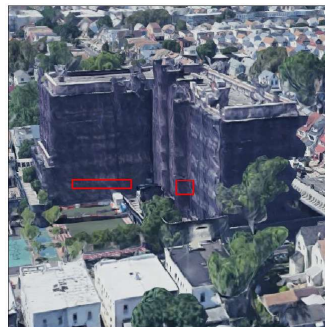
BRICK: DETERIORATED MASONRY SILLS - MINOR

REPAIR

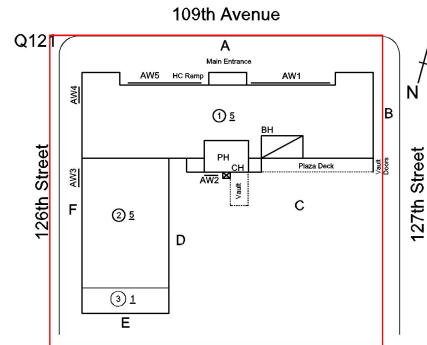
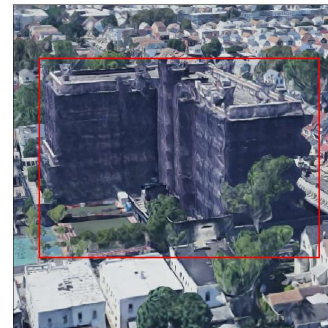
BRICK: DETERIORATED JOINTS

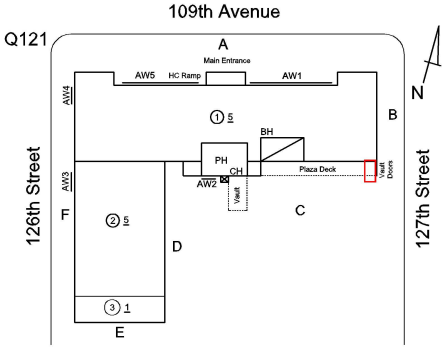
Question	Response
EXTERIOR	
PARAPETS	Inspected
Purpose of Action	LEVEL 1
Deficiency Photo1	No photo recorded
Violations	No violations recorded.
PLAZA DECK	Inspected
Instance on Concrete: Facade C	Inspected
Instance Condition	4 - Between Fair and Poor
Instance Quantity	500
Instance Quantity Uom	S.F.
Installation Year	2013
Source of Installation	Custodial Staff
Deficiency	CONCRETE: MAJOR CRACKS
Roof Plan reference

Deficiency Quantity	10
Quantity Uom	S.F.
Potential Action	REPLACE
Urgency of Action	PRIORITY 4
Purpose of Action	LEVEL 2
Deficiency Photo1

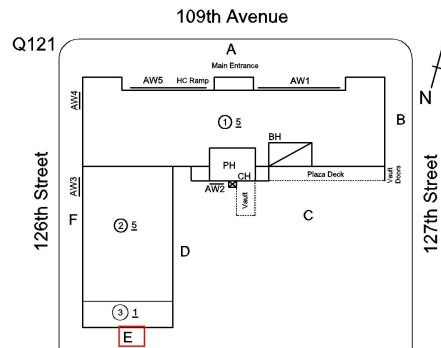
STONE: CRACKS/SPALLING - MINOR

10
S.F.
REPAIR
PRIORITY 3
LEVEL 2

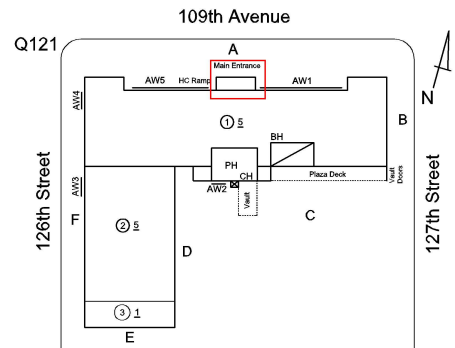
STONE: DETERIORATED JOINTS AT COPING STONES

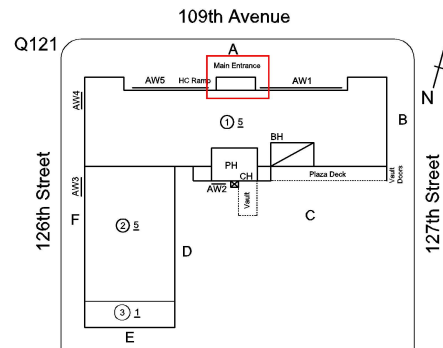
RUST - MAJOR

10
L.F.
REPLACE
PRIORITY 4
LEVEL 2

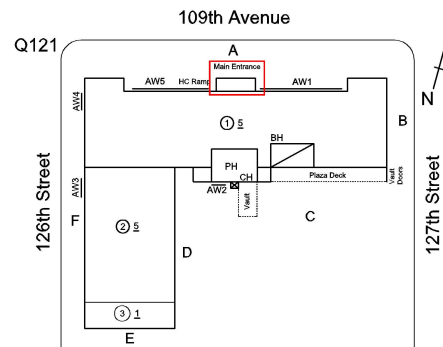
CONCRETE: WORN-OUT TREAD/RISER/NOSING

10
S.F.
REPLACE
PRIORITY 4
LEVEL 2

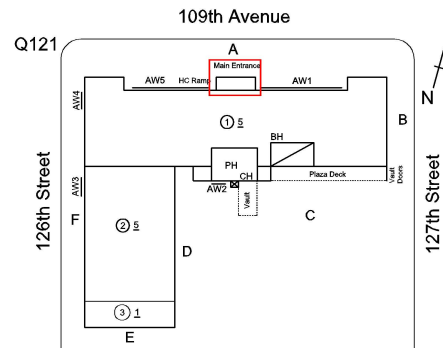
CONCRETE: CRACKS/SPALLING - MINOR

10
S.F.
REPAIR
PRIORITY 3
LEVEL 2

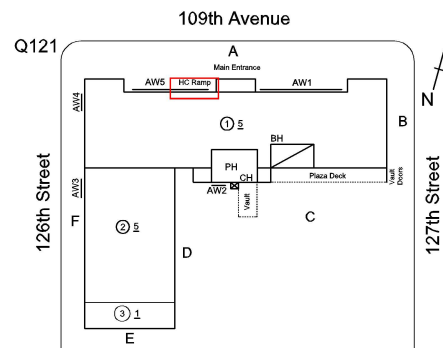
CONCRETE: CRACKS/SPALLING - MAJOR

10
S.F.
REPLACE
PRIORITY 4
LEVEL 2

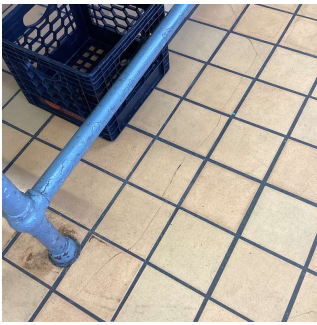
Condition	2 - Between Good and Fair
Deficiency	QUARRY TILE: BROKEN/MISSING TILES
Deficiency Location/Instance	Near center
Deficiency Quantity	20
Quantity Uom	S.F.
Potential Action	REPLACE
Urgency of Action	PRIORITY 3
Purpose of Action	LEVEL 2

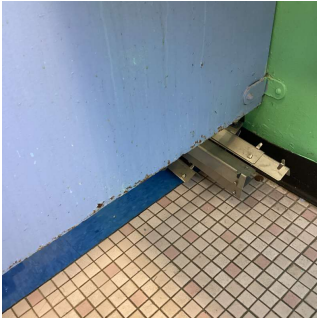
Question	Response
INTERIOR	
TOILET ROOMS - STAFF	
Floor Finish	Inspected
	Room 555
Violations	No violations recorded.
Stalls	Inspected
Condition	5 - Poor
Deficiency	RUST - MAJOR
Deficiency Location/Instance	Room 106 - Inside Cafeteria
Deficiency Quantity	1
Quantity Uom	EACH
Potential Action	REPLACE
Urgency of Action	PRIORITY 3
Purpose of Action	LEVEL 2
Deficiency Photo1

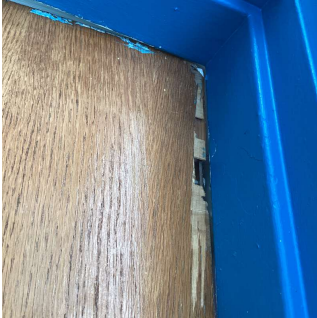
Question	Response
INTERIOR	
TOILET ROOMS - STUDENTS	
Door(s)	
Condition	5 - Poor
Deficiency	WOOD: DETERIORATED DOOR
Deficiency Location/Instance	Rooms 207, 452, 556
Deficiency Quantity	3
Quantity Uom	EACH
Potential Action	MAINTENANCE
Urgency of Action	PRIORITY 3
Purpose of Action	LEVEL 2
Deficiency Photo1

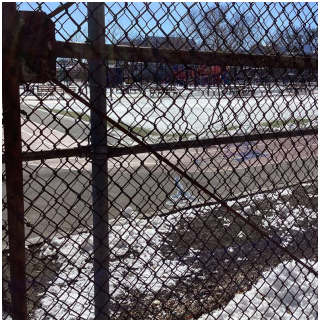
Question	Response
LIFE SAFETY	Inspected
STEEL STAIRS	Does not Exist
SITE	Inspected
CONTAINERIZATION	Inspected
Condition	5 - Poor
Deficiency	FENCING DAMAGED
Deficiency Location/Instance	127th Street
Deficiency Quantity	300
Quantity Uom	S.F.
Potential Action	REPAIR
Urgency of Action	PRIORITY 3
Purpose of Action	LEVEL 2
Deficiency Photo1

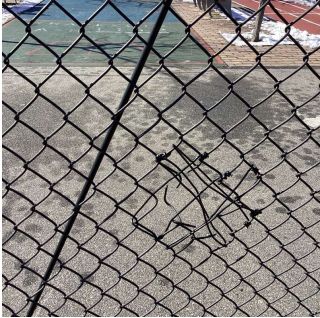
Violations	126th Street No violations recorded.
Deficiency	CHAIN LINK: DAMAGED/DETERIORATED
Deficiency Location/Instance	127th Street
Deficiency Quantity	50
Quantity Uom	S.F.
Potential Action	REPLACE
Urgency of Action	PRIORITY 3
Purpose of Action	LEVEL 2
