NYC Department of Education
Building Condition Assessment Survey 2023 - 2024

Architectural Inspection

Asset: P.S. 124 - QUEENS, 129-15 150 AVENUE, New York, 11420

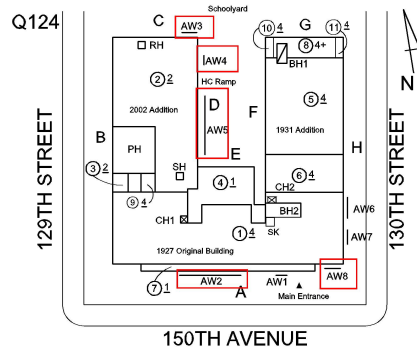
Roof Plan reference

AREAWAY WALLS: CRACKS AND SPALLING

50

REPAIR

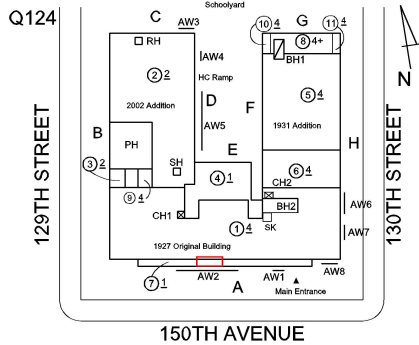
Violations	Facade C - AW3 No violations recorded.
AWNINGS AND CANOPIES	
	Does not Exist
CHIMNEY	
Material Type(s)	Inspected Masonry
Condition	2 - Between Good and Fair
Deficiency	No deficiencies recorded
COPING	
Condition	Inspected 3 - Fair
Deficiency	CAST STONE: DETERIORATED BED JOINT
Roof Plan reference

Deficiency Quantity	10
Quantity Uom	L.F.
Potential Action	REPOINT
Urgency of Action	PRIORITY 3
Purpose of Action	LEVEL 2
Deficiency Photo1

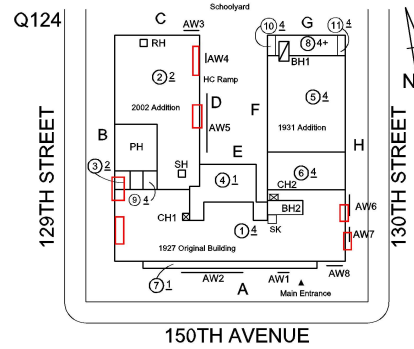
Roof Plan reference

Violations	Roof 1 No violations recorded.
Deficiency	CAST STONE: DISINTEGRATING / FREEZE THAW

50

REPLACE-IN-KIND

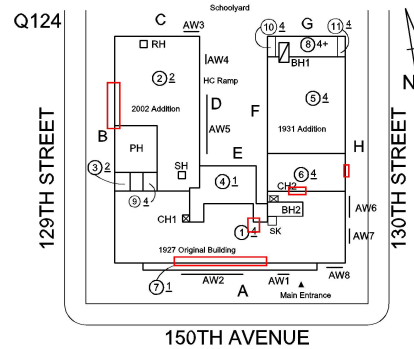
Roof Plan reference

CAST STONE: DETERIORATED TRANSVERSE JOINTS

50

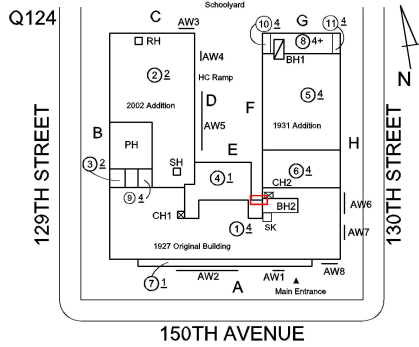
Violations	Roof 1 No violations recorded.
Deficiency	CAST STONE: CRACKED/BROKEN PIECES
Roof Plan reference

Deficiency Quantity	10
Quantity Uom	L.F.
Potential Action	REPLACE-IN-KIND
Urgency of Action	PRIORITY 4
Purpose of Action	LEVEL 2
Deficiency Photo1

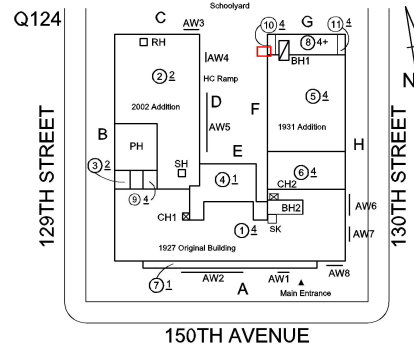
Roof Plan reference

Violations	Roof 4 No violations recorded.
CORNICE	
Condition	Inspected 2 - Between Good and Fair
Deficiency	No deficiencies recorded
DOORS	
Inspected	
DOORS AND FRAMES	
Condition	Inspected 3 - Fair
Deficiency	METAL CLAD: DETERIORATED DOOR AND FRAME - MAJOR DETERIORATION

1
EACH
REPLACE
PRIORITY 4
LEVEL 2

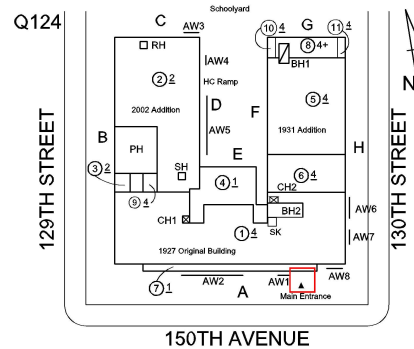
Roof Plan reference

METAL: DETERIORATED DOOR AND FRAME - MINOR DETERIORATION

2
EACH
MAINTENANCE
PRIORITY 3
LEVEL 2

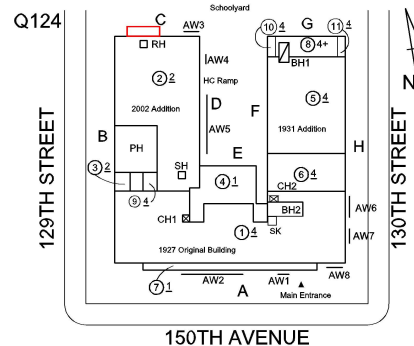
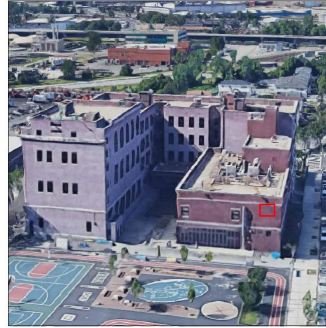
BRICK: EFFLORESCENCE

10

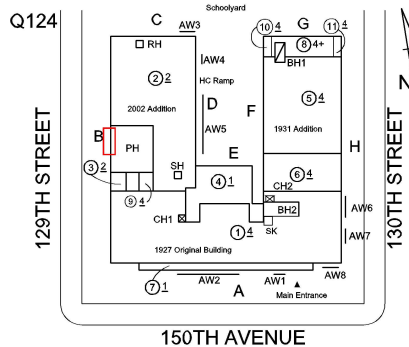
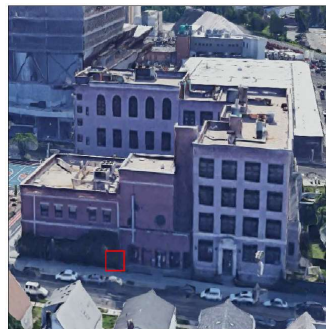
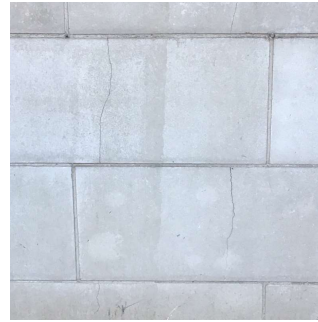
Facade B

CONCRETE MASONRY UNIT: MINOR CRACKS AND SPALLING

10

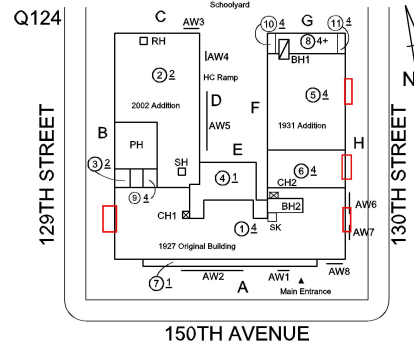
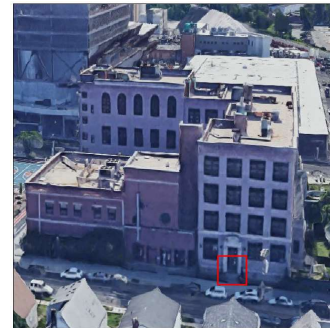
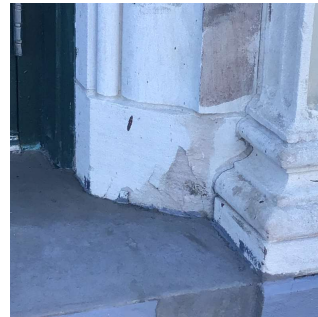
Facade B

STONE: CHIPPED/SPALLED/BROKEN PIECES - MINOR

40

REPAIR

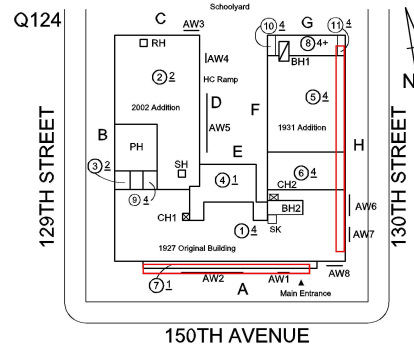
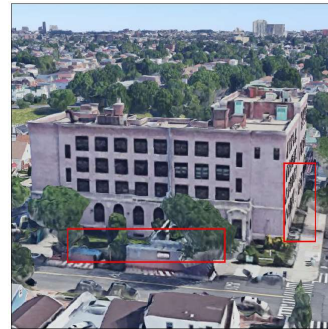
Roof Plan reference

BRICK: DETERIORATED MASONRY SILLS - MAJOR

100

REMOVE AND REPLACE

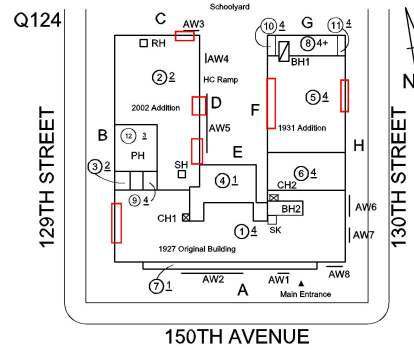
Roof Plan reference

BRICK: EFFLORESCENCE

100

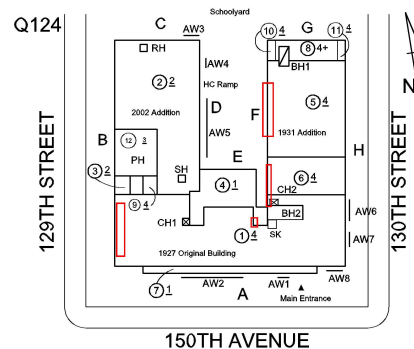
Roof Plan reference

BRICK: DETERIORATED JOINTS

200

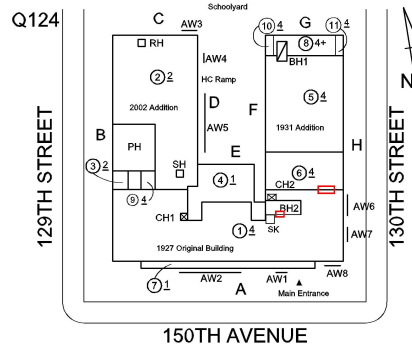
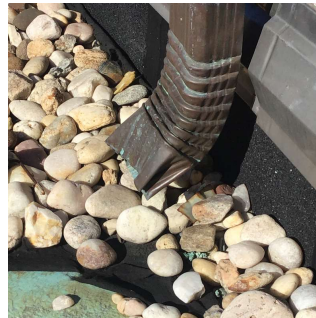
Roof 1

Deficiency	DAMAGED/MISSING
------------	-----------------

20

REPLACE

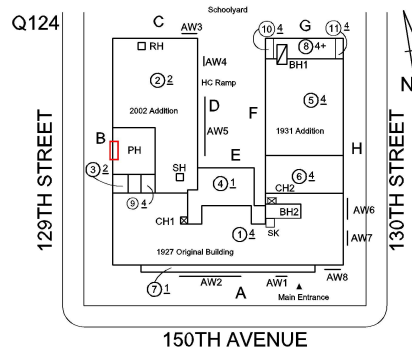
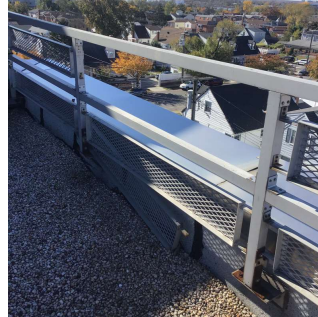
Roof 12

Deficiency	RAILINGS/PANELS: DETERIORATED, MAJOR RUSTING
------------	--

Deficiency Quantity	10
Quantity Uom	S.F.
Potential Action	REPLACE
Urgency of Action	PRIORITY 4
Purpose of Action	LEVEL 2
Deficiency Photo1

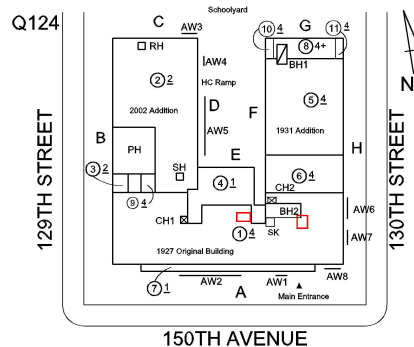
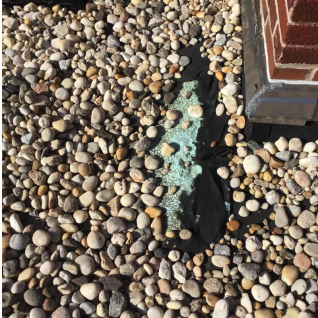
Deficiency	IRMA: ROOFING: DAMAGED INSULATION
------------	-----------------------------------

Question	Response
EXTERIOR	
ROOF	
Roofing	
ROOFING	
Deficiency Quantity	30
Quantity Uom	S.F.
Potential Action	REPLACE
Urgency of Action	PRIORITY 4
Purpose of Action	LEVEL 2
Deficiency Photo1

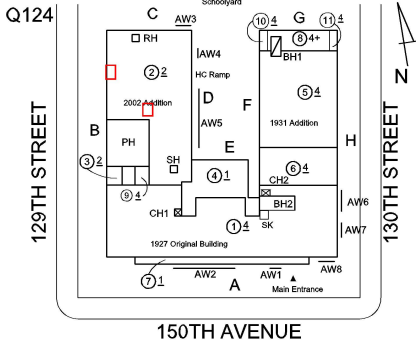
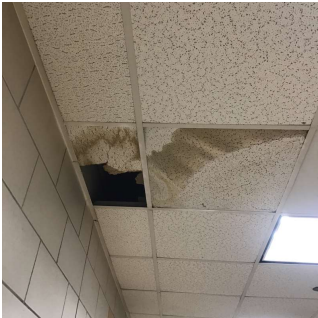
Roof 2
Instance Quantity	7,000
Instance Quantity Uom	S.F.
Does the roof have major mechanical equipment sitting on Dunnage Steel less than 18" above the Roofing?	No
Does this roof instance have a Sustainable Roof System?	No
Do solar panels exist on these roofs?	No
Is/Are the roof(s) suitable for Solar Panel installation?	No
Installation Year	2002
Source of Installation	Custodial Staff
Deficiency	BUILT-UP: ROOFING: MAJOR ACTIVE ROOF LEAKS IN INSTRUCTIONAL SPACE
Roof Plan reference

Deficiency Quantity	200

Question	Response
EXTERIOR	
ROOF	
Roofing	
ROOFING	
Quantity Uom	S.F.
Potential Action	REPLACE ROOFING WITH MAJOR EQUIPMENT REMOVAL
Urgency of Action	PRIORITY 5
Purpose of Action	LEVEL 2
Deficiency Photo1

Violations	Roof 2 - Corridor near Room 205, also Room 206 No violations recorded.
Instance on IRMA: Roof 5	Inspected
Instance Condition	3 - Fair
Instance Photo	 
	Room 5
Instance Quantity	5,000
Instance Quantity Uom	S.F.
Does the roof have major mechanical equipment sitting on Dunnage Steel less than 18" above the Roofing?	No
Does this roof instance have a Sustainable Roof System?	No
Do solar panels exist on these roofs?	No
Is/Are the roof(s) suitable for Solar Panel installation?	No
Installation Year	2010
Source of Installation	Custodial Staff
Deficiency	IRMA: ROOFING: DAMAGED INSULATION
Roof Plan reference

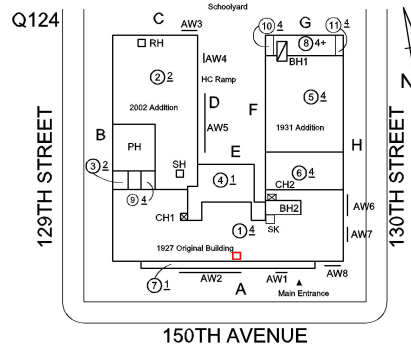
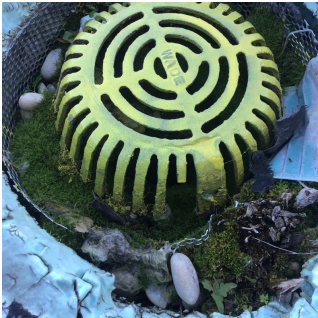
DETERIORATED

1

Question	Response
EXTERIOR	
ROOF	
Roofing	
ROOFING DRAINS	
Quantity Uom	EACH
Potential Action	REPLACE
Urgency of Action	PRIORITY 4
Purpose of Action	LEVEL 2
Deficiency Photo1

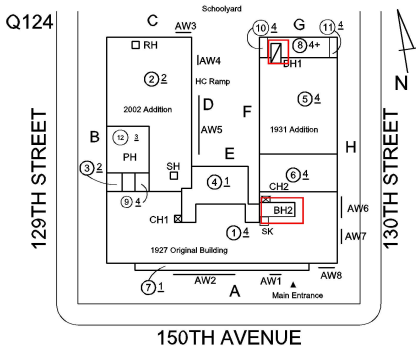
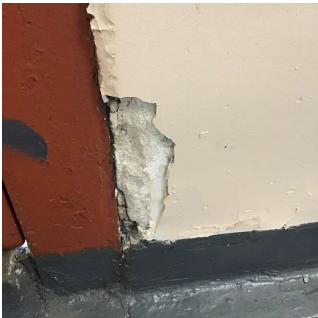
Violations	Roof 1 - Bulkhead 2 No violations recorded.

Violations	Roof 1 No violations recorded.
Specialties	Inspected
BULKHEAD/PENTHOUSE	Inspected
Condition	3 - Fair
Deficiency	BULKHEAD/PENTHOUSE WALLS/INTERIOR: PLASTER CRACKS/SPALLING
Roof Plan reference	<p>Q124</p>

Deficiency Quantity	20
Quantity Uom	S.F.
Potential Action	REPLACE
Urgency of Action	PRIORITY 3
Purpose of Action	LEVEL 2
Deficiency Photo1

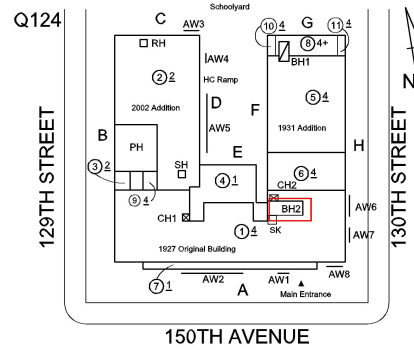
Roof Plan reference

BULKHEAD/PENTHOUSE DOORS: AIR/WATER INFILTRATION WITH DAMAGED CAULKING

15

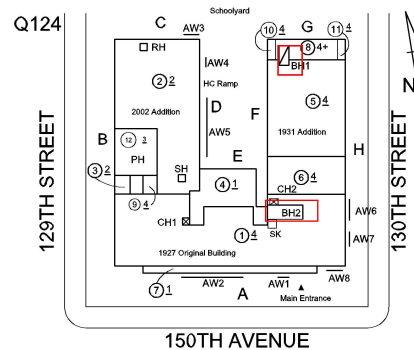
Roof Plan reference

BULKHEAD/PENTHOUSE WALLS/EXTERIOR: DETERIORATED JOINTS

50

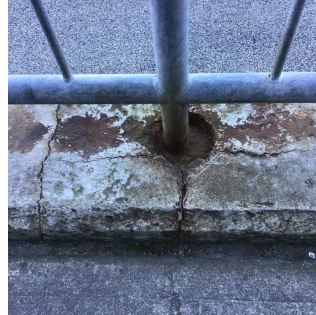
Facade C

Question	Response
EXTERIOR	
ROOF	
Specialties	
SKYLIGHT/ROOF VENT	
Condition	3 - Fair
Deficiency	BROKEN GLASS
Roof Plan reference	
Deficiency Quantity	20
Quantity Uom	S.F.
Potential Action	MAINTENANCE
Urgency of Action	PRIORITY 3
Purpose of Action	LEVEL 2
Deficiency Photo1	
Violations	Roof 1 No violations recorded.
ROOF/GRAVITY TANK	Does not Exist
STAIRS/RAMPS: EXTERIOR	Inspected
BUILDING CHEEK/FLANK WALLS	Inspected
Condition	5 - Poor
Deficiency	CAST IN PLACE CONCRETE: CRACKS/SPALLING - MINOR
Roof Plan reference	
Deficiency Quantity	20
Quantity Uom	S.F.
Potential Action	REPAIR

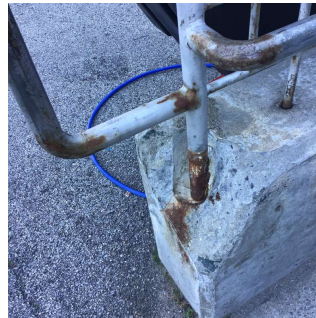
Facade D - at ramp

CAST IN PLACE CONCRETE: CRACKS/SPALLING - MAJOR

20
 S.F.
 REPLACE
 PRIORITY 4
 LEVEL 2

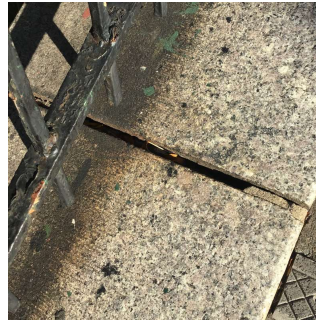
Facade A

STONE: DETERIORATED JOINTS AT COPING STONES

20
 L.F.
 MAINTENANCE
 PRIORITY 3
 LEVEL 2

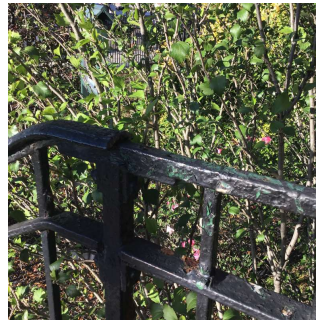
Facade A

RUST - MAJOR

REPLACE

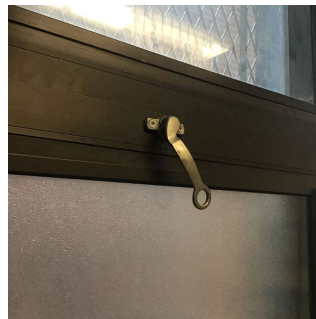
Facade J - Room 161

Deficiency	ALUMINUM - OTHER: HARDWARE POOR CONDITION/MISSING
------------	--

Deficiency Quantity	10
Quantity Uom	EACH
Potential Action	MAINTENANCE
Urgency of Action	PRIORITY 3
Purpose of Action	LEVEL 2

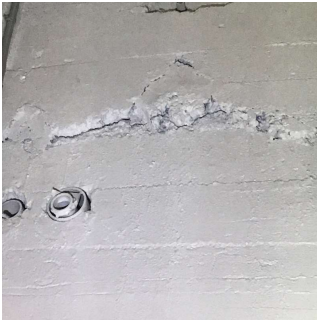
Question	Response
INTERIOR	
STRUCTURAL	
FLOOR STRUCTURE	
Deficiency Photo1	 
Violations	Room 151 No violations recorded.
FOUNDATION WALLS	
Material Type(s)	Inspected Concrete
Condition	4 - Between Fair and Poor
Deficiency	CONCRETE: WATER INFILTRATION IN NON- INSTRUCTIONAL SPACE
Deficiency Location/Instance	Basement - Storage
Deficiency Quantity	100
Quantity Uom	S.F.
Potential Action	INSTALL WATERPROOFING
Urgency of Action	PRIORITY 5
Purpose of Action	LEVEL 5
Deficiency Photo1	 
Violations	Basement - Storage No violations recorded.
Deficiency	CONCRETE: CRACKED/SPALLED/REINFORCEMENT EXPOSED
Deficiency Location/Instance	Basement - Storage, Boiler Room
Deficiency Quantity	10
Quantity Uom	S.F.
Potential Action	REPAIR
Urgency of Action	PRIORITY 3
Purpose of Action	LEVEL 5

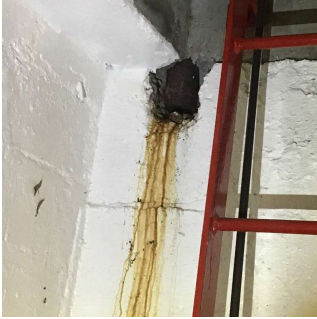
Violations	Basement - Boiler Room No violations recorded.
ROOF STRUCTURE	Inspected
Condition	2 - Between Good and Fair
Deficiency	No deficiencies recorded
VAULTS-BUNKERS	Inspected
Foundation Walls	Inspected
Condition	3 - Fair
Deficiency	WATER INFILTRATION IN NON- INSTRUCTIONAL SPACE
Deficiency Location/Instance	Basement - Ash Hoist Vault
Deficiency Quantity	50
Quantity Uom	S.F.
Potential Action	INSTALL WATERPROOFING
Urgency of Action	PRIORITY 5
Purpose of Action	LEVEL 5
Deficiency Photo1

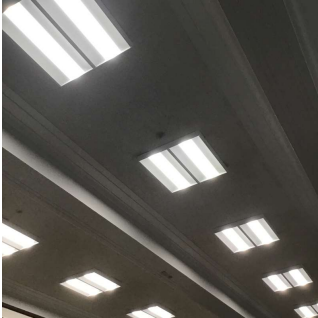
Instance on 1st Floor (Seats 585)	Inspected
Condition	2 - Between Good and Fair
Deficiency	PLASTER: CRACKS/SPALLING

Question	Response
INTERIOR	
AUDITORIUM	
Ceiling	
Deficiency Location/Instance	Right side
Deficiency Quantity	15
Quantity Uom	S.F.
Potential Action	REPLACE
Urgency of Action	PRIORITY 3
Purpose of Action	LEVEL 2
Deficiency Photo1

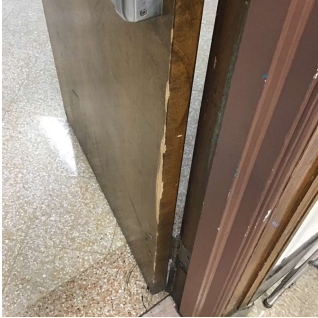
Violations	Right Side No violations recorded.
Door(s)	
Instance on 1st Floor (Seats 585)	Inspected
Condition	5 - Poor
Deficiency	WOOD: DETERIORATED DOOR
Deficiency Location/Instance	Entrance
Deficiency Quantity	1
Quantity Uom	EACH
Potential Action	MAINTENANCE
Urgency of Action	PRIORITY 3
Purpose of Action	LEVEL 2
Deficiency Photo1

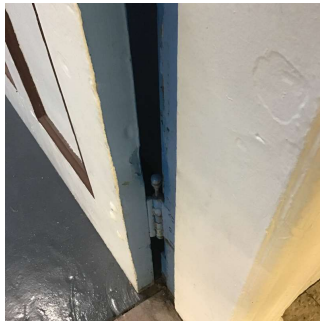
Violations	Entrance No violations recorded.
Deficiency	METAL: DETERIORATED DOOR
Deficiency Location/Instance	Right of Stage
Deficiency Quantity	1
Quantity Uom	EACH
Potential Action	MAINTENANCE
Urgency of Action	PRIORITY 3
Purpose of Action	LEVEL 2

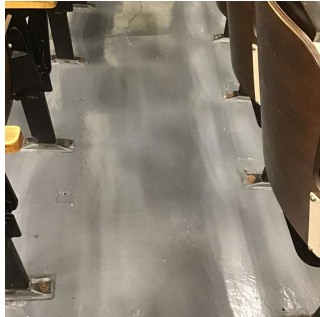
Question	Response
INTERIOR	
AUDITORIUM	
Floor Finish	
Purpose of Action	LEVEL 2
Deficiency Photo1	 
Violations	Center near row E No violations recorded.
Deficiency	CONCRETE: CRACKS
Deficiency Location/Instance	Row G Right Side
Deficiency Quantity	20
Quantity Uom	S.F.
Potential Action	REPLACE
Urgency of Action	PRIORITY 3
Purpose of Action	LEVEL 2
Deficiency Photo1

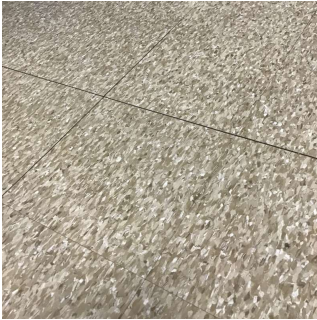
Question	Response
INTERIOR	
AUDITORIUM	
Floor Finish	
Violations	No violations recorded.
Sliding-folding Partition	
Instance on 1st Floor (Seats 585)	Does not Exist
Stage	
Instance on 1st Floor (Seats 585)	Inspected
Stage	Inspected
Instance on 1st Floor (Seats 585)	Inspected
Condition	3 - Fair
Deficiency	DAMAGED FLOOR
Deficiency Location/Instance	Center of Stage
Deficiency Quantity	30
Quantity Uom	S.F.
Potential Action	REPLACE
Urgency of Action	PRIORITY 3
Purpose of Action	LEVEL 2
Deficiency Photo1

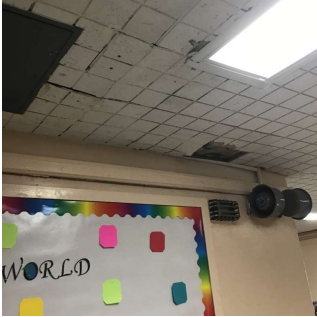
Question	Response
INTERIOR	
CAFETERIA	
Walls	
Instance on 1st Floor	Inspected
Condition	2 - Between Good and Fair
Deficiency	No deficiencies recorded
Window Curtains/Shades/Blinds	
Instance on 1st Floor	Does not Exist
CLASSROOMS/CORRIDORS/ADMIN SPACES	
Ceiling	Inspected
Condition	2 - Between Good and Fair
Deficiency	ACOUSTIC TILES ON PLASTER: DAMAGED/MISSING
Deficiency Location/Instance	Corridor near room 456,417, 356, 210, 109 and others
Deficiency Quantity	700
Quantity Uom	S.F.
Potential Action	REPLACE
Urgency of Action	PRIORITY 3
Purpose of Action	LEVEL 2
Deficiency Photo1

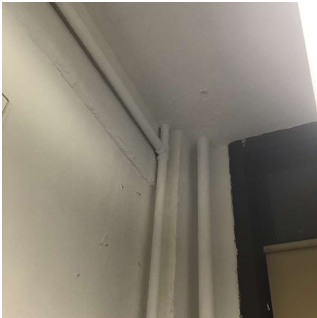
Violations	Corridor near room 210 No violations recorded.
Deficiency	PLASTER: CRACKS/SPALLING
Deficiency Location/Instance	Rooms 253, 315
Deficiency Quantity	50
Quantity Uom	S.F.
Potential Action	REPLACE
Urgency of Action	PRIORITY 3
Purpose of Action	LEVEL 2
Deficiency Photo1

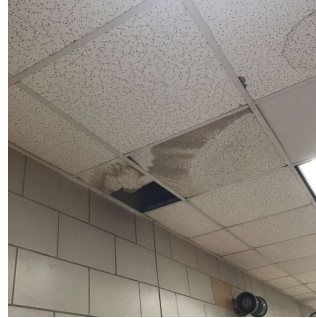
Corridor near 205

Violations	Room 253 No violations recorded.
Deficiency	ACOUSTIC TILES: DAMAGED/MISSING - ACTIVE LEAK

Deficiency Location/Instance	Corridor near 205, Room 206
Deficiency Quantity	30

Quantity Uom	S.F.
Potential Action	REPLACE
Urgency of Action	PRIORITY 5
Purpose of Action	LEVEL 2
Deficiency Photo1

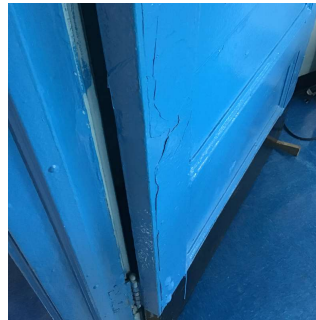
Deficiency	METAL: DETERIORATED DOOR
Deficiency Location/Instance	Room 415
Deficiency Quantity	1
Quantity Uom	EACH
Potential Action	MAINTENANCE
Urgency of Action	PRIORITY 3
Purpose of Action	LEVEL 2
Deficiency Photo1

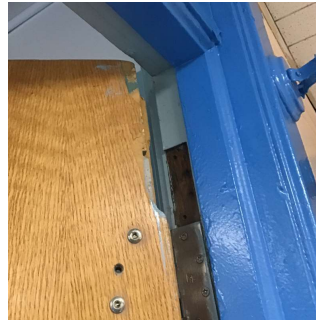
Room 418

Deficiency	WOOD: DETERIORATED DOOR
Deficiency Location/Instance	Rooms 418, 319, 316, 312,311 and others
Deficiency Quantity	18
Quantity Uom	EACH
Potential Action	MAINTENANCE
Urgency of Action	PRIORITY 3
Purpose of Action	LEVEL 2

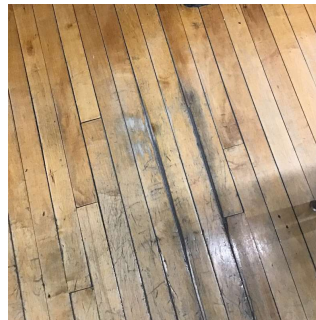
Room 310

WOOD: DAMAGED/DETERIORATED

REPLACE

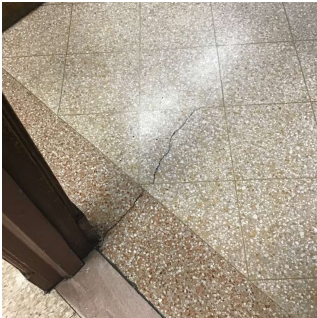
Question	Response
INTERIOR	
CLASSROOMS/CORRIDORS/ADMIN SPACES	
Floor Finish	
Violations	Corridor near Room 109 No violations recorded.
Deficiency	TERRAZZO: CRACKS
Deficiency Location/Instance	Near Auditorium Entrance, Corridor , Stair C/1, near room 161
Deficiency Quantity	30
Quantity Uom	S.F.
Potential Action	REPLACE
Urgency of Action	PRIORITY 3
Purpose of Action	LEVEL 2
Deficiency Photo1

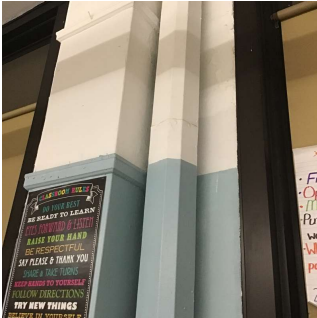
Violations	Near Auditorium Entrance No violations recorded.
Walls	Inspected
Condition	2 - Between Good and Fair
Deficiency	PLASTER: CRACKS/SPALLING
Deficiency Location/Instance	Room 315
Deficiency Quantity	20
Quantity Uom	S.F.
Potential Action	REPLACE
Urgency of Action	PRIORITY 3
Purpose of Action	LEVEL 2
Deficiency Photo1

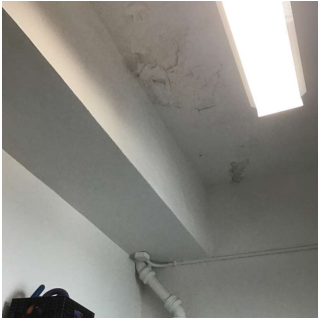
Question	Response
INTERIOR	
GYMNASIUM	
Ceiling	
Deficiency	PLASTER: CRACKS/SPALLING
Deficiency Location/Instance	Office, Center
Deficiency Quantity	50
Quantity Uom	S.F.
Potential Action	REPLACE
Urgency of Action	PRIORITY 3
Purpose of Action	LEVEL 2
Deficiency Photo1

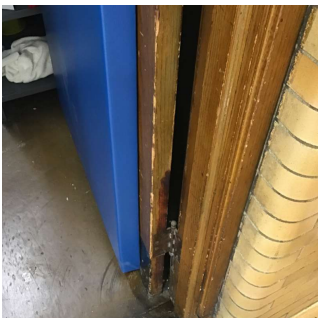
Violations	Office No violations recorded.
Door(s)	
Instance on 4th Floor	Inspected
Condition	3 - Fair
Deficiency	WOOD: DETERIORATED DOOR
Deficiency Location/Instance	Office
Deficiency Quantity	1
Quantity Uom	EACH
Potential Action	MAINTENANCE
Urgency of Action	PRIORITY 3
Purpose of Action	LEVEL 2
Deficiency Photo1

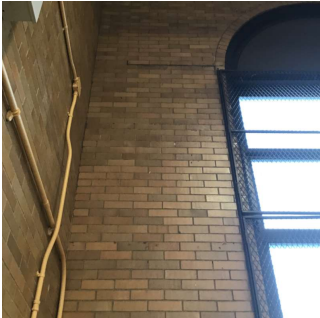
Question	Response
INTERIOR	
GYMNASIUM	
Seating	
Instance on 4th Floor	Inspected
Condition	1 - Good
Deficiency	No deficiencies recorded
Sliding-folding Partition	
Instance on 4th Floor	Does not Exist
Stage	
Instance on 4th Floor	Does not Exist
Walls	
Instance on 4th Floor	Inspected
Condition	2 - Between Good and Fair
Deficiency	SALT GLAZED BRICK: CRACKS/SPALLING
Deficiency Location/Instance	Along Windows Right Side
Deficiency Quantity	20
Quantity Uom	S.F.
Potential Action	REPLACE
Urgency of Action	PRIORITY 3
Purpose of Action	LEVEL 2
Deficiency Photo1

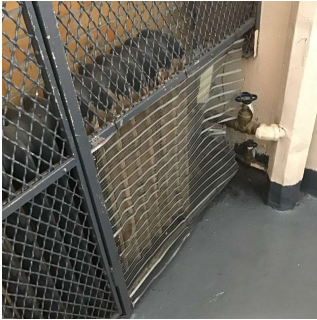
Question	Response
INTERIOR	
INTERIOR GUARDS	
Deficiency Photo1	 
Violations	Stair B/1 No violations recorded.
Deficiency	DETERIORATED/TORN-OUT/MISSING
Deficiency Location/Instance	Stair B/1,
Deficiency Quantity	15
Quantity Uom	S.F.
Potential Action	REPLACE
Urgency of Action	PRIORITY 5
Purpose of Action	LEVEL 6
Deficiency Photo1

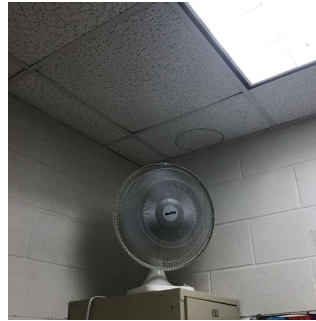
Violations	Stair B/1 No violations recorded.
KITCHEN	Inspected
Instance on 1st Floor	Inspected
Ceiling	Inspected
Instance on 1st Floor	Inspected
Condition	5 - Poor
Deficiency	ACOUSTIC TILES: DAMAGED/MISSING
Deficiency Location/Instance	Room 104C
Deficiency Quantity	10
Quantity Uom	S.F.
Potential Action	REPLACE
Urgency of Action	PRIORITY 3
Purpose of Action	LEVEL 2

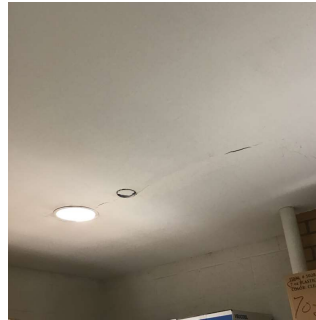
Storage room 104A

GYPSUM BOARD: DAMAGED/DETERIORATED

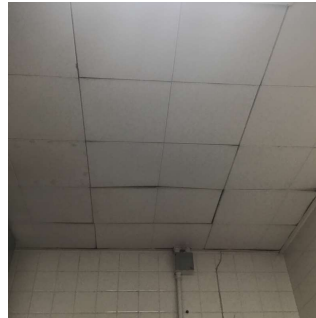
near storage room 104A

METAL PAN: DAMAGED/MISSING

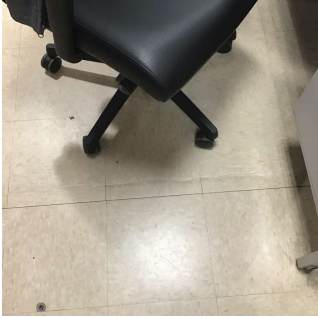
Question	Response
INTERIOR	
KITCHEN	
Door(s)	
Instance on 1st Floor	Inspected
Condition	2 - Between Good and Fair
Deficiency	No deficiencies recorded
Floor Finish	
Instance on 1st Floor	Inspected
Condition	4 - Between Fair and Poor
Deficiency	VINYL TILES: DETERIORATED SUBSTRATE
Deficiency Location/Instance	Room 104C
Deficiency Quantity	15
Quantity Uom	S.F.
Potential Action	REPLACE
Urgency of Action	PRIORITY 3
Purpose of Action	LEVEL 2
Deficiency Photo1

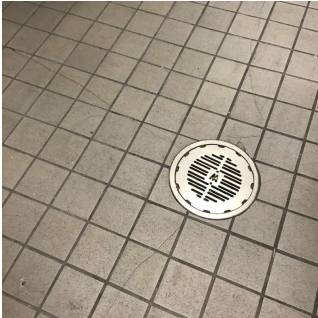
Violations	Room 104C No violations recorded.
Deficiency	QUARRY TILE: DETERIORATED SUBSTRATE
Deficiency Location/Instance	Near Refrigerator, Center, Servery 104F
Deficiency Quantity	60
Quantity Uom	S.F.
Potential Action	REPLACE
Urgency of Action	PRIORITY 3
Purpose of Action	LEVEL 2
Deficiency Photo1

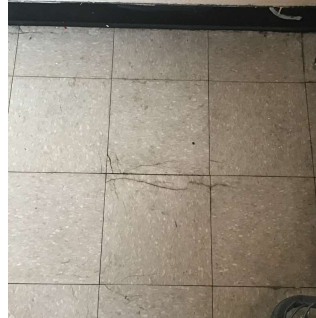
Stair A/2

VINYL TILES: DETERIORATED SUBSTRATE

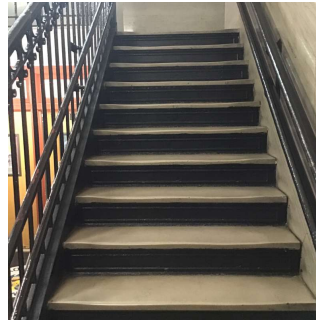
Stair A/1

STONE: WORN-OUT TREAD/NOSINGS

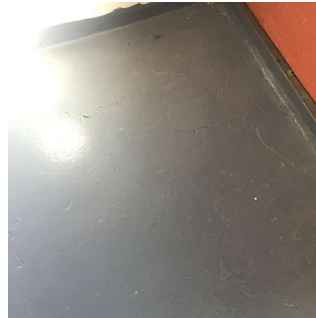
Stair C/Bulkhead

CONCRETE: CRACKS/SPALLING - MAJOR

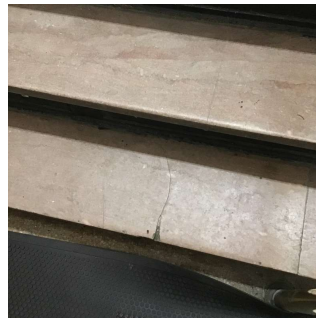
Exit 12 Vestibule

STONE: BROKEN/MISSING

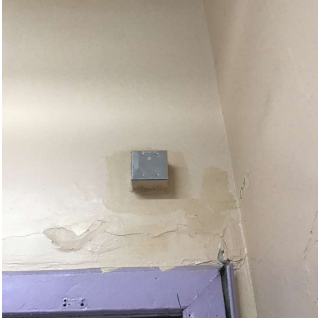
Question	Response
INTERIOR	
STAIRS/RAMPS: INTERIOR	
Walls	Inspected
Condition	2 - Between Good and Fair
Deficiency	PLASTER: CRACKS/SPALLING
Deficiency Location/Instance	Stair A/1,3,4
Deficiency Quantity	40
Quantity Uom	S.F.
Potential Action	REPLACE
Urgency of Action	PRIORITY 3
Purpose of Action	LEVEL 2
Deficiency Photo1

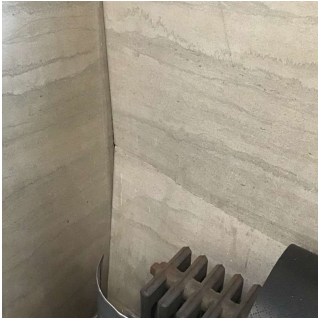
Violations	Stair A/3 No violations recorded.
Deficiency	STONE: CRACKS/SPALLING
Deficiency Location/Instance	Stair A/1, A/2
Deficiency Quantity	50
Quantity Uom	S.F.
Potential Action	REPLACE
Urgency of Action	PRIORITY 3
Purpose of Action	LEVEL 2
Deficiency Photo1

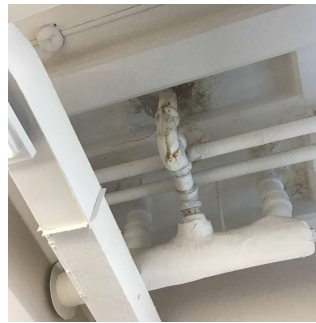
Violations	Main Entrance No violations recorded.
TOILET ROOMS - STAFF	
	Inspected
Ceiling	Inspected
Condition	5 - Poor
Deficiency	PLASTER: CRACKS/SPALLING - ACTIVE LEAK
Deficiency Location/Instance	Room 258
Deficiency Quantity	20
Quantity Uom	S.F.
Potential Action	REPLACE
Urgency of Action	PRIORITY 5
Purpose of Action	LEVEL 2

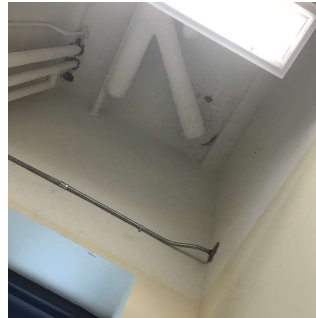
3rd Floor Women

PLASTER: CRACKS/SPALLING

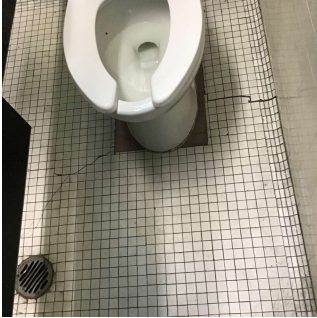
Question	Response
INTERIOR	
TOILET ROOMS - STAFF	
Door(s)	Inspected
	Women 1st Floor Restroom
Violations	No violations recorded.
Floor Finish	Inspected
Condition	4 - Between Fair and Poor
Deficiency	CERAMIC TILE: DETERIORATED SUBSTRATE
Deficiency Location/Instance	Room 460
Deficiency Quantity	20
Quantity Uom	S.F.
Potential Action	REPLACE
Urgency of Action	PRIORITY 3
Purpose of Action	LEVEL 2
Deficiency Photo1

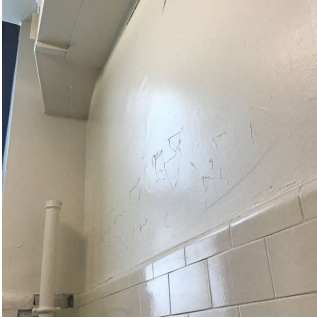
Room 460
Violations	No violations recorded.
Stalls	Inspected
Condition	2 - Between Good and Fair
Deficiency	No deficiencies recorded
Walls	Inspected
Condition	2 - Between Good and Fair
Deficiency	PLASTER: CRACKS/SPALLING
Deficiency Location/Instance	Room 460
Deficiency Quantity	15
Quantity Uom	S.F.
Potential Action	REPLACE
Urgency of Action	PRIORITY 3
Purpose of Action	LEVEL 2
Deficiency Photo1

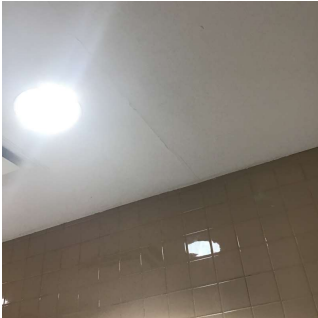
Violations	Room 460 No violations recorded.
TOILET ROOMS - STUDENTS	
Ceiling	Inspected
Condition	2 - Between Good and Fair
Deficiency	GYPSUM BOARD: DAMAGED/DETERIORATED
Deficiency Location/Instance	Room 200A, 101A
Deficiency Quantity	40
Quantity Uom	S.F.
Potential Action	REPLACE
Urgency of Action	PRIORITY 3
Purpose of Action	LEVEL 2
Deficiency Photo1

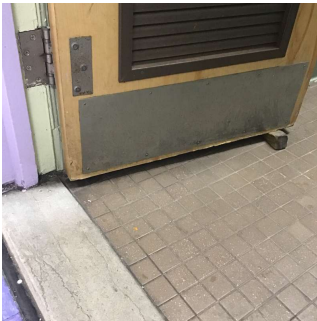
Violations	Room 200A No violations recorded.
Door(s)	
Condition	4 - Between Fair and Poor
Deficiency	WOOD: DETERIORATED DOOR
Deficiency Location/Instance	Room 356
Deficiency Quantity	1
Quantity Uom	EACH
Potential Action	MAINTENANCE
Urgency of Action	PRIORITY 3
Purpose of Action	LEVEL 2

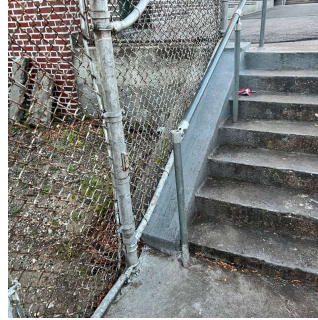
130th Avenue

Condition	2 - Between Good and Fair
Deficiency	No deficiencies recorded
FENCES	
FENCES	Inspected
Condition	4 - Between Fair and Poor
Deficiency	CHAIN LINK: RUST - MAJOR
Deficiency Location/Instance	130th Street, South Conduit Avenue
Deficiency Quantity	400
Quantity Uom	S.F.
Potential Action	REPLACE
Urgency of Action	PRIORITY 3
Purpose of Action	LEVEL 2

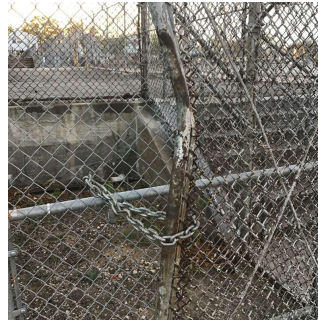
Along 130th Street

CHAIN LINK: DAMAGED/DETERIORATED

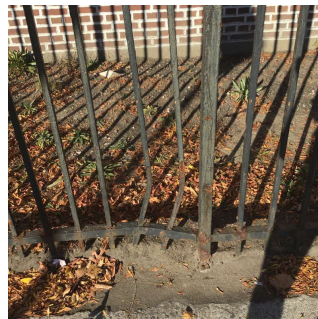
130th Street

WROUGHT IRON: DAMAGED/DETERIORATED

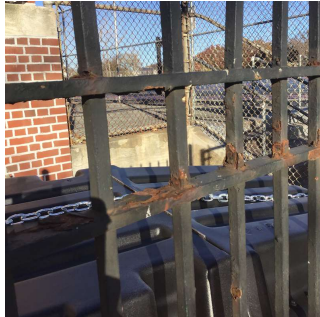
WROUGHT IRON: RUST - MAJOR

Question	Response
SITE	
FENCES	
Deficiency Location/Instance	130th Street
Deficiency Quantity	800
Quantity Uom	S.F.
Potential Action	REPLACE
Urgency of Action	PRIORITY 3
Purpose of Action	LEVEL 2
Deficiency Photo1

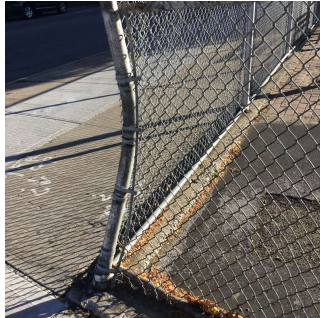
Violations	130th Street No violations recorded.
Deficiency	CHAIN LINK: DAMAGED POST/RAIL
Deficiency Location/Instance	129th Street, 130th Street
Deficiency Quantity	100
Quantity Uom	L.F.
Potential Action	REPLACE
Urgency of Action	PRIORITY 3
Purpose of Action	LEVEL 2
Deficiency Photo1

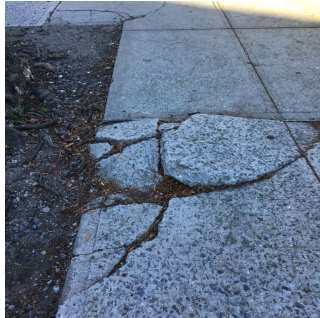
Violations	Along exit 9 No violations recorded.
Concrete	Inspected
Condition	2 - Between Good and Fair
Deficiency	No deficiencies recorded
Pavers	Does not Exist
DOT Sidewalk	Inspected
Asphalt	Does not Exist
Concrete	Inspected
Condition	4 - Between Fair and Poor
Deficiency	HEAVING
Deficiency Location/Instance	130th Street, 150th Avenue
Deficiency Quantity	150
Quantity Uom	S.F.
Potential Action	REPLACE
Urgency of Action	PRIORITY 5
Purpose of Action	LEVEL 6
Deficiency Photo1

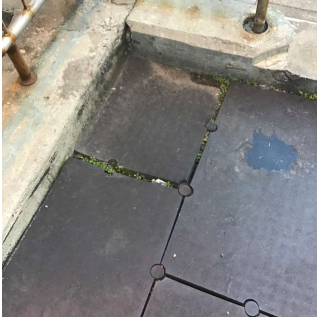
Deficiency	DETERIORATED/MISSING
Deficiency Location/Instance	Near Entrance
Deficiency Quantity	15
Quantity Uom	S.F.
Potential Action	REPLACE

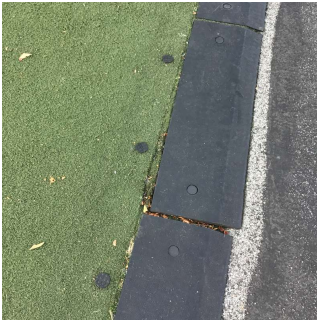
Near Entrance
Violations	No violations recorded.
Unpaved Area	
Instance on Schoolyard	Does not Exist
Instance on Courtyard	Does not Exist
PLAYING SURFACE	Inspected
Playing Field	Inspected
Instance on Schoolyard	Inspected
Instance Condition	2 - Between Good and Fair
Deficiency	ARTIFICIAL TURF: DAMAGED/WORN OUT
Deficiency Location/Instance	Schoolyard
Deficiency Quantity	15
Quantity Uom	S.F.
Potential Action	REPLACE
Urgency of Action	PRIORITY 3
Purpose of Action	LEVEL 2
Deficiency Photo1

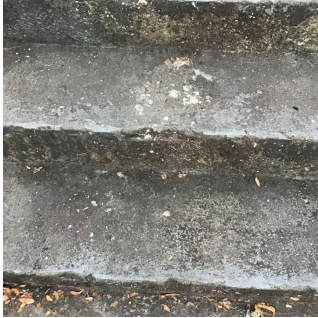
Question	Response
SITE	
STAIRS/RAMPS: EXTERIOR	
Stairs/ramps	Inspected
Condition	2 - Between Good and Fair
Deficiency	CAST IN PLACE CONCRETE: CRACKS/SPALLING - MAJOR
Deficiency Location/Instance	Along 130th Street
Deficiency Quantity	20
Quantity Uom	S.F.
Potential Action	REPLACE
Urgency of Action	PRIORITY 3
Purpose of Action	LEVEL 2
Deficiency Photo1
