**NYC Department of Education**  
**Building Condition Assessment Survey 2023 - 2024**

Architectural Inspection

**Asset:** P.S. 127 - QUEENS, 98-01 25 AVENUE, New York, 11369

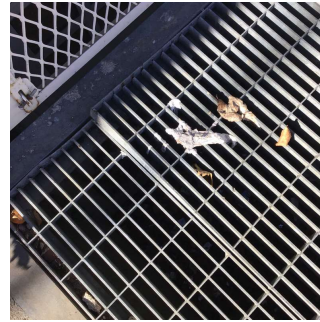
AW5

**AREAWAY**

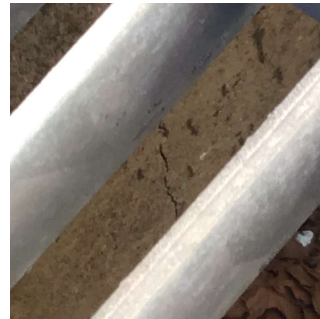
AW6

**AREAWAY WALLS: CRACKS AND SPALLING**

REPLACE

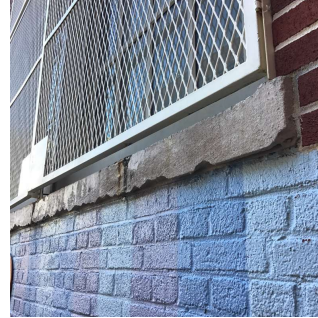
Facade F

BRICK: DETERIORATED MASONRY SILLS - MAJOR

REMOVE AND REPLACE  
 PRIORITY 4  
 LEVEL 2

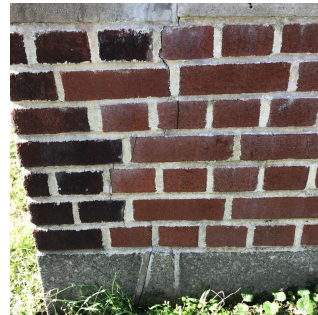
Facade H

BRICK: MAJOR / THRU CRACKS

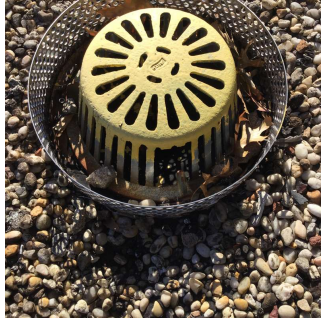
Question	Response
<b>EXTERIOR</b>	
<b>ROOF</b>	
<b>Roofing</b>	
<b>ROOFING DRAINS</b>	
Purpose of Action	LEVEL 2
Deficiency Photo1

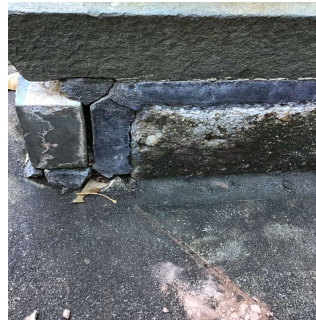
Facade F

**BUILDING CHEEK/FLANK WALLS**

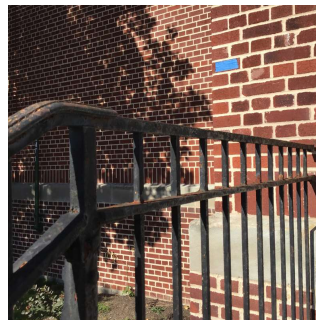
Facade A

RUST - MAJOR

REPLACE

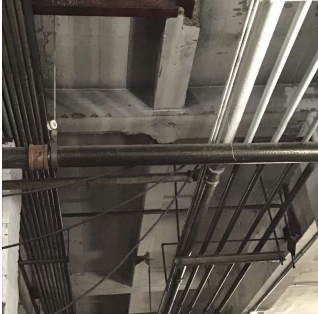
Question	Response
<b>EXTERIOR</b>	
<b>WINDOWS</b>	
<b>WINDOWS</b>	
Deficiency Quantity	10
Quantity Uom	EACH
Potential Action	MAINTENANCE
Urgency of Action	PRIORITY 3
Purpose of Action	LEVEL 2
Deficiency Photo1	No photo recorded
Violations	No violations recorded.
<b>INTERIOR</b>	Inspected
<b>POOLS</b>	Does not Exist
<b>STRUCTURAL</b>	Inspected
<b>COLUMNS/BEAMS/BEARING WALLS</b>	Inspected
Condition	3 - Fair
Deficiency	STEEL COLUMNS/BEAMS: DETERIORATED CONCRETE FIREPROOFING
Deficiency Location/Instance	Basement - Office, Boiler Room, Storage Room
Deficiency Quantity	60
Quantity Uom	S.F.
Potential Action	REPLACE
Urgency of Action	PRIORITY 4
Purpose of Action	LEVEL 5
Deficiency Photo1

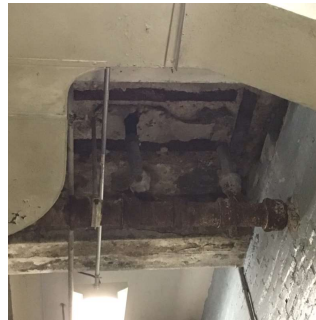
Basement - Office

CINDER CONCRETE FLAT SLAB:  
CRACKED/SPALLED/REINFORCEMENT EXPOSED

REPAIR

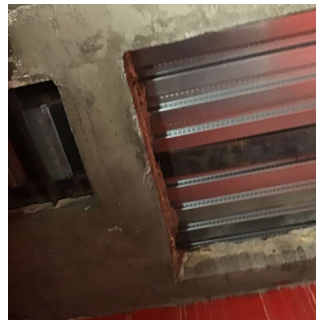
Basement - Vault

METAL DECK AND CONCRETE: DETERIORATED

REPAIR

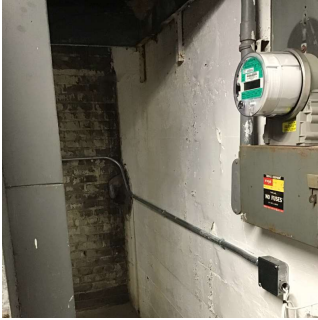
Question	Response
<b>INTERIOR</b>	
<b>STRUCTURAL</b>	
<b>FLOOR STRUCTURE</b>	Inspected
Violations	No violations recorded.
<b>FOUNDATION WALLS</b>	Inspected
Material Type(s)	Concrete
Condition	4 - Between Fair and Poor
Deficiency	CONCRETE: WATER INFILTRATION IN ELECTRICAL PANEL ROOM
Deficiency Location/Instance	Basement - Electrical Room
Deficiency Quantity	100
Quantity Uom	S.F.
Potential Action	INSTALL WATERPROOFING
Urgency of Action	PRIORITY 5
Purpose of Action	LEVEL 6
Deficiency Photo1

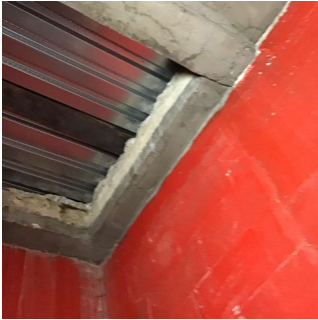
Violations	Basement - Vault No violations recorded.

Violations	Basement - Electrical Room No violations recorded.
<b>ROOF STRUCTURE</b>	Inspected
Condition	2 - Between Good and Fair
Deficiency	No deficiencies recorded
<b>VAULTS-BUNKERS</b>	Inspected
<b>Foundation Walls</b>	Inspected
Condition	4 - Between Fair and Poor
Deficiency	WATER INFILTRATION IN NON- INSTRUCTIONAL SPACE
Deficiency Location/Instance	Basement - Vault
Deficiency Quantity	100
Quantity Uom	S.F.
Potential Action	INSTALL WATERPROOFING

Urgency of Action	PRIORITY 5
Purpose of Action	LEVEL 5
Deficiency Photo1

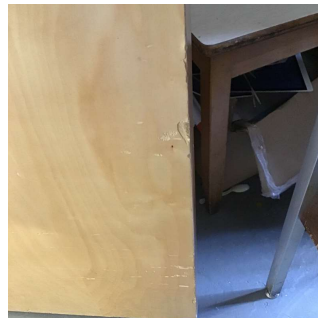
Deficiency	WOOD: DETERIORATED DOOR
Deficiency Location/Instance	Storage Room
Deficiency Quantity	1
Quantity Uom	EACH
Potential Action	MAINTENANCE
Urgency of Action	PRIORITY 3
Purpose of Action	LEVEL 2
Deficiency Photo1

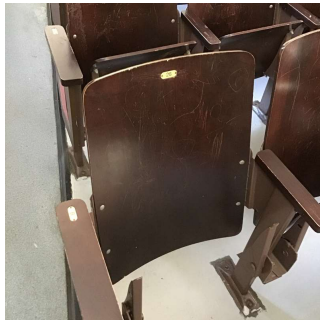
Question	Response
<b>INTERIOR</b>	
<b>AUDITORIUM</b>	
<b>Door(s)</b>	Storage Room
Violations	No violations recorded.
<b>Fixed H/C Lift</b>	
Instance on 1st Floor (585 Seats)	Does not Exist
<b>Fixed Seating</b>	
Instance on 1st Floor (585 Seats)	Inspected
Condition	3 - Fair
Deficiency	DAMAGED/BROKEN/INOPERABLE
Deficiency Location/Instance	Seat B/20, 28, C/7, E/6, 19, F/7, 11, G/5, H/17, J/17, K/17, M/19, 28, P/17, R/23, U/5, 8, 14
Deficiency Quantity	18
Quantity Uom	EACH
Potential Action	REPLACE
Urgency of Action	PRIORITY 5
Purpose of Action	LEVEL 6
Deficiency Photo1

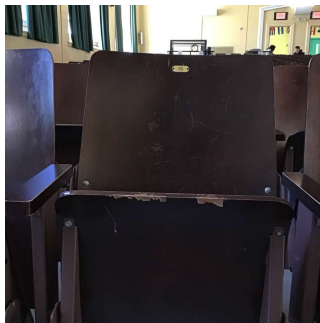
Violations	No violations recorded.
Deficiency	IMPROPERLY ANCHORED
Deficiency Location/Instance	Seats A/12,14
Deficiency Quantity	2
Quantity Uom	EACH
Potential Action	MAINTENANCE
Urgency of Action	PRIORITY 3
Purpose of Action	LEVEL 2
Deficiency Photo1	No photo recorded
Violations	No violations recorded.
Deficiency	DAMAGED/BROKEN/INOPERABLE
Deficiency Location/Instance	Seats A/16, E/24, O/14, S/14, 26, and others

Violations	Seat A/16 No violations recorded.
<b>Floor Finish</b>	
Instance on 1st Floor (585 Seats)	Inspected
Condition	2 - Between Good and Fair
Deficiency	CONCRETE: CRACKS
Deficiency Location/Instance	Storage Room
Deficiency Quantity	10
Quantity Uom	S.F.
Potential Action	REPLACE
Urgency of Action	PRIORITY 3
Purpose of Action	LEVEL 2
Deficiency Photo1

Deficiency Quantity	15
Quantity Uom	EACH
Potential Action	REPLACE
Urgency of Action	PRIORITY 3
Purpose of Action	LEVEL 2

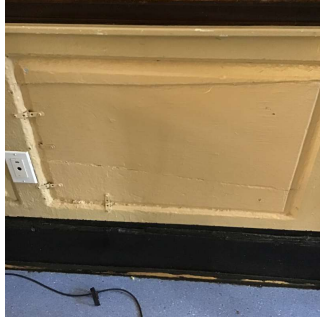
Violations	Storage Room No violations recorded.
<b>Sliding-folding Partition</b>	
Instance on 1st Floor (585 Seats)	Does not Exist
<b>Stage</b>	
Instance on 1st Floor (585 Seats)	Inspected
<b>Stage</b>	
Instance on 1st Floor (585 Seats)	Inspected
Condition	3 - Fair
Deficiency	DAMAGED FASCIA
Deficiency Location/Instance	Near Center, Piano Stage
Deficiency Quantity	20
Quantity Uom	S.F.
Potential Action	REPLACE
Urgency of Action	PRIORITY 3
Purpose of Action	LEVEL 2

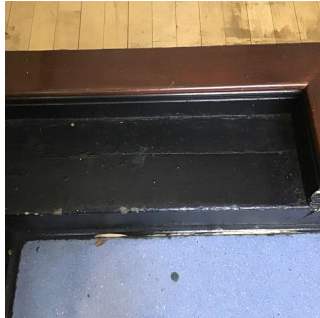
Near Center
Violations	No violations recorded.
Deficiency	DAMAGED STEPS
Deficiency Location/Instance	Piano Stage
Deficiency Quantity	10
Quantity Uom	S.F.
Potential Action	REPLACE
Urgency of Action	PRIORITY 3
Purpose of Action	LEVEL 2
Deficiency Photo1

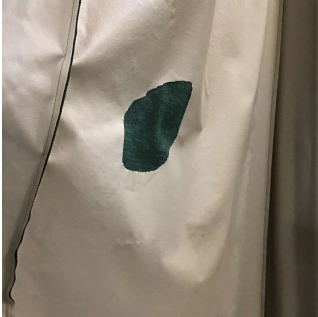
Piano Stage
Violations	No violations recorded.
<b>Stage Curtain Rigging</b>	Inspected
Instance on 1st Floor (585 Seats)	Inspected
Condition	2 - Between Good and Fair
Deficiency	No deficiencies recorded
<b>Stage Curtains</b>	Inspected
Instance on 1st Floor (585 Seats)	Inspected
Condition	3 - Fair
Deficiency	WORN/DETERIORATED
Deficiency Location/Instance	Main Right Side
Deficiency Quantity	100
Quantity Uom	S.F.
Potential Action	REPLACE
Urgency of Action	PRIORITY 3
Purpose of Action	LEVEL 2

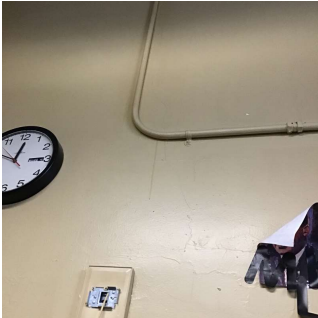
Storage Room
Violations	No violations recorded.

<b>Walls</b>	
Instance on 1st Floor (585 Seats)	Inspected
Condition	2 - Between Good and Fair
Deficiency	PLASTER: CRACKS/SPALLING
Deficiency Location/Instance	Storage Room, Near Exit 5, Near Windows
Deficiency Quantity	60
Quantity Uom	S.F.
Potential Action	REPLACE
Urgency of Action	PRIORITY 3
Purpose of Action	LEVEL 2
Deficiency Photo1

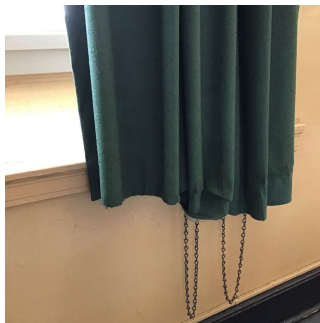
<b>Window Curtains/Shades/Blinds</b>	
Instance on 1st Floor (585 Seats)	Inspected
Condition	4 - Between Fair and Poor
Deficiency	WORN/DAMAGED CURTAINS
Deficiency Location/Instance	Right and Left Side
Deficiency Quantity	400
Quantity Uom	S.F.
Potential Action	MAINTENANCE
Urgency of Action	PRIORITY 3
Purpose of Action	LEVEL 2

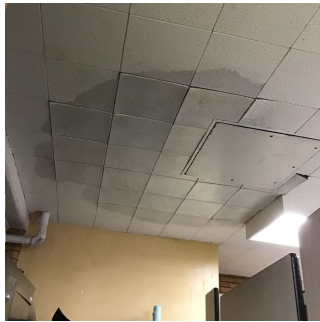
Violations	Left Side No violations recorded.
<b>CAFETERIA</b>	
Instance on 1st Floor	Inspected
Condition	Inspected
Deficiency	2 - Between Good and Fair
Deficiency Location/Instance	ACOUSTIC TILES ON PLASTER: DAMAGED/MISSING
Deficiency Quantity	Near Stair K
Quantity Uom	30
Potential Action	S.F.
Urgency of Action	REPLACE
Purpose of Action	PRIORITY 3
Deficiency Photo1	LEVEL 2

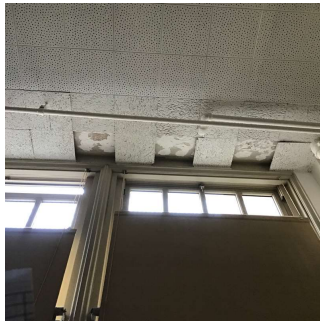
Violations	Near Windows No violations recorded.
<b>Window Curtains/Shades/Blinds</b>	
Instance on 1st Floor	Does not Exist
<b>CLASSROOMS/CORRIDORS/ADMIN SPACES</b>	
<b>Ceiling</b>	Inspected
Condition	2 - Between Good and Fair
Deficiency	ACOUSTIC TILES ON PLASTER: DAMAGED/MISSING
Deficiency Location/Instance	Rooms 106, 108, 109
Deficiency Quantity	130
Quantity Uom	S.F.
Potential Action	REPLACE
Urgency of Action	PRIORITY 3
Purpose of Action	LEVEL 2
Deficiency Photo1

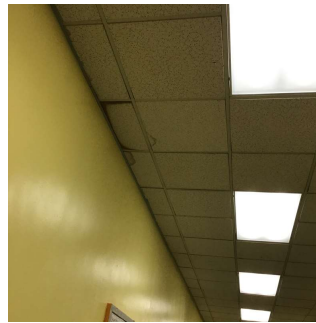
Violations	Room 108 No violations recorded.
Deficiency	ACOUSTIC TILES: DAMAGED/MISSING
Deficiency Location/Instance	Rooms 419, 420, Corridor near Room 421
Deficiency Quantity	50
Quantity Uom	S.F.
Potential Action	REPLACE
Urgency of Action	PRIORITY 3
Purpose of Action	LEVEL 2

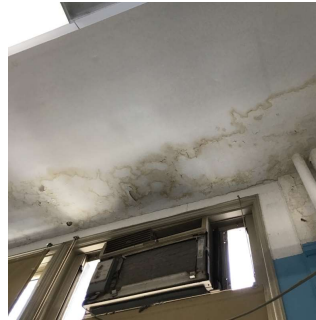
Room 209

PLASTER: CRACKS/SPALLING

REPLACE

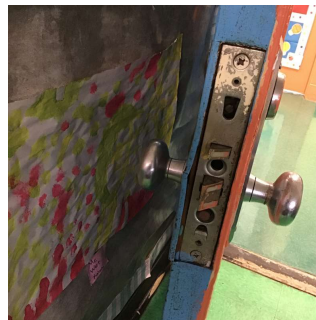
METAL: DETERIORATED DOOR

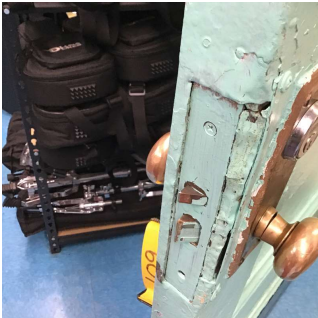
Question	Response
<b>INTERIOR</b>	
<b>CLASSROOMS/CORRIDORS/ADMIN SPACES</b>	
<b>Door(s)</b>	
Violations	Room 102 No violations recorded.
Deficiency	METAL CLAD WOOD: DETERIORATED DOOR
Deficiency Location/Instance	Room 109
Deficiency Quantity	1
Quantity Uom	EACH
Potential Action	MAINTENANCE
Urgency of Action	PRIORITY 3
Purpose of Action	LEVEL 2
Deficiency Photo1

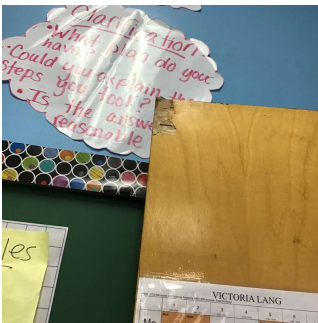
Violations	Room 109 No violations recorded.
Deficiency	WOOD: DETERIORATED DOOR
Deficiency Location/Instance	Rooms 103, 203, 304, 407, 420, and others.
Deficiency Quantity	30
Quantity Uom	EACH
Potential Action	MAINTENANCE
Urgency of Action	PRIORITY 3
Purpose of Action	LEVEL 2
Deficiency Photo1

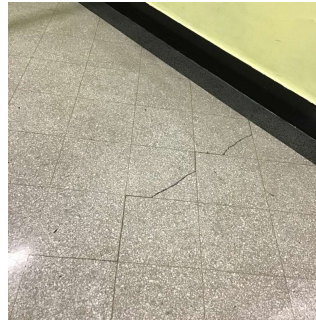
Corridor near Room 157

Violations	Room 420 No violations recorded.
<b>Floor Finish</b>	Inspected
Condition	2 - Between Good and Fair
Deficiency	TERRAZZO: CRACKS
Deficiency Location/Instance	Corridor near Rooms 109, 157
Deficiency Quantity	20
Quantity Uom	S.F.
Potential Action	REPLACE
Urgency of Action	PRIORITY 3

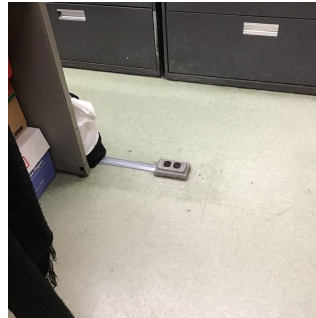
Room 216

VINYL TILES: TRIPPING HAZARD - ELECTRICAL OUTLET

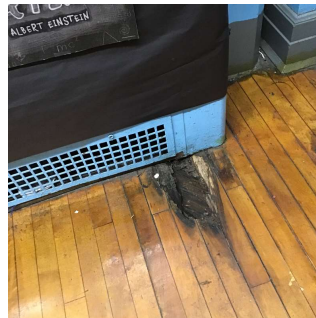
Room 304

WOOD: DAMAGED/DETERIORATED

REPLACE

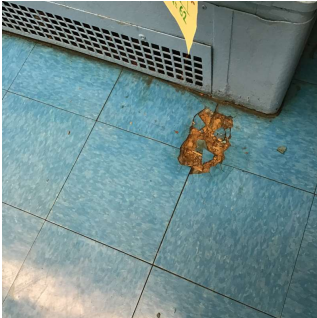
Question	Response
<b>INTERIOR</b>	
<b>CLASSROOMS/CORRIDORS/ADMIN SPACES</b>	
<b>Floor Finish</b>	
Deficiency	VINYL TILES: DETERIORATED SUBSTRATE
Deficiency Location/Instance	Rooms 203, 209, 405, 419, Corridor near Room 421, and others.
Deficiency Quantity	300
Quantity Uom	S.F.
Potential Action	REPLACE
Urgency of Action	PRIORITY 3
Purpose of Action	LEVEL 2
Deficiency Photo1

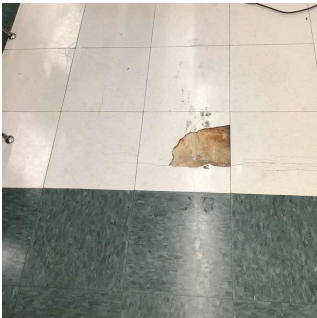
Room 203
Violations	No violations recorded.
Deficiency	VINYL TILES: BROKEN/DETERIORATED/MISSING TILES
Deficiency Location/Instance	Rooms 209, 216, 315, 405, Corridor near Room 421, and others.
Deficiency Quantity	250
Quantity Uom	S.F.
Potential Action	REPLACE
Urgency of Action	PRIORITY 3
Purpose of Action	LEVEL 2
Deficiency Photo1

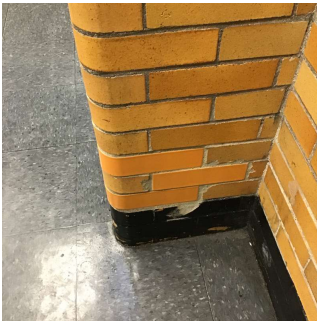
Room 209
Violations	No violations recorded.
<b>Walls</b>	Inspected
Condition	2 - Between Good and Fair
Deficiency	BRICK: CRACKS/SPALLING
Deficiency Location/Instance	Room 420
Deficiency Quantity	10
Quantity Uom	S.F.

Potential Action	REPLACE
Urgency of Action	PRIORITY 3
Purpose of Action	LEVEL 2

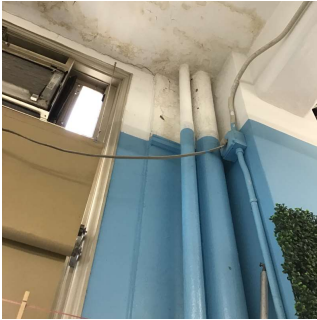
Violations	Room 420 No violations recorded.
Deficiency	PLASTER: CRACKS/SPALLING
Deficiency Location/Instance	Rooms 105, 207, 209, 306, Corridor near Stair K/1, and others.
Deficiency Quantity	350
Quantity Uom	S.F.
Potential Action	REPLACE
Urgency of Action	PRIORITY 3
Purpose of Action	LEVEL 2
Deficiency Photo1

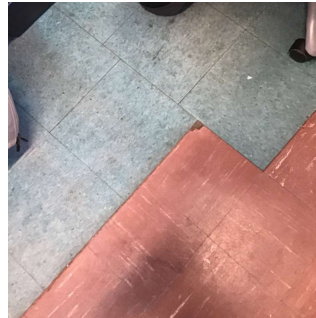
Deficiency	VINYL TILES: BROKEN/DETERIORATED/MISSING TILES
Deficiency Location/Instance	Inside Office
Deficiency Quantity	10
Quantity Uom	S.F.
Potential Action	REPLACE
Urgency of Action	PRIORITY 3
Purpose of Action	LEVEL 2
Deficiency Photo1

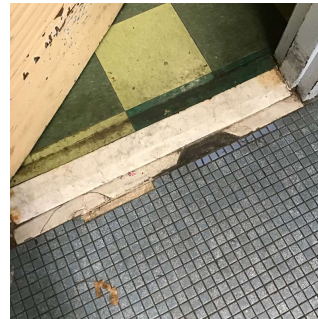
Entrance

CERAMIC TILE: BROKEN/MISSING TILES

REPLACE

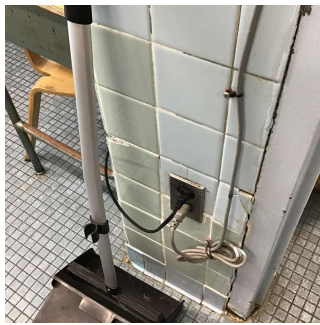
CERAMIC TILE: BROKEN/ MISSING

REPLACE

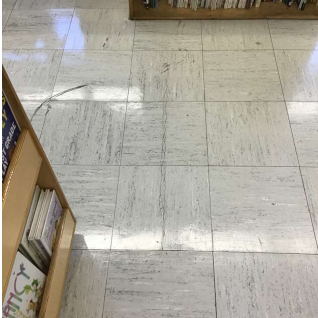
Deficiency	VINYL TILES: DETERIORATED SUBSTRATE

Question	Response
<b>INTERIOR</b>	
<b>LIBRARY</b>	
<b>Floor Finish</b>	
Deficiency Location/Instance	Near center
Deficiency Quantity	10
Quantity Uom	S.F.
Potential Action	REPLACE
Urgency of Action	PRIORITY 3
Purpose of Action	LEVEL 2
Deficiency Photo1

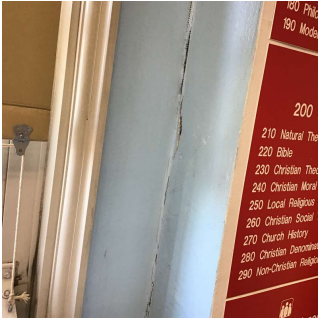
Violations	Near center No violations recorded.
<b>Walls</b>	
Instance on Room 301	Inspected
Condition	2 - Between Good and Fair
Deficiency	PLASTER: CRACKS/SPALLING
Deficiency Location/Instance	Near Windows
Deficiency Quantity	20
Quantity Uom	S.F.
Potential Action	REPLACE
Urgency of Action	PRIORITY 3
Purpose of Action	LEVEL 2
Deficiency Photo1

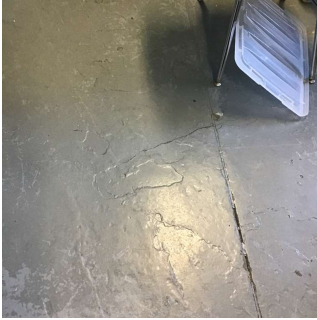
Question	Response
<b>INTERIOR</b>	
<b>LOCKER ROOM</b>	
<b>Door(s)</b>	
Condition	2 - Between Good and Fair
Deficiency	No deficiencies recorded
<b>Floor Finish</b>	
Instance on 4th Floor	Inspected
Condition	2 - Between Good and Fair
Deficiency	CONCRETE: CRACKS
Deficiency Location/Instance	Near Center
Deficiency Quantity	10
Quantity Uom	S.F.
Potential Action	REPLACE
Urgency of Action	PRIORITY 3
Purpose of Action	LEVEL 2
Deficiency Photo1

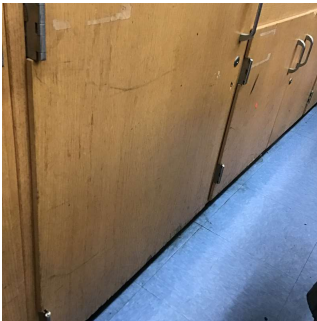
Violations	No violations recorded.
<b>Locker Room Lockers</b>	
Instance on 4th Floor	Does not Exist
<b>Walls</b>	
Instance on 4th Floor	Inspected
Condition	2 - Between Good and Fair
Deficiency	No deficiencies recorded
<b>MULTI-PURPOSE ROOM</b>	
Does not Exist	
<b>SCIENCE DEMO ROOM</b>	
Does not Exist	
<b>SCIENCE LAB</b>	
Inspected	
Instance on Room 408	Inspected
Alternative use	No
<b>Fixed Equipment</b>	
Instance on Room 408	Inspected
Condition	3 - Fair
Deficiency	CABINETS: MISSING/DAMAGED

Deficiency Location/Instance	Room 408
Deficiency Quantity	12
Quantity Uom	L.F.
Potential Action	REPLACE
Urgency of Action	PRIORITY 3
Purpose of Action	LEVEL 2

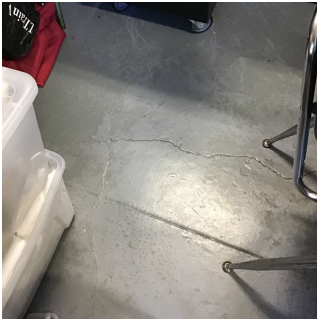
Room 408
Violations	No violations recorded.
<b>SCIENCE PREP ROOM</b>	Does not Exist
<b>SHOWER ROOM</b>	Inspected
Instance on 4th Floor	Inspected
Alternative use	Yes
<b>Ceiling</b>	
Instance on 4th Floor	Inspected
Condition	2 - Between Good and Fair
Deficiency	No deficiencies recorded
<b>Door(s)</b>	
Instance on 4th Floor	Inspected
Condition	2 - Between Good and Fair
Deficiency	No deficiencies recorded
<b>Floor Finish</b>	
Instance on 4th Floor	Inspected
Condition	3 - Fair
Deficiency	CONCRETE: CRACKS
Deficiency Location/Instance	Near center
Deficiency Quantity	10
Quantity Uom	S.F.
Potential Action	REPLACE
Urgency of Action	PRIORITY 3
Purpose of Action	LEVEL 2
Deficiency Photo1

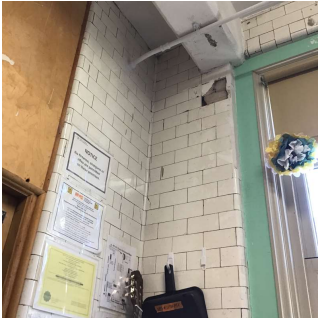
Question	Response
<b>INTERIOR</b>	
<b>SHOWER ROOM</b>	
<b>Walls</b>	
Deficiency	CERAMIC TILE: BROKEN/ MISSING
Deficiency Location/Instance	Near Windows
Deficiency Quantity	10
Quantity Uom	S.F.
Potential Action	REPLACE
Urgency of Action	PRIORITY 3
Purpose of Action	LEVEL 2
Deficiency Photo1

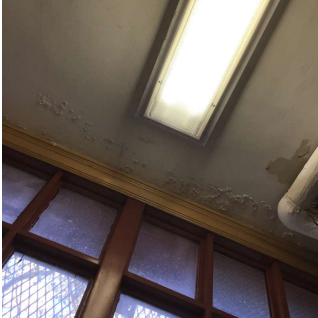
Violations	Near Windows No violations recorded.
<b>STAIRS/RAMPS: INTERIOR</b>	
Do Letter Stair Signs Exist?	Inspected Yes
<b>Ceiling</b>	
Condition	Inspected 2 - Between Good and Fair
Deficiency	PLASTER: CRACKS/SPALLING
Deficiency Location/Instance	Stairs L/1, M/1
Deficiency Quantity	30
Quantity Uom	S.F.
Potential Action	REPLACE
Urgency of Action	PRIORITY 3
Purpose of Action	LEVEL 2
Deficiency Photo1

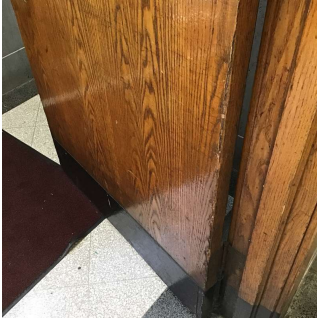
Violations	Stair M/1 No violations recorded.
<b>Door(s)</b>	
Condition	Inspected 3 - Fair
Deficiency	WOOD: DETERIORATED DOOR
Deficiency Location/Instance	Stair A/1 Vestibule
Deficiency Quantity	2
Quantity Uom	EACH
Potential Action	MAINTENANCE

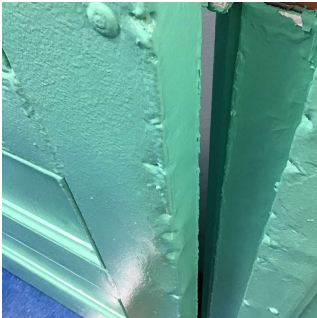
Violations	Stair A/1 Vestibule No violations recorded.
<b>Deficiency</b>	METAL CLAD WOOD: DETERIORATED DOOR
Deficiency Location/Instance	Stair M/2
Deficiency Quantity	2
Quantity Uom	EACH
Potential Action	MAINTENANCE
Urgency of Action	PRIORITY 3
Purpose of Action	LEVEL 2
Deficiency Photo1

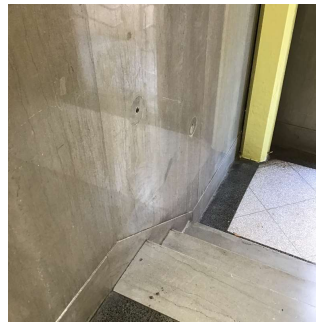
Violations	Stair M/2 No violations recorded.
<b>Partition</b>	Does not Exist
<b>Railings</b>	Inspected
Condition	3 - Fair
<b>Deficiency</b>	METAL: MISSING
Deficiency Location/Instance	Exit 7
Deficiency Quantity	10
Quantity Uom	L.F.
Potential Action	REPLACE
Urgency of Action	PRIORITY 5
Purpose of Action	LEVEL 6

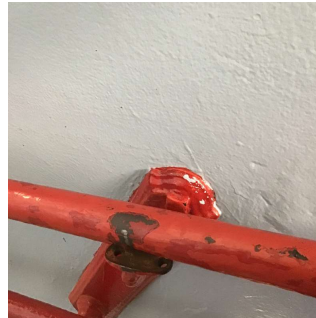
Stair J/1

METAL: BROKEN BRACKET

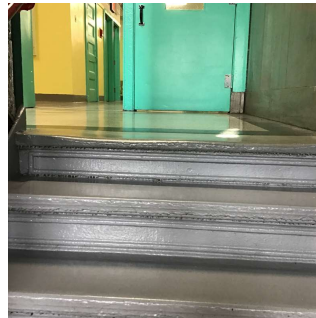
STONE: WORN-OUT TREAD/NOSINGS

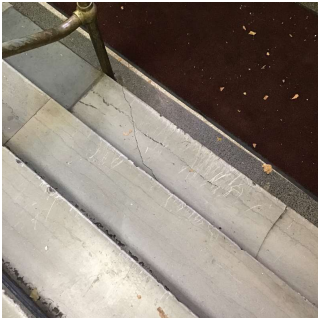
Question	Response
<b>INTERIOR</b>	
<b>STAIRS/RAMPS: INTERIOR</b>	
<b>Stairs and Landings</b>	
Violations	Stair A/1 No violations recorded.
Deficiency	STONE: BROKEN/MISSING
Deficiency Location/Instance	Stair A/1, Exit 6, 7
Deficiency Quantity	80
Quantity Uom	S.F.
Potential Action	REPLACE
Urgency of Action	PRIORITY 3
Purpose of Action	LEVEL 2
Deficiency Photo1

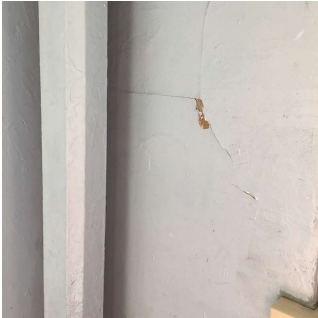
Violations	Exit 6 No violations recorded.
<b>Walls</b>	Inspected
Condition	2 - Between Good and Fair
Deficiency	PLASTER: CRACKS/SPALLING
Deficiency Location/Instance	Stair A/2, 3, B/2, 3, J/1, and others.
Deficiency Quantity	120
Quantity Uom	S.F.
Potential Action	REPLACE
Urgency of Action	PRIORITY 3
Purpose of Action	LEVEL 2
Deficiency Photo1

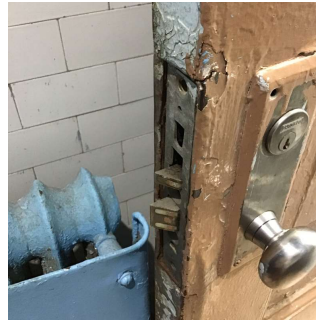
Room 360

Question	Response
<b>INTERIOR</b>	
<b>TOILET ROOMS - STAFF</b>	
<b>Ceiling</b>	
Quantity Uom	S.F.
Potential Action	REPLACE
Urgency of Action	PRIORITY 3
Purpose of Action	LEVEL 2
Deficiency Photo1	 
Violations	Room 257 No violations recorded.
<b>Door(s)</b>	Inspected
Condition	5 - Poor
Deficiency	WOOD: DETERIORATED DOOR AND FRAME
Deficiency Location/Instance	Room 356
Deficiency Quantity	1
Quantity Uom	EACH
Potential Action	MAINTENANCE
Urgency of Action	PRIORITY 3
Purpose of Action	LEVEL 2
Deficiency Photo1	 
Violations	Room 356 No violations recorded.
Deficiency	METAL CLAD WOOD: DETERIORATED DOOR
Deficiency Location/Instance	Rooms 151, 360
Deficiency Quantity	2
Quantity Uom	EACH
Potential Action	MAINTENANCE
Urgency of Action	PRIORITY 3
Purpose of Action	LEVEL 2

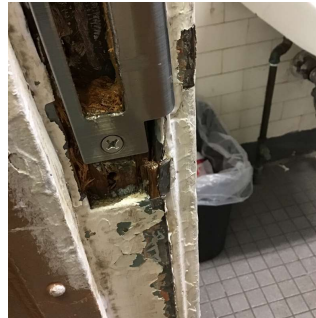
Room 460

METAL CLAD WOOD: DETERIORATED DOOR AND FRAME

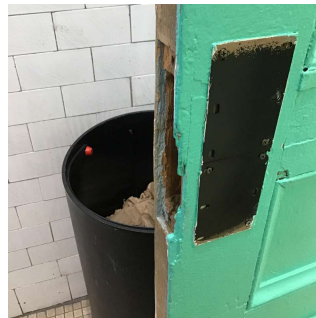
Room 257

WOOD: DETERIORATED DOOR

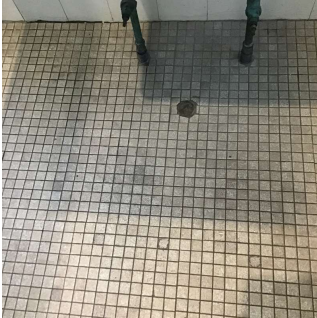
Question	Response
<b>INTERIOR</b>	
<b>TOILET ROOMS - STAFF</b>	
<b>Floor Finish</b>	Inspected
Condition	3 - Fair
Deficiency	CERAMIC TILE: BROKEN/MISSING TILES
Deficiency Location/Instance	Rooms 356, 456
Deficiency Quantity	20
Quantity Uom	S.F.
Potential Action	REPLACE
Urgency of Action	PRIORITY 3
Purpose of Action	LEVEL 2
Deficiency Photo1

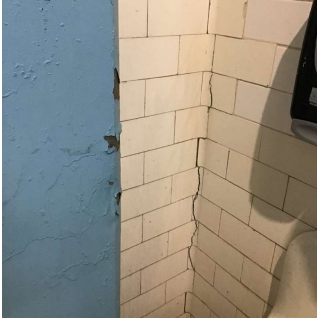
Violations	Room 356 No violations recorded.
<b>Stalls</b>	Inspected
Condition	2 - Between Good and Fair
Deficiency	No deficiencies recorded
<b>Walls</b>	Inspected
Condition	4 - Between Fair and Poor
Deficiency	PLASTER: CRACKS/SPALLING
Deficiency Location/Instance	Rooms 151, 257, 360
Deficiency Quantity	70
Quantity Uom	S.F.
Potential Action	REPLACE
Urgency of Action	PRIORITY 3
Purpose of Action	LEVEL 2
Deficiency Photo1	 
Violations	Room 360 No violations recorded.
Deficiency	CERAMIC TILE: BROKEN/ MISSING
Deficiency Location/Instance	Rooms 257, 356, 360, 456, 460
Deficiency Quantity	60

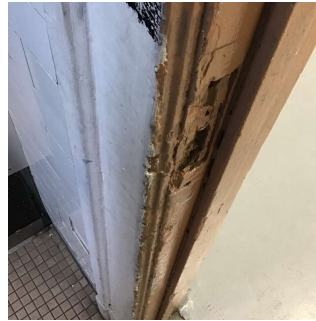
Room 354
Violations	No violations recorded.
<b>Door(s)</b>	
Condition	Inspected
	5 - Poor
Deficiency	WOOD: DETERIORATED DOOR AND FRAME
Deficiency Location/Instance	Rooms 354, 454
Deficiency Quantity	2
Quantity Uom	EACH
Potential Action	MAINTENANCE
Urgency of Action	PRIORITY 3
Purpose of Action	LEVEL 2

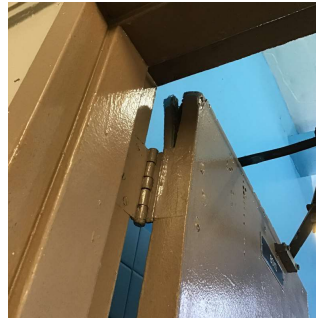
Room 355

WOOD: DETERIORATED DOOR

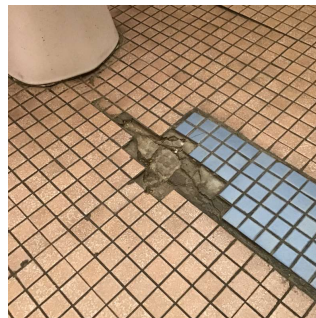
CERAMIC TILE: DETERIORATED SUBSTRATE

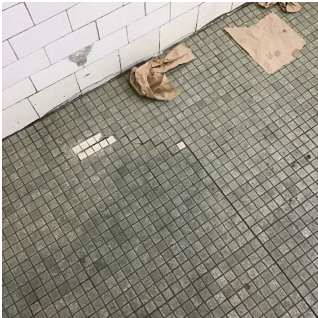
Question	Response
<b>INTERIOR</b>	
<b>TOILET ROOMS - STUDENTS</b>	
<b>Floor Finish</b>	
Violations	Room 108A No violations recorded.
Deficiency	CERAMIC TILE: BROKEN/MISSING TILES
Deficiency Location/Instance	Rooms 255, 256, 354, 453, 454, and others.
Deficiency Quantity	50
Quantity Uom	S.F.
Potential Action	REPLACE
Urgency of Action	PRIORITY 3
Purpose of Action	LEVEL 2
Deficiency Photo1

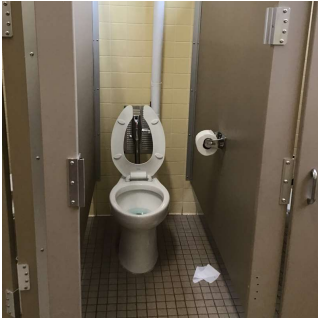
Violations	Room 454 No violations recorded.
<b>Stalls</b>	Inspected
Condition	3 - Fair
Deficiency	BROKEN/MISSING
Deficiency Location/Instance	Girls 1st Floor
Deficiency Quantity	1
Quantity Uom	EACH
Potential Action	REPLACE
Urgency of Action	PRIORITY 3
Purpose of Action	LEVEL 2
Deficiency Photo1

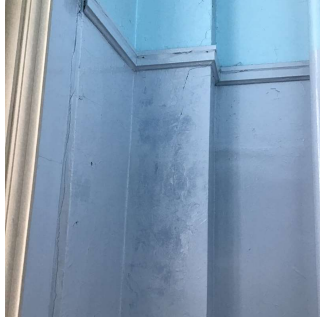
Violations	Girls 1st Floor No violations recorded.
<b>Walls</b>	Inspected
Condition	2 - Between Good and Fair
Deficiency	PLASTER: CRACKS/SPALLING
Deficiency Location/Instance	Rooms 109A, 354, 355
Deficiency Quantity	30
Quantity Uom	S.F.

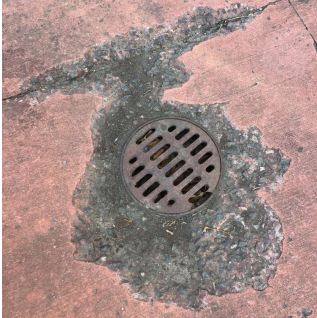
Question	Response
<b>SITE</b>	
<b>Drainage System for Asphalt</b>	
<b>Catch Basins/Manhole - Surrounded by asphalt</b>	Inspected
Condition	2 - Between Good and Fair
Deficiency	No deficiencies recorded
<b>Culverts - Asphalt Covering</b>	Does not Exist
<b>Drainage System for Concrete</b>	Inspected
<b>Catch Basins/Manhole - Surrounded by concrete</b>	Inspected
Condition	3 - Fair
Deficiency	DAMAGED COVER
Deficiency Location/Instance	Near Exit 9
Deficiency Quantity	10
Quantity Uom	EACH
Potential Action	REPLACE
Urgency of Action	PRIORITY 3
Purpose of Action	LEVEL 2
Deficiency Photo1

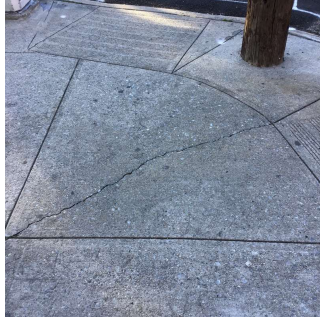
Question	Response
<b>SITE</b>	
<b>PAVING</b>	
<b>Student Use</b>	
<b>Concrete</b>	
Deficiency Photo1	 
	Near Exit 7
Violations	No violations recorded.
<b>Pavers</b>	Does not Exist
<b>Site Sidewalks &amp; Walkways</b>	Inspected
<b>Asphalt</b>	Does not Exist
<b>Concrete</b>	Inspected
Condition	3 - Fair
Deficiency	DAMAGED/DETERIORATED/MISSING SECTIONS
Deficiency Location/Instance	Near Exits 2, 4, 5, 25th Avenue.
Deficiency Quantity	175
Quantity Uom	S.F.
Potential Action	REPLACE
Urgency of Action	PRIORITY 3
Purpose of Action	LEVEL 2
Deficiency Photo1	 
	Near Exit 5
Violations	No violations recorded.
<b>Pavers</b>	Does not Exist
<b>DOT Sidewalk</b>	Inspected
<b>Asphalt</b>	Does not Exist
<b>Concrete</b>	Inspected
Condition	4 - Between Fair and Poor
Deficiency	DAMAGED/DETERIORATED/MISSING SECTIONS
Deficiency Location/Instance	25th Avenue, 98th Street
Deficiency Quantity	630
Quantity Uom	S.F.
Potential Action	REPLACE
Urgency of Action	PRIORITY 3

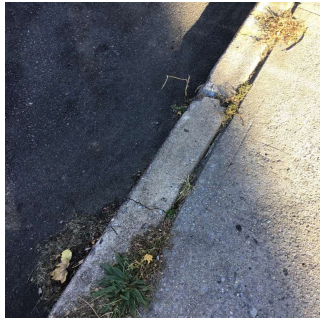
Violations	98th Street No violations recorded.
Deficiency	DAMAGED CURBS
Deficiency Location/Instance	25th Avenue, 98th Street
Deficiency Quantity	355
Quantity Uom	L.F.
Potential Action	REPLACE
Urgency of Action	PRIORITY 3
Purpose of Action	LEVEL 2
Deficiency Photo1
