NYC Department of Education
Building Condition Assessment Survey 2023 - 2024

Architectural Inspection

Asset: P.S. 129 - QUEENS, 128-02 7TH AVENUE, New York, 11356

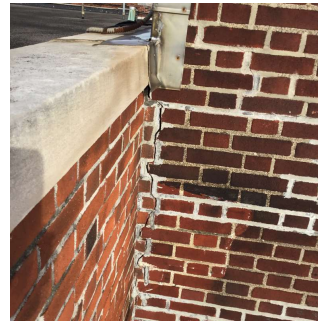
CH1
No violations recorded.

CHIMNEY

Deficiency

CAST STONE: CRACKED/BROKEN PIECES

60
S.F.
REMOVE AND REBUILD
PRIORITY 4
LEVEL 2

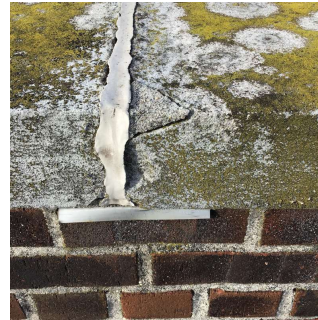
Roof 1

COPING

40
L.F.
REPLACE-IN-KIND
PRIORITY 4
LEVEL 2

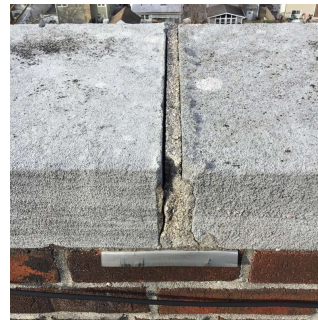
Roof 1

CAST STONE: DETERIORATED TRANSVERSE JOINTS

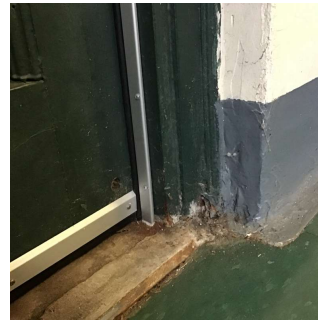
Facade B

Facade F
Violations	No violations recorded.
Deficiency	METAL CLAD: DETERIORATED DOOR AND FRAME - MAJOR DETERIORATION

5
 EACH
 REPLACE
 PRIORITY 4
 LEVEL 2

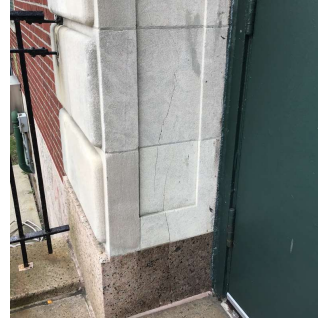
Facade B

STONE: CHIPPED/SPALLED/BROKEN PIECES - MINOR

S.F.
REPAIR
PRIORITY 3
LEVEL 2

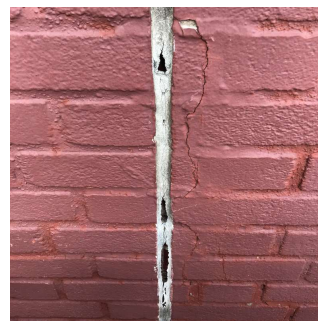
BRICK: DETERIORATED CONTROL/EXPANSION JOINTS

30
L.F.
MAINTENANCE
PRIORITY 3
LEVEL 2

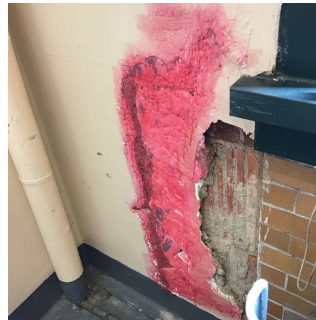
Facade E - Room 352E (Facade D - Room 352A similar)

BRICK: WATER INFILTRATION IN INSTRUCTIONAL SPACE

REPAIR

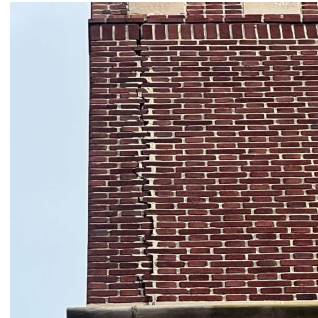
Facade A

BRICK: CRACKS/DISPLACED/SPALLED BRICK AT BUILDING CORNERS

PRIORITY 4
 LEVEL 2

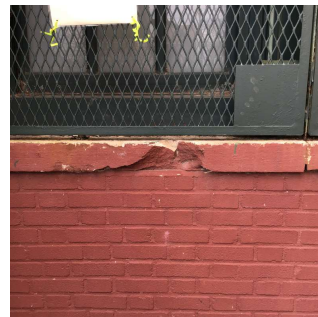
Facade F

BRICK: DETERIORATED MASONRY SILLS - MAJOR

70
 L.F.
 REMOVE AND REPLACE
 PRIORITY 4
 LEVEL 2

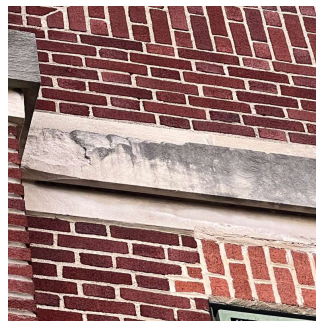
Facade A

STONE: CHIPPED/SPALLED/BROKEN PIECES - MAJOR

REPLACE

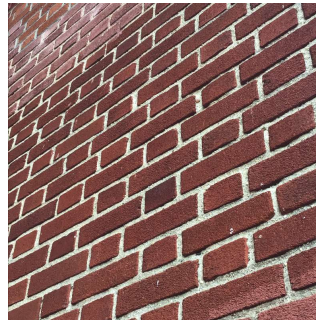
Facade F

BRICK: DETERIORATED JOINTS

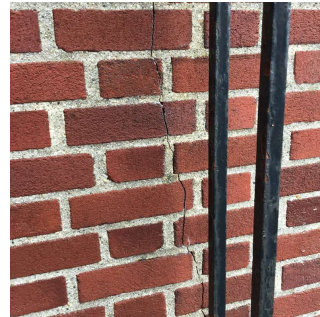
Facade B

BRICK: MAJOR / THRU CRACKS

40
S.F.
REMOVE AND REBUILD
PRIORITY 4
LEVEL 2

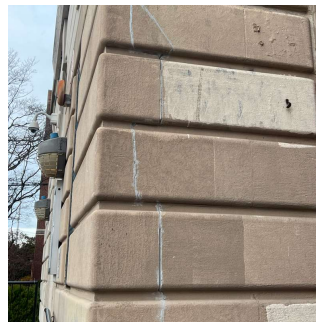
Facade A

STONE: CRACKS AT BUILDING CORNERS

20
S.F.
REPLACE
PRIORITY 4
LEVEL 2

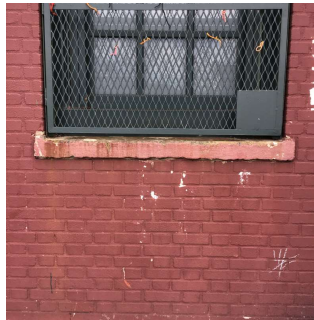
Facade F

BRICK: DETERIORATED MASONRY SILLS - MINOR

REPAIR

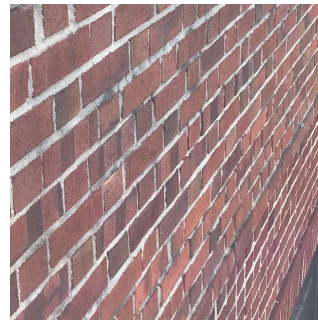
Roof 1

BRICK: DETERIORATED JOINTS

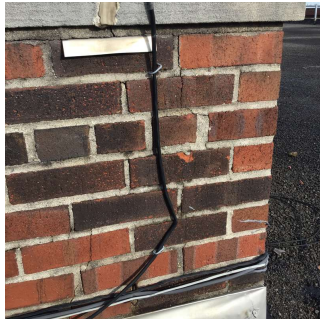
Violations	Roof 1 No violations recorded.
Deficiency	BRICK: MINOR CRACKS, SPALLING
Roof Plan reference

Deficiency Quantity	60
Quantity Uom	S.F.
Potential Action	REPAIR
Urgency of Action	PRIORITY 3
Purpose of Action	LEVEL 2
Deficiency Photo1

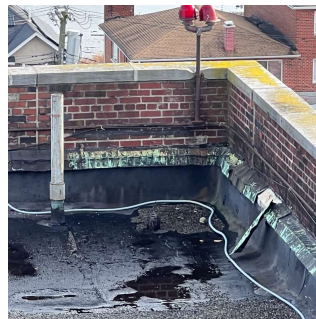
Roof 2

Deficiency **BUILT-UP: FLASHING: CAP FLASHING DAMAGED**

Deficiency Quantity	80
Quantity Uom	L.F.
Potential Action	REPLACE
Urgency of Action	PRIORITY 4
Purpose of Action	LEVEL 2
Deficiency Photo1

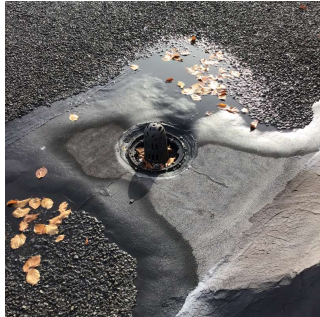
BUILT-UP: ROOFING: LOSS OF GRAVEL

200
 S.F.
 INSTALL NEW GRAVEL
 PRIORITY 3
 LEVEL 2

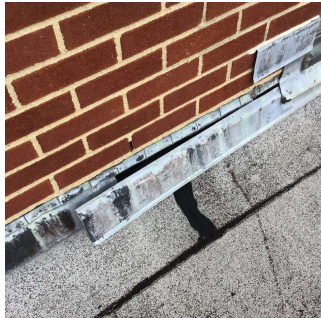
Roof 5
Instance Quantity	12,000
Instance Quantity Uom	S.F.
Does the roof have major mechanical equipment sitting on Dunnage Steel less than 18" above the Roofing?	No
Does this roof instance have a Sustainable Roof System?	No
Do solar panels exist on these roofs?	No
Is/Are the roof(s) suitable for Solar Panel installation?	No
Installation Year	2001
Source of Installation	Custodial Staff
Deficiency	MODIFIED BITUMEN: FLASHING: CAP FLASHING DAMAGED
Roof Plan reference

Deficiency Quantity	10
Quantity Uom	L.F.
Potential Action	REPLACE
Urgency of Action	PRIORITY 4
Purpose of Action	LEVEL 2

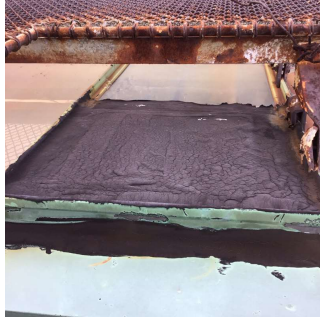
Question	Response
EXTERIOR	
ROOF	
Specialties	
SKYLIGHT/ROOF VENT	
Purpose of Action	LEVEL 2
Deficiency Photo1

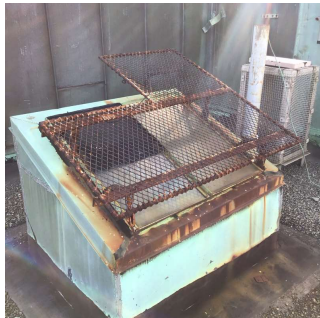
Violations	SK No violations recorded.
Deficiency	DAMAGED GUARDS
Roof Plan reference

Deficiency Quantity	20
Quantity Uom	S.F.
Potential Action	MAINTENANCE
Urgency of Action	PRIORITY 3
Purpose of Action	LEVEL 2
Deficiency Photo1

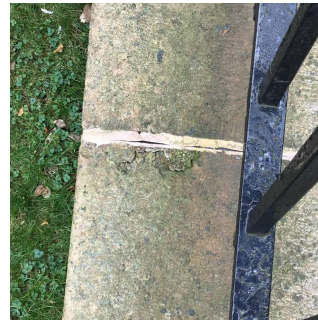
Facade B - Exit 3

Violations	SK No violations recorded.
ROOF/GRAVITY TANK	Does not Exist
STAIRS/RAMPS: EXTERIOR	Inspected
BUILDING CHEEK/FLANK WALLS	Inspected
Condition	5 - Poor
Deficiency	STONE: DETERIORATED COPING STONE

10
 S.F.
 REPAIR
 PRIORITY 3
 LEVEL 2

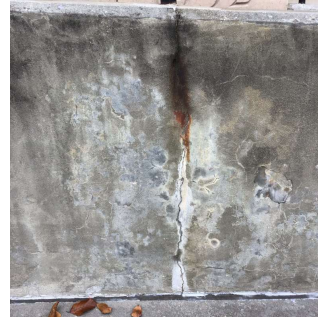
Facade A

CAST IN PLACE CONCRETE: CRACKS/SPALLING - MINOR

REPAIR

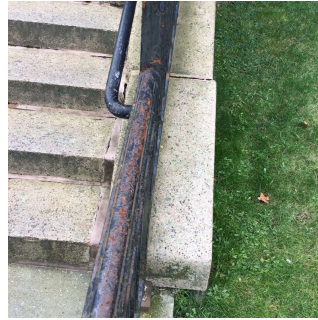
Facade C - Exit 7

STONE: BULGING/DISPLACED

Deficiency Quantity	10
Quantity Uom	S.F.
Potential Action	REPLACE
Urgency of Action	PRIORITY 4
Purpose of Action	LEVEL 2
Deficiency Photo1

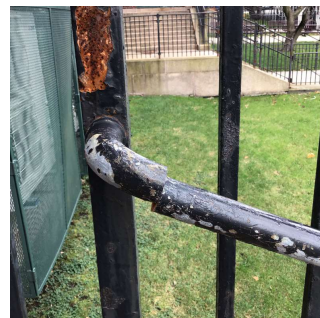
Facade C

DAMAGED

Deficiency Quantity	15
Quantity Uom	L.F.
Potential Action	REPLACE
Urgency of Action	PRIORITY 4
Purpose of Action	LEVEL 2
Deficiency Photo1

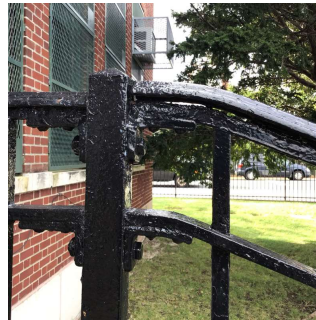
Facade B

RUST - MAJOR

15
L.F.
REPLACE
PRIORITY 4
LEVEL 2

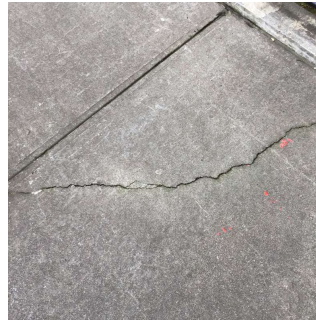
Facade A

CONCRETE: CRACKS/SPALLING - MINOR

10
S.F.
REPAIR
PRIORITY 3
LEVEL 2

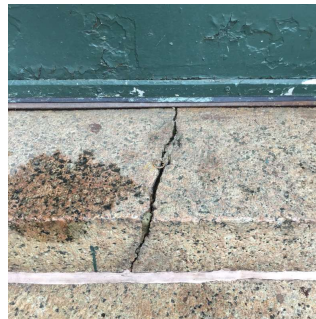
Facade B - Exit 2

STONE: CRACKS/SPALLING - MAJOR

REPLACE

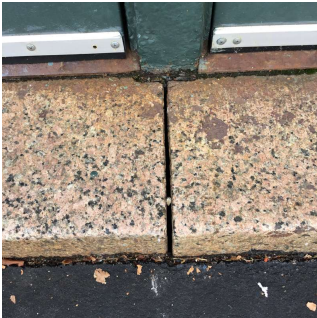
STONE: DETERIORATED JOINTS

Question	Response
EXTERIOR	
STAIRS/RAMPS: EXTERIOR	
STAIRS/RAMPS	
Deficiency Quantity	10
Quantity Uom	L.F.
Potential Action	REPOINT
Urgency of Action	PRIORITY 4
Purpose of Action	LEVEL 2
Deficiency Photo1

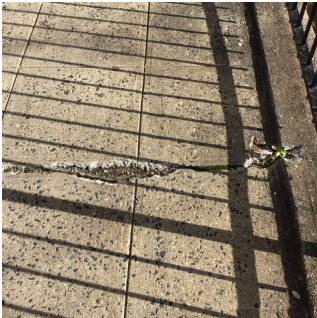
Violations	Facade F No violations recorded.
Deficiency	CONCRETE: CRACKS/SPALLING - MAJOR
Roof Plan reference

Deficiency Quantity	20
Quantity Uom	S.F.
Potential Action	REPLACE
Urgency of Action	PRIORITY 4
Purpose of Action	LEVEL 2
Deficiency Photo1

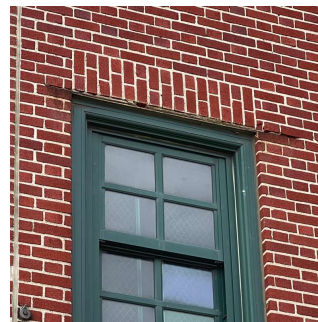
Facade D

STEEL: MAJOR RUSTING

REPLACE

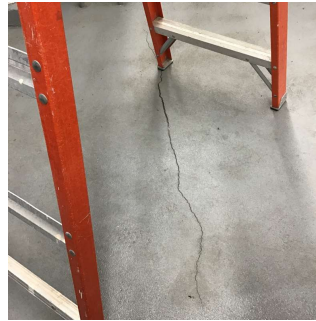
Question	Response
INTERIOR	
STRUCTURAL	
COLUMNS/BEAMS/BEARING WALLS	Inspected
Condition	3 - Fair
Deficiency	STEEL COLUMNS/BEAMS: DETERIORATED MASONRY FIREPROOFING
Deficiency Location/Instance	Basement - Boiler Room, Room B27
Deficiency Quantity	40
Quantity Uom	S.F.
Potential Action	REPLACE
Urgency of Action	PRIORITY 3
Purpose of Action	LEVEL 5
Deficiency Photo1	 
Violations	Room B27 No violations recorded.
Deficiency	STEEL COLUMNS/BEAMS: DETERIORATED CONCRETE FIREPROOFING
Deficiency Location/Instance	Basement - Boiler Room
Deficiency Quantity	60
Quantity Uom	S.F.
Potential Action	REPLACE
Urgency of Action	PRIORITY 3
Purpose of Action	LEVEL 5
Deficiency Photo1	 
Violations	Basement - Boiler Room No violations recorded.
FLOOR STRUCTURE	
Condition	Inspected
Condition	3 - Fair
Deficiency	CONCRETE: CRACKS/SPALLED/REINFORCEMENT EXPOSED
Deficiency Location/Instance	3rd Floor Boiler Room at 2020 Addition
Deficiency Quantity	20

Quantity Uom	S.F.
Potential Action	REPAIR
Urgency of Action	PRIORITY 4
Purpose of Action	LEVEL 5

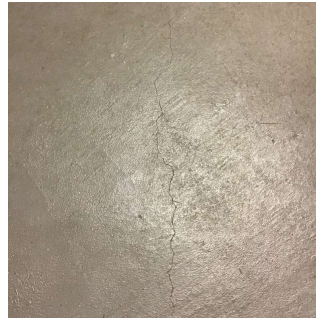
PH

CONCRETE: CRACKS/SPALLED/REINFORCEMENT EXPOSED

REPAIR

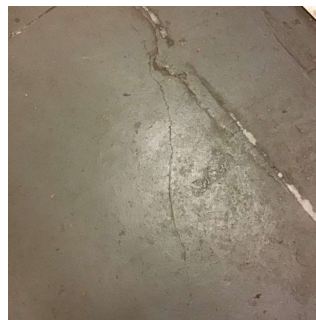
Gas Meter Room

CONCRETE SLAB ON GRADE: THRU CRACKS

REPAIR

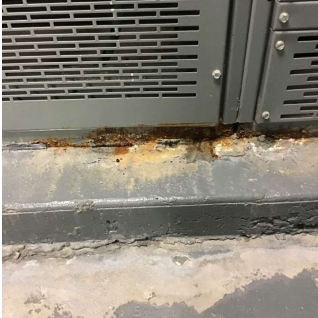
Question	Response
INTERIOR	
STRUCTURAL	
FLOOR STRUCTURE	Inspected
Violations	No violations recorded.
FOUNDATION WALLS	Inspected
Material Type(s)	Concrete
Condition	4 - Between Fair and Poor
Deficiency	CONCRETE: WATER INFILTRATION IN ELECTRICAL PANEL ROOM
Deficiency Location/Instance	Electrical Panel Room
Deficiency Quantity	100
Quantity Uom	S.F.
Potential Action	INSTALL WATERPROOFING
Urgency of Action	PRIORITY 5
Purpose of Action	LEVEL 6
Deficiency Photo1

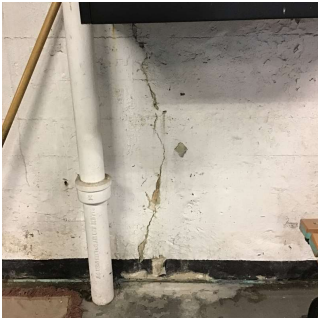
Violations	Electrical Panel Room No violations recorded.
Deficiency	CONCRETE: CRACKED/SPALLED/REINFORCEMENT EXPOSED
Deficiency Location/Instance	Boiler Room
Deficiency Quantity	20
Quantity Uom	S.F.
Potential Action	REPAIR
Urgency of Action	PRIORITY 3
Purpose of Action	LEVEL 5
Deficiency Photo1

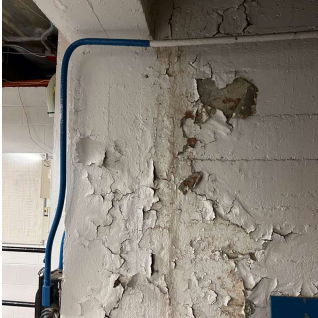
Question	Response
INTERIOR	
STRUCTURAL	
VAULTS-BUNKERS	
Foundation Walls	
Condition	3 - Fair
Deficiency	CRACKS, SPALLING
Deficiency Location/Instance	Ash Hoist Vault
Deficiency Quantity	10
Quantity Uom	S.F.
Potential Action	REPAIR
Urgency of Action	PRIORITY 4
Purpose of Action	LEVEL 5
Deficiency Photo1

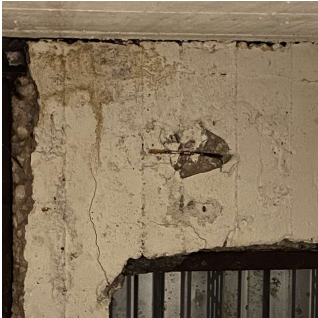
Violations	Ash Hoist Vault No violations recorded.
Slab Structure	
Condition	Inspected
Condition	3 - Fair
Deficiency	CINDER CONCRETE FLAT SLAB: CRACKS, SPALLED REINFORCEMENT EXPOSED
Deficiency Location/Instance	Ash Hoist Vault
Deficiency Quantity	30
Quantity Uom	S.F.
Potential Action	REPAIR
Urgency of Action	PRIORITY 4
Purpose of Action	LEVEL 5
Deficiency Photo1

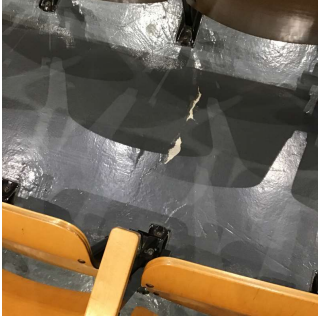
Question	Response
INTERIOR	
AUDITORIUM	
Floor Finish	
Potential Action	REPLACE
Urgency of Action	PRIORITY 3
Purpose of Action	LEVEL 2
Deficiency Photo1

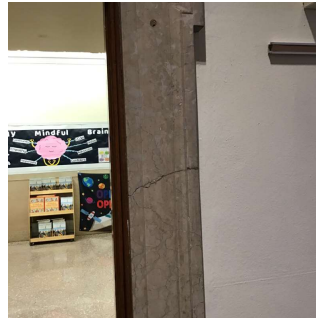
Main Entrance

STONE MOLDINGS: CRACKS/SPALLING

REPLACE

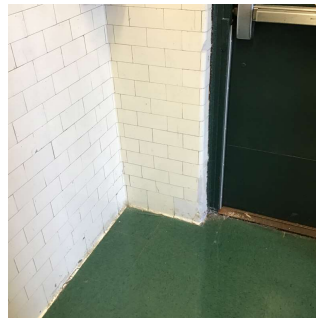
Right Side Vestibule Exit

CERAMIC TILE: BROKEN/ MISSING

REPLACE

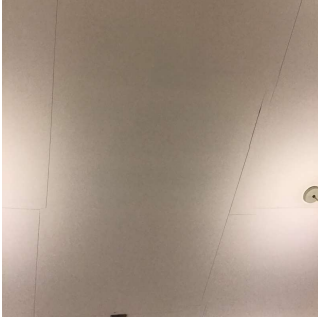
Question	Response
INTERIOR	
CLASSROOMS/CORRIDORS/ADMIN SPACES	
Ceiling	Inspected
Condition	2 - Between Good and Fair
Deficiency	GYPSUM BOARD: DAMAGED/DETERIORATED
Deficiency Location/Instance	Main Entrance Lobby
Deficiency Quantity	60
Quantity Uom	S.F.
Potential Action	REPLACE
Urgency of Action	PRIORITY 3
Purpose of Action	LEVEL 2
Deficiency Photo1

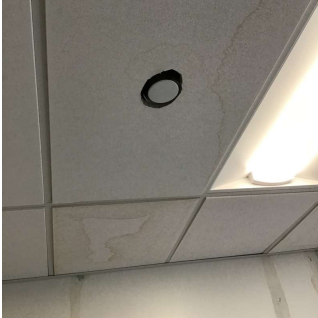
Violations	Main Entrance Lobby No violations recorded.
Deficiency	ACOUSTIC TILES: DAMAGED/MISSING - ACTIVE LEAK
Deficiency Location/Instance	Rooms 386, 383
Deficiency Quantity	20
Quantity Uom	S.F.
Potential Action	REPLACE
Urgency of Action	PRIORITY 5
Purpose of Action	LEVEL 2
Deficiency Photo1

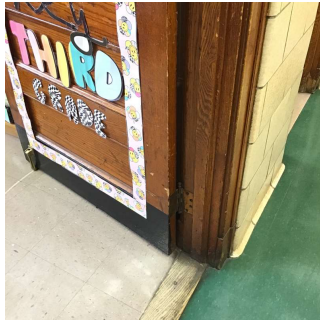
Question	Response
INTERIOR	
CLASSROOMS/CORRIDORS/ADMIN SPACES	
Ceiling	
Deficiency Photo1	 
	Room 419
Violations	No violations recorded.
Door(s)	
Condition	Inspected
	5 - Poor
Deficiency	WOOD: DETERIORATED DOOR
Deficiency Location/Instance	Rooms 462, 420, 416, 409, 408 and others
Deficiency Quantity	15
Quantity Uom	EACH
Potential Action	MAINTENANCE
Urgency of Action	PRIORITY 3
Purpose of Action	LEVEL 2
Deficiency Photo1

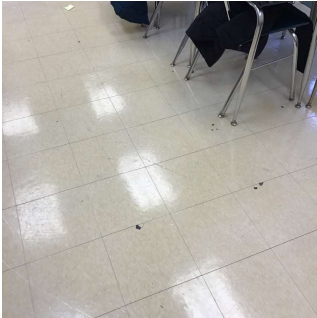
Question	Response
INTERIOR	
CLASSROOMS/CORRIDORS/ADMIN SPACES	
Floor Finish	
Deficiency	VINYL TILES: BROKEN/DETERIORATED/MISSING TILES
Deficiency Location/Instance	Rooms 418, 409, 405, 308 Corridor near Room 462 and others
Deficiency Quantity	600
Quantity Uom	S.F.
Potential Action	REPLACE
Urgency of Action	PRIORITY 3
Purpose of Action	LEVEL 2
Deficiency Photo1

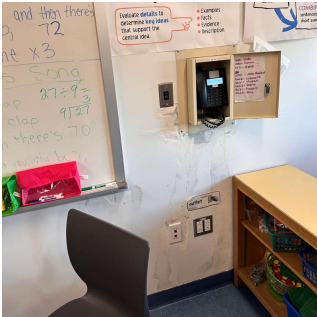
Violations	Room 418 No violations recorded.
Walls	
Condition	Inspected
Condition	2 - Between Good and Fair
Deficiency	GYPSUM BOARD: DETERIORATED - ACTIVE LEAK
Deficiency Location/Instance	Room 386
Deficiency Quantity	40
Quantity Uom	S.F.
Potential Action	REPLACE
Urgency of Action	PRIORITY 5
Purpose of Action	LEVEL 2
Deficiency Photo1

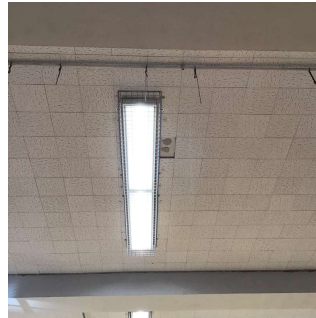
Near Room 352D

ACOUSTIC TILES ON PLASTER: DAMAGED/MISSING

REPLACE

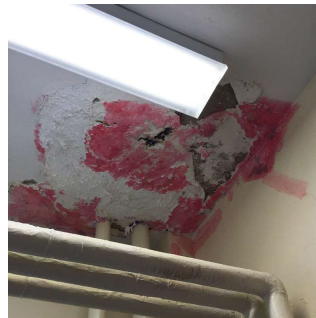
Room 352E

PLASTER: CRACKS/SPALLING - ACTIVE LEAK

REPLACE

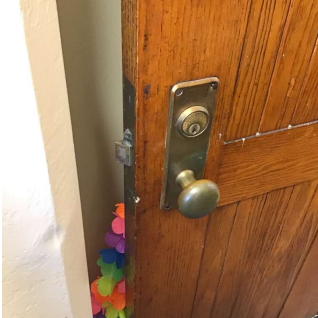
Question	Response
INTERIOR	
GYMNASIUM	
Door(s)	
Instance on 3rd Floor	Inspected
Condition	5 - Poor
Deficiency	WOOD: DETERIORATED DOOR
Deficiency Location/Instance	Rooms 352E, 352A, Main Entrance, Storage Room
Deficiency Quantity	5
Quantity Uom	EACH
Potential Action	MAINTENANCE
Urgency of Action	PRIORITY 3
Purpose of Action	LEVEL 2
Deficiency Photo1

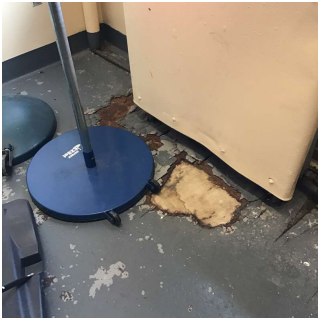
Room 352E
Violations	No violations recorded.
Fixed Equipment	
Instance on 3rd Floor	Inspected
Condition	2 - Between Good and Fair
Deficiency	No deficiencies recorded
Floor Finish	
Instance on 3rd Floor	Inspected
Condition	2 - Between Good and Fair
Deficiency	SHEET VINYL: DETERIORATED SUBSTRATE
Deficiency Location/Instance	Room 352E
Deficiency Quantity	20
Quantity Uom	S.F.
Potential Action	REPLACE
Urgency of Action	PRIORITY 3
Purpose of Action	LEVEL 2
Deficiency Photo1

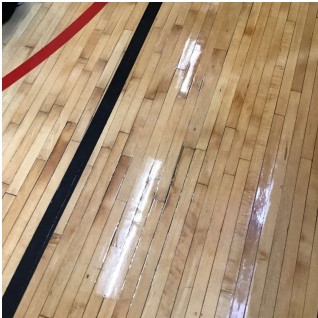
Room 352E
Violations	No violations recorded.
Deficiency	WOOD: DAMAGED/DETERIORATED
Deficiency Location/Instance	Right Side, Near Stair E

Question	Response
INTERIOR	
GYMNASIUM	
Floor Finish	
Deficiency Quantity	20
Quantity Uom	S.F.
Potential Action	REPLACE
Urgency of Action	PRIORITY 3
Purpose of Action	LEVEL 2
Deficiency Photo1

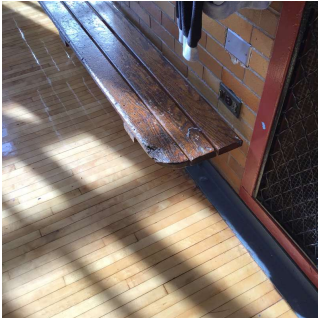
Right Side
Violations	No violations recorded.
Seating	
Instance on 3rd Floor	Inspected
Condition	3 - Fair
Deficiency	DAMAGED FIXED SEATING
Deficiency Location/Instance	Near Entrance
Deficiency Quantity	1
Quantity Uom	EACH
Potential Action	REPLACE
Urgency of Action	PRIORITY 3
Purpose of Action	LEVEL 2
Deficiency Photo1

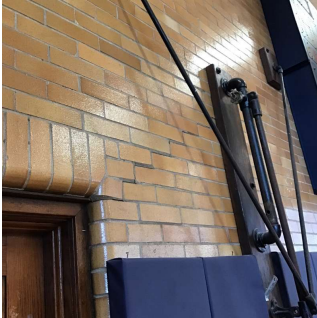
Near Entrance
Violations	No violations recorded.
Sliding-folding Partition	
Instance on 3rd Floor	Does not Exist
Stage	
Instance on 3rd Floor	Does not Exist
Walls	
Instance on 3rd Floor	Inspected
Condition	2 - Between Good and Fair
Deficiency	SALT GLAZED BRICK: CRACKS/SPALLING
Deficiency Location/Instance	Near Room 352A
Deficiency Quantity	20

Question	Response
INTERIOR	
GYMNASIUM	
Walls	
Quantity Uom	S.F.
Potential Action	REPLACE
Urgency of Action	PRIORITY 3
Purpose of Action	LEVEL 2
Deficiency Photo1

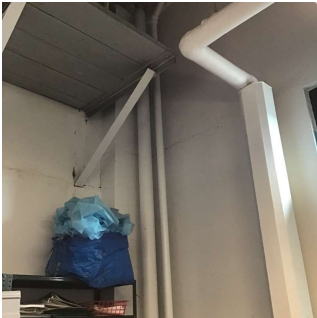
Near Room 352A
Violations	No violations recorded.
Deficiency	PLASTER: CRACKS/SPALLING
Deficiency Location/Instance	Room 352A
Deficiency Quantity	20
Quantity Uom	S.F.
Potential Action	REPLACE
Urgency of Action	PRIORITY 3
Purpose of Action	LEVEL 2
Deficiency Photo1

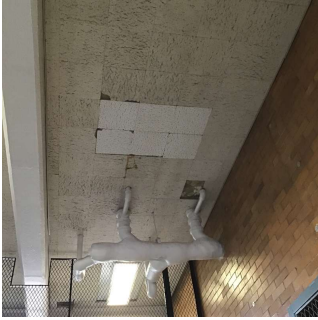
Question	Response
INTERIOR	
LOCKER ROOM	Inspected
Instance on 3rd Floor	Inaccessible
MULTI-PURPOSE ROOM	Inspected
Instance on 1st Floor	Inspected
Ceiling	
Instance on 1st Floor	Inspected
Condition	2 - Between Good and Fair
Deficiency	ACOUSTIC TILES ON PLASTER: DAMAGED/MISSING
Deficiency Location/Instance	Near Room 155A
Deficiency Quantity	20
Quantity Uom	S.F.
Potential Action	REPLACE
Urgency of Action	PRIORITY 3
Purpose of Action	LEVEL 2
Deficiency Photo1

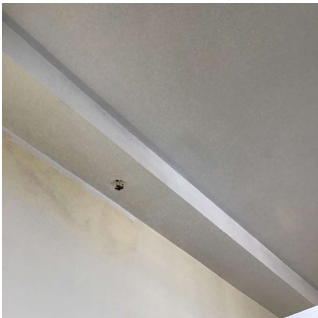
Question	Response
INTERIOR	
SCIENCE PREP ROOM	
Instance on Room 215	Inspected
Alternative use	Yes
Fixed Equipment	
Instance on Room 215	Inspected
Condition	2 - Between Good and Fair
Deficiency	No deficiencies recorded
SHOWER ROOM	
Instance on 3rd Floor	Inaccessible
STAIRS/RAMPS: INTERIOR	
Do Letter Stair Signs Exist?	Yes
Ceiling	
Condition	2 - Between Good and Fair
Deficiency	PLASTER: CRACKS/SPALLING
Deficiency Location/Instance	Stair C/4
Deficiency Quantity	10
Quantity Uom	S.F.
Potential Action	REPLACE
Urgency of Action	PRIORITY 3
Purpose of Action	LEVEL 2
Deficiency Photo1

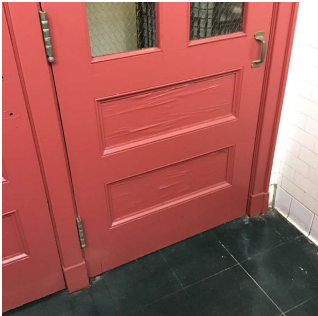
Violations	No violations recorded.
Door(s)	
Condition	4 - Between Fair and Poor
Deficiency	WOOD: DETERIORATED DOOR
Deficiency Location/Instance	Stairs D/Basement Vestibule, E/Basement Vestibule
Deficiency Quantity	4
Quantity Uom	EACH
Potential Action	MAINTENANCE
Urgency of Action	PRIORITY 3
Purpose of Action	LEVEL 2
Deficiency Photo1

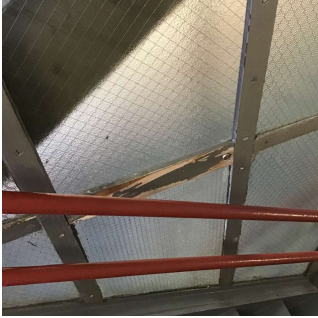
Question	Response
INTERIOR	
STAIRS/RAMPS: INTERIOR	
Door(s)	Inspected
	Stair D/Basement Vestibule
Violations	No violations recorded.
Partition	Inspected
Condition	3 - Fair
Deficiency	METAL FRAME: DAMAGED/DETERIORATED
Deficiency Location/Instance	Stair D/Basement
Deficiency Quantity	10
Quantity Uom	L.F.
Potential Action	REPLACE
Urgency of Action	PRIORITY 3
Purpose of Action	LEVEL 2
Deficiency Photo1

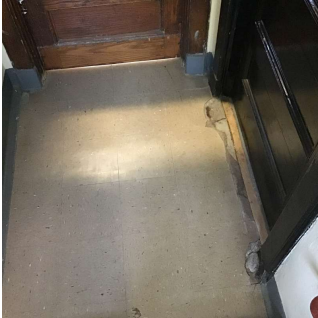
Violations	Stair D/Basement No violations recorded.
Railings	Inspected
Condition	2 - Between Good and Fair
Deficiency	No deficiencies recorded
Stairs and Landings	Inspected
Condition	2 - Between Good and Fair
Deficiency	VINYL TILES: BROKEN/DETERIORATED/MISSING TILES
Deficiency Location/Instance	Stair E/Basement, 1, 2, 3
Deficiency Quantity	120
Quantity Uom	S.F.
Potential Action	REPLACE
Urgency of Action	PRIORITY 3
Purpose of Action	LEVEL 2
Deficiency Photo1

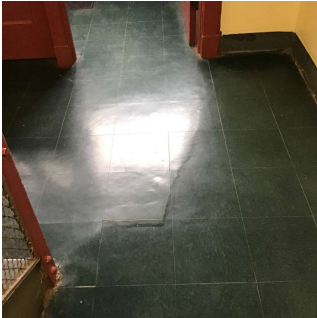
Violations	Stair E/Basement No violations recorded.
Deficiency	VINYL TILES: DETERIORATED SUBSTRATE

Deficiency Location/Instance	Stair D/Basement

Question	Response
INTERIOR	
STAIRS/RAMPS: INTERIOR	
Stairs and Landings	
Deficiency Quantity	20
Quantity Uom	S.F.
Potential Action	REPLACE
Urgency of Action	PRIORITY 3
Purpose of Action	LEVEL 2
Deficiency Photo1

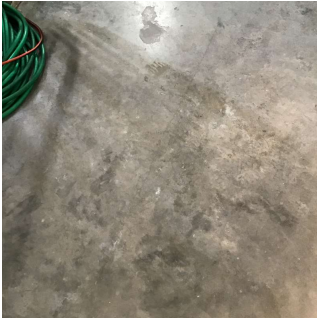
Stair D/Basement
Violations	No violations recorded.
Deficiency	CONCRETE: CRACKS/SPALLING - MAJOR
Deficiency Location/Instance	Stair I/ Bulkhead
Deficiency Quantity	25
Quantity Uom	S.F.
Potential Action	REPLACE
Urgency of Action	PRIORITY 3
Purpose of Action	LEVEL 2
Deficiency Photo1

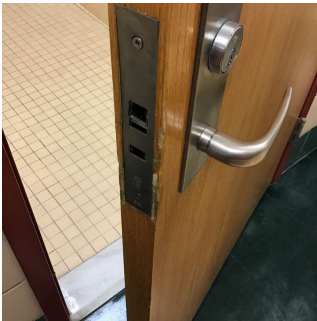
Question	Response
INTERIOR	
TOILET ROOMS - STAFF	
Door(s)	
Deficiency Photo1

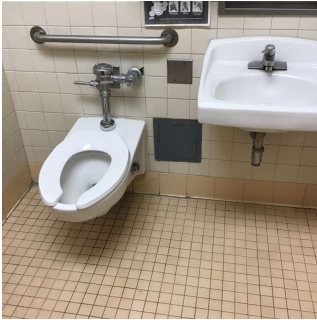
Room 468
Violations	No violations recorded.
Floor Finish	Inspected
Condition	2 - Between Good and Fair
Deficiency	No deficiencies recorded
Stalls	Inspected
Condition	2 - Between Good and Fair
Deficiency	No deficiencies recorded
Walls	Inspected
Condition	2 - Between Good and Fair
Deficiency	CERAMIC TILE: BROKEN/ MISSING
Deficiency Location/Instance	Rooms 468, 256, 253, 153
Deficiency Quantity	40
Quantity Uom	S.F.
Potential Action	REPLACE
Urgency of Action	PRIORITY 3
Purpose of Action	LEVEL 2
Deficiency Photo1

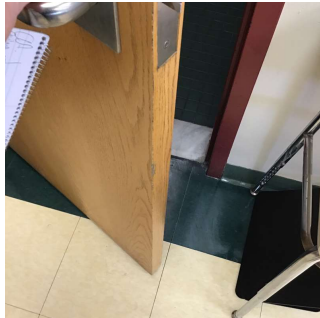
Violations	Room 418A No violations recorded.
Door(s)	Inspected
Condition	5 - Poor
Deficiency	WOOD: DETERIORATED DOOR
Deficiency Location/Instance	Rooms 459, 453, 418A, 317A, 259 and others
Deficiency Quantity	9
Quantity Uom	EACH
Potential Action	MAINTENANCE
Urgency of Action	PRIORITY 3
Purpose of Action	LEVEL 2
Deficiency Photo1

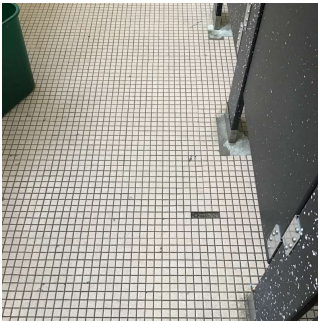
Violations	Room 418A No violations recorded.
Floor Finish	Inspected
Condition	2 - Between Good and Fair
Deficiency	CERAMIC TILE: BROKEN/MISSING TILES
Deficiency Location/Instance	Rooms 453, 207A, 255
Deficiency Quantity	30
Quantity Uom	S.F.
Potential Action	REPLACE
Urgency of Action	PRIORITY 3
Purpose of Action	LEVEL 2

Question	Response
INTERIOR	
TOILET ROOMS - STUDENTS	
Floor Finish	
Deficiency Photo1

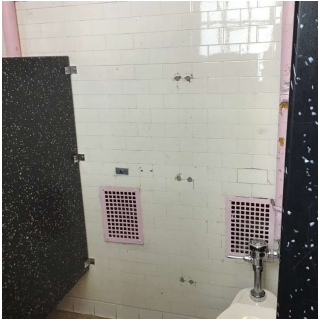
Room 207A
Violations	No violations recorded.
Stalls	
Condition	Inspected
	2 - Between Good and Fair
Deficiency	No deficiencies recorded
Walls	
Condition	Inspected
	2 - Between Good and Fair
Deficiency	CERAMIC TILE: BROKEN/ MISSING
Deficiency Location/Instance	Rooms 459, 453, 353, 317A, 259 and others
Deficiency Quantity	100
Quantity Uom	S.F.
Potential Action	REPLACE
Urgency of Action	PRIORITY 3
Purpose of Action	LEVEL 2
Deficiency Photo1

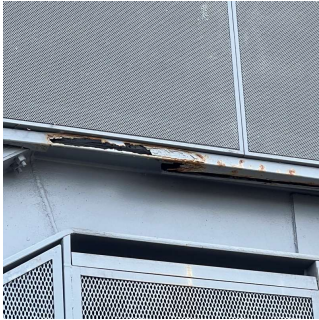
Room 459
Violations	No violations recorded.
LIFE SAFETY	
	Inspected
F.D. HOLDING AREA	
	Does not Exist
STEEL STAIRS	
Condition	Inspected
	5 - Poor
Deficiency	MAJOR RUSTING
Deficiency Location/Instance	Facade F - Steel Stairs
Deficiency Quantity	40
Quantity Uom	S.F.
Potential Action	REPLACE
Urgency of Action	PRIORITY 4
Purpose of Action	LEVEL 2

Question	Response
LIFE SAFETY	
STEEL STAIRS	
Deficiency Photo1

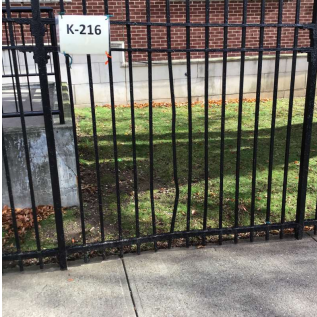
Question	Response
SITE	
FENCES	
Deficiency	WROUGHT IRON: DAMAGED/DETERIORATED
Deficiency Location/Instance	128th Street, 129th Street, 7th Avenue
Deficiency Quantity	440
Quantity Uom	S.F.
Potential Action	REPLACE
Urgency of Action	PRIORITY 3
Purpose of Action	LEVEL 2
Deficiency Photo1

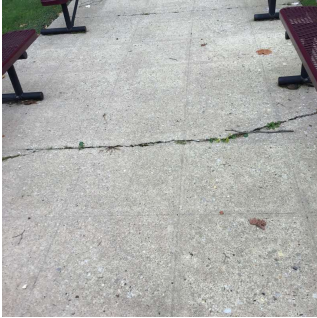
128th Street
Violations	No violations recorded.
IRRIGATION SYSTEM	Does not Exist
PAVING	Inspected
Student Non-Use	Inspected
Gravel Exists?	No
Asphalt	Does not Exist
Concrete	Inspected
Condition	3 - Fair
Deficiency	CRACKS - MAJOR
Deficiency Location/Instance	7th Avenue, 128th ave
Deficiency Quantity	100
Quantity Uom	S.F.
Potential Action	REPLACE
Urgency of Action	PRIORITY 3
Purpose of Action	LEVEL 2
Deficiency Photo1

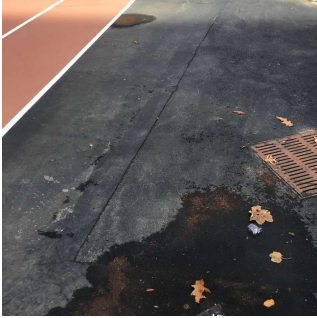
Question	Response
SITE	
PAVING	
Student Use	
Asphalt	
Deficiency	CRACKS - MAJOR
Deficiency Location/Instance	Schoolyard
Deficiency Quantity	200
Quantity Uom	S.F.
Potential Action	REPLACE
Urgency of Action	PRIORITY 3
Purpose of Action	LEVEL 2
Deficiency Photo1

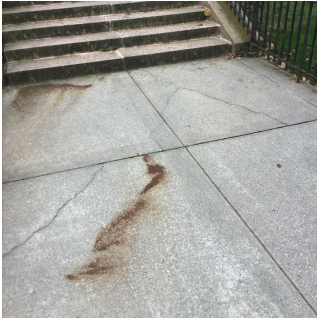
Violations	Schoolyard No violations recorded.
Concrete	Inspected
Condition	3 - Fair
Deficiency	CRACKS - MAJOR
Deficiency Location/Instance	Schoolyard
Deficiency Quantity	50
Quantity Uom	S.F.
Potential Action	REPLACE
Urgency of Action	PRIORITY 3
Purpose of Action	LEVEL 2
Deficiency Photo1	 
Violations	Schoolyard No violations recorded.
Pavers	Does not Exist
Site Sidewalks & Walkways	Inspected
Asphalt	Does not Exist
Concrete	Inspected
Condition	3 - Fair
Deficiency	CRACKS - MAJOR
Deficiency Location/Instance	Exit 2, 1
Deficiency Quantity	125

Question	Response
SITE	
PAVING	
Site Sidewalks & Walkways	
Concrete	
Quantity Uom	S.F.
Potential Action	REPLACE
Urgency of Action	PRIORITY 3
Purpose of Action	LEVEL 2
Deficiency Photo1

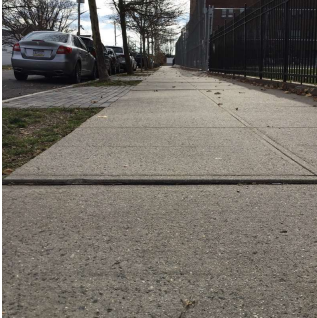
Violations	Exit 2 No violations recorded.
Pavers	Inspected
Condition	2 - Between Good and Fair
Deficiency	No deficiencies recorded
DOT Sidewalk	Inspected
Asphalt	Does not Exist
Concrete	Inspected
Condition	3 - Fair
Deficiency	HEAVING
Deficiency Location/Instance	129th Street, 128th Street
Deficiency Quantity	150
Quantity Uom	S.F.
Potential Action	REPLACE
Urgency of Action	PRIORITY 3
Purpose of Action	LEVEL 2
Deficiency Photo1

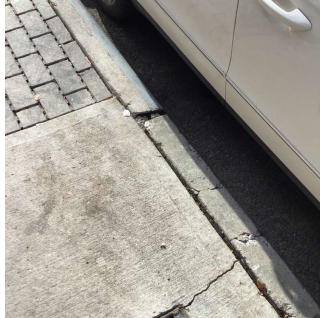
Violations	129th Street No violations recorded.
Deficiency	DAMAGED CURBS
Deficiency Location/Instance	128th Street, 129th Street, 7th Avenue, 9th Avenue
Deficiency Quantity	100
Quantity Uom	L.F.
Potential Action	REPLACE
Urgency of Action	PRIORITY 3

Question	Response
SITE	
PAVING	
DOT Sidewalk	
Concrete	
Purpose of Action	LEVEL 2
Deficiency Photo1

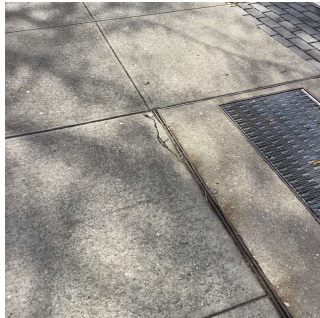
128th Street
Violations	No violations recorded.
Deficiency	DAMAGED/DETERIORATED/MISSING SECTIONS
Deficiency Location/Instance	128th Street, 7th Avenue
Deficiency Quantity	175
Quantity Uom	S.F.
Potential Action	REPLACE
Urgency of Action	PRIORITY 3
Purpose of Action	LEVEL 2
Deficiency Photo1

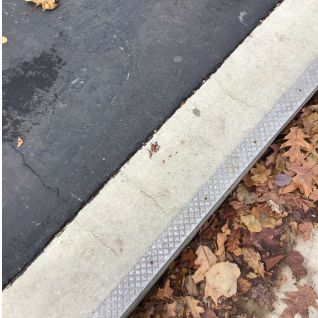
Deficiency	CAST IN PLACE CONCRETE: CRACKS/SPALLING - MAJOR
Deficiency Location/Instance	129th Street
Deficiency Quantity	10
Quantity Uom	S.F.
Potential Action	REPLACE
Urgency of Action	PRIORITY 3
Purpose of Action	LEVEL 2
Deficiency Photo1
