**NYC Department of Education**  
**Building Condition Assessment Survey 2023 - 2024**

Architectural Inspection

**Asset:** P.S. 132 - QUEENS, 132-15 218 STREET, New York, 11413

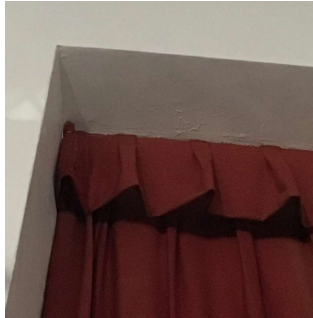
Facade E - Auditorium

ALUMINUM - DOUBLE HUNG: AIR/WATER INFILTRATION

REPLACE TRIM, SILLS OR WEATHERSTRIPPING

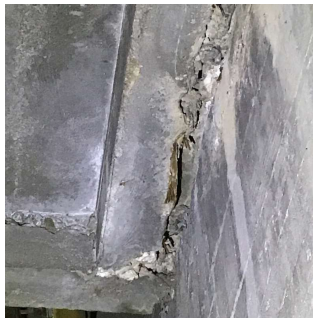
STEEL COLUMNS/BEAMS: DETERIORATED CONCRETE FIREPROOFING

REPLACE

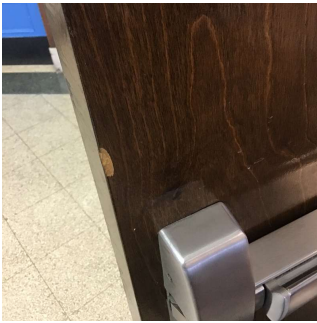
Question	Response
<b>INTERIOR</b>	
<b>STRUCTURAL</b>	
<b>VAULTS-BUNKERS</b>	
<b>Vault/Ash Hoist Doors and Framing</b>	
Deficiency Photo1	 
Violations	Basement - Ash Hoist Vault No violations recorded.
<b>AUDITORIUM</b>	
Instance on 1st Floor (Seats 562)	Inspected
Condition	2 - Between Good and Fair
Deficiency	PLASTER: CRACKS/SPALLING - ACTIVE LEAK
Deficiency Location/Instance	Near Stair C
Deficiency Quantity	10
Quantity Uom	S.F.
Potential Action	REPLACE
Urgency of Action	PRIORITY 5
Purpose of Action	LEVEL 2
Deficiency Photo1	 
Violations	Near Stair C No violations recorded.
<b>Door(s)</b>	
Instance on 1st Floor (Seats 562)	Inspected
Condition	3 - Fair
Deficiency	WOOD: DETERIORATED DOOR
Deficiency Location/Instance	Entrance
Deficiency Quantity	1
Quantity Uom	EACH
Potential Action	MAINTENANCE
Urgency of Action	PRIORITY 3
Purpose of Action	LEVEL 2

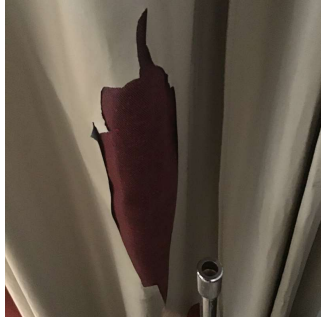
Right Side
Violations	No violations recorded.

Question	Response
<b>INTERIOR</b>	
<b>AUDITORIUM</b>	
<b>Stage</b>	
<b>Stage Curtains</b>	
Deficiency Photo1

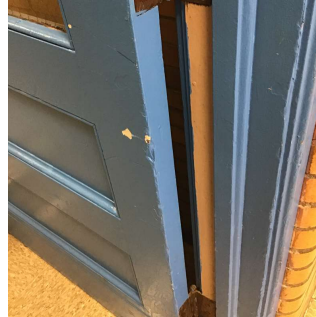
Near Drinking Fountain
Violations	No violations recorded.
<b>Door(s)</b>	
Instance on 1st Floor	Inspected
Condition	3 - Fair
Deficiency	WOOD: DETERIORATED DOOR
Deficiency Location/Instance	Near Girls Restroom
Deficiency Quantity	1

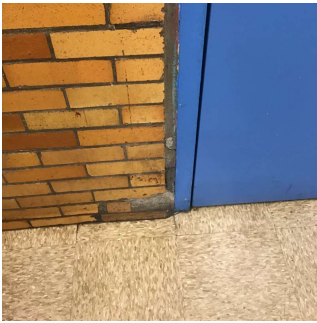
Near Stair B
Violations	No violations recorded.
<b>Window Curtains/Shades/Blinds</b>	
Instance on 1st Floor	Does not Exist
<b>CLASSROOMS/CORRIDORS/ADMIN SPACES</b>	
<b>Ceiling</b>	Inspected
Condition	2 - Between Good and Fair
Deficiency	ACOUSTIC TILES: DAMAGED/MISSING
Deficiency Location/Instance	Room 300
Deficiency Quantity	30
Quantity Uom	S.F.
Potential Action	REPLACE
Urgency of Action	PRIORITY 3
Purpose of Action	LEVEL 2
Deficiency Photo1	 
	Room 300
Violations	No violations recorded.
<b>Door(s)</b>	
Condition	5 - Poor
Deficiency	METAL CLAD WOOD: DETERIORATED DOOR
Deficiency Location/Instance	Room 351
Deficiency Quantity	1
Quantity Uom	EACH
Potential Action	MAINTENANCE
Urgency of Action	PRIORITY 3
Purpose of Action	LEVEL 2

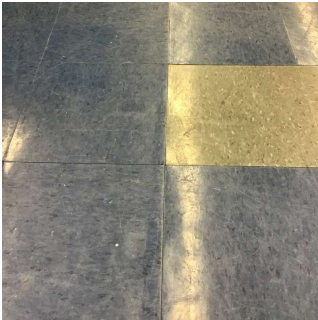
Question	Response
<b>INTERIOR</b>	
<b>LIBRARY</b>	
<b>Floor Finish</b>	
Instance on Room 209	Inspected
Condition	3 - Fair
Deficiency	VINYL TILES: DETERIORATED SUBSTRATE
Deficiency Location/Instance	Center
Deficiency Quantity	80
Quantity Uom	S.F.
Potential Action	REPLACE
Urgency of Action	PRIORITY 3
Purpose of Action	LEVEL 2
Deficiency Photo1

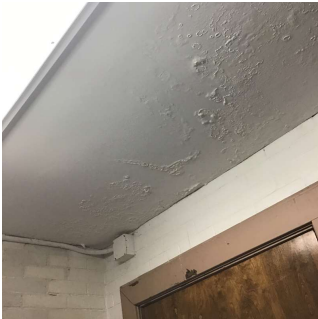
Question	Response
<b>INTERIOR</b>	
<b>SHOWER ROOM</b>	Does not Exist
<b>STAIRS/RAMPS: INTERIOR</b>	Inspected
Do Letter Stair Signs Exist?	Partially
<b>Ceiling</b>	Inspected
Condition	2 - Between Good and Fair
Deficiency	PLASTER: CRACKS/SPALLING - ACTIVE LEAK
Deficiency Location/Instance	Stair C - Exit 9 Vestibule, Stair C/2
Deficiency Quantity	15
Quantity Uom	S.F.
Potential Action	REPLACE
Urgency of Action	PRIORITY 5
Purpose of Action	LEVEL 2
Deficiency Photo1

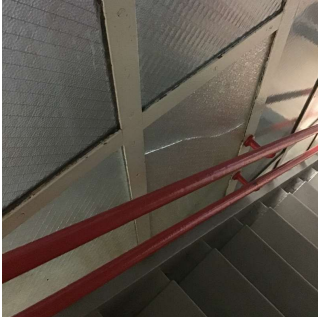
Violations	Stair A/1 No violations recorded.

Violations	Stair C - Exit 9 Vestibule No violations recorded.
<b>Door(s)</b>	Inspected
Condition	2 - Between Good and Fair
Deficiency	No deficiencies recorded
<b>Partition</b>	Inspected
Condition	2 - Between Good and Fair
Deficiency	GLASS PANEL: DAMAGED/DETERIORATED
Deficiency Location/Instance	Stair A/1
Deficiency Quantity	10
Quantity Uom	S.F.
Potential Action	REPLACE
Urgency of Action	PRIORITY 3
Purpose of Action	LEVEL 2
Deficiency Photo1

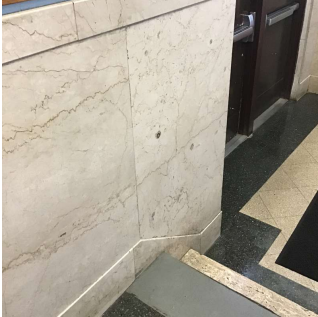
<b>Railings</b>	Inspected
Condition	3 - Fair
Deficiency	METAL: MISSING

Question	Response
<b>INTERIOR</b>	
<b>STAIRS/RAMPS: INTERIOR</b>	
<b>Railings</b>	
Deficiency Location/Instance	Main Entrance Vestibule, Exits 7, 8 Vestibule,
Deficiency Quantity	60
Quantity Uom	L.F.
Potential Action	REPLACE
Urgency of Action	PRIORITY 5
Purpose of Action	LEVEL 6
Deficiency Photo1

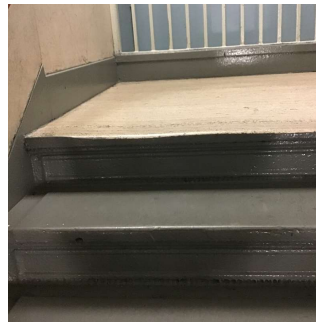
Stair A/2

Violations	Exit 7 Vestibule No violations recorded.
Deficiency	STONE: WORN-OUT TREAD/NOSINGS
Deficiency Location/Instance	Stair A/2,1
Deficiency Quantity	10
Quantity Uom	S.F.
Potential Action	REPLACE
Urgency of Action	PRIORITY 3
Purpose of Action	LEVEL 2

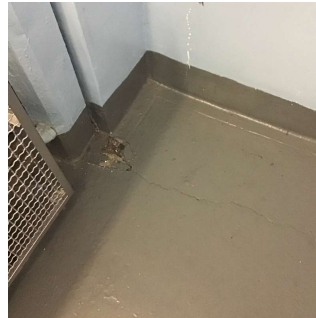
Stair C/1

CONCRETE: CRACKS/SPALLING - MAJOR

REPLACE

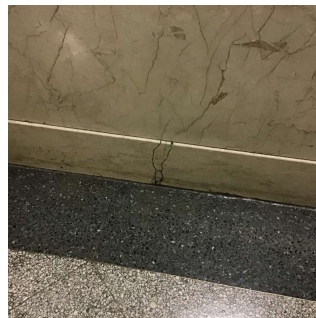
STONE MOLDINGS: CRACKS/SPALLING

REPLACE

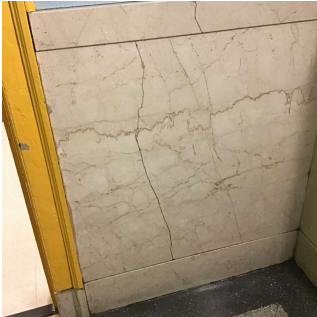
Question	Response
<b>INTERIOR</b>	
<b>STAIRS/RAMPS: INTERIOR</b>	
<b>Walls</b>	
Violations	Stair A/2 No violations recorded.
Deficiency	STONE: CRACKS/SPALLING
Deficiency Location/Instance	Stairs A/2, 1
Deficiency Quantity	60
Quantity Uom	S.F.
Potential Action	REPLACE
Urgency of Action	PRIORITY 3
Purpose of Action	LEVEL 2
Deficiency Photo1

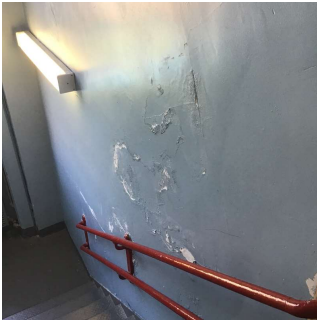
Violations	Stair A/2 No violations recorded.
Deficiency	PLASTER: CRACKS/SPALLING - ACTIVE LEAK
Deficiency Location/Instance	Stair C/3, 2
Deficiency Quantity	40
Quantity Uom	S.F.
Potential Action	REPLACE
Urgency of Action	PRIORITY 5
Purpose of Action	LEVEL 2
Deficiency Photo1

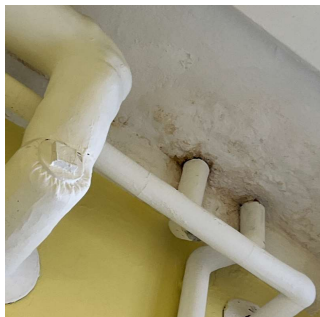
Question	Response
<b>INTERIOR</b>	
<b>TOILET ROOMS - STAFF</b>	
<b>Walls</b>	
Potential Action	REPLACE
Urgency of Action	PRIORITY 3
Purpose of Action	LEVEL 2
Deficiency Photo1	 
	Principal 2nd Floor
Violations	No violations recorded.
<b>TOILET ROOMS - STUDENTS</b>	
<b>Ceiling</b>	Inspected
Condition	2 - Between Good and Fair
Deficiency	PLASTER: CRACKS/SPALLING - ACTIVE LEAK
Deficiency Location/Instance	Room 258
Deficiency Quantity	15
Quantity Uom	S.F.
Potential Action	REPLACE
Urgency of Action	PRIORITY 5
Purpose of Action	LEVEL 2
Deficiency Photo1

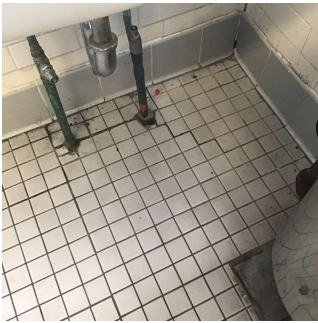
Room 258
Violations	No violations recorded.
<b>Door(s)</b>	Inspected
Condition	2 - Between Good and Fair
Deficiency	No deficiencies recorded
<b>Floor Finish</b>	Inspected
Condition	2 - Between Good and Fair
Deficiency	CERAMIC TILE: DETERIORATED SUBSTRATE
Deficiency Location/Instance	Room 357
Deficiency Quantity	15
Quantity Uom	S.F.
Potential Action	REPLACE
Urgency of Action	PRIORITY 3

Question	Response
<b>INTERIOR</b>	
<b>TOILET ROOMS - STUDENTS</b>	
<b>Floor Finish</b>	
Deficiency Photo1

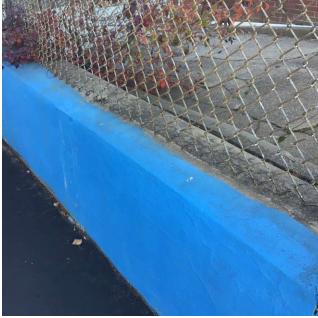
<b>FENCES</b>	Inspected
Condition	4 - Between Fair and Poor
Deficiency	CHAIN LINK: DAMAGED POST/RAIL
Deficiency Location/Instance	Rear Schoolyard
Deficiency Quantity	10

Question	Response
<b>SITE</b>	
<b>FENCES</b>	
Quantity Uom	L.F.
Potential Action	REPLACE
Urgency of Action	PRIORITY 3
Purpose of Action	LEVEL 2
Deficiency Photo1

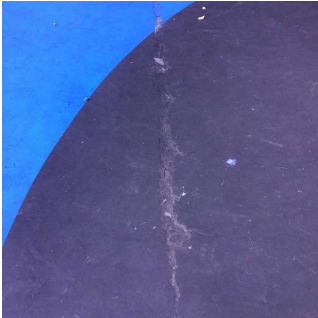
Question	Response
<b>SITE</b>	
<b>IRRIGATION SYSTEM</b>	Does not Exist
<b>PAVING</b>	Inspected
<b>Student Non-Use</b>	Inspected
Gravel Exists?	No
<b>Asphalt</b>	Does not Exist
<b>Concrete</b>	Inspected
Condition	2 - Between Good and Fair
Deficiency	No deficiencies recorded
<b>Pavers</b>	Does not Exist
<b>Student Use</b>	Inspected
Gravel Exists?	No
<b>Asphalt</b>	Inspected
Condition	3 - Fair
Deficiency	CRACKS - MAJOR
Deficiency Location/Instance	Schoolyard
Deficiency Quantity	300
Quantity Uom	S.F.
Potential Action	REPLACE
Urgency of Action	PRIORITY 3
Purpose of Action	LEVEL 2
Deficiency Photo1

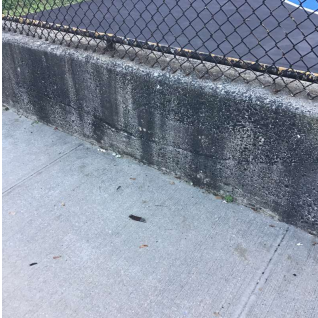
Question	Response
<b>SITE</b>	
<b>PLAYING SURFACE</b>	Inspected
<b>Playing Field</b>	Inspected
Deficiency	No deficiencies recorded
<b>Running Track</b>	Does not Exist
<b>RETAINING WALLS</b>	Inspected
Are there any Retaining Walls 6' OR higher facing public street/sidewalk?	No
Condition	3 - Fair
Deficiency	MASONRY UNIT: CRACKS/SPALLING - MAJOR
Deficiency Location/Instance	132nd Avenue
Deficiency Quantity	15
Quantity Uom	S.F.
Potential Action	REPLACE
Urgency of Action	PRIORITY 3
Purpose of Action	LEVEL 2
Deficiency Photo1
