**NYC Department of Education**  
**Building Condition Assessment Survey 2023 - 2024**

Architectural Inspection

**Asset:** M.S. 137 - QUEENS, 109-15 98TH STREET, New York, 11417

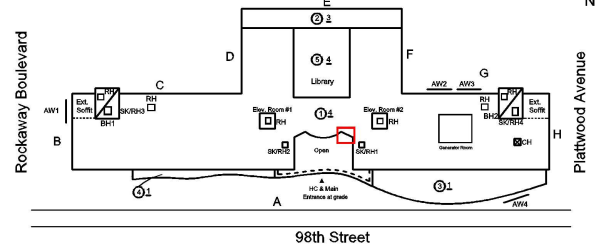
Roof Plan reference

Question	Response
<b>Architectural</b>	
<b>EXTERIOR</b>	Inspected
<b>AREAWAY</b>	Inspected
Instance on AW1-AW4	Inspected
Instance Condition	2 - Between Good and Fair
Instance Quantity	4
Instance Quantity Uom	EACH
Deficiency	No deficiencies recorded
<b>AWNINGS AND CANOPIES</b>	Does not Exist
<b>CHIMNEY</b>	Inspected
Material Type(s)	Masonry
Condition	2 - Between Good and Fair
Deficiency	No deficiencies recorded
<b>COPING</b>	Inspected
Condition	3 - Fair
Deficiency	CAST STONE: CRACKED/BROKEN PIECES

10  
 L.F.  
 REPLACE-IN-KIND  
 PRIORITY 4  
 LEVEL 2

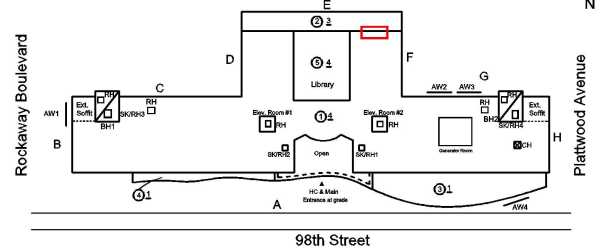
Roof Plan reference

**METAL: DETERIORATED JOINTS**

10  
 L.F.  
 REPAIR  
 PRIORITY 3  
 LEVEL 2

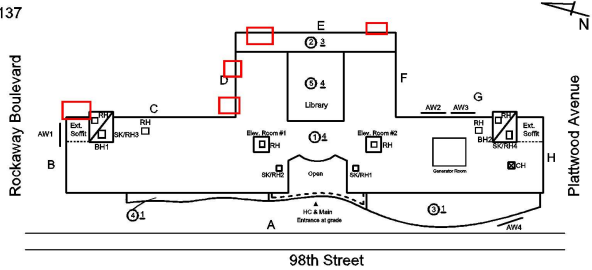
Question	Response
<b>EXTERIOR</b>	
<b>CORNICE</b>	Does not Exist
<b>DOORS</b>	Inspected
<b>DOORS AND FRAMES</b>	Inspected
Condition	5 - Poor
Deficiency	METAL: DETERIORATED DOOR AND FRAME - MAJOR DETERIORATION
Roof Plan reference	Q137

Deficiency Quantity	10
Quantity Uom	EACH
Potential Action	REPLACE
Urgency of Action	PRIORITY 4
Purpose of Action	LEVEL 2
Deficiency Photo1

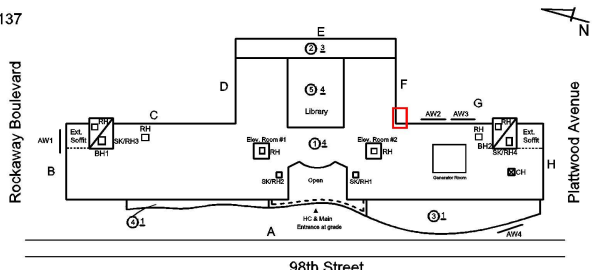
Violations	Facade D No violations recorded.
Deficiency	METAL: DETERIORATED DOOR AND FRAME - MINOR DETERIORATION
Roof Plan reference	Q137

Deficiency Quantity	2
Quantity Uom	EACH
Potential Action	MAINTENANCE
Urgency of Action	PRIORITY 3
Purpose of Action	LEVEL 2
Deficiency Photo1	No photo recorded
Violations	No violations recorded.
<b>DOOR HARDWARE</b>	Inspected
Condition	3 - Fair
Deficiency	No deficiencies recorded

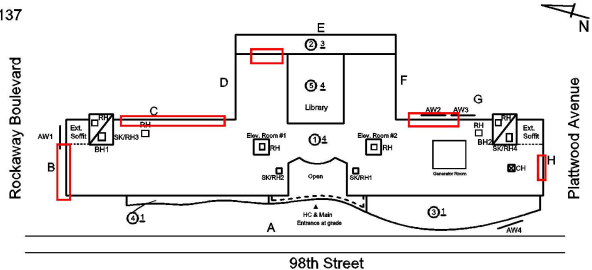
Question	Response
<b>EXTERIOR</b>	
<b>PARAPETS</b>	
Replacement Quantity	9,800
Replacement Uom	C.F.
Instance on All Facades	Inspected
Instance Condition	4 - Between Fair and Poor
Instance Quantity	9,800
Instance Quantity Uom	C.F.
Deficiency	BRICK: DETERIORATED JOINTS
Roof Plan reference	Q137

Deficiency Quantity	100
Quantity Uom	S.F.
Potential Action	REPOINT
Urgency of Action	PRIORITY 4
Purpose of Action	LEVEL 2
Deficiency Photo1

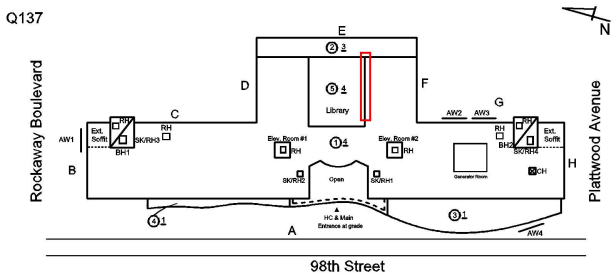
Violations	No violations recorded.
<b>PLAZA DECK</b>	Does not Exist
<b>ROOF</b>	Inspected
<b>Roofing</b>	Inspected
Replacement Quantity	49,000
Replacement Uom	S.F.
<b>ROOF HATCH/SMOKE HATCH</b>	Inspected
Condition	2 - Between Good and Fair
Deficiency	No deficiencies recorded
<b>LEADERS, GUTTERS, DOWNSPOUTS, SCUPPERS</b>	Inspected
Condition	3 - Fair
Deficiency	DAMAGED/MISSING

Deficiency Quantity	20
Quantity Uom	L.F.
Potential Action	REPLACE
Urgency of Action	PRIORITY 4
Purpose of Action	LEVEL 2
Deficiency Photo1

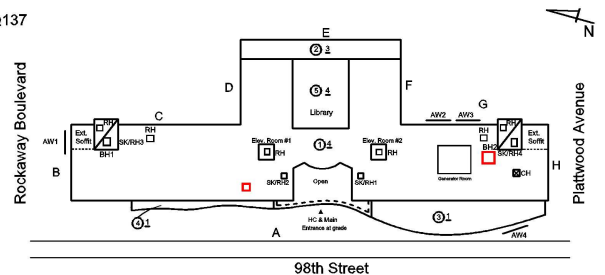
**ROOFING DRAINS**

Condition	Inspected
Deficiency	4 - Between Fair and Poor
Roof Plan reference	Q137

Deficiency Quantity	2
Quantity Uom	EACH
Potential Action	REPLACE
Urgency of Action	PRIORITY 4
Purpose of Action	LEVEL 2

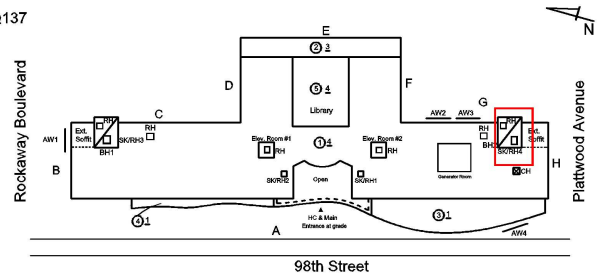
Roof Plan reference

**BULKHEAD/PENTHOUSE WALLS/INTERIOR: CMU  
 CRACKS/SPALLING**

REPLACE

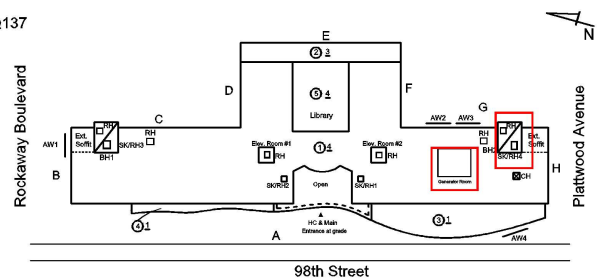
Roof Plan reference

**BULKHEAD/PENTHOUSE DOORS: DETERIORATED DOOR  
 AND FRAME**

REPLACE DOOR AND FRAME

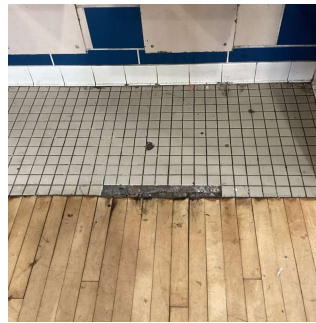
Drinking Fountain Area

**Floor Finish**

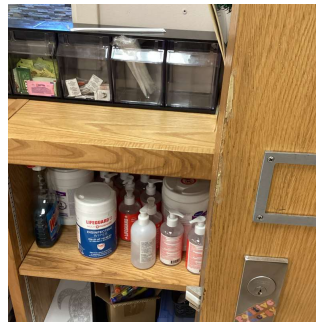
Office

**Door(s)**

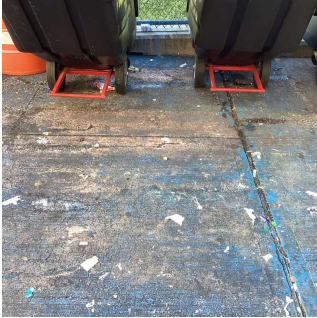
Question	Response
<b>SITE</b>	
<b>IRRIGATION SYSTEM</b>	Does not Exist
<b>PAVING</b>	Inspected
<b>Student Non-Use</b>	Inspected
Gravel Exists?	No
<b>Asphalt</b>	Does not Exist
<b>Concrete</b>	Inspected
Condition	3 - Fair
Deficiency	DAMAGED/DETERIORATED/MISSING SECTIONS
Deficiency Location/Instance	98th Street
Deficiency Quantity	125
Quantity Uom	S.F.
Potential Action	REPLACE
Urgency of Action	PRIORITY 3
Purpose of Action	LEVEL 2
Deficiency Photo1

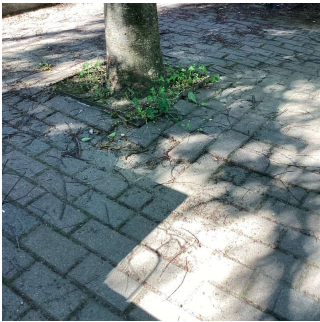
Question	Response
<b>SITE</b>	
<b>PAVING</b>	Inspected
<b>Student Use</b>	
<b>Concrete</b>	Does not Exist
<b>Pavers</b>	Inspected
Condition	2 - Between Good and Fair
Deficiency	HEAVING
Deficiency Location/Instance	Running Track Area
Deficiency Quantity	40
Quantity Uom	S.F.
Potential Action	REPLACE
Urgency of Action	PRIORITY 3
Purpose of Action	LEVEL 2
Deficiency Photo1

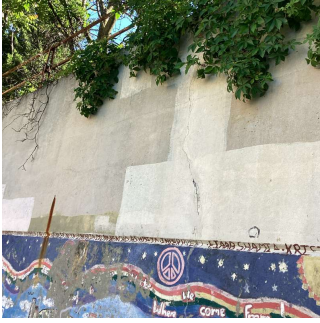
Near Seats Area
Violations	No violations recorded.
<b>STAIRS/RAMPS: EXTERIOR</b>	
	Does not Exist
<b>ARTWORK</b>	
	Inspected
Instance	Interior - Lobby - 10030
Instance Photo

Question	Response
<b>SITE</b>	
<b>SITE WALLS (NOT RETAINING WALLS)</b>	
Condition	3 - Fair
Deficiency	CAST IN PLACE CONCRETE: CRACKS/SPALLING - MAJOR
Deficiency Location/Instance	Near Seats Area, Neighbors
Deficiency Quantity	50
Quantity Uom	S.F.
Potential Action	REPLACE
Urgency of Action	PRIORITY 3
Purpose of Action	LEVEL 2
Deficiency Photo1
