NYC Department of Education
Building Condition Assessment Survey 2023 - 2024

Architectural Inspection

Asset: P.S. 752 (OLD J142) - QUEENS, 142-10 LINDEN BLVD, New York, 11436

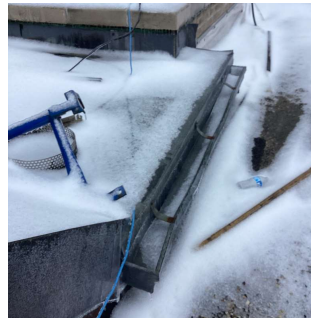
| Question | Response |
|---|--|
| Violations | Roof 1 - Bulkhead 1 No violations recorded. |

| Question | Response |
|---|--|
| Deficiency | DAMAGED/MISSING |

| Question | Response |
|---|--|
| Potential Action | REPLACE |

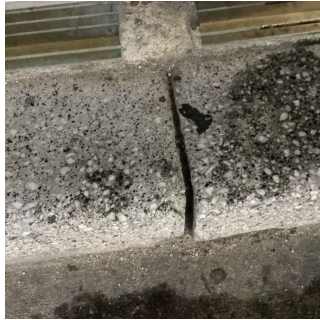
| Question | Response |
|---|---|
| Violations | <p>Facade A</p> <p>No violations recorded.</p> |

STONE: DETERIORATED JOINTS

| Question | Response |
|---|---|
| <p>Deficiency Quantity</p> <p>Quantity Uom</p> <p>Potential Action</p> <p>Urgency of Action</p> <p>Purpose of Action</p> <p>Deficiency Photo1</p> | <p>30</p> <p>L.F.</p> <p>REPOINT</p> <p>PRIORITY 4</p> <p>LEVEL 2</p> |

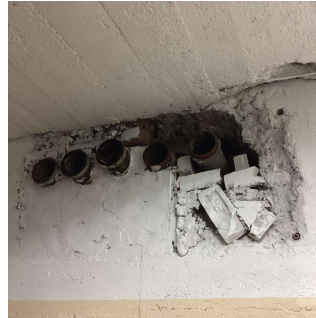
Basement - Storage Room

| Question | Response |
|---|--|
| Deficiency | CONCRETE: CRACKS/SPALLED/REINFORCEMENT EXPOSED |

| Question | Response |
|---|--|
| Potential Action | REPAIR |

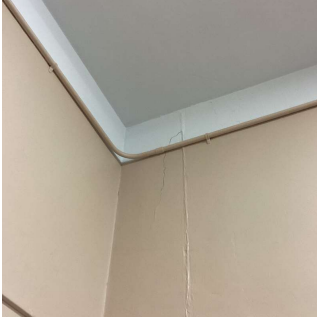
| Question | Response |
|---|--|
| | Left Side |

| Question | Response |
|---|--|
| Condition | 2 - Between Good and Fair |
| Deficiency | PLASTER: CRACKS/SPALLING |

| Question | Response |
|---|--|
| Potential Action | REPLACE |

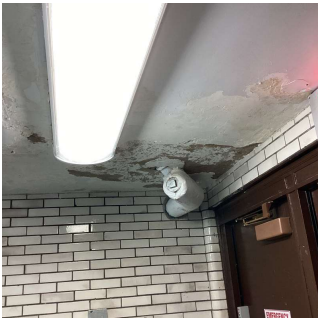
| Question | Response |
|---|--|
| Violations | Stair EF/1 Vestibule No violations recorded. |

| Question | Response |
|---|--|
| Deficiency | PLASTER: CRACKS/SPALLING |
| Deficiency Location/Instance | Stairs B/1 Vestibule, CD/1 Vestibule, EF/1 Vestibule |

| Question | Response |
|---|--|
| Potential Action | REPLACE |

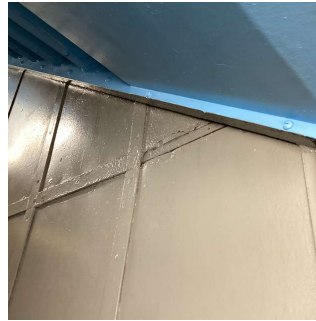
Stair A/2

| Question | Response |
|---|--|
| Deficiency | METAL FRAME: DAMAGED/DETERIORATED |
| Deficiency Location/Instance | Stairs A/1,2, EF/2 |

| Question | Response |
|---|--|
| Potential Action | REPLACE |

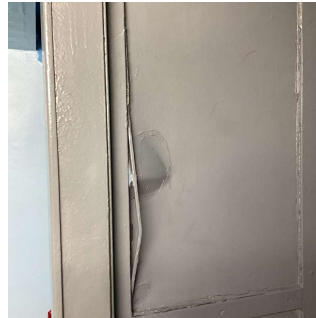
Stair CD/3

METAL PANEL: DAMAGED/DETERIORATED

REPLACE

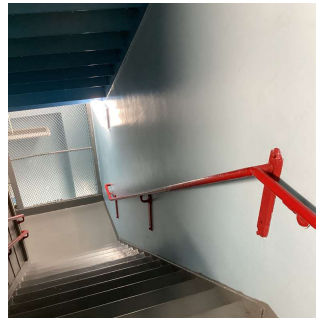
| Question | Response |
|---|--|
| Violations | Stair EF/3 No violations recorded. |

METAL: DAMAGED

REPLACE

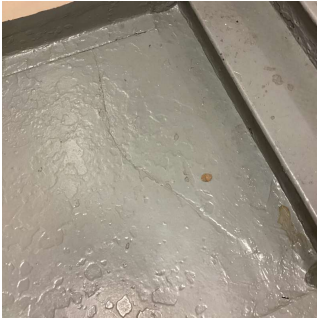
| Question | Response |
|---|--|
| Violations | Stair G/1 No violations recorded. |

| Question | Response |
|---|--|
| Deficiency | CONCRETE: CRACKS/SPALLING - MAJOR |
| Deficiency Location/Instance | Stair G/1 |

| Question | Response |
|---|--|
| Potential Action | REPLACE |

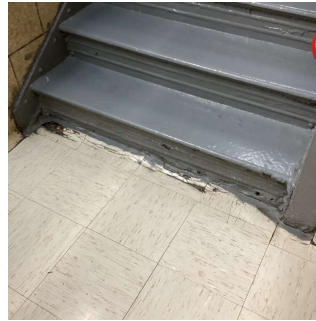
| Question | Response |
|---|--|
| Deficiency | METAL: RUST - MAJOR |
| Deficiency Location/Instance | Stair A/Basement |

| Question | Response |
|---|--|
| Potential Action | REPLACE |

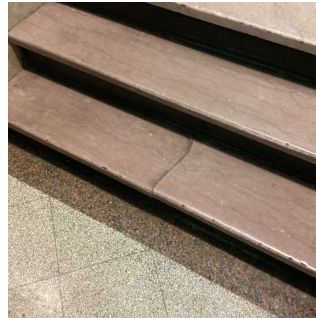
Main Entrance Vestibule

STONE: BROKEN/MISSING

REPLACE

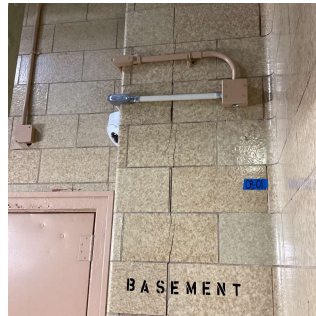
| Question | Response |
|---|--|
| Violations | Stair A/Basement 35658024N |

GLAZED BLOCK: CRACKS/SPALLING

REPLACE

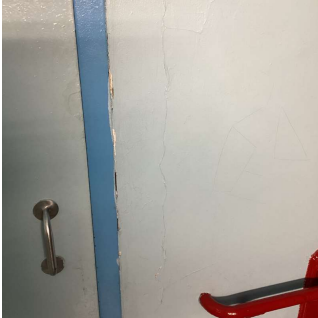
| Question | Response |
|---|--|
| Violations | Stair CD/2 No violations recorded. |

| Question | Response |
|---|--|
| Deficiency | PLASTER: CRACKS/SPALLING |
| Deficiency Location/Instance | Stair CD/2 |

| Question | Response |
|---|--|
| Potential Action | REPLACE |

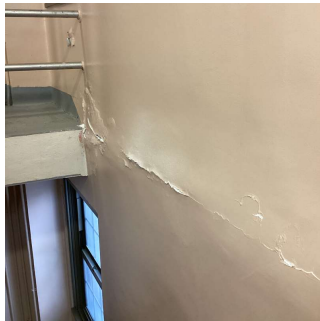
| Question | Response |
|---|--|
| Violations | Stair G/4 35658020X |

| Question | Response |
|---|--|
| Deficiency | PLASTER: CRACKS/SPALLING |
| Deficiency Location/Instance | Stair G/1,4 |

| Question | Response |
|---|--|
| Potential Action | REPLACE |

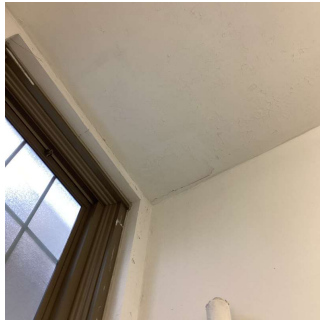
| Question | Response |
|---|--|
| Violations | 4th Floor Men No violations recorded. |

| Question | Response |
|---|--|
| Deficiency | PLASTER: CRACKS/SPALLING |
| Deficiency Location/Instance | 4th Floor Men |

| Question | Response |
|---|--|
| Potential Action | REPLACE |

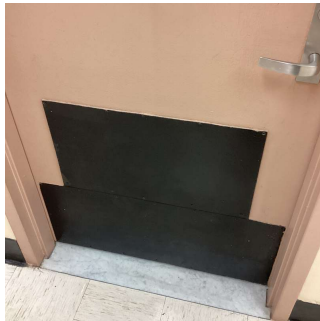
| Question | Response |
|---|--|
| Violations | Room 335 No violations recorded. |

| Question | Response |
|---|--|
| Deficiency | METAL: DAMAGED LOUVER |
| Deficiency Location/Instance | Rooms 233, 335, 4th Floor Men |

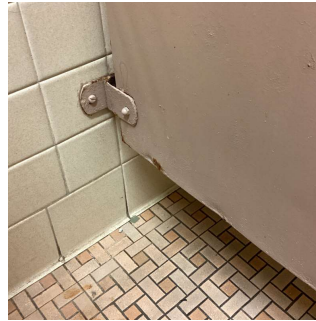
Kitchen Staff Men

| Question | Response |
|---|--|
| Deficiency | RUST - MAJOR |
| Deficiency Location/Instance | Kitchen Staff Men, Kitchen Staff Women |

| Question | Response |
|---|--|
| Potential Action | REPLACE |

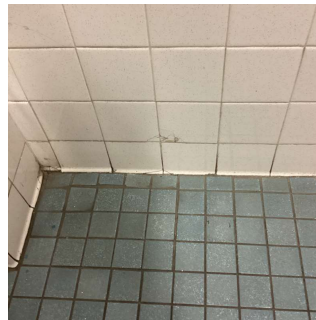
4th Floor Men

CERAMIC TILE: BROKEN/ MISSING

REPLACE

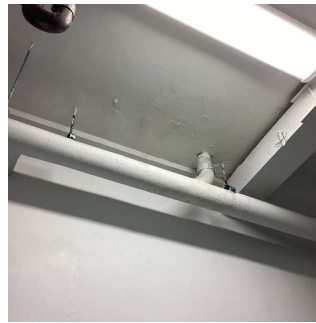
Room 234

PLASTER: CRACKS/SPALLING

REPLACE

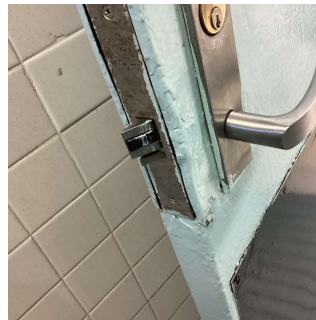
Room 234

METAL: DETERIORATED DOOR

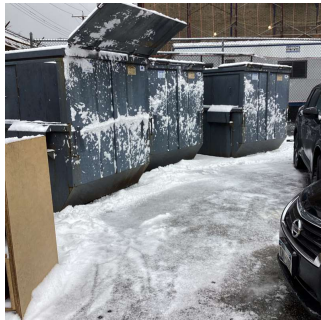
| Question | Response |
|---|--|
| Violations | Parking Lot No violations recorded. |

| Question | Response |
|---|--|
| Deficiency | CONCRETE PAD MISSING |

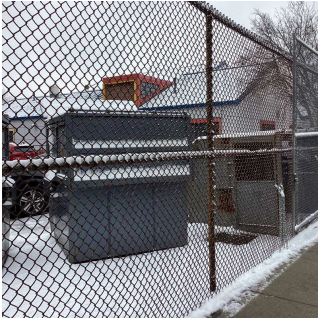
| Question | Response |
|---|--|
| Violations | 142nd Street No violations recorded. |

| Question | Response |
|---|--|
| Deficiency | CHAIN LINK: RUST - MAJOR |

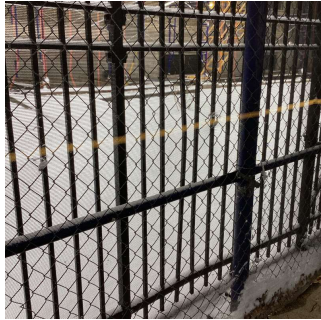
| Question | Response |
|---|--|
| Violations | Linden Boulevard No violations recorded. |

| Question | Response |
|---|--|
| Deficiency | WROUGHT IRON: DAMAGED/DETERIORATED |
