NYC Department of Education
Building Condition Assessment Survey 2023 - 2024

Architectural Inspection

Asset: P.S. 146 - QUEENS, 98-01 159 AVENUE, New York, 11414

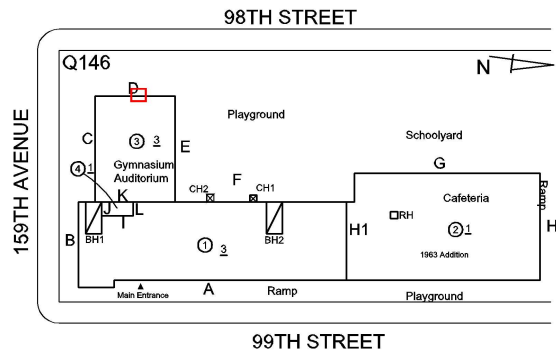
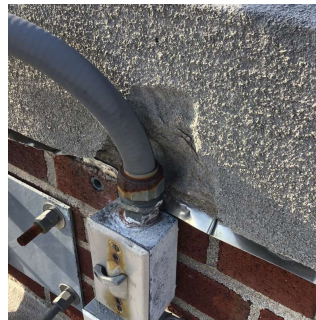
Roof 3
No violations recorded.

EXTERIOR	Inspected
AREAWAY	Does not Exist
AWNINGS AND CANOPIES	Does not Exist
CHIMNEY	Inspected
Material Type(s)	Masonry
Condition	2 - Between Good and Fair
Deficiency	No deficiencies recorded
COPING	Inspected
Condition	3 - Fair
Deficiency	CAST STONE: CRACKED/BROKEN PIECES
Roof Plan reference

10
L.F.
REPLACE-IN-KIND
PRIORITY 4
LEVEL 2

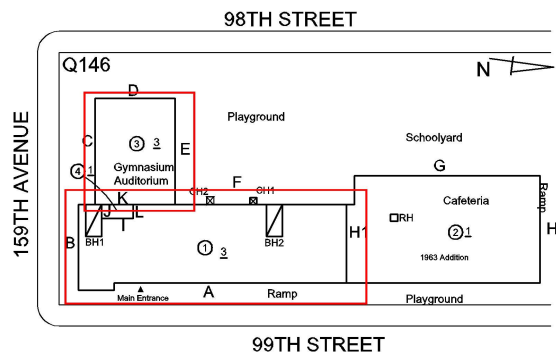
Deficiency	CAST STONE: DETERIORATED TRANSVERSE JOINTS
Roof Plan reference

50
L.F.

Question	Response
EXTERIOR	
COPING	
Potential Action	MAINTENANCE
Urgency of Action	PRIORITY 3
Purpose of Action	LEVEL 2
Deficiency Photo1

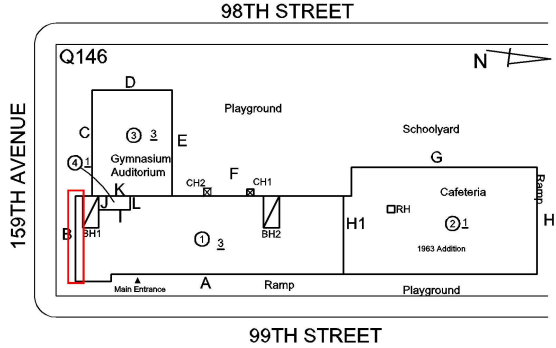
Violations	Roof 3 No violations recorded.
CORNICE	
Condition	Inspected 3 - Fair
Deficiency	STONE: MAJOR CRACKS, SPALLING
Roof Plan reference

Deficiency Quantity	50
Quantity Uom	S.F.
Potential Action	REPLACE
Urgency of Action	PRIORITY 4
Purpose of Action	LEVEL 2
Deficiency Photo1

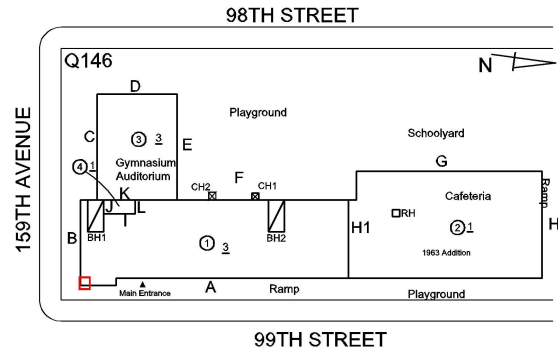
Violations	Facade B No violations recorded.
Deficiency	STONE: DETERIORATED JOINTS

10
 L.F.
 REPOINT
 PRIORITY 3
 LEVEL 2

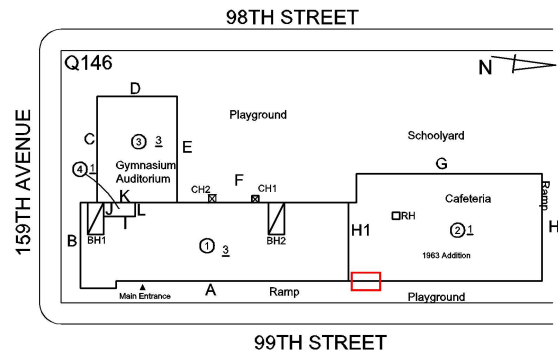
METAL CLAD: DETERIORATED DOOR AND FRAME - MAJOR DETERIORATION

1
 EACH
 REPLACE
 PRIORITY 4
 LEVEL 2

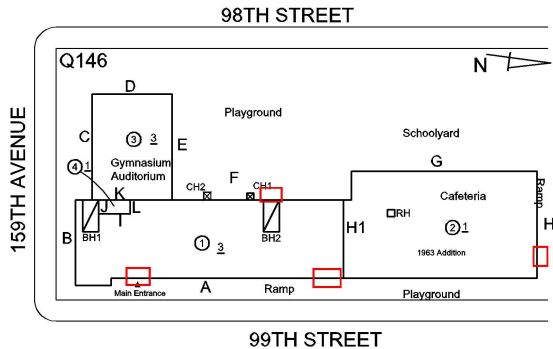
Violations	Facade A No violations recorded.
Deficiency	METAL: DETERIORATED DOOR AND FRAME - MINOR DETERIORATION
Roof Plan reference

Deficiency Quantity	9
Quantity Uom	EACH
Potential Action	MAINTENANCE
Urgency of Action	PRIORITY 3
Purpose of Action	LEVEL 2
Deficiency Photo1

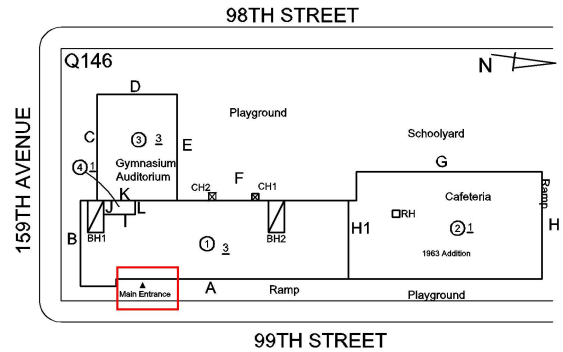
Facade A
 No violations recorded.

METAL: BROKEN GLASS

10
 S.F.
 MAINTENANCE
 PRIORITY 3
 LEVEL 2

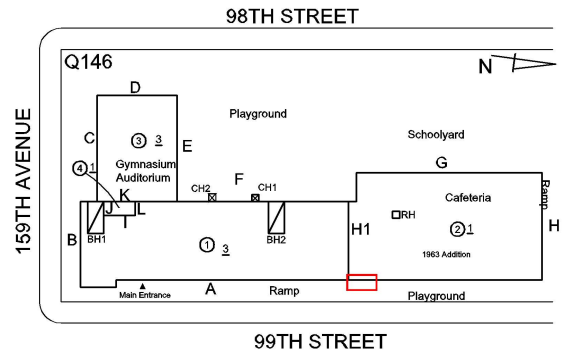
METAL: DENTED, MAJOR RUSTING

10
 S.F.
 REPLACE
 PRIORITY 4
 LEVEL 2

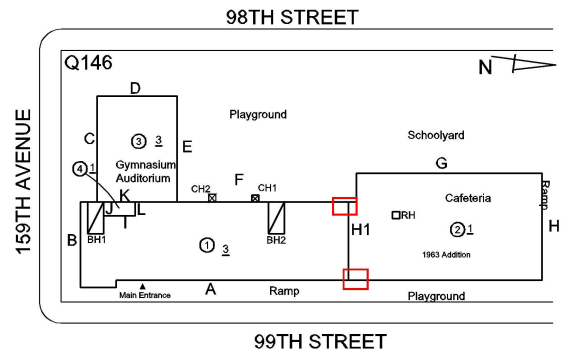
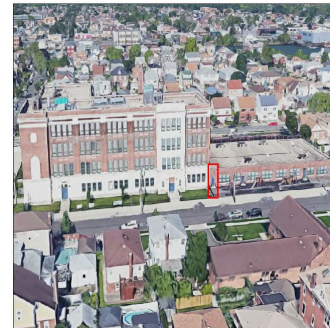
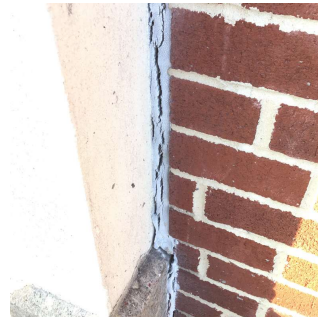
Facade A

BRICK: DETERIORATED CONTROL/EXPANSION JOINTS

30

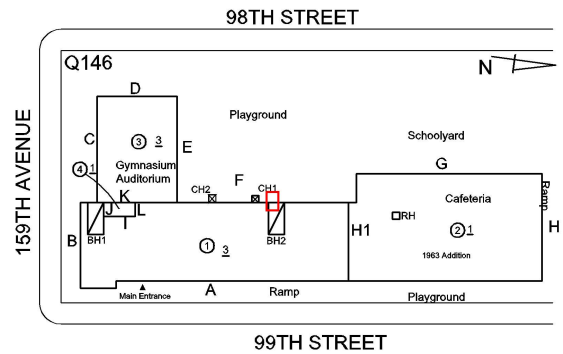
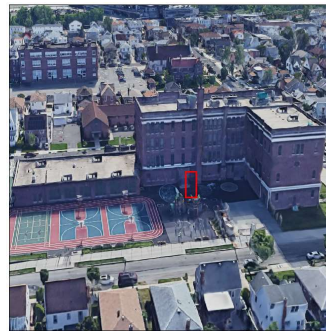
BRICK: CRACKS/DISPLACED/SPALLED BRICK AT BUILDING CORNERS

10

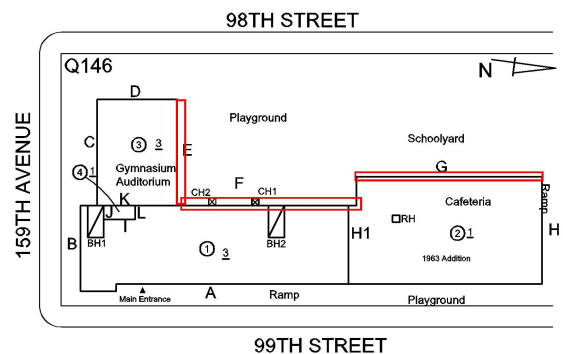
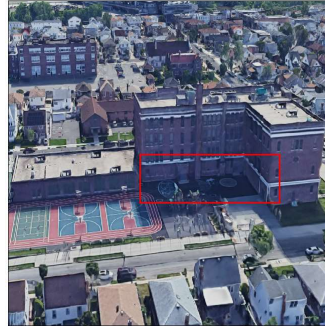
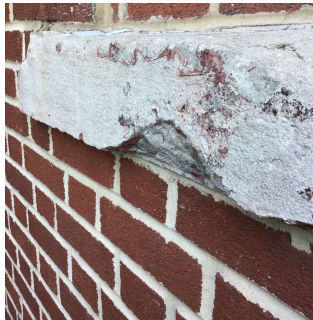
Facade F

BRICK: DETERIORATED MASONRY SILLS - MAJOR

100

REMOVE AND REPLACE

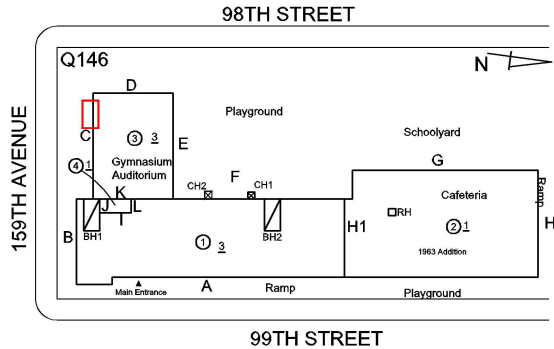
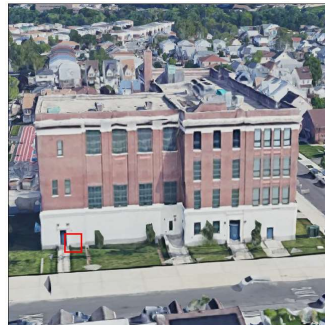
STONE: CHIPPED/SPALLED/BROKEN PIECES - MAJOR

10

REPLACE

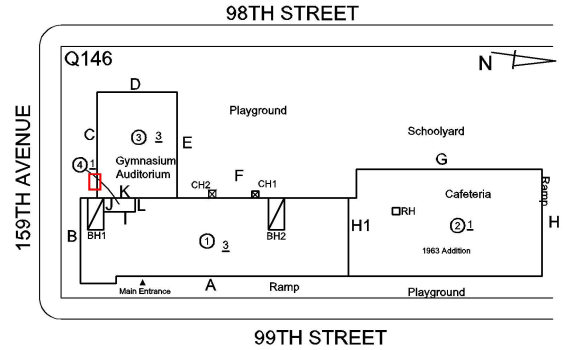
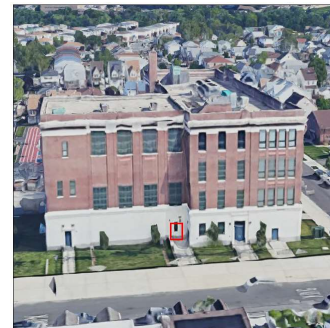
STONE: CHIPPED/SPALLED/BROKEN PIECES - MINOR

10

REPAIR

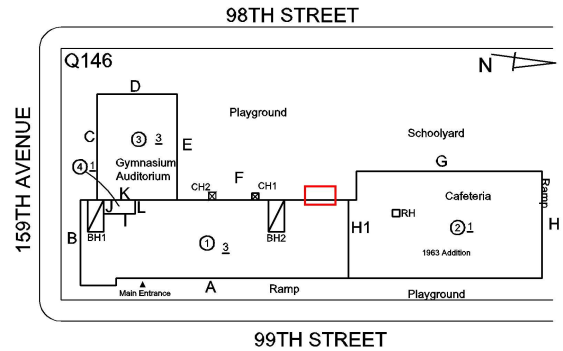
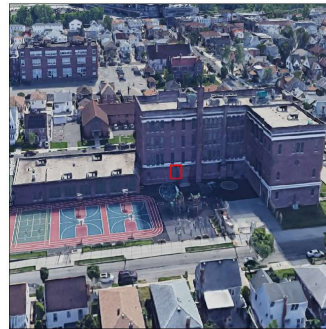
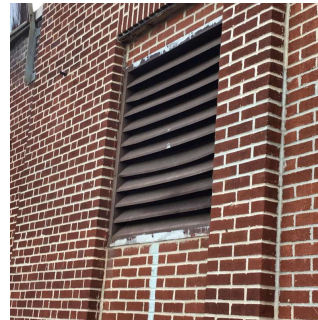
Facade F

Question	Response
EXTERIOR	
EXTERIOR WALLS	
Violations	No violations recorded.
Deficiency	STONE: CRACKS AT BUILDING CORNERS
Roof Plan reference	
Elevation	
Deficiency Quantity	100
Quantity Uom	S.F.
Potential Action	REPLACE
Urgency of Action	PRIORITY 4
Purpose of Action	LEVEL 2
Deficiency Photo1	
Violations	Facade B No violations recorded.
EXTERIOR SOFFITS	Does not Exist
LOADING DOCK	Does not Exist
LOUVER	Inspected
Condition	3 - Fair
Deficiency	BROKEN/ DENTED BLADES

10

REPLACE

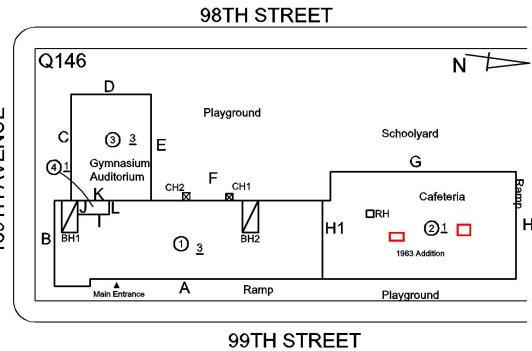
BUILT-UP: ROOFING: MAJOR ACTIVE ROOF LEAKS IN INSTRUCTIONAL SPACE

200

REPLACE ROOFING WITHOUT MAJOR EQUIPMENT REMOVAL

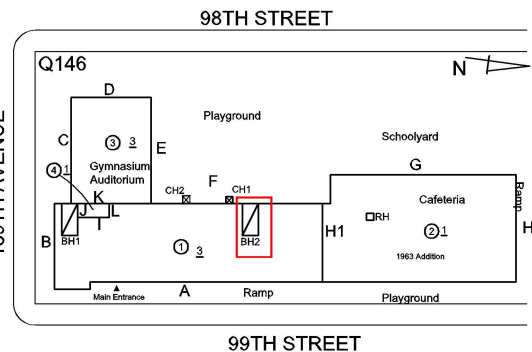
BULKHEAD/PENTHOUSE WALLS/INTERIOR: PLASTER CRACKS/SPALLING

10

Question	Response
EXTERIOR	
ROOF	
Specialties	
BULKHEAD/PENTHOUSE	
Quantity Uom	S.F.
Potential Action	REPLACE
Urgency of Action	PRIORITY 3
Purpose of Action	LEVEL 2
Deficiency Photo1

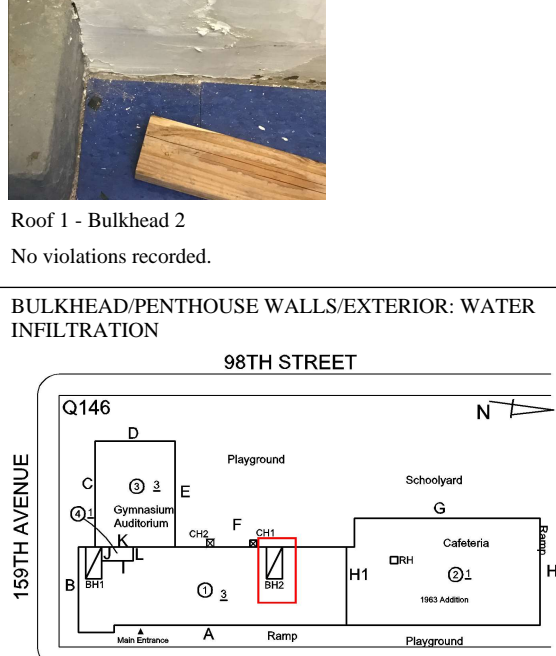
Violations	Roof 1 - Bulkhead 2
Violations	No violations recorded.
Deficiency	BULKHEAD/PENTHOUSE WALLS/EXTERIOR: WATER INFILTRATION
Roof Plan reference

Deficiency Quantity	50
Quantity Uom	S.F.
Potential Action	REPAIR
Urgency of Action	PRIORITY 5
Purpose of Action	LEVEL 2
Deficiency Photo1

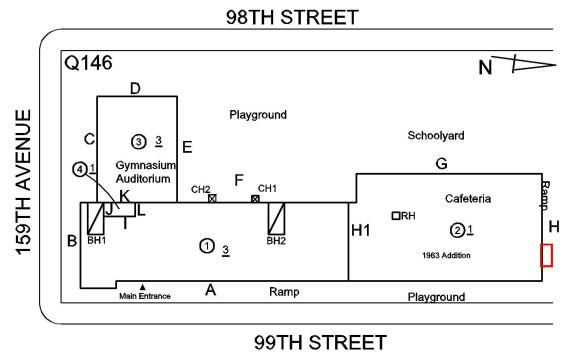
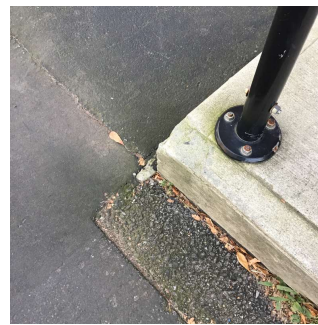
Facade H

Question	Response
EXTERIOR	
ROOF	
Specialties	
BULKHEAD/PENTHOUSE	
Roof Plan reference	
Deficiency Quantity	20
Quantity Uom	S.F.
Potential Action	REPLACE
Urgency of Action	PRIORITY 4
Purpose of Action	LEVEL 2
Deficiency Photo1	
Violations	Roof 1 - Bulkhead 1 No violations recorded.
CUPOLA/ SPIRES/ TOWERS	Does not Exist
DORMER	Does not Exist
DUNNAGE STEEL	Inspected
Condition	2 - Between Good and Fair
Deficiency	No deficiencies recorded
SKYLIGHT/ROOF VENT	Does not Exist
ROOF/GRAVITY TANK	Does not Exist
STAIRS/RAMPS: EXTERIOR	Inspected
BUILDING CHEEK/FLANK WALLS	Inspected
Condition	2 - Between Good and Fair
Deficiency	No deficiencies recorded
RAILINGS	Inspected
Condition	2 - Between Good and Fair
Deficiency	No deficiencies recorded
STAIRS/RAMPS	Inspected
Condition	3 - Fair
Deficiency	CONCRETE: CRACKS/SPALLING - MINOR

10
S.F.
REPAIR
PRIORITY 3
LEVEL 2

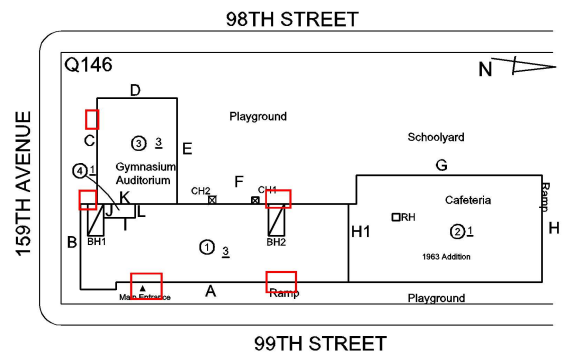
STONE: CRACKS/SPALLING - MINOR

40
S.F.
REPAIR
PRIORITY 3
LEVEL 2

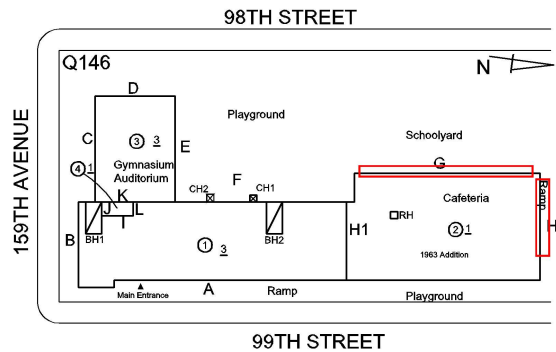
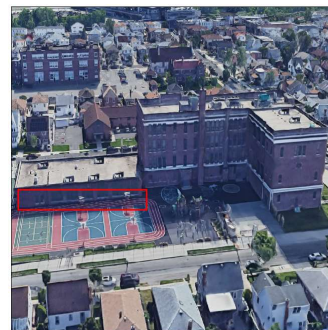
DETERIORATED/TORN-OUT/MISSING

500

REPLACE

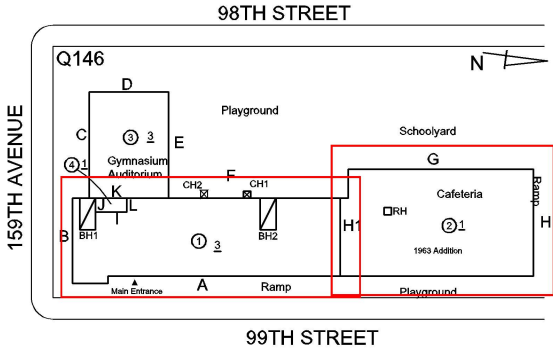
Question	Response
EXTERIOR	
WINDOWS	
EXTERIOR GUARDS	
Deficiency Photo1	 
Violations	Facade G No violations recorded.
LINTELS	Inspected
Condition	2 - Between Good and Fair
Deficiency	No deficiencies recorded
WINDOWS	Inspected
Material Type(s)	Aluminum
Instance on Aluminum - Other: All Facades	Inspected
Instance Condition	4 - Between Fair and Poor
Instance Quantity	12,000
Instance Quantity Uom	S.F.
Are these windows insulated	Yes
Installation Year	1997
Source of Installation	Custodial Staff
Deficiency	ALUMINUM - OTHER: AIR/WATER INFILTRATION
Roof Plan reference

Deficiency Quantity	3,030
Quantity Uom	L.F.
Potential Action	REPLACE TRIM, SILLS OR WEATHERSTRIPPING
Urgency of Action	PRIORITY 5

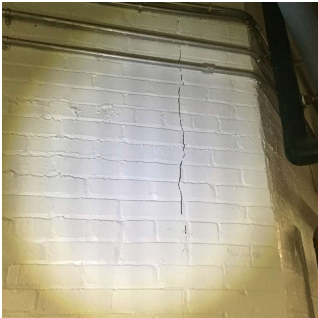
Question	Response
EXTERIOR	
WINDOWS	
WINDOWS	
Purpose of Action	LEVEL 2
Deficiency Photo1	 
Violations	Facade F - Room 314, also Rooms 314B, 308, 214, Facade A - Rooms 313, 311, 309, 307, 305, 303, 213, 209, 205, 201, 107, 109, 115, Facade B - Room 301, Facade G and H - Gymnasium, Room 116, Facade B - Main Office Room 150 No violations recorded.
INTERIOR	
	Inspected
POOLS	
	Does not Exist
STRUCTURAL	
COLUMNS/BEAMS/BEARING WALLS	
Condition	Inspected
Deficiency	3 - Fair
Deficiency Location/Instance	MASONRY BEARING WALL: CRACKED/SPALLED
Deficiency Quantity	Basement - Boiler Room
Quantity Uom	20
Potential Action	S.F.
Urgency of Action	RESTITCH
Purpose of Action	PRIORITY 3
Deficiency Photo1	LEVEL 5

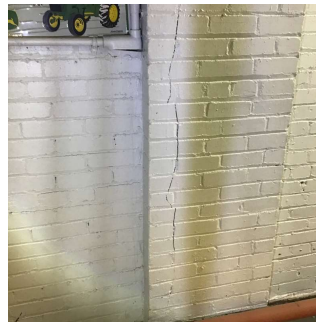
Violations	Basement - Boiler Room No violations recorded.
Deficiency	STEEL COLUMNS/BEAMS: DETERIORATED MASONRY FIREPROOFING
Deficiency Location/Instance	Basement - Boiler Room
Deficiency Quantity	10
Quantity Uom	S.F.
Potential Action	REPLACE

Urgency of Action	PRIORITY 3
Purpose of Action	LEVEL 5

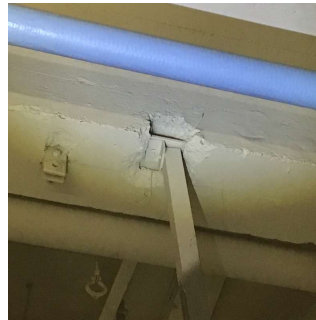
Basement - Boiler Room

STEEL COLUMNS/BEAMS: DETERIORATED CONCRETE FIREPROOFING

REPLACE

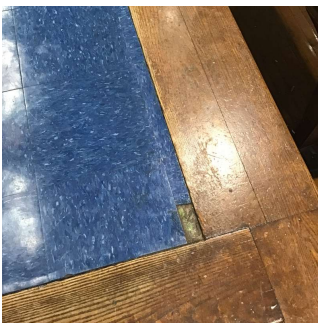
Question	Response
INTERIOR	
AUDITORIUM	
Fixed Seating	
Deficiency Photo1	 
	Seat O/1
Violations	No violations recorded.
Floor Finish	
Instance on 1st Floor (508 seats)	Inspected
Condition	2 - Between Good and Fair
Deficiency	No deficiencies recorded
Sliding-folding Partition	
Instance on 1st Floor (508 seats)	Does not Exist
Stage	
Instance on 1st Floor (508 seats)	Inspected
Stage	
Instance on 1st Floor (508 seats)	Inspected
Condition	2 - Between Good and Fair
Deficiency	DAMAGED FLOOR
Deficiency Location/Instance	Right Side, Left Side
Deficiency Quantity	20
Quantity Uom	S.F.
Potential Action	REPLACE
Urgency of Action	PRIORITY 3
Purpose of Action	LEVEL 2
Deficiency Photo1

Right Side
Violations	No violations recorded.
Stage Curtain Rigging	
Instance on 1st Floor (508 seats)	Inspected
Condition	2 - Between Good and Fair
Deficiency	No deficiencies recorded
Stage Curtains	
Instance on 1st Floor (508 seats)	Inspected
Condition	2 - Between Good and Fair

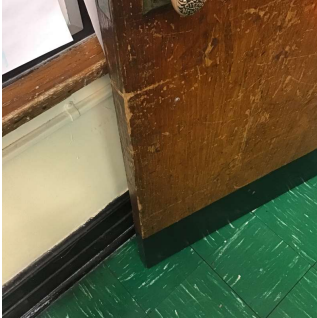
Question	Response
INTERIOR	
CLASSROOMS/CORRIDORS/ADMIN SPACES	
Door(s)	Inspected
Condition	5 - Poor
Deficiency	WOOD: DETERIORATED DOOR
Deficiency Location/Instance	Room 314, 311, B16, B14, B12 and others
Deficiency Quantity	22
Quantity Uom	EACH
Potential Action	MAINTENANCE
Urgency of Action	PRIORITY 3
Purpose of Action	LEVEL 2
Deficiency Photo1

Violations	Room 311 No violations recorded.
Floor Finish	Inspected
Condition	2 - Between Good and Fair
Deficiency	VINYL TILES: DETERIORATED SUBSTRATE
Deficiency Location/Instance	Corridor near room B18, Rooms 201,211 309, 311, 314 and others
Deficiency Quantity	500
Quantity Uom	S.F.
Potential Action	REPLACE
Urgency of Action	PRIORITY 3
Purpose of Action	LEVEL 2
Deficiency Photo1

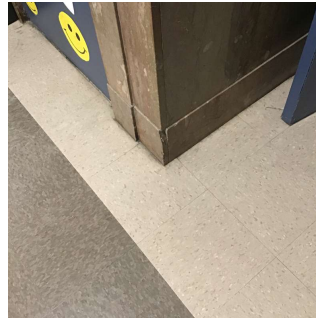
Violations	Corridor near room B18 No violations recorded.
Walls	Inspected
Condition	2 - Between Good and Fair
Deficiency	STONE MOLDINGS: CRACKS/SPALLING
Deficiency Location/Instance	Lobby
Deficiency Quantity	15

Quantity Uom	L.F.
Potential Action	REPLACE
Urgency of Action	PRIORITY 3

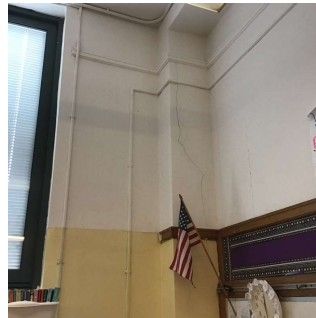
Room 301

PLASTER: CRACKS/SPALLING

REPLACE

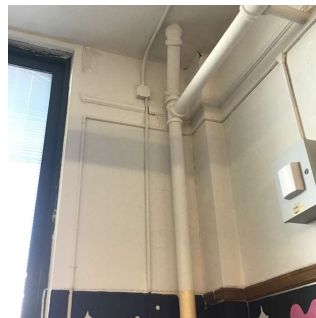
GYPSUM BOARD: DETERIORATED - ACTIVE LEAK

Question	Response
INTERIOR	
CLASSROOMS/CORRIDORS/ADMIN SPACES	
Walls	
Violations	Room 314 No violations recorded.
Deficiency	GLAZED BLOCK: CRACKS/SPALLING
Deficiency Location/Instance	Corridor near rooms B10, B14, B16, B18 311,353 and others
Deficiency Quantity	80
Quantity Uom	S.F.
Potential Action	REPLACE
Urgency of Action	PRIORITY 3
Purpose of Action	LEVEL 2
Deficiency Photo1	 
Violations	Corridor near room B14 No violations recorded.
Specialties	Does not Exist
GYMNASIUM	
Instance on 3rd Floor	Inspected
Ceiling	Inspected
Instance on 3rd Floor	Inspected
Condition	2 - Between Good and Fair
Deficiency	PLASTER: CRACKS/SPALLING - ACTIVE LEAK
Deficiency Location/Instance	Along Windows
Deficiency Quantity	60
Quantity Uom	S.F.
Potential Action	REPLACE
Urgency of Action	PRIORITY 5
Purpose of Action	LEVEL 2
Deficiency Photo1	 
Violations	Along Windows No violations recorded.
Door(s)	
Instance on 3rd Floor	Inspected

REPLACE

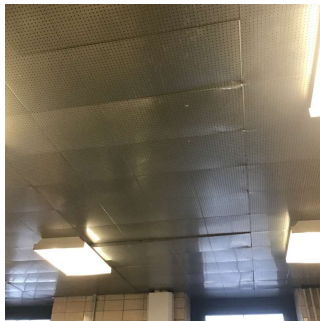
Violations	Stair AB/3 No violations recorded.
KITCHEN	Inspected
Instance on Basement	Inspected
Ceiling	
Instance on Basement	Inspected
Condition	2 - Between Good and Fair
Deficiency	METAL PAN: DAMAGED/MISSING
Deficiency Location/Instance	Near Food Prep
Deficiency Quantity	20
Quantity Uom	S.F.
Potential Action	REPLACE
Urgency of Action	PRIORITY 3
Purpose of Action	LEVEL 2
Deficiency Photo1

Violations	Near Food Prep No violations recorded.
Door(s)	
Instance on Basement	Inspected
Condition	2 - Between Good and Fair
Deficiency	No deficiencies recorded
Floor Finish	
Instance on Basement	Inspected
Condition	2 - Between Good and Fair
Deficiency	CONCRETE: CRACKS
Deficiency Location/Instance	Near Exit 9
Deficiency Quantity	15
Quantity Uom	S.F.
Potential Action	REPLACE
Urgency of Action	PRIORITY 3
Purpose of Action	LEVEL 2

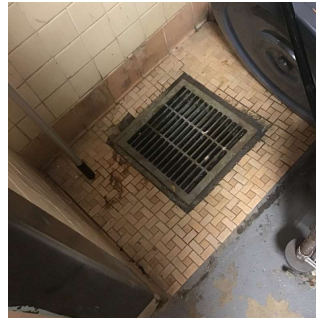
Storage room

CERAMIC TILE: BROKEN/MISSING TILES

REPLACE

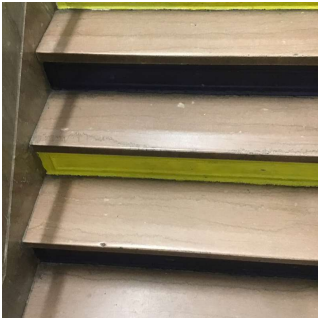
Question	Response
INTERIOR	
LIBRARY	Inspected
Walls	
Deficiency	No deficiencies recorded
LOCKER ROOM	Does not Exist
MULTI-PURPOSE ROOM	Does not Exist
SCIENCE DEMO ROOM	Does not Exist
SCIENCE LAB	Does not Exist
SCIENCE PREP ROOM	Does not Exist
SHOWER ROOM	Does not Exist
STAIRS/RAMPS: INTERIOR	Inspected
Do Letter Stair Signs Exist?	Yes
Ceiling	Inspected
Condition	2 - Between Good and Fair
Deficiency	No deficiencies recorded
Door(s)	Inspected
Condition	2 - Between Good and Fair
Deficiency	No deficiencies recorded
Partition	Inspected
Condition	2 - Between Good and Fair
Deficiency	No deficiencies recorded
Railings	Inspected
Condition	2 - Between Good and Fair
Deficiency	No deficiencies recorded
Stairs and Landings	Inspected
Condition	2 - Between Good and Fair
Deficiency	STONE: BROKEN/MISSING
Deficiency Location/Instance	Lobby
Deficiency Quantity	70
Quantity Uom	S.F.
Potential Action	REPLACE
Urgency of Action	PRIORITY 3
Purpose of Action	LEVEL 2

Lobby	
Violations	No violations recorded.
Walls	Inspected
Condition	2 - Between Good and Fair
Deficiency	PLASTER: CRACKS/SPALLING
Deficiency Location/Instance	Stair D/3, AB/3
Deficiency Quantity	60
Quantity Uom	S.F.

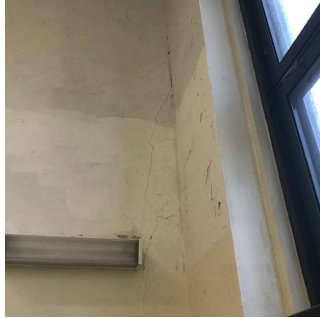
Stair D/3
Violations	No violations recorded.
Deficiency	STONE MOLDINGS: CRACKS/SPALLING
Deficiency Location/Instance	Stair A/B
Deficiency Quantity	10
Quantity Uom	L.F.
Potential Action	REPLACE
Urgency of Action	PRIORITY 3
Purpose of Action	LEVEL 2
Deficiency Photo1

Question	Response
INTERIOR	
STAIRS/RAMPS: INTERIOR	
Walls	
Potential Action	REPLACE
Urgency of Action	PRIORITY 3
Purpose of Action	LEVEL 2
Deficiency Photo1

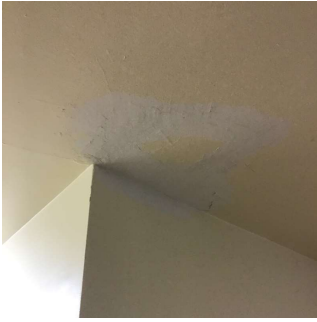
Violations	Room B10 No violations recorded.
Walls	Inspected
Condition	2 - Between Good and Fair
Deficiency	No deficiencies recorded
TOILET ROOMS - STUDENTS	
Ceiling	Inspected
Condition	2 - Between Good and Fair
Deficiency	PLASTER: CRACKS/SPALLING
Deficiency Location/Instance	Room B7, B/1
Deficiency Quantity	20
Quantity Uom	S.F.
Potential Action	REPLACE
Urgency of Action	PRIORITY 3
Purpose of Action	LEVEL 2
Deficiency Photo1

Violations	Room B7 No violations recorded.
Door(s)	Inspected
Condition	5 - Poor
Deficiency	METAL: DETERIORATED DOOR
Deficiency Location/Instance	Room B7, B1
Deficiency Quantity	2
Quantity Uom	EACH
Potential Action	MAINTENANCE
Urgency of Action	PRIORITY 3
Purpose of Action	LEVEL 2

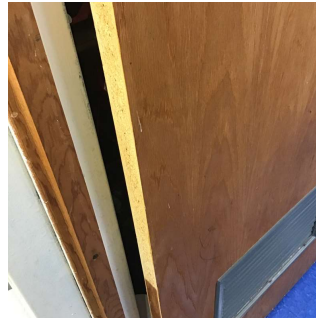
Room B18

WOOD: DETERIORATED DOOR

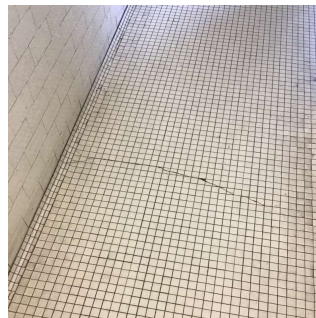
CERAMIC TILE: DETERIORATED SUBSTRATE

Question	Response
INTERIOR	
TOILET ROOMS - STUDENTS	
Floor Finish	Inspected
	Room 357
Violations	No violations recorded.
Stalls	Inspected
Condition	5 - Poor
Deficiency	RUST - MAJOR
Deficiency Location/Instance	Rooms 357, 253, B1
Deficiency Quantity	8
Quantity Uom	EACH
Potential Action	REPLACE
Urgency of Action	PRIORITY 3
Purpose of Action	LEVEL 2
Deficiency Photo1

REPLACE

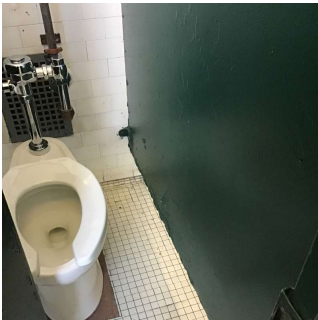
Room 357
Violations	No violations recorded.
Walls	Inspected
Condition	2 - Between Good and Fair
Deficiency	CERAMIC TILE: BROKEN/ MISSING
Deficiency Location/Instance	Rooms B1, B7, 357
Deficiency Quantity	30
Quantity Uom	S.F.
Potential Action	REPLACE
Urgency of Action	PRIORITY 3
Purpose of Action	LEVEL 2
Deficiency Photo1

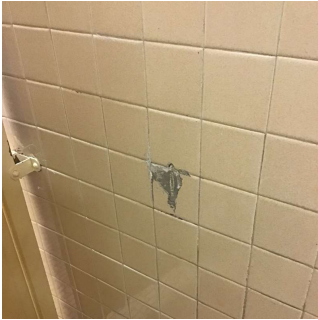
Room B1
Violations	No violations recorded.
LIFE SAFETY	Inspected
F.D. HOLDING AREA	Does not Exist
STEEL STAIRS	Does not Exist
SITE	Inspected

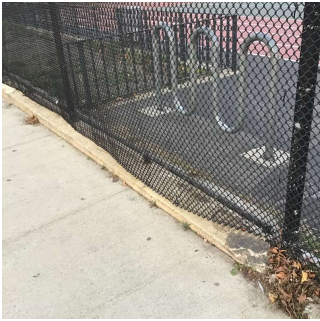
Question	Response
SITE	
Drainage System for Concrete	Inspected
Culverts - Concrete Covering	Inspected
Deficiency	No deficiencies recorded
Drainage System for Soil	Inspected
Catch Basins/Manhole - Surrounded by Soil	Does not Exist
Culverts - Soil Covering	Inspected
Condition	2 - Between Good and Fair
Deficiency	No deficiencies recorded
DRINKING FOUNTAINS	
Condition	5 - Poor
Deficiency	INOPERABLE
Deficiency Location/Instance	Schoolyard
Deficiency Quantity	1
Quantity Uom	EACH
Potential Action	MAINTENANCE
Urgency of Action	PRIORITY 3
Purpose of Action	LEVEL 2
Deficiency Photo1	No photo recorded
Violations	No violations recorded.
FENCES	
Condition	4 - Between Fair and Poor
Deficiency	CHAIN LINK: DAMAGED/DETERIORATED
Deficiency Location/Instance	98th Street
Deficiency Quantity	300
Quantity Uom	S.F.
Potential Action	REPLACE
Urgency of Action	PRIORITY 3
Purpose of Action	LEVEL 2
Deficiency Photo1

Violations	98th Street No violations recorded.

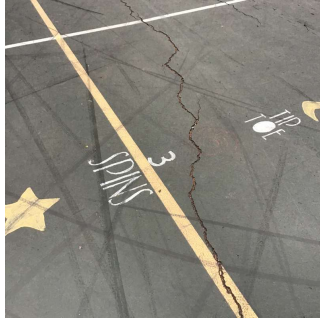
Question	Response
SITE	
FENCES	
Deficiency Photo1	 
Violations	99th Street No violations recorded.
Deficiency	WROUGHT IRON: DAMAGED/DETERIORATED
Deficiency Location/Instance	99th Street, 159th Street, 98th Street
Deficiency Quantity	280
Quantity Uom	S.F.
Potential Action	REPLACE
Urgency of Action	PRIORITY 3
Purpose of Action	LEVEL 2
Deficiency Photo1	 
Violations	99th Street No violations recorded.
IRRIGATION SYSTEM	Does not Exist
PAVING	Inspected
Student Non-Use	Inspected
Gravel Exists?	No
Asphalt	Does not Exist
Concrete	Inspected
Condition	2 - Between Good and Fair
Deficiency	No deficiencies recorded
Pavers	Does not Exist
Student Use	Inspected
Gravel Exists?	Yes
Asphalt	Inspected
Condition	4 - Between Fair and Poor
Deficiency	CRACKS - MAJOR
Deficiency Location/Instance	Schoolyard
Deficiency Quantity	1,000
Quantity Uom	S.F.
Potential Action	REPLACE

Question	Response
SITE	
PAVING	
Student Use	
Asphalt	
Urgency of Action	PRIORITY 3
Purpose of Action	LEVEL 2
Deficiency Photo1

Violations	Schoolyard No violations recorded.
Concrete	Inspected
Condition	3 - Fair
Deficiency	CRACKS - MAJOR
Deficiency Location/Instance	Schoolyard
Deficiency Quantity	50
Quantity Uom	S.F.
Potential Action	REPLACE
Urgency of Action	PRIORITY 3
Purpose of Action	LEVEL 2
Deficiency Photo1

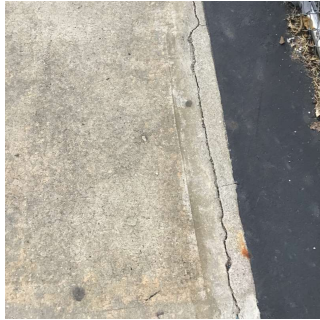
Violations	Schoolyard No violations recorded.
Pavers	Inspected
Condition	2 - Between Good and Fair
Deficiency	No deficiencies recorded
Site Sidewalks & Walkways	Inspected
Asphalt	Inspected
Condition	2 - Between Good and Fair
Deficiency	No deficiencies recorded
Concrete	Inspected
Condition	2 - Between Good and Fair
Deficiency	No deficiencies recorded
Pavers	Does not Exist
DOT Sidewalk	Inspected
Asphalt	Does not Exist

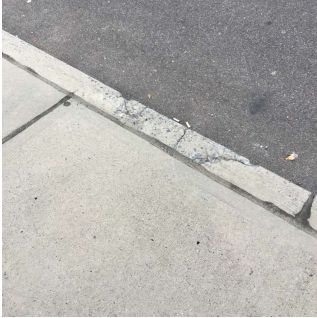
Question	Response
SITE	
PAVING	
DOT Sidewalk	
Concrete	Inspected
Condition	4 - Between Fair and Poor
Deficiency	DAMAGED CURBS
Deficiency Location/Instance	99th Street
Deficiency Quantity	40
Quantity Uom	L.F.
Potential Action	REPLACE
Urgency of Action	PRIORITY 3
Purpose of Action	LEVEL 2
Deficiency Photo1

Violations	99th Street No violations recorded.
Deficiency	DAMAGED/DETERIORATED/MISSING SECTIONS
Deficiency Location/Instance	99th Street, 159th Street, 98th Street
Deficiency Quantity	600
Quantity Uom	S.F.
Potential Action	REPLACE
Urgency of Action	PRIORITY 3
Purpose of Action	LEVEL 2
Deficiency Photo1

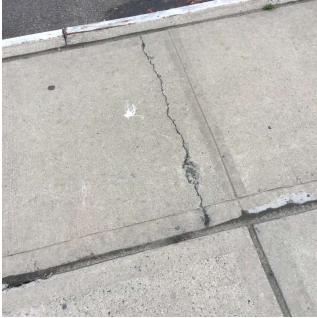
Violations	99th Street No violations recorded.
Pavers	Does not Exist
PLAYGROUNDS	Inspected
Instance on 99th Street	Inspected
Instance on Schoolyard	Inspected
Benches	
Instance on 99th Street	Does not Exist
Instance on Schoolyard	Inspected
Condition	1 - Good
Deficiency	No deficiencies recorded

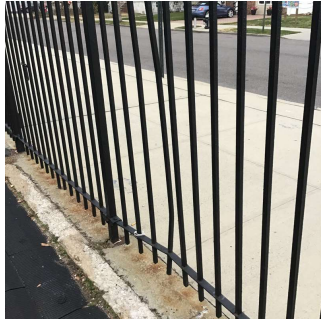
99th Street
 No violations recorded.

Instance on 99th Street	Inspected
Condition	3 - Fair
Deficiency	WROUGHT IRON: DAMAGED/DETERIORATED
Deficiency Location/Instance	99th Street
Deficiency Quantity	160
Quantity Uom	S.F.
Potential Action	REPLACE
Urgency of Action	PRIORITY 3
Purpose of Action	LEVEL 2
Deficiency Photo1

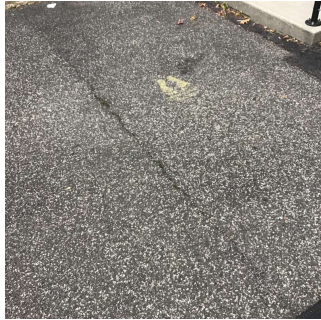
99th Street
 No violations recorded.

Instance on 99th Street	Inspected
Condition	3 - Fair
Deficiency	ASPHALT: CRACKS - MAJOR
Deficiency Location/Instance	99th Street
Deficiency Quantity	100
Quantity Uom	S.F.
Potential Action	REPLACE
Urgency of Action	PRIORITY 3
Purpose of Action	LEVEL 2
Deficiency Photo1

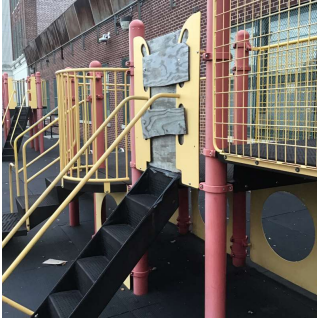
Instance on 99th Street	Inspected
Condition	5 - Poor
Deficiency	BROKEN/DETERIORATED/MISSING
Deficiency Location/Instance	99th Street
Deficiency Quantity	1

Question	Response
SITE	
PLAYGROUNDS	
Play Equipment	
Quantity Uom	EACH
Potential Action	REPLACE
Urgency of Action	PRIORITY 3
Purpose of Action	LEVEL 2
Deficiency Photo1

99th Street
Violations	No violations recorded.
Safety Surfacing	
Instance on Schoolyard	Inspected
Condition	2 - Between Good and Fair
Deficiency	DETERIORATED/MISSING
Deficiency Location/Instance	Center
Deficiency Quantity	20
Quantity Uom	S.F.
Potential Action	REPLACE
Urgency of Action	PRIORITY 3
Purpose of Action	LEVEL 2
Deficiency Photo1

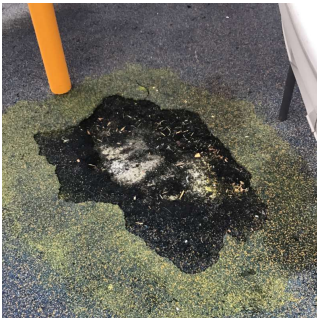
Center
Violations	No violations recorded.
Unpaved Area	
Instance on Schoolyard	Inspected
Condition	2 - Between Good and Fair
Deficiency	No deficiencies recorded
Instance on 99th Street	Does not Exist
PLAYING SURFACE	
	Does not Exist
RETAINING WALLS	
Are there any Retaining Walls 6' OR higher facing public street/sidewalk?	Inspected
	No
Condition	3 - Fair
Deficiency	CAST IN PLACE CONCRETE: CRACKS/SPALLING - MAJOR
