**NYC Department of Education**  
**Building Condition Assessment Survey 2023 - 2024**

Architectural Inspection

Q147

**Asset:** P.S. 147 - QUEENS, 218-01 116 AVENUE, New York, 11411

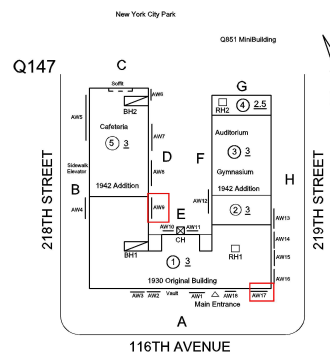
Question	Response
<b>Architectural</b>	
<b>EXTERIOR</b>	Inspected
<b>AREAWAY</b>	Inspected
Instance on AW1-AW18	Inspected
Instance Condition	3 - Fair
Instance Quantity	18
Instance Quantity Uom	EACH
Deficiency	AREAWAY WALLS: CRACKS AND SPALLING
Roof Plan reference

Question	Response
<b>EXTERIOR</b>	
<b>AREAWAY</b>	
Quantity Uom	S.F.
Potential Action	REPAIR
Urgency of Action	PRIORITY 3
Purpose of Action	LEVEL 2
Deficiency Photo1

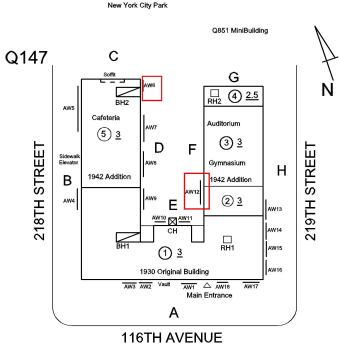
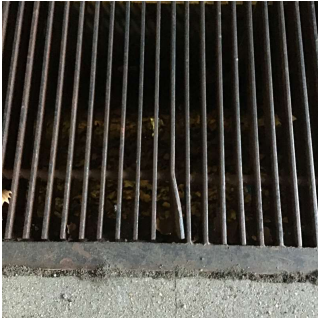
Violations	Facade D - AW6 No violations recorded.
<b>AWNINGS AND CANOPIES</b>	Does not Exist
<b>CHIMNEY</b>	Inspected
Material Type(s)	Masonry
Condition	3 - Fair
Deficiency	BRICK: DETERIORATED JOINTS

Violations	Facade D - AW9 No violations recorded.
Deficiency	AREAWAY GRATINGS: MAJOR RUSTING / OR BROKEN
Roof Plan reference

Deficiency Quantity	50
Quantity Uom	S.F.
Potential Action	REPLACE
Urgency of Action	PRIORITY 4
Purpose of Action	LEVEL 2
Deficiency Photo1

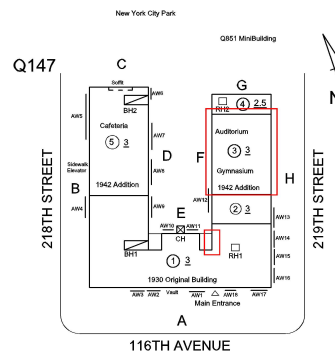
CAST STONE: DETERIORATED TRANSVERSE JOINTS

50  
L.F.  
MAINTENANCE  
PRIORITY 3  
LEVEL 2

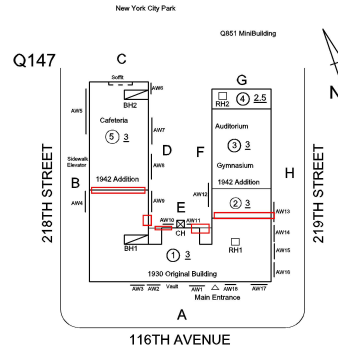
**CAST STONE: CRACKED/BROKEN PIECES**

REPLACE-IN-KIND

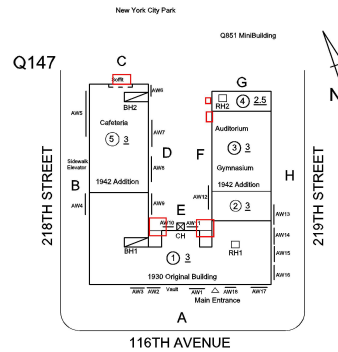
METAL CLAD: DETERIORATED DOOR AND FRAME - MAJOR DETERIORATION

10  
EACH  
REPLACE  
PRIORITY 4  
LEVEL 2

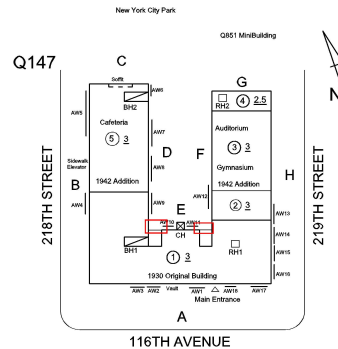
STEEL: MAJOR RUSTING

20  
L.F.  
REPLACE  
PRIORITY 4  
LEVEL 2

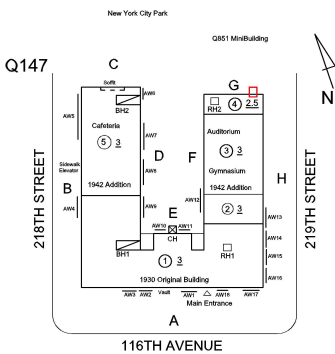
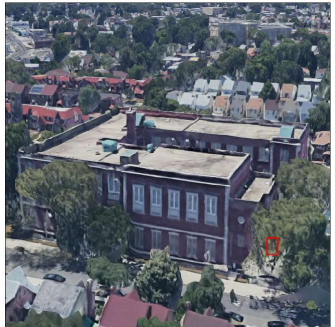
Violations	Facade E No violations recorded.
<b>TRANSOM/SIDE LIGHT</b>	Does not Exist
<b>EXTERIOR WALLS</b>	Inspected
Material Type(s)	Masonry
Replacement Quantity	14,000
Replacement Uom	S.F.
Instance on All Facades	Inspected
Instance Condition	3 - Fair
Instance Quantity	14,000
Instance Quantity Uom	S.F.
Deficiency	STONE: CHIPPED/SPALLED/BROKEN PIECES - MINOR
Roof Plan reference

Deficiency Quantity	10
Quantity Uom	S.F.
Potential Action	REPAIR
Urgency of Action	PRIORITY 3
Purpose of Action	LEVEL 2

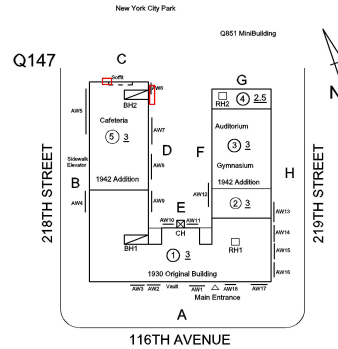
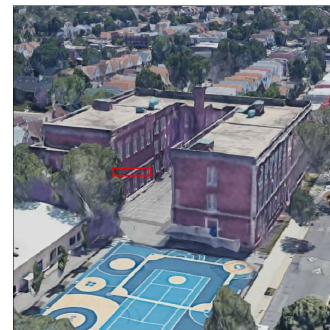
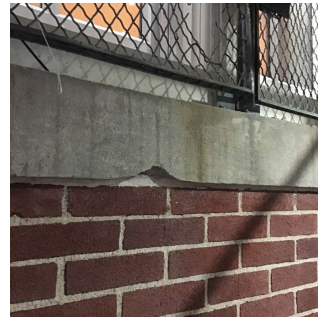
Facade F

**BRICK: DETERIORATED MASONRY SILLS - MAJOR**

REMOVE AND REPLACE

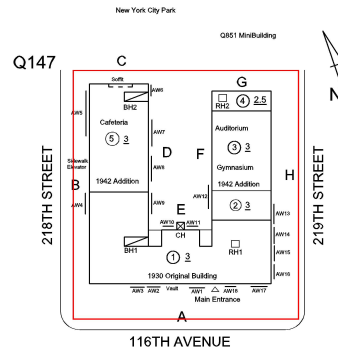
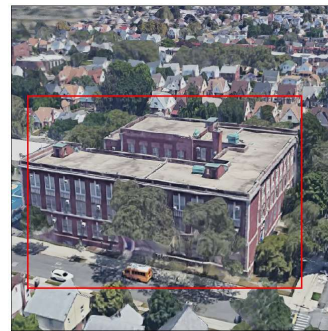
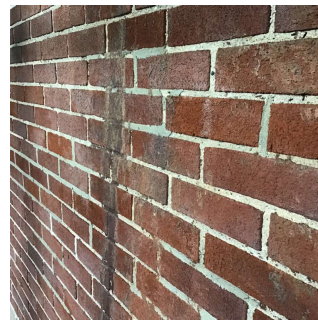
Facade C

**BRICK: DETERIORATED JOINTS**

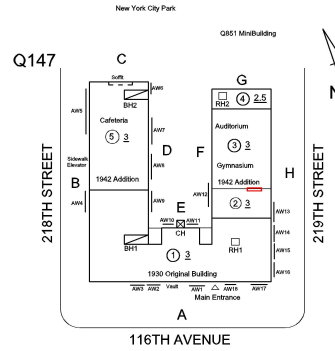
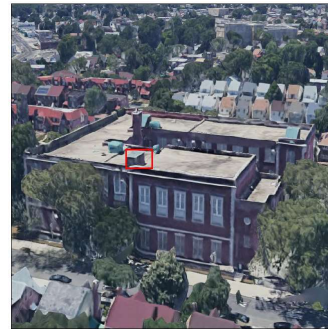
BROKEN/ DENTED BLADES

REPLACE

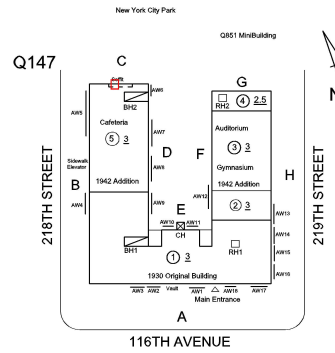
BRICK: MINOR CRACKS, SPALLING

REPAIR

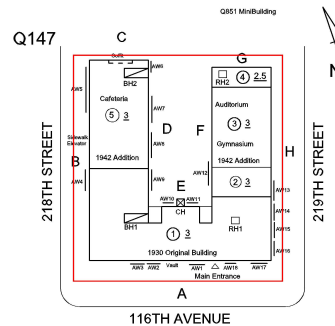
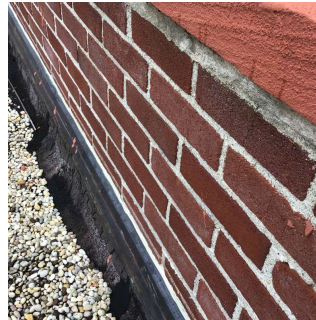
Roof 1

**BRICK: DETERIORATED JOINTS**

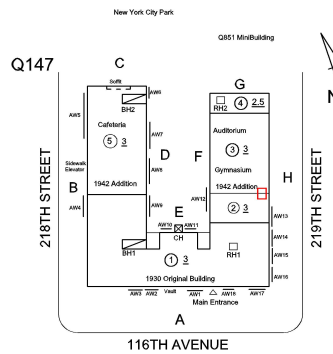
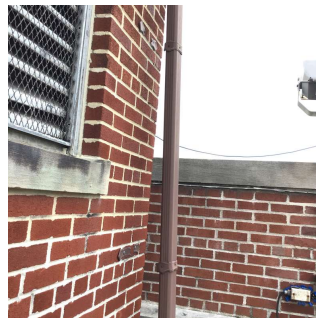
Roof 2

DAMAGED/MISSING

REPLACE

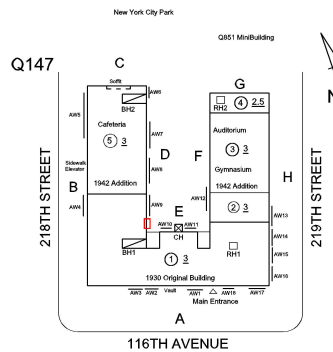
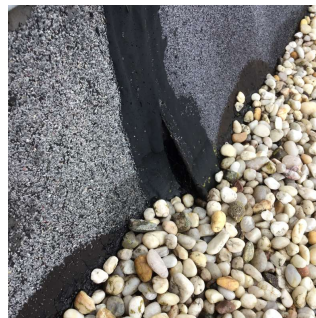
BUILT-UP: FLASHING: BASE FLASHING DETERIORATED

REMOVE AND REPLACE

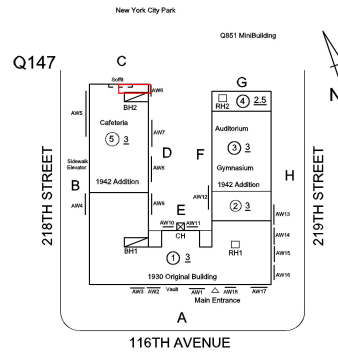
**BUILT-UP: FLASHING: CAP FLASHING MISSING**

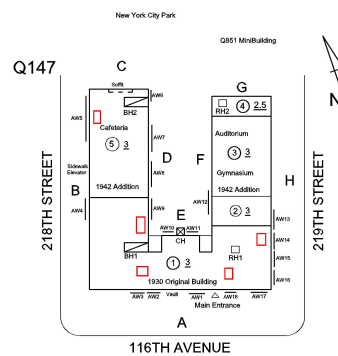
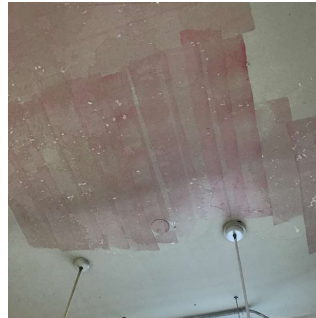
**BUILT-UP: ROOFING: MAJOR ACTIVE ROOF LEAKS IN INSTRUCTIONAL SPACE**

Roof 1 - Room 315, also Rooms 307, 305, 364, Corridor near the Gymnasium, Roof 5 - Rooms 325, 325A

REPLACE ROOFING WITHOUT MAJOR EQUIPMENT REMOVAL

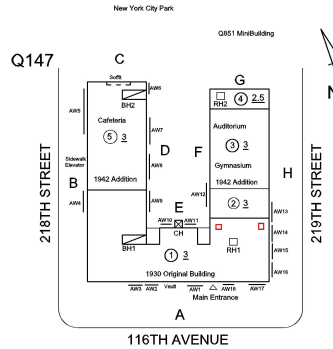
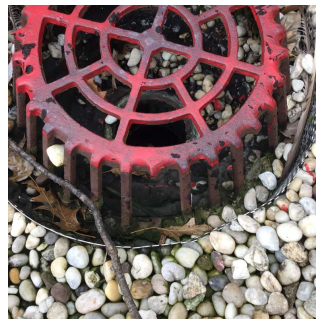
Roof 1

**DETERIORATED**

REPLACE

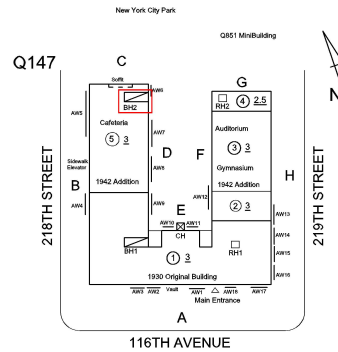
**BULKHEAD/PENTHOUSE WALLS/INTERIOR: GLAZED BLOCK DETERIORATED JOINTS**

30  
S.F.  
REPOINT  
PRIORITY 3  
LEVEL 2

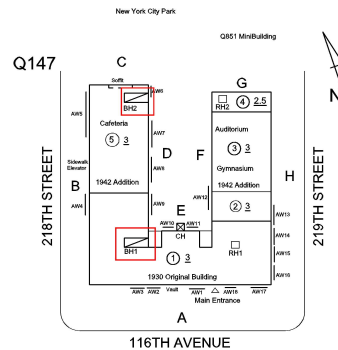
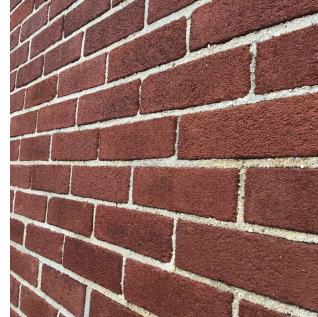
Roof 1 - Bulkhead 1

**BULKHEAD/PENTHOUSE WALLS/EXTERIOR: DETERIORATED JOINTS**

200  
S.F.  
REPOINT  
PRIORITY 3  
LEVEL 2

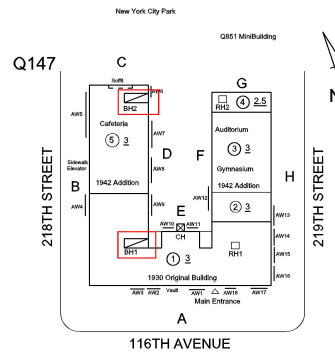
**BULKHEAD/PENTHOUSE WINDOWS: DAMAGED, DETERIORATED WINDOWS**

REPLACE

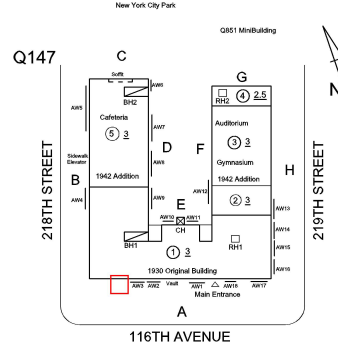
STONE: DETERIORATED JOINTS AT COPING STONES

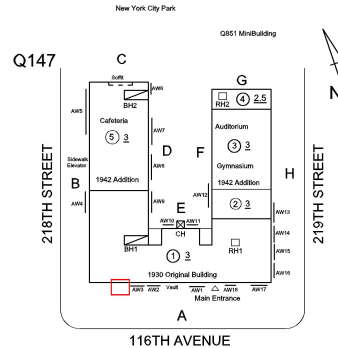
RUST - MAJOR

REPLACE

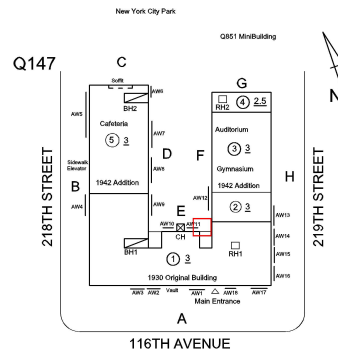
**CONCRETE: CRACKS/SPALLING - MINOR**

REPAIR

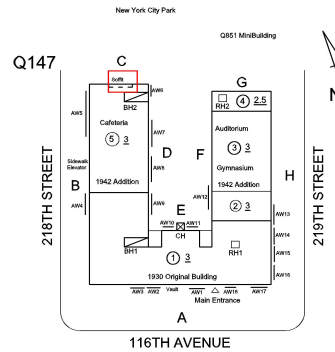
**STONE: DETERIORATED JOINTS**

20  
L.F.  
REPOINT  
PRIORITY 4  
LEVEL 2

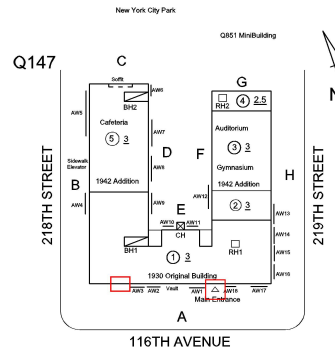
**STONE: DETERIORATED SUBSTRATE**

50  
S.F.  
REPLACE SUBSTRATE AND RESET  
PRIORITY 4  
LEVEL 2

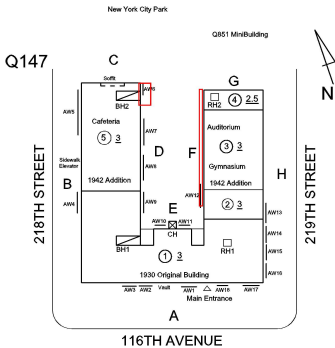
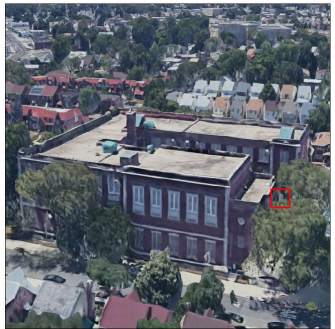
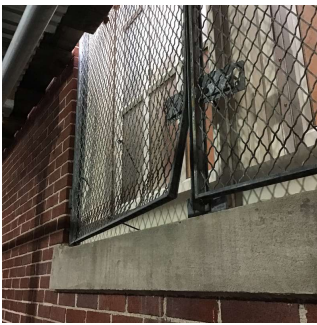
Violations	Facade A No violations recorded.
<b>WINDOWS</b>	Inspected
Replacement Quantity	14,060
Replacement Uom	S.F.
<b>EXTERIOR GUARDS</b>	Inspected
Condition	4 - Between Fair and Poor
Deficiency	DETERIORATED/TORN-OUT/MISSING
Roof Plan reference

Deficiency Quantity	200
Quantity Uom	S.F.
Potential Action	REPLACE
Urgency of Action	PRIORITY 4
Purpose of Action	LEVEL 2

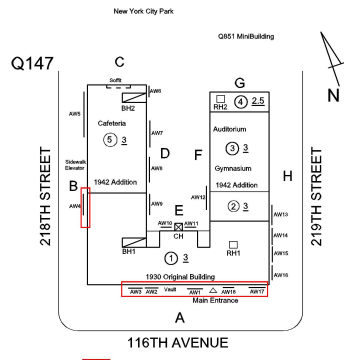
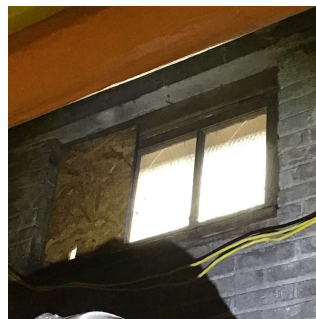
Basement - Facade A and B  
No violations recorded.

Purpose of Action	LEVEL 2
Deficiency Photo1	No photo recorded
Violations	No violations recorded.
Instance on Wood: Facades A, B	Inspected
Instance Condition	5 - Poor
Instance Quantity	60
Instance Quantity Uom	S.F.
Are these windows insulated	No
Installation Year	1930
Source of Installation	Custodial Staff
Deficiency	WOOD: DETERIORATED
Roof Plan reference

Deficiency Quantity	60
Quantity Uom	S.F.
Potential Action	REPLACE WINDOW
Urgency of Action	PRIORITY 5
Purpose of Action	LEVEL 2
Deficiency Photo1

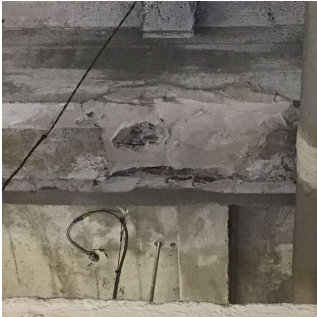
Question	Response
<b>INTERIOR</b>	
<b>POOLS</b>	Does not Exist
<b>STRUCTURAL</b>	Inspected
<b>COLUMNS/BEAMS/BEARING WALLS</b>	Inspected
Condition	3 - Fair
Deficiency	STEEL COLUMNS/BEAMS: DETERIORATED CONCRETE FIREPROOFING
Deficiency Location/Instance	Basement - Fan Area
Deficiency Quantity	30
Quantity Uom	S.F.
Potential Action	REPLACE
Urgency of Action	PRIORITY 3
Purpose of Action	LEVEL 5
Deficiency Photo1

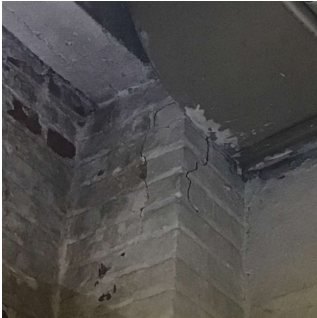
Basement - Fan Area
Violations	No violations recorded.
Deficiency	STEEL COLUMNS/BEAMS: DETERIORATED MASONRY FIREPROOFING
Deficiency Location/Instance	Basement - Storage
Deficiency Quantity	10
Quantity Uom	S.F.
Potential Action	REPLACE
Urgency of Action	PRIORITY 3
Purpose of Action	LEVEL 5
Deficiency Photo1

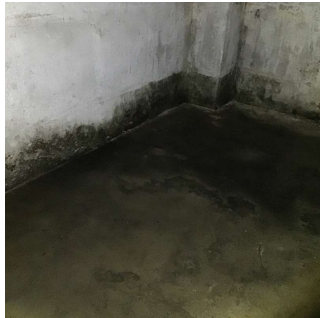
Basement - Boiler Room
Violations	No violations recorded.
<b>FOUNDATION WALLS</b>	
	Inspected
Material Type(s)	Concrete
Condition	4 - Between Fair and Poor
Deficiency	CONCRETE: WATER INFILTRATION IN NON- INSTRUCTIONAL SPACE
Deficiency Location/Instance	Basement - Storage
Deficiency Quantity	100
Quantity Uom	S.F.
Potential Action	INSTALL WATERPROOFING
Urgency of Action	PRIORITY 5
Purpose of Action	LEVEL 5
Deficiency Photo1

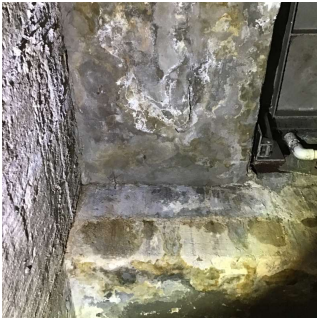
Deficiency	CONCRETE: WATER INFILTRATION IN NON- INSTRUCTIONAL SPACE
Deficiency Location/Instance	Basement - Ash Hoist Vault
Deficiency Quantity	100

Question	Response
<b>INTERIOR</b>	
<b>STRUCTURAL</b>	
<b>VAULTS-BUNKERS</b>	
<b>Slab Structure</b>	
Quantity Uom	S.F.
Potential Action	INSTALL WATERPROOFING
Urgency of Action	PRIORITY 5
Purpose of Action	LEVEL 5
Deficiency Photo1

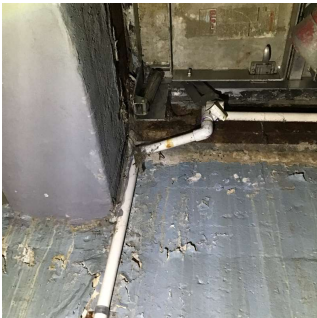
Violations	Basement - Ash Hoist Vault No violations recorded.
<b>Vault/Ash Hoist Doors and Framing</b>	Inspected
Condition	5 - Poor
Deficiency	WATER INFILTRATION
Deficiency Location/Instance	Basement - Ash Hoist Vault
Deficiency Quantity	10
Quantity Uom	S.F.
Potential Action	REPAIR
Urgency of Action	PRIORITY 5
Purpose of Action	LEVEL 2
Deficiency Photo1

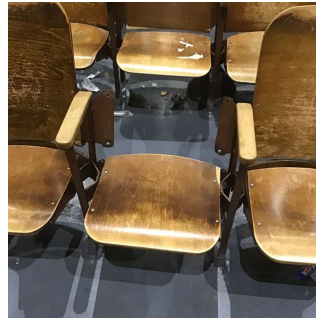
Seat B112

DAMAGED/BROKEN/INOPERABLE

REPLACE

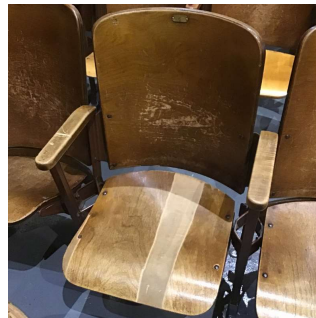
Seat B/6

DAMAGED/BROKEN/INOPERABLE

REPLACE

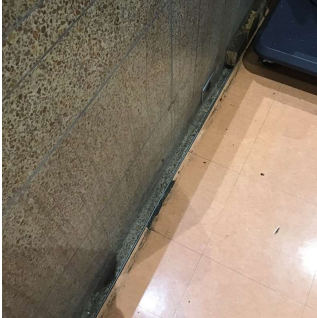
Question	Response
<b>INTERIOR</b>	
<b>AUDITORIUM</b>	
<b>Floor Finish</b>	
Instance on 1st Floor (532)	Inspected
Condition	2 - Between Good and Fair
Deficiency	VINYL TILES: BROKEN/DETERIORATED/MISSING TILES
Deficiency Location/Instance	Along Front of Stage
Deficiency Quantity	20
Quantity Uom	S.F.
Potential Action	REPLACE
Urgency of Action	PRIORITY 3
Purpose of Action	LEVEL 2
Deficiency Photo1

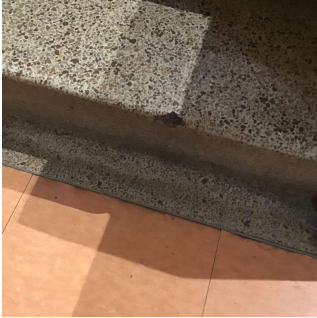
Violations	Along Front of Stage No violations recorded.
<b>Sliding-folding Partition</b>	
Instance on 1st Floor (532)	Does not Exist
<b>Stage</b>	
Instance on 1st Floor (532)	Inspected
<b>Stage</b>	
Instance on 1st Floor (532)	Inspected
Condition	2 - Between Good and Fair
Deficiency	DAMAGED STEPS
Deficiency Location/Instance	Right Side
Deficiency Quantity	10
Quantity Uom	S.F.
Potential Action	REPLACE
Urgency of Action	PRIORITY 3
Purpose of Action	LEVEL 2
Deficiency Photo1

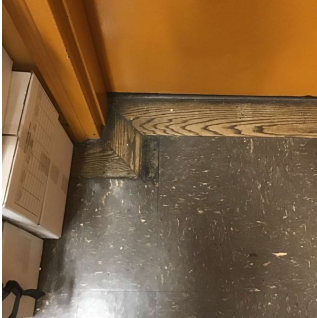
Violations	Right Side No violations recorded.
Deficiency	DAMAGED FLOOR

Question	Response
<b>INTERIOR</b>	
<b>AUDITORIUM</b>	
<b>Stage</b>	
<b>Stage</b>	
Deficiency Quantity	10
Quantity Uom	S.F.
Potential Action	REPLACE
Urgency of Action	PRIORITY 3
Purpose of Action	LEVEL 2
Deficiency Photo1

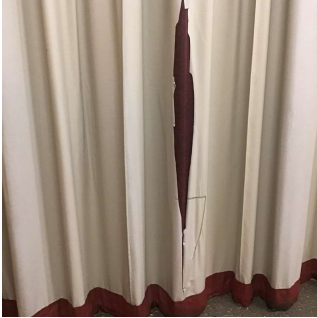
Violations	Left side No violations recorded.
<b>Stage Curtain Rigging</b>	Inspected
Instance on 1st Floor (532)	Inspected
Condition	2 - Between Good and Fair
Deficiency	No deficiencies recorded
<b>Stage Curtains</b>	Inspected
Instance on 1st Floor (532)	Inspected
Condition	3 - Fair
Deficiency	WORN/DETERIORATED
Deficiency Location/Instance	Left Side
Deficiency Quantity	100
Quantity Uom	S.F.
Potential Action	REPLACE
Urgency of Action	PRIORITY 3
Purpose of Action	LEVEL 2
Deficiency Photo1

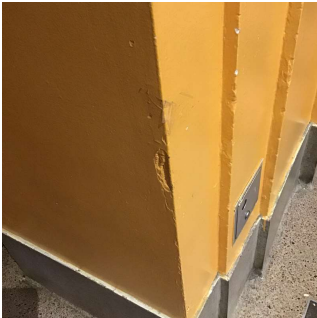
Violations	Left Side No violations recorded.
<b>Walls</b>	
Instance on 1st Floor (532)	Inspected
Condition	2 - Between Good and Fair
Deficiency	PLASTER: CRACKS/SPALLING
Deficiency Location/Instance	Left Side, Ride Sides

Question	Response
<b>INTERIOR</b>	
<b>AUDITORIUM</b>	
<b>Walls</b>	
Deficiency Quantity	20
Quantity Uom	S.F.
Potential Action	REPLACE
Urgency of Action	PRIORITY 3
Purpose of Action	LEVEL 2
Deficiency Photo1

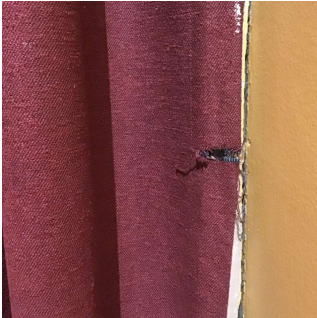
Left Side
Violations	No violations recorded.
<b>Window Curtains/Shades/Blinds</b>	
Instance on 1st Floor (532)	Inspected
Condition	3 - Fair
Deficiency	WORN/DAMAGED CURTAINS
Deficiency Location/Instance	Rear left side
Deficiency Quantity	100
Quantity Uom	S.F.
Potential Action	MAINTENANCE
Urgency of Action	PRIORITY 3
Purpose of Action	LEVEL 2
Deficiency Photo1

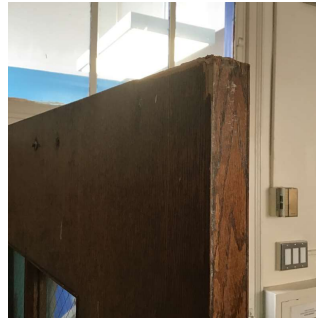
Room 327

WOOD: DETERIORATED DOOR

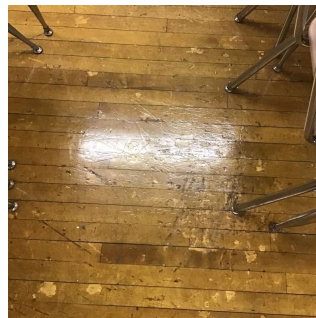
WOOD: DAMAGED/DETERIORATED

REPLACE

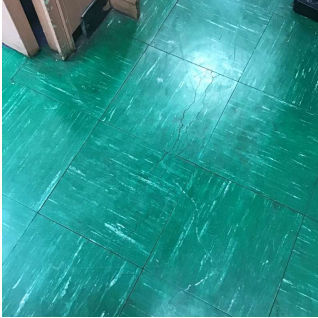
Main Entrance
Violations	No violations recorded.
<b>Fixed Equipment</b>	
Instance on 3rd Floor	Inspected
Condition	2 - Between Good and Fair
Deficiency	No deficiencies recorded
<b>Floor Finish</b>	
Instance on 3rd Floor	Inspected
Condition	2 - Between Good and Fair
Deficiency	VINYL TILES: DETERIORATED SUBSTRATE
Deficiency Location/Instance	Office
Deficiency Quantity	20
Quantity Uom	S.F.
Potential Action	REPLACE
Urgency of Action	PRIORITY 3
Purpose of Action	LEVEL 2
Deficiency Photo1

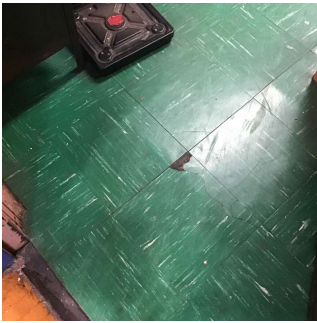
Office
Violations	No violations recorded.
Deficiency	VINYL TILES: BROKEN/DETERIORATED/MISSING TILES
Deficiency Location/Instance	Office
Deficiency Quantity	10
Quantity Uom	S.F.
Potential Action	REPLACE
Urgency of Action	PRIORITY 3
Purpose of Action	LEVEL 2

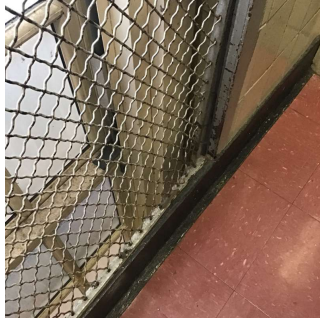
Office
Violations	No violations recorded.
<b>Window Curtains/Shades/Blinds</b>	
Instance on 3rd Floor	Does not Exist
<b>INTERIOR DOOR HARDWARE</b>	
Condition	Inspected
Deficiency	3 - Fair
	No deficiencies recorded
<b>INTERIOR GUARDS</b>	
Condition	Inspected
Deficiency	2 - Between Good and Fair
Deficiency Location/Instance	DETERIORATED/TORN-OUT/MISSING
Deficiency Quantity	Stair E/1
Quantity Uom	20
Potential Action	S.F.
Urgency of Action	REPLACE
Purpose of Action	PRIORITY 3
Deficiency Photo1	LEVEL 2

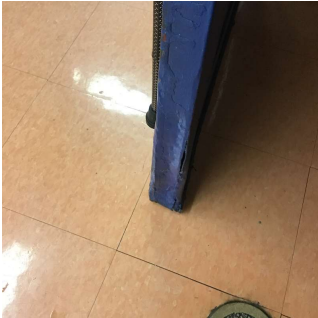
Stair E/1
Violations	No violations recorded.
<b>KITCHEN</b>	
Instance on Basement	Inspected
	Inspected
<b>Ceiling</b>	
Instance on Basement	Inspected
Condition	2 - Between Good and Fair
Deficiency	No deficiencies recorded
<b>Door(s)</b>	
Instance on Basement	Inspected
Condition	3 - Fair
Deficiency	METAL: DETERIORATED DOOR
Deficiency Location/Instance	Entrance

Question	Response
<b>INTERIOR</b>	
<b>KITCHEN</b>	
<b>Door(s)</b>	
Deficiency Quantity	1
Quantity Uom	EACH
Potential Action	MAINTENANCE
Urgency of Action	PRIORITY 3
Purpose of Action	LEVEL 2
Deficiency Photo1

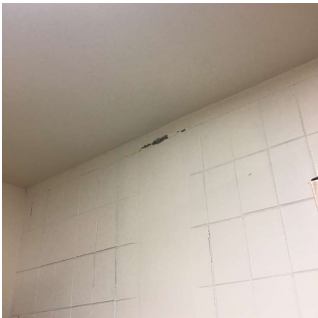
Instance on Basement	Inspected
Condition	3 - Fair
Deficiency	GLAZED BLOCK: CRACKS/SPALLING
Deficiency Location/Instance	Storage Room
Deficiency Quantity	20
Quantity Uom	S.F.
Potential Action	REPLACE
Urgency of Action	PRIORITY 3
Purpose of Action	LEVEL 2
Deficiency Photo1

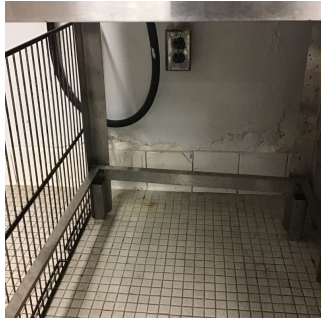
Question	Response
<b>INTERIOR</b>	
<b>KITCHEN</b>	
<b>Walls</b>	
Violations	Storage Room No violations recorded.
Deficiency	PLASTER: CRACKS/SPALLING
Deficiency Location/Instance	Left Side, Center
Deficiency Quantity	30
Quantity Uom	S.F.
Potential Action	REPLACE
Urgency of Action	PRIORITY 3
Purpose of Action	LEVEL 2
Deficiency Photo1

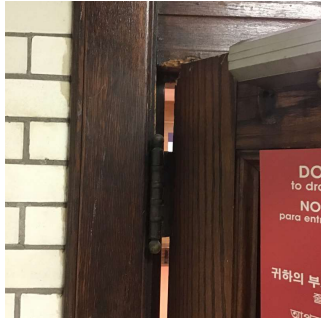
Question	Response
<b>INTERIOR</b>	
<b>MULTI-PURPOSE ROOM</b>	
<b>Door(s)</b>	
Deficiency	WOOD: DETERIORATED DOOR AND FRAME
Deficiency Location/Instance	Exit 2, Main Entrance
Deficiency Quantity	4
Quantity Uom	EACH
Potential Action	MAINTENANCE
Urgency of Action	PRIORITY 3
Purpose of Action	LEVEL 2
Deficiency Photo1

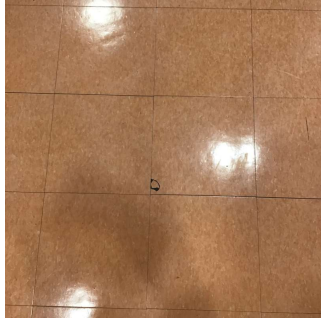
Violations	Exit 2 No violations recorded.
<b>Fixed Equipment</b>	
Instance on 1st Floor	Inspected
Condition	2 - Between Good and Fair
Deficiency	No deficiencies recorded
<b>Floor Finish</b>	
Instance on 1st Floor	Inspected
Condition	2 - Between Good and Fair
Deficiency	VINYL TILES: BROKEN/DETERIORATED/MISSING TILES
Deficiency Location/Instance	Center
Deficiency Quantity	10
Quantity Uom	S.F.
Potential Action	REPLACE
Urgency of Action	PRIORITY 3
Purpose of Action	LEVEL 2
Deficiency Photo1

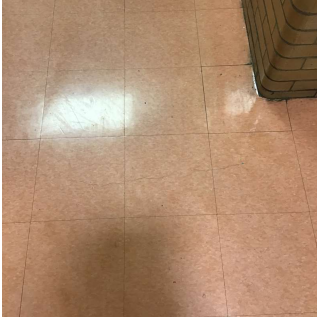
Violations	Center No violations recorded.
Deficiency	VINYL TILES: DETERIORATED SUBSTRATE
Deficiency Location/Instance	Near Stair C/D

Question	Response
<b>INTERIOR</b>	
<b>MULTI-PURPOSE ROOM</b>	
<b>Floor Finish</b>	
Potential Action	REPLACE
Urgency of Action	PRIORITY 3
Purpose of Action	LEVEL 2
Deficiency Photo1

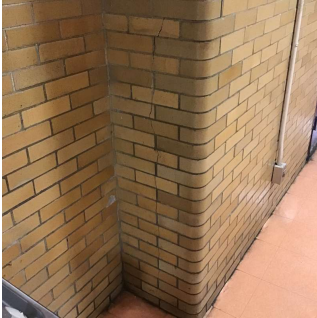
Near Drinking Fountain
Violations	No violations recorded.
<b>Window Curtains/Shades/Blinds</b>	
Instance on 1st Floor	Does not Exist
<b>SCIENCE DEMO ROOM</b>	
	Does not Exist
<b>SCIENCE LAB</b>	
Instance on Room 324	Inspected
Alternative use	No
<b>Fixed Equipment</b>

Near Stair C/D
Violations	No violations recorded.
<b>Sliding-folding Partition</b>	
Instance on 1st Floor	Does not Exist
<b>Stage</b>	
Instance on 1st Floor	Does not Exist
<b>Walls</b>	
Instance on 1st Floor	Inspected
Condition	2 - Between Good and Fair
Deficiency	SALT GLAZED BRICK: CRACKS/SPALLING
Deficiency Location/Instance	Near Drinking Fountain
Deficiency Quantity	20
Quantity Uom	S.F.
Potential Action	REPLACE
Urgency of Action	PRIORITY 3
Purpose of Action	LEVEL 2
Deficiency Photo1

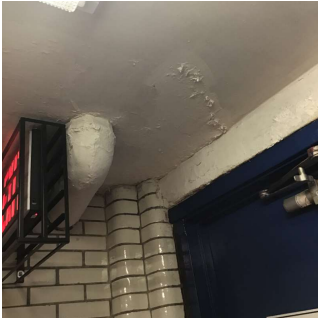
Question	Response
<b>INTERIOR</b>	
<b>SCIENCE LAB</b>	Inspected
<b>Fixed Equipment</b>	
Condition	2 - Between Good and Fair
Deficiency	No deficiencies recorded
<b>SCIENCE PREP ROOM</b>	Does not Exist
<b>SHOWER ROOM</b>	Inspected
Instance on 3rd Floor	Inaccessible
<b>STAIRS/RAMPS: INTERIOR</b>	Inspected
Do Letter Stair Signs Exist?	Yes
<b>Ceiling</b>	Inspected
Condition	2 - Between Good and Fair
Deficiency	PLASTER: CRACKS/SPALLING
Deficiency Location/Instance	Stair A/B1 Vestibule
Deficiency Quantity	20
Quantity Uom	S.F.
Potential Action	REPLACE
Urgency of Action	PRIORITY 3
Purpose of Action	LEVEL 2
Deficiency Photo1

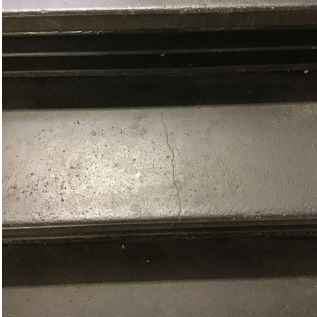
Stair E/1
Violations	No violations recorded.
Deficiency	CONCRETE: CRACKS/SPALLING - MAJOR

Question	Response
<b>INTERIOR</b>	
<b>STAIRS/RAMPS: INTERIOR</b>	
<b>Door(s)</b>	
Deficiency	METAL CLAD WOOD: DETERIORATED DOOR
Deficiency Location/Instance	Stair A/B 1
Deficiency Quantity	1
Quantity Uom	EACH
Potential Action	MAINTENANCE
Urgency of Action	PRIORITY 3
Purpose of Action	LEVEL 2
Deficiency Photo1	 
	Stair A/B 1
Violations	No violations recorded.
<b>Partition</b>	Inspected
Condition	2 - Between Good and Fair
Deficiency	No deficiencies recorded
<b>Railings</b>	Inspected
Condition	2 - Between Good and Fair
Deficiency	No deficiencies recorded
<b>Stairs and Landings</b>	Inspected
Condition	5 - Poor
Deficiency	STONE: BROKEN/MISSING
Deficiency Location/Instance	Gymnasium Stairs, Stair E Basement-3rd Floor and others
Deficiency Quantity	415
Quantity Uom	S.F.
Potential Action	REPLACE
Urgency of Action	PRIORITY 3
Purpose of Action	LEVEL 2
Deficiency Photo1

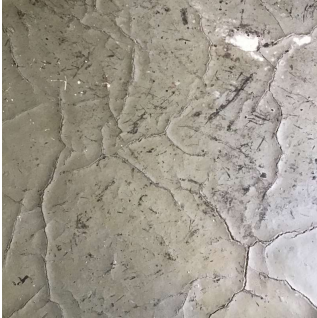
Deficiency Location/Instance	Stair D/3,Bulkhead,
Deficiency Quantity	80

Question	Response
<b>INTERIOR</b>	
<b>STAIRS/RAMPS: INTERIOR</b>	
<b>Stairs and Landings</b>	
Quantity Uom	S.F.
Potential Action	REPLACE
Urgency of Action	PRIORITY 3
Purpose of Action	LEVEL 2
Deficiency Photo1

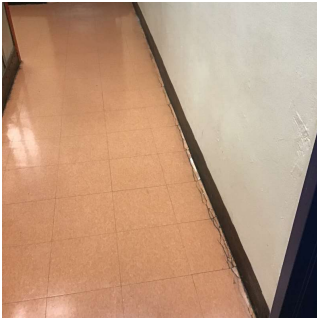
Violations	Stair D/Bulkhead No violations recorded.
Deficiency	VINYL TILES: BROKEN/DETERIORATED/MISSING TILES
Deficiency Location/Instance	Stairs C/D 1, E/Bulkhead, Stair F/2
Deficiency Quantity	120
Quantity Uom	S.F.
Potential Action	REPLACE
Urgency of Action	PRIORITY 3
Purpose of Action	LEVEL 2
Deficiency Photo1

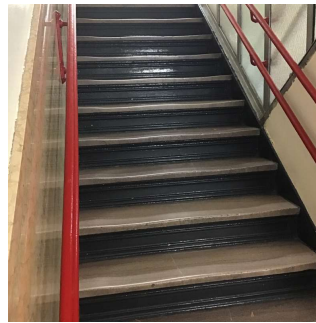
Violations	Stair C/D 1 No violations recorded.
Deficiency	STONE: WORN-OUT TREAD/NOSINGS
Deficiency Location/Instance	Stair A/B 1
Deficiency Quantity	140
Quantity Uom	S.F.
Potential Action	REPLACE
Urgency of Action	PRIORITY 3
Purpose of Action	LEVEL 2

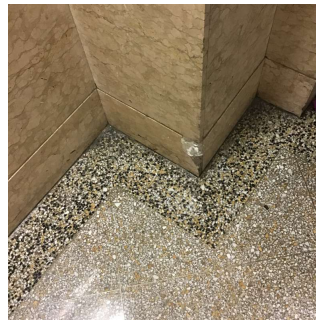
Stair A/B 1

STONE: CRACKS/SPALLING

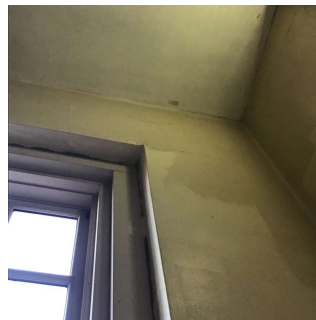
PLASTER: CRACKS/SPALLING

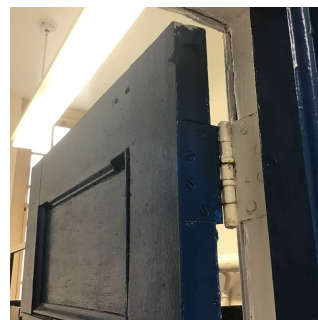
WOOD: DETERIORATED DOOR  
Rooms 360, C29, Gymnasium, 217, 207/209, others  
9  
EACH  
MAINTENANCE  
PRIORITY 3  
LEVEL 2

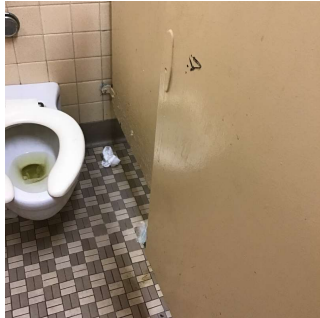
Gymnasium
Violations	No violations recorded.
<b>Walls</b>	Inspected
Condition	2 - Between Good and Fair
Deficiency	PLASTER: CRACKS/SPALLING

Question	Response
<b>INTERIOR</b>	
<b>TOILET ROOMS - STUDENTS</b>	
<b>Door(s)</b>	Inspected
	Room 360
Violations	No violations recorded.
<b>Floor Finish</b>	Inspected
Condition	2 - Between Good and Fair
Deficiency	CERAMIC TILE: BROKEN/MISSING TILES
Deficiency Location/Instance	Boys 3rd Floor, Rooms 360,207/209 Gymnasium, 260 and others
Deficiency Quantity	80
Quantity Uom	S.F.
Potential Action	REPLACE
Urgency of Action	PRIORITY 3
Purpose of Action	LEVEL 2
Deficiency Photo1	 
	Boys 3rd Floor
Violations	No violations recorded.
<b>Stalls</b>	Inspected
Condition	3 - Fair
Deficiency	BROKEN/MISSING
Deficiency Location/Instance	Boys 3rd Floor, Gymnasium
Deficiency Quantity	3
Quantity Uom	EACH
Potential Action	REPLACE
Urgency of Action	PRIORITY 3
Purpose of Action	LEVEL 2
Deficiency Photo1

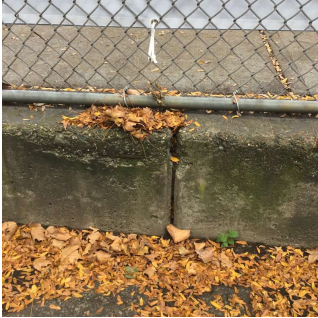
Question	Response
<b>LIFE SAFETY</b>	Inspected
<b>STEEL STAIRS</b>	Does not Exist
<b>SITE</b>	Inspected
<b>CONTAINERIZATION</b>	Does not Exist
<b>Drainage System for Asphalt</b>	Inspected
<b>Catch Basins/Manhole - Surrounded by asphalt</b>	Inspected
Condition	2 - Between Good and Fair
Deficiency	No deficiencies recorded
<b>Culverts - Asphalt Covering</b>	Does not Exist
<b>Drainage System for Concrete</b>	Inspected
<b>Catch Basins/Manhole - Surrounded by concrete</b>	Inspected
Condition	2 - Between Good and Fair
Deficiency	No deficiencies recorded
<b>Culverts - Concrete Covering</b>	Does not Exist
<b>Drainage System for Soil</b>	Inspected
<b>Catch Basins/Manhole - Surrounded by Soil</b>	Does not Exist
<b>Culverts - Soil Covering</b>	Inaccessible
<b>DRINKING FOUNTAINS</b>	Does not Exist
<b>FENCES</b>	Inspected
Condition	4 - Between Fair and Poor
Deficiency	CONCRETE CURB: DAMAGED/DETERIORATED
Deficiency Location/Instance	Along 219th Street

Deficiency Quantity	30
Quantity Uom	S.F.
Potential Action	REPLACE
Urgency of Action	PRIORITY 3
Purpose of Action	LEVEL 2
Deficiency Photo1

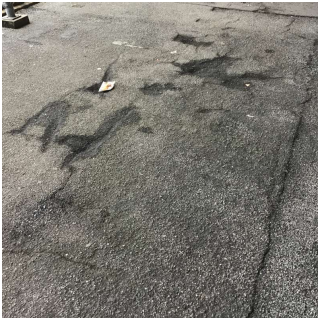
Violations	Along Exit 1 of Mini School No violations recorded.
Deficiency	<b>CHAIN LINK: RUST - MAJOR</b>
Deficiency Location/Instance	Along Exit 1 of Mini School
Deficiency Quantity	950
Quantity Uom	S.F.
Potential Action	REPLACE
Urgency of Action	PRIORITY 3
Purpose of Action	LEVEL 2
Deficiency Photo1	 
Violations	Along Exit 1 of Mini School No violations recorded.
<b>IRRIGATION SYSTEM</b>	Does not Exist
<b>PAVING</b>	Inspected
<b>Student Non-Use</b>	Inspected
Gravel Exists?	No
<b>Asphalt</b>	Does not Exist
<b>Concrete</b>	Inaccessible
<b>Pavers</b>	Does not Exist
<b>Student Use</b>	Inspected
Gravel Exists?	No
<b>Asphalt</b>	Inaccessible
<b>Concrete</b>	Does not Exist
<b>Pavers</b>	Does not Exist
<b>Site Sidewalks &amp; Walkways</b>	Inspected
<b>Asphalt</b>	Inspected
Condition	4 - Between Fair and Poor
Deficiency	<b>CRACKS - MAJOR</b>
Deficiency Location/Instance	Near Exit 10, Along Mini School Exits 3,2,1, 219st

Question	Response
<b>SITE</b>	
<b>PAVING</b>	
<b>Site Sidewalks &amp; Walkways</b>	
<b>Asphalt</b>	
Quantity Uom	S.F.
Potential Action	REPLACE
Urgency of Action	PRIORITY 3
Purpose of Action	LEVEL 2
Deficiency Photo1

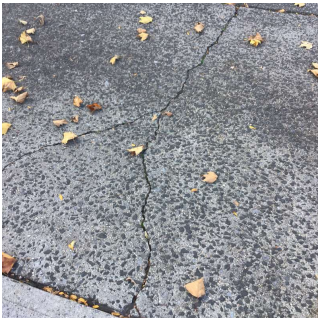
Near Exit 2
Violations	No violations recorded.
Deficiency	DAMAGED CURBS
Deficiency Location/Instance	Along Exit 2 of Mini School
Deficiency Quantity	10
Quantity Uom	L.F.
Potential Action	REPLACE
Urgency of Action	PRIORITY 3
Purpose of Action	LEVEL 2

Near Exit 10
Violations	No violations recorded.
<b>Concrete</b>	
	Inspected
Condition	4 - Between Fair and Poor
Deficiency	CRACKS - MAJOR
Deficiency Location/Instance	Near Exit 2 of Mini School, Main Entrance and Exit 2
Deficiency Quantity	500
Quantity Uom	S.F.
Potential Action	REPLACE
Urgency of Action	PRIORITY 3
Purpose of Action	LEVEL 2
Deficiency Photo1

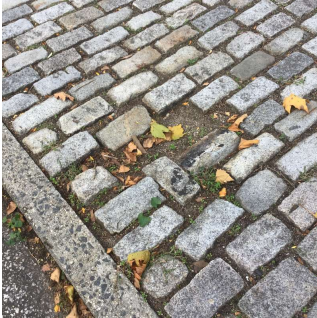
Violations	U No violations recorded.
<b>Pavers</b>	Inspected
Condition	2 - Between Good and Fair
Deficiency	DAMAGED/MISSING
Deficiency Location/Instance	Near exit 2 of Mini School
Deficiency Quantity	20
Quantity Uom	S.F.
Potential Action	REPLACE
Urgency of Action	PRIORITY 3
Purpose of Action	LEVEL 2
Deficiency Photo1
