NYC Department of Education
Building Condition Assessment Survey 2023 - 2024

Architectural Inspection

Asset: P.S. 148 - QUEENS, 89-02 32 AVENUE, New York, 11369

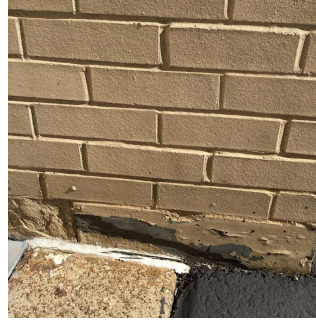
CH

AREAWAY WALLS: CRACKS AND SPALLING

CHIMNEY

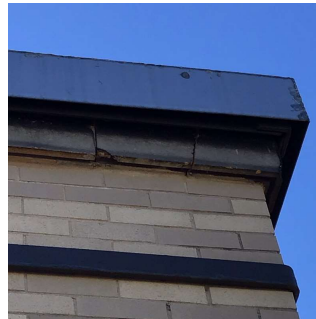
CH

BRICK: DETERIORATED CAP

REPLACE

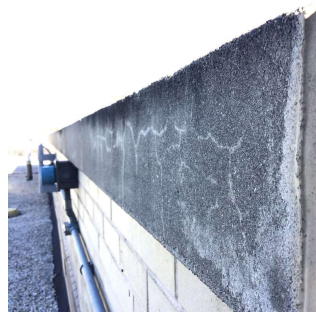
Roof 1

CAST STONE: DETERIORATED TRANSVERSE JOINTS

COPING

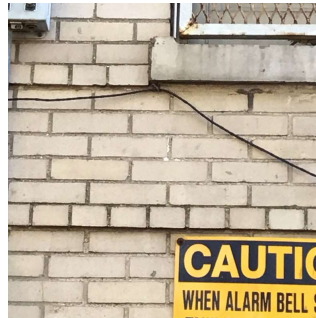
Facade B

BRICK: DETERIORATED JOINTS

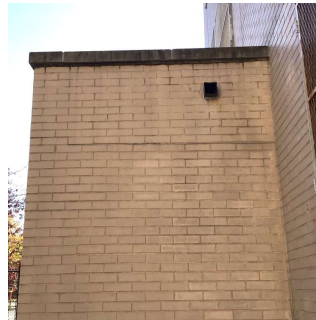
Facade F

BRICK: MAJOR / THRU CRACKS

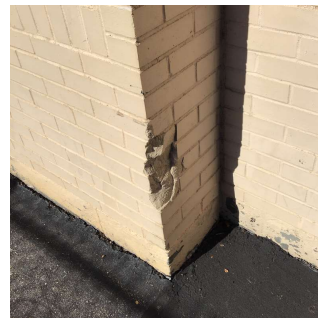
BRICK: CRACKS/DISPLACED/SPALLED BRICK AT BUILDING CORNERS

50
S.F.
REMOVE AND REBUILD
PRIORITY 4
LEVEL 2

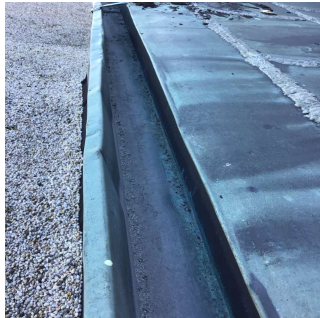
Question	Response
EXTERIOR	
ROOF	
Roofing	
LEADERS, GUTTERS, DOWNSPOUTS, SCUPPERS	
Deficiency Photo1

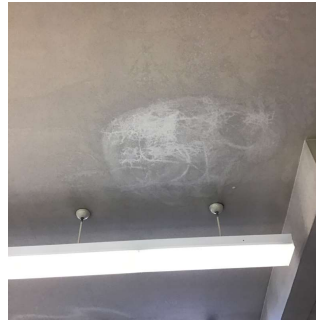
Room 445 - Roof 2

Roof 1
Instance Quantity	18,000
Instance Quantity Uom	S.F.
Does the roof have major mechanical equipment sitting on Dunnage Steel less than 18" above the Roofing?	No
Does this roof instance have a Sustainable Roof System?	No
Do solar panels exist on these roofs?	No
Is/Are the roof(s) suitable for Solar Panel installation?	Yes
Installation Year	2005
Source of Installation	Custodial Staff
Deficiency	BUILT-UP: ROOFING: MAJOR ACTIVE ROOF LEAKS IN INSTRUCTIONAL SPACE
Roof Plan reference	Q148

Quantity Uom	S.F.
Potential Action	REPLACE ROOFING WITHOUT MAJOR EQUIPMENT REMOVAL
Urgency of Action	PRIORITY 5
Purpose of Action	LEVEL 2
Deficiency Photo1

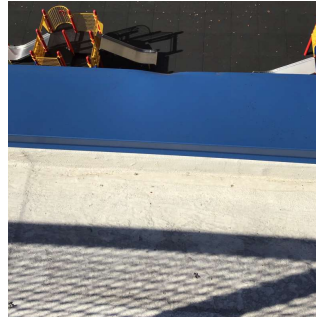
Roof 8

Deficiency	SINGLE PLY, FULLY ADHERED ROOF: FLASHING: CAP FLASHING DAMAGED
------------	--

Deficiency Quantity	10
Quantity Uom	L.F.
Potential Action	REPLACE
Urgency of Action	PRIORITY 4
Purpose of Action	LEVEL 2
Deficiency Photo1

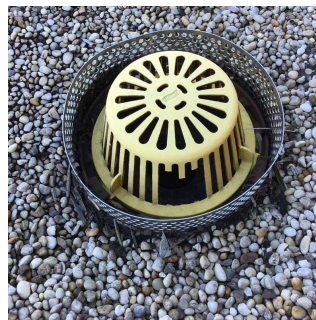
Roof 1

Q148
1
EACH
REPLACE
PRIORITY 4
LEVEL 2

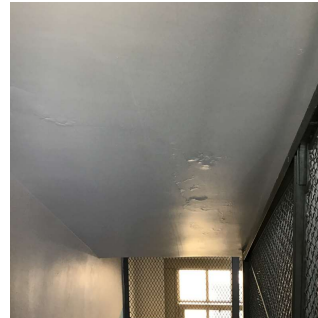
BH1

Question	Response
EXTERIOR	
ROOF	
Specialties	
BULKHEAD/PENTHOUSE	Inspected
Condition	3 - Fair
Deficiency	BULKHEAD/PENTHOUSE WALLS/EXTERIOR: DETERIORATED JOINTS
Roof Plan reference	<p>Q148</p>
Deficiency Quantity	10
Quantity Uom	S.F.
Potential Action	REPOINT
Urgency of Action	PRIORITY 3
Purpose of Action	LEVEL 2
Deficiency Photo1	
Violations	BH2 No violations recorded.
Deficiency	BULKHEAD/PENTHOUSE ROOF: MINOR LEAKAGE
Roof Plan reference	<p>Q148</p>
Deficiency Quantity	50
Quantity Uom	S.F.
Potential Action	MAINTENANCE
Urgency of Action	PRIORITY 3
Purpose of Action	LEVEL 2

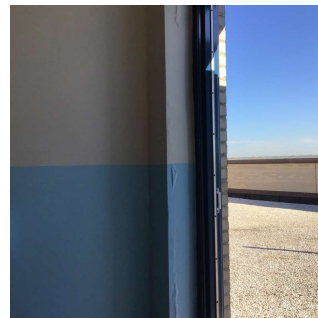
BH1

BULKHEAD/PENTHOUSE WALLS/EXTERIOR: WATER INFILTRATION

REPAIR

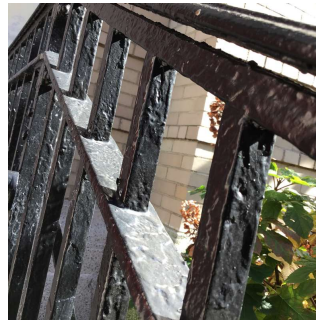
Facade H

RUST - MAJOR

REPLACE

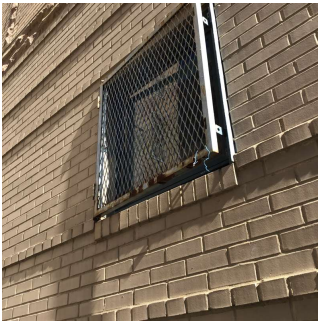
Question	Response
EXTERIOR	
WINDOWS	
EXTERIOR GUARDS	
Deficiency Photo1

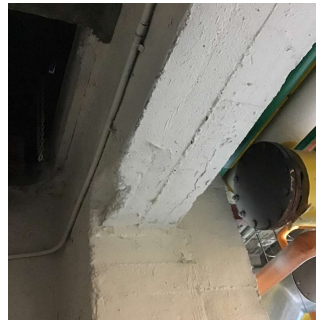
Basement near vault

STEEL COLUMNS/BEAMS: DETERIORATED CONCRETE FIREPROOFING

REPLACE

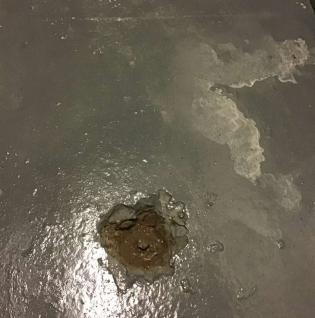
Question	Response
INTERIOR	
STRUCTURAL	
FLOOR STRUCTURE	
Deficiency Photo1	Inspected

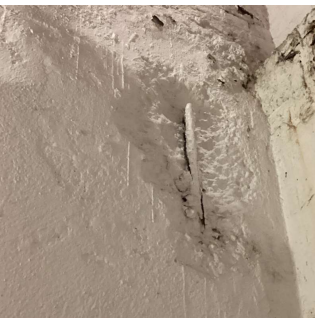
Oil Tank Room No violations recorded.
Violations	
FOUNDATION WALLS	
Material Type(s)	Inspected Concrete, Masonry
Condition	5 - Poor
Deficiency	CONCRETE: CRACKED/SPALLED/REINFORCEMENT EXPOSED
Deficiency Location/Instance	Basement - Circular Staircase, Crawlspace West
Deficiency Quantity	20
Quantity Uom	S.F.
Potential Action	REPAIR
Urgency of Action	PRIORITY 4
Purpose of Action	LEVEL 5
Deficiency Photo1

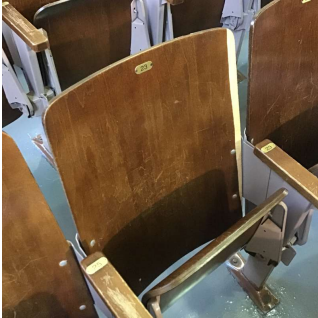
Question	Response
INTERIOR	
AUDITORIUM	
Fixed Seating	
Deficiency Location/Instance	Seats I/23, P/1, R/5, S/7, 11, and others.
Deficiency Quantity	41
Quantity Uom	EACH
Potential Action	REPLACE
Urgency of Action	PRIORITY 3
Purpose of Action	LEVEL 2
Deficiency Photo1

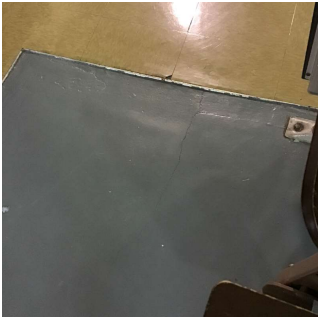
Violations	Seat I/23 No violations recorded.
Floor Finish	
Instance on 1st Floor (549 Seats)	Inspected
Condition	2 - Between Good and Fair
Deficiency	CONCRETE: CRACKS
Deficiency Location/Instance	Near Seats C/2, E/19, H/2, I/25
Deficiency Quantity	100
Quantity Uom	S.F.
Potential Action	REPLACE
Urgency of Action	PRIORITY 3
Purpose of Action	LEVEL 2
Deficiency Photo1

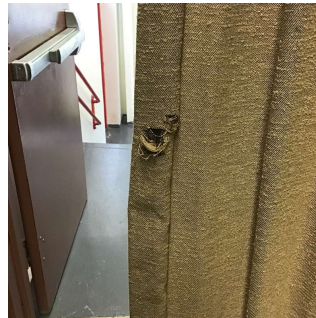
Lateral left Side

WORN/DETERIORATED

REPLACE

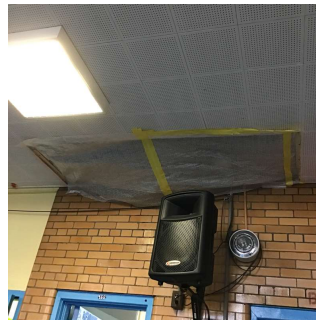
Near Room 155

ACOUSTIC TILES ON PLASTER: DAMAGED/MISSING

REPLACE

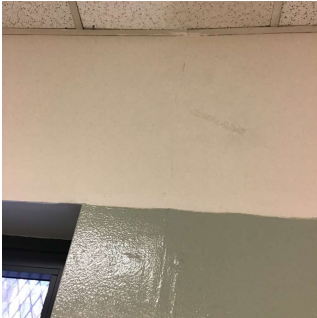
Question	Response
INTERIOR	
CAFETERIA	
Walls	
Deficiency	GYPSUM BOARD: DETERIORATED
Deficiency Location/Instance	Near Windows
Deficiency Quantity	10
Quantity Uom	S.F.
Potential Action	REPLACE
Urgency of Action	PRIORITY 3
Purpose of Action	LEVEL 2
Deficiency Photo1

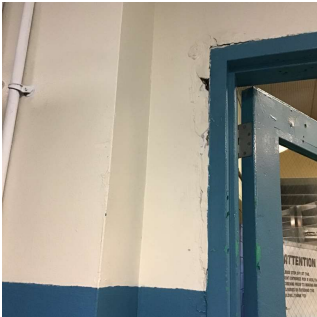
Near Windows
Violations	No violations recorded.
Instance on 1st Floor - original building	Inspected
Condition	2 - Between Good and Fair
Deficiency	PLASTER: CRACKS/SPALLING
Deficiency Location/Instance	Near Kitchen
Deficiency Quantity	20
Quantity Uom	S.F.
Potential Action	REPLACE
Urgency of Action	PRIORITY 3
Purpose of Action	LEVEL 2
Deficiency Photo1

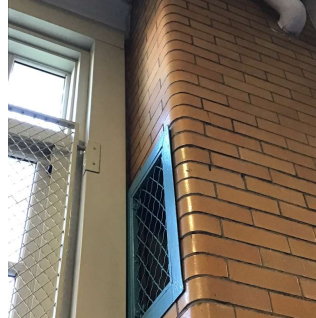
Near Windows

SALT GLAZED BRICK: CRACKS/SPALLING

REPLACE

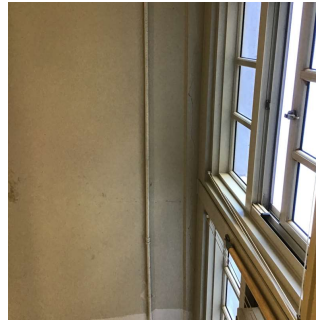
Room 305

PLASTER: CRACKS/SPALLING

REPLACE

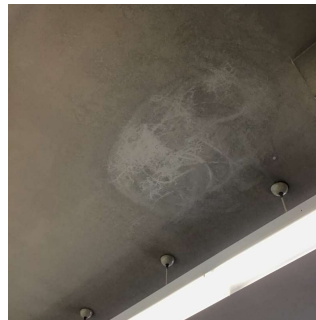
Room 445

PLASTER: CRACKS/SPALLING - ACTIVE LEAK

REPLACE

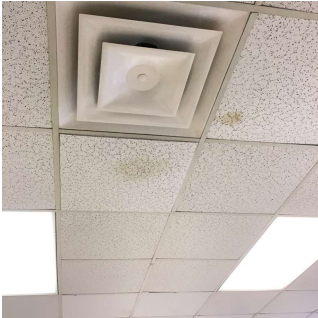
Question	Response
INTERIOR	
CLASSROOMS/CORRIDORS/ADMIN SPACES	
Ceiling	
Deficiency	ACOUSTIC TILES: DAMAGED/MISSING
Deficiency Location/Instance	Rooms 224, 225, 325, 326, 329, and others.
Deficiency Quantity	150
Quantity Uom	S.F.
Potential Action	REPLACE
Urgency of Action	PRIORITY 3
Purpose of Action	LEVEL 2
Deficiency Photo1

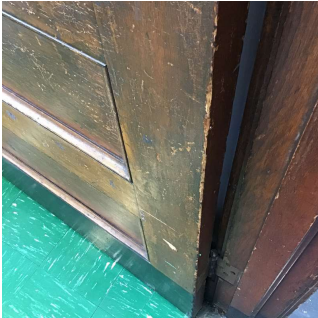
Violations	Room 325 No violations recorded.
Door(s)	Inspected
Condition	5 - Poor
Deficiency	WOOD: DETERIORATED DOOR
Deficiency Location/Instance	Rooms 101, 213, 309, 405, 417, Vestibule Exit 10, and others.
Deficiency Quantity	27
Quantity Uom	EACH
Potential Action	MAINTENANCE
Urgency of Action	PRIORITY 3
Purpose of Action	LEVEL 2
Deficiency Photo1

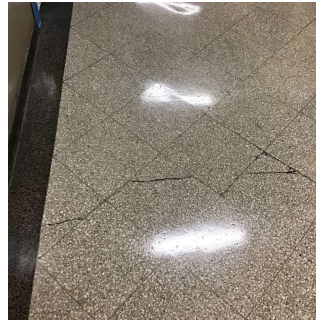
Corridor near Room 153

Violations	Room 417 No violations recorded.
Floor Finish	Inspected
Condition	3 - Fair
Deficiency	TERRAZZO: CRACKS
Deficiency Location/Instance	Main Entrance, Corridor near Room 153, Vestibule Exit 10
Deficiency Quantity	60
Quantity Uom	S.F.
Potential Action	REPLACE

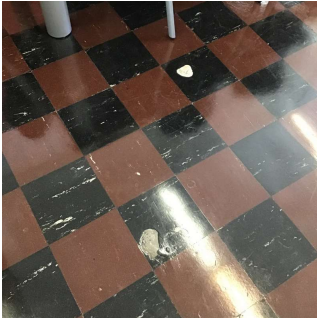
Question	Response
INTERIOR	
CLASSROOMS/CORRIDORS/ADMIN SPACES	
Floor Finish	
Deficiency	VINYL TILES: BROKEN/DETERIORATED/MISSING TILES
Deficiency Location/Instance	Rooms 407, 415, 417, 419A, 450, and others.
Deficiency Quantity	1,200
Quantity Uom	S.F.
Potential Action	REPLACE
Urgency of Action	PRIORITY 3
Purpose of Action	LEVEL 2
Deficiency Photo1

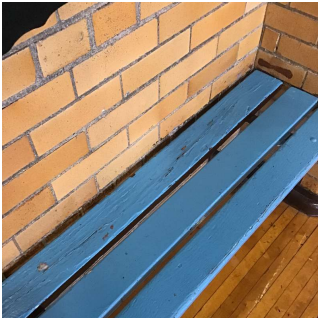
Question	Response
INTERIOR	
GYMNASIUM	
Fixed Equipment	
Instance on 3rd Floor	Inspected
Condition	2 - Between Good and Fair
Deficiency	No deficiencies recorded
Floor Finish	
Instance on 3rd Floor	Inspected
Condition	2 - Between Good and Fair
Deficiency	CONCRETE: CRACKS
Deficiency Location/Instance	Storage Room
Deficiency Quantity	20
Quantity Uom	S.F.
Potential Action	REPLACE
Urgency of Action	PRIORITY 3
Purpose of Action	LEVEL 2
Deficiency Photo1	 
	Storage Room
Violations	No violations recorded.
Deficiency	WOOD: DAMAGED/DETERIORATED
Deficiency Location/Instance	Near Windows
Deficiency Quantity	40
Quantity Uom	S.F.
Potential Action	REPLACE
Urgency of Action	PRIORITY 3
Purpose of Action	LEVEL 2
Deficiency Photo1	 
	Near Windows
Violations	No violations recorded.
Seating	
Instance on 3rd Floor	Inspected
Condition	4 - Between Fair and Poor
Deficiency	DAMAGED FIXED SEATING
Deficiency Location/Instance	Near Windows

Question	Response
INTERIOR	
GYMNASIUM	
Seating	
Deficiency Quantity	2
Quantity Uom	EACH
Potential Action	REPLACE
Urgency of Action	PRIORITY 3
Purpose of Action	LEVEL 2
Deficiency Photo1

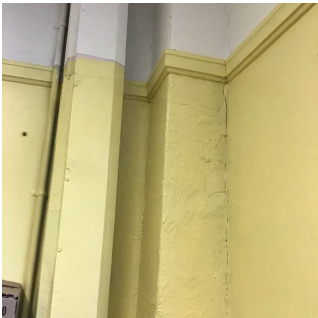
Violations	Near Windows No violations recorded.
Sliding-folding Partition	
Instance on 3rd Floor	Does not Exist
Stage	
Instance on 3rd Floor	Does not Exist
Walls	
Instance on 3rd Floor	Inspected
Condition	2 - Between Good and Fair
Deficiency	PLASTER: CRACKS/SPALLING
Deficiency Location/Instance	Inside Office
Deficiency Quantity	10
Quantity Uom	S.F.
Potential Action	REPLACE
Urgency of Action	PRIORITY 3
Purpose of Action	LEVEL 2
Deficiency Photo1

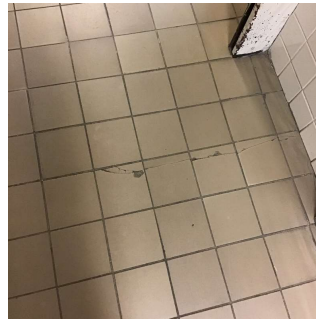
Near Kitchen Addition

Deficiency QUARRY TILE: BROKEN/MISSING TILES

Deficiency Location/Instance Near kitchen Addition

Potential Action REPLACE

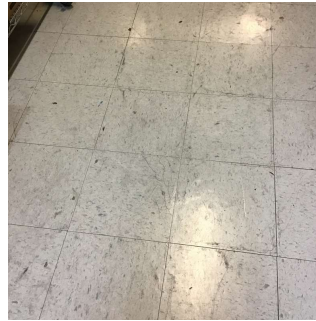
Deficiency VINYL TILES: DETERIORATED SUBSTRATE

Deficiency Location/Instance Storage Room

Potential Action REPLACE

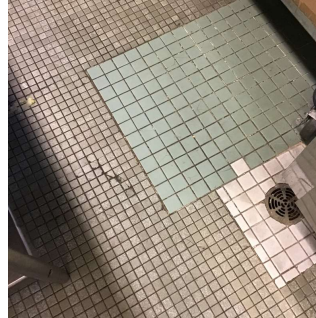
Near Sink

CERAMIC TILE: BROKEN/MISSING TILES

REPLACE

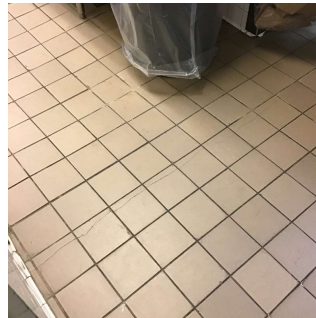
QUARRY TILE: BROKEN/MISSING TILES

REPLACE

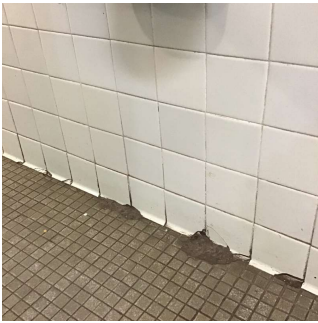
Question	Response
INTERIOR	
KITCHEN	
Floor Finish	
	Near Room 127
Violations	No violations recorded.
Walls	
Instance on 1st Floor - original Building	Inspected
Condition	2 - Between Good and Fair
Deficiency	CERAMIC TILE: BROKEN/ MISSING
Deficiency Location/Instance	Near Serving Area
Deficiency Quantity	10
Quantity Uom	S.F.
Potential Action	REPLACE
Urgency of Action	PRIORITY 3
Purpose of Action	LEVEL 2
Deficiency Photo1

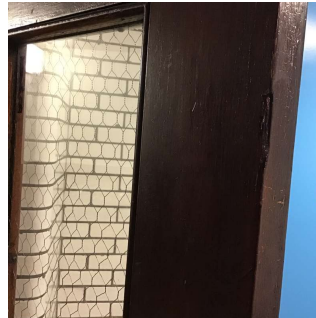
Stair AB/1

WOOD: DETERIORATED DOOR

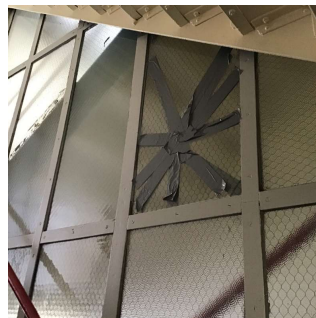
GLASS PANEL: DAMAGED/DETERIORATED

REPLACE

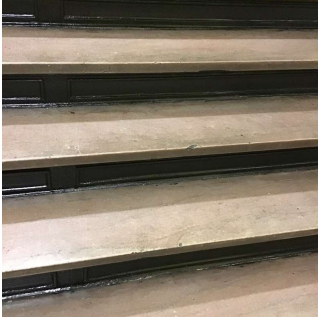
Question	Response
INTERIOR	
STAIRS/RAMPS: INTERIOR	
Partition	Inspected
	Stair AB/3
Violations	No violations recorded.
Railings	Inspected
Condition	2 - Between Good and Fair
Deficiency	No deficiencies recorded
Stairs and Landings	Inspected
Condition	2 - Between Good and Fair
Deficiency	TERRAZZO: CRACKS
Deficiency Location/Instance	Stair AB/1
Deficiency Quantity	50
Quantity Uom	S.F.
Potential Action	REPLACE
Urgency of Action	PRIORITY 3
Purpose of Action	LEVEL 2
Deficiency Photo1	 
Violations	Stair AB/1 No violations recorded.
Deficiency	CONCRETE: CRACKS/SPALLING - MAJOR
Deficiency Location/Instance	Stair M/1
Deficiency Quantity	10
Quantity Uom	S.F.
Potential Action	REPLACE
Urgency of Action	PRIORITY 3
Purpose of Action	LEVEL 2
Deficiency Photo1	 
Violations	Stair M/1 No violations recorded.
Deficiency	STONE: DETERIORATED SUBSTRATE
Deficiency Location/Instance	Vestibule Exit 10
Deficiency Quantity	10
Quantity Uom	S.F.

Question	Response
INTERIOR	
STAIRS/RAMPS: INTERIOR	
Stairs and Landings	
Potential Action	REPLACE
Urgency of Action	PRIORITY 3
Purpose of Action	LEVEL 2
Deficiency Photo1

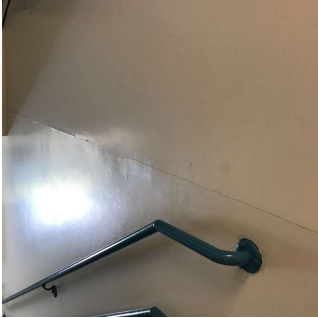
Violations	Vestibule Exit 10 No violations recorded.
Walls	
Condition	Inspected 2 - Between Good and Fair
Deficiency	GYPSUM BOARD: DETERIORATED
Deficiency Location/Instance	Stair I/1, 2
Deficiency Quantity	80
Quantity Uom	S.F.
Potential Action	REPLACE
Urgency of Action	PRIORITY 3
Purpose of Action	LEVEL 2
Deficiency Photo1

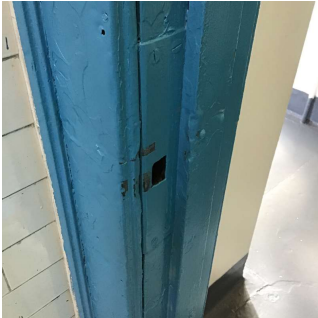
Question	Response
INTERIOR	
TOILET ROOMS - STAFF	Inspected
Ceiling	Inspected
Condition	2 - Between Good and Fair
Deficiency	No deficiencies recorded
Door(s)	Inspected
Condition	5 - Poor
Deficiency	METAL CLAD WOOD: DETERIORATED DOOR AND FRAME
Deficiency Location/Instance	Room 458
Deficiency Quantity	1
Quantity Uom	EACH
Potential Action	MAINTENANCE
Urgency of Action	PRIORITY 3
Purpose of Action	LEVEL 2
Deficiency Photo1

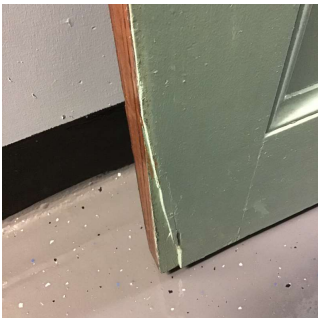
Violations	Room 458 No violations recorded.
Deficiency	WOOD: DETERIORATED DOOR
Deficiency Location/Instance	Rooms 257, 258, 458
Deficiency Quantity	3
Quantity Uom	EACH
Potential Action	MAINTENANCE
Urgency of Action	PRIORITY 3
Purpose of Action	LEVEL 2
Deficiency Photo1

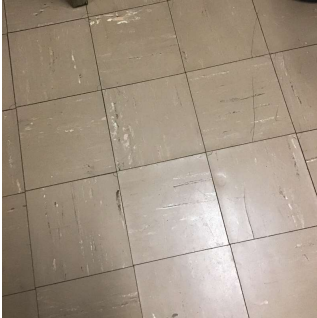
Violations	Room 257 No violations recorded.
Floor Finish	Inspected
Condition	5 - Poor
Deficiency	VINYL TILES: BROKEN/DETERIORATED/MISSING TILES
Deficiency Location/Instance	Room 158
Deficiency Quantity	10
Quantity Uom	S.F.
Potential Action	REPLACE

Question	Response
INTERIOR	
TOILET ROOMS - STAFF	
Floor Finish	
Urgency of Action	PRIORITY 3
Purpose of Action	LEVEL 2
Deficiency Photo1

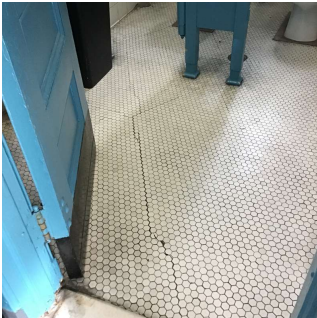
Room 158
Violations	No violations recorded.
Deficiency	CERAMIC TILE: BROKEN/MISSING TILES
Deficiency Location/Instance	Rooms 257, 258, 458
Deficiency Quantity	30
Quantity Uom	S.F.
Potential Action	REPLACE
Urgency of Action	PRIORITY 3
Purpose of Action	LEVEL 2
Deficiency Photo1

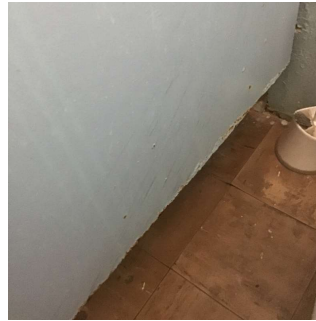
Room 158

Room 458
Violations	No violations recorded.
Stalls	Inspected
Condition	5 - Poor
Deficiency	RUST - MAJOR
Deficiency Location/Instance	Room 158, 258, 458
Deficiency Quantity	3
Quantity Uom	EACH
Potential Action	REPLACE
Urgency of Action	PRIORITY 3
Purpose of Action	LEVEL 2

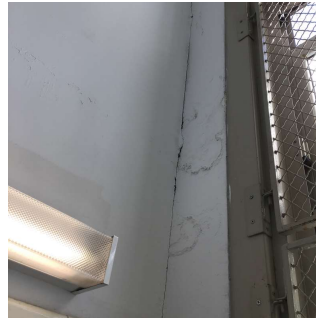
Room 458

PLASTER: CRACKS/SPALLING

REPLACE

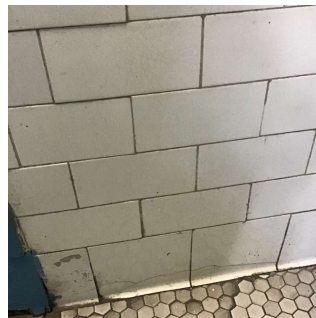
CERAMIC TILE: BROKEN/ MISSING

REPLACE

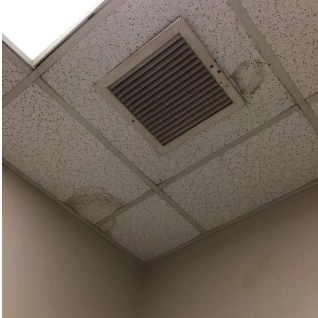
Question	Response
INTERIOR	
TOILET ROOMS - STAFF	Inspected
Walls	Inspected
Violations	Room 458 No violations recorded.
TOILET ROOMS - STUDENTS	Inspected
Ceiling	Inspected
Condition	2 - Between Good and Fair
Deficiency	ACOUSTIC TILES: DAMAGED/MISSING
Deficiency Location/Instance	Rooms 124, 224
Deficiency Quantity	20
Quantity Uom	S.F.
Potential Action	REPLACE
Urgency of Action	PRIORITY 3
Purpose of Action	LEVEL 2
Deficiency Photo1

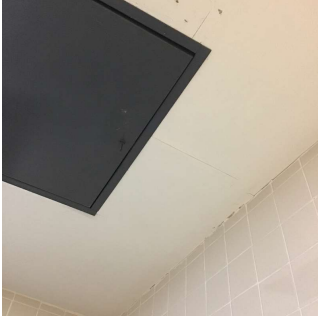
Violations	Room 224 No violations recorded.
Deficiency	GYPSUM BOARD: DAMAGED/DETERIORATED
Deficiency Location/Instance	Room 160
Deficiency Quantity	10
Quantity Uom	S.F.
Potential Action	REPLACE
Urgency of Action	PRIORITY 3
Purpose of Action	LEVEL 2
Deficiency Photo1

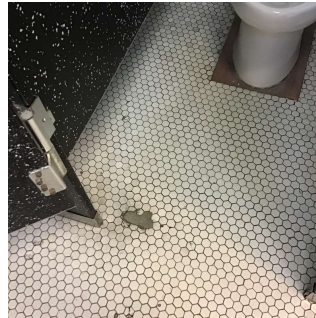
Room 157

CERAMIC TILE: BROKEN/MISSING TILES

REPLACE

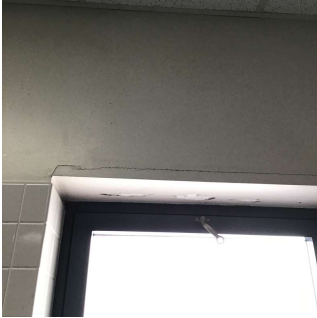
Question	Response
INTERIOR	
TOILET ROOMS - STUDENTS	
Stalls	Inspected
	Room 351
Violations	No violations recorded.
Walls	Inspected
Condition	2 - Between Good and Fair
Deficiency	GYPSUM BOARD: DETERIORATED
Deficiency Location/Instance	Rooms 126, 322C
Deficiency Quantity	10
Quantity Uom	S.F.
Potential Action	REPLACE
Urgency of Action	PRIORITY 3
Purpose of Action	LEVEL 2
Deficiency Photo1

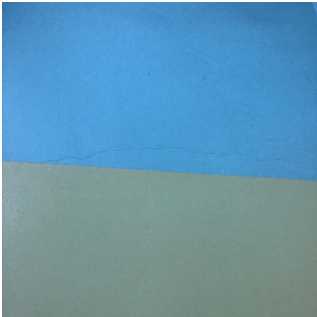
Room 322C
Violations	No violations recorded.
Deficiency	PLASTER: CRACKS/SPALLING
Deficiency Location/Instance	Room 201
Deficiency Quantity	10
Quantity Uom	S.F.
Potential Action	REPLACE
Urgency of Action	PRIORITY 3
Purpose of Action	LEVEL 2
Deficiency Photo1

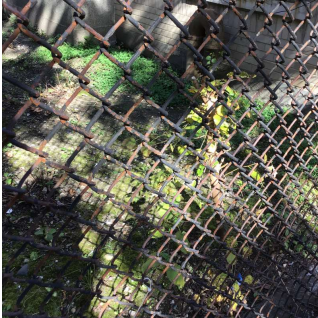
Question	Response
INTERIOR	
TOILET ROOMS - STUDENTS	
Walls	Inspected
Deficiency Photo1	 
	Room 157
Violations	No violations recorded.
LIFE SAFETY	
F.D. HOLDING AREA	Does not Exist
STEEL STAIRS	Does not Exist
SITE	
CONTAINERIZATION	Does not Exist
Drainage System for Asphalt	Does not Exist
Drainage System for Concrete	Does not Exist
Drainage System for Soil	Inspected
Catch Basins/Manhole - Surrounded by Soil	Inspected
Condition	2 - Between Good and Fair
Deficiency	No deficiencies recorded
Culverts - Soil Covering	Does not Exist
DRINKING FOUNTAINS	
FENCES	
Condition	4 - Between Fair and Poor
Deficiency	WROUGHT IRON: RUST - MAJOR
Deficiency Location/Instance	89th Street , 32 Avenue
Deficiency Quantity	80
Quantity Uom	S.F.
Potential Action	REPLACE
Urgency of Action	PRIORITY 3
Purpose of Action	LEVEL 2
Deficiency Photo1	 
	89th Street
Violations	No violations recorded.
Deficiency	CHAIN LINK: RUST - MAJOR
Deficiency Location/Instance	Near Exit 12

Question	Response
SITE	
FENCES	
Deficiency Quantity	200
Quantity Uom	S.F.
Potential Action	REPLACE
Urgency of Action	PRIORITY 3
Purpose of Action	LEVEL 2
Deficiency Photo1

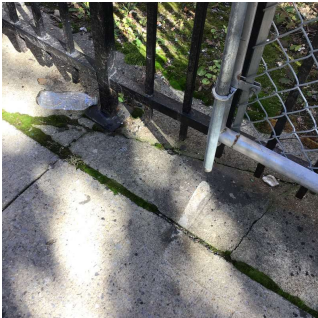
Near Exit 12
Violations	No violations recorded.
Deficiency	CONCRETE CURB: DAMAGED/DETERIORATED
Deficiency Location/Instance	89th Street, 90th Street, 32nd Avenue
Deficiency Quantity	300
Quantity Uom	S.F.
Potential Action	REPLACE
Urgency of Action	PRIORITY 3
Purpose of Action	LEVEL 2
Deficiency Photo1

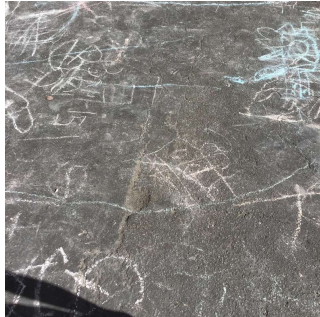
Violations	Between NYC Park and School No violations recorded.
Pavers	Does not Exist
Student Use	Inspected
Gravel Exists?	No
Asphalt	Inspected
Condition	3 - Fair
Deficiency	CRACKS - MAJOR
Deficiency Location/Instance	Near Playground
Deficiency Quantity	200
Quantity Uom	S.F.
Potential Action	REPLACE
Urgency of Action	PRIORITY 3
Purpose of Action	LEVEL 2
Deficiency Photo1

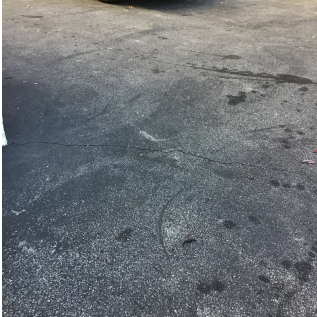
Violations	Near Playground No violations recorded.
Concrete	Does not Exist
Pavers	Does not Exist
Site Sidewalks & Walkways	Inspected
Asphalt	Inspected
Condition	2 - Between Good and Fair
Deficiency	CRACKS - MAJOR
Deficiency Location/Instance	Near Exit 13
Deficiency Quantity	20
Quantity Uom	S.F.
Potential Action	REPLACE
Urgency of Action	PRIORITY 3
Purpose of Action	LEVEL 2

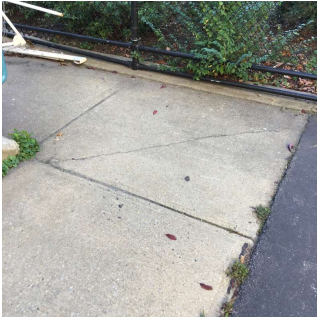
Near Exit 13
Violations	No violations recorded.
Concrete	Inspected
Condition	3 - Fair
Deficiency	DAMAGED/DETERIORATED/MISSING SECTIONS
Deficiency Location/Instance	Near Exits 5,7, 8, 11
Deficiency Quantity	125
Quantity Uom	S.F.
Potential Action	REPLACE
Urgency of Action	PRIORITY 3
Purpose of Action	LEVEL 2
Deficiency Photo1
