NYC Department of Education
Building Condition Assessment Survey 2023 - 2024

Architectural Inspection

Asset: P.S. 150 - QUEENS, 40-01 43 AVENUE, New York, 11104

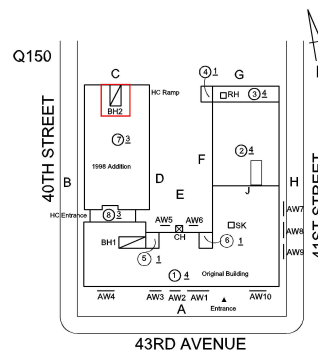
ROOFING DRAINS	Under Construction
Specialties	Inspected
BULKHEAD/PENTHOUSE	Inspected
Condition	3 - Fair
Deficiency	BULKHEAD/PENTHOUSE WALLS/EXTERIOR: CRACKS/SPALLING - MINOR
Roof Plan reference

Quantity Uom	S.F.
Potential Action	REPAIR
Urgency of Action	PRIORITY 3
Purpose of Action	LEVEL 2
Deficiency Photo1

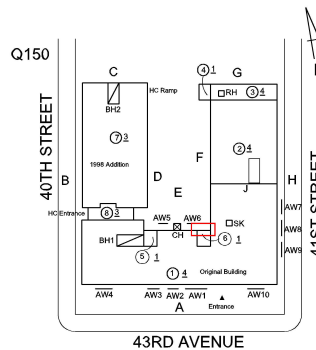
Condition 3 - Fair

Deficiency RUST - MAJOR

Deficiency Quantity	10
Quantity Uom	L.F.
Potential Action	REPLACE
Urgency of Action	PRIORITY 5
Purpose of Action	LEVEL 2

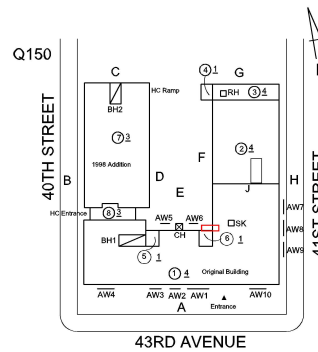
BROKEN BRACKET

REPLACE

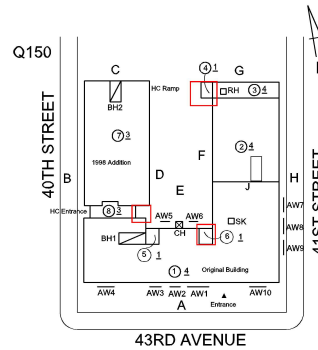
CONCRETE: CRACKS/SPALLING - MAJOR

30
S.F.
REPLACE
PRIORITY 4
LEVEL 2

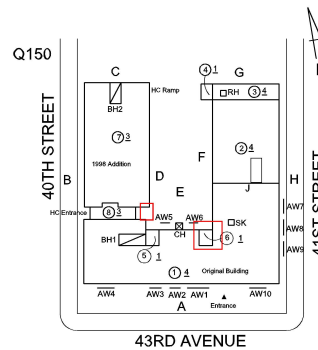
CONCRETE: WORN-OUT TREAD/RISER/NOSING

20
S.F.
REPLACE
PRIORITY 4
LEVEL 2

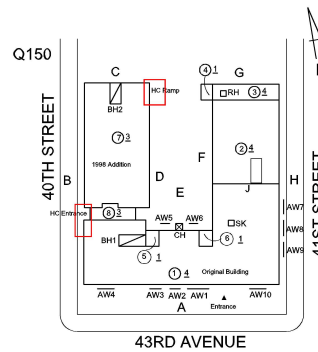
CONCRETE: CRACKS/SPALLING - MINOR

REPAIR

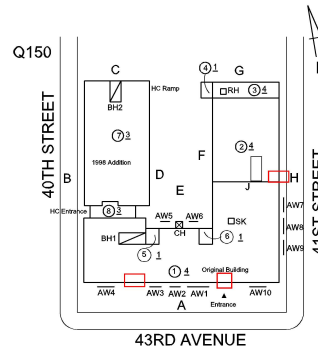
STONE: DETERIORATED JOINTS

25
L.F.
REPOINT
PRIORITY 3
LEVEL 2

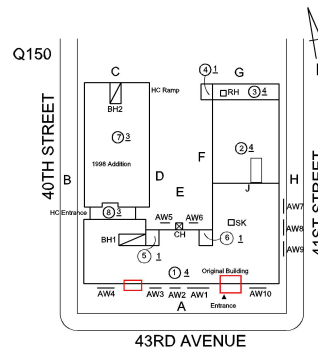
STONE: CRACKS/SPALLING - MAJOR

15
S.F.
REPLACE
PRIORITY 4
LEVEL 2

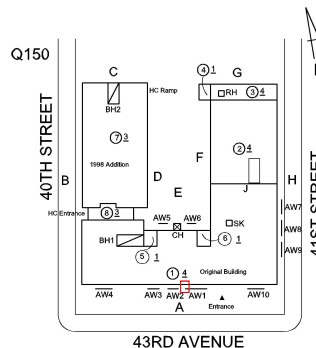
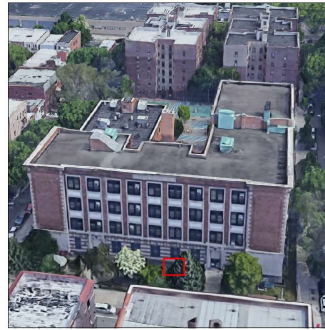
WOOD: DETERIORATED

30
S.F.
REPLACE WINDOW
PRIORITY 4
LEVEL 2

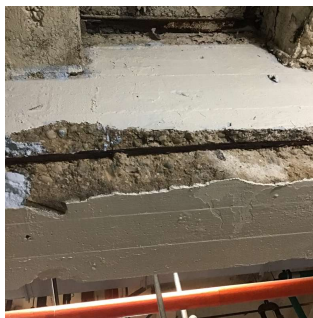
CONCRETE COLUMNS/BEAMS:
CRACKED/SPALLED/REINFORCEMENT EXPOSED

REPLACE

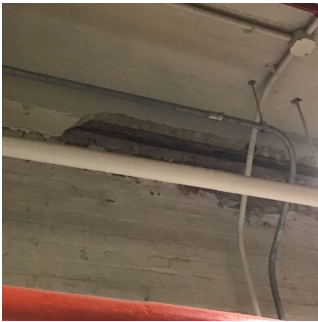
Question	Response
INTERIOR	
STRUCTURAL	
COLUMNS/BEAMS/BEARING WALLS	
Violations	Basement - Ash Hoist Vault No violations recorded.
Deficiency	STEEL COLUMNS/BEAMS: DETERIORATED CONCRETE FIREPROOFING
Deficiency Location/Instance	Basement - Workshop
Deficiency Quantity	60
Quantity Uom	S.F.
Potential Action	REPLACE
Urgency of Action	PRIORITY 4
Purpose of Action	LEVEL 5
Deficiency Photo1

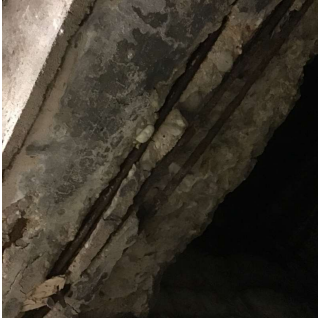
Violations	Basement - Paint Storage Room, Storage Room No violations recorded.
Deficiency	CONCRETE COLUMNS/BEAMS: CRACKED/SPALLED/REINFORCEMENT EXPOSED
Deficiency Location/Instance	Basement - Electrical Room
Deficiency Quantity	20
Quantity Uom	S.F.
Potential Action	REPLACE
Urgency of Action	PRIORITY 5
Purpose of Action	LEVEL 6
Deficiency Photo1

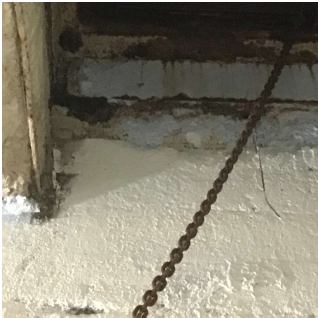
Question	Response
INTERIOR	
STRUCTURAL	
FOUNDATION WALLS	Inspected
Violations	No violations recorded.
ROOF STRUCTURE	Inspected
Condition	2 - Between Good and Fair
Deficiency	No deficiencies recorded
VAULTS-BUNKERS	Inspected
Foundation Walls	Inspected
Condition	3 - Fair
Deficiency	CRACKS, SPALLING
Deficiency Location/Instance	Basement - Vault Bunker
Deficiency Quantity	20
Quantity Uom	S.F.
Potential Action	REPAIR
Urgency of Action	PRIORITY 4
Purpose of Action	LEVEL 5
Deficiency Photo1

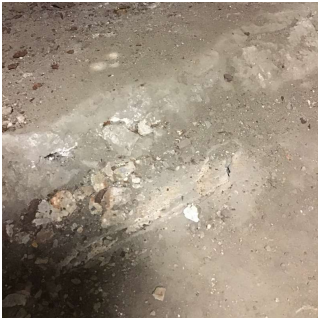
Violations	Basement - Vault Bunker No violations recorded.
Slab Structure	Inspected
Condition	3 - Fair
Deficiency	CONCRETE SLAB ON GRADE: THRU CRACKS
Deficiency Location/Instance	Basement - Electrical Room Vault
Deficiency Quantity	25
Quantity Uom	S.F.
Potential Action	REPLACE
Urgency of Action	PRIORITY 4
Purpose of Action	LEVEL 5
Deficiency Photo1

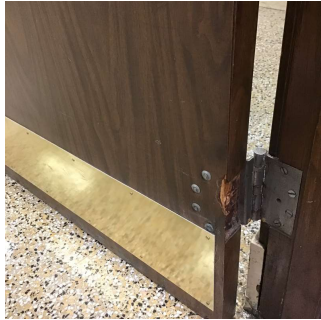
Entrance

Instance on 1st Floor (559 Seats)	Inspected
Condition	5 - Poor
Deficiency	WOOD: DETERIORATED DOOR
Deficiency Location/Instance	Entrances
Deficiency Quantity	4
Quantity Uom	EACH
Potential Action	MAINTENANCE
Urgency of Action	PRIORITY 3
Purpose of Action	LEVEL 2
Deficiency Photo1

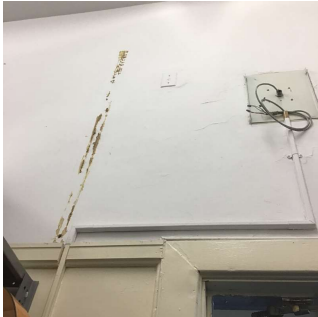
Violations	Left side No violations recorded.
Deficiency	PLASTER: CRACKS/SPALLING
Deficiency Location/Instance	Storage Room - 2nd Floor
Deficiency Quantity	20
Quantity Uom	S.F.
Potential Action	REPLACE
Urgency of Action	PRIORITY 3
Purpose of Action	LEVEL 2
Deficiency Photo1

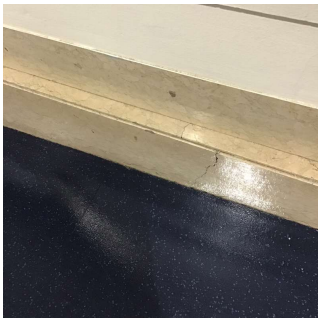
Violations	Near Windows

Violations	Storage Room - 2nd Floor No violations recorded.
Deficiency	STONE MOLDINGS: CRACKS/SPALLING
Deficiency Location/Instance	Near Windows
Deficiency Quantity	30
Quantity Uom	L.F.
Potential Action	REPLACE
Urgency of Action	PRIORITY 3
Purpose of Action	LEVEL 2
Deficiency Photo1

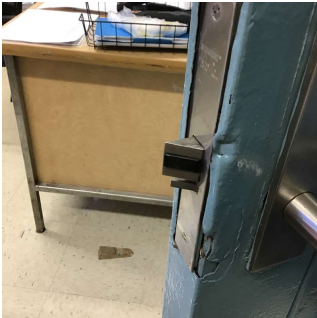
Room 162
Violations	No violations recorded.
Door(s)	Inspected
Condition	5 - Poor
Deficiency	METAL CLAD WOOD: DETERIORATED DOOR
Deficiency Location/Instance	Room 369
Deficiency Quantity	1
Quantity Uom	EACH
Potential Action	MAINTENANCE
Urgency of Action	PRIORITY 3
Purpose of Action	LEVEL 2
Deficiency Photo1

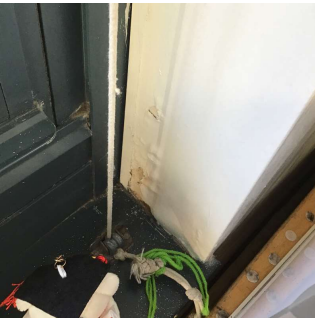
Question	Response
INTERIOR	
CLASSROOMS/CORRIDORS/ADMIN SPACES	
Walls	
Deficiency Photo1 Violations	  Room 305 No violations recorded.
Deficiency Deficiency Location/Instance Deficiency Quantity Quantity Uom Potential Action Urgency of Action Purpose of Action Deficiency Photo1 Violations	GYPSUM BOARD: DETERIORATED - ACTIVE LEAK Room 329 10 S.F. REPLACE PRIORITY 5 LEVEL 2

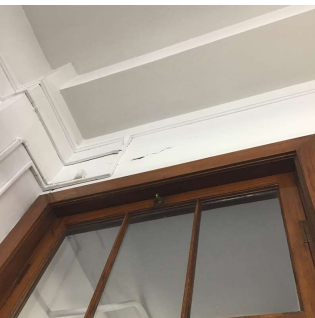
Room 319 No violations recorded.

Room 329 No violations recorded.
Deficiency Deficiency Location/Instance Deficiency Quantity Quantity Uom Potential Action Urgency of Action Purpose of Action Deficiency Photo1 Violations	PLASTER: CRACKS/SPALLING Rooms 217, 219, 229, 315, 319, and others. 80 S.F. REPLACE PRIORITY 3 LEVEL 2

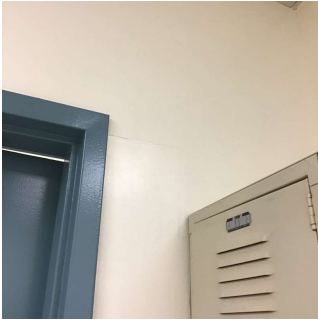
Violations	Room A108 No violations recorded.
Walls	
Instance on 1st Floor	Inspected
Condition	2 - Between Good and Fair
Deficiency	GYP SUM BOARD: DETERIORATED
Deficiency Location/Instance	Room A108
Deficiency Quantity	10
Quantity Uom	S.F.
Potential Action	REPLACE
Urgency of Action	PRIORITY 3
Purpose of Action	LEVEL 2
Deficiency Photo1

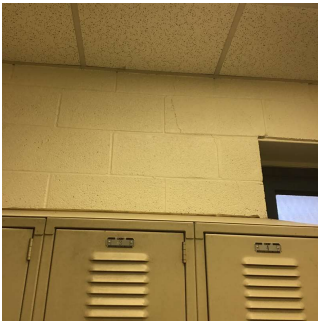
Violations	Room A108 No violations recorded.
Deficiency	MASONRY: CRACKS/SPALLING
Deficiency Location/Instance	Rooms A108, A113
Deficiency Quantity	10
Quantity Uom	S.F.
Potential Action	REPLACE
Urgency of Action	PRIORITY 3
Purpose of Action	LEVEL 2

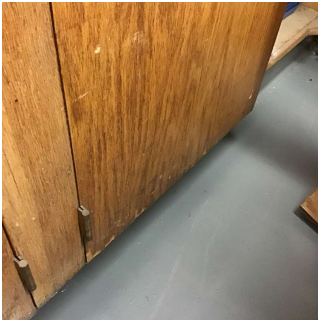
Violations	Room A108 No violations recorded.
LIBRARY	Inspected
Instance on Room 309	Inspected
Built-in Furnishing	
Instance on Room 309	Inspected
Condition	2 - Between Good and Fair
Deficiency	SINK/STORAGE CABINET - DAMAGED/DETERIORATED
Deficiency Location/Instance	Near Center
Deficiency Quantity	10
Quantity Uom	L.F.
Potential Action	REPLACE
Urgency of Action	PRIORITY 3
Purpose of Action	LEVEL 2
Deficiency Photo1

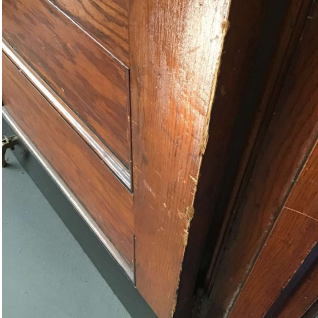
Room 309
Violations	No violations recorded.

Violations	Near Center No violations recorded.
Ceiling	
Instance on Room 309	Inspected
Condition	2 - Between Good and Fair
Deficiency	No deficiencies recorded
Door(s)	
Instance on Room 309	Inspected
Condition	2 - Between Good and Fair
Deficiency	WOOD: DETERIORATED DOOR
Deficiency Location/Instance	Room 309
Deficiency Quantity	1
Quantity Uom	EACH
Potential Action	MAINTENANCE
Urgency of Action	PRIORITY 3

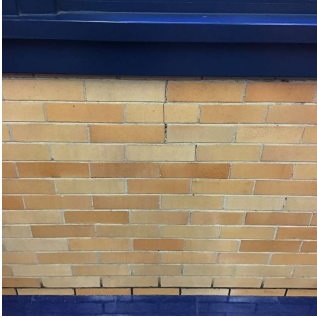
Near Exit 2
Violations	No violations recorded.
Sliding-folding Partition	
Instance on 1st Floor	Does not Exist
Stage	
Instance on 1st Floor	Does not Exist
Walls	
Instance on 1st Floor	Inspected
Condition	2 - Between Good and Fair
Deficiency	SALT GLAZED BRICK: CRACKS/SPALLING
Deficiency Location/Instance	Near Windows
Deficiency Quantity	10
Quantity Uom	S.F.
Potential Action	REPLACE
Urgency of Action	PRIORITY 3
Purpose of Action	LEVEL 2
Deficiency Photo1

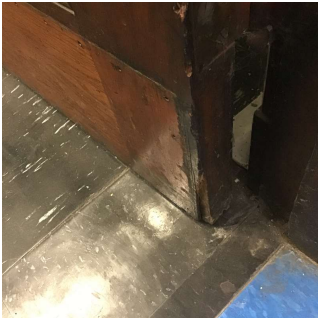
Question	Response
INTERIOR	
STAIRS/RAMPS: INTERIOR	
Door(s)	
Urgency of Action	PRIORITY 3
Purpose of Action	LEVEL 2
Deficiency Photo1	 
	Stair EF/2
Violations	No violations recorded.
Deficiency	WOOD: DETERIORATED DOOR
Deficiency Location/Instance	Stair G/1 - Exit 9 Vestibule
Deficiency Quantity	1
Quantity Uom	EACH
Potential Action	MAINTENANCE
Urgency of Action	PRIORITY 3
Purpose of Action	LEVEL 2
Deficiency Photo1

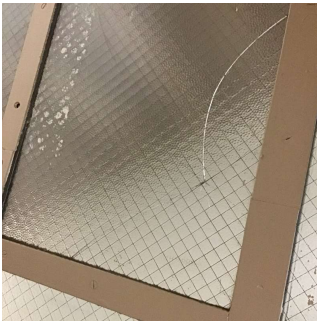
Stair G/1 - Exit 9 Vestibule
Violations	No violations recorded.
Partition	Inspected
Condition	2 - Between Good and Fair
Deficiency	GLASS PANEL: DAMAGED/DETERIORATED
Deficiency Location/Instance	Stairs CD/2, EF/2
Deficiency Quantity	10
Quantity Uom	S.F.
Potential Action	REPLACE
Urgency of Action	PRIORITY 3
Purpose of Action	LEVEL 2

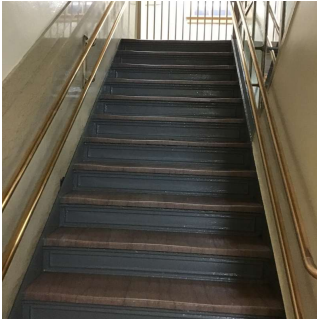
Violations	Stair EF/2 No violations recorded.
Railings	Inspected
Condition	2 - Between Good and Fair
Deficiency	No deficiencies recorded
Stairs and Landings	Inspected
Condition	3 - Fair
Deficiency	STONE: WORN-OUT TREAD/NOSINGS
Deficiency Location/Instance	Stair EF/1
Deficiency Quantity	130
Quantity Uom	S.F.
Potential Action	REPLACE
Urgency of Action	PRIORITY 3
Purpose of Action	LEVEL 2
Deficiency Photo1

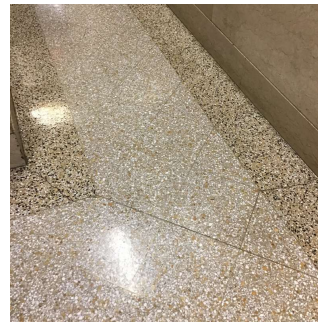
Violations	Stair EF/1 No violations recorded.
Deficiency	TERRAZZO: CRACKS
Deficiency Location/Instance	Stair EF/1
Deficiency Quantity	10
Quantity Uom	S.F.
Potential Action	REPLACE
Urgency of Action	PRIORITY 3
Purpose of Action	LEVEL 2

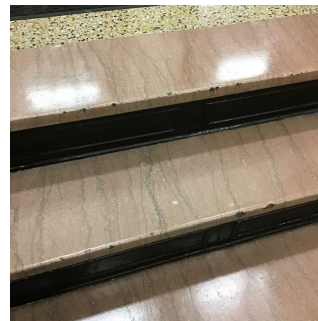
Stair G/1- Exit 7 Vestibule

STONE: BROKEN/MISSING

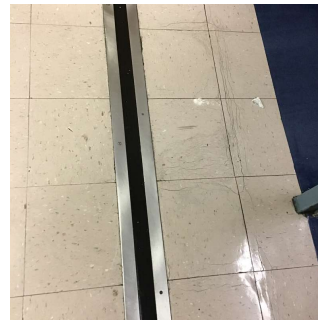
Stair A/1

VINYL TILES: BROKEN/DETERIORATED/MISSING TILES

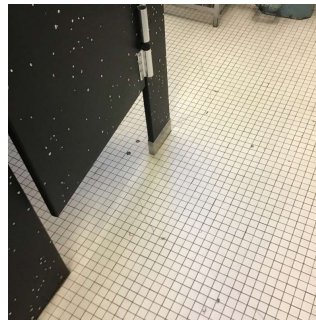
Room 257

CERAMIC TILE: DETERIORATED SUBSTRATE

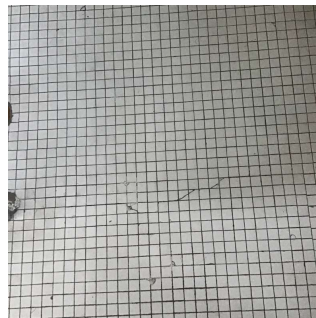
CERAMIC TILE: BROKEN/MISSING TILES

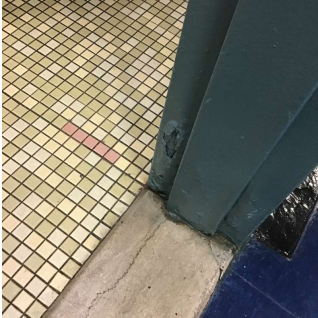
Question	Response
INTERIOR	
TOILET ROOMS - STUDENTS	
Door(s)	Inspected
Condition	5 - Poor
Deficiency	METAL: DETERIORATED DOOR AND FRAME
Deficiency Location/Instance	Room 259
Deficiency Quantity	1
Quantity Uom	EACH
Potential Action	MAINTENANCE
Urgency of Action	PRIORITY 3
Purpose of Action	LEVEL 2
Deficiency Photo1

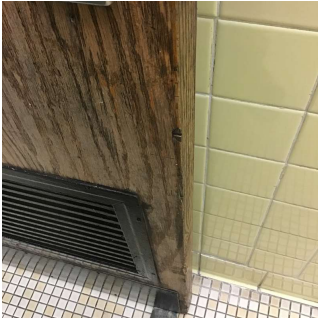
Room 259
Violations	No violations recorded.
Deficiency	WOOD: DETERIORATED DOOR
Deficiency Location/Instance	Room 260A
Deficiency Quantity	1
Quantity Uom	EACH
Potential Action	MAINTENANCE
Urgency of Action	PRIORITY 3
Purpose of Action	LEVEL 2
Deficiency Photo1

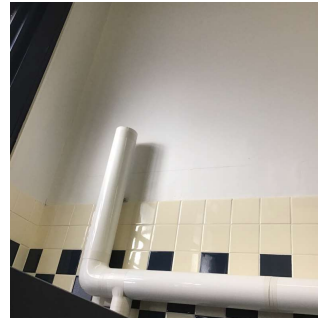
Room 160

PLASTER: CRACKS/SPALLING

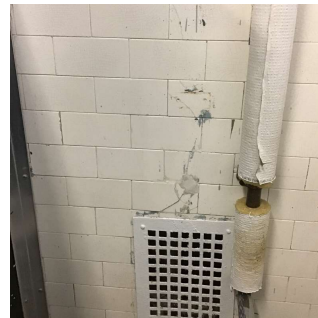
Room 359

CERAMIC TILE: BROKEN/ MISSING

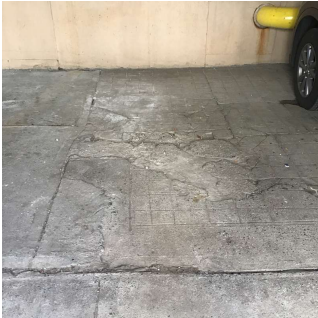
Question	Response
LIFE SAFETY	Inspected
F.D. HOLDING AREA	Does not Exist
STEEL STAIRS	Does not Exist
SITE	Inspected
CONTAINERIZATION	Does not Exist
Drainage System for Asphalt	Inspected
Catch Basins/Manhole - Surrounded by asphalt	Inspected
Condition	2 - Between Good and Fair
Deficiency	No deficiencies recorded
Culverts - Asphalt Covering	Does not Exist
Drainage System for Concrete	Inspected
Catch Basins/Manhole - Surrounded by concrete	Inspected
Condition	2 - Between Good and Fair
Deficiency	No deficiencies recorded
Culverts - Concrete Covering	Does not Exist
Drainage System for Soil	Does not Exist
DRINKING FOUNTAINS	Does not Exist
FENCES	Inaccessible
IRRIGATION SYSTEM	Does not Exist
PAVING	Inspected
Student Non-Use	Inspected
Gravel Exists?	No
Asphalt	Does not Exist
Concrete	Inspected
Condition	3 - Fair
Deficiency	DAMAGED/DETERIORATED/MISSING SECTIONS
Deficiency Location/Instance	40th Street
Deficiency Quantity	125

Quantity Uom	S.F.
Potential Action	REPLACE
Urgency of Action	PRIORITY 3
Purpose of Action	LEVEL 2
Deficiency Photo1

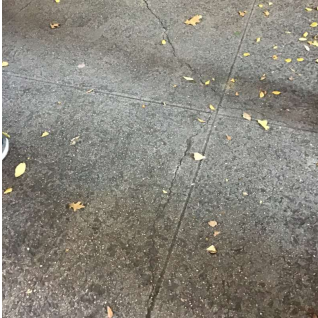
Violations	Near Exit 13 No violations recorded.
Concrete	Inspected
Condition	3 - Fair
Deficiency	DAMAGED/DETERIORATED/MISSING SECTIONS
Deficiency Location/Instance	Near Exit 2, 40th Street.
Deficiency Quantity	150
Quantity Uom	S.F.

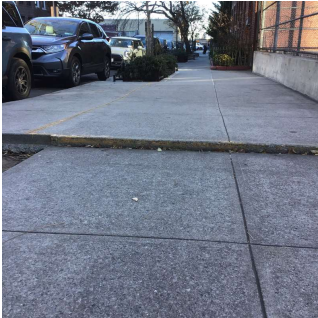
Near Exit 2
Violations	No violations recorded.
Pavers	Does not Exist
DOT Sidewalk	Inspected
Asphalt	Does not Exist
Concrete	Inspected
Condition	4 - Between Fair and Poor
Deficiency	HEAVING
Deficiency Location/Instance	40th Street
Deficiency Quantity	100
Quantity Uom	S.F.
Potential Action	REPLACE
Urgency of Action	PRIORITY 5
Purpose of Action	LEVEL 6
Deficiency Photo1

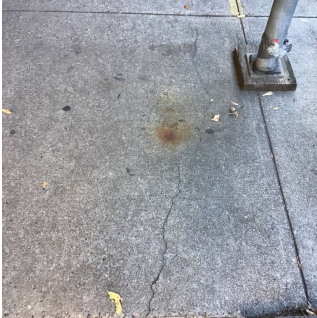
40th Street
Violations	No violations recorded.
Deficiency	DAMAGED/DETERIORATED/MISSING SECTIONS
Deficiency Location/Instance	40th Street, 41st Street, 43rd Avenue
Deficiency Quantity	425
Quantity Uom	S.F.
Potential Action	REPLACE
Urgency of Action	PRIORITY 3
Purpose of Action	LEVEL 2

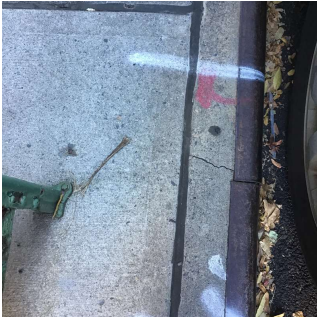
Violations	43rd Avenue No violations recorded.
Deficiency	DAMAGED CURBS
Deficiency Location/Instance	40th Street, 41st Street, 43rd Avenue
Deficiency Quantity	60
Quantity Uom	L.F.
Potential Action	REPLACE
Urgency of Action	PRIORITY 3
Purpose of Action	LEVEL 2
Deficiency Photo1

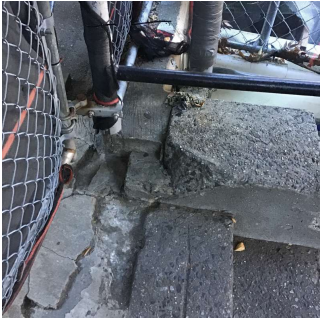
Question	Response
SITE	
SITE WALLS (NOT RETAINING WALLS)	Does not Exist
STAIRS/RAMPS: EXTERIOR	Inspected
Railings	Inspected
Condition	2 - Between Good and Fair
Deficiency	No deficiencies recorded
Site Cheek/flank Walls	Inspected
Condition	2 - Between Good and Fair
Deficiency	CAST IN PLACE CONCRETE: CRACKS/SPALLING - MAJOR
Deficiency Location/Instance	Near Exit 9
Deficiency Quantity	10
Quantity Uom	S.F.
Potential Action	REPLACE
Urgency of Action	PRIORITY 3
Purpose of Action	LEVEL 2
Deficiency Photo1

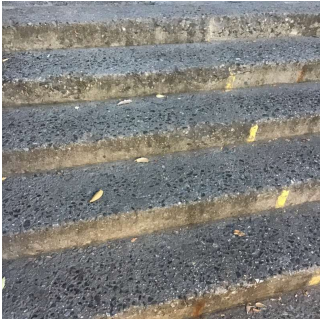
Near Exit 9
Violations	No violations recorded.
Stairs/ramps	Inspected
Condition	3 - Fair
Deficiency	CAST IN PLACE CONCRETE: CRACKS/SPALLING - MAJOR
Deficiency Location/Instance	Near Exit 9
Deficiency Quantity	50
Quantity Uom	S.F.
Potential Action	REPLACE
Urgency of Action	PRIORITY 3
Purpose of Action	LEVEL 2
Deficiency Photo1
