NYC Department of Education
Building Condition Assessment Survey 2023 - 2024

Architectural Inspection

Asset: P.S. 155 - QUEENS, 130-02 115 AVENUE, New York, 11420

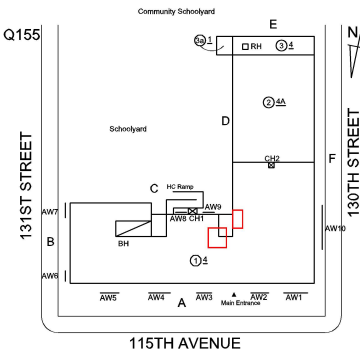
Question	Response
EXTERIOR	
AWNINGS AND CANOPIES	Does not Exist
CHIMNEY	Inspected
Material Type(s)	Masonry
Condition	1 - Good
Deficiency	No deficiencies recorded
COPING	Inspected
Condition	3 - Fair
Deficiency	TERRA COTTA: CRACKED/BROKEN PIECES
Roof Plan reference

Deficiency Quantity	20
Quantity Uom	L.F.
Potential Action	REPLACE-IN-KIND
Urgency of Action	PRIORITY 4
Purpose of Action	LEVEL 2
Deficiency Photo1

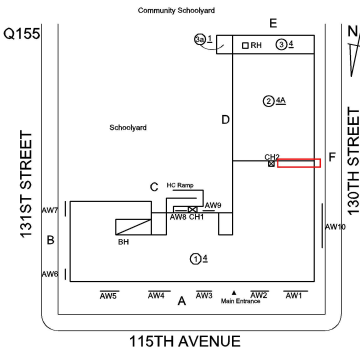
Question	Response
EXTERIOR	
PARAPETS	Inspected
Material Type(s)	Masonry
Replacement Quantity	6,000
Replacement Uom	C.F.
Instance on All Facades	Inspected
Instance Condition	2 - Between Good and Fair
Instance Quantity	6,000
Instance Quantity Uom	C.F.
Deficiency	BRICK: EFFLORESCENCE
Roof Plan reference

Deficiency Quantity	50
Quantity Uom	S.F.
Potential Action	MAINTENANCE
Urgency of Action	PRIORITY 1
Purpose of Action	LEVEL 1
Deficiency Photo1

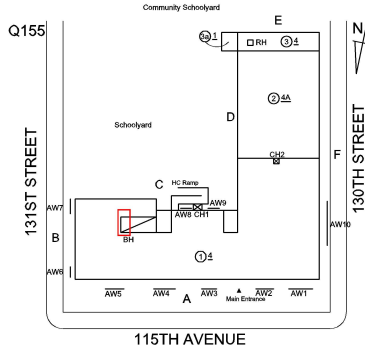
Roof 1
Instance Quantity	18,500
Instance Quantity Uom	S.F.
Does the roof have major mechanical equipment sitting on Dunnage Steel less than 18" above the Roofing?	No
Does this roof instance have a Sustainable Roof System?	Yes
Sustainable Roof Type	White Roof
Sustainable Roof Location (Roof Number)	All Roofs
Do solar panels exist on these roofs?	No
Is/Are the roof(s) suitable for Solar Panel installation?	Yes
Installation Year	2024
Source of Installation	Documented
Deficiency	No deficiencies recorded
ROOFING DRAINS	Inspected
Condition	2 - Between Good and Fair
Deficiency	No deficiencies recorded
Specialties	Inspected
BULKHEAD/PENTHOUSE	Inspected
Condition	3 - Fair
Deficiency	BULKHEAD/PENTHOUSE WALLS/INTERIOR: PLASTER CRACKS/SPALLING
Roof Plan reference

Deficiency Quantity	40

Quantity Uom	S.F.
Potential Action	REPLACE
Urgency of Action	PRIORITY 3
Purpose of Action	LEVEL 2

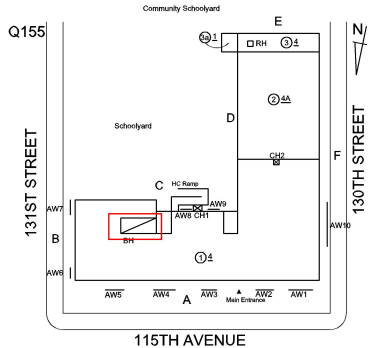
Violations	Roof 1 No violations recorded.
Deficiency	BULKHEAD/PENTHOUSE WALLS/EXTERIOR: EFFLORESCENCE
Roof Plan reference

Deficiency Quantity	50
Quantity Uom	S.F.
Potential Action	MAINTENANCE
Urgency of Action	PRIORITY 1
Purpose of Action	LEVEL 1
Deficiency Photo1

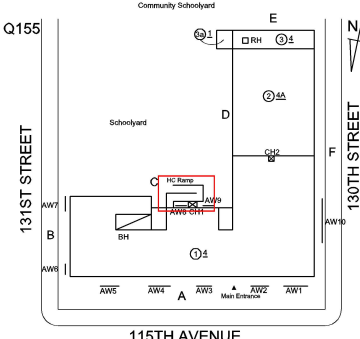
Condition	3 - Fair
Deficiency	CAST IN PLACE CONCRETE: CRACKS/SPALLING - MINOR
Roof Plan reference

Deficiency Quantity	20
Quantity Uom	S.F.
Potential Action	REPAIR
Urgency of Action	PRIORITY 3
Purpose of Action	LEVEL 2
Deficiency Photo1

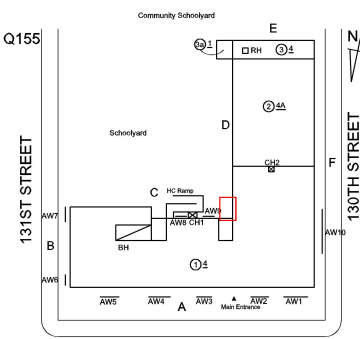
Condition	Inspected
Condition	3 - Fair
Deficiency	RUST - MAJOR
Roof Plan reference

Deficiency Quantity	10
Quantity Uom	L.F.
Potential Action	REPLACE
Urgency of Action	PRIORITY 4
Purpose of Action	LEVEL 2

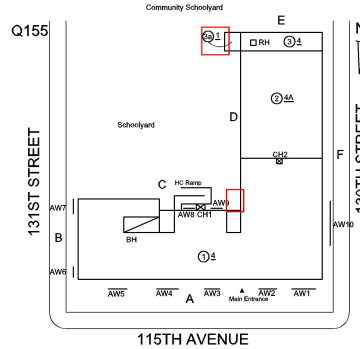
STONE: WORN-OUT TREAD/RISER/NOSING

REPLACE

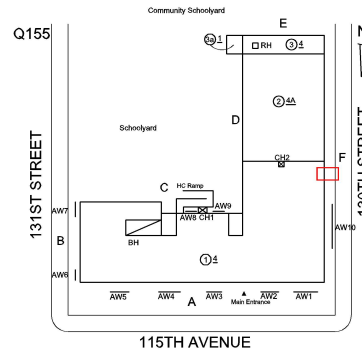
STONE: DETERIORATED SUBSTRATE

30
S.F.
REPLACE SUBSTRATE AND RESET
PRIORITY 4
LEVEL 2

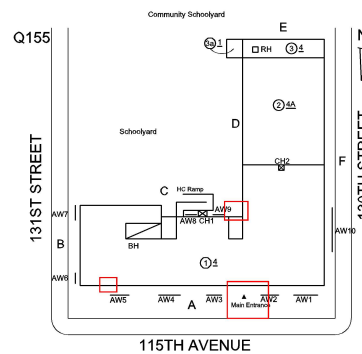
STONE: DETERIORATED JOINTS

20
L.F.
REPOINT
PRIORITY 4
LEVEL 2

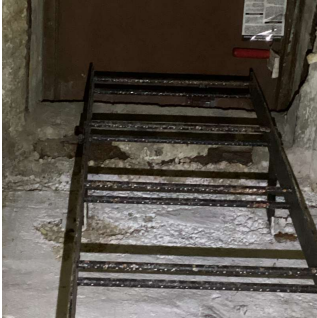
Question	Response
INTERIOR	
STRUCTURAL	
VAULTS-BUNKERS	
Slab Structure	
Potential Action	REPAIR
Urgency of Action	PRIORITY 4
Purpose of Action	LEVEL 5
Deficiency Photo1

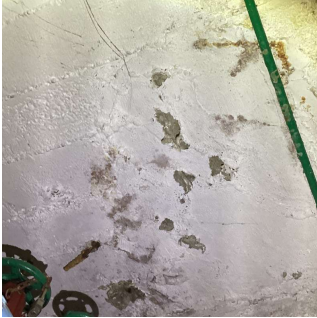
Violations	Basement - Ash Hoist Vault No violations recorded.
Deficiency	CONCRETE: WATER INFILTRATION IN NON- INSTRUCTIONAL SPACE
Deficiency Location/Instance	Basement - Ash Hoist Vault
Deficiency Quantity	50
Quantity Uom	S.F.
Potential Action	INSTALL WATERPROOFING
Urgency of Action	PRIORITY 5
Purpose of Action	LEVEL 5
Deficiency Photo1

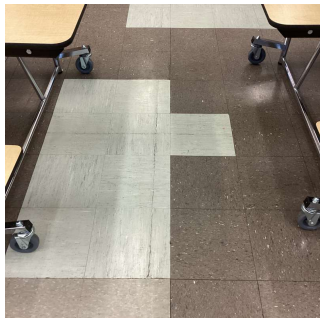
Question	Response
INTERIOR	
CAFETERIA	
Fixed Equipment	
Purpose of Action	LEVEL 2
Deficiency Photo1	 
Violations	Near Windows No violations recorded.
Floor Finish	
Instance on 1st Floor	Inspected
Condition	3 - Fair
Deficiency	VINYL TILES: BROKEN/DETERIORATED/MISSING TILES
Deficiency Location/Instance	Near center, Windows, Exit 1, Room 106, kitchen, and others.
Deficiency Quantity	150
Quantity Uom	S.F.
Potential Action	REPLACE
Urgency of Action	PRIORITY 3
Purpose of Action	LEVEL 2
Deficiency Photo1

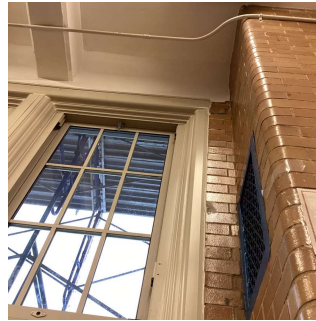
Near Windows

Violations	Near center No violations recorded.
Sliding-folding Partition	
Instance on 1st Floor	Does not Exist
Stage	
Instance on 1st Floor	Does not Exist
Walls	
Instance on 1st Floor	Inspected
Condition	2 - Between Good and Fair
Deficiency	SALT GLAZED BRICK: CRACKS/SPALLING
Deficiency Location/Instance	Near Windows, Electrical Panel
Deficiency Quantity	20
Quantity Uom	S.F.
Potential Action	REPLACE
Urgency of Action	PRIORITY 3

Purpose of Action	LEVEL 2

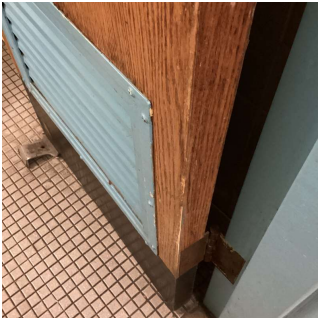
Question	Response
INTERIOR	
TOILET ROOMS - STAFF	Inspected
Door(s)	
Deficiency Quantity	2
Quantity Uom	EACH
Potential Action	MAINTENANCE
Urgency of Action	PRIORITY 3
Purpose of Action	LEVEL 2
Deficiency Photo1
