NYC Department of Education
Building Condition Assessment Survey 2023 - 2024

Architectural Inspection

Asset: P.S. 159 - QUEENS, 205-01 33 AVENUE, New York, 11361

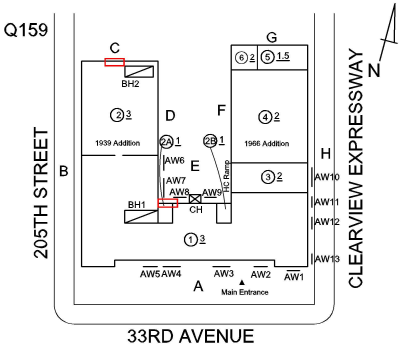
Question	Response
Architectural	
EXTERIOR	Inspected
AREAWAY	Inspected
Instance on AW1-AW13	Inspected
Instance Condition	2 - Between Good and Fair
Instance Quantity	13
Instance Quantity Uom	EACH
Deficiency	No deficiencies recorded
AWNINGS AND CANOPIES	Inspected
Condition	2 - Between Good and Fair
Deficiency	No deficiencies recorded
CHIMNEY	Under Construction
COPING	Under Construction
CORNICE	Does not Exist
DOORS	Inspected
DOORS AND FRAMES	Inspected
Condition	5 - Poor
Deficiency	METAL CLAD: DETERIORATED DOOR - MAJOR DETERIORATION
Roof Plan reference

Deficiency Quantity	6
Quantity Uom	EACH
Potential Action	REPLACE
Urgency of Action	PRIORITY 4
Purpose of Action	LEVEL 2
Deficiency Photo1

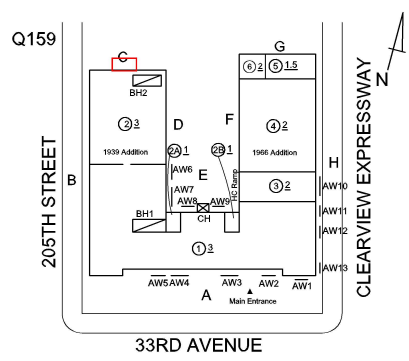
Roof Plan reference

Question	Response
EXTERIOR	
PARAPETS	
Replacement Uom	C.F.
Instance on All Roofs	Under Construction
Instance Quantity	6,000
Instance Quantity Uom	C.F.
PLAZA DECK	
	Does not Exist
ROOF	
	Inspected
Roofing	
Replacement Quantity	24,000
Replacement Uom	S.F.
ROOF HATCH/SMOKE HATCH	
	Does not Exist
LEADERS, GUTTERS, DOWNSPOUTS, SCUPPERS	
Condition	2 - Between Good and Fair
Deficiency	No deficiencies recorded
ROOF BARRIER/FENCE	
	Under Construction
ROOF CAGE	
	Does not Exist
ROOFING	
	Inspected
Instance on Built-Up: All Roofs	Under Construction
Instance Quantity	24,000
Instance Quantity Uom	S.F.
ROOFING DRAINS	
	Under Construction
Specialties	
	Inspected
BULKHEAD/PENTHOUSE	
	Under Construction
CUPOLA/ SPIRES/ TOWERS	
	Does not Exist
DORMER	
	Does not Exist
DUNNAGE STEEL	
	Does not Exist
SKYLIGHT/ROOF VENT	
	Does not Exist
ROOF/GRAVITY TANK	
	Does not Exist
STAIRS/RAMPS: EXTERIOR	
	Inspected
BUILDING CHEEK/FLANK WALLS	
Condition	3 - Fair
Deficiency	STONE: DETERIORATED COPING STONE

Deficiency Quantity	10
Quantity Uom	S.F.
Potential Action	REPLACE
Urgency of Action	PRIORITY 4
Purpose of Action	LEVEL 2

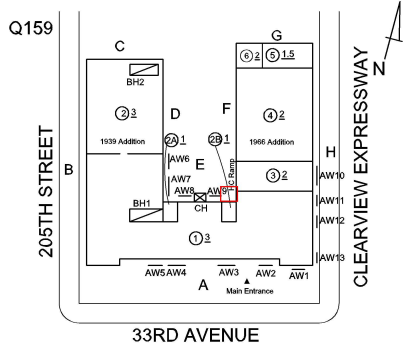
Question	Response
EXTERIOR	
STAIRS/RAMPS: EXTERIOR	
BUILDING CHEEK/FLANK WALLS	
Deficiency Photo1	 
Violations	Facade C No violations recorded.
RAILINGS	Inspected
Condition	2 - Between Good and Fair
Deficiency	No deficiencies recorded
STAIRS/RAMPS	Inspected
Condition	5 - Poor
Deficiency	CONCRETE: CRACKS/SPALLING - MINOR
Roof Plan reference

Deficiency Quantity	10
Quantity Uom	S.F.
Potential Action	REPAIR
Urgency of Action	PRIORITY 3
Purpose of Action	LEVEL 2
Deficiency Photo1

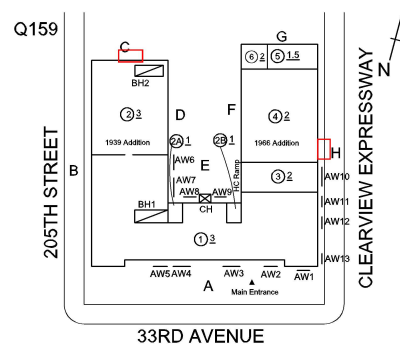
Roof Plan reference

STAIRS/RAMPS

20
L.F.
REPOINT
PRIORITY 4
LEVEL 2

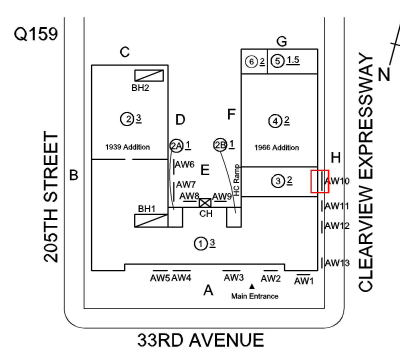
Roof Plan reference

STONE: DETERIORATED SUBSTRATE

10
S.F.
REPLACE SUBSTRATE AND RESET
PRIORITY 4
LEVEL 2

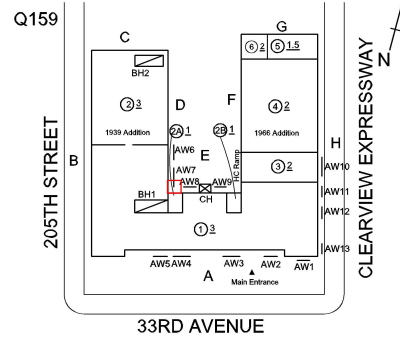
Roof Plan reference

CONCRETE: CRACKS/SPALLING - MAJOR

REPLACE

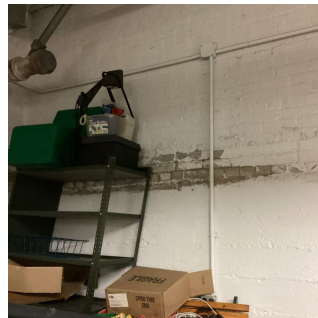
Basement - Storage Area

BRICK: WATER INFILTRATION IN NON- INSTRUCTIONAL SPACE

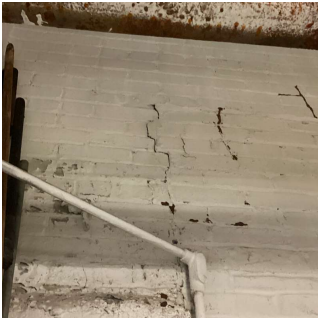
Boiler Room
Violations	No violations recorded.
Deficiency	BRICK: CRACKED/SPALLED
Deficiency Location/Instance	Basement - Boiler Room, Storage Area, Oil Tank Room
Deficiency Quantity	60
Quantity Uom	S.F.
Potential Action	RESTITCH
Urgency of Action	PRIORITY 3
Purpose of Action	LEVEL 5
Deficiency Photo1

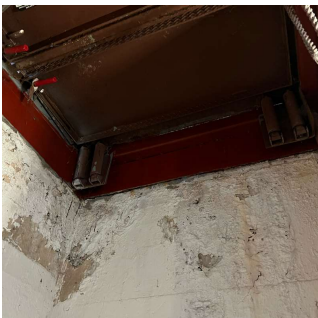
Violations	Ash Hoist Vault No violations recorded.
Vault/Ash Hoist Doors and Framing	Inspected
Condition	5 - Poor
Deficiency	WATER INFILTRATION
Deficiency Location/Instance	Ash Hoist Vault
Deficiency Quantity	10
Quantity Uom	S.F.
Potential Action	REPAIR
Urgency of Action	PRIORITY 5
Purpose of Action	LEVEL 2
Deficiency Photo1

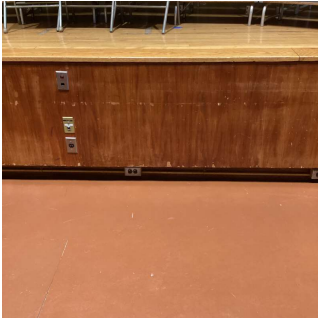
Near seat C/101
Violations	No violations recorded.
Sliding-folding Partition	
Instance on 1st Floor (380 Seats)	Does not Exist
Stage	
Instance on 1st Floor (380 Seats)	Inspected
Stage	Inspected
Instance on 1st Floor (380 Seats)	Inspected
Condition	3 - Fair
Deficiency	DAMAGED FASCIA
Deficiency Location/Instance	Front, left and Right Side
Deficiency Quantity	40
Quantity Uom	S.F.
Potential Action	REPLACE
Urgency of Action	PRIORITY 3
Purpose of Action	LEVEL 2
Deficiency Photo1

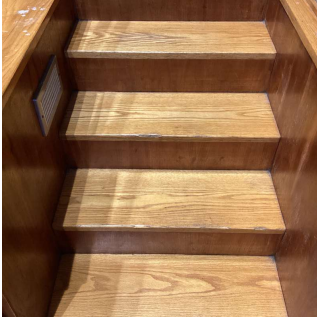
Front
Violations	No violations recorded.
Deficiency	DAMAGED STEPS
Deficiency Location/Instance	Left Side
Deficiency Quantity	10
Quantity Uom	S.F.
Potential Action	REPLACE

Question	Response
INTERIOR	
AUDITORIUM	
Stage	
Stage	
Urgency of Action	PRIORITY 3
Purpose of Action	LEVEL 2
Deficiency Photo1

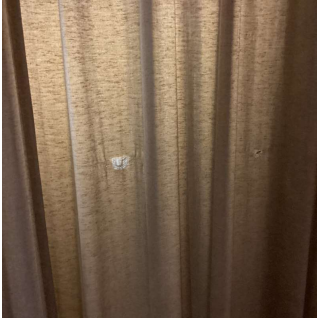
Left Side
Violations	No violations recorded.
Stage Curtain Rigging	Inspected
Instance on 1st Floor (380 Seats)	Inspected
Condition	2 - Between Good and Fair
Deficiency	No deficiencies recorded
Stage Curtains	Inspected
Instance on 1st Floor (380 Seats)	Inspected
Condition	3 - Fair
Deficiency	WORN/DETERIORATED
Deficiency Location/Instance	Rear
Deficiency Quantity	100
Quantity Uom	S.F.
Potential Action	REPLACE
Urgency of Action	PRIORITY 3
Purpose of Action	LEVEL 2
Deficiency Photo1

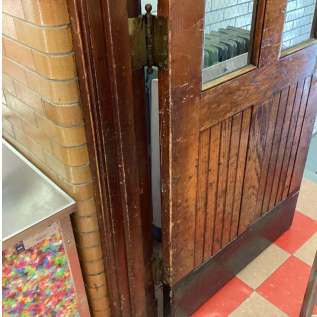
Question	Response
INTERIOR	
AUDITORIUM	
Walls	
Urgency of Action	PRIORITY 3
Purpose of Action	LEVEL 2
Deficiency Photo1	 
Violations	Right Side of Stage No violations recorded.
Window Curtains/Shades/Blinds	
Instance on 1st Floor (380 Seats)	Inspected
Condition	2 - Between Good and Fair
Deficiency	No deficiencies recorded
CAFETERIA	
Instance on 1st Floor	Inspected
Ceiling	
Instance on 1st Floor	Inspected
Condition	2 - Between Good and Fair
Deficiency	No deficiencies recorded
Door(s)	
Instance on 1st Floor	Inspected
Condition	4 - Between Fair and Poor
Deficiency	WOOD: DETERIORATED DOOR
Deficiency Location/Instance	Exit 2 Vestibule
Deficiency Quantity	2
Quantity Uom	EACH
Potential Action	MAINTENANCE
Urgency of Action	PRIORITY 3
Purpose of Action	LEVEL 2
Deficiency Photo1

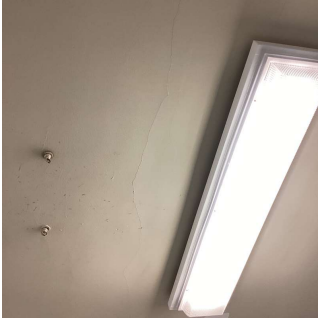
Question	Response
INTERIOR	
CAFETERIA	Inspected
Walls	
Condition	2 - Between Good and Fair
Deficiency	No deficiencies recorded
Window Curtains/Shades/Blinds	
Instance on 1st Floor	Does not Exist
CLASSROOMS/CORRIDORS/ADMIN SPACES	Inspected
Ceiling	Inspected
Condition	2 - Between Good and Fair
Deficiency	PLASTER: CRACKS/SPALLING
Deficiency Location/Instance	Corridor near Room 207
Deficiency Quantity	10
Quantity Uom	S.F.
Potential Action	REPLACE
Urgency of Action	PRIORITY 3
Purpose of Action	LEVEL 2
Deficiency Photo1

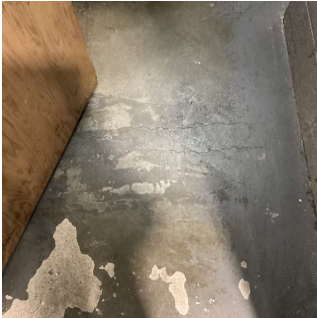
Question	Response
INTERIOR	
GYMNASIUM	
Door(s)	
Purpose of Action	LEVEL 2
Deficiency Photo1	 
	Storage Room
Violations	No violations recorded.
Fixed Equipment	
Instance on 2nd Floor	Inspected
Condition	2 - Between Good and Fair
Deficiency	No deficiencies recorded
Floor Finish	
Instance on 2nd Floor	Inspected
Condition	2 - Between Good and Fair
Deficiency	CONCRETE: CRACKS
Deficiency Location/Instance	Storage Room
Deficiency Quantity	25
Quantity Uom	S.F.
Potential Action	REPLACE
Urgency of Action	PRIORITY 3
Purpose of Action	LEVEL 2
Deficiency Photo1

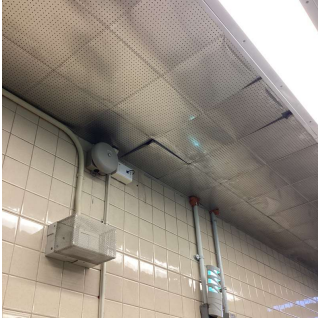
Question	Response
INTERIOR	
KITCHEN	
Ceiling	
Condition	2 - Between Good and Fair
Deficiency	METAL PAN: DAMAGED/MISSING
Deficiency Location/Instance	Near Storage Room
Deficiency Quantity	10
Quantity Uom	S.F.
Potential Action	REPLACE
Urgency of Action	PRIORITY 3
Purpose of Action	LEVEL 2
Deficiency Photo1

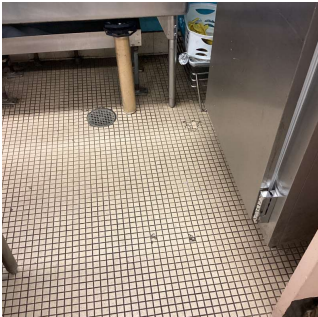
Violations	Near Storage Room No violations recorded.
Door(s)	
Instance on 1st Floor	Inspected
Condition	2 - Between Good and Fair
Deficiency	No deficiencies recorded
Floor Finish	
Instance on 1st Floor	Inspected
Condition	5 - Poor
Deficiency	CERAMIC TILE: BROKEN/MISSING TILES
Deficiency Location/Instance	Right Side
Deficiency Quantity	10
Quantity Uom	S.F.
Potential Action	REPLACE
Urgency of Action	PRIORITY 3
Purpose of Action	LEVEL 2
Deficiency Photo1

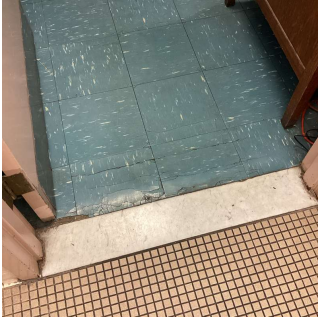
Violations	Right Side No violations recorded.
Deficiency	VINYL TILES: BROKEN/DETERIORATED/MISSING TILES
Deficiency Location/Instance	Storage Room, Locker Room
Deficiency Quantity	120

Question	Response
INTERIOR	
KITCHEN	
Floor Finish	
Quantity Uom	S.F.
Potential Action	REPLACE
Urgency of Action	PRIORITY 3
Purpose of Action	LEVEL 2
Deficiency Photo1

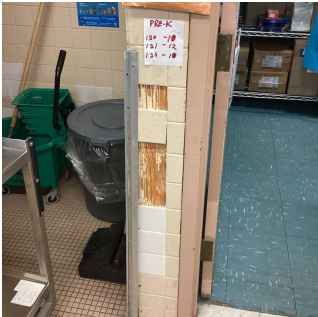
Storage Room
Violations	No violations recorded.
Walls	
Instance on 1st Floor	Inspected
Condition	2 - Between Good and Fair
Deficiency	CERAMIC TILE: BROKEN/ MISSING
Deficiency Location/Instance	Near Storage Room
Deficiency Quantity	10
Quantity Uom	S.F.
Potential Action	REPLACE
Urgency of Action	PRIORITY 3
Purpose of Action	LEVEL 2
Deficiency Photo1

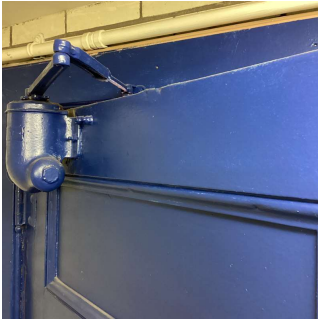
Question	Response
INTERIOR	
STAIRS/RAMPS: INTERIOR	
Ceiling	Inspected
Violations	No violations recorded.
Door(s)	Inspected
Condition	5 - Poor
Deficiency	METAL CLAD WOOD: DETERIORATED DOOR
Deficiency Location/Instance	Stair CD/1 Vestibule
Deficiency Quantity	1
Quantity Uom	EACH
Potential Action	MAINTENANCE
Urgency of Action	PRIORITY 3
Purpose of Action	LEVEL 2
Deficiency Photo1

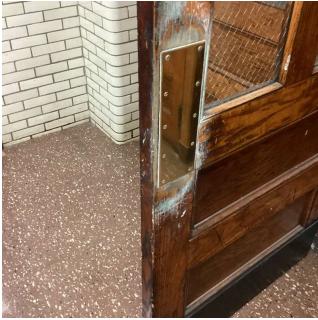
Violations	Stair CD/1 Vestibule No violations recorded.
Deficiency	WOOD: DETERIORATED DOOR
Deficiency Location/Instance	Stairs AB/1 Vestibule, CD/1 Vestibule
Deficiency Quantity	4
Quantity Uom	EACH
Potential Action	MAINTENANCE
Urgency of Action	PRIORITY 3
Purpose of Action	LEVEL 2
Deficiency Photo1

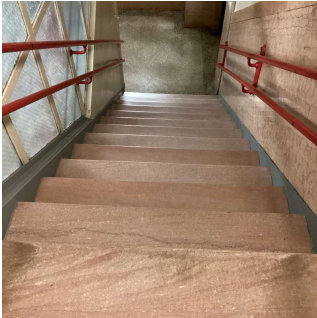
Question	Response
INTERIOR	
STAIRS/RAMPS: INTERIOR	
Stairs and Landings	
Deficiency	STONE: WORN-OUT TREAD/NOSINGS
Deficiency Location/Instance	Stair AB/1
Deficiency Quantity	120
Quantity Uom	S.F.
Potential Action	REPLACE
Urgency of Action	PRIORITY 3
Purpose of Action	LEVEL 2
Deficiency Photo1

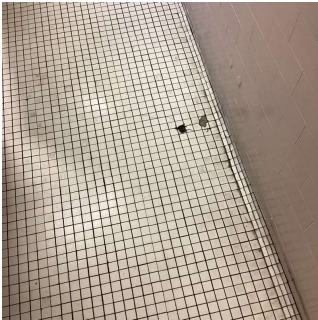
Question	Response
INTERIOR	
TOILET ROOMS - STAFF	
Door(s)	
Deficiency Quantity	1
Quantity Uom	EACH
Potential Action	MAINTENANCE
Urgency of Action	PRIORITY 3
Purpose of Action	LEVEL 2
Deficiency Photo1	No photo recorded
Violations	No violations recorded.
Floor Finish	Inspected
Condition	3 - Fair
Deficiency	CERAMIC TILE: BROKEN/MISSING TILES
Deficiency Location/Instance	Rooms 258
Deficiency Quantity	20
Quantity Uom	S.F.
Potential Action	REPLACE
Urgency of Action	PRIORITY 3
Purpose of Action	LEVEL 2
Deficiency Photo1

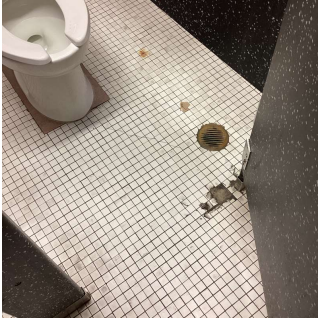
Deficiency	CERAMIC TILE: BROKEN/MISSING TILES

Question	Response
INTERIOR	
TOILET ROOMS - STUDENTS	Inspected
Floor Finish	
Deficiency Location/Instance	Rooms 358, 281A, 159
Deficiency Quantity	30
Quantity Uom	S.F.
Potential Action	REPLACE
Urgency of Action	PRIORITY 3
Purpose of Action	LEVEL 2
Deficiency Photo1

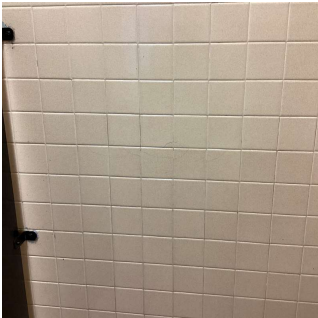
Room 358
Violations	No violations recorded.
Stalls	Inspected
Condition	2 - Between Good and Fair
Deficiency	No deficiencies recorded
Walls	Inspected
Condition	2 - Between Good and Fair
Deficiency	CERAMIC TILE: BROKEN/ MISSING
Deficiency Location/Instance	Room 281A
Deficiency Quantity	10
Quantity Uom	S.F.
Potential Action	REPLACE
Urgency of Action	PRIORITY 3
Purpose of Action	LEVEL 2
Deficiency Photo1

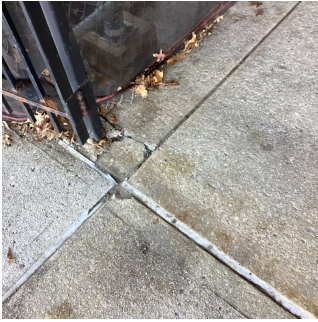
Question	Response
SITE	
PAVING	
Student Use	
Asphalt	Inspected
Deficiency	No deficiencies recorded
Concrete	Inspected
Condition	1 - Good
Deficiency	No deficiencies recorded
Pavers	Inspected
Condition	1 - Good
Deficiency	No deficiencies recorded
Site Sidewalks & Walkways	Inspected
Asphalt	Inspected
Condition	1 - Good
Deficiency	No deficiencies recorded
Concrete	Inspected
Condition	2 - Between Good and Fair
Deficiency	CRACKS - MAJOR
Deficiency Location/Instance	Exit 6
Deficiency Quantity	25
Quantity Uom	S.F.
Potential Action	REPLACE
Urgency of Action	PRIORITY 3
Purpose of Action	LEVEL 2
Deficiency Photo1

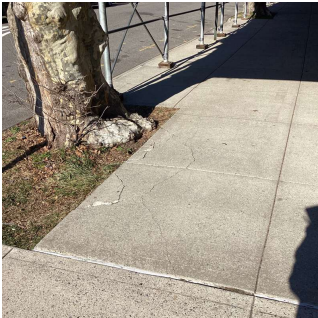
Question	Response
SITE	
PAVING	
DOT Sidewalk	
Concrete	
Violations	No violations recorded.
Deficiency	DAMAGED/DETERIORATED/MISSING SECTIONS
Deficiency Location/Instance	205th Street, 33rd Avenue, Clearview Expressway
Deficiency Quantity	1,050
Quantity Uom	S.F.
Potential Action	REPLACE
Urgency of Action	PRIORITY 3
Purpose of Action	LEVEL 2
Deficiency Photo1

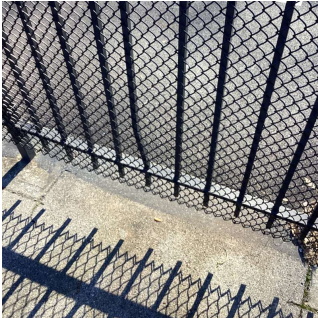
Violations	205th Street No violations recorded.
Pavers	Does not Exist
PLAYGROUNDS	Inspected
Instance on Schoolyard	Inspected
Benches	
Instance on Schoolyard	Inspected
Condition	2 - Between Good and Fair
Deficiency	No deficiencies recorded
Fence	
Instance on Schoolyard	Inspected
Condition	2 - Between Good and Fair
Deficiency	WROUGHT IRON: DAMAGED/DETERIORATED
Deficiency Location/Instance	Near Entrance
Deficiency Quantity	40
Quantity Uom	S.F.
Potential Action	REPLACE
Urgency of Action	PRIORITY 3
Purpose of Action	LEVEL 2
Deficiency Photo1

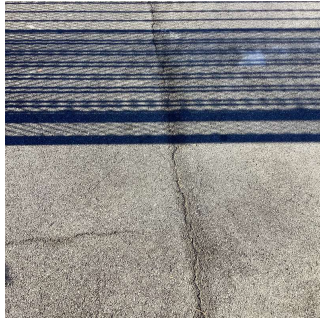
Question	Response
SITE	
PLAYGROUNDS	
Fence	
Violations	No violations recorded.
Pavement	
Instance on Schoolyard	Inspected
Condition	3 - Fair
Deficiency	ASPHALT: CRACKS - MAJOR
Deficiency Location/Instance	Near Entrance, Right and Left Side
Deficiency Quantity	200
Quantity Uom	S.F.
Potential Action	REPLACE
Urgency of Action	PRIORITY 3
Purpose of Action	LEVEL 2
Deficiency Photo1

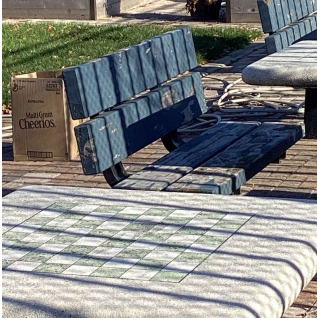
Instance on Schoolyard	Does not Exist
SEATING	
Instance on Schoolyard	Inspected
Benches	
Instance on Schoolyard	Inspected
Concrete	
Instance on Schoolyard	Does not Exist
Metal/Wood/Plastic	
Instance on Schoolyard	Inspected
Condition	5 - Poor
Deficiency	DAMAGED/DETERIORATED
Deficiency Location/Instance	Garden area near Schoolyard

Question	Response
SITE	
SEATING	
Benches	
Metal/Wood/Plastic	
Deficiency Quantity	3
Quantity Uom	EACH
Potential Action	REPLACE
Urgency of Action	PRIORITY 3
Purpose of Action	LEVEL 2
Deficiency Photo1

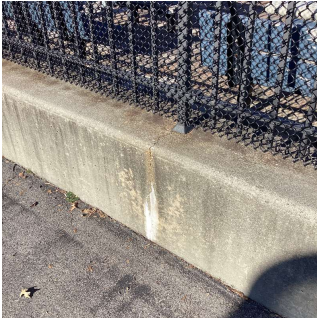
Violations	Garden area near Schoolyard No violations recorded.
Bleachers	Does not Exist
SITE WALLS (NOT RETAINING WALLS)	Inspected
Condition	3 - Fair
Deficiency	CAST IN PLACE CONCRETE: CRACKS/SPALLING - MAJOR
Deficiency Location/Instance	Near playground, near garden
Deficiency Quantity	50
Quantity Uom	S.F.
Potential Action	REPLACE
Urgency of Action	PRIORITY 3
Purpose of Action	LEVEL 2
Deficiency Photo1
