**NYC Department of Education**  
**Building Condition Assessment Survey 2023 - 2024**

Architectural Inspection

**Asset:** P.S. 160 - QUEENS, 109-59 INWOOD STREET, New York, 11435

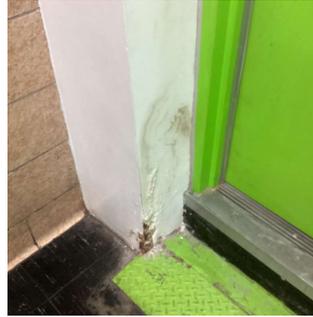
Facade F1 - Corridor near Room 402

Facade F
Violations	No violations recorded.
<b>EXTERIOR WALLS</b>	
Material Type(s)	Inspected Masonry
Replacement Quantity	32,000
Replacement Uom	S.F.
Instance on All Facades except Facades C, D, E, F	Inspected
Instance Condition	3 - Fair
Instance Quantity	22,000
Instance Quantity Uom	S.F.
Deficiency	BRICK: WATER INFILTRATION IN INSTRUCTIONAL SPACE
Roof Plan reference	Q160

Deficiency Quantity	100
Quantity Uom	S.F.
Potential Action	REPAIR
Urgency of Action	PRIORITY 5
Purpose of Action	LEVEL 2

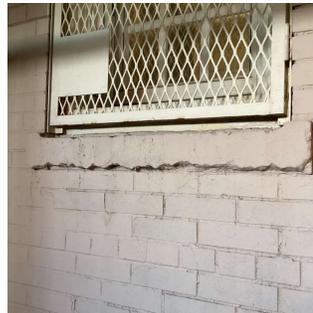
Facade G

**BRICK: DETERIORATED MASONRY SILLS - MAJOR**

10

REMOVE AND REPLACE

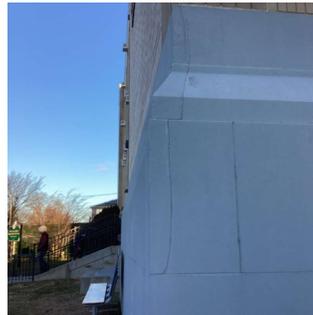
Facade H

STONE: CRACKS AT BUILDING CORNERS

30

REPLACE

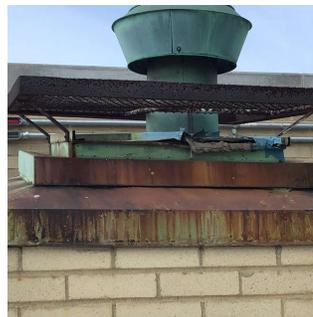
Roof 1  
 No violations recorded.

10  
 S.F.  
 MAINTENANCE  
 PRIORITY 3  
 LEVEL 2

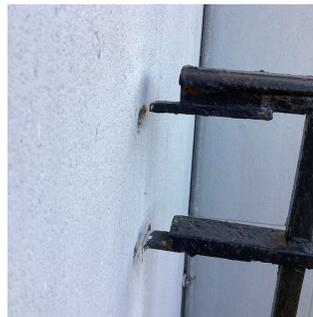
Facade H

BROKEN BRACKET

3

REPLACE

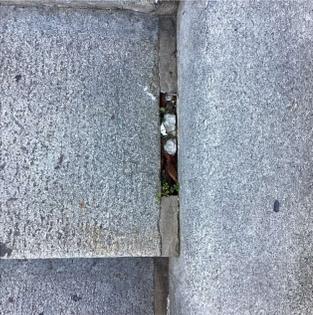
Question	Response
<b>EXTERIOR</b>	
<b>STAIRS/RAMPS: EXTERIOR</b>	
<b>STAIRS/RAMPS</b>	
Rooftop reference	<p>Q160</p>

Deficiency Quantity	20
Quantity Uom	L.F.
Potential Action	REPOINT
Urgency of Action	PRIORITY 4
Purpose of Action	LEVEL 2
Deficiency Photo1

<p>Facade A</p>
Violations	No violations recorded.
<b>WINDOWS</b>	Inspected
Replacement Quantity	10,000
Replacement Uom	S.F.
<b>EXTERIOR GUARDS</b>	Inspected
Condition	2 - Between Good and Fair
Deficiency	No deficiencies recorded
<b>LINTELS</b>	Inspected
Condition	2 - Between Good and Fair
Deficiency	No deficiencies recorded
<b>WINDOWS</b>	Inspected
Material Type(s)	Aluminum
Instance on Aluminum - Double Hung: All Facades	Inspected
Instance Condition	3 - Fair
Instance Quantity	10,000
Instance Quantity Uom	S.F.
Are these windows insulated	No
Installation Year	1999
Source of Installation	Custodial Staff
Deficiency	ALUMINUM - DOUBLE HUNG: INOPERABLE BALANCE

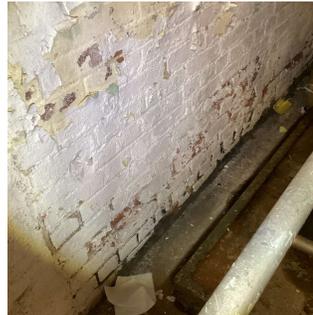
Basement - Storage

**MASONRY BEARING WALL: CRACKED/SPALLED**

LEVEL 5

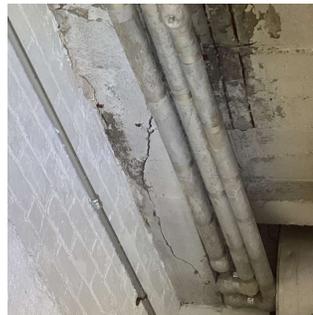
Basement - Storage

**STEEL COLUMNS/BEAMS: DETERIORATED CONCRETE FIREPROOFING**

REPLACE

LEVEL 5

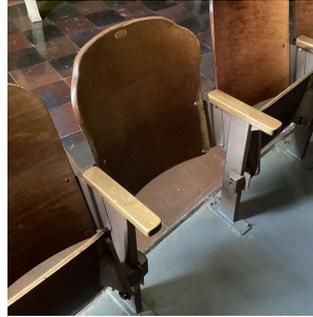
Seat W/25

<b>Door(s)</b>	
Instance on 1st Floor (618 Seats)	Inspected
Condition	2 - Between Good and Fair
Deficiency	No deficiencies recorded
<b>Fixed H/C Lift</b>	
Instance on 1st Floor (618 Seats)	Does not Exist
<b>Fixed Seating</b>	
Instance on 1st Floor (618 Seats)	Inspected
Condition	5 - Poor
Deficiency	DAMAGED/BROKEN/INOPERABLE
Deficiency Location/Instance	Seats A/7, M/27, Q/5, 27, S/22, W/17, 25
Deficiency Quantity	7
Quantity Uom	EACH

Potential Action	REPLACE
Urgency of Action	PRIORITY 5
Purpose of Action	LEVEL 6
Deficiency Photo1

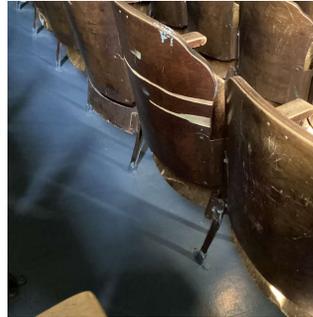
Seat U/23

Deficiency	DAMAGED/BROKEN/INOPERABLE
Deficiency Location/Instance	Seats N/23, 25, P/17, 19, U/23, and others.
Deficiency Quantity	310
Quantity Uom	EACH
Potential Action	REPLACE
Urgency of Action	PRIORITY 3
Purpose of Action	LEVEL 2
Deficiency Photo1

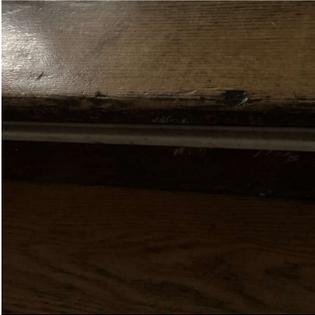
Violations	Near Step Right Side No violations recorded.
Deficiency	DAMAGED STEPS
Deficiency Location/Instance	Right and Left Side
Deficiency Quantity	20
Quantity Uom	S.F.
Potential Action	REPLACE
Urgency of Action	PRIORITY 3
Purpose of Action	LEVEL 2
Deficiency Photo1

Violations	Left Side No violations recorded.
<b>Stage Curtain Rigging</b>	Inspected
Instance on 1st Floor (618 Seats)	Inspected
Condition	2 - Between Good and Fair
Deficiency	No deficiencies recorded
<b>Stage Curtains</b>	Inspected
Instance on 1st Floor (618 Seats)	Inspected
Condition	2 - Between Good and Fair
Deficiency	No deficiencies recorded
<b>Walls</b>	
Instance on 1st Floor (618 Seats)	Inspected
Condition	2 - Between Good and Fair
Deficiency	STONE MOLDINGS: CRACKS/SPALLING
Deficiency Location/Instance	Near Stair F , Entrance
Deficiency Quantity	20

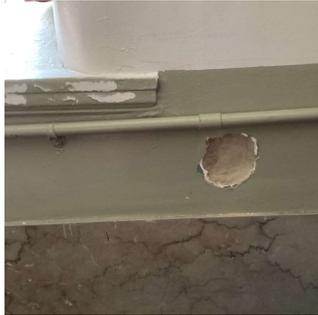
Near Stair Exit 9
Violations	No violations recorded.
Deficiency	PLASTER: CRACKS/SPALLING
Deficiency Location/Instance	Near Windows, Stage
Deficiency Quantity	30
Quantity Uom	S.F.
Potential Action	REPLACE
Urgency of Action	PRIORITY 3
Purpose of Action	LEVEL 2
Deficiency Photo1

Near Windows
Violations	No violations recorded.
<b>Window Curtains/Shades/Blinds</b>	
Instance on 1st Floor (618 Seats)	Inspected
Condition	2 - Between Good and Fair
Deficiency	No deficiencies recorded
<b>CAFETERIA</b>	
Instance on 1st Floor	Inspected
<b>Ceiling</b>	
Instance on 1st Floor	Inspected
Condition	2 - Between Good and Fair
Deficiency	ACOUSTIC TILES ON PLASTER: DAMAGED/MISSING
Deficiency Location/Instance	Near Windows, kitchen Locker Room
Deficiency Quantity	20
Quantity Uom	S.F.
Potential Action	REPLACE
Urgency of Action	PRIORITY 3

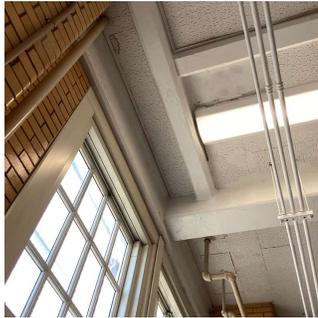
Question	Response
<b>INTERIOR</b>	
<b>CAFETERIA</b>	
<b>Ceiling</b>	
Deficiency Photo1

Violations	Near Windows No violations recorded.
<b>Door(s)</b>	
Instance on 1st Floor	Inspected
Condition	5 - Poor
Deficiency	WOOD: DETERIORATED DOOR
Deficiency Location/Instance	Entrances, Vestibule - Exit 2
Deficiency Quantity	3
Quantity Uom	EACH
Potential Action	MAINTENANCE
Urgency of Action	PRIORITY 3
Purpose of Action	LEVEL 2
Deficiency Photo1

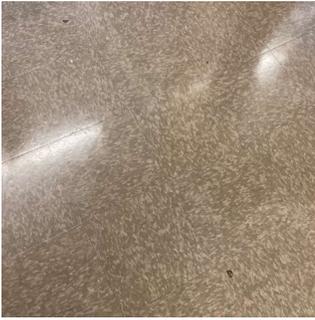
Violations	Entrance No violations recorded.
<b>Fixed Equipment</b>	
Instance on 1st Floor	Does not Exist
<b>Floor Finish</b>	
Instance on 1st Floor	Inspected
Condition	2 - Between Good and Fair
Deficiency	VINYL TILES: BROKEN/DETERIORATED/MISSING TILES
Deficiency Location/Instance	Near Entrance
Deficiency Quantity	10
Quantity Uom	S.F.
Potential Action	REPLACE
Urgency of Action	PRIORITY 3
Purpose of Action	LEVEL 2

Near Entrance
Violations	No violations recorded.
<b>Sliding-folding Partition</b>	
Instance on 1st Floor	Does not Exist
<b>Stage</b>	
Instance on 1st Floor	Does not Exist
<b>Walls</b>	
Instance on 1st Floor	Inspected
Condition	2 - Between Good and Fair
Deficiency	No deficiencies recorded
<b>Window Curtains/Shades/Blinds</b>	
Instance on 1st Floor	Does not Exist
<b>CLASSROOMS/CORRIDORS/ADMIN SPACES</b>	
<b>Ceiling</b>	Inspected
Condition	2 - Between Good and Fair
Deficiency	PLASTER: CRACKS/SPALLING
Deficiency Location/Instance	Room 428, Corridor near Rooms 306, 402, 411, 419, and others.
Deficiency Quantity	50
Quantity Uom	S.F.
Potential Action	REPLACE
Urgency of Action	PRIORITY 3
Purpose of Action	LEVEL 2
Deficiency Photo1

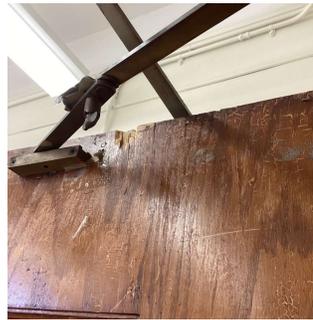
Room 221

Room 428
Violations	No violations recorded.
<b>Deficiency</b>	<b>WOOD: DETERIORATED DOOR</b>
Deficiency Location/Instance	Rooms 111, 128, 221, 319, 423, and others.
Deficiency Quantity	12
Quantity Uom	EACH
Potential Action	MAINTENANCE
Urgency of Action	PRIORITY 3
Purpose of Action	LEVEL 2

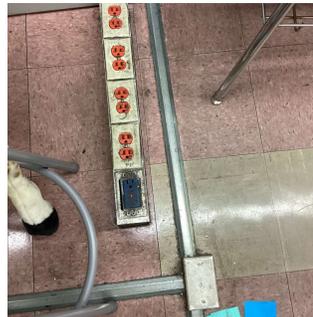
Room 415

VINYL TILES: TRIPPING HAZARD - ELECTRICAL OUTLET

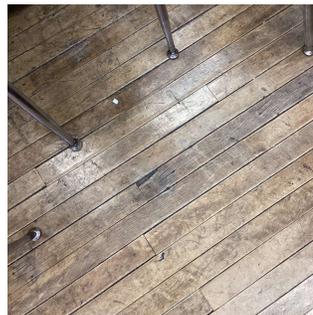
WOOD: DAMAGED/DETERIORATED

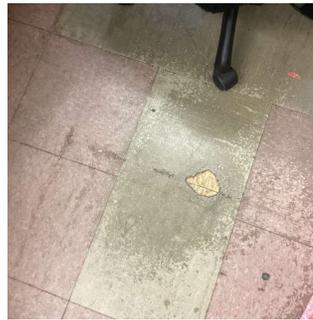
Room 415

Violations	Room 328 No violations recorded.
Deficiency	VINYL TILES: BROKEN/DETERIORATED/MISSING TILES
Deficiency Location/Instance	Rooms 127, 128, 415, Corridor near Rooms 319, 415, and others.
Deficiency Quantity	4,000

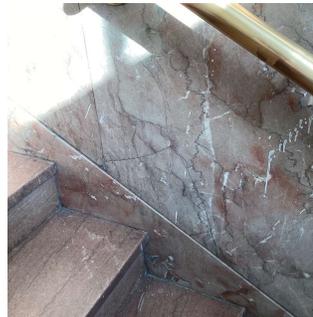
Exit 7 - Vestibule

STONE: CRACKS/SPALLING

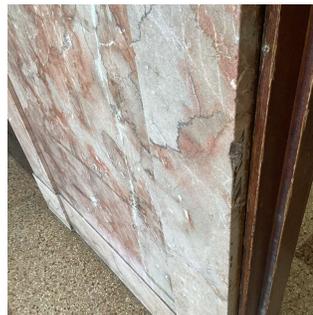
STONE MOLDINGS: CRACKS/SPALLING

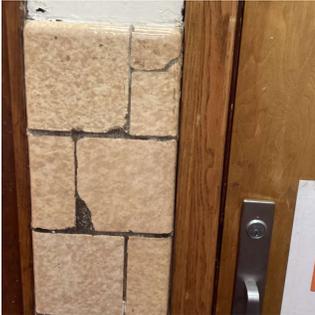
Question	Response
<b>INTERIOR</b>	
<b>CLASSROOMS/CORRIDORS/ADMIN SPACES</b>	
<b>Walls</b>	
Violations	Exit 7 - Vestibule No violations recorded.
Deficiency	GLAZED BLOCK: CRACKS/SPALLING
Deficiency Location/Instance	Near Gymnasium Entrance, Corridor near Room 419
Deficiency Quantity	20
Quantity Uom	S.F.
Potential Action	REPLACE
Urgency of Action	PRIORITY 3
Purpose of Action	LEVEL 2
Deficiency Photo1

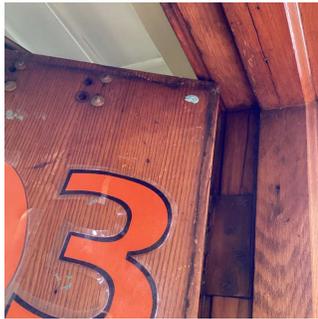
Violations	Room 128 No violations recorded.
<b>Specialties</b>	Does not Exist
<b>GYMNASIUM</b>	
Instance on 3rd Floor	Inspected
<b>Ceiling</b>	Inspected
Instance on 3rd Floor	Inspected
Condition	2 - Between Good and Fair
Deficiency	No deficiencies recorded
<b>Door(s)</b>	
Instance on 3rd Floor	Inspected
Condition	5 - Poor
Deficiency	WOOD: DETERIORATED DOOR AND FRAME
Deficiency Location/Instance	Room 303
Deficiency Quantity	1
Quantity Uom	EACH
Potential Action	MAINTENANCE
Urgency of Action	PRIORITY 3
Purpose of Action	LEVEL 2
Deficiency Photo1

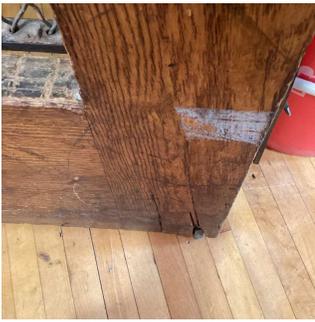
Violations	Room 303 No violations recorded.
Deficiency	WOOD: DETERIORATED DOOR
Deficiency Location/Instance	Storage Room, Room Near Stair
Deficiency Quantity	3
Quantity Uom	EACH
Potential Action	MAINTENANCE
Urgency of Action	PRIORITY 3
Purpose of Action	LEVEL 2

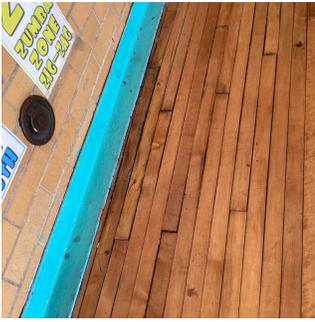
Violations	Storage Room No violations recorded.
<b>Fixed Equipment</b>	
Instance on 3rd Floor	Inspected
Condition	2 - Between Good and Fair
Deficiency	No deficiencies recorded
<b>Floor Finish</b>	
Instance on 3rd Floor	Inspected
Condition	2 - Between Good and Fair
Deficiency	WOOD: DAMAGED/DETERIORATED
Deficiency Location/Instance	Near center, windows
Deficiency Quantity	60
Quantity Uom	S.F.
Potential Action	REPLACE
Urgency of Action	PRIORITY 3
Purpose of Action	LEVEL 2
Deficiency Photo1

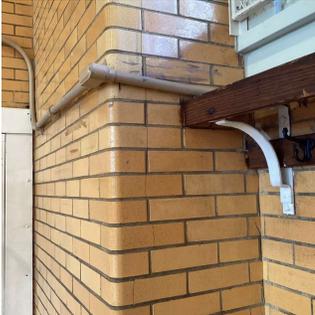
Question	Response
<b>INTERIOR</b>	
<b>GYMNASIUM</b>	
<b>Walls</b>	
Deficiency	BRICK: CRACKS/SPALLING
Deficiency Location/Instance	Near Windows
Deficiency Quantity	50
Quantity Uom	S.F.
Potential Action	REPLACE
Urgency of Action	PRIORITY 3
Purpose of Action	LEVEL 2
Deficiency Photo1

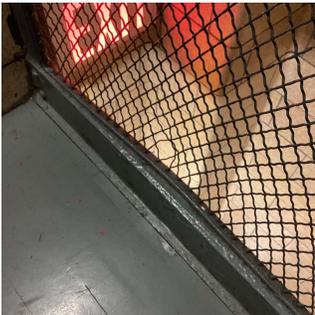
Violations	Near Windows No violations recorded.
<b>Window Curtains/Shades/Blinds</b>	
Instance on 3rd Floor	Does not Exist
<b>INTERIOR DOOR HARDWARE</b>	
Condition	Inspected
Deficiency	3 - Fair
Deficiency	No deficiencies recorded
<b>INTERIOR GUARDS</b>	
Condition	Inspected
Condition	3 - Fair
Deficiency	DETERIORATED/TORN-OUT/MISSING
Deficiency Location/Instance	Stair AB/1, 3
Deficiency Quantity	50
Quantity Uom	S.F.
Potential Action	REPLACE
Urgency of Action	PRIORITY 3
Purpose of Action	LEVEL 2
Deficiency Photo1

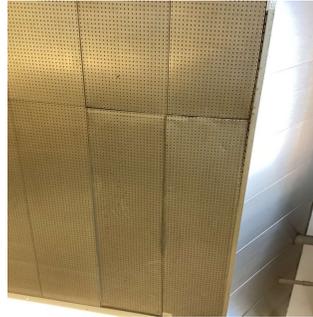
Near Windows

Condition	2 - Between Good and Fair
Deficiency	METAL PAN: DAMAGED/MISSING
Deficiency Location/Instance	Near Windows, Center
Deficiency Quantity	10
Quantity Uom	S.F.
Potential Action	REPLACE
Urgency of Action	PRIORITY 3
Purpose of Action	LEVEL 2
Deficiency Photo1

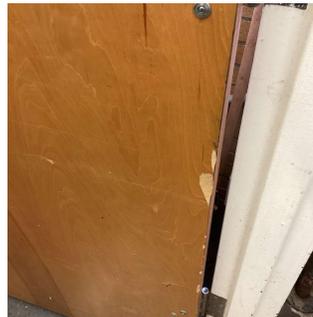
Instance on 1st Floor	Inspected
Condition	3 - Fair
Deficiency	WOOD: DETERIORATED DOOR
Deficiency Location/Instance	Office
Deficiency Quantity	1
Quantity Uom	EACH
Potential Action	MAINTENANCE
Urgency of Action	PRIORITY 3
Purpose of Action	LEVEL 2
Deficiency Photo1

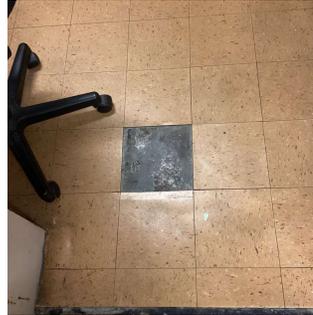
Locker - Inside Cafeteria

Instance on 1st Floor	Inspected
Condition	3 - Fair
Deficiency	VINYL TILES: BROKEN/DETERIORATED/MISSING TILES
Deficiency Location/Instance	Locker - Inside Cafeteria, Office
Deficiency Quantity	10
Quantity Uom	S.F.

Potential Action	REPLACE
Urgency of Action	PRIORITY 3
Purpose of Action	LEVEL 2
Deficiency Photo1

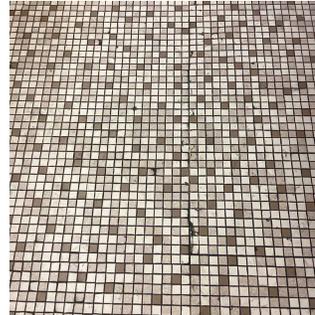
Near center

Deficiency	CERAMIC TILE: BROKEN/MISSING TILES
Deficiency Location/Instance	Near center, Entrance, Walk in Fridge, near Office
Deficiency Quantity	40
Quantity Uom	S.F.
Potential Action	REPLACE
Urgency of Action	PRIORITY 3
Purpose of Action	LEVEL 2
Deficiency Photo1

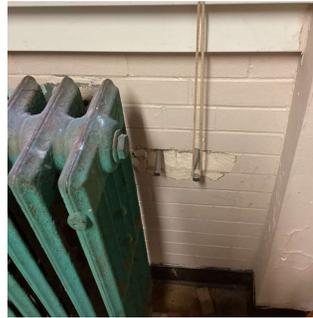
Instance on 1st Floor	Inspected
Condition	2 - Between Good and Fair
Deficiency	BRICK: CRACKS/SPALLING
Deficiency Location/Instance	Locker - Inside Cafeteria
Deficiency Quantity	10
Quantity Uom	S.F.
Potential Action	REPLACE
Urgency of Action	PRIORITY 3
Purpose of Action	LEVEL 2

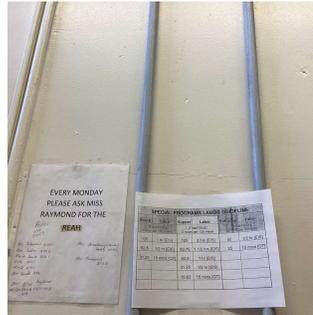
Office

PLASTER: CRACKS/SPALLING

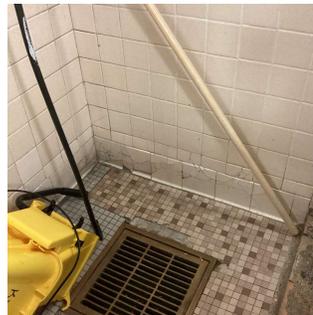
Mop Room

CERAMIC TILE: BROKEN/ MISSING

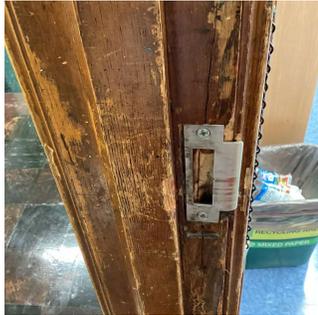
Question	Response
<b>INTERIOR</b>	
<b>LIBRARY</b>	Inspected
Instance on Room 317	Inspected
<b>Built-in Furnishing</b>	
Instance on Room 317	Inspected
Condition	1 - Good
Deficiency	No deficiencies recorded
<b>Ceiling</b>	
Instance on Room 317	Inspected
Condition	2 - Between Good and Fair
Deficiency	No deficiencies recorded
<b>Door(s)</b>	
Instance on Room 317	Inspected
Condition	3 - Fair
Deficiency	WOOD: DETERIORATED DOOR AND FRAME
Deficiency Location/Instance	Room 317
Deficiency Quantity	1
Quantity Uom	EACH
Potential Action	MAINTENANCE
Urgency of Action	PRIORITY 3
Purpose of Action	LEVEL 2
Deficiency Photo1

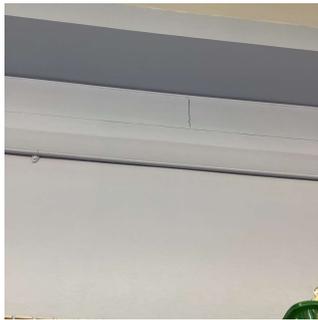
Room 317
Violations	No violations recorded.
<b>Floor Finish</b>	
Instance on Room 317	Inspected
Condition	2 - Between Good and Fair
Deficiency	No deficiencies recorded
<b>Walls</b>	
Instance on Room 317	Inspected
Condition	2 - Between Good and Fair
Deficiency	PLASTER: CRACKS/SPALLING
Deficiency Location/Instance	Near Entrance

Deficiency Quantity	10
Quantity Uom	S.F.
Potential Action	REPLACE
Urgency of Action	PRIORITY 3
Purpose of Action	LEVEL 2

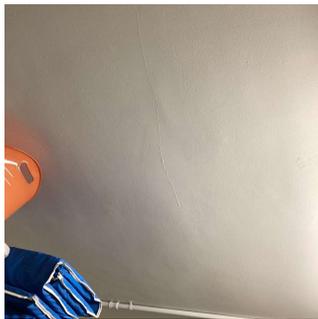
Violations	Near Entrance No violations recorded.
<b>LOCKER ROOM</b>	
Instance on 4th Floor (400 SF)	Inspected
Alternative use	Inspected
	Yes
<b>Ceiling</b>	
Instance on 4th Floor (400 SF)	Inspected
Condition	2 - Between Good and Fair
Deficiency	PLASTER: CRACKS/SPALLING
Deficiency Location/Instance	Near Shower Room
Deficiency Quantity	10
Quantity Uom	S.F.
Potential Action	REPLACE
Urgency of Action	PRIORITY 3
Purpose of Action	LEVEL 2
Deficiency Photo1

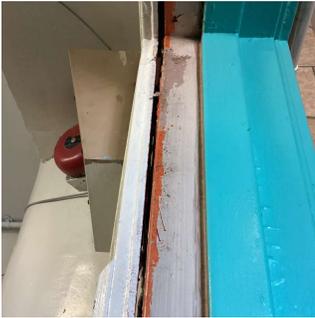
Violations	Near Shower Room No violations recorded.
<b>Door(s)</b>	
Instance on 4th Floor (400 SF)	Inspected
Condition	3 - Fair
Deficiency	METAL: DETERIORATED DOOR AND FRAME
Deficiency Location/Instance	Entrance
Deficiency Quantity	1
Quantity Uom	EACH
Potential Action	MAINTENANCE
Urgency of Action	PRIORITY 3
Purpose of Action	LEVEL 2

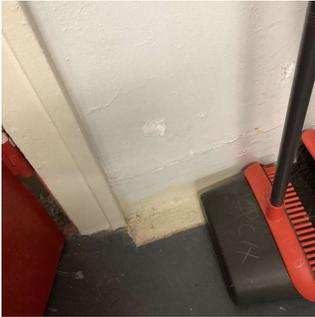
Violations	Entrance No violations recorded.
<b>Floor Finish</b>	
Instance on 4th Floor (400 SF)	Inspected
Condition	2 - Between Good and Fair
Deficiency	No deficiencies recorded
<b>Locker Room Lockers</b>	
Instance on 4th Floor (400 SF)	Does not Exist
<b>Walls</b>	
Instance on 4th Floor (400 SF)	Inspected
Condition	2 - Between Good and Fair
Deficiency	PLASTER: CRACKS/SPALLING
Deficiency Location/Instance	Near Entrance
Deficiency Quantity	10
Quantity Uom	S.F.
Potential Action	REPLACE
Urgency of Action	PRIORITY 3
Purpose of Action	LEVEL 2
Deficiency Photo1

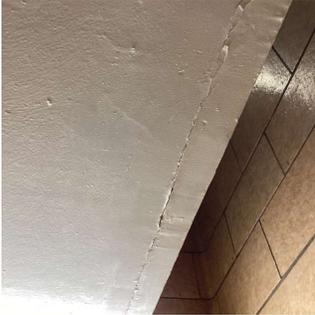
Question	Response
<b>INTERIOR</b>	
<b>STAIRS/RAMPS: INTERIOR</b>	
<b>Ceiling</b>	Inspected
Condition	2 - Between Good and Fair
Deficiency	PLASTER: CRACKS/SPALLING
Deficiency Location/Instance	Stair AB/2, 3
Deficiency Quantity	30
Quantity Uom	S.F.
Potential Action	REPLACE
Urgency of Action	PRIORITY 3
Purpose of Action	LEVEL 2
Deficiency Photo1

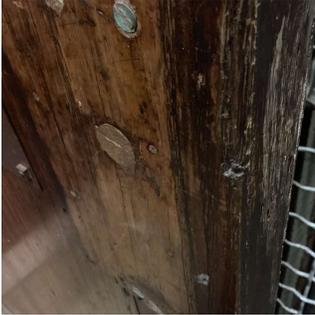
Violations	Stair AB/2 No violations recorded.
<b>Door(s)</b>	Inspected
Condition	5 - Poor
Deficiency	WOOD: DETERIORATED DOOR
Deficiency Location/Instance	Vestibule Exit 8
Deficiency Quantity	2
Quantity Uom	EACH
Potential Action	MAINTENANCE
Urgency of Action	PRIORITY 3
Purpose of Action	LEVEL 2
Deficiency Photo1

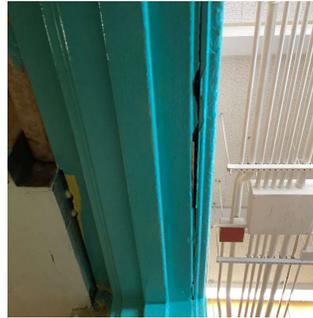
Violations	Vestibule Exit 8 No violations recorded.
Deficiency	METAL: DETERIORATED DOOR AND FRAME
Deficiency Location/Instance	Stair CD/1
Deficiency Quantity	1
Quantity Uom	EACH
Potential Action	MAINTENANCE
Urgency of Action	PRIORITY 3
Purpose of Action	LEVEL 2

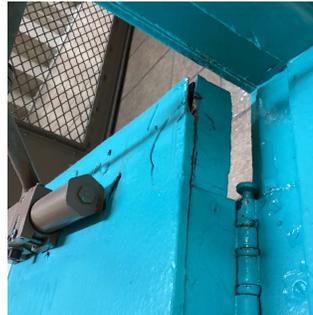
Stair CD/2

METAL: DETERIORATED DOOR

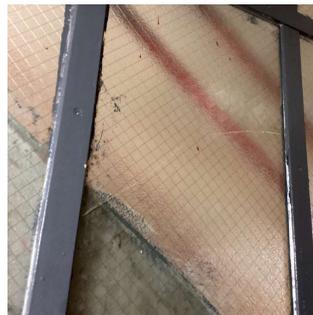
GLASS PANEL: DAMAGED/DETERIORATED

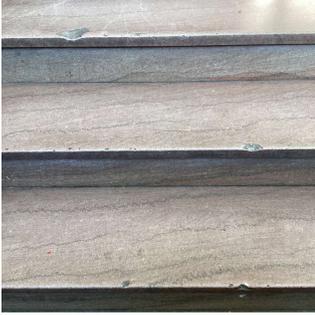
Question	Response
<b>INTERIOR</b>	
<b>STAIRS/RAMPS: INTERIOR</b>	
<b>Partition</b>	Inspected
	Stair AB/2
Violations	No violations recorded.
<b>Railings</b>	Inspected
Condition	2 - Between Good and Fair
Deficiency	No deficiencies recorded
<b>Stairs and Landings</b>	Inspected
Condition	5 - Poor
Deficiency	STONE: BROKEN/MISSING
Deficiency Location/Instance	Exit 7 - Vestibule, Entrance Exit 2 - Vestibule
Deficiency Quantity	40
Quantity Uom	S.F.
Potential Action	REPLACE
Urgency of Action	PRIORITY 3
Purpose of Action	LEVEL 2
Deficiency Photo1

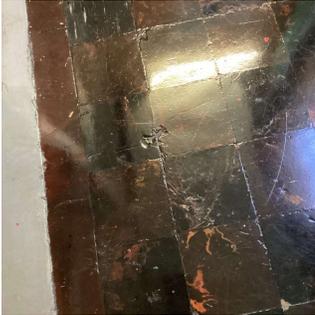
Violations	Exit 7 - Vestibule No violations recorded.
Deficiency	VINYL TILES: BROKEN/DETERIORATED/MISSING TILES
Deficiency Location/Instance	Stair AB/1, 3, 4, CD/4, 3, and others.
Deficiency Quantity	900
Quantity Uom	S.F.
Potential Action	REPLACE
Urgency of Action	PRIORITY 3
Purpose of Action	LEVEL 2
Deficiency Photo1

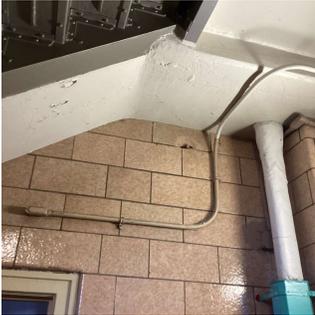
Condition	2 - Between Good and Fair
Deficiency	GLAZED BLOCK: CRACKS/SPALLING
Deficiency Location/Instance	Stair E/1, Exit 9 - Vestibule

Question	Response
<b>INTERIOR</b>	
<b>STAIRS/RAMPS: INTERIOR</b>	
<b>Walls</b>	
Deficiency Quantity	10
Quantity Uom	S.F.
Potential Action	REPLACE
Urgency of Action	PRIORITY 3
Purpose of Action	LEVEL 2
Deficiency Photo1

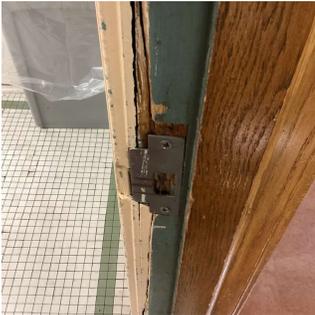
Room 104
Violations	No violations recorded.
Deficiency	METAL: DETERIORATED DOOR
Deficiency Location/Instance	2nd Floor
Deficiency Quantity	1
Quantity Uom	EACH
Potential Action	MAINTENANCE
Urgency of Action	PRIORITY 3
Purpose of Action	LEVEL 2

Stair E/1
Violations	No violations recorded.
<b>TOILET ROOMS - STAFF</b>	Inspected
<b>Ceiling</b>	Inspected
Condition	2 - Between Good and Fair
Deficiency	No deficiencies recorded
<b>Door(s)</b>	Inspected
Condition	5 - Poor
Deficiency	WOOD: DETERIORATED DOOR AND FRAME
Deficiency Location/Instance	Room 104
Deficiency Quantity	1
Quantity Uom	EACH
Potential Action	MAINTENANCE
Urgency of Action	PRIORITY 3
Purpose of Action	LEVEL 2
Deficiency Photo1

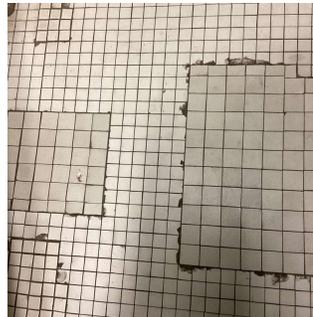
Kitchen - Inside Cafeteria

CERAMIC TILE: BROKEN/MISSING TILES

REPLACE

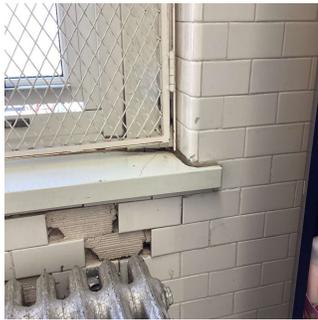
Room 106
Violations	No violations recorded.
Deficiency	CERAMIC TILE: BROKEN/ MISSING
Deficiency Location/Instance	Room 106, 2nd Floor, 4th Floor, Kitchen - Inside Cafeteria, Gymnasium- Inside Stair Case, and others.
Deficiency Quantity	30
Quantity Uom	S.F.
Potential Action	REPLACE
Urgency of Action	PRIORITY 3
Purpose of Action	LEVEL 2

Question	Response
<b>INTERIOR</b>	
<b>TOILET ROOMS - STAFF</b>	Inspected
<b>Walls</b>	
Deficiency Photo1

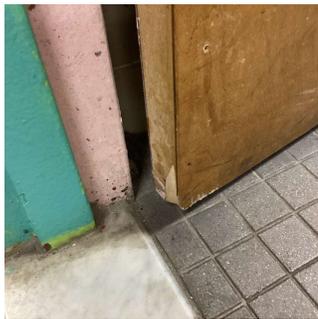
Violations	4th Floor No violations recorded.
<b>TOILET ROOMS - STUDENTS</b>	Inspected
<b>Ceiling</b>	Inspected
Condition	2 - Between Good and Fair
Deficiency	No deficiencies recorded
<b>Door(s)</b>	Inspected
Condition	5 - Poor
Deficiency	WOOD: DETERIORATED DOOR
Deficiency Location/Instance	Boys 2nd Floor, Girls - 3rd Floor
Deficiency Quantity	2
Quantity Uom	EACH
Potential Action	MAINTENANCE
Urgency of Action	PRIORITY 3
Purpose of Action	LEVEL 2
Deficiency Photo1

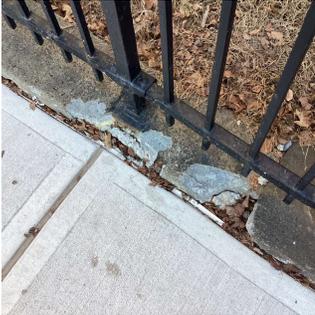
Question	Response
<b>SITE</b>	
<b>FENCES</b>	
Deficiency Photo1

Violations	110th Street No violations recorded.
<b>IRRIGATION SYSTEM</b>	Does not Exist
<b>PAVING</b>	Inspected
<b>Student Non-Use</b>	Inspected
Gravel Exists?	No
<b>Asphalt</b>	Under Construction
<b>Concrete</b>	Inspected
Condition	3 - Fair
Deficiency	DAMAGED/DETERIORATED/MISSING SECTIONS
Deficiency Location/Instance	Near Exit 2
Deficiency Quantity	125
Quantity Uom	S.F.
Potential Action	REPLACE
Urgency of Action	PRIORITY 3
Purpose of Action	LEVEL 2
Deficiency Photo1

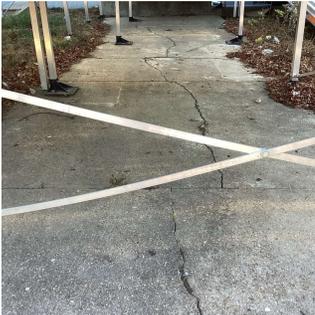
Violations	Near Exit 2 No violations recorded.
<b>Pavers</b>	Does not Exist
<b>Student Use</b>	Under Construction
<b>Site Sidewalks &amp; Walkways</b>	Inspected
<b>Asphalt</b>	Inspected
Condition	2 - Between Good and Fair
Deficiency	CRACKS - MAJOR
Deficiency Location/Instance	Near Exit 9
Deficiency Quantity	30
Quantity Uom	S.F.
Potential Action	REPLACE
Urgency of Action	PRIORITY 3

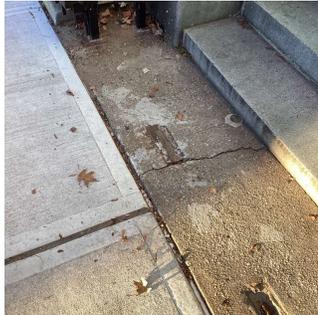
Violations	Near Exit 9 No violations recorded.
<b>Concrete</b>	Inspected
Condition	2 - Between Good and Fair
Deficiency	DAMAGED/DETERIORATED/MISSING SECTIONS
Deficiency Location/Instance	Near Exit 7
Deficiency Quantity	25
Quantity Uom	S.F.
Potential Action	REPLACE
Urgency of Action	PRIORITY 3
Purpose of Action	LEVEL 2
Deficiency Photo1

Violations	Near Exit 7 No violations recorded.
<b>Pavers</b>	Does not Exist
<b>DOT Sidewalk</b>	Inspected
<b>Asphalt</b>	Does not Exist
<b>Concrete</b>	Inspected
Condition	4 - Between Fair and Poor
Deficiency	DAMAGED/DETERIORATED/MISSING SECTIONS
Deficiency Location/Instance	Inwood Street, 110th Street, Glassboro Avenue.
Deficiency Quantity	900
Quantity Uom	S.F.
Potential Action	REPLACE
Urgency of Action	PRIORITY 3
Purpose of Action	LEVEL 2

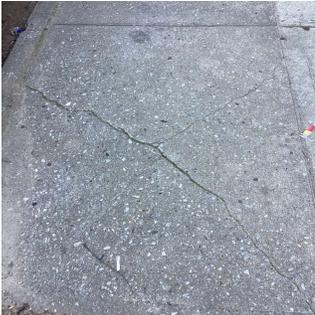
Violations	110th Street No violations recorded.
Deficiency	DAMAGED CURBS
Deficiency Location/Instance	Inwood Street, 110th Street, Glassboro Avenue.
Deficiency Quantity	130
Quantity Uom	L.F.
Potential Action	REPLACE
Urgency of Action	PRIORITY 3
Purpose of Action	LEVEL 2
Deficiency Photo1
