NYC Department of Education
Building Condition Assessment Survey 2023 - 2024

Architectural Inspection

Asset: P.S. 161 - QUEENS, 101-33 124TH STREET, New York, 11419

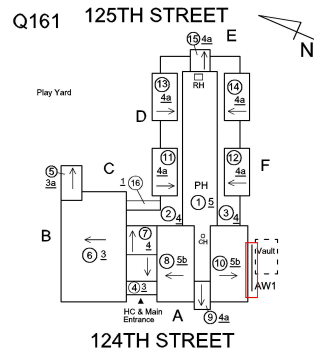
AREAWAY SLAB: CRACKS AND SPALLING

30
 S.F.
 REPAIR
 PRIORITY 3
 LEVEL 2

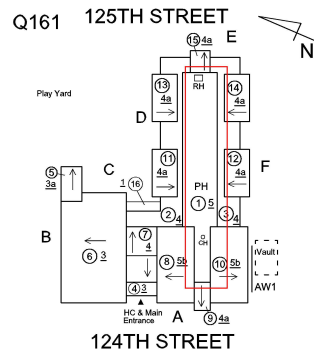
CAST STONE: DETERIORATED TRANSVERSE JOINTS

Question	Response
EXTERIOR	
COPING	
Quantity Uom	L.F.
Potential Action	MAINTENANCE
Urgency of Action	PRIORITY 3
Purpose of Action	LEVEL 2
Deficiency Photo1

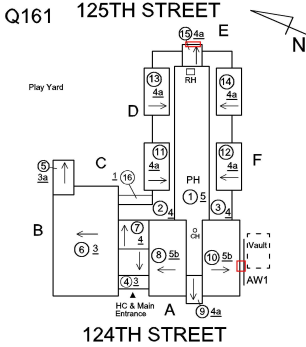
Violations	Roof 1 No violations recorded.
CORNICE	Does not Exist
DOORS	Inspected
DOORS AND FRAMES	Inspected
Condition	4 - Between Fair and Poor
Deficiency	METAL: DETERIORATED DOOR AND FRAME - MAJOR DETERIORATION
Roof Plan reference	Q161 125TH STREET

Deficiency Quantity	4
Quantity Uom	EACH
Potential Action	REPLACE
Urgency of Action	PRIORITY 4
Purpose of Action	LEVEL 2
Deficiency Photo1

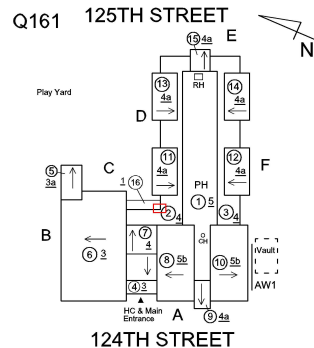
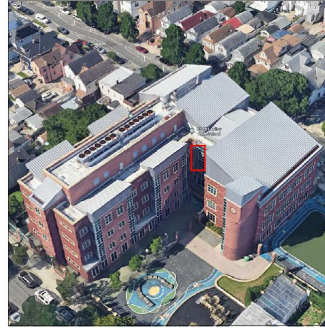
BRICK: WATER INFILTRATION IN INSTRUCTIONAL SPACE

REPAIR

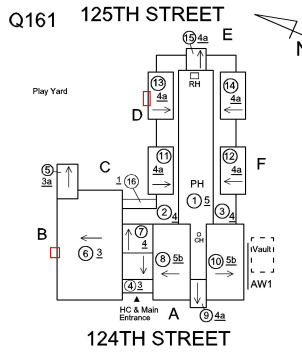
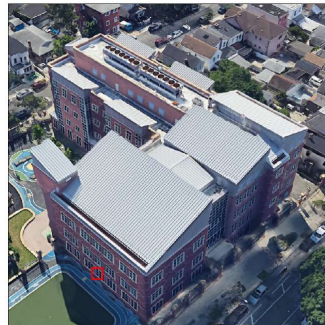
BRICK: MASONRY SILLS - DETERIORATED JOINTS

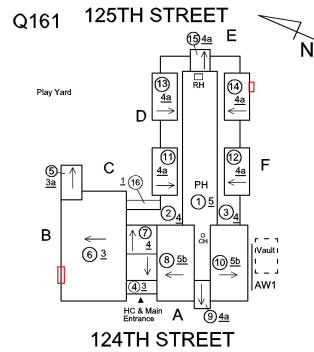
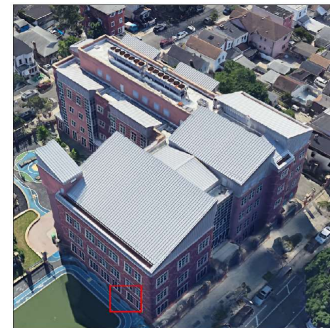
BRICK: DETERIORATED MASONRY SILLS - MINOR

REPAIR

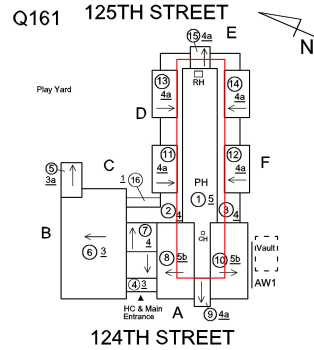
BRICK: EFFLORESCENCE

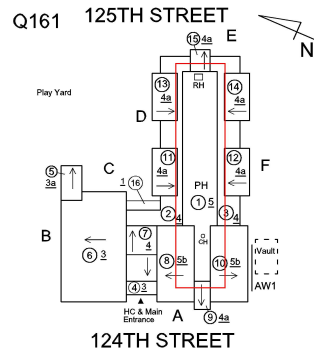
BRICK: DETERIORATED JOINTS

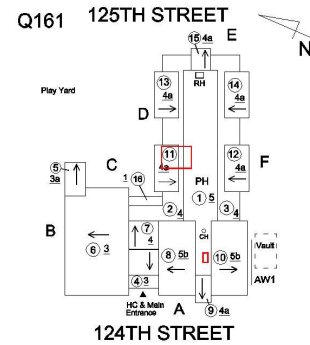
MODIFIED BITUMEN: ROOFING: MAJOR ACTIVE ROOF
LEAKS IN INSTRUCTIONAL SPACE

REPLACE ROOFING WITHOUT MAJOR EQUIPMENT
REMOVAL

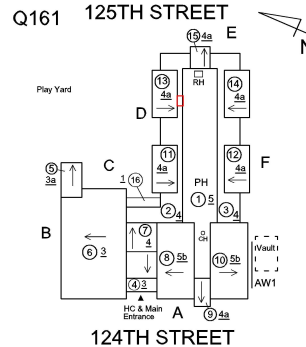
MODIFIED BITUMEN: ROOFING: DELAMINATION

REPLACE ROOFING WITHOUT MAJOR EQUIPMENT
REMOVAL

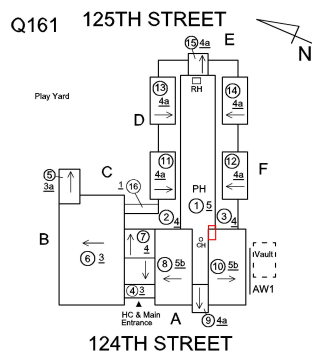
BULKHEAD/PENTHOUSE WALLS/EXTERIOR: WATER INFILTRATION

Question	Response
EXTERIOR	
ROOF	
Specialties	
BULKHEAD/PENTHOUSE	
Quantity Uom	S.F.
Potential Action	REPAIR
Urgency of Action	PRIORITY 5
Purpose of Action	LEVEL 2
Deficiency Photo1

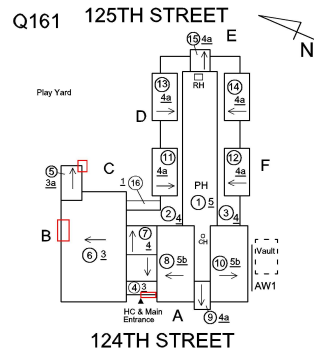
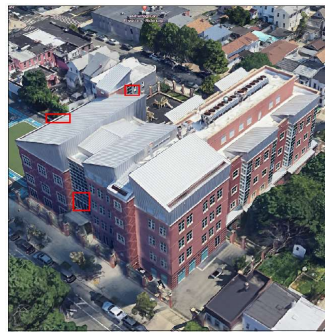
Facade A
No violations recorded.

Deficiency	ALUMINUM - DOUBLE HUNG: DETERIORATED

120
S.F.
REPLACE WINDOW
PRIORITY 4
LEVEL 2

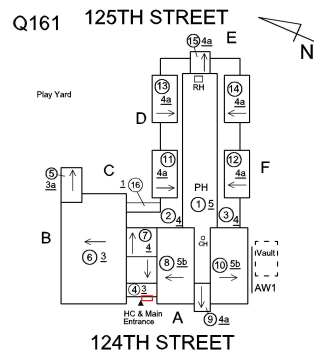
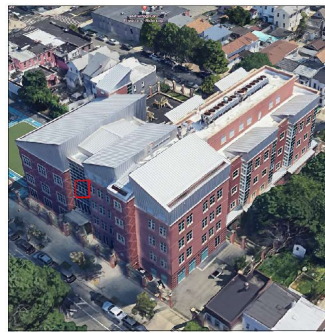
Instance on Aluminum - Other: All Facades	Inspected
Instance Condition	4 - Between Fair and Poor
Instance Quantity	2,000
Instance Quantity Uom	S.F.
Are these windows insulated	Yes
Installation Year	2000
Source of Installation	Custodial Staff
Deficiency	ALUMINUM - OTHER: BROKEN PANE

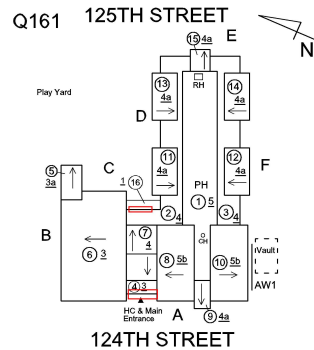
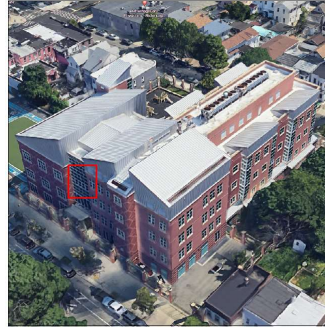
Facade A
No violations recorded.

ALUMINUM - OTHER: DETERIORATED

400
S.F.
REPLACE WINDOW
PRIORITY 4
LEVEL 2

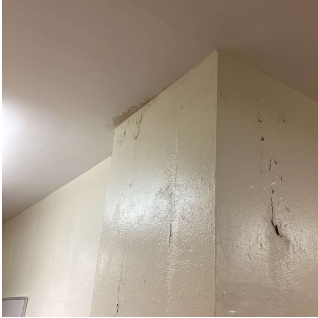
Question	Response
INTERIOR	
STRUCTURAL	
COLUMNS/BEAMS/BEARING WALLS	Inspected
Violations	Basement - Oil Tank Room No violations recorded.
FLOOR STRUCTURE	Inspected
Condition	2 - Between Good and Fair
Deficiency	No deficiencies recorded
FOUNDATION WALLS	Inspected
Material Type(s)	Concrete
Condition	4 - Between Fair and Poor
Deficiency	CONCRETE: WATER INFILTRATION IN INSTRUCTIONAL SPACE
Deficiency Location/Instance	Basement - Gymnasium Storage
Deficiency Quantity	100
Quantity Uom	S.F.
Potential Action	INSTALL WATERPROOFING
Urgency of Action	PRIORITY 5
Purpose of Action	LEVEL 5
Deficiency Photo1

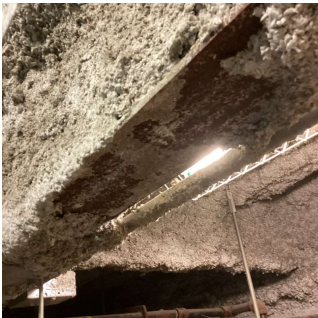
Violations	Penthouse Roof

Violations	Basement - Gymnasium Storage No violations recorded.
ROOF STRUCTURE	Inspected
Condition	3 - Fair
Deficiency	STEEL COLUMNS/BEAMS: DETERIORATED/MISSING SPRAY-ON FIREPROOFING
Deficiency Location/Instance	Penthouse Roof
Deficiency Quantity	30
Quantity Uom	S.F.
Potential Action	REPLACE
Urgency of Action	PRIORITY 3
Purpose of Action	LEVEL 5

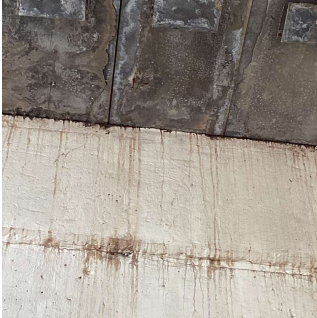
Question	Response
INTERIOR	
STRUCTURAL	
ROOF STRUCTURE	Inspected
Violations	No violations recorded.
VAULTS-BUNKERS	Inspected
Foundation Walls	Inspected
Condition	3 - Fair
Deficiency	CRACKS, SPALLING
Deficiency Location/Instance	Sub Basement - Vault
Deficiency Quantity	30
Quantity Uom	S.F.
Potential Action	REPAIR
Urgency of Action	PRIORITY 3
Purpose of Action	LEVEL 5
Deficiency Photo1	 
Violations	Sub Basement - Vault No violations recorded.
Slab Structure	Inspected
Condition	4 - Between Fair and Poor
Deficiency	CONCRETE: WATER INFILTRATION IN NON- INSTRUCTIONAL SPACE
Deficiency Location/Instance	Sub Basement - Vault
Deficiency Quantity	100
Quantity Uom	S.F.
Potential Action	INSTALL WATERPROOFING
Urgency of Action	PRIORITY 5
Purpose of Action	LEVEL 5
Deficiency Photo1

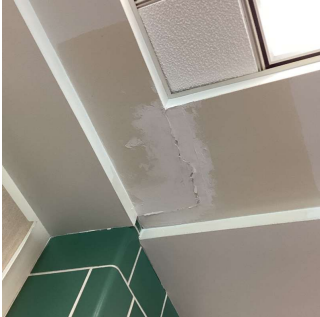
Question	Response
INTERIOR	
CAFETERIA	
Instance on 2nd Floor	Inspected
Ceiling	
Instance on 2nd Floor	Inspected
Condition	2 - Between Good and Fair
Deficiency	GYPSUM BOARD: DAMAGED/DETERIORATED
Deficiency Location/Instance	Near Main Entrance
Deficiency Quantity	10
Quantity Uom	S.F.
Potential Action	REPLACE
Urgency of Action	PRIORITY 3
Purpose of Action	LEVEL 2
Deficiency Photo1

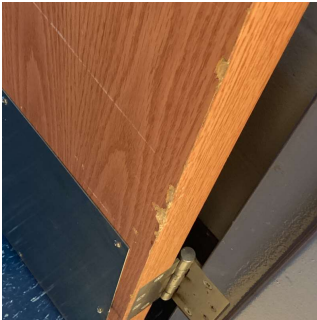
Violations	Main Entrance Vestibule No violations recorded.
Door(s)	Inspected
Condition	4 - Between Fair and Poor
Deficiency	WOOD: DETERIORATED DOOR
Deficiency Location/Instance	Rooms 238, 331, 433
Deficiency Quantity	3
Quantity Uom	EACH
Potential Action	MAINTENANCE
Urgency of Action	PRIORITY 3
Purpose of Action	LEVEL 2
Deficiency Photo1

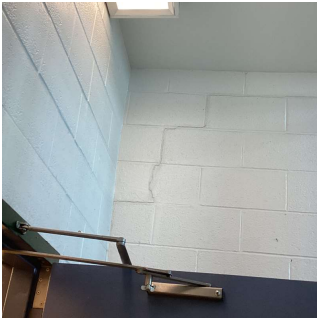
SHOWER ROOM	Does not Exist
STAIRS/RAMPS: INTERIOR	Inspected
Do Letter Stair Signs Exist?	Yes
Ceiling	Inspected
Condition	2 - Between Good and Fair
Deficiency	GYPSUM BOARD: DAMAGED/DETERIORATED
Deficiency Location/Instance	Stair B/4

Question	Response
INTERIOR	
STAIRS/RAMPS: INTERIOR	
Walls	
Deficiency Quantity	30
Quantity Uom	S.F.
Potential Action	REPLACE
Urgency of Action	PRIORITY 3
Purpose of Action	LEVEL 2
Deficiency Photo1

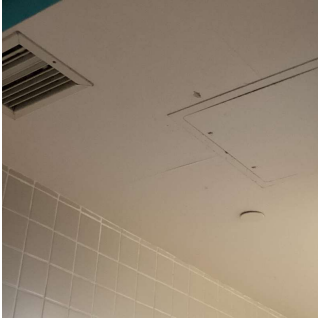
Question	Response
INTERIOR	
TOILET ROOMS - STAFF	Inspected
Walls	Inspected
Violations	Inside the Gymnasium Office No violations recorded.
TOILET ROOMS - STUDENTS	Inspected
Ceiling	Inspected
Condition	2 - Between Good and Fair
Deficiency	GYPSUM BOARD: DAMAGED/DETERIORATED
Deficiency Location/Instance	Room 203
Deficiency Quantity	10
Quantity Uom	S.F.
Potential Action	REPLACE
Urgency of Action	PRIORITY 3
Purpose of Action	LEVEL 2
Deficiency Photo1

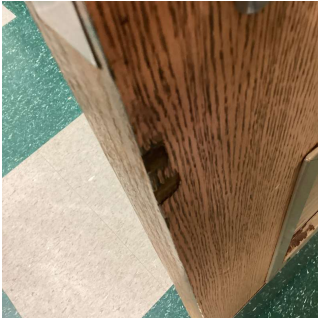
Violations	Room 203 No violations recorded.
Door(s)	Inspected
Condition	3 - Fair
Deficiency	WOOD: DETERIORATED DOOR
Deficiency Location/Instance	Inside Room 140
Deficiency Quantity	1
Quantity Uom	EACH
Potential Action	MAINTENANCE
Urgency of Action	PRIORITY 3
Purpose of Action	LEVEL 2
Deficiency Photo1

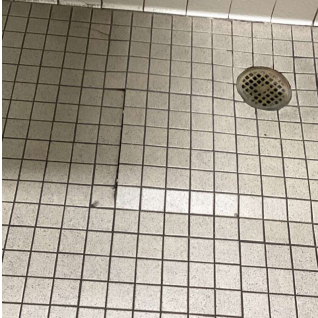
Violations	Inside Room 140 No violations recorded.
Floor Finish	Inspected
Condition	2 - Between Good and Fair
Deficiency	CERAMIC TILE: DETERIORATED SUBSTRATE

Question	Response
INTERIOR	
TOILET ROOMS - STUDENTS	Inspected
Floor Finish	
Deficiency Location/Instance	Inside Room 242
Deficiency Quantity	10
Quantity Uom	S.F.
Potential Action	REPLACE
Urgency of Action	PRIORITY 3
Purpose of Action	LEVEL 2
Deficiency Photo1

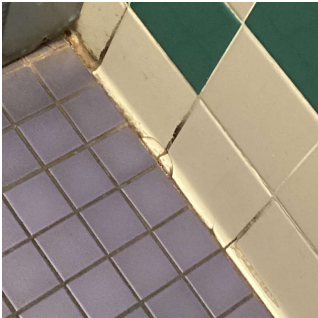
Violations	Inside Room 242 No violations recorded.
Stalls	Inspected
Condition	2 - Between Good and Fair
Deficiency	No deficiencies recorded
Walls	Inspected
Condition	2 - Between Good and Fair
Deficiency	CERAMIC TILE: BROKEN/ MISSING
Deficiency Location/Instance	Rooms B29, 202
Deficiency Quantity	10
Quantity Uom	S.F.
Potential Action	REPLACE
Urgency of Action	PRIORITY 3
Purpose of Action	LEVEL 2
Deficiency Photo1

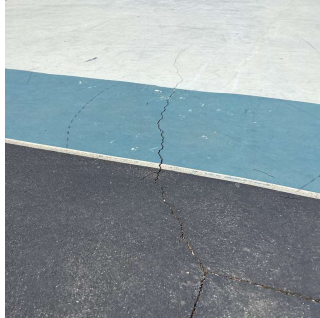
Gravel Exists?	No
Asphalt	Does not Exist
Concrete	Inspected
Condition	2 - Between Good and Fair
Deficiency	No deficiencies recorded
Pavers	Does not Exist
Student Use	Inspected
Gravel Exists?	No
Asphalt	Inspected
Condition	4 - Between Fair and Poor
Deficiency	CRACKS - MAJOR
Deficiency Location/Instance	Schoolyards - North, East
Deficiency Quantity	500
Quantity Uom	S.F.
Potential Action	REPLACE
Urgency of Action	PRIORITY 3
Purpose of Action	LEVEL 2

Question	Response
SITE	
PAVING	
Student Use	
Asphalt	
Deficiency Photo1

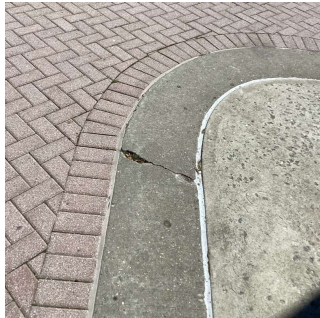
Violations	Schoolyard - North No violations recorded.
Concrete	Inspected
Condition	3 - Fair
Deficiency	CRACKS - MAJOR
Deficiency Location/Instance	East Schoolyard
Deficiency Quantity	50
Quantity Uom	S.F.
Potential Action	REPLACE
Urgency of Action	PRIORITY 3
Purpose of Action	LEVEL 2
Deficiency Photo1

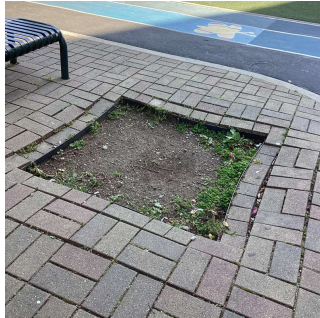
Question	Response
SITE	
PAVING	
Student Use	
Pavers	
Deficiency Photo1	 
Violations	Schoolyard - East No violations recorded.
Deficiency	HEAVING
Deficiency Location/Instance	Schoolyard - North
Deficiency Quantity	20
Quantity Uom	S.F.
Potential Action	REPLACE
Urgency of Action	PRIORITY 5
Purpose of Action	LEVEL 6
Deficiency Photo1

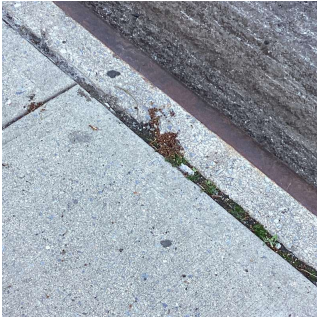
Question	Response
SITE	
PAVING	
Site Sidewalks & Walkways	
Asphalt	
Deficiency Photo1	 
Violations	24th Street No violations recorded.
Concrete	Inspected
Condition	2 - Between Good and Fair
Deficiency	DAMAGED/DETERIORATED/MISSING SECTIONS
Deficiency Location/Instance	Main Entrance
Deficiency Quantity	25
Quantity Uom	S.F.
Potential Action	REPLACE
Urgency of Action	PRIORITY 3
Purpose of Action	LEVEL 2
Deficiency Photo1	 
Violations	Main Entrance No violations recorded.
Pavers	Inspected
Condition	2 - Between Good and Fair
Deficiency	No deficiencies recorded
DOT Sidewalk	Inspected
Asphalt	Does not Exist
Concrete	Inspected
Condition	4 - Between Fair and Poor
Deficiency	DAMAGED CURBS
Deficiency Location/Instance	101st Avenue, 24th Street
Deficiency Quantity	30
Quantity Uom	L.F.
Potential Action	REPLACE
Urgency of Action	PRIORITY 3
Purpose of Action	LEVEL 2

Question	Response
SITE	
PAVING	
DOT Sidewalk	
Concrete	
Deficiency Photo1

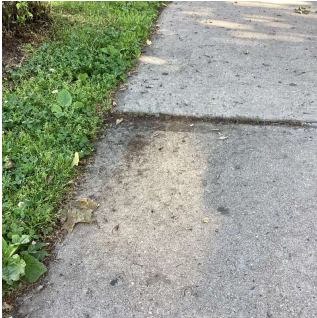
Violations	24th Street No violations recorded.
Deficiency	HEAVING
Deficiency Location/Instance	24th Street, 25th Street
Deficiency Quantity	50
Quantity Uom	S.F.
Potential Action	REPLACE
Urgency of Action	PRIORITY 3
Purpose of Action	LEVEL 2
Deficiency Photo1

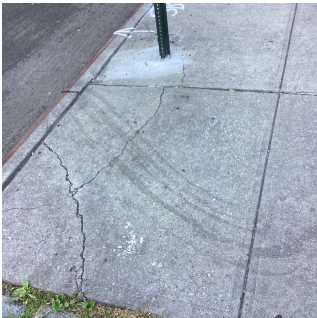
Violations	24th Street No violations recorded.
Deficiency	DAMAGED/DETERIORATED/MISSING SECTIONS
Deficiency Location/Instance	101st Avenue, 24th Street
Deficiency Quantity	625
Quantity Uom	S.F.
Potential Action	REPLACE
Urgency of Action	PRIORITY 3
Purpose of Action	LEVEL 2
Deficiency Photo1

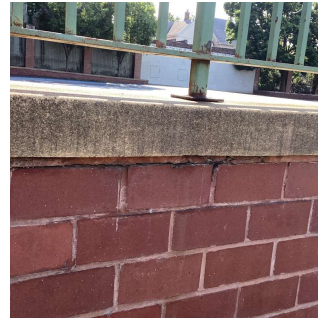
124th Street

BRICK: DETERIORATED JOINTS

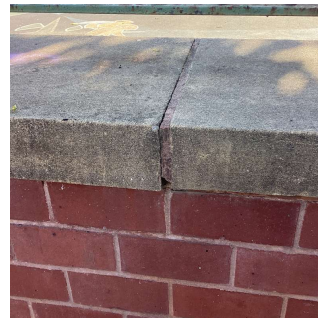
124th Street

BRICK: DETERIORATED JOINT AT COPING STONE

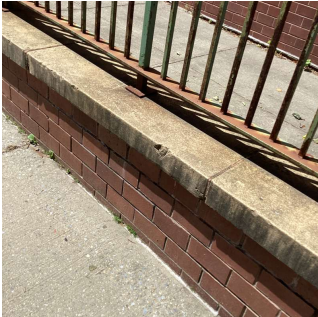
124th Street
Violations	No violations recorded.
SEATING	
	Inspected
Benches	
	Inspected
Concrete	
	Does not Exist
Metal/Wood/Plastic	
	Inspected
Condition	2 - Between Good and Fair
Deficiency	No deficiencies recorded
Bleachers	
	Does not Exist
SITE WALLS (NOT RETAINING WALLS)	
	Inspected
Condition	3 - Fair
Deficiency	BRICK: DETERIORATED COPING STONE
Deficiency Location/Instance	101st Avenue, 124th Street, 125th Street
Deficiency Quantity	50
Quantity Uom	S.F.
Potential Action	REPLACE
Urgency of Action	PRIORITY 3
Purpose of Action	LEVEL 2
Deficiency Photo1

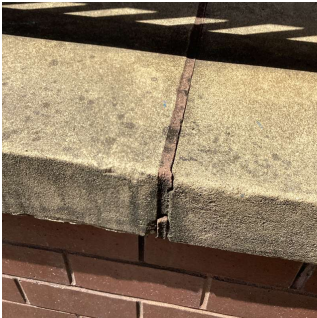
Question	Response
SITE	
SITE WALLS (NOT RETAINING WALLS)	
Quantity Uom	S.F.
Potential Action	REPAIR
Urgency of Action	PRIORITY 3
Purpose of Action	LEVEL 2
Deficiency Photo1	No photo recorded
Violations	No violations recorded.
Deficiency	BRICK: DETERIORATED JOINTS
Deficiency Location/Instance	101st Avenue, 125th Street
Deficiency Quantity	20
Quantity Uom	S.F.
Potential Action	REPOINT
Urgency of Action	PRIORITY 3
Purpose of Action	LEVEL 2
Deficiency Photo1

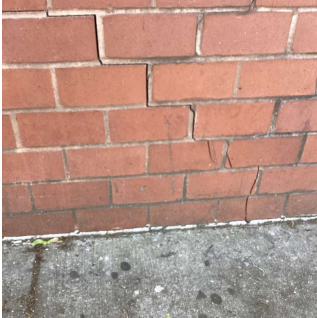
Violations	125th Street No violations recorded.
Deficiency	BRICK: CRACKS/SPALLING - MAJOR
Deficiency Location/Instance	101st Avenue, 24th Street, Schoolyard
Deficiency Quantity	60
Quantity Uom	S.F.
Potential Action	REPLACE
Urgency of Action	PRIORITY 3
Purpose of Action	LEVEL 2
Deficiency Photo1

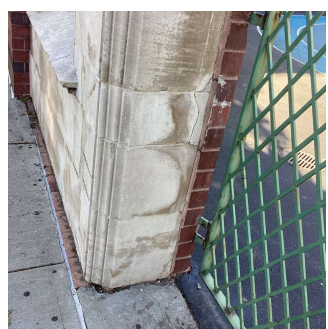
101st Avenue
Violations	No violations recorded.
STAIRS/RAMPS: EXTERIOR	
	Does not Exist
ARTWORK	
Instance	Inspected
Instance Photo	Interior - Auditorium Lobby - 71427

Violations	24th Street No violations recorded.
Deficiency	STONE: CRACKS/SPALLING - MAJOR
Deficiency Location/Instance	101st Avenue
Deficiency Quantity	30
Quantity Uom	S.F.

Potential Action	REPLACE
Urgency of Action	PRIORITY 3

Question	Response
SITE	
SITE WALLS (NOT RETAINING WALLS)	
Purpose of Action	LEVEL 2
Deficiency Photo1
