**NYC Department of Education**  
**Building Condition Assessment Survey 2023 - 2024**

Architectural Inspection

**Asset:** P.S. 162 - QUEENS, 201-02 53 AVENUE, New York, 11364

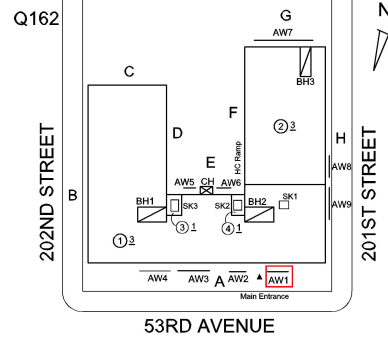
AREAWAY GRATINGS: MAJOR RUSTING / OR BROKEN

10  
S.F.  
REPLACE  
PRIORITY 4  
LEVEL 2

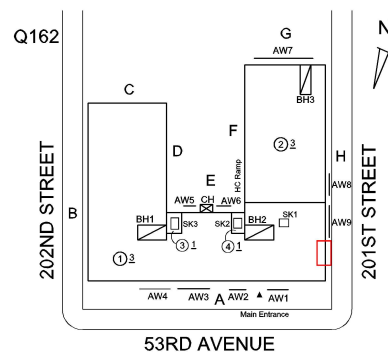
METAL: DETERIORATION/DAMAGED/MISSING PIECES

10  
S.F.  
REPLACE  
PRIORITY 4  
LEVEL 2

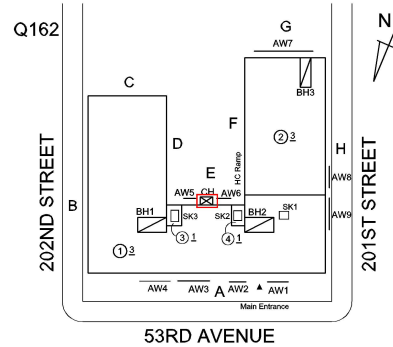
BRICK: MINOR CRACKS AND SPALLING

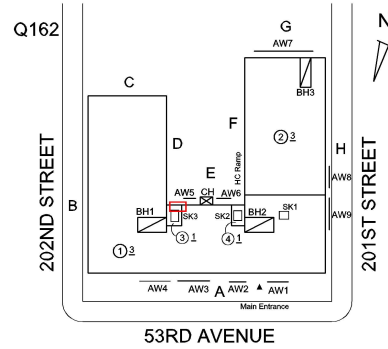
CAST STONE: CRACKED/BROKEN PIECES

REPLACE-IN-KIND

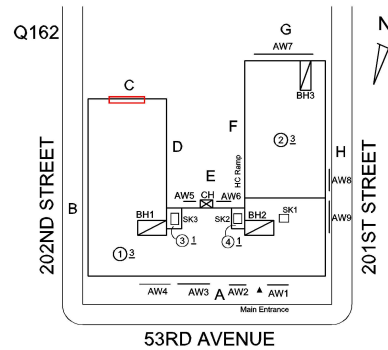
METAL CLAD: DETERIORATED DOOR AND FRAME - MAJOR DETERIORATION

REPLACE

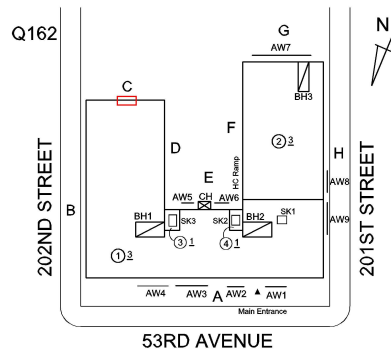
METAL: DENTED, MAJOR RUSTING

REPLACE

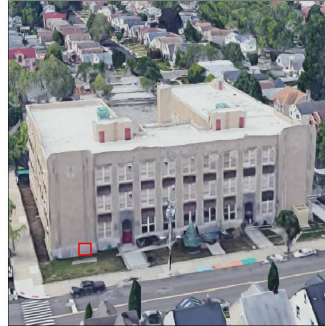
Deficiency	STONE: CHIPPED/SPALLED/BROKEN PIECES - MAJOR
Roof Plan reference

REPLACE

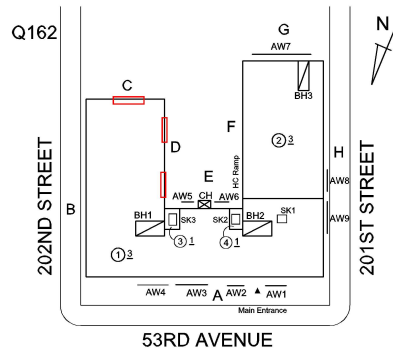
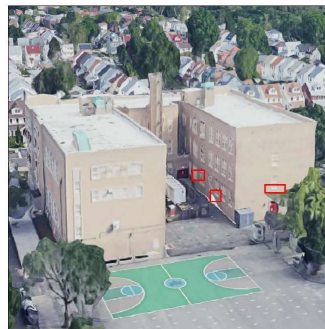
BRICK: DETERIORATED MASONRY SILLS - MINOR

REPAIR

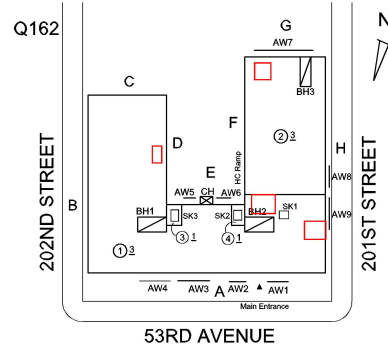
Violations	No violations recorded.
Deficiency	<p>MODIFIED BITUMEN; ROOFING; MAJOR ACTIVE ROOF LEAKS IN INSTRUCTIONAL SPACE</p>

400  
S.F.  
REPLACE ROOFING WITHOUT MAJOR EQUIPMENT  
REMOVAL  
PRIORITY 5  
LEVEL 4

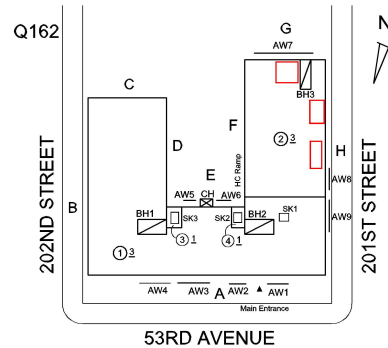
MODIFIED BITUMEN; ROOFING; MAJOR ACTIVE ROOF  
LEAKS IN INSTRUCTIONAL SPACE

300  
S.F.  
REPLACE ROOFING WITHOUT MAJOR EQUIPMENT  
REMOVAL  
PRIORITY 5  
LEVEL 2

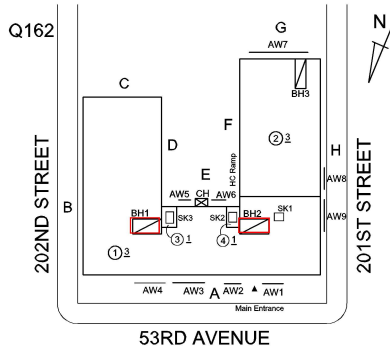
Violations	Roof 2 - Gymnasium (Roof 2 - Room 341) No violations recorded.
<b>ROOFING DRAINS</b>	Inspected
Condition	1 - Good
Deficiency	No deficiencies recorded
<b>Specialties</b>	Inspected
<b>BULKHEAD/PENTHOUSE</b>	Inspected
Condition	4 - Between Fair and Poor
Deficiency	BULKHEAD/PENTHOUSE WINDOWS: DAMAGED, DETERIORATED WINDOWS
Roof Plan reference

Deficiency Quantity	60
Quantity Uom	S.F.
Potential Action	REPLACE
Urgency of Action	PRIORITY 4
Purpose of Action	LEVEL 2
Deficiency Photo1

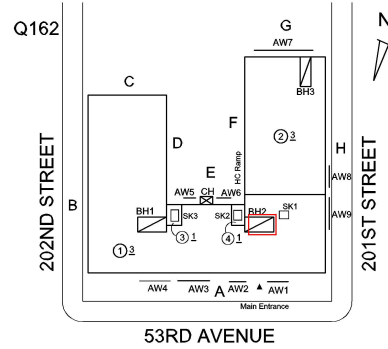
Violations	BH2 (BH1 similar) No violations recorded.
Deficiency	BULKHEAD/PENTHOUSE WALLS/INTERIOR: GLAZED BLOCK CRACKS/SPALLING

20  
S.F.  
REPLACE  
PRIORITY 3  
LEVEL 2

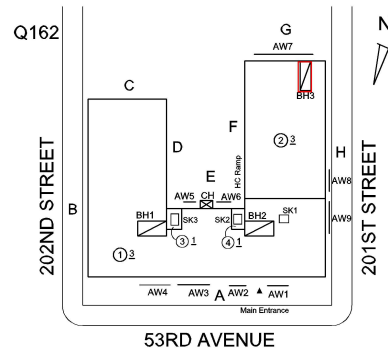
**BULKHEAD/PENTHOUSE ROOF: MAJOR LEAKAGE**

100  
S.F.  
REPLACE  
PRIORITY 5  
LEVEL 4

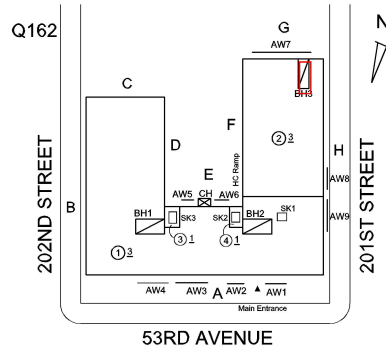
**BULKHEAD/PENTHOUSE CEILING: PLASTER DAMAGED/DETERIORATED**

REPLACE

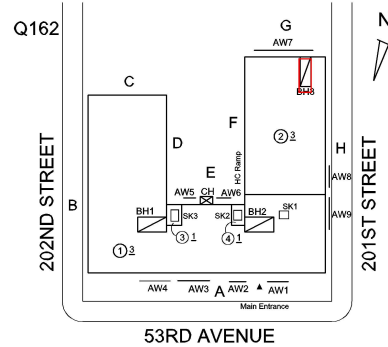
**BULKHEAD/PENTHOUSE WALLS/INTERIOR: PLASTER CRACKS/SPALLING**

20  
S.F.  
REPLACE  
PRIORITY 4  
LEVEL 2

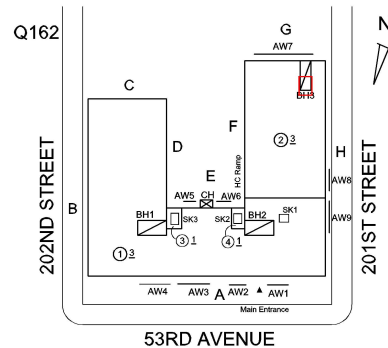
**BULKHEAD/PENTHOUSE WALLS/EXTERIOR: WATER INFILTRATION**

100  
S.F.  
REPAIR  
PRIORITY 5  
LEVEL 2

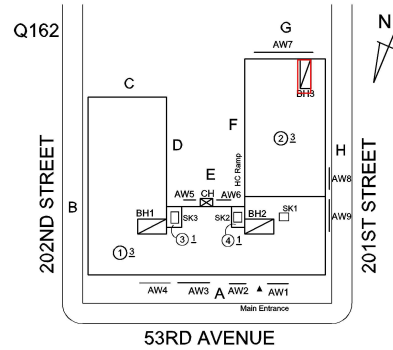
**BULKHEAD/PENTHOUSE WALLS/EXTERIOR:  
CRACKS/SPALLING - MINOR**

REPAIR

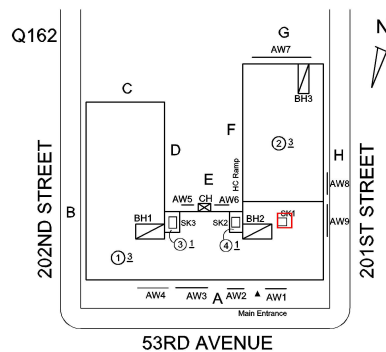
Deficiency **BROKEN GLASS**

Deficiency Quantity	20
Quantity Uom	S.F.
Potential Action	MAINTENANCE
Urgency of Action	PRIORITY 3
Purpose of Action	LEVEL 2
Deficiency Photo1	No photo recorded
Violations	No violations recorded.

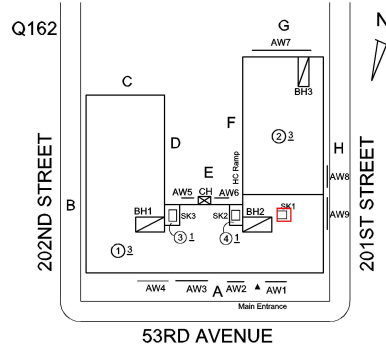
Deficiency **DAMAGED GUARDS**

25  
 S.F.  
 MAINTENANCE  
 PRIORITY 3  
 LEVEL 2

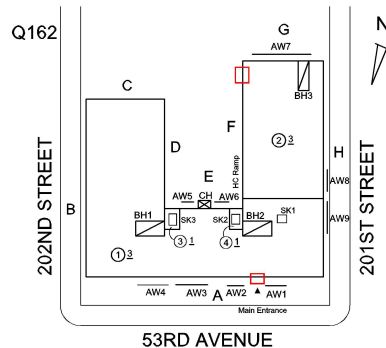
DAMAGED

20  
 L.F.  
 REPLACE

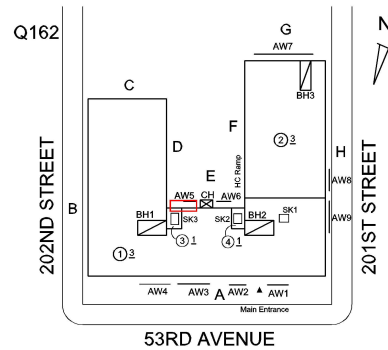
STONE: WORN-OUT TREAD/RISER/NOSING

REPLACE

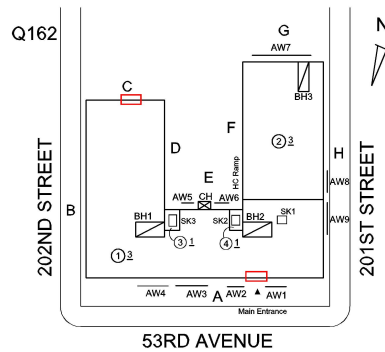
STONE: DETERIORATED JOINTS

20  
 L.F.  
 REPOINT  
 PRIORITY 4  
 LEVEL 2

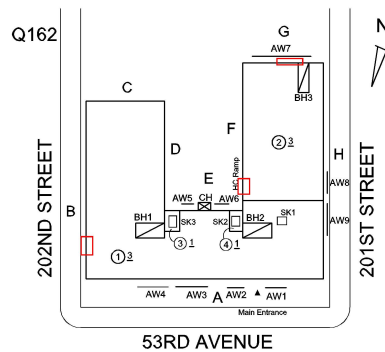
Inspected  
 3 - Fair  
 DETERIORATED/TORN-OUT/MISSING

Question	Response
<b>EXTERIOR</b>	
<b>WINDOWS</b>	
<b>EXTERIOR GUARDS</b>	
Elevation	 
Deficiency Quantity	90
Quantity Uom	S.F.
Potential Action	REPLACE
Urgency of Action	PRIORITY 4
Purpose of Action	LEVEL 2
Deficiency Photo1	 
Violations	Facade F No violations recorded.
<b>LINTELS</b>	Inspected
Condition	2 - Between Good and Fair
Deficiency	No deficiencies recorded
<b>WINDOWS</b>	Inspected
Material Type(s)	Solid Wood, Steel
Instance on Steel: All Facades	Inspected
Instance Condition	4 - Between Fair and Poor
Instance Quantity	2,100
Instance Quantity Uom	S.F.
Are these windows insulated	No
Installation Year	1954
Source of Installation	Custodial Staff
Deficiency	STEEL: DETERIORATED

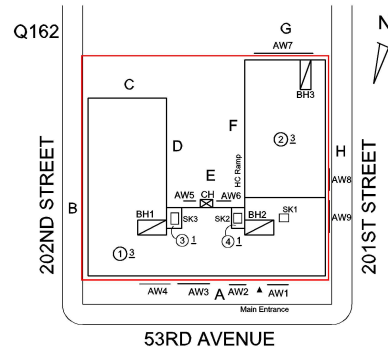
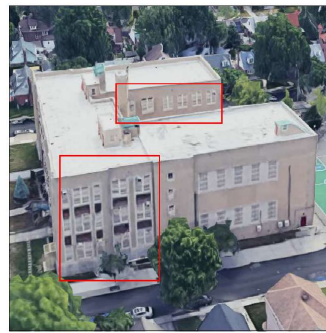
Instance on Wood: All Facades	Inspected
Instance Condition	4 - Between Fair and Poor
Instance Quantity	4,900
Instance Quantity Uom	S.F.
Are these windows insulated	No
Installation Year	2004
Source of Installation	Custodial Staff
Deficiency	WOOD: BROKEN PANE

50  
S.F.  
MAINTENANCE  
PRIORITY 3  
LEVEL 2

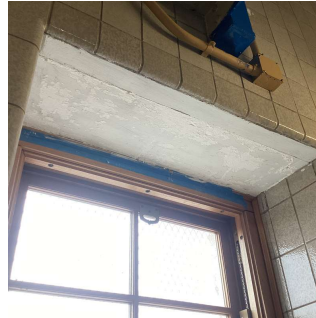
Facade G - Stair EF/3 (Facade F - Room 212, Facade E - Stair CD/3, similar throughout)

150  
L.F.  
REPLACE TRIM, SILLS OR WEATHERSTRIPPING  
PRIORITY 5  
LEVEL 2

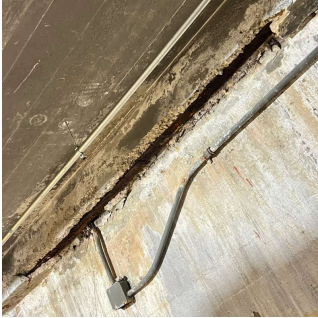
Violations	Facade H - Room 211 (similar throughout) No violations recorded.
<b>INTERIOR</b>	Inspected
<b>POOLS</b>	Does not Exist
<b>STRUCTURAL</b>	Inspected
<b>COLUMNS/BEAMS/BEARING WALLS</b>	
Condition	3 - Fair
Deficiency	STEEL COLUMNS/BEAMS: MAJOR RUSTING
Deficiency Location/Instance	Basement - East Crawlspace
Deficiency Quantity	20
Quantity Uom	S.F.
Potential Action	REPLACE
Urgency of Action	PRIORITY 4
Purpose of Action	LEVEL 5
Deficiency Photo1

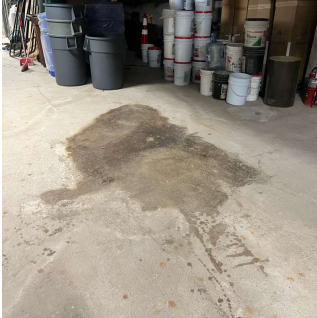
Question	Response
<b>INTERIOR</b>	
<b>STRUCTURAL</b>	
<b>COLUMNS/BEAMS/BEARING WALLS</b>	Inspected
Violations	Basement - West Crawlspace No violations recorded.
<b>FLOOR STRUCTURE</b>	Inspected
Condition	4 - Between Fair and Poor
Deficiency	CONCRETE SLAB ON GRADE: WATER INFILTRATION IN NON-INSTRUCTIONAL SPACE
Deficiency Location/Instance	Basement
Deficiency Quantity	200
Quantity Uom	S.F.
Potential Action	INSTALL WATERPROOFING
Urgency of Action	PRIORITY 5
Purpose of Action	LEVEL 5
Deficiency Photo1

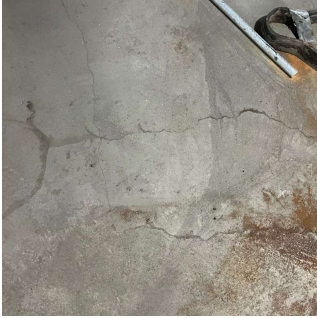
Violations	Basement - West Crawlspace No violations recorded.
Deficiency	CONCRETE SLAB ON GRADE: THRU CRACKS
Deficiency Location/Instance	Basement
Deficiency Quantity	100
Quantity Uom	S.F.
Potential Action	REPAIR
Urgency of Action	PRIORITY 3
Purpose of Action	LEVEL 5
Deficiency Photo1

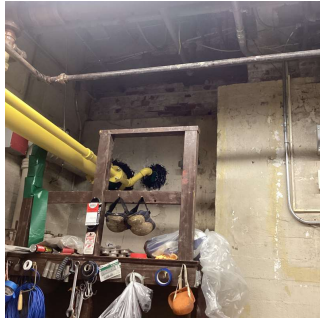
Basement - Firemans Shop
Violations	No violations recorded.
<b>FOUNDATION WALLS</b>	
Material Type(s)	Inspected Concrete, Masonry
Condition	5 - Poor
Deficiency	BRICK: CRACKED/SPALLED
Deficiency Location/Instance	Basement - Firemans Shop
Deficiency Quantity	20
Quantity Uom	S.F.
Potential Action	RESTITCH
Urgency of Action	PRIORITY 4
Purpose of Action	LEVEL 5
Deficiency Photo1

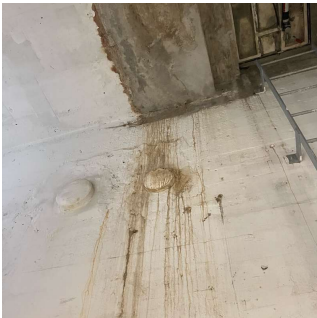
Question	Response
<b>INTERIOR</b>	
<b>STRUCTURAL</b>	
<b>FOUNDATION WALLS</b>	Inspected
Violations	35643596R
<b>ROOF STRUCTURE</b>	Inspected
Condition	2 - Between Good and Fair
Deficiency	No deficiencies recorded
<b>VAULTS-BUNKERS</b>	Inspected
<b>Foundation Walls</b>	Inspected
Condition	3 - Fair
Deficiency	WATER INFILTRATION IN NON- INSTRUCTIONAL SPACE
Deficiency Location/Instance	Vault
Deficiency Quantity	50
Quantity Uom	S.F.
Potential Action	INSTALL WATERPROOFING
Urgency of Action	PRIORITY 5
Purpose of Action	LEVEL 5
Deficiency Photo1

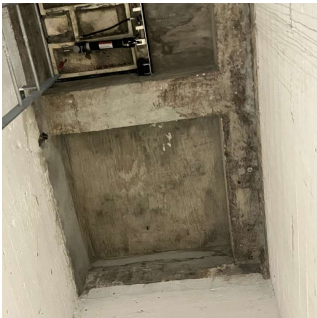
Violations	Vault No violations recorded.
<b>Slab Structure</b>	Inspected
Condition	3 - Fair
Deficiency	CONCRETE: WATER INFILTRATION IN NON- INSTRUCTIONAL SPACE
Deficiency Location/Instance	Vault
Deficiency Quantity	50
Quantity Uom	S.F.
Potential Action	INSTALL WATERPROOFING
Urgency of Action	PRIORITY 5
Purpose of Action	LEVEL 5
Deficiency Photo1

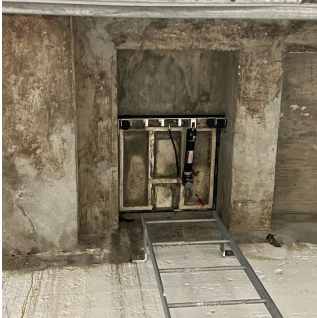
Question	Response
<b>INTERIOR</b>	
<b>STRUCTURAL</b>	
<b>VAULTS-BUNKERS</b>	
<b>Vault/Ash Hoist Doors and Framing</b>	
Condition	5 - Poor
Deficiency	WATER INFILTRATION
Deficiency Location/Instance	Vault
Deficiency Quantity	10
Quantity Uom	S.F.
Potential Action	REPAIR
Urgency of Action	PRIORITY 5
Purpose of Action	LEVEL 2
Deficiency Photo1

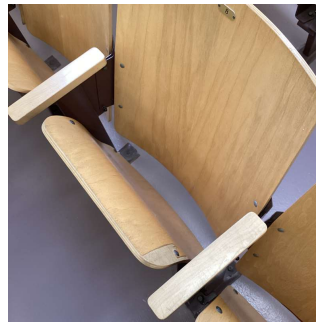
Seat G/8

Violations	Vault No violations recorded.
<b>AUDITORIUM</b>	
Instance on 1st Floor (450 Seats)	Inspected
<b>Ceiling</b>	Inspected
Instance on 1st Floor (450 Seats)	Inspected
Condition	2 - Between Good and Fair
Deficiency	No deficiencies recorded
<b>Door(s)</b>	
Instance on 1st Floor (450 Seats)	Inspected
Condition	2 - Between Good and Fair
Deficiency	No deficiencies recorded
<b>Fixed H/C Lift</b>	
Instance on 1st Floor (450 Seats)	Does not Exist
<b>Fixed Seating</b>	
Instance on 1st Floor (450 Seats)	Inspected
Condition	2 - Between Good and Fair
Deficiency	DAMAGED/BROKEN/INOPERABLE

Deficiency Location/Instance	Seats G/8, L/102
Deficiency Quantity	2
Quantity Uom	EACH
Potential Action	REPLACE
Urgency of Action	PRIORITY 3
Purpose of Action	LEVEL 2

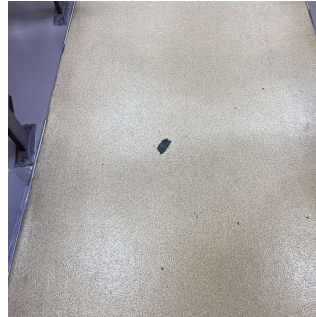
Near Entrance

Deficiency SHEET VINYL: BROKEN/DETERIORATED

Potential Action REPLACE

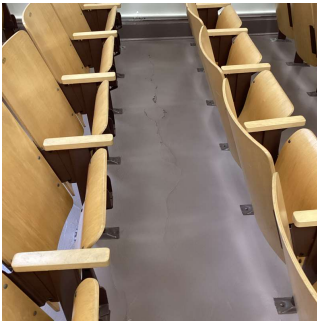
Deficiency CONCRETE: CRACKS

Deficiency Location/Instance Along Row K

Potential Action REPLACE

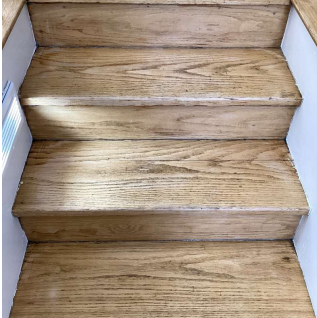
Violations	Along Row K No violations recorded.
<b>Sliding-folding Partition</b>	
Instance on 1st Floor (450 Seats)	Does not Exist
<b>Stage</b>	
Instance on 1st Floor (450 Seats)	Inspected
<b>Stage</b>	Inspected
Instance on 1st Floor (450 Seats)	Inspected
Condition	2 - Between Good and Fair
Deficiency	DAMAGED STEPS
Deficiency Location/Instance	Left and Right Side
Deficiency Quantity	20
Quantity Uom	S.F.
Potential Action	REPLACE
Urgency of Action	PRIORITY 3
Purpose of Action	LEVEL 2
Deficiency Photo1

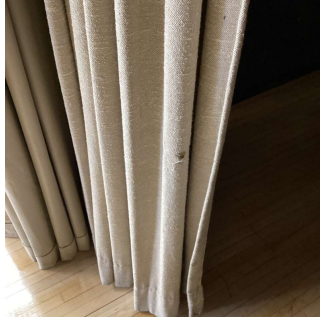
Violations	Left Side No violations recorded.
<b>Stage Curtain Rigging</b>	
Instance on 1st Floor (450 Seats)	Inspected
Condition	2 - Between Good and Fair
Deficiency	No deficiencies recorded
<b>Stage Curtains</b>	
Instance on 1st Floor (450 Seats)	Inspected
Condition	3 - Fair
Deficiency	WORN/DETERIORATED
Deficiency Location/Instance	Right Side, Rear

Question	Response
<b>INTERIOR</b>	
<b>AUDITORIUM</b>	
<b>Stage</b>	
<b>Stage Curtains</b>	
Potential Action	REPLACE
Urgency of Action	PRIORITY 3
Purpose of Action	LEVEL 2
Deficiency Photo1

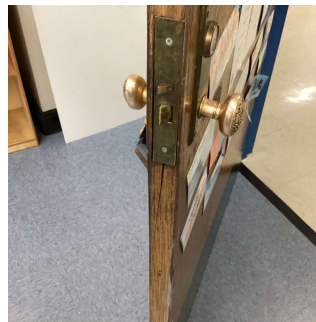
Room 338

WOOD: DETERIORATED DOOR

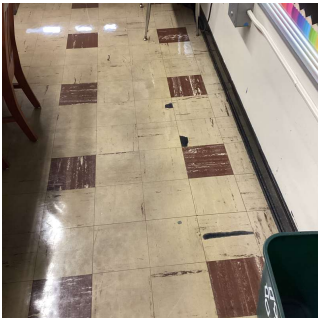
Question	Response
<b>INTERIOR</b>	
<b>CLASSROOMS/CORRIDORS/ADMIN SPACES</b>	
<b>Floor Finish</b>	
Deficiency	WOOD: DAMAGED/DETERIORATED
Deficiency Location/Instance	Rooms 325, 323
Deficiency Quantity	40
Quantity Uom	S.F.
Potential Action	REPLACE
Urgency of Action	PRIORITY 3
Purpose of Action	LEVEL 2
Deficiency Photo1	 
	Room 325
Violations	No violations recorded.
Deficiency	VINYL TILES: BROKEN/DETERIORATED/MISSING TILES
Deficiency Location/Instance	Rooms 335, 332, 319, 313, 223 and others
Deficiency Quantity	1,600
Quantity Uom	S.F.
Potential Action	REPLACE
Urgency of Action	PRIORITY 3
Purpose of Action	LEVEL 2
Deficiency Photo1

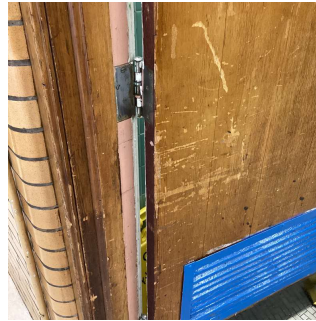
Main Entrance

<b>Door(s)</b>	
Instance on 1st Floor	Inspected
Condition	4 - Between Fair and Poor
Deficiency	WOOD: DETERIORATED DOOR
Deficiency Location/Instance	Main Entrance, Office
Deficiency Quantity	2
Quantity Uom	EACH
Potential Action	MAINTENANCE
Urgency of Action	PRIORITY 3
Purpose of Action	LEVEL 2

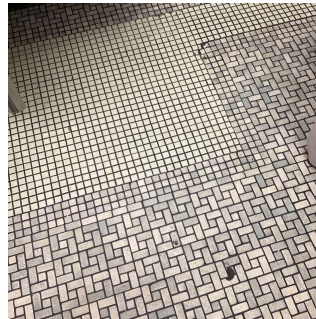
Instance on 1st Floor	Inspected
Condition	2 - Between Good and Fair
Deficiency	CERAMIC TILE: BROKEN/MISSING TILES
Deficiency Location/Instance	Center
Deficiency Quantity	10
Quantity Uom	S.F.
Potential Action	REPLACE
Urgency of Action	PRIORITY 3
Purpose of Action	LEVEL 2
Deficiency Photo1

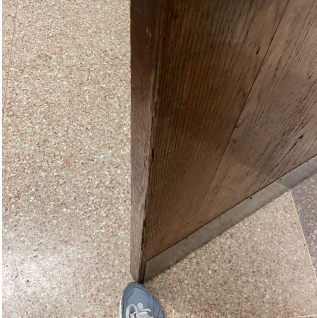
Question	Response
<b>INTERIOR</b>	
<b>STAIRS/RAMPS: INTERIOR</b>	
<b>Door(s)</b>	
Quantity Uom	EACH
Potential Action	MAINTENANCE
Urgency of Action	PRIORITY 3
Purpose of Action	LEVEL 2
Deficiency Photo1

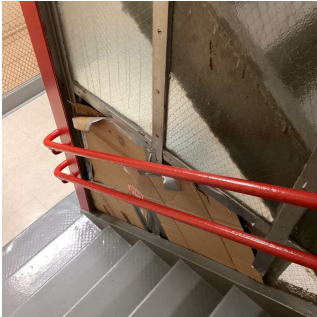
Stair EF/1 Vestibule
Violations	No violations recorded.
<b>Partition</b>	Inspected
Condition	2 - Between Good and Fair
Deficiency	GLASS PANEL: DAMAGED/DETERIORATED
Deficiency Location/Instance	Stair EF/2
Deficiency Quantity	10
Quantity Uom	S.F.
Potential Action	REPLACE
Urgency of Action	PRIORITY 3
Purpose of Action	LEVEL 2
Deficiency Photo1

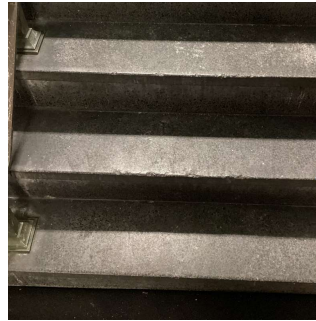
Stair AB/1

Stair EF/2
Violations	No violations recorded.
<b>Railings</b>	Inspected
Condition	2 - Between Good and Fair
Deficiency	No deficiencies recorded
<b>Stairs and Landings</b>	Inspected
Condition	2 - Between Good and Fair
Deficiency	TERRAZZO: CRACKS
Deficiency Location/Instance	Stairs AB/1, CD/1 Vestibule, G/1, 2, H/1, Exit 7 Vestibule
Deficiency Quantity	100
Quantity Uom	S.F.
Potential Action	REPLACE

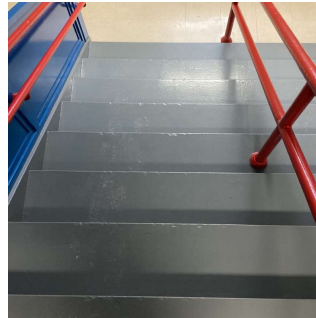
Stair AB/2

STONE: BROKEN/MISSING

REPLACE

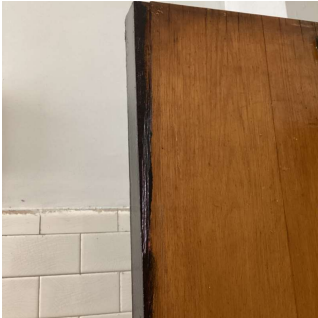
Question	Response
<b>INTERIOR</b>	
<b>STAIRS/RAMPS: INTERIOR</b>	Inspected
<b>Walls</b>	Inspected
Violations	Stair AB/3 No violations recorded.
<b>TOILET ROOMS - STAFF</b>	Inspected
<b>Ceiling</b>	Inspected
Condition	2 - Between Good and Fair
Deficiency	No deficiencies recorded
<b>Door(s)</b>	Inspected
Condition	5 - Poor
Deficiency	WOOD: DETERIORATED DOOR
Deficiency Location/Instance	Rooms 316, 130A, Inside Gymnasium
Deficiency Quantity	3
Quantity Uom	EACH
Potential Action	MAINTENANCE
Urgency of Action	PRIORITY 3
Purpose of Action	LEVEL 2
Deficiency Photo1

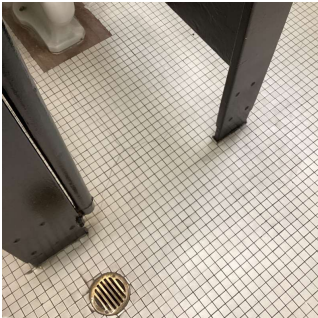
Violations	Room 316 No violations recorded.
<b>Floor Finish</b>	Inspected
Condition	3 - Fair
Deficiency	CERAMIC TILE: DETERIORATED SUBSTRATE
Deficiency Location/Instance	Rooms 316, 1st Floor - Men
Deficiency Quantity	20
Quantity Uom	S.F.
Potential Action	REPLACE
Urgency of Action	PRIORITY 3
Purpose of Action	LEVEL 2
Deficiency Photo1

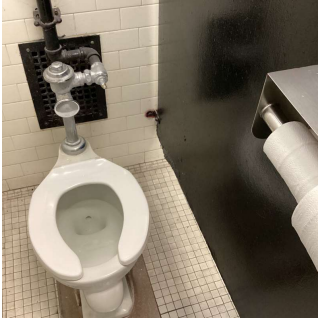
Question	Response
<b>INTERIOR</b>	
<b>TOILET ROOMS - STAFF</b>	Inspected
<b>Stalls</b>	
Condition	5 - Poor
Deficiency	RUST - MAJOR
Deficiency Location/Instance	Rooms 316, 1st Floor - Men, 1st Floor - Women
Deficiency Quantity	3
Quantity Uom	EACH
Potential Action	REPLACE
Urgency of Action	PRIORITY 3
Purpose of Action	LEVEL 2
Deficiency Photo1

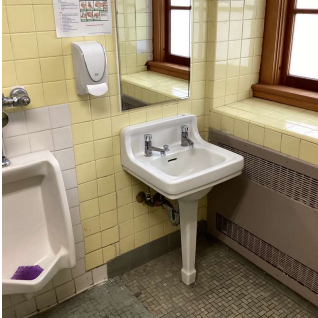
Room 316
Violations	No violations recorded.
<b>Walls</b>	Inspected
Condition	2 - Between Good and Fair
Deficiency	CERAMIC TILE: BROKEN/ MISSING
Deficiency Location/Instance	1st Floor - Men, Room 316
Deficiency Quantity	20
Quantity Uom	S.F.
Potential Action	REPLACE
Urgency of Action	PRIORITY 3
Purpose of Action	LEVEL 2
Deficiency Photo1

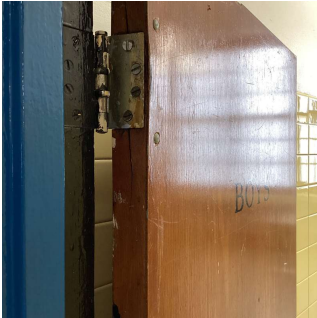
1st Floor - Men
Violations	No violations recorded.
<b>TOILET ROOMS - STUDENTS</b>	Inspected
<b>Ceiling</b>	Inspected
Condition	2 - Between Good and Fair
Deficiency	No deficiencies recorded
<b>Door(s)</b>	Inspected
Condition	5 - Poor
Deficiency	WOOD: DETERIORATED DOOR

Deficiency Location/Instance	Rooms 336, 320, 218, 216, 214 and others

Question	Response
<b>INTERIOR</b>	
<b>TOILET ROOMS - STUDENTS</b>	
<b>Door(s)</b>	
Deficiency Quantity	6
Quantity Uom	EACH
Potential Action	MAINTENANCE
Urgency of Action	PRIORITY 3
Purpose of Action	LEVEL 2
Deficiency Photo1

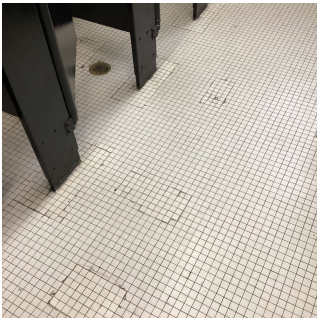
Room 336
Violations	No violations recorded.
<b>Floor Finish</b>	Inspected
Condition	2 - Between Good and Fair
Deficiency	CERAMIC TILE: DETERIORATED SUBSTRATE
Deficiency Location/Instance	Rooms 218, 216, 320
Deficiency Quantity	30
Quantity Uom	S.F.
Potential Action	REPLACE
Urgency of Action	PRIORITY 3
Purpose of Action	LEVEL 2
Deficiency Photo1

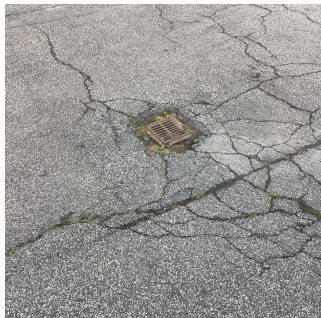
Near Park
Violations	No violations recorded.

53rd Avenue
Violations	No violations recorded.
<b>IRRIGATION SYSTEM</b>	Does not Exist
<b>PAVING</b>	Inspected
<b>Student Non-Use</b>	Inspected
Gravel Exists?	No
<b>Asphalt</b>	Does not Exist
<b>Concrete</b>	Inspected
Condition	1 - Good
Deficiency	No deficiencies recorded
<b>Pavers</b>	Does not Exist
<b>Student Use</b>	Inspected
Gravel Exists?	No
<b>Asphalt</b>	Inspected
Condition	4 - Between Fair and Poor
Deficiency	LOCALIZED SINK AREA
Deficiency Location/Instance	Near Park
Deficiency Quantity	50
Quantity Uom	S.F.
Potential Action	REPAIR
Urgency of Action	PRIORITY 3
Purpose of Action	LEVEL 2
Deficiency Photo1

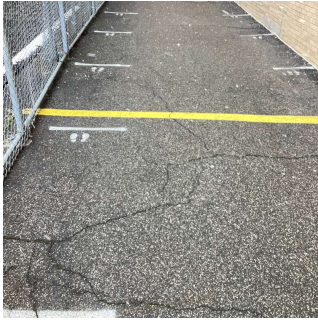
Violations	Schoolyard No violations recorded.
<b>Concrete</b>	Does not Exist
<b>Pavers</b>	Does not Exist
<b>Site Sidewalks &amp; Walkways</b>	Inspected
<b>Asphalt</b>	Inspected
Condition	3 - Fair
Deficiency	CRACKS - MAJOR
Deficiency Location/Instance	Near Exits 4, 3
Deficiency Quantity	100
Quantity Uom	S.F.
Potential Action	REPLACE
Urgency of Action	PRIORITY 3
Purpose of Action	LEVEL 2
Deficiency Photo1
