NYC Department of Education
Building Condition Assessment Survey 2023 - 2024

Architectural Inspection

Q175

Asset: P.S. 175 - QUEENS, 64-35 102 STREET, New York, 11374

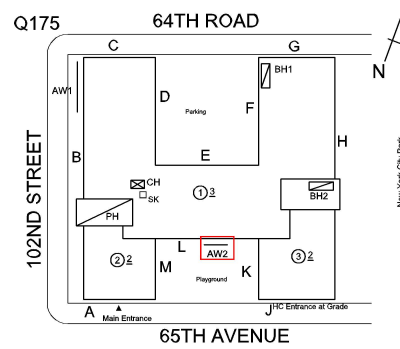
Roof Plan reference

Question	Response
Architectural	
EXTERIOR	Inspected
AREAWAY	Inspected
Instance on AW1 - AW2	Inspected
Instance Condition	4 - Between Fair and Poor
Instance Quantity	2
Instance Quantity Uom	EACH
Deficiency	AREAWAY WALLS: CRACKS AND SPALLING

10
 S.F.
 REPLACE
 PRIORITY 4
 LEVEL 2

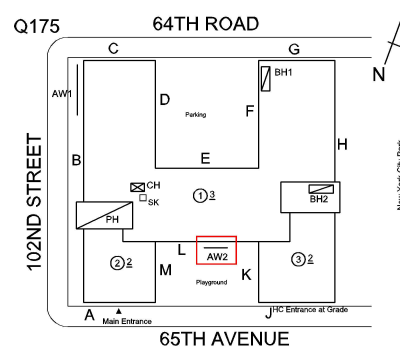
Roof Plan reference

AREAWAY STAIRS: DETERIORATED
 TREADS/RISERS/NOSINGS

10
 S.F.
 REPAIR
 PRIORITY 3
 LEVEL 2

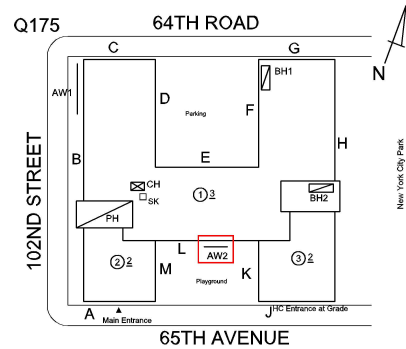
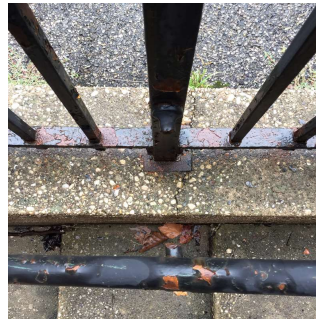
AW2

AREAWAY STAIRS: DETERIORATED RAILINGS

REPLACE

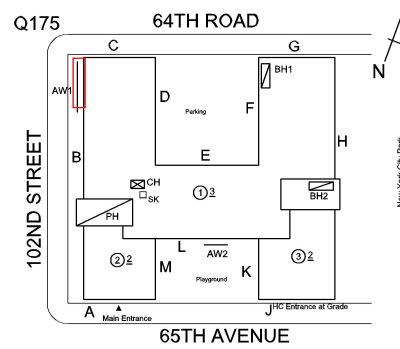
Roof Plan reference

AREAWAY WALLS: CRACKS AND SPALLING

40
S.F.
REPAIR
PRIORITY 3
LEVEL 2

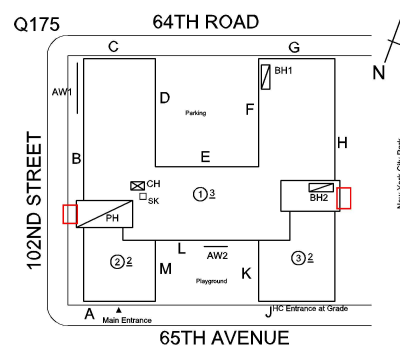
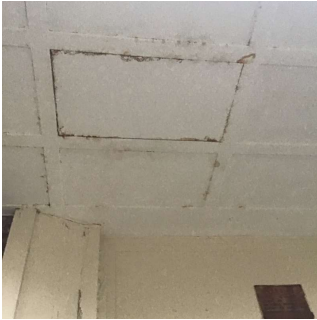
METAL: WATER PENETRATION

100
S.F.
REPAIR
PRIORITY 5
LEVEL 2

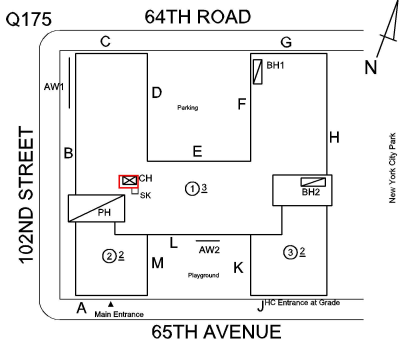
Violations	Facade B No violations recorded.
CHIMNEY	
Material Type(s)	Inspected Masonry
Condition	2 - Between Good and Fair
Deficiency	BRICK: DETERIORATED JOINTS
Roof Plan reference

Deficiency Quantity	10
Quantity Uom	S.F.
Potential Action	REPOINT
Urgency of Action	PRIORITY 3
Purpose of Action	LEVEL 2
Deficiency Photo1

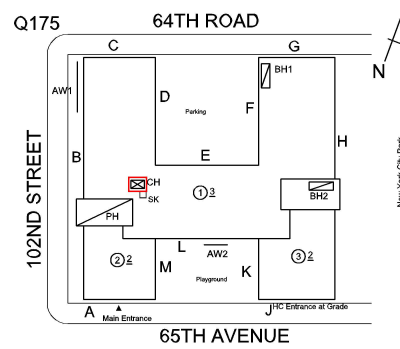
Roof Plan reference

Violations	CH No violations recorded.
Deficiency	BRICK: DETERIORATED CAP

10
L.F.
REPLACE
PRIORITY 3
LEVEL 2

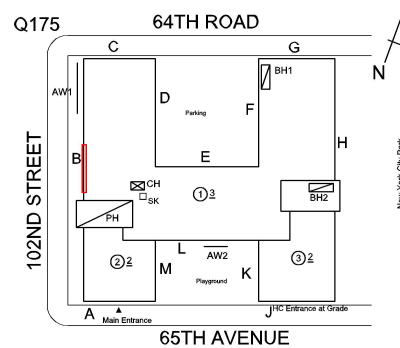
Roof Plan reference

CAST STONE: DETERIORATED TRANSVERSE JOINTS

30
L.F.
MAINTENANCE
PRIORITY 3
LEVEL 2

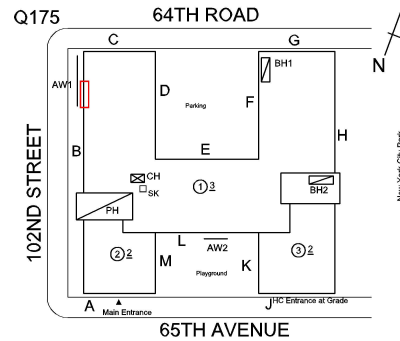
Roof Plan reference

CAST STONE: CRACKED/BROKEN PIECES

REPLACE-IN-KIND

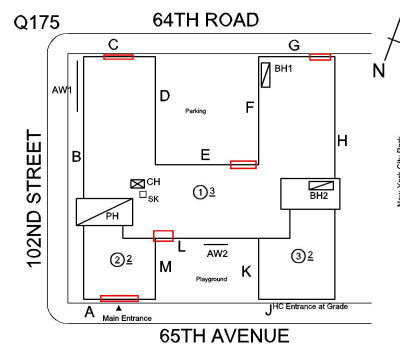
Roof Plan reference

METAL CLAD: DETERIORATED DOOR AND FRAME - MAJOR DETERIORATION

9
EACH
REPLACE
PRIORITY 4
LEVEL 2

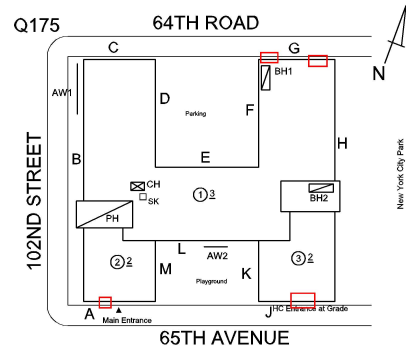
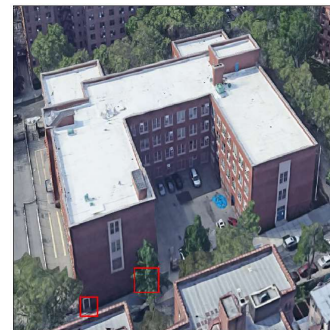
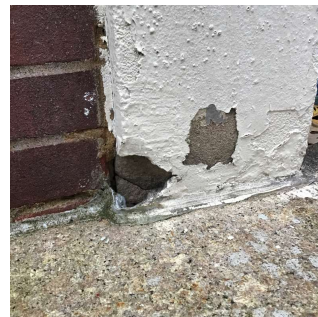
Facade G - Exit 6

STONE: CHIPPED/SPALLED/BROKEN PIECES - MAJOR

REPLACE

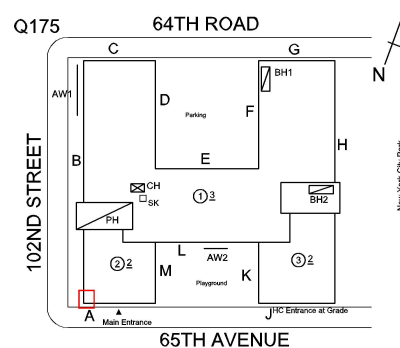
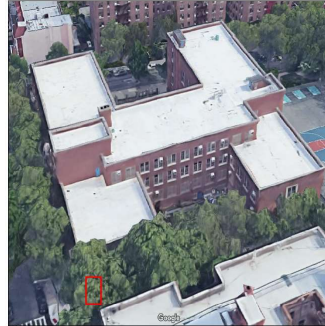
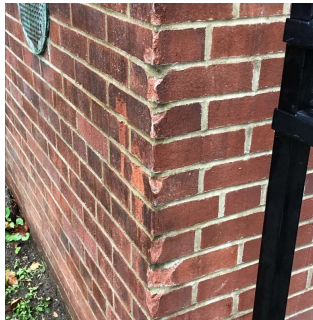
Facade A/B

BRICK: MAJOR / THRU CRACKS

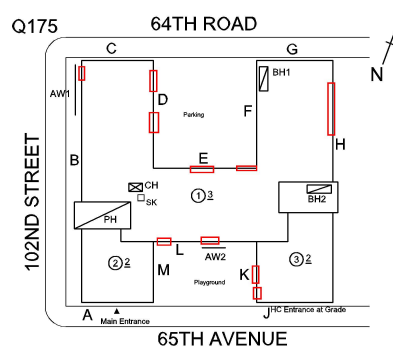
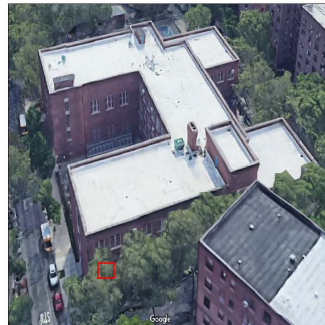
Elevation

BRICK: DETERIORATED MASONRY SILLS - MINOR

REPAIR

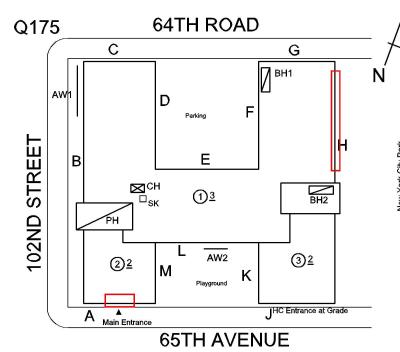
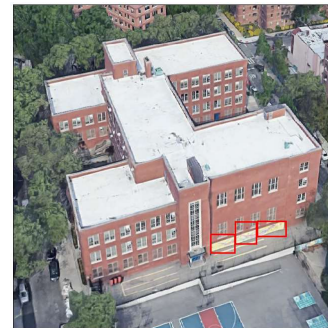
Roof Plan reference

BRICK: DETERIORATED JOINTS

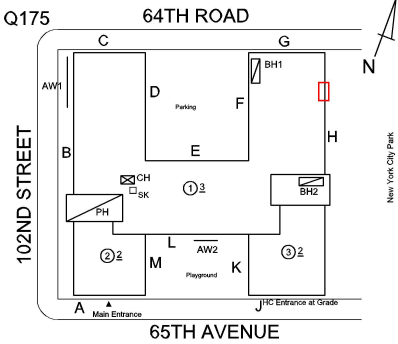
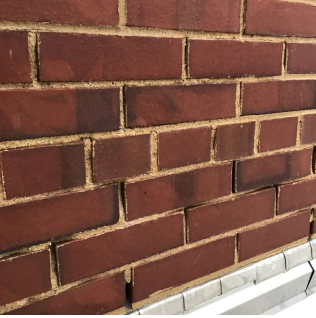
Question	Response
EXTERIOR	
EXTERIOR WALLS	Inspected
Violations	No violations recorded.
EXTERIOR SOFFITS	Inspected
Condition	2 - Between Good and Fair
Deficiency	No deficiencies recorded
LOADING DOCK	Does not Exist
LOUVER	Inspected
Condition	2 - Between Good and Fair
Deficiency	No deficiencies recorded
PARAPETS	Inspected
Material Type(s)	Masonry
Replacement Quantity	7,000
Replacement Uom	C.F.
Instance on All Roofs	Inspected
Instance Condition	3 - Fair
Instance Quantity	7,000
Instance Quantity Uom	C.F.
Deficiency	BRICK: DETERIORATED JOINTS
Roof Plan reference

Deficiency Quantity	20
Quantity Uom	S.F.
Potential Action	REPOINT
Urgency of Action	PRIORITY 4
Purpose of Action	LEVEL 2
Deficiency Photo1

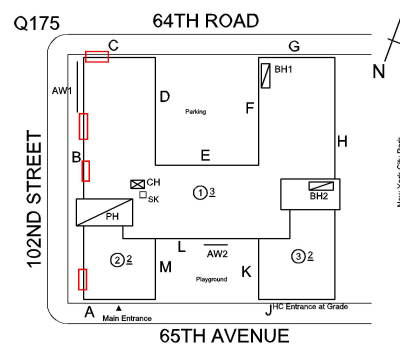
Roof Plan reference

Roof 1	No violations recorded.
Violations	No violations recorded.
Deficiency	BRICK: EFFLORESCENCE

120
S.F.
MAINTENANCE
PRIORITY 1
LEVEL 1

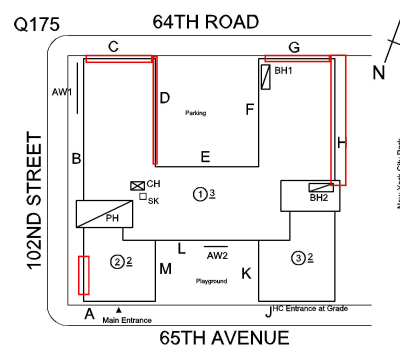
Roof Plan reference

BRICK: DETERIORATED JOINTS

200
S.F.
REPOINT
PRIORITY 3
LEVEL 2

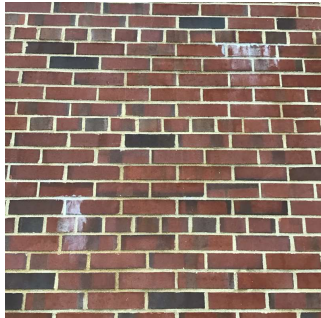
Question	Response
EXTERIOR	
ROOF	
Specialties	Inspected
BULKHEAD/PENTHOUSE	Inspected
Condition	3 - Fair
Deficiency	BULKHEAD/PENTHOUSE WALLS/INTERIOR: PLASTER CRACKS/SPALLING
Roof Plan reference	
Deficiency Quantity	80
Quantity Uom	S.F.
Potential Action	REPLACE
Urgency of Action	PRIORITY 3
Purpose of Action	LEVEL 2
Deficiency Photo1	
Violations	BH2 No violations recorded.
Deficiency	BULKHEAD/PENTHOUSE WALLS/EXTERIOR: EFFLORESCENCE
Roof Plan reference	
Deficiency Quantity	10
Quantity Uom	S.F.
Potential Action	MAINTENANCE
Urgency of Action	PRIORITY 1
Purpose of Action	LEVEL 1

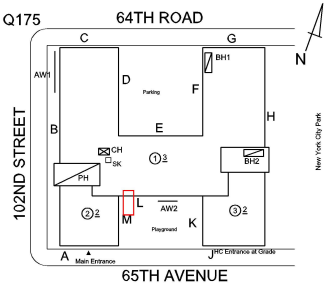
Question	Response
EXTERIOR	
ROOF	Inspected
Specialties	Inspected
ROOF/GRAVITY TANK	Does not Exist
STAIRS/RAMPS: EXTERIOR	Inspected
BUILDING CHEEK/FLANK WALLS	Inspected
Condition	2 - Between Good and Fair
Deficiency	No deficiencies recorded
RAILINGS	Inspected
Condition	2 - Between Good and Fair
Deficiency	No deficiencies recorded
STAIRS/RAMPS	Inspected
Condition	4 - Between Fair and Poor
Deficiency	STONE: CRACKS/SPALLING - MAJOR
Roof Plan reference	<p>Q175</p>

Deficiency Quantity	10
Quantity Uom	S.F.
Potential Action	REPLACE
Urgency of Action	PRIORITY 4
Purpose of Action	LEVEL 2
Deficiency Photo1

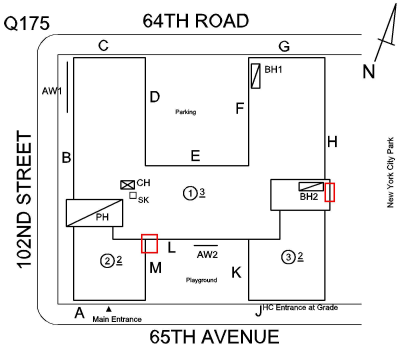
Violations	Facade L No violations recorded.
Deficiency	STONE: DETERIORATED JOINTS

Deficiency Quantity	10
Quantity Uom	L.F.
Potential Action	REPOINT
Urgency of Action	PRIORITY 4
Purpose of Action	LEVEL 2
Deficiency Photo1

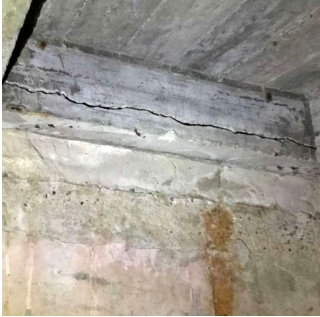
Question	Response
INTERIOR	
STRUCTURAL	
COLUMNS/BEAMS/BEARING WALLS	
Violations	Basement - Storage Room No violations recorded.
Deficiency	STEEL COLUMNS/BEAMS: DETERIORATED CONCRETE FIREPROOFING
Deficiency Location/Instance	Sub-Basement - Crawlspace
Deficiency Quantity	20
Quantity Uom	S.F.
Potential Action	REPLACE
Urgency of Action	PRIORITY 4
Purpose of Action	LEVEL 5
Deficiency Photo1

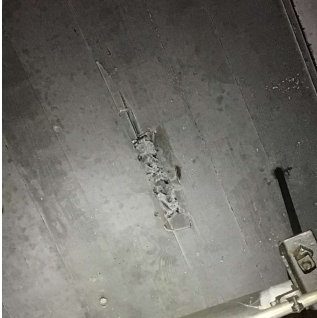
Violations	Boiler Room No violations recorded.
Deficiency	CONCRETE: CRACKS/SPALLED/REINFORCEMENT EXPOSED
Deficiency Location/Instance	Boiler Room, Subbasement - Crawlspace
Deficiency Quantity	20
Quantity Uom	S.F.

Potential Action	REPAIR
Urgency of Action	PRIORITY 4

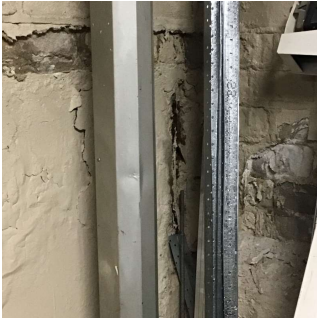
Boiler Room
Violations	No violations recorded.
FOUNDATION WALLS	
Material Type(s)	Inspected Concrete, Masonry
Condition	3 - Fair
Deficiency	CONCRETE: CRACKED/SPALLED/REINFORCEMENT EXPOSED
Deficiency Location/Instance	Basement - Storage Room, Crawlspace
Deficiency Quantity	20
Quantity Uom	S.F.
Potential Action	REPAIR
Urgency of Action	PRIORITY 4
Purpose of Action	LEVEL 5
Deficiency Photo1

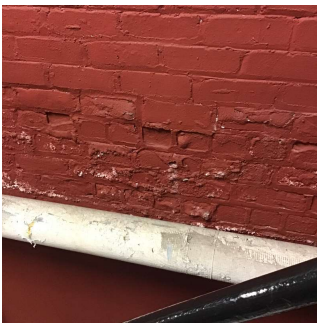
Basement - Storage Room
Violations	No violations recorded.
Deficiency	BRICK: CRACKED/SPALLED
Deficiency Location/Instance	Basement - Boiler Room, Electrical Panel Room, Storage Room
Deficiency Quantity	60
Quantity Uom	S.F.
Potential Action	RESTITCH
Urgency of Action	PRIORITY 4
Purpose of Action	LEVEL 5

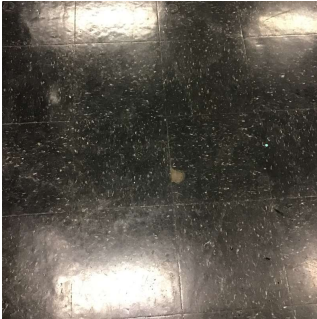
Question	Response
INTERIOR	
CAFETERIA	
Instance on Basement	Does not Exist
Floor Finish	
Instance on Basement	Inspected
Condition	2 - Between Good and Fair
Deficiency	VINYL TILES: BROKEN/DETERIORATED/MISSING TILES
Deficiency Location/Instance	Near Office
Deficiency Quantity	10
Quantity Uom	S.F.
Potential Action	REPLACE
Urgency of Action	PRIORITY 3
Purpose of Action	LEVEL 2
Deficiency Photo1

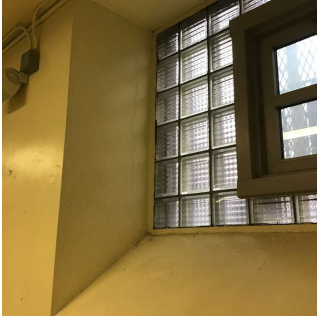
Violations	Near Office No violations recorded.
Sliding-folding Partition	
Instance on Basement	Does not Exist
Stage	
Instance on Basement	Does not Exist
Walls	
Instance on Basement	Inspected
Condition	2 - Between Good and Fair
Deficiency	PLASTER: CRACKS/SPALLING
Deficiency Location/Instance	Near windows
Deficiency Quantity	25
Quantity Uom	S.F.
Potential Action	REPLACE
Urgency of Action	PRIORITY 3
Purpose of Action	LEVEL 2
Deficiency Photo1

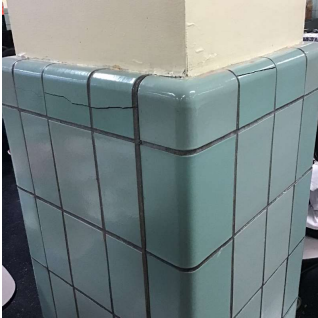
Violations	Near windows No violations recorded.
Deficiency	CERAMIC TILE: BROKEN/ MISSING

Question	Response
INTERIOR	
CAFETERIA	
Walls	
Deficiency Location/Instance	Center
Deficiency Quantity	20
Quantity Uom	S.F.
Potential Action	REPLACE
Urgency of Action	PRIORITY 3
Purpose of Action	LEVEL 2
Deficiency Photo1

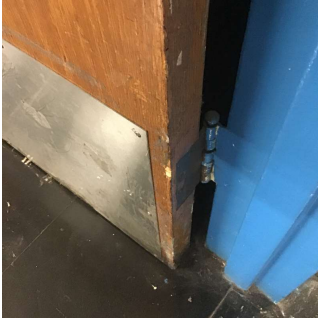
Violations	Center No violations recorded.
Window Curtains/Shades/Blinds	
Instance on Basement	Does not Exist
CLASSROOMS/CORRIDORS/ADMIN SPACES	
Ceiling	Inspected
Condition	2 - Between Good and Fair
Deficiency	No deficiencies recorded
Door(s)	Inspected
Condition	5 - Poor
Deficiency	WOOD: DETERIORATED DOOR
Deficiency Location/Instance	Rooms 306, 316, 202, 120, 107 and others
Deficiency Quantity	10
Quantity Uom	EACH
Potential Action	MAINTENANCE
Urgency of Action	PRIORITY 3
Purpose of Action	LEVEL 2
Deficiency Photo1

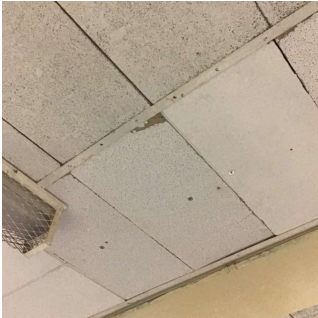
Question	Response
INTERIOR	
INTERIOR DOOR HARDWARE	Inspected
Condition	3 - Fair
Deficiency	No deficiencies recorded
INTERIOR GUARDS	Inspected
Condition	2 - Between Good and Fair
Deficiency	No deficiencies recorded
KITCHEN	Inspected
Instance on Basement	Inspected
Ceiling	
Instance on Basement	Inspected
Condition	2 - Between Good and Fair
Deficiency	TECTUM: DAMAGED/MISSING
Deficiency Location/Instance	Center
Deficiency Quantity	10
Quantity Uom	S.F.
Potential Action	REPLACE
Urgency of Action	PRIORITY 3
Purpose of Action	LEVEL 2
Deficiency Photo1

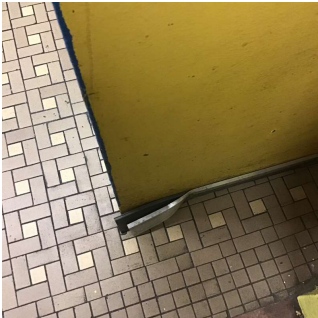
Violations	Center No violations recorded.
Door(s)	
Instance on Basement	Inspected
Condition	4 - Between Fair and Poor
Deficiency	METAL: DETERIORATED DOOR
Deficiency Location/Instance	Entrance, Storage Door
Deficiency Quantity	2
Quantity Uom	EACH
Potential Action	MAINTENANCE
Urgency of Action	PRIORITY 3
Purpose of Action	LEVEL 2
Deficiency Photo1

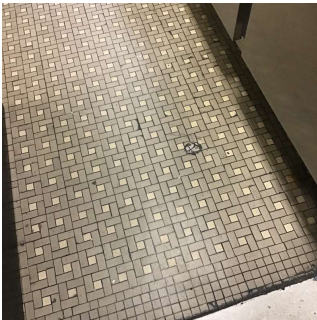
Question	Response
INTERIOR	
KITCHEN	
Door(s)	
Violations	No violations recorded.
Floor Finish	
Instance on Basement	Inspected
Condition	2 - Between Good and Fair
Deficiency	CERAMIC TILE: BROKEN/MISSING TILES
Deficiency Location/Instance	Entrance
Deficiency Quantity	10
Quantity Uom	S.F.
Potential Action	REPLACE
Urgency of Action	PRIORITY 3
Purpose of Action	LEVEL 2
Deficiency Photo1

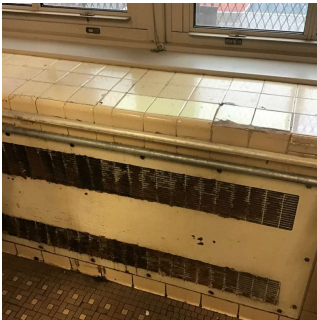
Violations	Entrance No violations recorded.
Walls	
Instance on Basement	Inspected
Condition	2 - Between Good and Fair
Deficiency	CERAMIC TILE: BROKEN/ MISSING
Deficiency Location/Instance	Near Window
Deficiency Quantity	20
Quantity Uom	S.F.
Potential Action	REPLACE
Urgency of Action	PRIORITY 3
Purpose of Action	LEVEL 2
Deficiency Photo1

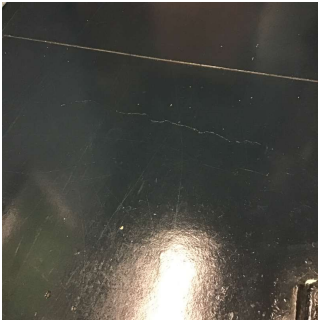
Near Shower Room
Violations	No violations recorded.
Instance on 2nd Floor	Inspected
Condition	2 - Between Good and Fair
Deficiency	CONCRETE: CRACKS
Deficiency Location/Instance	Near Entrance
Deficiency Quantity	10
Quantity Uom	S.F.
Potential Action	REPLACE
Urgency of Action	PRIORITY 3
Purpose of Action	LEVEL 2
Deficiency Photo1

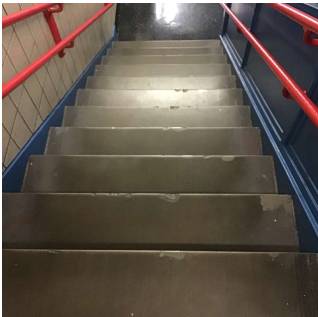
Violations	Stair 1/F No violations recorded.
Deficiency	STONE: BROKEN/MISSING
Deficiency Location/Instance	Stair F/1
Deficiency Quantity	100
Quantity Uom	S.F.
Potential Action	REPLACE
Urgency of Action	PRIORITY 3
Purpose of Action	LEVEL 2
Deficiency Photo1

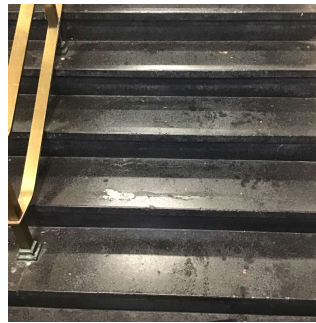
Violations	Stair 1/F No violations recorded.
Deficiency	TERRAZZO: CRACKS
Deficiency Location/Instance	Main Entrance Vestibule, Stair F /1
Deficiency Quantity	60
Quantity Uom	S.F.
Potential Action	REPLACE
Urgency of Action	PRIORITY 3
Purpose of Action	LEVEL 2

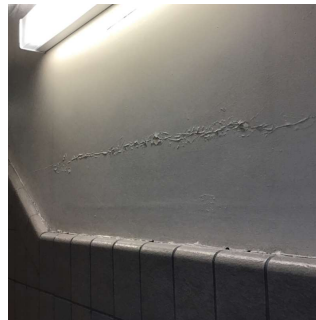
PLASTER: CRACKS/SPALLING

REPLACE

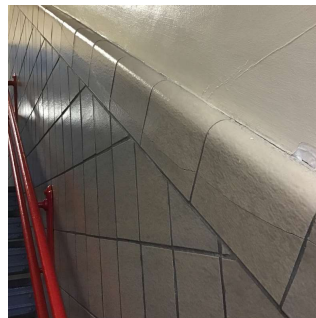
GLAZED BLOCK: CRACKS/SPALLING

REPLACE

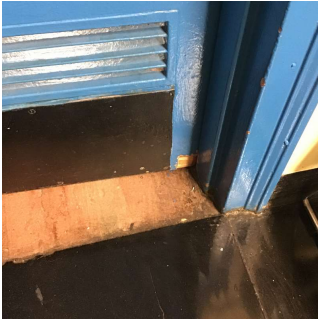
Question	Response
INTERIOR	
STAIRS/RAMPS: INTERIOR	Inspected
Walls	Inspected
Violations	Stair E/2 No violations recorded.
TOILET ROOMS - STAFF	Inspected
Ceiling	Inspected
Condition	2 - Between Good and Fair
Deficiency	No deficiencies recorded
Door(s)	Inspected
Condition	5 - Poor
Deficiency	WOOD: DAMAGED LOUVER
Deficiency Location/Instance	Room 230, 105
Deficiency Quantity	2
Quantity Uom	EACH
Potential Action	MAINTENANCE
Urgency of Action	PRIORITY 3
Purpose of Action	LEVEL 2
Deficiency Photo1

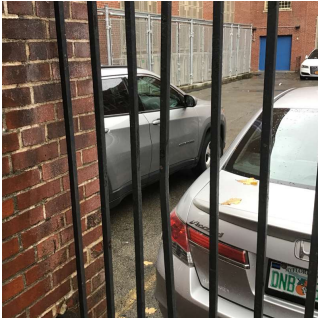
Potential Action	MAINTENANCE
Urgency of Action	PRIORITY 3
Purpose of Action	LEVEL 2
Deficiency Photo1	No photo recorded
Violations	No violations recorded.
FENCES	Inspected
Condition	2 - Between Good and Fair
Deficiency	WROUGHT IRON: DAMAGED/DETERIORATED
Deficiency Location/Instance	Along 64th Street
Deficiency Quantity	40
Quantity Uom	S.F.
Potential Action	REPLACE
Urgency of Action	PRIORITY 3
Purpose of Action	LEVEL 2

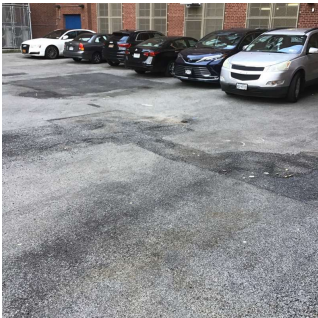
Violations	Along 64th Street No violations recorded.
IRRIGATION SYSTEM	Does not Exist
PAVING	Inspected
Student Non-Use	Inspected
Gravel Exists?	Yes
Asphalt	Inspected
Condition	3 - Fair
Deficiency	LOCALIZED SINK AREA
Deficiency Location/Instance	Courtyard Parking Area
Deficiency Quantity	200
Quantity Uom	S.F.
Potential Action	REPAIR
Urgency of Action	PRIORITY 3
Purpose of Action	LEVEL 2
Deficiency Photo1

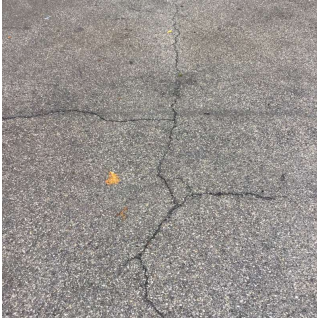
Violations	West side No violations recorded.
Deficiency	CRACKS - MAJOR
Deficiency Location/Instance	Parking Lot
Deficiency Quantity	175
Quantity Uom	S.F.
Potential Action	REPLACE
Urgency of Action	PRIORITY 3
Purpose of Action	LEVEL 2

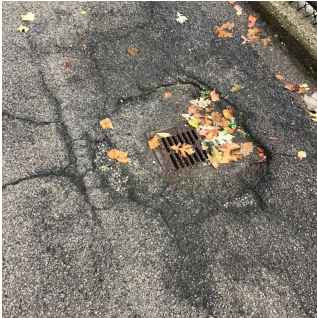
Violations	Parking Lot No violations recorded.
Concrete	Inspected
Condition	2 - Between Good and Fair
Deficiency	No deficiencies recorded
Pavers	Does not Exist
Student Use	Does not Exist
Site Sidewalks & Walkways	Inspected
Asphalt	Inspected
Condition	4 - Between Fair and Poor
Deficiency	POTHOLES
Deficiency Location/Instance	Along Park Walkway
Deficiency Quantity	100
Quantity Uom	S.F.
Potential Action	REPAIR
Urgency of Action	PRIORITY 5
Purpose of Action	LEVEL 6
Deficiency Photo1

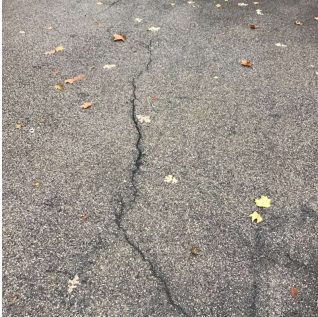
Violations	Along Park Walkway No violations recorded.
Deficiency	CRACKS - MAJOR
Deficiency Location/Instance	Along Park Walkway
Deficiency Quantity	500
Quantity Uom	S.F.
Potential Action	REPLACE
Urgency of Action	PRIORITY 3
Purpose of Action	LEVEL 2

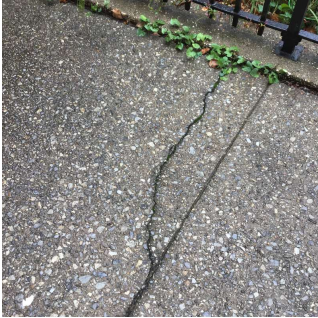
Violations	Along Park Walkway No violations recorded.
Concrete	Inspected
Condition	3 - Fair
Deficiency	CRACKS - MAJOR
Deficiency Location/Instance	Along Playground
Deficiency Quantity	50
Quantity Uom	S.F.
Potential Action	REPLACE
Urgency of Action	PRIORITY 3
Purpose of Action	LEVEL 2
Deficiency Photo1

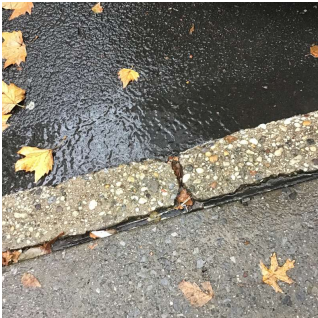
Question	Response
SITE	
PAVING	
DOT Sidewalk	
Concrete	
Violations	No violations recorded.
Deficiency	DAMAGED CURBS
Deficiency Location/Instance	Along 65 Avenue, 102nd Street, 64th Avenue
Deficiency Quantity	150
Quantity Uom	L.F.
Potential Action	REPLACE
Urgency of Action	PRIORITY 3
Purpose of Action	LEVEL 2
Deficiency Photo1

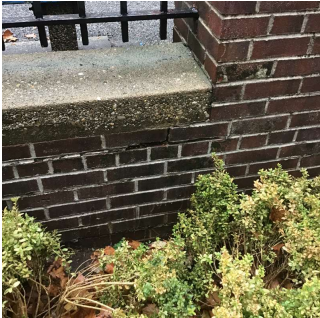
Deficiency	BRICK: CRACKS/SPALLING - MAJOR

Question	Response
SITE	
RETAINING WALLS	
Deficiency Location/Instance	Along 65th Avenue
Deficiency Quantity	100
Quantity Uom	S.F.
Potential Action	REPLACE
Urgency of Action	PRIORITY 3
Purpose of Action	LEVEL 2
Deficiency Photo1

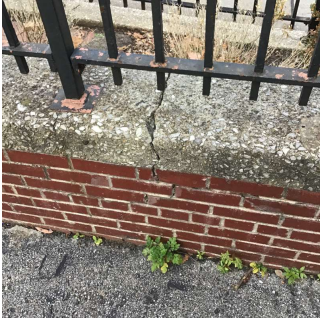
Violations	Along 65th Avenue No violations recorded.
SEATING	Does not Exist
SITE WALLS (NOT RETAINING WALLS)	Inspected
Condition	3 - Fair
Deficiency	BRICK: DETERIORATED COPING STONE
Deficiency Location/Instance	Courtyard
Deficiency Quantity	10
Quantity Uom	S.F.
Potential Action	REPLACE
Urgency of Action	PRIORITY 3
Purpose of Action	LEVEL 2
Deficiency Photo1

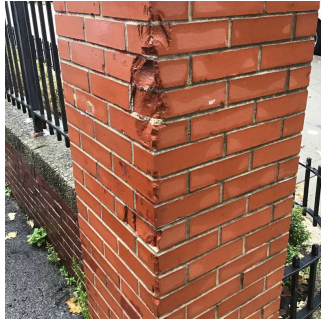
Question	Response
SITE	
SITE WALLS (NOT RETAINING WALLS)	
Deficiency Photo1

Violations	Near entrance No violations recorded.
Deficiency	BRICK: CRACKS/SPALLING - MAJOR
Deficiency Location/Instance	Along 65th Avenue, Parking Lot
Deficiency Quantity	30
Quantity Uom	S.F.
Potential Action	REPLACE
Urgency of Action	PRIORITY 3
Purpose of Action	LEVEL 2

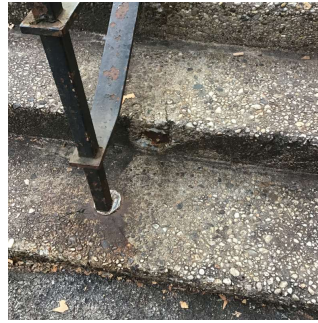
Violations	Parking Lot No violations recorded.
STAIRS/RAMPS: EXTERIOR	
Railings	Inspected
Condition	5 - Poor
Deficiency	RUST - MAJOR
Deficiency Location/Instance	Near Park
Deficiency Quantity	30
Quantity Uom	L.F.
Potential Action	REPLACE
Urgency of Action	PRIORITY 3
Purpose of Action	LEVEL 2
Deficiency Photo1	 
Violations	Near Park No violations recorded.
Site Cheek/flank Walls	
Condition	Inspected 2 - Between Good and Fair
Deficiency	No deficiencies recorded
Stairs/ramps	
Condition	Inspected 2 - Between Good and Fair
Deficiency	CAST IN PLACE CONCRETE: CRACKS/SPALLING - MAJOR
Deficiency Location/Instance	Near Park
Deficiency Quantity	20
Quantity Uom	S.F.
Potential Action	REPLACE
Urgency of Action	PRIORITY 3
Purpose of Action	LEVEL 2
