NYC Department of Education
Building Condition Assessment Survey 2023 - 2024

Architectural Inspection

Asset: P.S. 176 - QUEENS, 120-45 235 STREET, New York, 11411

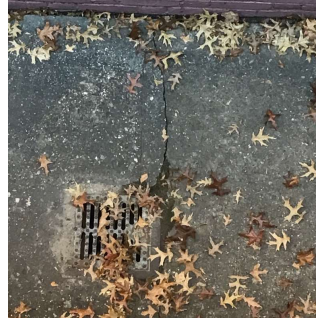
Facade G - AW7

AREAWAY SLAB: CRACKS AND SPALLING

20
S.F.
REPAIR
PRIORITY 3
LEVEL 2

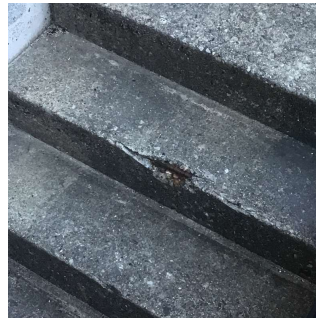
Facade J - AW8

**AREAWAY STAIRS: DETERIORATED
TREADS/RISERS/NOSINGS**

REPAIR

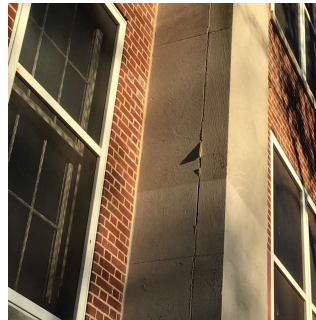
Facade G

STONE: DETERIORATED JOINTS

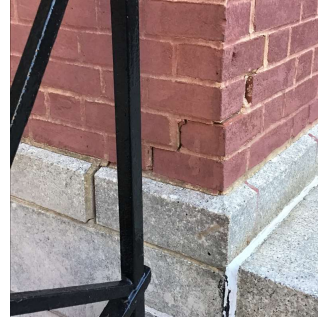
Facade K

BRICK: CRACKS/DISPLACED/SPALLED BRICK AT BUILDING CORNERS

REMOVE AND REBUILD
PRIORITY 4
LEVEL 2

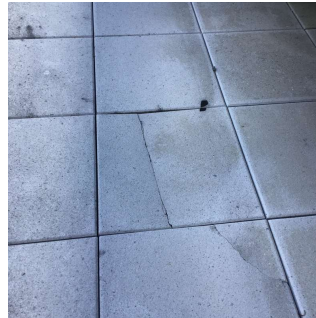
Roof 3

Deficiency	IRMA: ROOFING: DETERIORATED PAVERS WITH INTEGRAL INSULATION
------------	-------------------------------------------------------------

Potential Action	REPLACE
------------------	---------

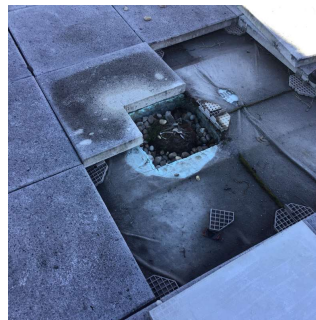
Roof 3

IRMA: ROOFING: DAMAGED INSULATION

REPLACE

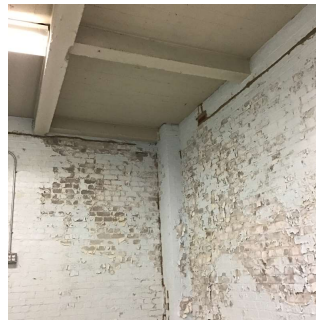
Roof 1 BH1 Fan Room

BULKHEAD/PENTHOUSE WALLS/INTERIOR: BRICK
 CRACKS/SPALLING

80
S.F.
REPLACE
PRIORITY 3
LEVEL 2

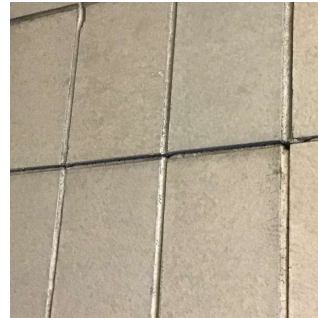
Roof 1 - Bulkhead 1

BULKHEAD/PENTHOUSE WALLS/INTERIOR: GLAZED BLOCK DETERIORATED JOINTS

20
S.F.
REPOINT
PRIORITY 3
LEVEL 2

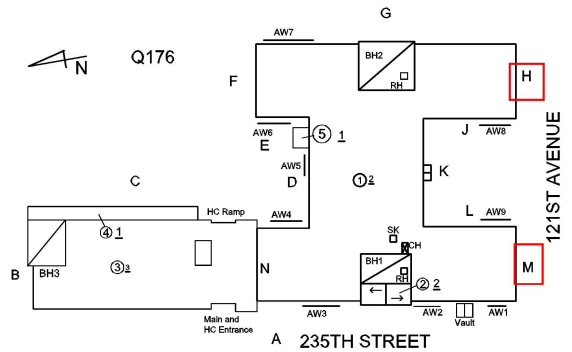
Roof Plan reference

RAILINGS

30
L.F.
REPLACE
PRIORITY 4
LEVEL 2

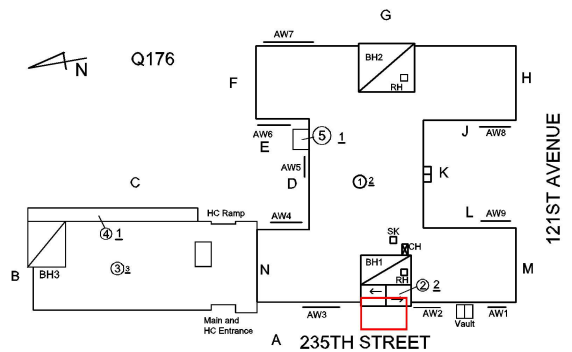
Roof Plan reference

DAMAGED

10
L.F.
REPLACE
PRIORITY 4
LEVEL 2

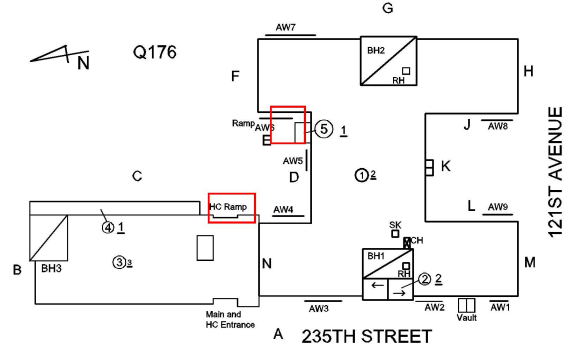
Roof Plan reference

CONCRETE: CRACKS/SPALLING - MINOR

REPAIR

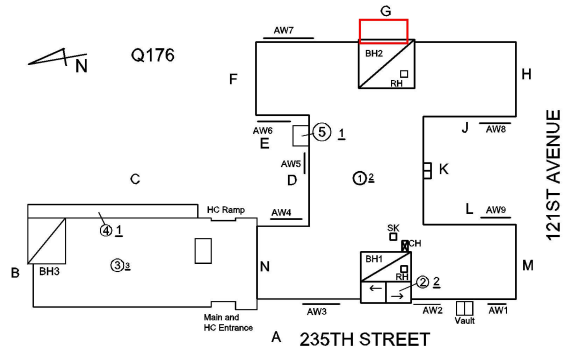
Roof Plan reference

STONE: DETERIORATED JOINTS

20
 L.F.
 REPOINT
 PRIORITY 4
 LEVEL 2

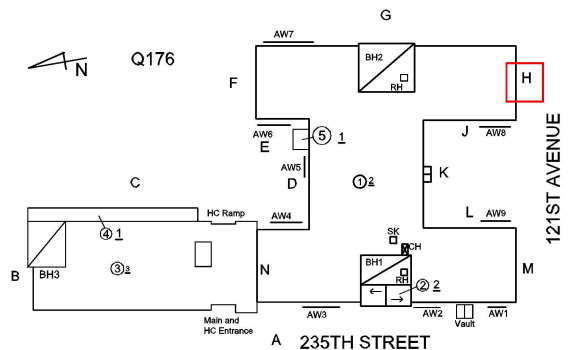
Roof Plan reference

STONE: WORN-OUT TREAD/RISER/NOSING

20
 S.F.
 REPLACE
 PRIORITY 4
 LEVEL 2

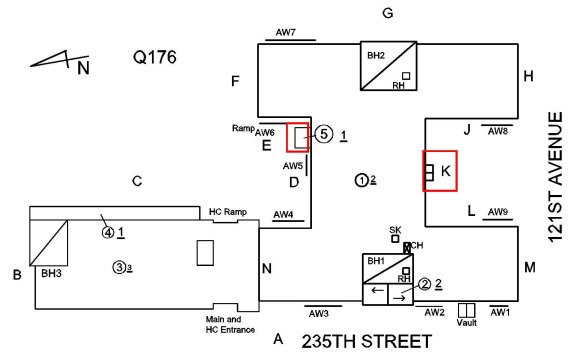
Roof Plan reference

STONE: CRACKS/SPALLING - MAJOR

REPLACE

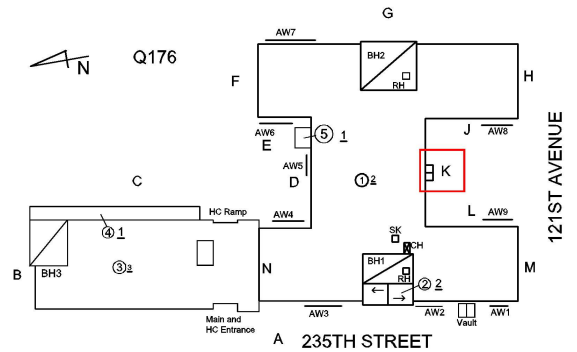
Roof Plan reference

STONE: CRACKS/SPALLING - MINOR

10
S.F.
REPAIR
PRIORITY 3
LEVEL 2

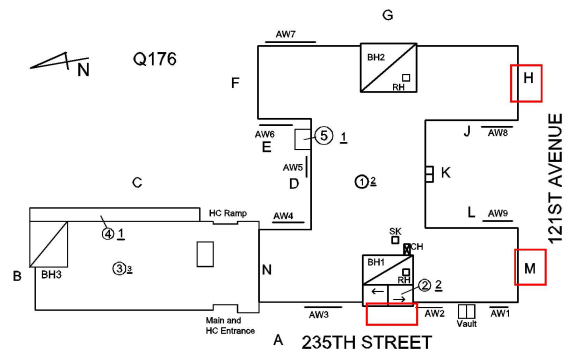
Roof Plan reference

STONE: DETERIORATED JOINTS

40
L.F.
REPOINT
PRIORITY 3
LEVEL 2

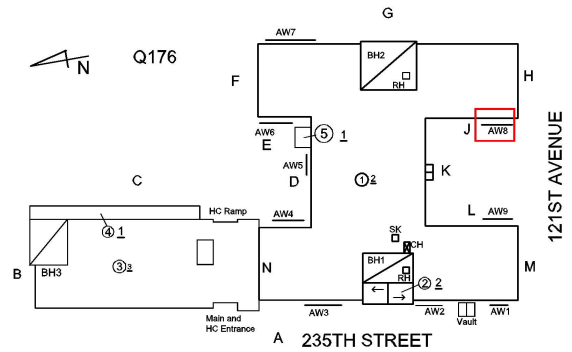
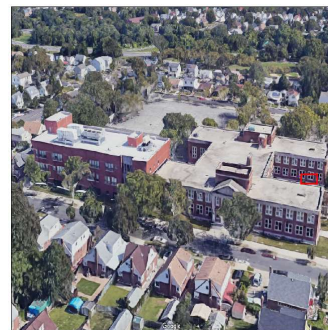
Roof Plan reference

RUST - MAJOR

REPLACE

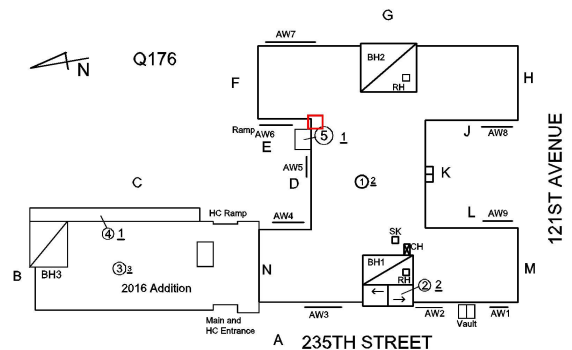
Roof Plan reference

WOOD: DETERIORATED

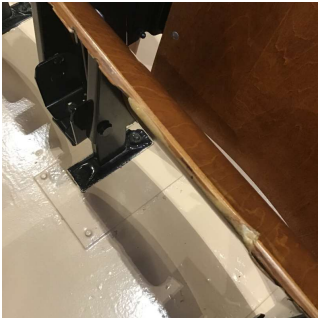
Question	Response
INTERIOR	
AUDITORIUM	
Door(s)	
Instance on 1st Floor (413 Seats)	Inspected
Condition	2 - Between Good and Fair
Deficiency	No deficiencies recorded
Fixed H/C Lift	
Instance on 1st Floor (413 Seats)	Does not Exist
Fixed Seating	
Instance on 1st Floor (413 Seats)	Inspected
Condition	2 - Between Good and Fair
Deficiency	DAMAGED/BROKEN/INOPERABLE
Deficiency Location/Instance	Row E/110, 109, 108,F/101, K/112, L/2,101
Deficiency Quantity	7
Quantity Uom	EACH
Potential Action	REPLACE
Urgency of Action	PRIORITY 3
Purpose of Action	LEVEL 2
Deficiency Photo1

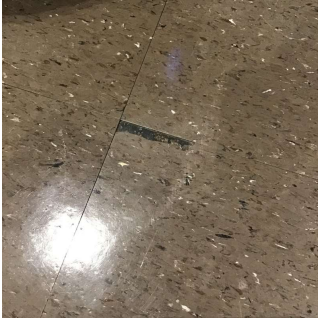
Violations	Right Side Near Stage No violations recorded.

Violations	Row E/110 No violations recorded.
Floor Finish	
Instance on 1st Floor (413 Seats)	Inspected
Condition	2 - Between Good and Fair
Deficiency	VINYL TILES: BROKEN/DETERIORATED/MISSING TILES
Deficiency Location/Instance	Right Side Near Stage
Deficiency Quantity	10
Quantity Uom	S.F.
Potential Action	REPLACE
Urgency of Action	PRIORITY 3
Purpose of Action	LEVEL 2

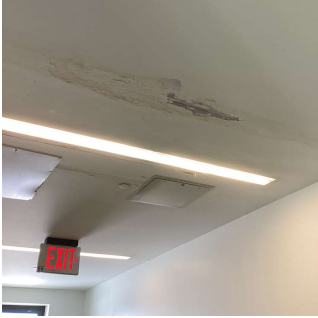
Question	Response
INTERIOR	
CAFETERIA	Inspected
Window Curtains/Shades/Blinds	
Instance on 1st Floor	Does not Exist
CLASSROOMS/CORRIDORS/ADMIN SPACES	Inspected
Ceiling	Inspected
Condition	2 - Between Good and Fair
Deficiency	GYPSUM BOARD: DAMAGED/DETERIORATED
Deficiency Location/Instance	Near Room 338, Corridor near Stair D/3
Deficiency Quantity	20
Quantity Uom	S.F.
Potential Action	REPLACE
Urgency of Action	PRIORITY 3
Purpose of Action	LEVEL 2
Deficiency Photo1

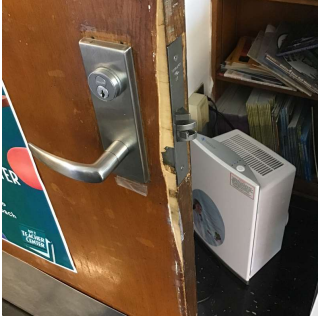
Violations	Corridor near Stair D/3 No violations recorded.
Door(s)	Inspected
Condition	5 - Poor
Deficiency	WOOD: DETERIORATED DOOR
Deficiency Location/Instance	Rooms 123, 201, 202,207, 228 and others
Deficiency Quantity	9
Quantity Uom	EACH
Potential Action	MAINTENANCE
Urgency of Action	PRIORITY 3
Purpose of Action	LEVEL 2
Deficiency Photo1

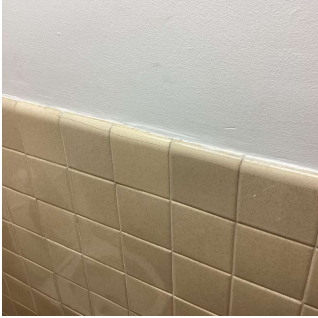
Question	Response
INTERIOR	
TOILET ROOMS - STAFF	
Floor Finish	Inspected
Condition	2 - Between Good and Fair
Deficiency	No deficiencies recorded
Stalls	Inspected
Condition	2 - Between Good and Fair
Deficiency	No deficiencies recorded
Walls	Inspected
Condition	2 - Between Good and Fair
Deficiency	CERAMIC TILE: BROKEN/ MISSING
Deficiency Location/Instance	Room 226A
Deficiency Quantity	10
Quantity Uom	S.F.
Potential Action	REPLACE
Urgency of Action	PRIORITY 3
Purpose of Action	LEVEL 2
Deficiency Photo1

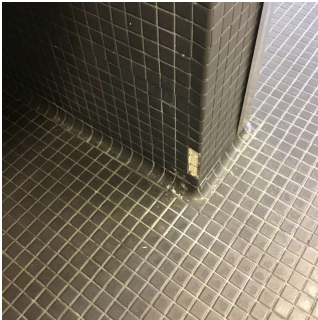
Question	Response
INTERIOR	
TOILET ROOMS - STUDENTS	
Stalls	
Deficiency Photo1	 
	Room 141
Violations	No violations recorded.
Walls	
Condition	Inspected
	2 - Between Good and Fair
Deficiency	CERAMIC TILE: BROKEN/ MISSING
Deficiency Location/Instance	Room 211
Deficiency Quantity	10
Quantity Uom	S.F.
Potential Action	REPLACE
Urgency of Action	PRIORITY 3
Purpose of Action	LEVEL 2
Deficiency Photo1

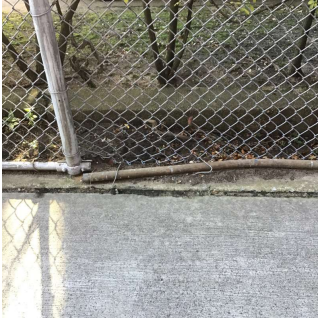
Question	Response
SITE	
FENCES	
Deficiency	CHAIN LINK: DAMAGED POST/RAIL
Deficiency Location/Instance	Near Exit 11
Deficiency Quantity	10
Quantity Uom	L.F.
Potential Action	REPLACE
Urgency of Action	PRIORITY 3
Purpose of Action	LEVEL 2
Deficiency Photo1

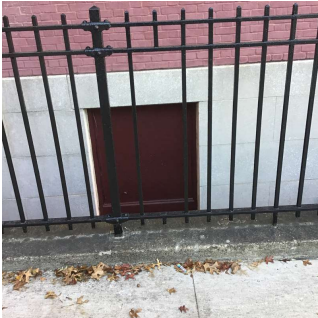
Near Exit 11
Violations	No violations recorded.
Deficiency	WROUGHT IRON: DAMAGED/DETERIORATED
Deficiency Location/Instance	Schoolyard, Near exit 2, courtyard in front playground
Deficiency Quantity	200
Quantity Uom	S.F.
Potential Action	REPLACE
Urgency of Action	PRIORITY 3
Purpose of Action	LEVEL 2
Deficiency Photo1

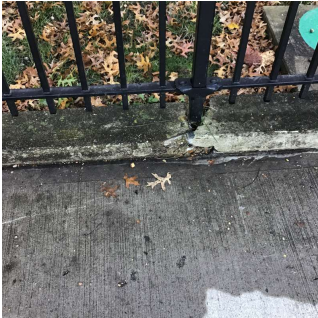
Schoolyard
Violations	No violations recorded.
Deficiency	CONCRETE CURB: DAMAGED/DETERIORATED
Deficiency Location/Instance	Along 235th Street, 121 Avenue, Near Playground, Schoolyard
Deficiency Quantity	50
Quantity Uom	S.F.
Potential Action	REPLACE
Urgency of Action	PRIORITY 3
Purpose of Action	LEVEL 2

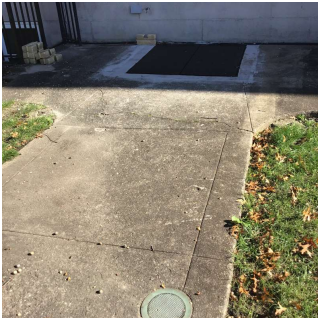
Violations	Along 235th Street No violations recorded.
IRRIGATION SYSTEM	Does not Exist
PAVING	Inspected
Student Non-Use	Inspected
Gravel Exists?	No
Asphalt	Does not Exist
Concrete	Inspected
Condition	3 - Fair
Deficiency	CRACKS - MAJOR
Deficiency Location/Instance	Along 235th Street
Deficiency Quantity	50
Quantity Uom	S.F.
Potential Action	REPLACE
Urgency of Action	PRIORITY 3
Purpose of Action	LEVEL 2
Deficiency Photo1

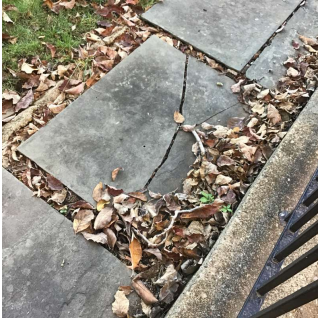
Violations	Along 235th Street No violations recorded.
Pavers	Does not Exist
Student Use	Inspected
Gravel Exists?	Yes
Asphalt	Does not Exist
Concrete	Inspected
Condition	2 - Between Good and Fair
Deficiency	No deficiencies recorded
Pavers	Inspected
Condition	2 - Between Good and Fair
Deficiency	DAMAGED/MISSING
Deficiency Location/Instance	Courtyard in front of Playground

Question	Response
SITE	
PAVING	
Student Use	
Pavers	
Deficiency Quantity	30
Quantity Uom	S.F.
Potential Action	REPLACE
Urgency of Action	PRIORITY 3
Purpose of Action	LEVEL 2
Deficiency Photo1

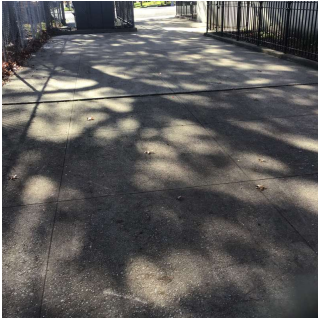
Violations	Courtyard in front of Playground No violations recorded.
Site Sidewalks & Walkways	
Asphalt	
Inspected	
Does not Exist	
Concrete	
Inspected	
Condition	3 - Fair
Deficiency	HEAVING
Deficiency Location/Instance	Near Exit 2
Deficiency Quantity	100
Quantity Uom	S.F.
Potential Action	REPLACE
Urgency of Action	PRIORITY 3
Purpose of Action	LEVEL 2
Deficiency Photo1

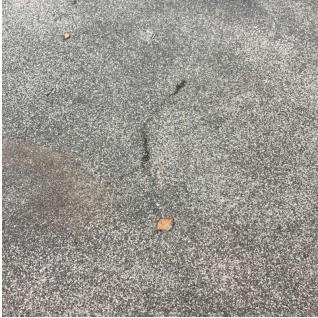
Question	Response
SITE	
PLAYGROUNDS	
Pavement	
Potential Action	REPLACE
Urgency of Action	PRIORITY 3
Purpose of Action	LEVEL 2
Deficiency Photo1

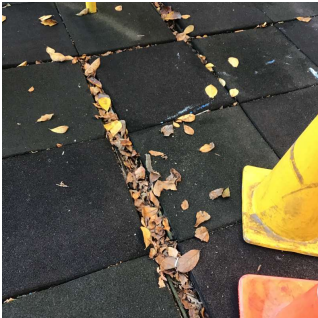
Violations	Right side No violations recorded.
Play Equipment	
Instance on 121st Avenue	Inspected
Condition	2 - Between Good and Fair
Deficiency	No deficiencies recorded
Safety Surfacing	
Instance on 121st Avenue	Inspected
Condition	5 - Poor
Deficiency	DETERIORATED/MISSING
Deficiency Location/Instance	121st Avenue
Deficiency Quantity	600
Quantity Uom	S.F.
Potential Action	REPLACE
Urgency of Action	PRIORITY 3
Purpose of Action	LEVEL 2
Deficiency Photo1	No photo recorded
Violations	No violations recorded.
Deficiency	DETERIORATED/MISSING
Deficiency Location/Instance	Right side
Deficiency Quantity	60
Quantity Uom	S.F.
Potential Action	REPLACE
Urgency of Action	PRIORITY 5
Purpose of Action	LEVEL 6
Deficiency Photo1

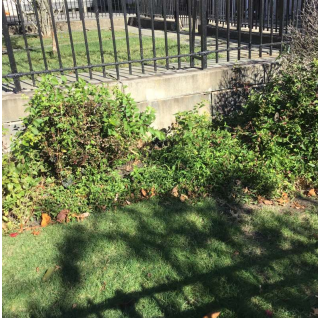
Question	Response
SITE	
PLAYGROUNDS	
Safety Surfacing	
Violations	No violations recorded.
Unpaved Area	
Instance on 121st Avenue	Inspected
Condition	2 - Between Good and Fair
Deficiency	No deficiencies recorded
PLAYING SURFACE	Does not Exist
RETAINING WALLS	Inspected
Are there any Retaining Walls 6' OR higher facing public street/sidewalk?	No
Condition	3 - Fair
Deficiency	STONE: BULGING/DISPLACED
Deficiency Location/Instance	Seating Area at South Side of Playground
Deficiency Quantity	25
Quantity Uom	S.F.
Potential Action	REPLACE
Urgency of Action	PRIORITY 3
Purpose of Action	LEVEL 2
Deficiency Photo1	No photo recorded
Violations	No violations recorded.
Deficiency	STONE: DETERIORATED JOINTS
Deficiency Location/Instance	121st Avenue
Deficiency Quantity	40
Quantity Uom	S.F.
Potential Action	REPOINT
Urgency of Action	PRIORITY 3
Purpose of Action	LEVEL 2
Deficiency Photo1

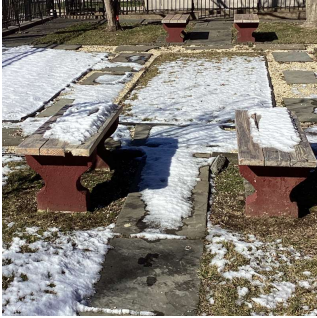
SEATING	Inspected
Benches	Inspected
Concrete	Does not Exist
Metal/Wood/Plastic	Inspected
Condition	4 - Between Fair and Poor
Deficiency	DAMAGED/DETERIORATED
Deficiency Location/Instance	Courtyard
Deficiency Quantity	2
Quantity Uom	EACH
Potential Action	REPLACE

Question	Response
SITE	
SEATING	
Benches	
Metal/Wood/Plastic	
Urgency of Action	PRIORITY 3
Purpose of Action	LEVEL 2
Deficiency Photo1

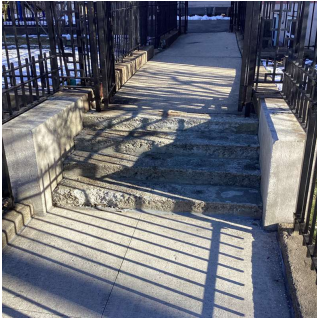
Violations	Courtyard No violations recorded.
Bleachers	Does not Exist
SITE WALLS (NOT RETAINING WALLS)	Does not Exist
STAIRS/RAMPS: EXTERIOR	Inspected
Railings	Inspected
Condition	3 - Fair
Deficiency	MISSING
Deficiency Location/Instance	121st Avenue
Deficiency Quantity	15
Quantity Uom	L.F.
Potential Action	REPLACE
Urgency of Action	PRIORITY 5
Purpose of Action	LEVEL 6
Deficiency Photo1

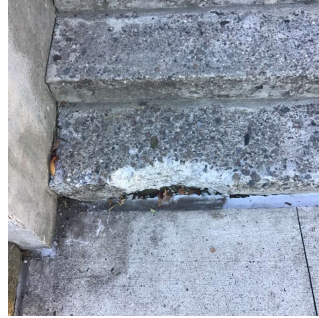
Violations	121st Avenue No violations recorded.
Site Cheek/flank Walls	Inspected
Condition	2 - Between Good and Fair
Deficiency	No deficiencies recorded
Stairs/ramps	Inspected
Condition	2 - Between Good and Fair
Deficiency	CAST IN PLACE CONCRETE: CRACKS/SPALLING - MAJOR
Deficiency Location/Instance	121st Avenue
Deficiency Quantity	20
Quantity Uom	S.F.
Potential Action	REPLACE

Question	Response
SITE	
STAIRS/RAMPS: EXTERIOR	
Stairs/ramps	
Urgency of Action	PRIORITY 5
Purpose of Action	LEVEL 6
Deficiency Photo1
