**NYC Department of Education**  
**Building Condition Assessment Survey 2023 - 2024**

Architectural Inspection

**Asset:** P.S. 179 - QUEENS, 196-25 PECK AVENUE, New York, 11365

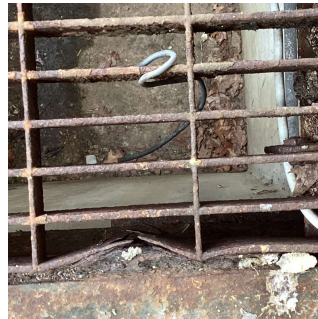
AW1  
No violations recorded.

Instance Condition	5 - Poor
Instance Quantity	4
Instance Quantity Uom	EACH
Deficiency	AREAWAY GRATINGS: MAJOR RUSTING / OR BROKEN
Roof Plan reference	Q179

Deficiency Quantity	80
Quantity Uom	S.F.
Potential Action	REPLACE
Urgency of Action	PRIORITY 4
Purpose of Action	LEVEL 2
Deficiency Photo1

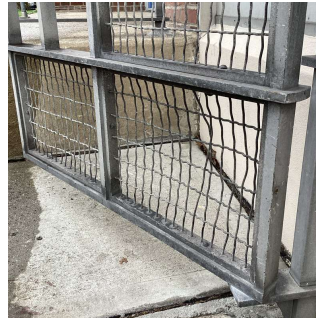
AW2

AREAWAY STAIRS: DETERIORATED RAILINGS

REPLACE

PRIORITY 4  
LEVEL 2

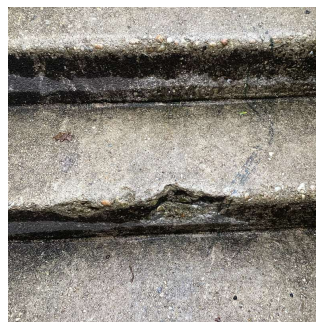
AW2

AREAWAY STAIRS: DETERIORATED  
TREADS/RISERS/NOSINGS

20  
S.F.  
REPLACE  
PRIORITY 4  
LEVEL 2

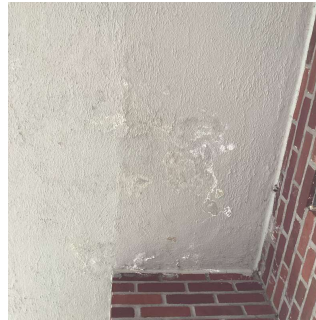
Facade C  
 No violations recorded.

**AWNINGS AND CANOPIES**

50  
 S.F.  
 REPLACE  
 PRIORITY 5  
 LEVEL 2

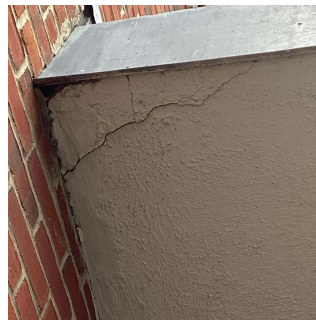
Facade D

CONCRETE: DETERIORATED

50  
 S.F.  
 REPLACE  
 PRIORITY 4  
 LEVEL 2

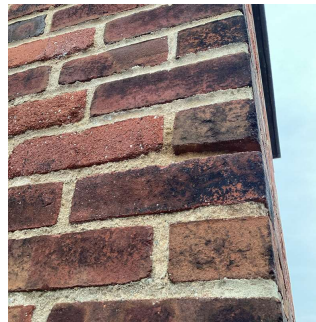
CH

BRICK: DETERIORATED JOINTS

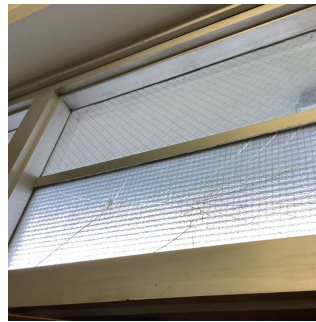
Facade A

Deficiency	METAL: BROKEN GLASS
------------	---------------------

Deficiency Quantity	20
Quantity Uom	S.F.
Potential Action	MAINTENANCE
Urgency of Action	PRIORITY 3
Purpose of Action	LEVEL 2
Deficiency Photo1

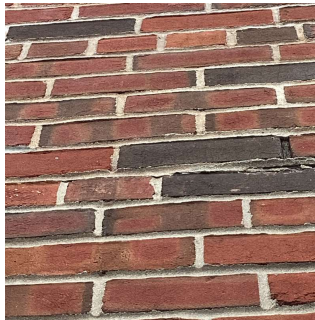
Facade E

Deficiency	BRICK: DETERIORATED JOINTS
------------	----------------------------

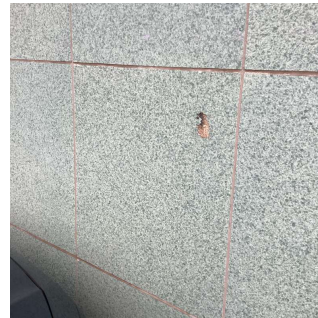
Facade F

CERAMIC TILE: CHIPPED, SPALLED, BROKEN PIECES

REPLACE

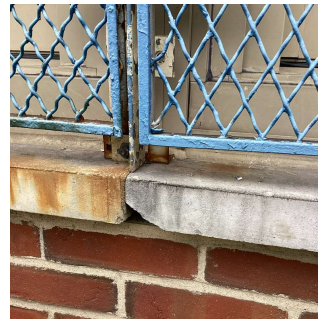
Facade A

BRICK: DETERIORATED MASONRY SILLS - MAJOR

REMOVE AND REPLACE

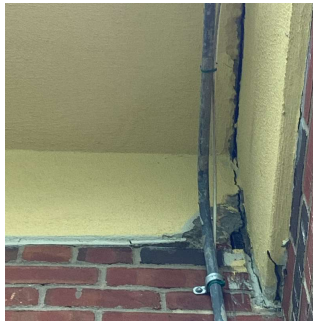
Facade A

CAST IN PLACE / PRE-CAST CONCRETE: MAJOR  
 CRACKS/SPALLING

REPLACE

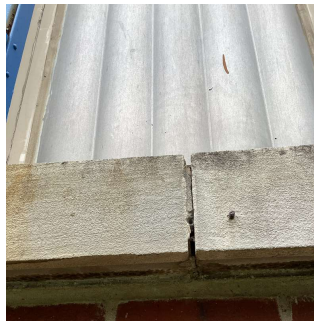
Facade A  
No violations recorded.

BRICK: MASONRY SILLS - DETERIORATED JOINTS

10  
L.F.  
REPOINT  
PRIORITY 3  
LEVEL 2

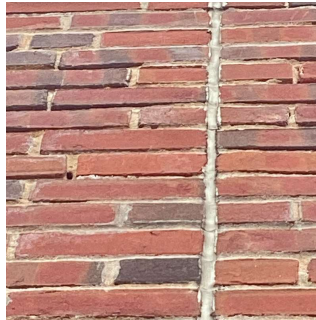
Roof 3  
 No violations recorded.

BRICK: DETERIORATED CONTROL/EXPANSION JOINT

10  
 L.F.  
 MAINTENANCE  
 PRIORITY 3  
 LEVEL 2

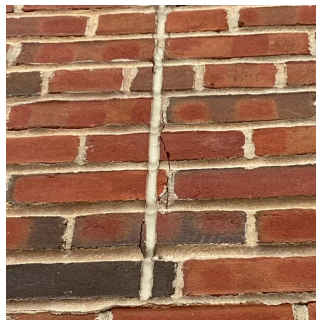
Roof 3

**BRICK: MINOR CRACKS, SPALLING**

10  
 S.F.  
 REPAIR  
 PRIORITY 3  
 LEVEL 2

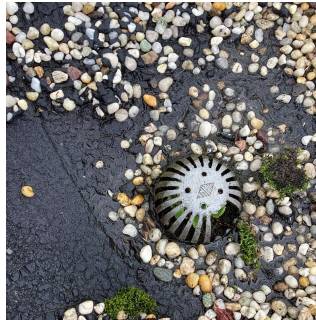
Roof 4  
 No violations recorded.

Roof 2
Violations	No violations recorded.
<b>ROOFING DRAINS</b>	
Condition	Inspected
Deficiency	5 - Poor
	DETERIORATED

5  
 EACH  
 REPLACE  
 PRIORITY 4  
 LEVEL 2

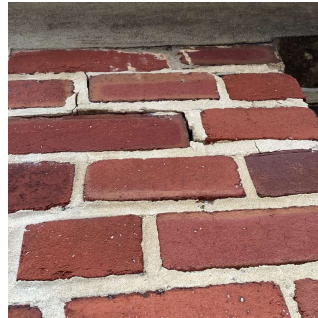
BH2

BULKHEAD/PENTHOUSE WALLS/EXTERIOR:  
 BULGING/BOWING

10  
 S.F.  
 REPLACE  
 PRIORITY 4  
 LEVEL 2

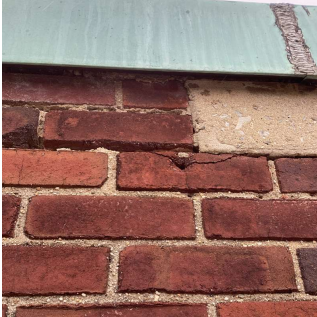
**BULKHEAD/PENTHOUSE WALLS/EXTERIOR: DETERIORATED JOINTS**

Question	Response
<b>EXTERIOR</b>	
<b>ROOF</b>	
<b>Specialties</b>	
<b>BULKHEAD/PENTHOUSE</b>	
Deficiency Quantity	50
Quantity Uom	S.F.
Potential Action	REPOINT
Urgency of Action	PRIORITY 3
Purpose of Action	LEVEL 2
Deficiency Photo1

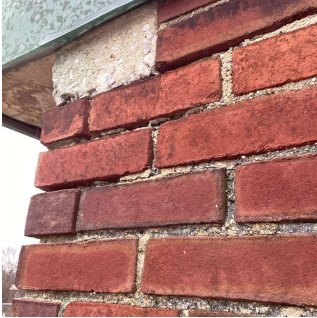
Violations	BH1 No violations recorded.
Deficiency	BULKHEAD/PENTHOUSE WALLS/EXTERIOR: DETERIORATED JOINTS
Roof Plan reference	Q179

HORACE HARDING EXPY PECK AVENUE
Deficiency Quantity	40
Quantity Uom	S.F.
Potential Action	REPOINT
Urgency of Action	PRIORITY 4
Purpose of Action	LEVEL 2
Deficiency Photo1

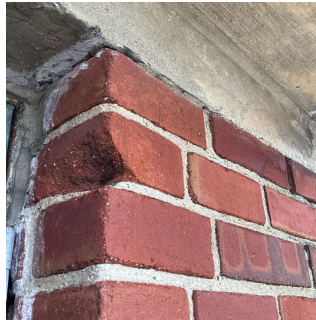
Violations	BH1 No violations recorded.
Deficiency	BULKHEAD/PENTHOUSE WALLS/EXTERIOR: CRACKS/SPALLING - MAJOR

20  
 S.F.  
 REPLACE  
 PRIORITY 4  
 LEVEL 2

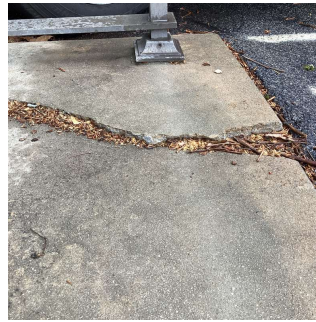
Facade F

CONCRETE: DETERIORATED SUBSTRATE

10  
S.F.  
REPLACE SUBSTRATE AND RESET  
PRIORITY 4  
LEVEL 2

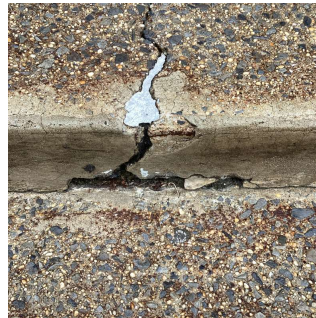
Facade A

CONCRETE: WORN-OUT TREAD/RISER/NOSING

20  
S.F.  
REPLACE  
PRIORITY 4  
LEVEL 2

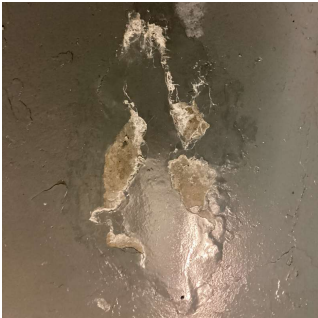
Question	Response
<b>INTERIOR</b>	
<b>STRUCTURAL</b>	
<b>FLOOR STRUCTURE</b>	
Violations	No violations recorded.
Deficiency	CONCRETE SLAB ON GRADE: THRU CRACKS
Deficiency Location/Instance	Basement - Corridor
Deficiency Quantity	10
Quantity Uom	S.F.
Potential Action	REPLACE
Urgency of Action	PRIORITY 4
Purpose of Action	LEVEL 5
Deficiency Photo1

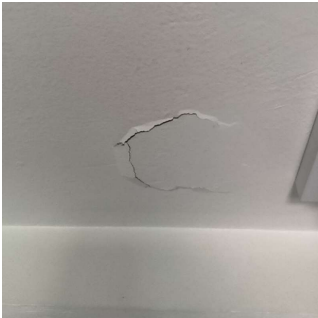
Violations	Basement - Corridor No violations recorded.
Deficiency	CONCRETE: CRACKS/SPALLED/REINFORCEMENT EXPOSED
Deficiency Location/Instance	Stair 9/3
Deficiency Quantity	10
Quantity Uom	S.F.
Potential Action	REPAIR
Urgency of Action	PRIORITY 3
Purpose of Action	LEVEL 5
Deficiency Photo1

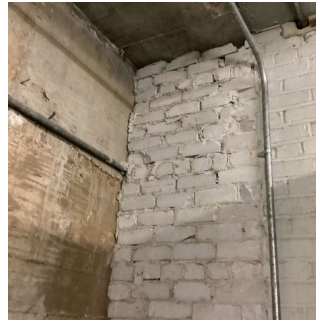
Violations	Stair 9/3 No violations recorded.
<b>FOUNDATION WALLS</b>	
Material Type(s)	Inspected Concrete, Masonry
Condition	4 - Between Fair and Poor
Deficiency	BRICK: CRACKED/SPALLED
Deficiency Location/Instance	Basement - Electrical Room
Deficiency Quantity	30
Quantity Uom	S.F.
Potential Action	RESTITCH

Urgency of Action	PRIORITY 4
Purpose of Action	LEVEL 5

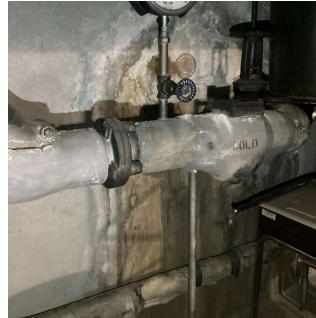
Basement - Fan Room

CONCRETE: WATER INFILTRATION IN NON- INSTRUCTIONAL SPACE

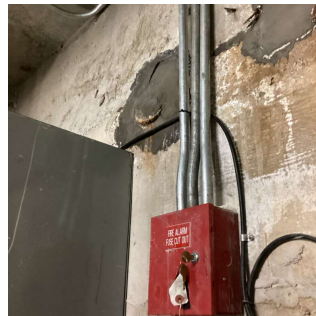
Basement - Electrical Room

CONCRETE: WATER INFILTRATION IN ELECTRICAL PANEL ROOM

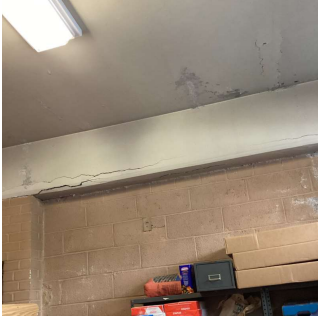
Question	Response
<b>INTERIOR</b>	
<b>STRUCTURAL</b>	
<b>FOUNDATION WALLS</b>	Inspected
Violations	No violations recorded.
<b>ROOF STRUCTURE</b>	Inspected
Condition	4 - Between Fair and Poor
Deficiency	CONCRETE COLUMNS AND BEAMS: CRACKED/SPALLED/REINFORCEMENT EXPOSED
Deficiency Location/Instance	1st Floor - Storage Room near Exit 11
Deficiency Quantity	60
Quantity Uom	S.F.
Potential Action	REPLACE
Urgency of Action	PRIORITY 5
Purpose of Action	LEVEL 5
Deficiency Photo1

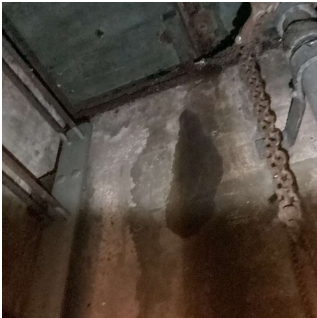
<b>Foundation Walls</b>	Inspected
Condition	4 - Between Fair and Poor
Deficiency	WATER INFILTRATION IN NON- INSTRUCTIONAL SPACE
Deficiency Location/Instance	Basement - Ash hoist vault
Deficiency Quantity	100

Question	Response
<b>INTERIOR</b>	
<b>STRUCTURAL</b>	
<b>VAULTS-BUNKERS</b>	
<b>Foundation Walls</b>	
Quantity Uom	S.F.
Potential Action	INSTALL WATERPROOFING
Urgency of Action	PRIORITY 5
Purpose of Action	LEVEL 5
Deficiency Photo1

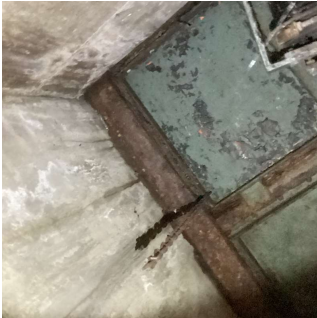
Violations	Basement - Ash hoist vault No violations recorded.
<b>Slab Structure</b>	Inspected
Condition	2 - Between Good and Fair
Deficiency	No deficiencies recorded
<b>Vault/Ash Hoist Doors and Framing</b>	Inspected
Condition	5 - Poor
Deficiency	DETERIORATED/DAMAGED VAULT/ASH HOIST DOORS AND FRAMING
Deficiency Location/Instance	Basement - Ash hoist vault
Deficiency Quantity	2
Quantity Uom	EACH
Potential Action	REPLACE
Urgency of Action	PRIORITY 4
Purpose of Action	LEVEL 2
Deficiency Photo1

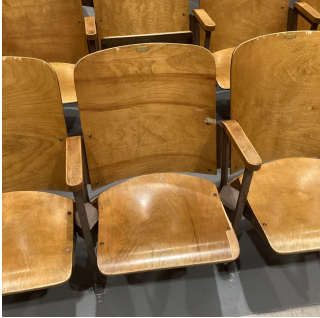
Question	Response
<b>INTERIOR</b>	
<b>AUDITORIUM</b>	
<b>Door(s)</b>	
Instance on 1st Floor (409 Seats)	Inspected
Condition	2 - Between Good and Fair
Deficiency	No deficiencies recorded
<b>Fixed H/C Lift</b>	
Instance on 1st Floor (409 Seats)	Does not Exist
<b>Fixed Seating</b>	
Instance on 1st Floor (409 Seats)	Inspected
Condition	5 - Poor
Deficiency	DAMAGED/BROKEN/INOPERABLE
Deficiency Location/Instance	Seats A/101, 102, 103, 104, 105 and others
Deficiency Quantity	74
Quantity Uom	EACH
Potential Action	REPLACE
Urgency of Action	PRIORITY 3
Purpose of Action	LEVEL 2
Deficiency Photo1

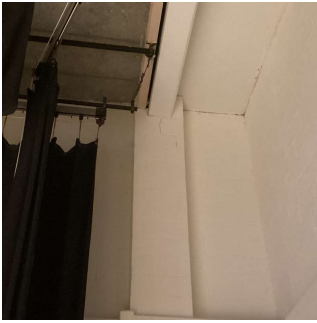
Question	Response
<b>INTERIOR</b>	
<b>AUDITORIUM</b>	
<b>Walls</b>	
Deficiency Photo1

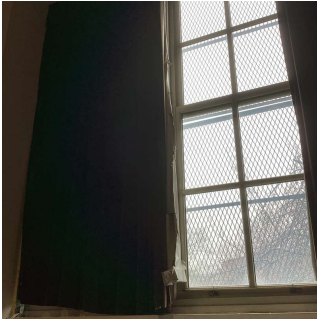
Left Side of Stage
Violations	No violations recorded.
<b>Window Curtains/Shades/Blinds</b>	
Instance on 1st Floor (409 Seats)	Inspected
Condition	3 - Fair
Deficiency	WORN/DAMAGED CURTAINS
Deficiency Location/Instance	Right Side
Deficiency Quantity	100
Quantity Uom	S.F.
Potential Action	MAINTENANCE
Urgency of Action	PRIORITY 3
Purpose of Action	LEVEL 2
Deficiency Photo1

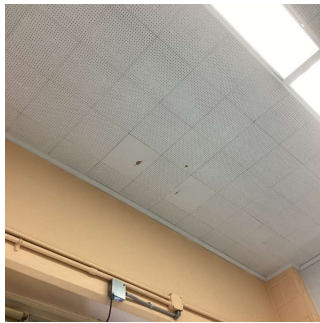
Right Side
Violations	No violations recorded.
<b>CAFETERIA</b>	
Instance on 1st Floor	Inspected
Instance on 1st Floor	Inspected
<b>Ceiling</b>	
Instance on 1st Floor	Inspected
Condition	2 - Between Good and Fair
Deficiency	ACOUSTIC TILES ON PLASTER: DAMAGED/MISSING
Deficiency Location/Instance	Left Side Near Windows
Deficiency Quantity	10
Quantity Uom	S.F.
Potential Action	REPLACE
Urgency of Action	PRIORITY 3
Purpose of Action	LEVEL 2

Question	Response
<b>INTERIOR</b>	
<b>CAFETERIA</b>	
<b>Ceiling</b>	
Deficiency Photo1

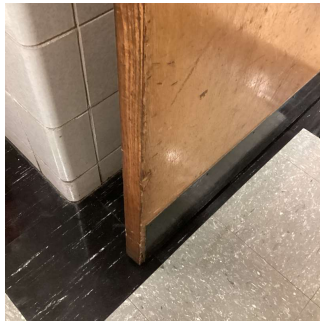
Violations	Left Side Near Windows No violations recorded.
<b>Door(s)</b>	
Instance on 1st Floor	Inspected
Condition	4 - Between Fair and Poor
Deficiency	WOOD: DETERIORATED DOOR
Deficiency Location/Instance	Entrance near Exit 5
Deficiency Quantity	2
Quantity Uom	EACH
Potential Action	MAINTENANCE
Urgency of Action	PRIORITY 3
Purpose of Action	LEVEL 2
Deficiency Photo1

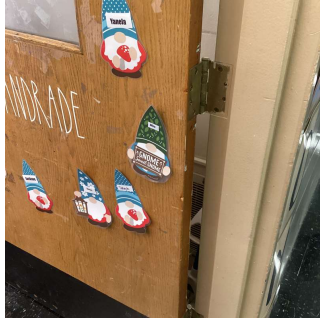
Condition	5 - Poor
Deficiency	WOOD: DETERIORATED DOOR
Deficiency Location/Instance	Rooms 213, 210, 206, 205, 204 and others
Deficiency Quantity	8

Question	Response
<b>INTERIOR</b>	
<b>CLASSROOMS/CORRIDORS/ADMIN SPACES</b>	
<b>Door(s)</b>	
Quantity Uom	EACH
Potential Action	MAINTENANCE
Urgency of Action	PRIORITY 3
Purpose of Action	LEVEL 2
Deficiency Photo1

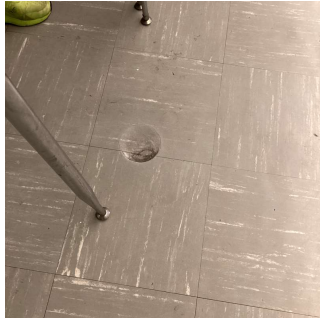
Room 205
Violations	No violations recorded.
Deficiency	TERRAZZO: CRACKS
Deficiency Location/Instance	Corridor near Cafeteria, Corridor near Gymnasium, Exit 6 Vestibule
Deficiency Quantity	80
Quantity Uom	S.F.
Potential Action	REPLACE
Urgency of Action	PRIORITY 3
Purpose of Action	LEVEL 2

Room 206
Violations	No violations recorded.
<b>Floor Finish</b>	Inspected
Condition	2 - Between Good and Fair
Deficiency	VINYL TILES: BROKEN/DETERIORATED/MISSING TILES
Deficiency Location/Instance	Rooms 206, 205 109, 107, 103 and others
Deficiency Quantity	120
Quantity Uom	S.F.
Potential Action	REPLACE
Urgency of Action	PRIORITY 3
Purpose of Action	LEVEL 2
Deficiency Photo1

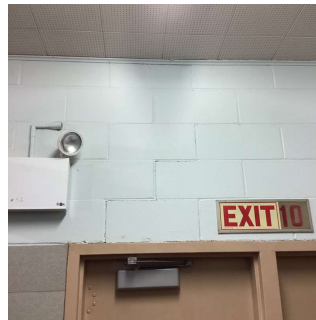
Corridor near Stair A/2

MASONRY: CRACKS/SPALLING

REPLACE

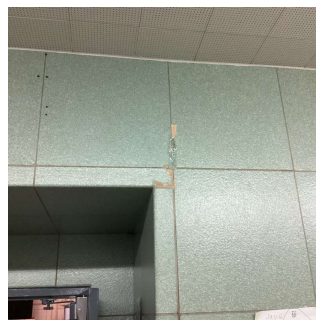
GLAZED BLOCK: CRACKS/SPALLING

REPLACE

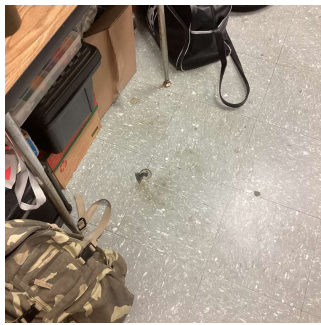
Condition	2 - Between Good and Fair
Deficiency	VINYL TILES: BROKEN/DETERIORATED/MISSING TILES
Deficiency Location/Instance	Office
Deficiency Quantity	20
Quantity Uom	S.F.
Potential Action	REPLACE
Urgency of Action	PRIORITY 3
Purpose of Action	LEVEL 2

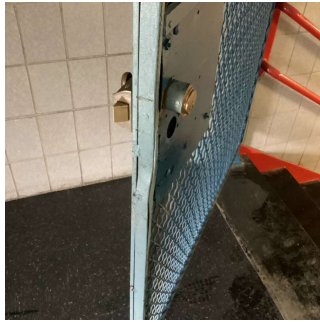
Violations	Right Side Near Windows No violations recorded.
<b>Window Curtains/Shades/Blinds</b>	
Instance on 1st Floor	Does not Exist
<b>INTERIOR DOOR HARDWARE</b>	
Condition	Inspected
Deficiency	3 - Fair
Deficiency	No deficiencies recorded
<b>INTERIOR GUARDS</b>	
Condition	Inspected
Condition	2 - Between Good and Fair
Deficiency	DETERIORATED/TORN-OUT/MISSING
Deficiency Location/Instance	Stair A/Bulkhead
Deficiency Quantity	10
Quantity Uom	S.F.
Potential Action	REPLACE
Urgency of Action	PRIORITY 3
Purpose of Action	LEVEL 2
Deficiency Photo1

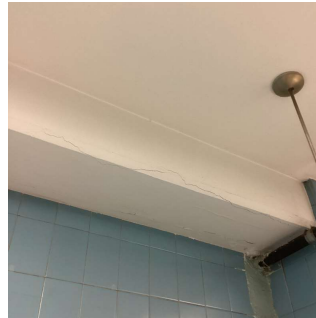
Serving area  
No violations recorded.

Violations	Stair A/Bulkhead No violations recorded.
<b>KITCHEN</b>	
Condition	Inspected
Instance on 1st Floor	Inspected
<b>Ceiling</b>	
Condition	Inspected
Condition	2 - Between Good and Fair
Deficiency	PLASTER: CRACKS/SPALLING
Deficiency Location/Instance	Serving area
Deficiency Quantity	10

Quantity Uom	S.F.
Potential Action	REPLACE
Urgency of Action	PRIORITY 3

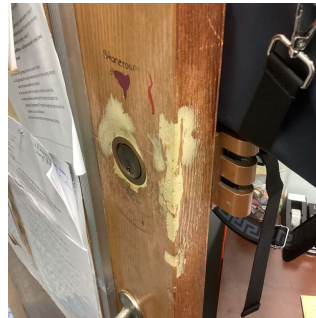
Office  
No violations recorded.

WOOD: DETERIORATED DOOR

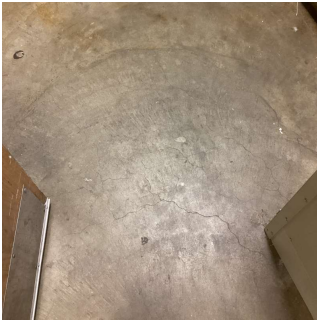
CONCRETE: CRACKS

REPLACE

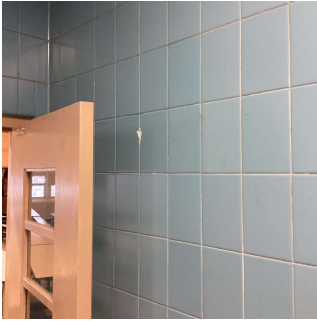
Serving area
Violations	No violations recorded.
Deficiency	MASONRY: CRACKS/SPALLING
Deficiency Location/Instance	Rotate Stock Storage Room
Deficiency Quantity	10
Quantity Uom	S.F.
Potential Action	REPLACE
Urgency of Action	PRIORITY 3
Purpose of Action	LEVEL 2

Rotate Stock Storage Room
Violations	No violations recorded.
<b>Walls</b>	
Instance on 1st Floor	Inspected
Condition	2 - Between Good and Fair
Deficiency	CERAMIC TILE: BROKEN/ MISSING
Deficiency Location/Instance	Serving area
Deficiency Quantity	10
Quantity Uom	S.F.
Potential Action	REPLACE
Urgency of Action	PRIORITY 3
Purpose of Action	LEVEL 2
Deficiency Photo1

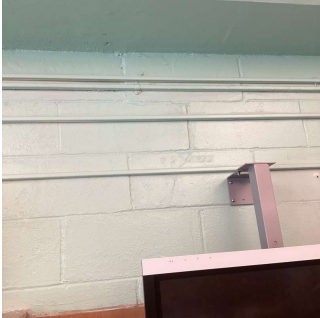
Question	Response
<b>INTERIOR</b>	
<b>LIBRARY</b>	Inspected
<b>Walls</b>	
Instance on Room 214	Inspected
Condition	2 - Between Good and Fair
Deficiency	MASONRY: CRACKS/SPALLING
Deficiency Location/Instance	Left Side
Deficiency Quantity	10
Quantity Uom	S.F.
Potential Action	REPLACE
Urgency of Action	PRIORITY 3
Purpose of Action	LEVEL 2
Deficiency Photo1

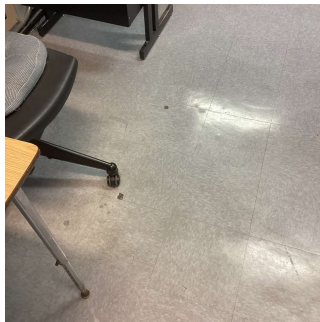
Question	Response
<b>INTERIOR</b>	
<b>LOCKER ROOM</b>	
<b>Door(s)</b>	
Deficiency Photo1	 
Violations	Main Entrance No violations recorded.
<b>Floor Finish</b>	
Instance on 2nd Floor (10 Lockers)	Inspected
Condition	2 - Between Good and Fair
Deficiency	VINYL TILES: BROKEN/DETERIORATED/MISSING TILES
Deficiency Location/Instance	Center
Deficiency Quantity	10
Quantity Uom	S.F.
Potential Action	REPLACE
Urgency of Action	PRIORITY 3
Purpose of Action	LEVEL 2
Deficiency Photo1

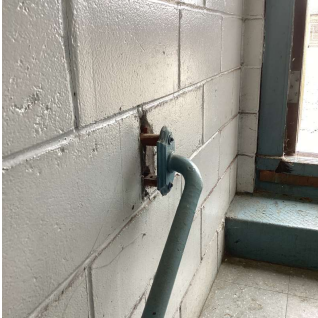
Question	Response
<b>INTERIOR</b>	
<b>SCIENCE DEMO ROOM</b>	Does not Exist
<b>SCIENCE LAB</b>	Does not Exist
<b>SCIENCE PREP ROOM</b>	Does not Exist
<b>SHOWER ROOM</b>	Inspected
Instance on 1st Floor	Inaccessible
Instance on 2nd Floor	Inaccessible
<b>STAIRS/RAMPS: INTERIOR</b>	Inspected
Do Letter Stair Signs Exist?	Yes
<b>Ceiling</b>	Inspected
Condition	2 - Between Good and Fair
Deficiency	No deficiencies recorded
<b>Door(s)</b>	Inspected
Condition	2 - Between Good and Fair
Deficiency	No deficiencies recorded
<b>Partition</b>	Does not Exist
<b>Railings</b>	Inspected
Condition	3 - Fair
Deficiency	METAL: BROKEN BRACKET
Deficiency Location/Instance	Stair D/Bulkhead
Deficiency Quantity	1
Quantity Uom	EACH
Potential Action	REPLACE
Urgency of Action	PRIORITY 3
Purpose of Action	LEVEL 2
Deficiency Photo1

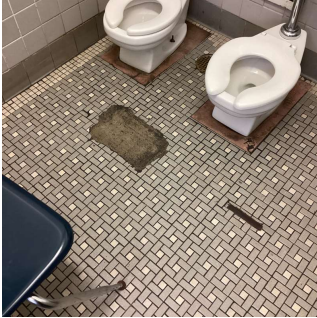
Deficiency Location/Instance	Inside Room 102, Rooms 215, 121, 115
Deficiency Quantity	40

Question	Response
<b>INTERIOR</b>	
<b>TOILET ROOMS - STUDENTS</b>	
<b>Floor Finish</b>	
Quantity Uom	S.F.
Potential Action	REPLACE
Urgency of Action	PRIORITY 3
Purpose of Action	LEVEL 2
Deficiency Photo1

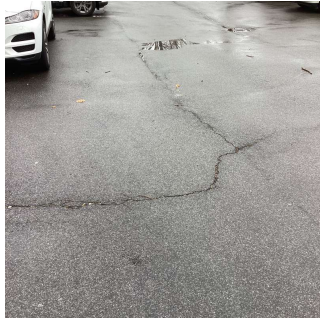
Violations	Parking Lot No violations recorded.
Deficiency	CRACKS - MAJOR
Deficiency Location/Instance	Parking Lot
Deficiency Quantity	600
Quantity Uom	S.F.
Potential Action	REPLACE
Urgency of Action	PRIORITY 3
Purpose of Action	LEVEL 2
Deficiency Photo1

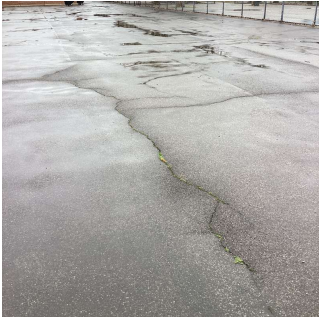
Question	Response
<b>SITE</b>	
<b>PAVING</b>	
<b>Student Non-Use</b>	
<b>Concrete</b>	Inspected
Deficiency Photo1	 
	Peck Avenue
Violations	No violations recorded.
<b>Pavers</b>	Does not Exist
<b>Student Use</b>	Inspected
Gravel Exists?	No
<b>Asphalt</b>	Inspected
Condition	4 - Between Fair and Poor
Deficiency	CRACKS - MAJOR
Deficiency Location/Instance	Schoolyard
Deficiency Quantity	600
Quantity Uom	S.F.
Potential Action	REPLACE
Urgency of Action	PRIORITY 3
Purpose of Action	LEVEL 2
Deficiency Photo1

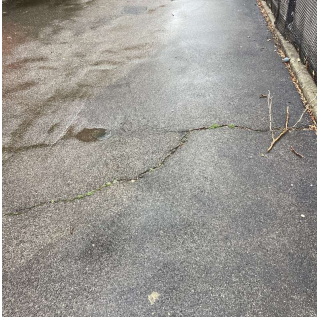
Schoolyard
Violations	No violations recorded.
<b>Concrete</b>	Does not Exist
<b>Pavers</b>	Does not Exist
<b>Site Sidewalks &amp; Walkways</b>	Inspected
<b>Asphalt</b>	Inspected
Condition	3 - Fair
Deficiency	CRACKS - MAJOR
Deficiency Location/Instance	Exits 4, 2
Deficiency Quantity	100
Quantity Uom	S.F.
Potential Action	REPLACE
Urgency of Action	PRIORITY 3
Purpose of Action	LEVEL 2

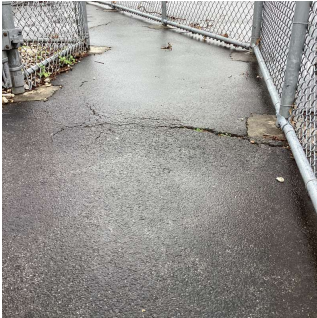
Violations	Exit 4 No violations recorded.
Deficiency	HEAVING
Deficiency Location/Instance	Near Playgrounds, near Exit 3
Deficiency Quantity	100
Quantity Uom	S.F.
Potential Action	REPLACE
Urgency of Action	PRIORITY 3
Purpose of Action	LEVEL 2
Deficiency Photo1

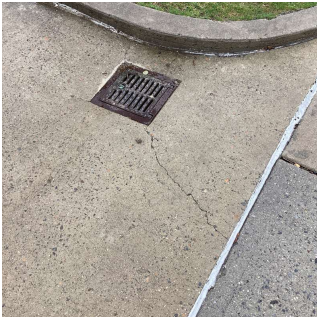
Violations	Near Playgrounds No violations recorded.
<b>Concrete</b>	Inspected
Condition	3 - Fair
Deficiency	CRACKS - MAJOR
Deficiency Location/Instance	Exits 1, 1A, 3, 7&8, 9&10, Peck Avenue
Deficiency Quantity	350
Quantity Uom	S.F.
Potential Action	REPLACE
Urgency of Action	PRIORITY 3
Purpose of Action	LEVEL 2

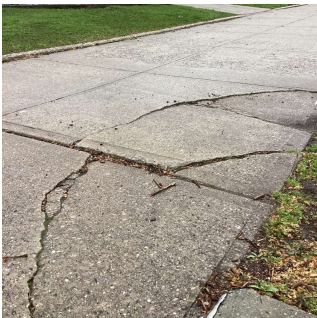
Peck Avenue
Violations	No violations recorded.
Deficiency	HEAVING
Deficiency Location/Instance	Peck Avenue
Deficiency Quantity	275
Quantity Uom	S.F.
Potential Action	REPLACE
Urgency of Action	PRIORITY 5
Purpose of Action	LEVEL 6

Exit 1
Violations	No violations recorded.
<b>Pavers</b>	Does not Exist
<b>DOT Sidewalk</b>	Inspected
<b>Asphalt</b>	Does not Exist
<b>Concrete</b>	Inspected
Condition	4 - Between Fair and Poor
Deficiency	HEAVING
Deficiency Location/Instance	Peck Avenue
Deficiency Quantity	150
Quantity Uom	S.F.
Potential Action	REPLACE
Urgency of Action	PRIORITY 3
Purpose of Action	LEVEL 2
Deficiency Photo1
