NYC Department of Education
Building Condition Assessment Survey 2023 - 2024

Architectural Inspection

Asset: I.S. 323 (OLD IS 180) - QUEENS, 320 BEACH 104 STREET, New York, 11694

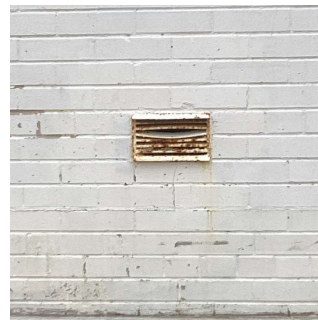
Facade C

Violations	Facade D No violations recorded.
DOOR HARDWARE	Inspected
Condition	3 - Fair
Deficiency	No deficiencies recorded
LINTELS	Inspected
Condition	2 - Between Good and Fair
Deficiency	No deficiencies recorded
TRANSOM/SIDE LIGHT	Inspected
Condition	2 - Between Good and Fair
Deficiency	No deficiencies recorded
EXTERIOR WALLS	Inspected
Material Type(s)	Masonry, Steel
Replacement Quantity	34,000
Replacement Uom	S.F.
Instance on All Facades	Under Construction
Instance Quantity	34,000
Instance Quantity Uom	S.F.
EXTERIOR SOFFITS	Inspected
Condition	2 - Between Good and Fair
Deficiency	No deficiencies recorded
LOADING DOCK	Does not Exist
LOUVER	Inspected
Condition	3 - Fair
Deficiency	BROKEN/ DENTED BLADES

Deficiency Quantity

20

REPLACE

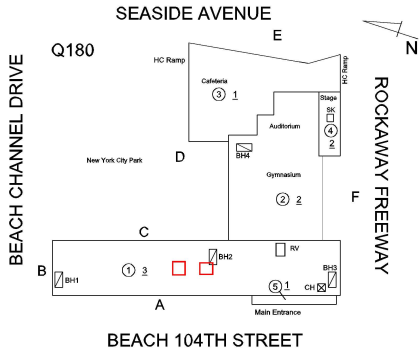
Installation Year	2011
Source of Installation	Custodial Staff
Deficiency	MODIFIED BITUMEN: ROOFING: MAJOR ACTIVE ROOF LEAKS IN INSTRUCTIONAL SPACE
Roof Plan reference

Deficiency Quantity	200
Quantity Uom	S.F.
Potential Action	REPLACE ROOFING WITHOUT MAJOR EQUIPMENT REMOVAL
Urgency of Action	PRIORITY 5

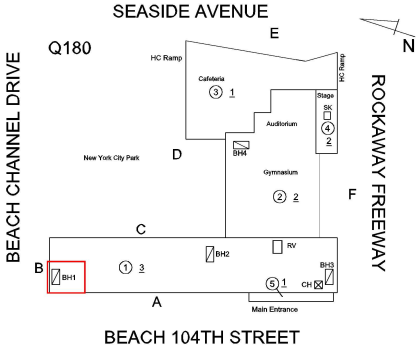
Violations	Room 1 - Room 304, also Corridor near Room 308 No violations recorded.
Instance on Built-Up: Roofs 2-4	Under Construction
Instance Quantity	38,000
Instance Quantity Uom	S.F.
Instance on Modified Bitumen: Roof 5	Inspected
Instance Condition	2 - Between Good and Fair
Instance Quantity	1,500
Instance Quantity Uom	S.F.
Does the roof have major mechanical equipment sitting on Dunnage Steel less than 18" above the Roofing?	No
Does this roof instance have a Sustainable Roof System?	No
Do solar panels exist on these roofs?	No
Is/Are the roof(s) suitable for Solar Panel installation?	No
Installation Year	2015
Source of Installation	Custodial Staff
Deficiency	No deficiencies recorded
ROOFING DRAINS	Under Construction
Specialties	Inspected
BULKHEAD/PENTHOUSE	Inspected
Condition	3 - Fair
Deficiency	BULKHEAD/PENTHOUSE WALLS/INTERIOR: CMU CRACKS/SPALLING

Deficiency Quantity	10
Quantity Uom	S.F.
Potential Action	REPLACE
Urgency of Action	PRIORITY 3

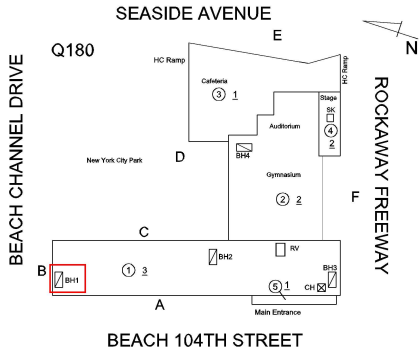
Violations	Roof 1 - Bulkhead 1 No violations recorded.
Deficiency	BULKHEAD/PENTHOUSE WALLS/EXTERIOR: WATER INFILTRATION
Roof Plan reference

Deficiency Quantity	100
Quantity Uom	S.F.
Potential Action	REPAIR
Urgency of Action	PRIORITY 5
Purpose of Action	LEVEL 2
Deficiency Photo1

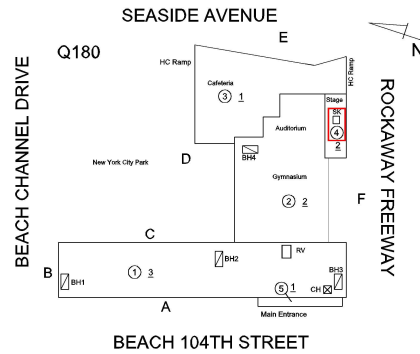
Deficiency **WATER INFILTRATION**

100
S.F.
MAINTENANCE
PRIORITY 3
LEVEL 2

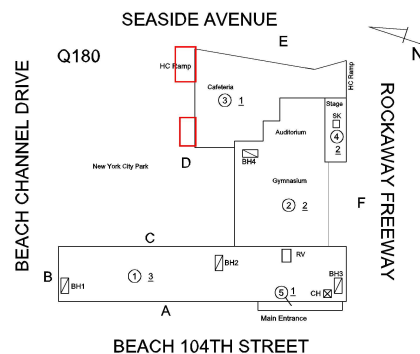
Deficiency **CAST IN PLACE CONCRETE: CRACKS/SPALLING - MINOR**

20
S.F.
REPAIR

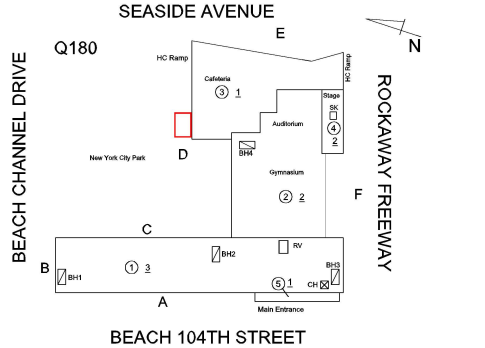
CONCRETE: WORN-OUT TREAD/RISER/NOSING

30
 S.F.
 REPLACE
 PRIORITY 4
 LEVEL 2

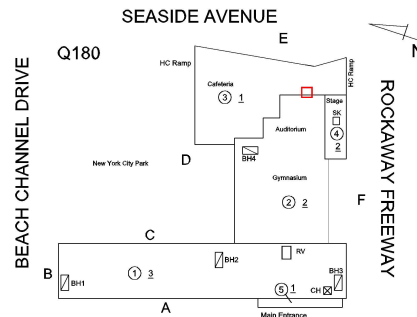
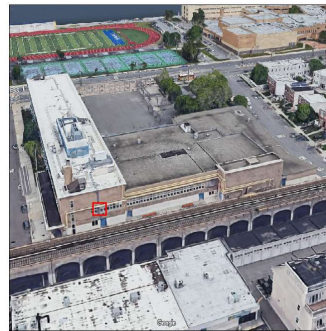
BEACH 104TH STREET

Deficiency	ALUMINUM - OTHER: BROKEN PANE
------------	-------------------------------

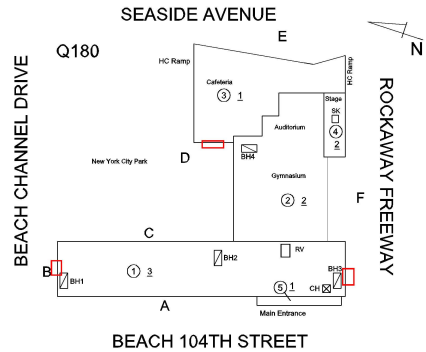
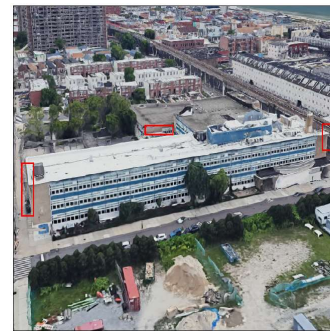
ALUMINUM - OTHER: AIR/WATER INFILTRATION

REPLACE TRIM, SILLS OR WEATHERSTRIPPING

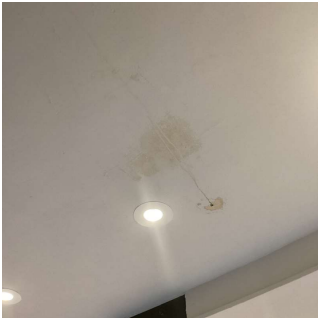
Question	Response
EXTERIOR	Inspected
WINDOWS	Inspected
WINDOWS	
Violations	No violations recorded.
INTERIOR	Inspected
POOLS	Does not Exist
STRUCTURAL	Inspected
COLUMNS/BEAMS/BEARING WALLS	Inspected
Condition	2 - Between Good and Fair
Deficiency	No deficiencies recorded
FLOOR STRUCTURE	Inspected
Condition	2 - Between Good and Fair
Deficiency	No deficiencies recorded
FOUNDATION WALLS	Inspected
Material Type(s)	Concrete
Condition	2 - Between Good and Fair
Deficiency	No deficiencies recorded
ROOF STRUCTURE	Inspected
Condition	2 - Between Good and Fair
Deficiency	No deficiencies recorded
VAULTS-BUNKERS	Does not Exist
AUDITORIUM	Inspected
Instance on 1st Floor (510 Seats)	Inspected
Ceiling	
Instance on 1st Floor (510 Seats)	Inspected
Condition	2 - Between Good and Fair
Deficiency	PLASTER: CRACKS/SPALLING
Deficiency Location/Instance	Stage Area, Near Stage
Deficiency Quantity	100
Quantity Uom	S.F.
Potential Action	REPLACE
Urgency of Action	PRIORITY 3

Purpose of Action	LEVEL 2
Deficiency Photo1

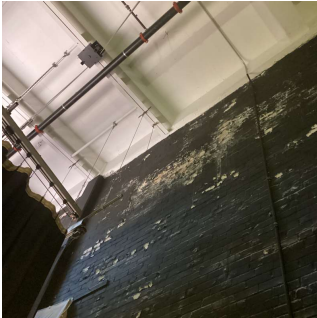
Question	Response
INTERIOR	
AUDITORIUM	
Stage	
Stage	Inspected
Instance on 1st Floor (510 Seats)	Inspected
Condition	2 - Between Good and Fair
Deficiency	No deficiencies recorded
Stage Curtain Rigging	Inspected
Instance on 1st Floor (510 Seats)	Inspected
Condition	1 - Good
Deficiency	No deficiencies recorded
Stage Curtains	Inspected
Instance on 1st Floor (510 Seats)	Inspected
Condition	1 - Good
Deficiency	No deficiencies recorded
Walls	
Instance on 1st Floor (510 Seats)	Inspected
Condition	4 - Between Fair and Poor
Deficiency	BRICK: CRACKS/SPALLING
Deficiency Location/Instance	Back Stage
Deficiency Quantity	400
Quantity Uom	S.F.
Potential Action	REPLACE
Urgency of Action	PRIORITY 3
Purpose of Action	LEVEL 2
Deficiency Photo1
