**NYC Department of Education**  
**Building Condition Assessment Survey 2023 - 2024**

Architectural Inspection

**Asset:** P.S. 181 - QUEENS, 148-15 230 STREET, New York, 11413

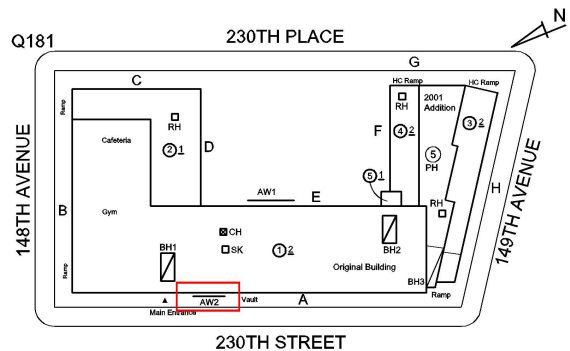
Question	Response
<b>Architectural</b>	
<b>EXTERIOR</b>	Inspected
<b>AREAWAY</b>	Inspected
Instance on AW1, AW2	Inspected
Instance Condition	3 - Fair
Instance Quantity	2
Instance Quantity Uom	EACH
Deficiency	AREAWAY STAIRS: DETERIORATED MATERIAL SLIDE
Roof Plan reference

Deficiency Quantity	25
Quantity Uom	S.F.

Question	Response
<b>EXTERIOR</b>	
<b>AREAWAY</b>	
Potential Action	REPLACE
Urgency of Action	PRIORITY 3
Purpose of Action	LEVEL 2
Deficiency Photo1

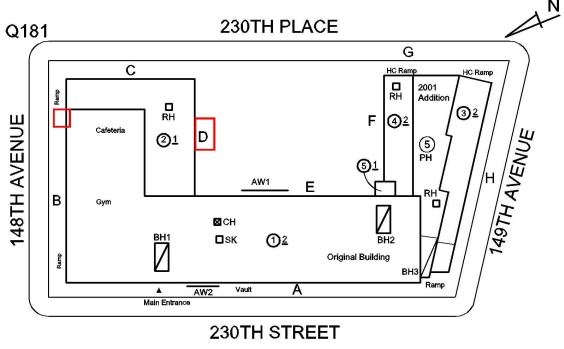
Question	Response
<b>EXTERIOR</b>	
<b>DOORS</b>	Inspected
<b>DOORS AND FRAMES</b>	Inspected
Condition	4 - Between Fair and Poor
Deficiency	METAL CLAD: DETERIORATED DOOR - MAJOR DETERIORATION
Roof Plan reference

Deficiency Quantity	3
Quantity Uom	EACH
Potential Action	REPLACE
Urgency of Action	PRIORITY 4
Purpose of Action	LEVEL 2
Deficiency Photo1

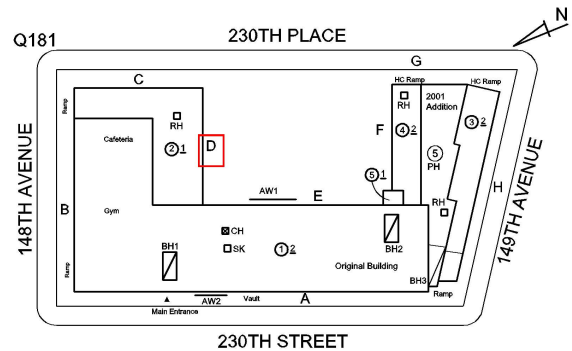
METAL: BROKEN GLASS

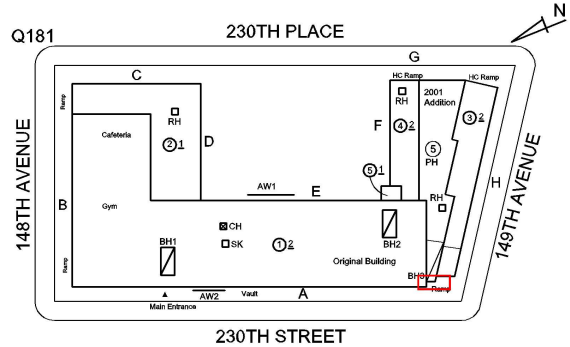
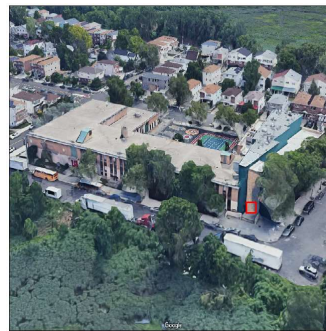
Question	Response
<b>EXTERIOR</b>	
<b>EXTERIOR WALLS</b>	
Material Type(s)	Masonry
Replacement Quantity	29,000
Replacement Uom	S.F.
Instance on Original Building -All Facades	Inspected
Instance Condition	3 - Fair
Instance Quantity	20,000
Instance Quantity Uom	S.F.
Deficiency	BRICK: DETERIORATED MASONRY SILLS - MAJOR
Roof Plan reference	 
Elevation	 
Deficiency Quantity	10
Quantity Uom	L.F.
Potential Action	REMOVE AND REPLACE
Urgency of Action	PRIORITY 4
Purpose of Action	LEVEL 2
Deficiency Photo1	 
Violations	Facade A No violations recorded.
Deficiency	BRICK: MINOR CRACKS AND SPALLING

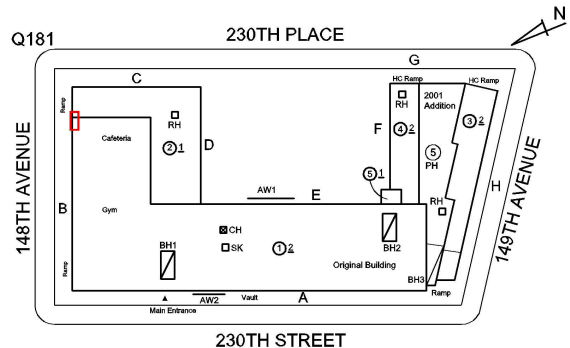
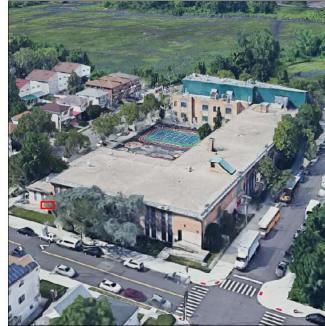
BRICK: DETERIORATED MASONRY SILLS - MINOR

REPAIR

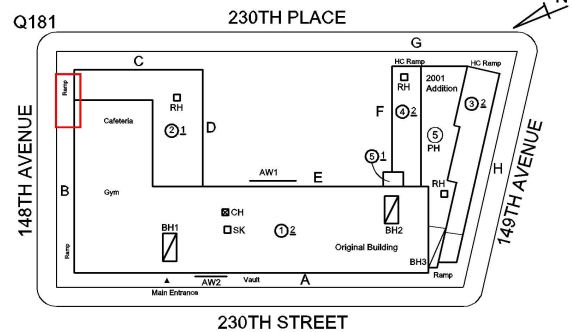
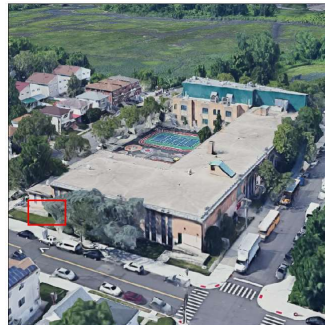
BRICK: DETERIORATED JOINTS

Question	Response
<b>EXTERIOR</b>	
<b>EXTERIOR WALLS</b>	
Urgency of Action	PRIORITY 3
Purpose of Action	LEVEL 2
Deficiency Photo1

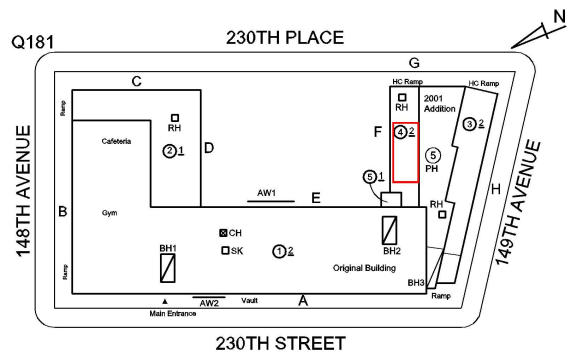
Condition	3 - Fair
Deficiency	HEIGHT LESS THAN 18"
Roof Plan reference

Deficiency Quantity	100
Quantity Uom	L.F.
Potential Action	REPLACE
Urgency of Action	PRIORITY 3
Purpose of Action	LEVEL 2

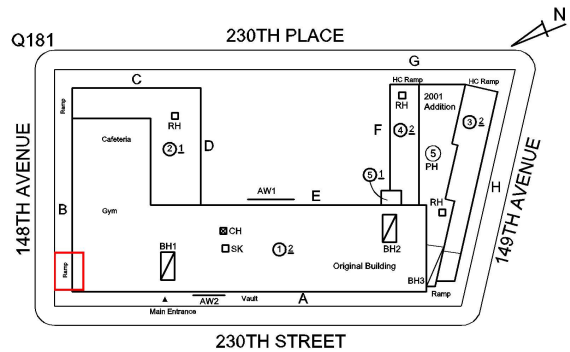
Question	Response
<b>EXTERIOR</b>	
<b>ROOF</b>	
<b>Specialties</b>	
<b>DUNNAGE STEEL</b>	
Deficiency Photo1	 
Violations	Roof 4 No violations recorded.
<b>SKYLIGHT/ROOF VENT</b>	Under Construction
<b>ROOF/GRAVITY TANK</b>	Does not Exist
<b>STAIRS/RAMPS: EXTERIOR</b>	Inspected
<b>BUILDING CHEEK/FLANK WALLS</b>	Inspected
Condition	3 - Fair
Deficiency	CAST IN PLACE CONCRETE: CRACKS/SPALLING - MINOR
Roof Plan reference	<p>Q181</p>  
Deficiency Quantity	30
Quantity Uom	S.F.
Potential Action	REPAIR
Urgency of Action	PRIORITY 3
Purpose of Action	LEVEL 2
Deficiency Photo1	 
Violations	Facade B No violations recorded.
Deficiency	CAST IN PLACE CONCRETE: CRACKS/SPALLING - MAJOR

10  
S.F.  
REPLACE  
PRIORITY 4  
LEVEL 2

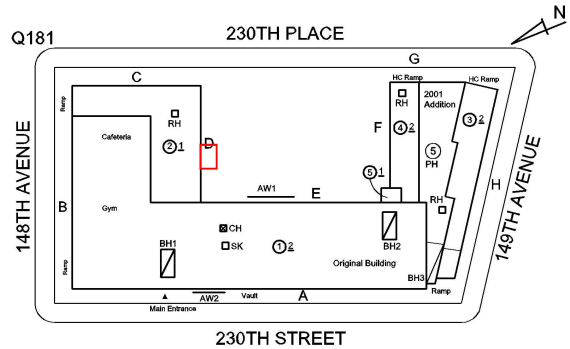
STONE: DETERIORATED JOINTS

10  
L.F.  
REPOINT  
PRIORITY 4  
LEVEL 2

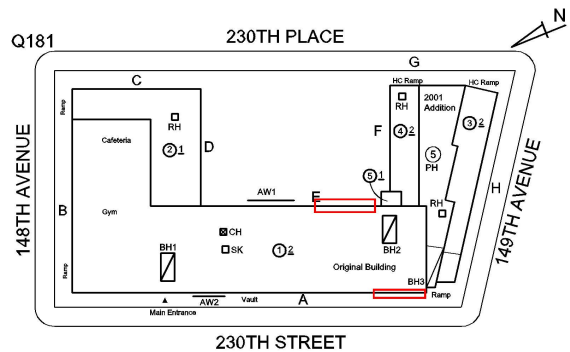
DETERIORATED/TORN-OUT/MISSING

Question	Response
<b>EXTERIOR</b>	
<b>WINDOWS</b>	
<b>EXTERIOR GUARDS</b>	
Elevation	 
Deficiency Quantity	100
Quantity Uom	S.F.
Potential Action	REPLACE
Urgency of Action	PRIORITY 4
Purpose of Action	LEVEL 2
Deficiency Photo1

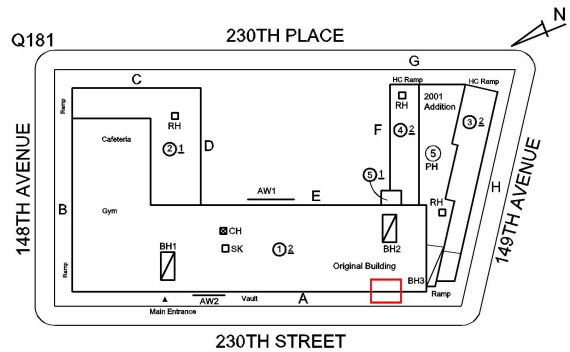
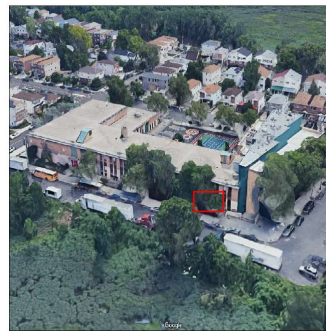
Violations	Facade E No violations recorded.
<b>LINTELS</b>	Inspected
Condition	2 - Between Good and Fair
Deficiency	No deficiencies recorded
<b>WINDOWS</b>	Inspected
Material Type(s)	Aluminum
Instance on Aluminum - Double Hung: Original Building	Inspected
Instance Condition	3 - Fair
Instance Quantity	5,400
Instance Quantity Uom	S.F.
Are these windows insulated	No
Installation Year	2001
Source of Installation	Custodial Staff
Deficiency	ALUMINUM - DOUBLE HUNG: BROKEN PANE

90  
S.F.  
MAINTENANCE  
PRIORITY 3  
LEVEL 2
