**NYC Department of Education**  
**Building Condition Assessment Survey 2023 - 2024**

Architectural Inspection

Q185

**Asset:** J.H.S. 185 - QUEENS, 147-26 25 DRIVE, New York, 11354

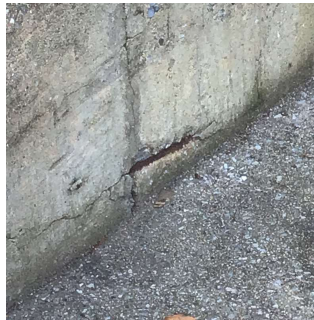
Question	Response
<b>Architectural</b>	
<b>EXTERIOR</b>	Inspected
<b>AREAWAY</b>	Inspected
Instance on AW1	Inspected
Instance Condition	3 - Fair
Instance Quantity	1
Instance Quantity Uom	EACH
Deficiency	AREAWAY WALLS: CRACKS AND SPALLING

10  
S.F.  
REPLACE  
PRIORITY 4  
LEVEL 2

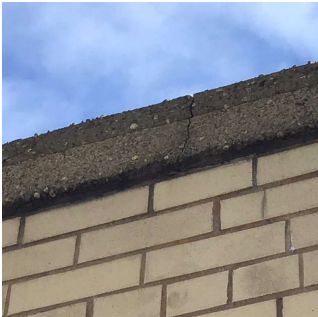
Violations	AW1 No violations recorded.
<b>AWNINGS AND CANOPIES</b>	
	Does not Exist
<b>CHIMNEY</b>	
Material Type(s)	Inspected Masonry
Condition	2 - Between Good and Fair
Deficiency	BRICK: DETERIORATED CAP
Roof Plan reference	Q185
Deficiency Quantity	10
Quantity Uom	L.F.
Potential Action	REPLACE
Urgency of Action	PRIORITY 3
Purpose of Action	LEVEL 2
Deficiency Photo1

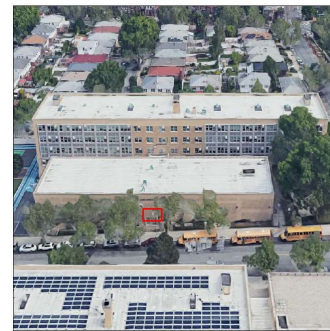
STONE: DETERIORATED JOINTS

10

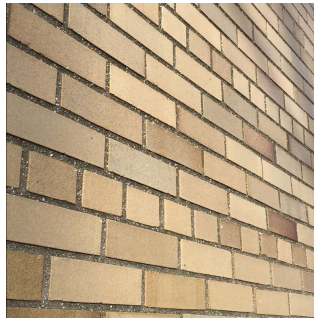
Facade B

BRICK: DETERIORATED JOINTS

1,000

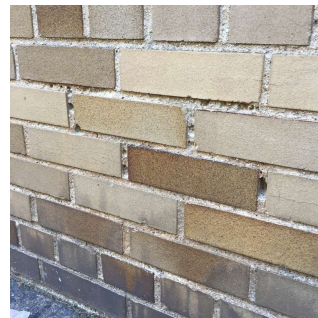
Facade C

**BRICK: DETERIORATED JOINTS**

20

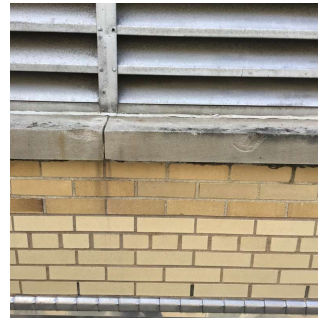
Facade E - Gymnasium Fan Room

BRICK: DETERIORATED MASONRY SILLS - MINOR

20

REPAIR

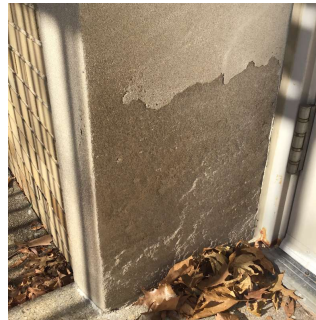
Facade G

STONE: CHIPPED/SPALLED/BROKEN PIECES - MAJOR

20

REPLACE

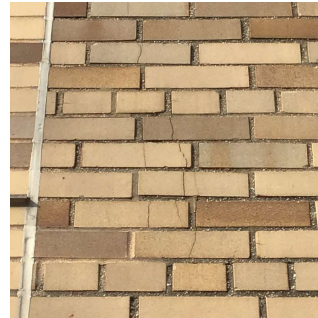
Facade B

BRICK: MINOR CRACKS AND SPALLING

60

PRIORITY 3  
LEVEL 2

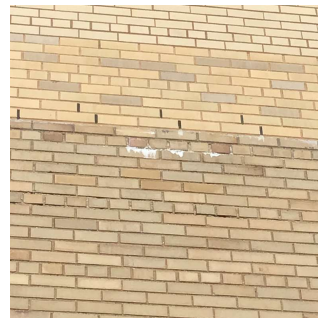
Facade G

BRICK: EFFLORESCENCE

20

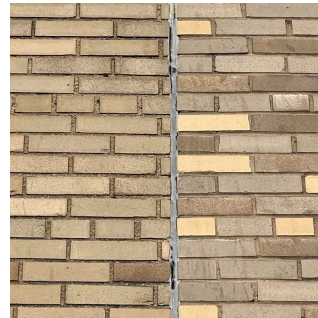
Facade G

BRICK: DETERIORATED CONTROL/EXPANSION JOINTS

20

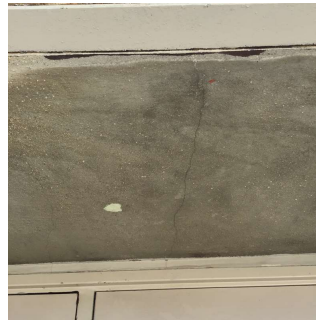
Facade B  
No violations recorded.

CONCRETE: MINOR CRACKS/SPALLING

10  
S.F.  
REPAIR  
PRIORITY 3  
LEVEL 2

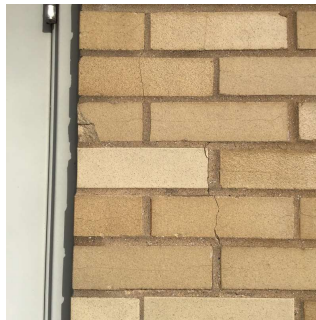
BH2  
 No violations recorded.

Deficiency	BULKHEAD/PENTHOUSE WALLS/EXTERIOR: CRACKS/SPALLING - MINOR
------------	--

10  
 S.F.  
 REPAIR  
 PRIORITY 3  
 LEVEL 2

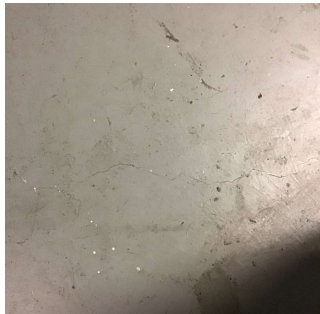
Violations	Room B9 No violations recorded.
Deficiency	CONCRETE: CRACKS/SPALLED/REINFORCEMENT EXPOSED
Deficiency Location/Instance	Gymnasium Fan Room, Room 114
Deficiency Quantity	20
Quantity Uom	S.F.
Potential Action	REPAIR
Urgency of Action	PRIORITY 3

Purpose of Action	LEVEL 5
Deficiency Photo1

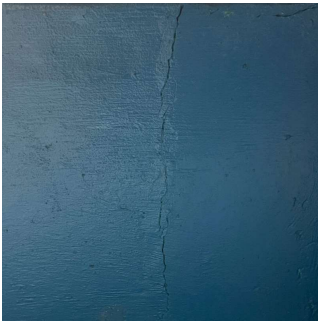
Question	Response
<b>INTERIOR</b>	
<b>STRUCTURAL</b>	
<b>FLOOR STRUCTURE</b>	Inspected
	Gymnasium Fan Room
Violations	No violations recorded.
<b>FOUNDATION WALLS</b>	Inspected
Material Type(s)	Concrete
Condition	3 - Fair
Deficiency	CONCRETE: CRACKED/SPALLED/REINFORCEMENT EXPOSED
Deficiency Location/Instance	Boiler Room
Deficiency Quantity	30
Quantity Uom	S.F.
Potential Action	REPAIR
Urgency of Action	PRIORITY 3
Purpose of Action	LEVEL 5
Deficiency Photo1

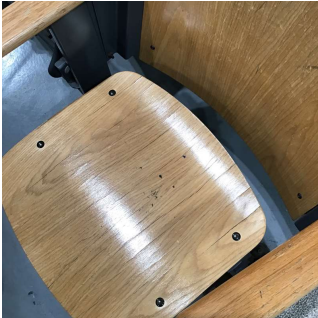
Question	Response
<b>INTERIOR</b>	
<b>AUDITORIUM</b>	
<b>Fixed H/C Lift</b>	
Instance on Ground Floor (476 Seats)	Does not Exist
<b>Fixed Seating</b>	
Instance on Ground Floor (476 Seats)	Inspected
Condition	2 - Between Good and Fair
Deficiency	DAMAGED/BROKEN/INOPERABLE
Deficiency Location/Instance	Seats A/18, L/297
Deficiency Quantity	2
Quantity Uom	EACH
Potential Action	REPLACE
Urgency of Action	PRIORITY 3
Purpose of Action	LEVEL 2
Deficiency Photo1

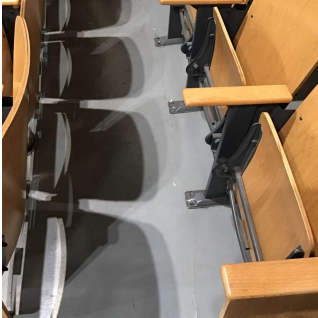
Violations	Seat L/297 No violations recorded.
<b>Floor Finish</b>	
Instance on Ground Floor (476 Seats)	Inspected
Condition	2 - Between Good and Fair
Deficiency	CONCRETE: CRACKS
Deficiency Location/Instance	Left Side Along Row P, Near Seat K/255, Exit K Vestibule
Deficiency Quantity	60
Quantity Uom	S.F.
Potential Action	REPLACE
Urgency of Action	PRIORITY 3
Purpose of Action	LEVEL 2
Deficiency Photo1

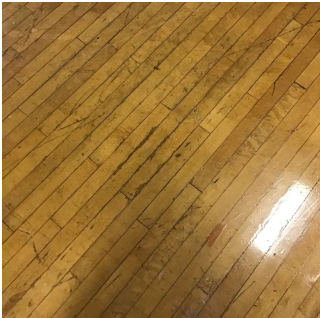
Question	Response
<b>INTERIOR</b>	
<b>AUDITORIUM</b>	
<b>Stage</b>	
<b>Stage</b>	Inspected
Instance on Ground Floor (476 Seats)	Inspected
Condition	2 - Between Good and Fair
Deficiency	DAMAGED FLOOR
Deficiency Location/Instance	Center
Deficiency Quantity	10
Quantity Uom	S.F.
Potential Action	REPLACE
Urgency of Action	PRIORITY 3
Purpose of Action	LEVEL 2
Deficiency Photo1

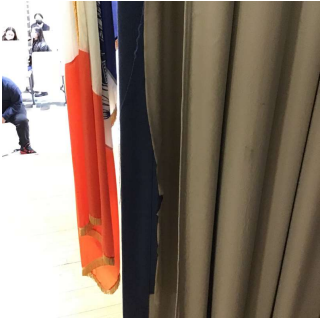
Violations	Center No violations recorded.
<b>Stage Curtain Rigging</b>	
<b>Stage Curtain Rigging</b>	Inspected
Instance on Ground Floor (476 Seats)	Inspected
Condition	2 - Between Good and Fair
Deficiency	No deficiencies recorded
<b>Stage Curtains</b>	
<b>Stage Curtains</b>	Inspected
Instance on Ground Floor (476 Seats)	Inspected
Condition	3 - Fair
Deficiency	WORN/DETERIORATED
Deficiency Location/Instance	Right Side
Deficiency Quantity	100
Quantity Uom	S.F.
Potential Action	REPLACE
Urgency of Action	PRIORITY 3
Purpose of Action	LEVEL 2
Deficiency Photo1

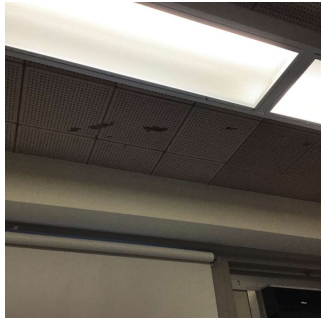
Question	Response
<b>INTERIOR</b>	
<b>AUDITORIUM</b>	
<b>Walls</b>	
Instance on Ground Floor (476 Seats)	Inspected
Condition	2 - Between Good and Fair
Deficiency	No deficiencies recorded
<b>Window Curtains/Shades/Blinds</b>	
Instance on Ground Floor (476 Seats)	Inspected
Condition	2 - Between Good and Fair
Deficiency	No deficiencies recorded
<b>CAFETERIA</b>	
Instance on Ground Floor - Staff (600 SF)	Inspected
Instance on Ground Floor - Students	Inspected
<b>Ceiling</b>	
Instance on Ground Floor - Staff (600 SF)	Inspected
Condition	3 - Fair
Deficiency	ACOUSTIC TILES: DAMAGED/MISSING
Deficiency Location/Instance	Near Windows, Center
Deficiency Quantity	20
Quantity Uom	S.F.
Potential Action	REPLACE
Urgency of Action	PRIORITY 3
Purpose of Action	LEVEL 2
Deficiency Photo1

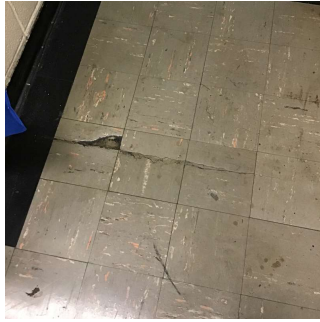
Violations	Center No violations recorded.
<b>Door(s)</b>	
Instance on Ground Floor - Staff (600 SF)	Inspected
Condition	2 - Between Good and Fair
Deficiency	No deficiencies recorded
Instance on Ground Floor - Students	Inspected
Condition	2 - Between Good and Fair
Deficiency	No deficiencies recorded
<b>Fixed Equipment</b>	
Instance on Ground Floor - Staff (600 SF)	Does not Exist
Instance on Ground Floor - Students	Does not Exist
<b>Floor Finish</b>	
Instance on Ground Floor - Staff (600 SF)	Inspected
Condition	3 - Fair
Deficiency	VINYL TILES: BROKEN/DETERIORATED/MISSING TILES
Deficiency Location/Instance	Right Side, Main Entrance, Near Servery
Deficiency Quantity	30
Quantity Uom	S.F.
Potential Action	REPLACE
Urgency of Action	PRIORITY 3
Purpose of Action	LEVEL 2
Deficiency Photo1

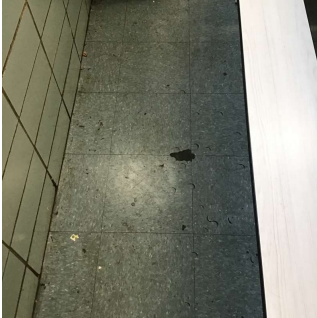
Instance on Ground Floor - Students	Inspected
Condition	2 - Between Good and Fair
Deficiency	VINYL TILES: BROKEN/DETERIORATED/MISSING TILES
Deficiency Location/Instance	Left Side Near Windows, Center, Near Entrance, Near Serving area
Deficiency Quantity	40

Question	Response
<b>INTERIOR</b>	
<b>CAFETERIA</b>	
<b>Floor Finish</b>	
Quantity Uom	S.F.
Potential Action	REPLACE
Urgency of Action	PRIORITY 3
Purpose of Action	LEVEL 2
Deficiency Photo1

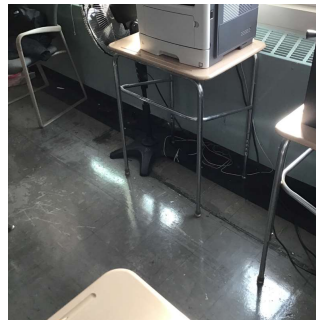
Room 329

VINYL TILES: BROKEN/DETERIORATED/MISSING TILES

REPLACE

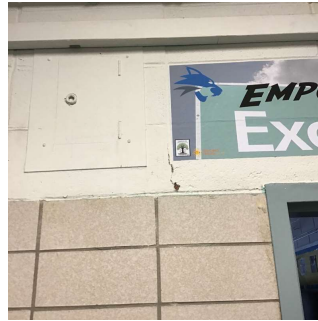
Corridor near Room 107

MASONRY: CRACKS/SPALLING

REPLACE

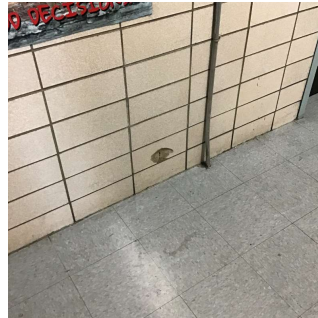
Corridor near Room 204

GLAZED BLOCK: CRACKS/SPALLING

REPLACE

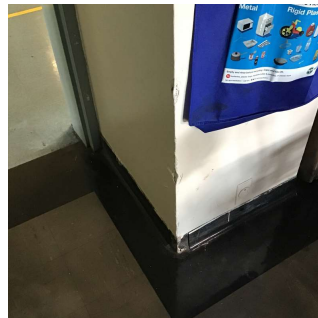
Room 329

PLASTER: CRACKS/SPALLING

REPLACE

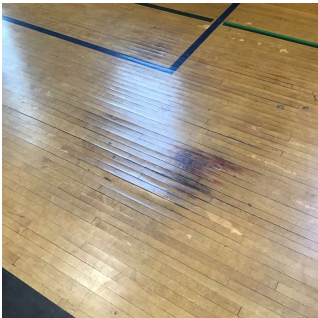
Question	Response
<b>INTERIOR</b>	
<b>CLASSROOMS/CORRIDORS/ADMIN SPACES</b>	Inspected
Specialties	Does not Exist
<b>GYMNASIUM</b>	Inspected
Instance on Ground Floor	Inspected
<b>Ceiling</b>	
Instance on Ground Floor	Inspected
Condition	2 - Between Good and Fair
Deficiency	No deficiencies recorded
<b>Door(s)</b>	
Instance on Ground Floor	Inspected
Condition	2 - Between Good and Fair
Deficiency	No deficiencies recorded
<b>Fixed Equipment</b>	
Instance on Ground Floor	Inspected
Condition	2 - Between Good and Fair
Deficiency	No deficiencies recorded
<b>Floor Finish</b>	
Instance on Ground Floor	Inspected
Condition	2 - Between Good and Fair
Deficiency	WOOD: DAMAGED/DETERIORATED
Deficiency Location/Instance	Left Side Near Bleachers
Deficiency Quantity	20
Quantity Uom	S.F.
Potential Action	REPLACE
Urgency of Action	PRIORITY 3
Purpose of Action	LEVEL 2
Deficiency Photo1

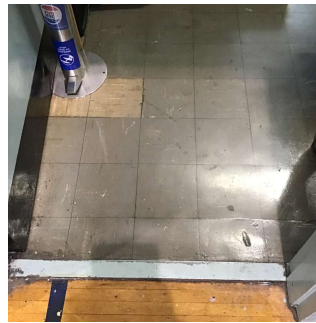
Deficiency	VINYL TILES: BROKEN/DETERIORATED/MISSING TILES
Deficiency Location/Instance	Office 1, Office 2
Deficiency Quantity	50
Quantity Uom	S.F.
Potential Action	REPLACE
Urgency of Action	PRIORITY 3
Purpose of Action	LEVEL 2

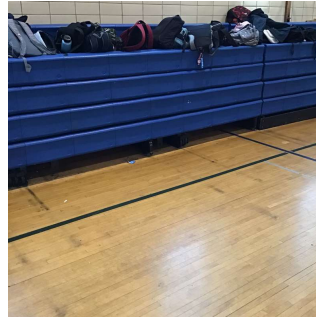
Deficiency DAMAGED BLEACHERS

Deficiency Location/Instance Left Side

Deficiency Quantity 20

Potential Action REPLACE

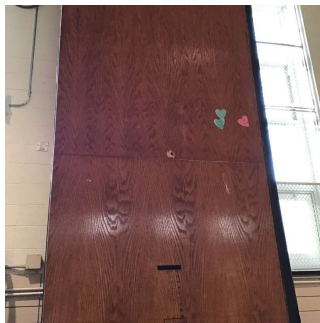
Deficiency MOVABLE PANELS: DAMAGED

Deficiency Location/Instance Center

Deficiency Quantity 80

Potential Action REPLACE

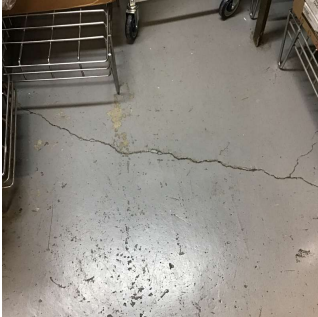
Exit to Staff Cafeteria
Violations	No violations recorded.
<b>Floor Finish</b>	
Instance on Ground Floor	Inspected
Condition	4 - Between Fair and Poor
Deficiency	CONCRETE: CRACKS
Deficiency Location/Instance	Exit 15 Vestibule, Storage Room
Deficiency Quantity	50
Quantity Uom	S.F.
Potential Action	REPLACE
Urgency of Action	PRIORITY 3
Purpose of Action	LEVEL 2
Deficiency Photo1

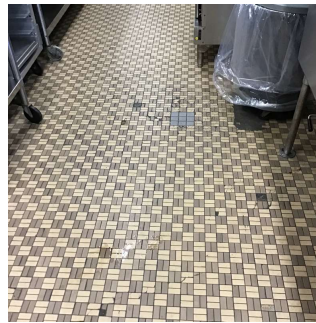
Near Prep Area

Storage Room
Violations	No violations recorded.
Deficiency	CERAMIC TILE: BROKEN/MISSING TILES
Deficiency Location/Instance	Near Prep Area, Student Serving area, near Staff Serving area, Near Sinks
Deficiency Quantity	50
Quantity Uom	S.F.
Potential Action	REPLACE
Urgency of Action	PRIORITY 3
Purpose of Action	LEVEL 2

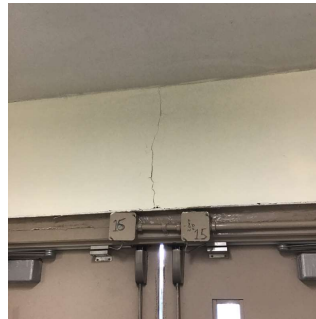
Deficiency PLASTER: CRACKS/SPALLING

Deficiency Location/Instance Exit 15 Vestibule

Deficiency Quantity 10

Potential Action REPLACE

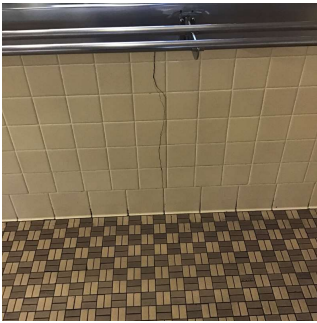
Deficiency CERAMIC TILE: BROKEN/ MISSING

Deficiency Location/Instance Students Serving area (multiple locations), sinks area, Near Staff Serving area,

Deficiency Quantity 90

Potential Action REPLACE

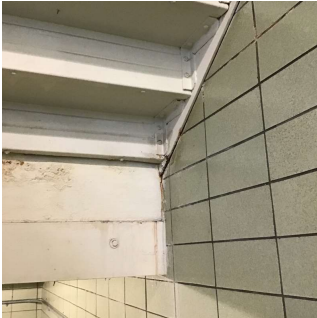
Question	Response
<b>INTERIOR</b>	
<b>STAIRS/RAMPS: INTERIOR</b>	
<b>Stairs and Landings</b>	
Deficiency	METAL: RUST - MAJOR
Deficiency Location/Instance	Stair AB/Ground Floor
Deficiency Quantity	10
Quantity Uom	S.F.
Potential Action	REPLACE
Urgency of Action	PRIORITY 3
Purpose of Action	LEVEL 2
Deficiency Photo1

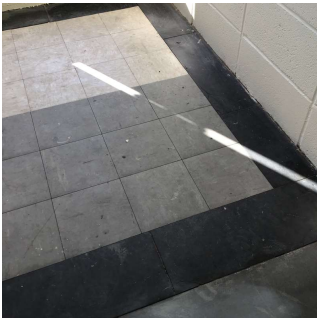
Violations	Stair AB/Ground Floor No violations recorded.
Deficiency	VINYL TILES: BROKEN/DETERIORATED/MISSING TILES
Deficiency Location/Instance	Stairs AB/Ground Floor, 1, 3, CD/Bulkhead, 3 and others
Deficiency Quantity	100
Quantity Uom	S.F.
Potential Action	REPLACE
Urgency of Action	PRIORITY 3
Purpose of Action	LEVEL 2
Deficiency Photo1

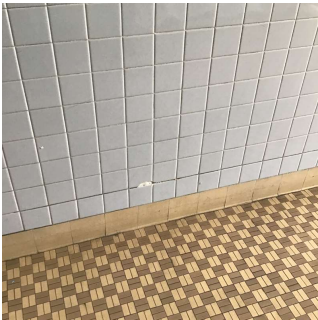
Question	Response
<b>INTERIOR</b>	
<b>TOILET ROOMS - STUDENTS</b>	
<b>Stalls</b>	Inspected
	Room 324
Violations	No violations recorded.
<b>Walls</b>	Inspected
Condition	2 - Between Good and Fair
Deficiency	CERAMIC TILE: BROKEN/ MISSING
Deficiency Location/Instance	Rooms 324, 320, 223, 220, 129 and others
Deficiency Quantity	70
Quantity Uom	S.F.
Potential Action	REPLACE
Urgency of Action	PRIORITY 3
Purpose of Action	LEVEL 2
Deficiency Photo1

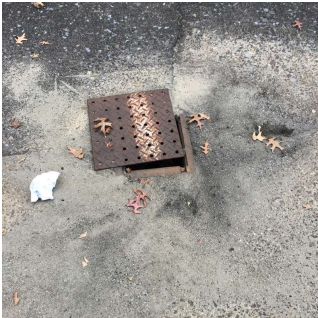
Question	Response
<b>SITE</b>	
<b>Drainage System for Asphalt</b>	Inspected
<b>Catch Basins/Manhole - Surrounded by asphalt</b>	Inspected
Condition	2 - Between Good and Fair
Deficiency	No deficiencies recorded
<b>Culverts - Asphalt Covering</b>	Does not Exist
<b>Drainage System for Concrete</b>	Inspected
<b>Catch Basins/Manhole - Surrounded by concrete</b>	Inspected
Condition	3 - Fair
Deficiency	DAMAGED COVER
Deficiency Location/Instance	Courtyard
Deficiency Quantity	1
Quantity Uom	EACH
Potential Action	REPLACE
Urgency of Action	PRIORITY 3
Purpose of Action	LEVEL 2
Deficiency Photo1

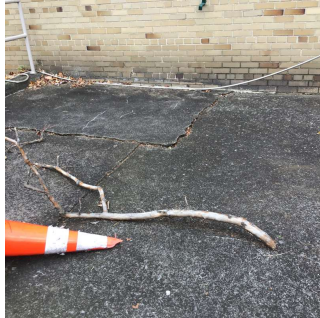
Violations	25th Drive No violations recorded.
Deficiency	CRACKS - MAJOR
Deficiency Location/Instance	25th Drive, Courtyard
Deficiency Quantity	800
Quantity Uom	S.F.
Potential Action	REPLACE
Urgency of Action	PRIORITY 3
Purpose of Action	LEVEL 2
Deficiency Photo1

Question	Response
<b>SITE</b>	
<b>PAVING</b>	
<b>Student Non-Use</b>	
<b>Concrete</b>	
Deficiency Photo1

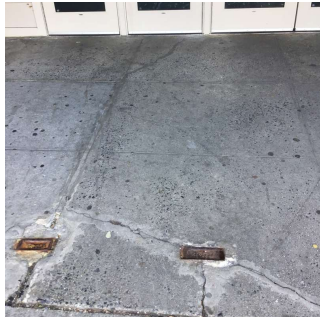
Question	Response
<b>SITE</b>	
<b>PAVING</b>	
<b>Site Sidewalks &amp; Walkways</b>	
<b>Concrete</b>	
Deficiency Photo1

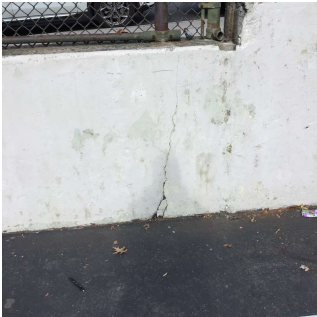
Question	Response
<b>SITE</b>	
<b>RETAINING WALLS</b>	
Urgency of Action	PRIORITY 3
Purpose of Action	LEVEL 2
Deficiency Photo1

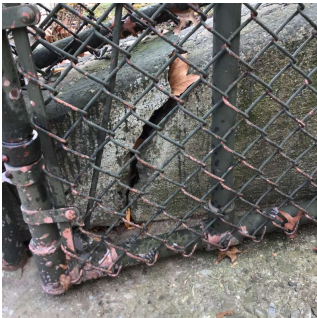
Violations	149th Street No violations recorded.
<b>Stairs/ramps</b>	Inspected

Violations	25th Drive No violations recorded.
<b>SEATING</b>	Inspected
<b>Benches</b>	Inspected
<b>Concrete</b>	Does not Exist
<b>Metal/Wood/Plastic</b>	Inspected
Condition	2 - Between Good and Fair
Deficiency	No deficiencies recorded
<b>Bleachers</b>	Does not Exist
<b>SITE WALLS (NOT RETAINING WALLS)</b>	Inspected
Condition	2 - Between Good and Fair
Deficiency	No deficiencies recorded
<b>STAIRS/RAMPS: EXTERIOR</b>	Inspected
<b>Railings</b>	Inspected
Condition	2 - Between Good and Fair
Deficiency	No deficiencies recorded
<b>Site Cheek/flank Walls</b>	Inspected
Condition	2 - Between Good and Fair
Deficiency	CAST IN PLACE CONCRETE: CRACKS/SPALLING - MAJOR
Deficiency Location/Instance	149th Street
Deficiency Quantity	20
Quantity Uom	S.F.
Potential Action	REPLACE
Urgency of Action	PRIORITY 3
