NYC Department of Education
Building Condition Assessment Survey 2023 - 2024

Architectural Inspection

Asset: I.S. 192 - QUEENS, 109-89 204 STREET, New York, 11412

Inspection Id	Inspection Type	Time In	Last Edited
SA : Q192	Architectural - Senior	2023-12-19 7:30 AM	2024-01-04 3:46 PM
AA : Q192	Architectural - Associate	2023-12-19 7:28 AM	2024-01-02 6:17 PM

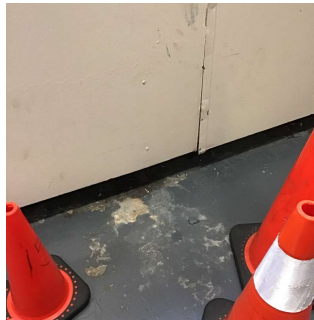
Facade A - 1st Floor Boys Locker Room

Question	Response
EXTERIOR	
DOORS	
DOORS AND FRAMES	
Rooftop reference	
Deficiency Quantity	3
Quantity Uom	EACH
Potential Action	REPLACE
Urgency of Action	PRIORITY 4
Purpose of Action	LEVEL 2
Deficiency Photo1	
Violations	Facade A No violations recorded.
DOOR HARDWARE	Inspected
Condition	3 - Fair
Deficiency	No deficiencies recorded
LINTELS	Inspected
Condition	2 - Between Good and Fair
Deficiency	No deficiencies recorded
TRANSOM/SIDE LIGHT	Inspected
Condition	2 - Between Good and Fair
Deficiency	No deficiencies recorded
EXTERIOR WALLS	Inspected
Material Type(s)	Masonry
Replacement Quantity	35,000
Replacement Uom	S.F.
Instance on All Facades	Inspected
Instance Condition	3 - Fair
Instance Quantity	35,000
Instance Quantity Uom	S.F.
Deficiency	BRICK: WATER INFILTRATION IN INSTRUCTIONAL SPACE

REPAIR

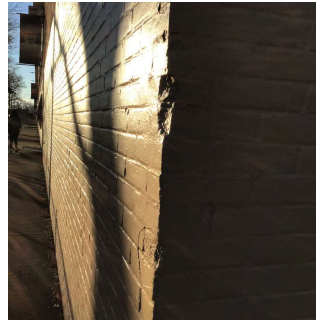
Facade B

BRICK: CRACKS/DISPLACED/SPALLED BRICK AT BUILDING CORNERS

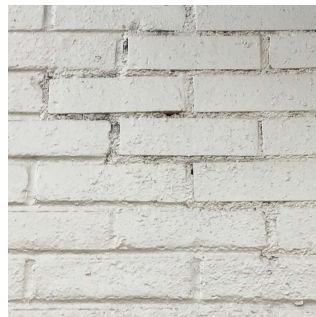
Facade A

BRICK: DETERIORATED JOINTS

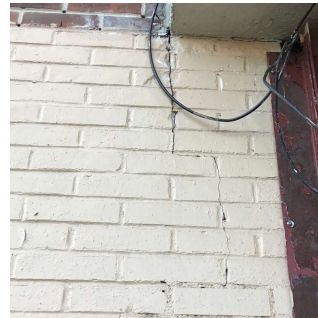
Facade A

BRICK: MINOR CRACKS AND SPALLING

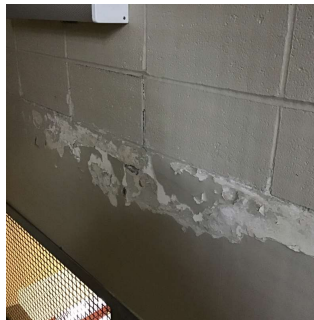
Roof 1 - Bulkhead 3

BULKHEAD/PENTHOUSE WALLS/EXTERIOR: WATER INFILTRATION

100
S.F.
REPAIR
PRIORITY 5
LEVEL 2

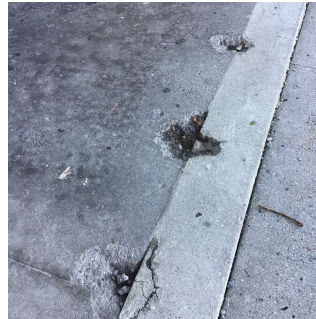
Facade A

CONCRETE: CRACKS/SPALLING - MAJOR

REPLACE

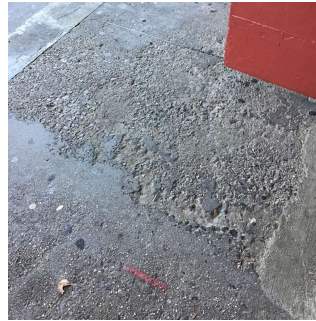
Facade A

CONCRETE: WORN-OUT TREAD/RISER/NOSING

REPLACE

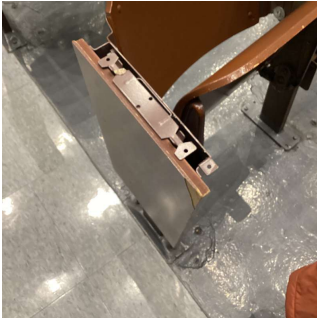
Question	Response
INTERIOR	
AUDITORIUM	
Door(s)	
Condition	2 - Between Good and Fair
Deficiency	No deficiencies recorded
Fixed H/C Lift	
Instance on 1st Floor (600 Seats)	Does not Exist
Fixed Seating	
Instance on 1st Floor (600 Seats)	Inspected
Condition	5 - Poor
Deficiency	DAMAGED/BROKEN/INOPERABLE
Deficiency Location/Instance	Seats A/111, B/102, D/101, V/1
Deficiency Quantity	4
Quantity Uom	EACH
Potential Action	REPLACE
Urgency of Action	PRIORITY 5
Purpose of Action	LEVEL 6
Deficiency Photo1

Violations	Seat D/101 No violations recorded.
Deficiency	DAMAGED/BROKEN/INOPERABLE
Deficiency Location/Instance	Seats A/101,115, B/101, C/115, D/1, and others
Deficiency Quantity	57
Quantity Uom	EACH
Potential Action	REPLACE
Urgency of Action	PRIORITY 3
Purpose of Action	LEVEL 2
Deficiency Photo1

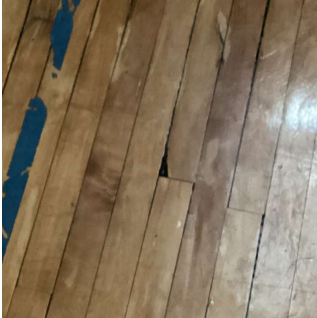
Question	Response
INTERIOR	
AUDITORIUM	
Sliding-folding Partition	
Instance on 1st Floor (600 Seats)	Does not Exist
Stage	
Instance on 1st Floor (600 Seats)	Inspected
Stage	Inspected
Instance on 1st Floor (600 Seats)	Inspected
Condition	2 - Between Good and Fair
Deficiency	DAMAGED FLOOR
Deficiency Location/Instance	Near the center
Deficiency Quantity	10
Quantity Uom	S.F.
Potential Action	REPLACE
Urgency of Action	PRIORITY 3
Purpose of Action	LEVEL 2
Deficiency Photo1

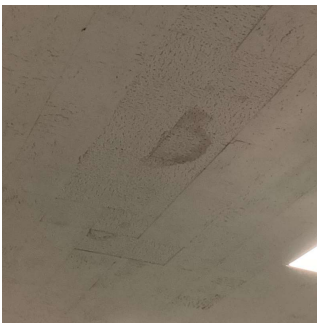
Near the center
Violations	No violations recorded.
Deficiency	ACOUSTIC TILES: DAMAGED/MISSING
Deficiency Location/Instance	Near the Drinking Fountain
Deficiency Quantity	20
Quantity Uom	S.F.
Potential Action	REPLACE
Urgency of Action	PRIORITY 3
Purpose of Action	LEVEL 2
Deficiency Photo1

Question	Response
INTERIOR	
CAFETERIA	
Ceiling	
Deficiency Photo1

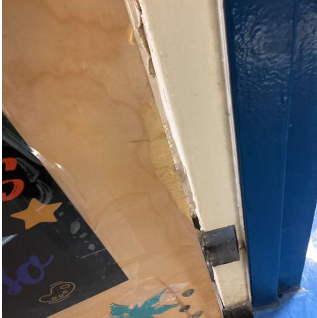
Question	Response
INTERIOR	
CLASSROOMS/CORRIDORS/ADMIN SPACES	
Door(s)	
Urgency of Action	PRIORITY 3
Purpose of Action	LEVEL 2
Deficiency Photo1

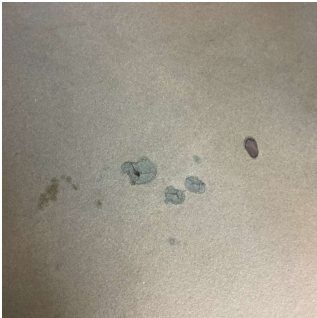
Room 405/407
Violations	No violations recorded.
Deficiency	VINYL TILES: BROKEN/DETERIORATED/MISSING TILES
Deficiency Location/Instance	Rooms 301, 406, 422, 424, 426B, and others
Deficiency Quantity	200
Quantity Uom	S.F.
Potential Action	REPLACE
Urgency of Action	PRIORITY 3
Purpose of Action	LEVEL 2

Room 431
Violations	No violations recorded.
Floor Finish	Inspected
Condition	2 - Between Good and Fair
Deficiency	EPOXY FLOORING: CRACKS/SPALLING
Deficiency Location/Instance	Room 405/407
Deficiency Quantity	10
Quantity Uom	S.F.
Potential Action	REPLACE
Urgency of Action	PRIORITY 3
Purpose of Action	LEVEL 2
Deficiency Photo1

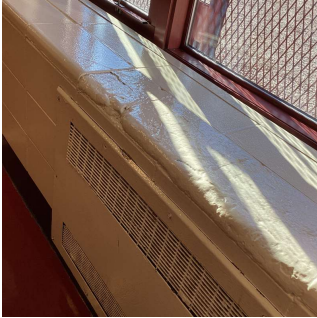
Corridor near Room 244
Violations	No violations recorded.
Deficiency	PLASTER: CRACKS/SPALLING
Deficiency Location/Instance	Room 243
Deficiency Quantity	10
Quantity Uom	S.F.
Potential Action	REPLACE
Urgency of Action	PRIORITY 3
Purpose of Action	LEVEL 2
Deficiency Photo1

Question	Response
INTERIOR	
CLASSROOMS/CORRIDORS/ADMIN SPACES	
Walls	Inspected
Condition	2 - Between Good and Fair
Deficiency	GLAZED BLOCK: CRACKS/SPALLING
Deficiency Location/Instance	Corridor near Room 244
Deficiency Quantity	20
Quantity Uom	S.F.
Potential Action	REPLACE
Urgency of Action	PRIORITY 3
Purpose of Action	LEVEL 2
Deficiency Photo1

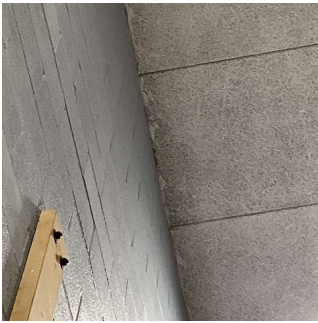
Question	Response
INTERIOR	
GYMNASIUM	
Ceiling	
Deficiency Photo1

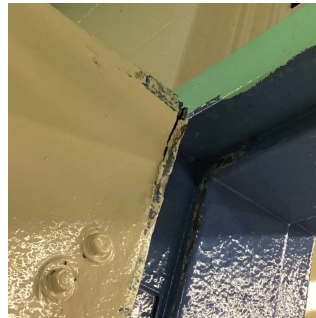
METAL: DETERIORATED DOOR
Servery Entrance
1
EACH
MAINTENANCE
PRIORITY 3
LEVEL 2

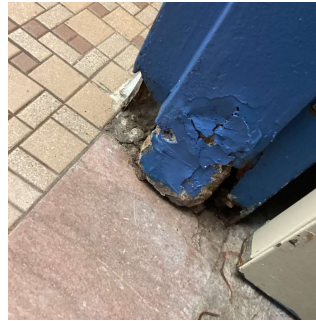
Vestibule Door

METAL: DETERIORATED DOOR AND FRAME
Storage Room, Office, Vestibule
3
EACH
MAINTENANCE
PRIORITY 3
LEVEL 2

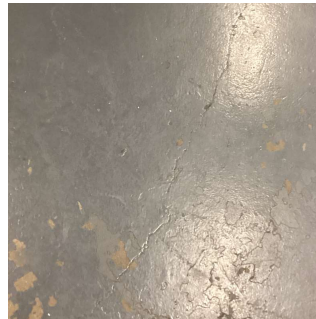
Deficiency CONCRETE: CRACKS

Deficiency Location/Instance Storage Room

Potential Action REPLACE

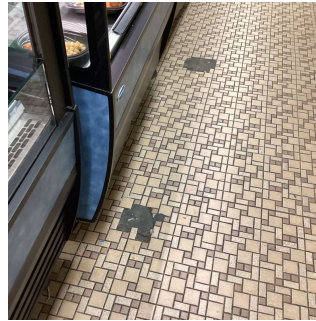
Servery Area

Deficiency CERAMIC TILE: BROKEN/MISSING TILES

Deficiency Location/Instance Servery, Food Preparation Area

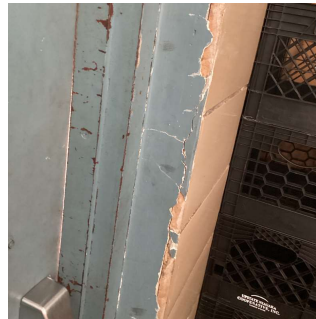
Near Exit to outside

Instance on 1st Floor	Inspected
Condition	3 - Fair
Deficiency	PLASTER: CRACKS/SPALLING
Deficiency Location/Instance	Office, near Exit to outside
Deficiency Quantity	30
Quantity Uom	S.F.
Potential Action	REPLACE
Urgency of Action	PRIORITY 3
Purpose of Action	LEVEL 2
Deficiency Photo1

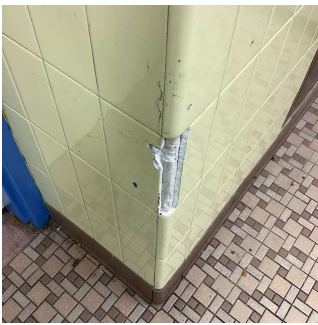
Deficiency	CERAMIC TILE: BROKEN/ MISSING
Deficiency Location/Instance	Servery, Food Preparation Area
Deficiency Quantity	20
Quantity Uom	S.F.
Potential Action	REPLACE
Urgency of Action	PRIORITY 3
Purpose of Action	LEVEL 2

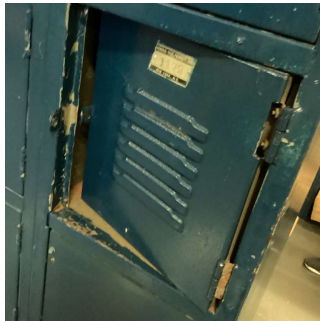
Near Locker 1170
Violations	No violations recorded.
Locker Room Lockers	
Instance on 1st Floor - Boys (1418 Lockers)	Inspected
Condition	2 - Between Good and Fair
Deficiency	DAMAGED UNITS
Deficiency Location/Instance	Near Lockers #653, 1244, 1284, 1304, at Locker 1178, and others
Deficiency Quantity	20
Quantity Uom	EACH
Potential Action	REPLACE
Urgency of Action	PRIORITY 3
Purpose of Action	LEVEL 2

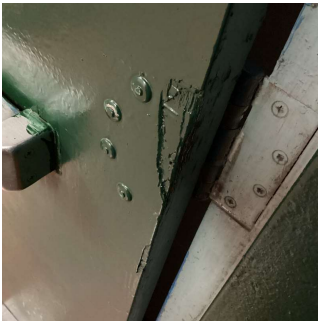
Do Letter Stair Signs Exist?	Partially
Ceiling	Inspected
Condition	2 - Between Good and Fair
Deficiency	No deficiencies recorded
Door(s)	Inspected
Condition	3 - Fair
Deficiency	WOOD: DETERIORATED DOOR
Deficiency Location/Instance	Stairs E/1, F/1 - Leading to Auditorium Stage
Deficiency Quantity	2
Quantity Uom	EACH
Potential Action	MAINTENANCE
Urgency of Action	PRIORITY 3
Purpose of Action	LEVEL 2

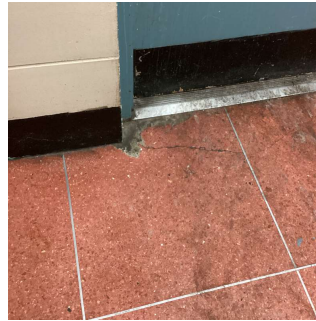
Stair C/1 Vestibule

Violations	Stair D/2 No violations recorded.
Stairs and Landings	Inspected
Condition	3 - Fair
Deficiency	TERRAZZO: CRACKS
Deficiency Location/Instance	Stairs C/1 Vestibule, D/1 Vestibule, Exit 5 Vestibule
Deficiency Quantity	50
Quantity Uom	S.F.
Potential Action	REPLACE
Urgency of Action	PRIORITY 3
Purpose of Action	LEVEL 2

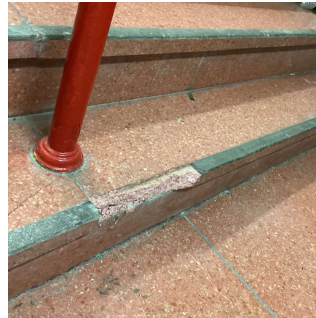
Stair F/1 Vestibule

TERRAZZO: CRACKS

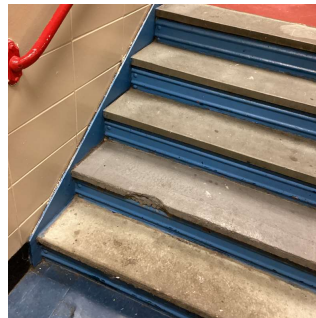
Stair D/1

STONE: BROKEN/MISSING

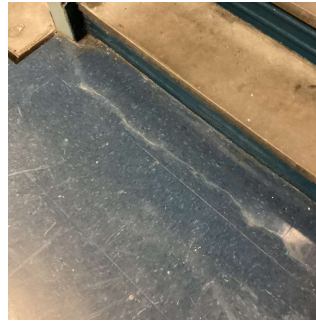
Stair A/2

Question	Response
INTERIOR	
STAIRS/RAMPS: INTERIOR	
Stairs and Landings	
Deficiency	STONE: BROKEN/MISSING
Deficiency Location/Instance	Stairs A/1,2, C/1, G/2, in Exit 4, and others
Deficiency Quantity	200
Quantity Uom	S.F.
Potential Action	REPLACE
Urgency of Action	PRIORITY 3
Purpose of Action	LEVEL 2
Deficiency Photo1

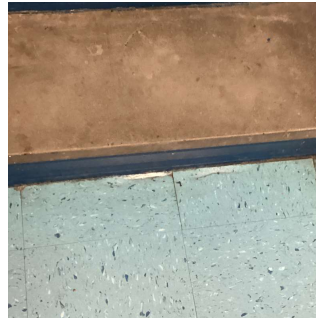
Stair B/4

VINYL TILES: BROKEN/DETERIORATED/MISSING TILES

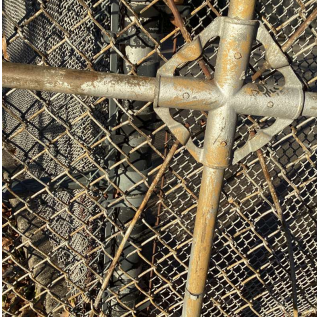
Question	Response
SITE	
FENCES	
Deficiency	CHAIN LINK: RUST - MAJOR
Deficiency Location/Instance	205th Street
Deficiency Quantity	100
Quantity Uom	S.F.
Potential Action	REPLACE
Urgency of Action	PRIORITY 3
Purpose of Action	LEVEL 2
Deficiency Photo1

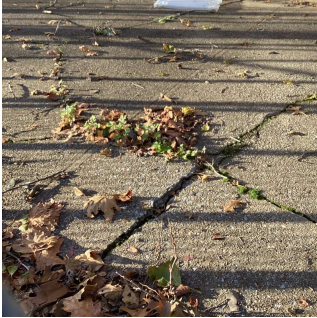
205th Street
Violations	No violations recorded.
CRACKS - MAJOR	
Deficiency	CRACKS - MAJOR
Deficiency Location/Instance	205th Street
Deficiency Quantity	250
Quantity Uom	S.F.
Potential Action	REPLACE

205th Street
Violations	No violations recorded.
IRRIGATION SYSTEM	
	Does not Exist
PAVING	
	Inspected
Student Non-Use	
Gravel Exists?	No
Asphalt	
	Does not Exist
Concrete	
Condition	3 - Fair
Deficiency	HEAVING
Deficiency Location/Instance	205th Street
Deficiency Quantity	50
Quantity Uom	S.F.
Potential Action	REPLACE
Urgency of Action	PRIORITY 3
Purpose of Action	LEVEL 2
Deficiency Photo1

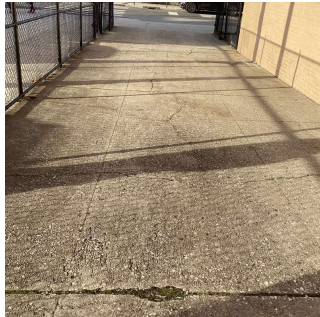
Violations	205th Street No violations recorded.
Pavers	Does not Exist
Student Use	Does not Exist
Site Sidewalks & Walkways	Inspected
Asphalt	Does not Exist
Concrete	Inspected
Condition	4 - Between Fair and Poor
Deficiency	HEAVING
Deficiency Location/Instance	204th Street, 205th Street
Deficiency Quantity	100
Quantity Uom	S.F.
Potential Action	REPLACE
Urgency of Action	PRIORITY 3
Purpose of Action	LEVEL 2
Deficiency Photo1
