NYC Department of Education
Building Condition Assessment Survey 2023 - 2024

Architectural Inspection

Asset: J.H.S. 194 - QUEENS, 154-60 17 AVENUE, New York, 11357

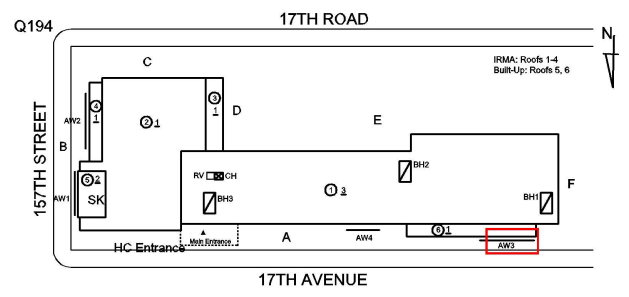
Question	Response
Architectural	
EXTERIOR	Inspected
AREAWAY	Inspected
Instance on AW1 - AW4	Inspected
Instance Condition	3 - Fair
Instance Quantity	4
Instance Quantity Uom	EACH
Deficiency	AREAWAY WALLS: CRACKS AND SPALLING
Roof Plan reference	Q194
Deficiency Quantity	10
Quantity Uom	S.F.
Potential Action	REPLACE
Urgency of Action	PRIORITY 4
Purpose of Action	LEVEL 2
Deficiency Photo1

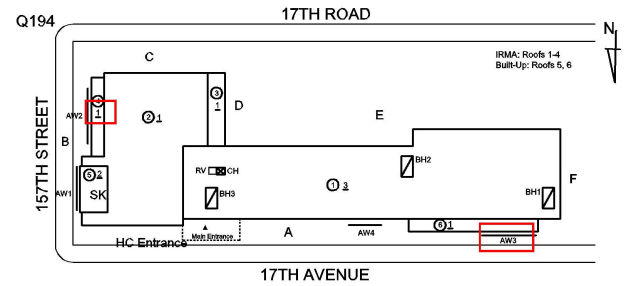
AW3
 No violations recorded.

AREAWAY SLAB: CRACKS AND SPALLING

20
 S.F.
 REPLACE
 PRIORITY 4
 LEVEL 2

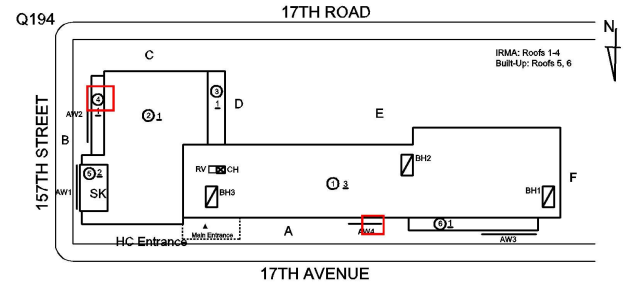
AW3
 No violations recorded.

AREAWAY STAIRS: DETERIORATED TREADS/RISERS/NOSINGS

50
 S.F.
 REPAIR
 PRIORITY 3
 LEVEL 2

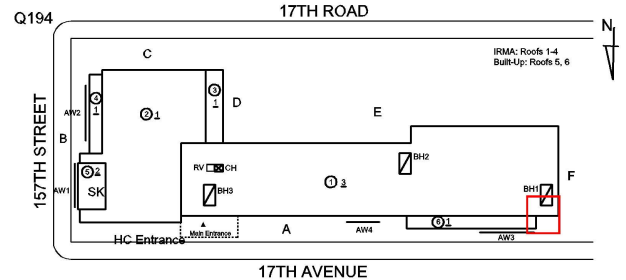
METAL: DETERIORATED DOOR - MINOR DETERIORATION

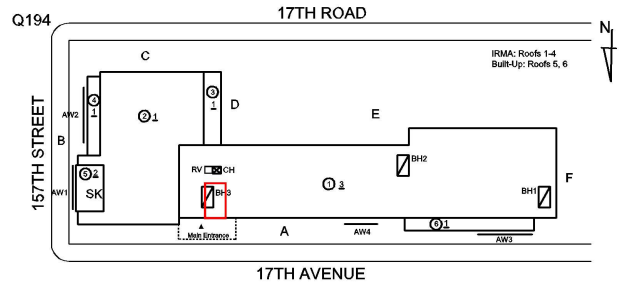
BULKHEAD/PENTHOUSE

10
S.F.
REPLACE
PRIORITY 3
LEVEL 2

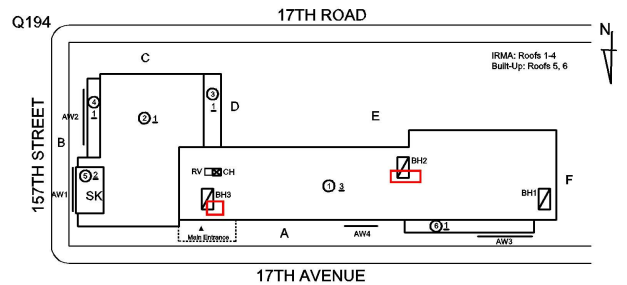
BULKHEAD/PENTHOUSE ROOF: DETERIORATED

30
S.F.
REPLACE
PRIORITY 4
LEVEL 2

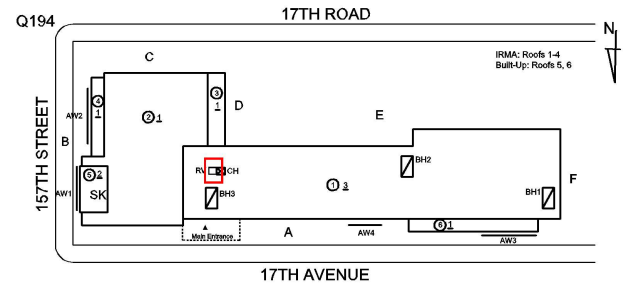
SHAFT VENTS DAMAGED

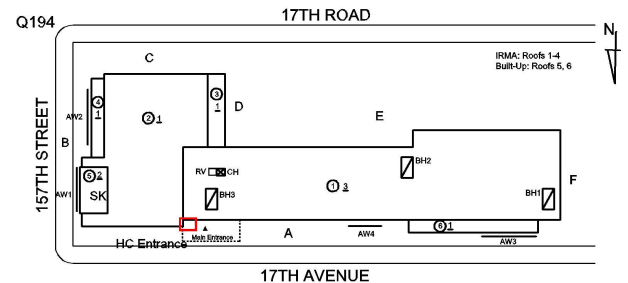
STONE: CRACKS/SPALLING - MINOR

Deficiency Quantity	10
Quantity Uom	S.F.
Potential Action	REPAIR
Urgency of Action	PRIORITY 3
Purpose of Action	LEVEL 2
Deficiency Photo1

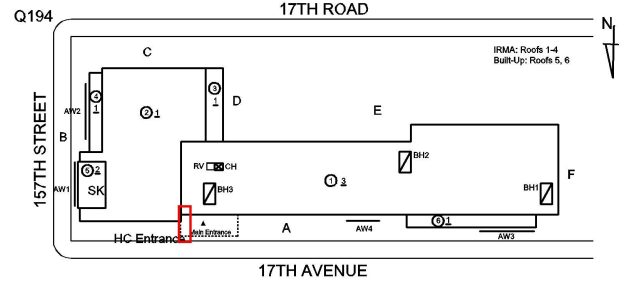
Deficiency	STONE: DETERIORATED JOINTS
------------	----------------------------

Deficiency Quantity	10
Quantity Uom	S.F.
Potential Action	REPOINT
Urgency of Action	PRIORITY 4
Purpose of Action	LEVEL 2
Deficiency Photo1

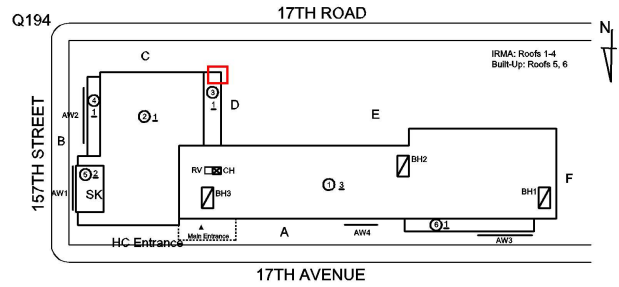
Deficiency	BRICK: CRACKS/SPALLING - MAJOR
------------	--------------------------------

BUILDING CHEEK/FLANK WALLS

10
 S.F.
 REPLACE
 PRIORITY 4
 LEVEL 2

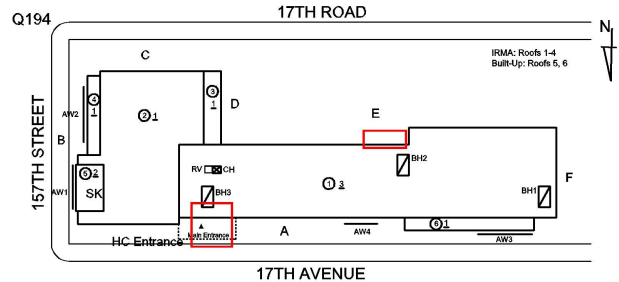
STONE: DETERIORATED JOINTS

50
 L.F.
 REPOINT
 PRIORITY 3
 LEVEL 2

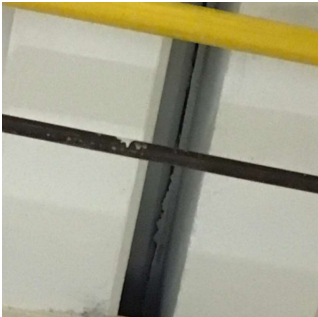
Violations	Basement - House Trap C No violations recorded.
FLOOR STRUCTURE	
Condition	Inspected
Deficiency	3 - Fair
Deficiency Location/Instance	CONCRETE: CRACKS/SPALLED/REINFORCEMENT EXPOSED Vault
Deficiency Quantity	10
Quantity Uom	S.F.
Potential Action	REPAIR
Urgency of Action	PRIORITY 3
Purpose of Action	LEVEL 5
Deficiency Photo1

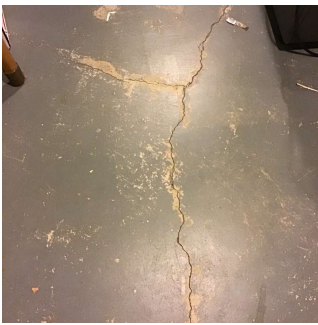
Violations	Basement - Vault No violations recorded.
Deficiency	CONCRETE SLAB ON GRADE: THRU CRACKS
Deficiency Location/Instance	Basement - B22, B26, B9, Mechanical Room, Boiler Room, Tool Room, Electrical Room
Deficiency Quantity	120
Quantity Uom	S.F.
Potential Action	REPAIR
Urgency of Action	PRIORITY 3
Purpose of Action	LEVEL 5

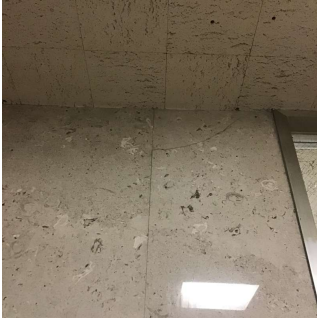
Question	Response
INTERIOR	
CLASSROOMS/CORRIDORS/ADMIN SPACES	
Floor Finish	Inspected
	Room 301
Violations	No violations recorded.
Walls	Inspected
Condition	2 - Between Good and Fair
Deficiency	MASONRY: CRACKS/SPALLING
Deficiency Location/Instance	Room B30
Deficiency Quantity	10
Quantity Uom	S.F.
Potential Action	REPLACE
Urgency of Action	PRIORITY 3
Purpose of Action	LEVEL 2
Deficiency Photo1	 
	Room B30
Violations	No violations recorded.
Deficiency	STONE: CRACKS/SPALLING
Deficiency Location/Instance	Main Entrance hall
Deficiency Quantity	10
Quantity Uom	S.F.
Potential Action	REPLACE
Urgency of Action	PRIORITY 3
Purpose of Action	LEVEL 2
Deficiency Photo1

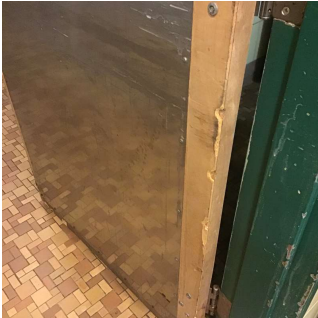
Question	Response
INTERIOR	
KITCHEN	
Door(s)	
Deficiency Quantity	3
Quantity Uom	EACH
Potential Action	MAINTENANCE
Urgency of Action	PRIORITY 3
Purpose of Action	LEVEL 2
Deficiency Photo1

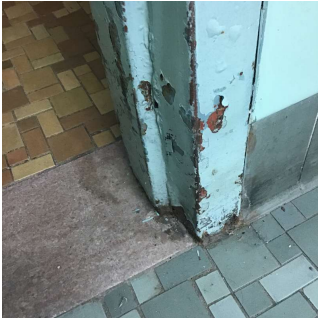
Sink Room
Violations	No violations recorded.
Deficiency	METAL: DETERIORATED DOOR AND FRAME
Deficiency Location/Instance	Sink Room, Serving Area, Staff Cafeteria.
Deficiency Quantity	3
Quantity Uom	EACH
Potential Action	MAINTENANCE
Urgency of Action	PRIORITY 3
Purpose of Action	LEVEL 2
Deficiency Photo1

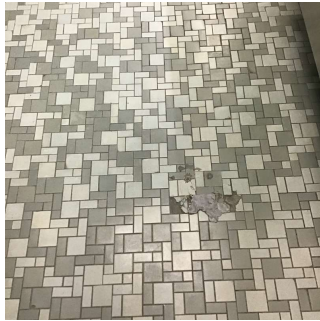
Sink Room
Violations	No violations recorded.
Floor Finish	
Instance on Basement	Inspected
Condition	3 - Fair
Deficiency	CERAMIC TILE: BROKEN/MISSING TILES
Deficiency Location/Instance	Near Serving Area, Oven area, Storage Room, staff Cafeteria, and others.
Deficiency Quantity	40
Quantity Uom	S.F.
Potential Action	REPLACE
Urgency of Action	PRIORITY 3
Purpose of Action	LEVEL 2

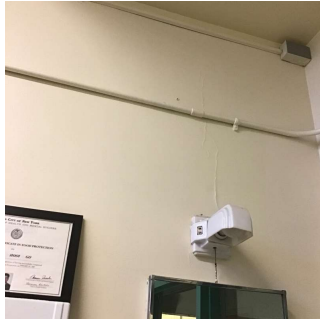
Violations	Near Serving Area No violations recorded.
Walls	
Instance on Basement	Inspected
Condition	2 - Between Good and Fair
Deficiency	PLASTER: CRACKS/SPALLING
Deficiency Location/Instance	Office
Deficiency Quantity	10
Quantity Uom	S.F.
Potential Action	REPLACE
Urgency of Action	PRIORITY 3
Purpose of Action	LEVEL 2
Deficiency Photo1

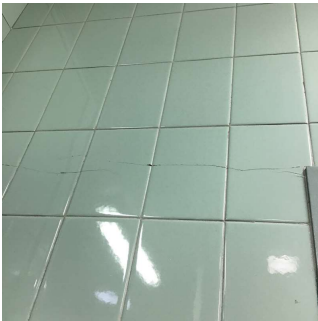
Violations	Office No violations recorded.
Deficiency	CERAMIC TILE: BROKEN/ MISSING
Deficiency Location/Instance	Near Serving Area
Deficiency Quantity	20
Quantity Uom	S.F.
Potential Action	REPLACE
Urgency of Action	PRIORITY 3
Purpose of Action	LEVEL 2

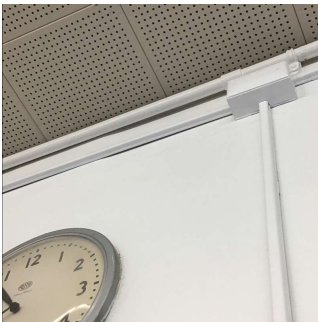
Question	Response
INTERIOR	
LIBRARY	Inspected
Walls	
Instance on Room 214/216	Inspected
Condition	2 - Between Good and Fair
Deficiency	PLASTER: CRACKS/SPALLING
Deficiency Location/Instance	Near Librarian Desk
Deficiency Quantity	10
Quantity Uom	S.F.
Potential Action	REPLACE
Urgency of Action	PRIORITY 3
Purpose of Action	LEVEL 2
Deficiency Photo1

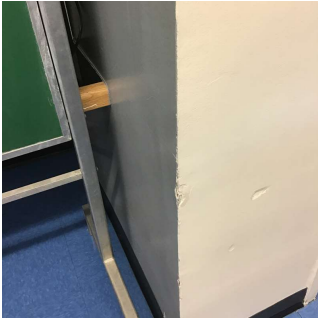
Violations	Near Librarian Desk No violations recorded.
Deficiency	GYPSUM BOARD: DETERIORATED
Deficiency Location/Instance	Near Exit
Deficiency Quantity	10
Quantity Uom	S.F.
Potential Action	REPLACE
Urgency of Action	PRIORITY 3
Purpose of Action	LEVEL 2
Deficiency Photo1

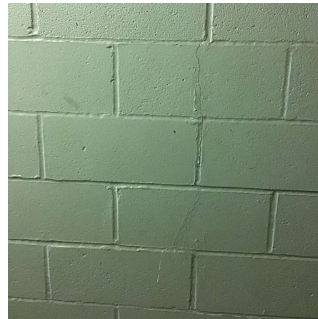
Instance on Basement - Boys (1220 Lockers)	Inspected
Condition	2 - Between Good and Fair
Deficiency	MASONRY: CRACKS/SPALLING
Deficiency Location/Instance	Near Entrance
Deficiency Quantity	10
Quantity Uom	S.F.
Potential Action	REPLACE
Urgency of Action	PRIORITY 3
Purpose of Action	LEVEL 2
Deficiency Photo1

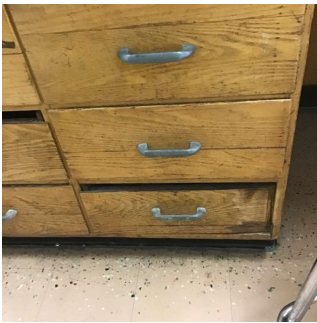
Violations	Room 212 No violations recorded.
Instance on Rooms 117, 208	Inspected
Condition	3 - Fair
Deficiency	CABINETRY: MISSING/DAMAGED
Deficiency Location/Instance	Rooms 117, 208
Deficiency Quantity	10
Quantity Uom	L.F.
Potential Action	REPLACE
Urgency of Action	PRIORITY 3
Purpose of Action	LEVEL 2

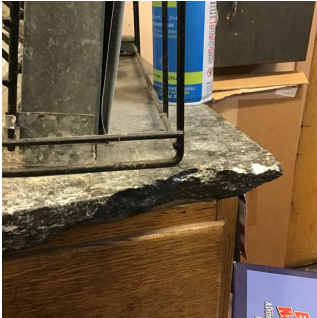
Violations	Room 208 No violations recorded.
SCIENCE LAB	Does not Exist
SCIENCE PREP ROOM	Inspected
Instance on Room 110	Inspected
Alternative use	No
Instance on Room 210	Inspected
Alternative use	No
Fixed Equipment	
Instance on Room 210	Inspected
Condition	5 - Poor
Deficiency	DEMO TABLE: DAMAGED/DETERIORATED
Deficiency Location/Instance	Room 210
Deficiency Quantity	1
Quantity Uom	EACH
Potential Action	REPLACE
Urgency of Action	PRIORITY 3
Purpose of Action	LEVEL 2
Deficiency Photo1

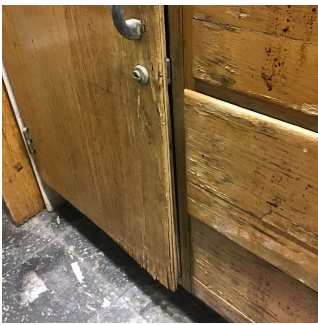
Violations	Room 210 No violations recorded.
Instance on Room 110	Inspected
Condition	3 - Fair
Deficiency	CABINETS: MISSING/DAMAGED
Deficiency Location/Instance	Room 110
Deficiency Quantity	12
Quantity Uom	L.F.
Potential Action	REPLACE
Urgency of Action	PRIORITY 3
Purpose of Action	LEVEL 2

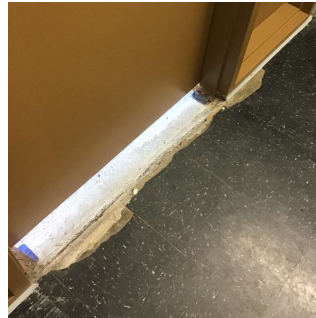
Stair C/Basement

VINYL TILES: BROKEN/DETERIORATED/MISSING TILES

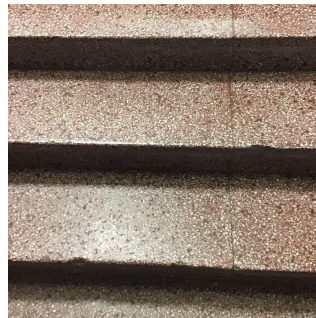
Main Entrance

TERRAZZO: CRACKS

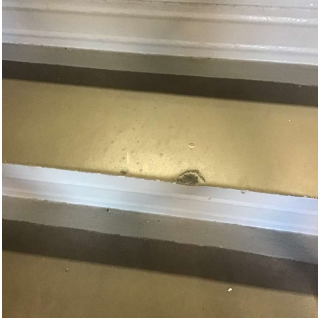
Stair HI/1

Deficiency	STONE: BROKEN/MISSING
Deficiency Location/Instance	Stairs FG/1, 2, HI/1, JK/1, Near Room B20, and others.
Deficiency Quantity	150
Quantity Uom	S.F.
Potential Action	REPLACE
Urgency of Action	PRIORITY 3
Purpose of Action	LEVEL 2
Deficiency Photo1

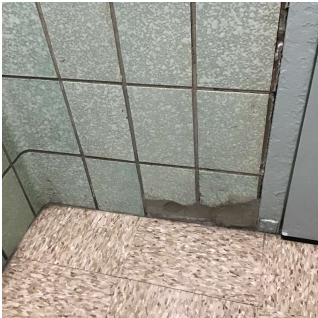
Stair C/Basement

Condition	2 - Between Good and Fair
Deficiency	GLAZED BLOCK: CRACKS/SPALLING
Deficiency Location/Instance	Stairs C/Basement, E/Basement, FG/Basement, JK/1.
Deficiency Quantity	30
Quantity Uom	S.F.
Potential Action	REPLACE
Urgency of Action	PRIORITY 3
Purpose of Action	LEVEL 2
Deficiency Photo1

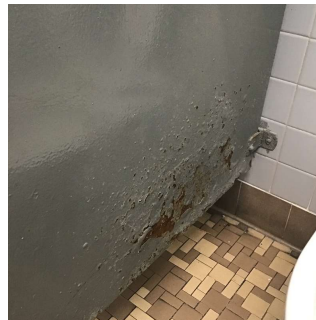
Room 330

RUST - MAJOR

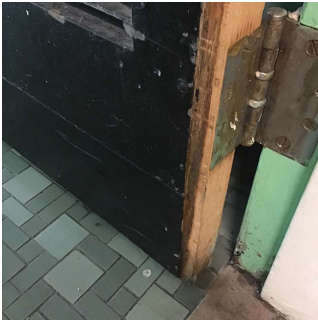
Violations	Inside Girls Locker Room No violations recorded.
Door(s)	Inspected
Condition	5 - Poor
Deficiency	WOOD: DETERIORATED DOOR
Deficiency Location/Instance	Rooms B6, 111, 215, 311, 315, and others.
Deficiency Quantity	10
Quantity Uom	EACH
Potential Action	MAINTENANCE
Urgency of Action	PRIORITY 3
Purpose of Action	LEVEL 2
Deficiency Photo1

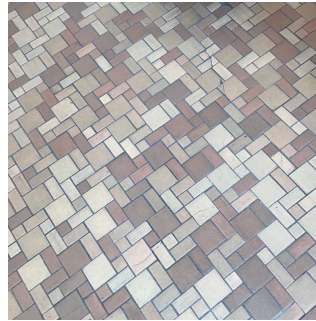
Room 311

Violations	Room 315 No violations recorded.
Floor Finish	Inspected
Condition	2 - Between Good and Fair
Deficiency	CERAMIC TILE: DETERIORATED SUBSTRATE
Deficiency Location/Instance	Rooms 211, 215, 311
Deficiency Quantity	30
Quantity Uom	S.F.
Potential Action	REPLACE
Urgency of Action	PRIORITY 3
Purpose of Action	LEVEL 2

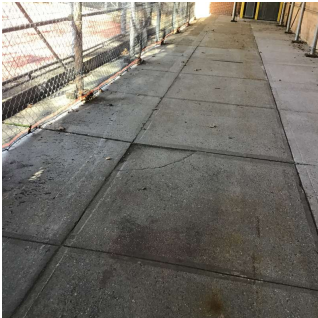
Question	Response
SITE	
PAVING	
Student Non-Use	
Gravel Exists?	No
Asphalt	Does not Exist
Concrete	Inspected
Condition	2 - Between Good and Fair
Deficiency	No deficiencies recorded
Pavers	Does not Exist
Student Use	Does not Exist
Site Sidewalks & Walkways	Inspected
Asphalt	Does not Exist
Concrete	Inspected
Condition	4 - Between Fair and Poor
Deficiency	DAMAGED/DETERIORATED/MISSING SECTIONS
Deficiency Location/Instance	Near Exit 4, 5, NYC Park
Deficiency Quantity	600
Quantity Uom	S.F.
Potential Action	REPLACE
Urgency of Action	PRIORITY 3
Purpose of Action	LEVEL 2
Deficiency Photo1

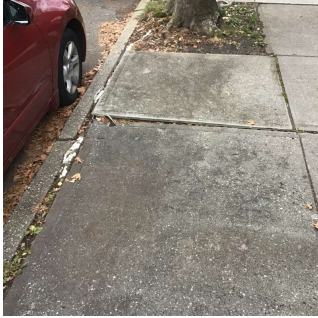
Violations	Near Exit 4 No violations recorded.
Pavers	Does not Exist
DOT Sidewalk	Inspected
Asphalt	Does not Exist
Concrete	Inspected
Condition	4 - Between Fair and Poor
Deficiency	HEAVING
Deficiency Location/Instance	17th Avenue, 157th Street, 17th Road
Deficiency Quantity	275
Quantity Uom	S.F.
Potential Action	REPLACE
Urgency of Action	PRIORITY 3
