NYC Department of Education
Building Condition Assessment Survey 2023 - 2024

Architectural Inspection

Q196

Asset: P.S. 196 - QUEENS, 71-25 113TH STREET, New York, 11375

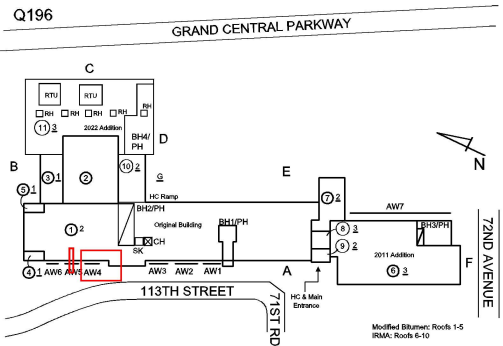
AREAWAY SLAB: CRACKS AND SPALLING

20
 S.F.
 REPAIR
 PRIORITY 3
 LEVEL 2

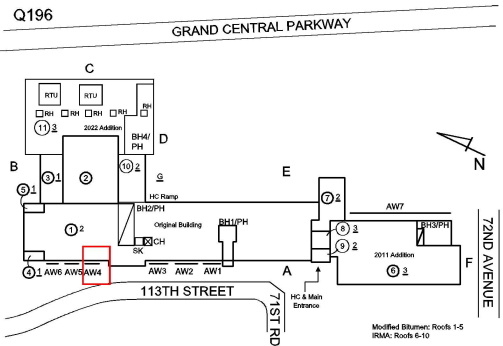
AREAWAY STAIRS: DETERIORATED TREADS/RISERS/NOSINGS

10
 S.F.
 REPAIR
 PRIORITY 3
 LEVEL 2

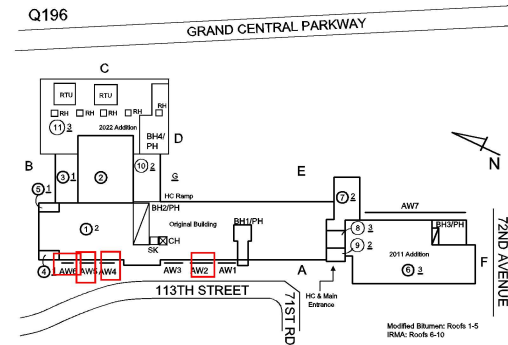
AREAWAY WALLS: CRACKS AND SPALLING

REPAIR

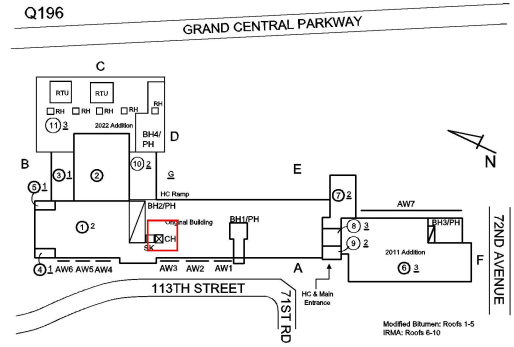
BRICK: MINOR CRACKS AND SPALLING

30
 S.F.
 RESTITCH
 PRIORITY 3
 LEVEL 2

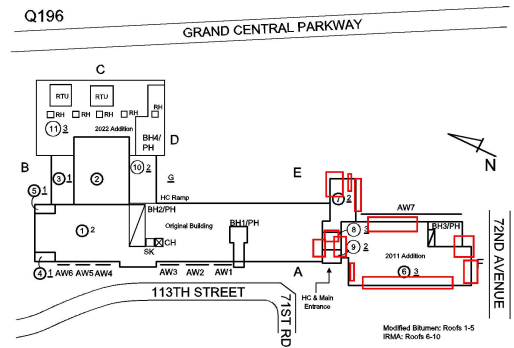
CAST STONE: DETERIORATED TRANSVERSE JOINTS

200
 L.F.
 MAINTENANCE
 PRIORITY 3
 LEVEL 2

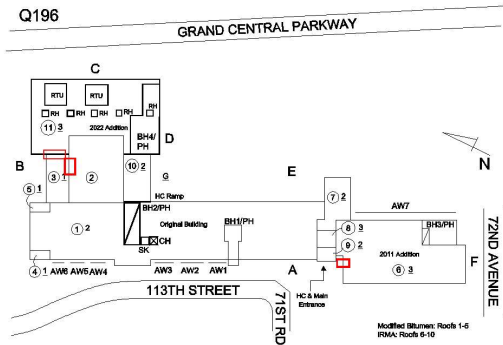
CAST STONE: CRACKED/BROKEN PIECES

REPLACE-IN-KIND

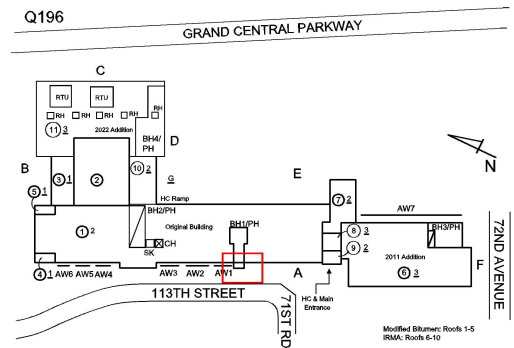
METAL: DETERIORATED DOOR AND FRAME - MINOR DETERIORATION

2
EACH
MAINTENANCE
PRIORITY 3
LEVEL 2

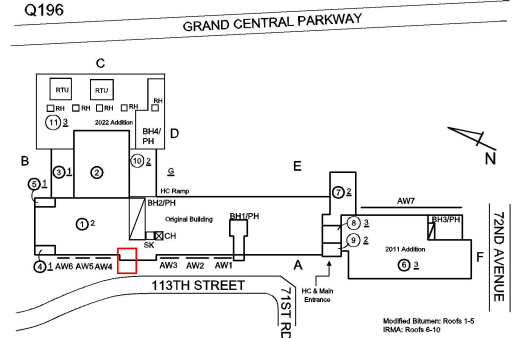
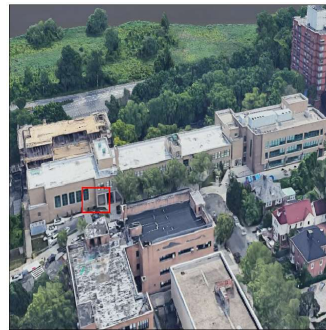
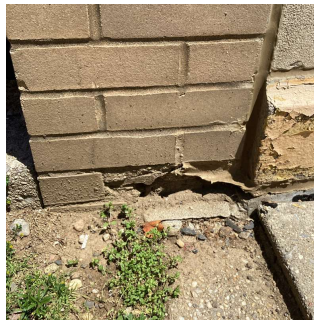
Facade A

BRICK: MAJOR / THRU CRACKS

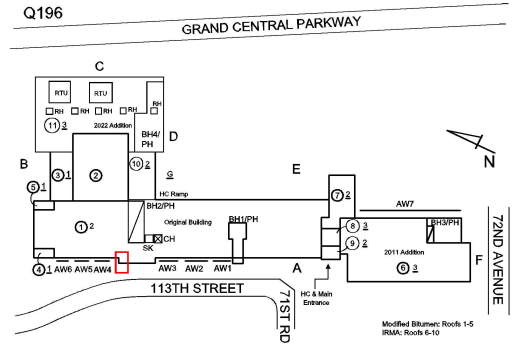
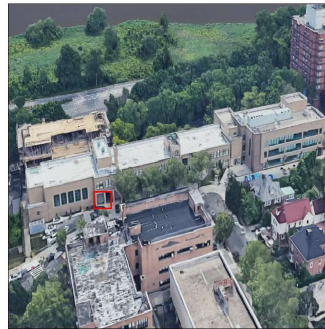
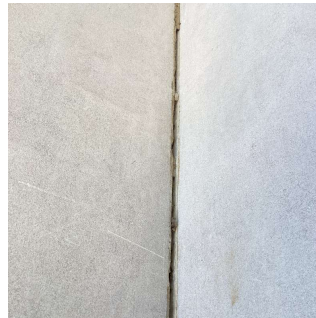
Facade A

CAST IN PLACE / PRE-CAST CONCRETE: DETERIORATED JOINTS

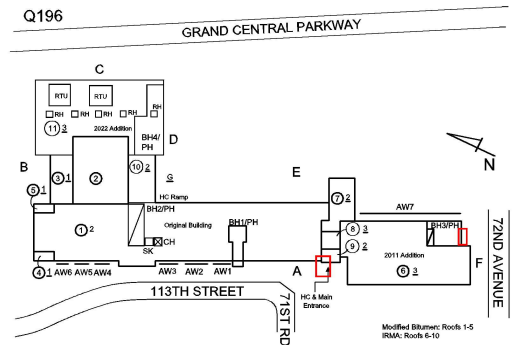
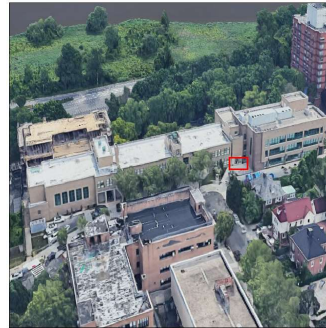
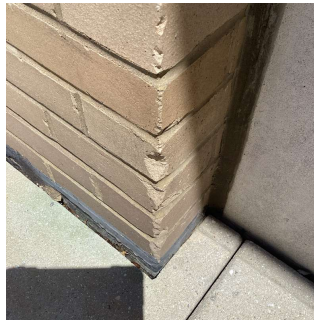
Facade A

BRICK: CRACKS/DISPLACED/SPALLED BRICK AT BUILDING CORNERS

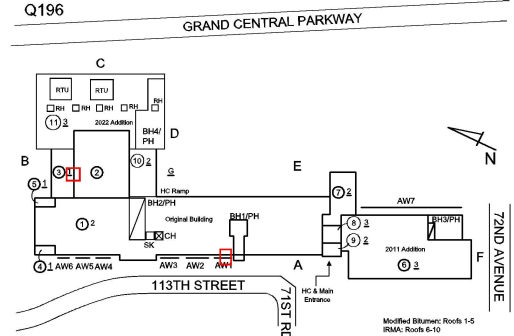
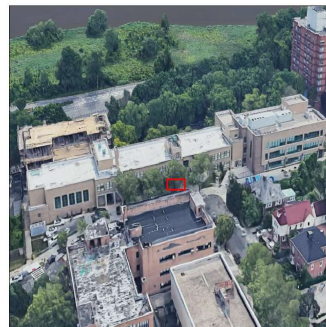
BRICK: DETERIORATED MASONRY SILLS - MINOR

REPAIR

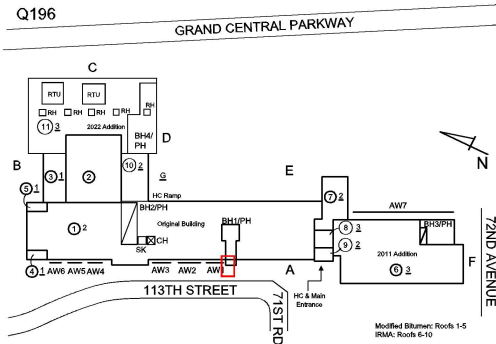
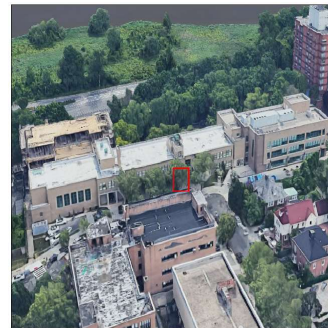
CAST IN PLACE / PRE-CAST CONCRETE: MINOR CRACKS/SPALLING

10
S.F.
REPAIR
PRIORITY 3
LEVEL 2

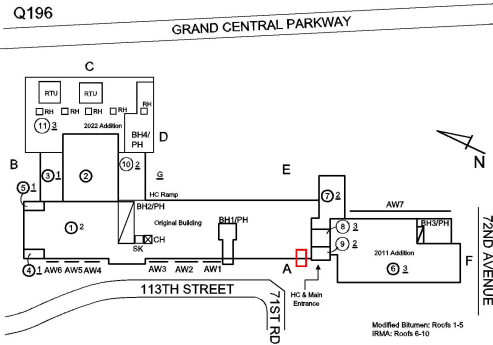
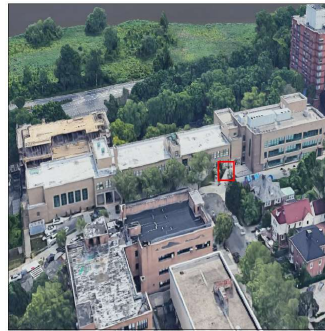
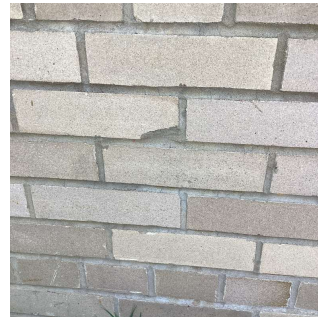
Facade A

BRICK: MINOR CRACKS AND SPALLING

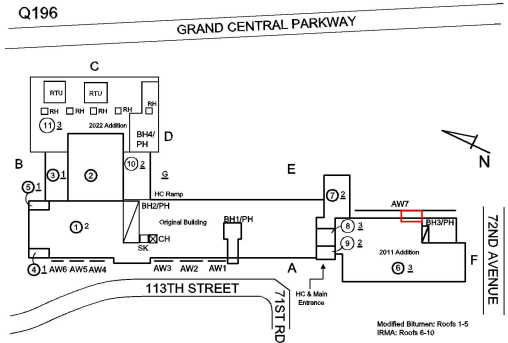
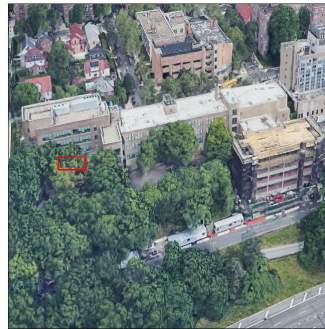
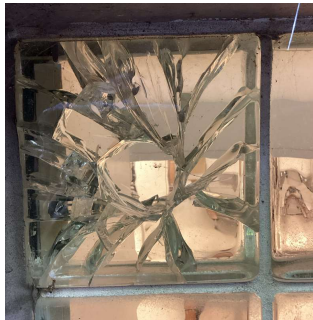
Facade E

GLASS BLOCK: CHIPPED/ BROKEN PIECES

REPLACE-IN-KIND

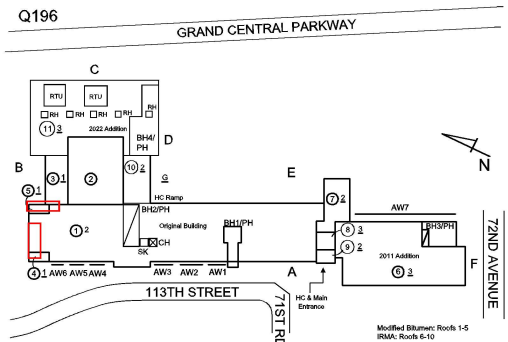
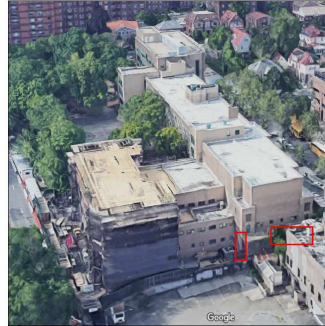
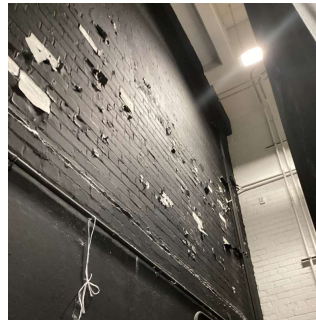
Auditorium Stage

BRICK: WATER INFILTRATION IN INSTRUCTIONAL SPACE

REPAIR

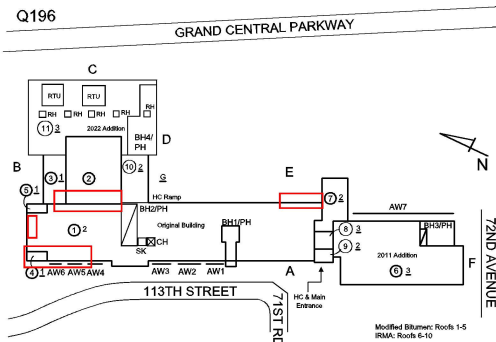
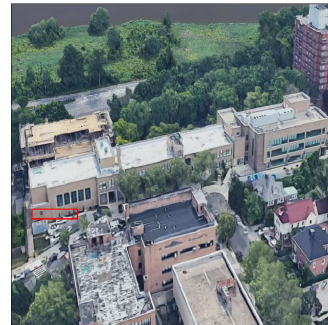
BRICK: DETERIORATED JOINTS

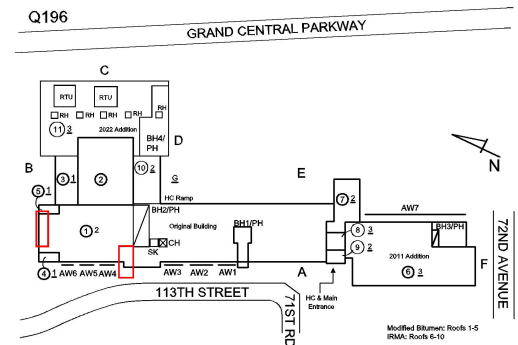
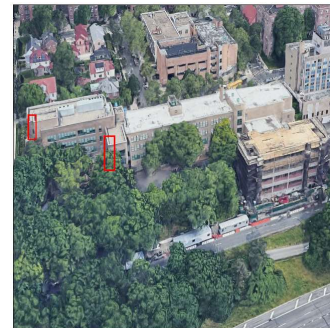
BRICK: EFFLORESCENCE

70
S.F.
MAINTENANCE
PRIORITY 1
LEVEL 1
No photo recorded
No violations recorded.

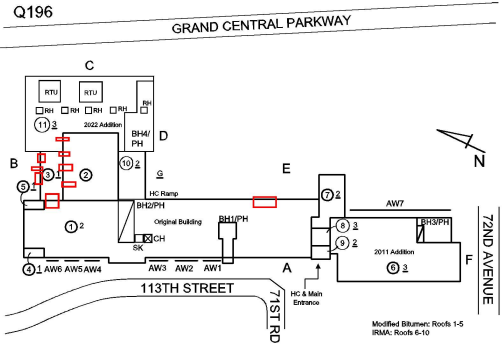
Sustainable Roof Location (Roof Number)	Roofs 1 - 5
Do solar panels exist on these roofs?	No
Is/Are the roof(s) suitable for Solar Panel installation?	Yes
Installation Year	2016
Source of Installation	Custodial Staff
Deficiency	MODIFIED BITUMEN: FLASHING: BASE FLASHING DETERIORATED

70
 S.F.
 REPLACE
 PRIORITY 4
 LEVEL 2

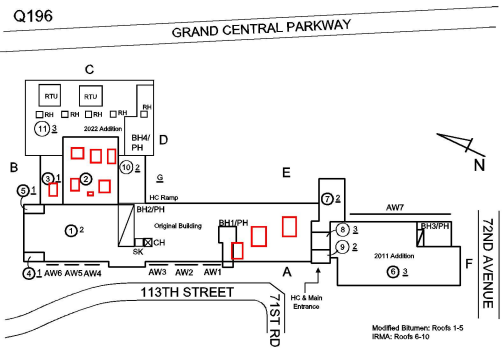
MODIFIED BITUMEN: ROOFING: DELAMINATION

180
 S.F.
 REPLACE ROOFING WITHOUT MAJOR EQUIPMENT
 REMOVAL
 PRIORITY 4
 LEVEL 2

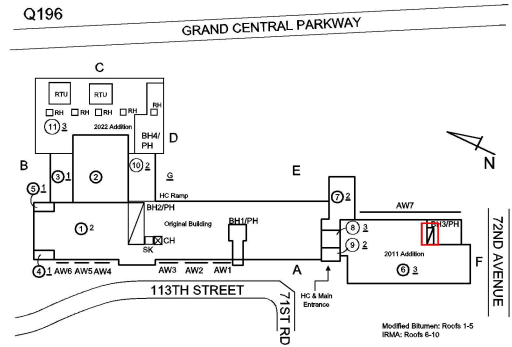
Violations	Roof 6 No violations recorded.
ROOFING DRAINS	Inspected
Condition	2 - Between Good and Fair
Deficiency	No deficiencies recorded
Specialties	Inspected
BULKHEAD/PENTHOUSE	Inspected
Condition	3 - Fair
Deficiency	BULKHEAD/PENTHOUSE CEILING: ACOUSTIC TILES DAMAGED/MISSING
Roof Plan reference	Q196

Deficiency Quantity	10
Quantity Uom	S.F.
Potential Action	REPLACE
Urgency of Action	PRIORITY 3
Purpose of Action	LEVEL 2
Deficiency Photo1

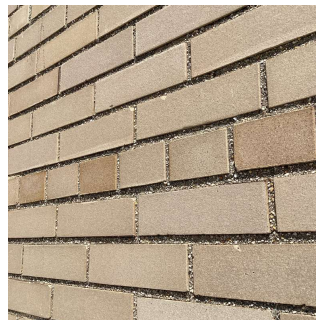
BH1
 No violations recorded.

BULKHEAD/PENTHOUSE WALLS/EXTERIOR: DETERIORATED JOINTS

180
 S.F.
 REPOINT
 PRIORITY 3
 LEVEL 2

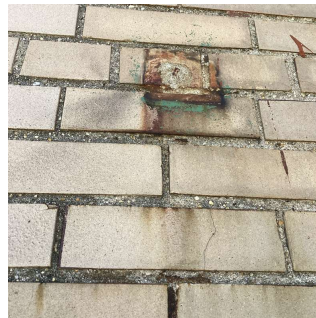
BH1
 No violations recorded.

BULKHEAD/PENTHOUSE WALLS/EXTERIOR: CRACKS/SPALLING - MINOR

30
 S.F.
 REPAIR
 PRIORITY 3
 LEVEL 2

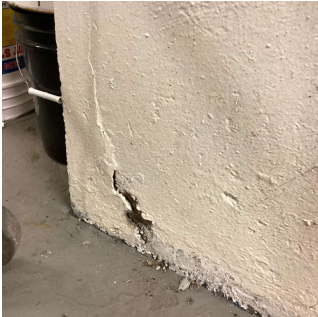
Question	Response
INTERIOR	Inspected
POOLS	Does not Exist
STRUCTURAL	Inspected
COLUMNS/BEAMS/BEARING WALLS	Inspected
Condition	3 - Fair
Deficiency	STEEL COLUMNS/BEAMS: DETERIORATED CONCRETE FIREPROOFING
Deficiency Location/Instance	Basement - Boiler Room, Crawl Space
Deficiency Quantity	50
Quantity Uom	S.F.
Potential Action	REPLACE
Urgency of Action	PRIORITY 4
Purpose of Action	LEVEL 5
Deficiency Photo1

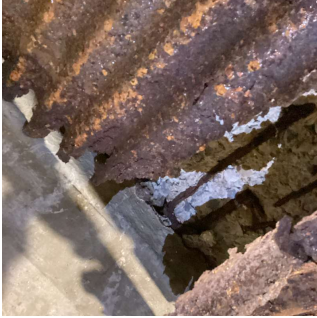
Violations	Basement - Room G13 No violations recorded.
Deficiency	CINDER CONCRETE FLAT SLAB: CRACKED/SPALLED/REINFORCEMENT EXPOSED

Deficiency Location/Instance	Basement - Crawl Space Corridor
Deficiency Quantity	220
Quantity Uom	S.F.

Question	Response
INTERIOR	
STRUCTURAL	
FLOOR STRUCTURE	
Potential Action	REPAIR
Urgency of Action	PRIORITY 5
Purpose of Action	LEVEL 6
Deficiency Photo1

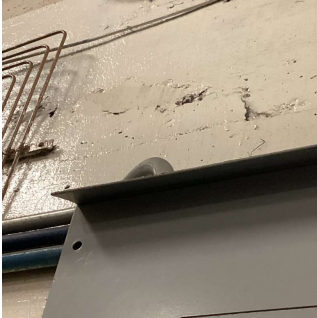
Violations	Basement - Crawl Space Corridor No violations recorded.
FOUNDATION WALLS	
Material Type(s)	Inspected Concrete
Condition	4 - Between Fair and Poor
Deficiency	CONCRETE: CRACKED/SPALLED/REINFORCEMENT EXPOSED
Deficiency Location/Instance	Basement - Boiler Room, Storage Room near Boiler Room
Deficiency Quantity	40
Quantity Uom	S.F.
Potential Action	REPAIR
Urgency of Action	PRIORITY 4
Purpose of Action	LEVEL 5
Deficiency Photo1

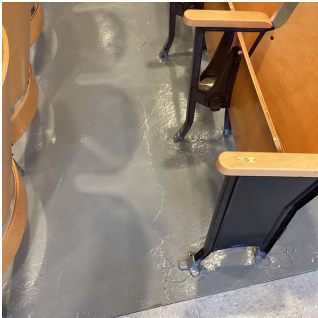
Question	Response
INTERIOR	
AUDITORIUM	
Ceiling	
Deficiency	No deficiencies recorded
Door(s)	
Instance on 1st Floor (399 Seats)	Inspected
Condition	2 - Between Good and Fair
Deficiency	No deficiencies recorded
Fixed H/C Lift	
Instance on 1st Floor (399 Seats)	Does not Exist
Fixed Seating	
Instance on 1st Floor (399 Seats)	Inspected
Condition	2 - Between Good and Fair
Deficiency	No deficiencies recorded
Floor Finish	
Instance on 1st Floor (399 Seats)	Inspected
Condition	2 - Between Good and Fair
Deficiency	CONCRETE: CRACKS
Deficiency Location/Instance	Near Seats C/6, G/113
Deficiency Quantity	50
Quantity Uom	S.F.
Potential Action	REPLACE
Urgency of Action	PRIORITY 3
Purpose of Action	LEVEL 2
Deficiency Photo1

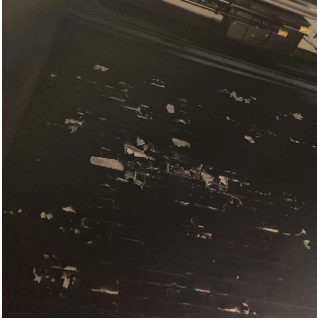
Question	Response
INTERIOR	
AUDITORIUM	
Stage	
Stage Curtains	
Deficiency	No deficiencies recorded
Walls	
Instance on 1st Floor (399 Seats)	Inspected
Condition	2 - Between Good and Fair
Deficiency	BRICK: CRACKS/SPALLING - ACTIVE LEAK
Deficiency Location/Instance	Rear of Stage
Deficiency Quantity	100
Quantity Uom	S.F.
Potential Action	REPLACE
Urgency of Action	PRIORITY 5
Purpose of Action	LEVEL 2
Deficiency Photo1

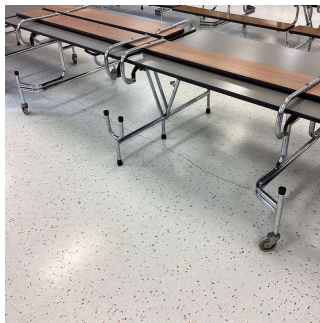
Question	Response
INTERIOR	
CAFETERIA	
Floor Finish	
Deficiency Photo1

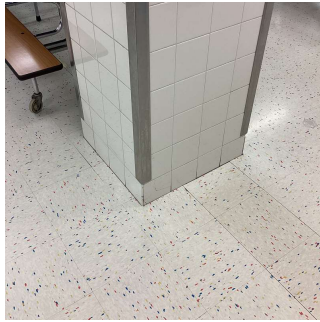
Violations	Center No violations recorded.
Sliding-folding Partition	
Instance on Ground Floor	Does not Exist
Stage	
Instance on Ground Floor	Does not Exist
Walls	
Instance on Ground Floor	Inspected
Condition	2 - Between Good and Fair
Deficiency	CERAMIC TILE: BROKEN/ MISSING
Deficiency Location/Instance	Columns, Near Serving Area, Near Entrance
Deficiency Quantity	30
Quantity Uom	S.F.
Potential Action	REPLACE
Urgency of Action	PRIORITY 3
Purpose of Action	LEVEL 2
Deficiency Photo1

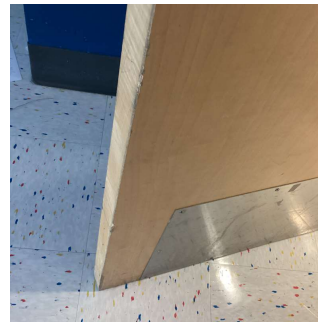
Room 335

Corridor near Auditorium
Violations	No violations recorded.
Door(s)	Inspected
Condition	5 - Poor
Deficiency	WOOD: DETERIORATED DOOR
Deficiency Location/Instance	Rooms 335, 216, 205, 119, 20 and others
Deficiency Quantity	9
Quantity Uom	EACH
Potential Action	MAINTENANCE
Urgency of Action	PRIORITY 3
Purpose of Action	LEVEL 2

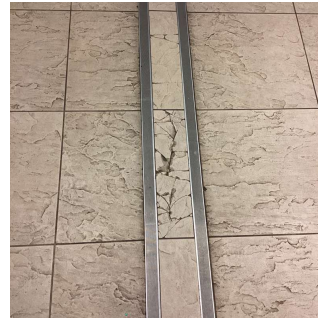
Main Entrance Lobby

CERAMIC TILE: BROKEN/MISSING TILES

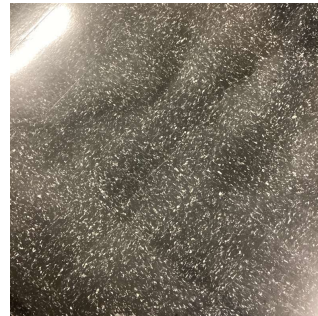
VINYL TILES: DETERIORATED SUBSTRATE

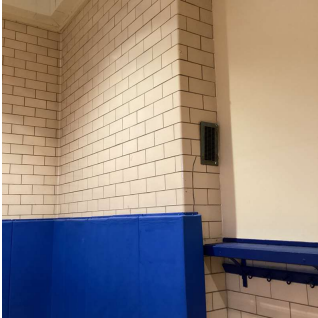
Question	Response
INTERIOR	
GYMNASIUM	
Walls	
Condition	3 - Fair
Deficiency	GLAZED BLOCK: CRACKS/SPALLING
Deficiency Location/Instance	Right Side, Near Windows
Deficiency Quantity	40
Quantity Uom	S.F.
Potential Action	REPLACE
Urgency of Action	PRIORITY 3
Purpose of Action	LEVEL 2
Deficiency Photo1

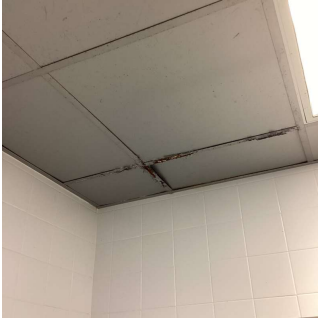
Question	Response
INTERIOR	
KITCHEN	
Ceiling	
Instance on Ground Floor	Inspected
Condition	2 - Between Good and Fair
Deficiency	METAL PAN: DAMAGED/MISSING
Deficiency Location/Instance	Room 30E
Deficiency Quantity	10
Quantity Uom	S.F.
Potential Action	REPLACE
Urgency of Action	PRIORITY 3
Purpose of Action	LEVEL 2
Deficiency Photo1

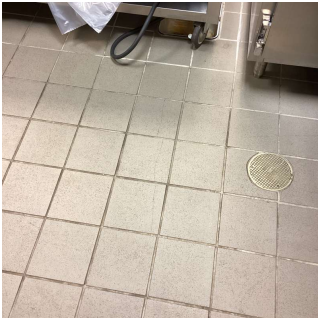
Violations	Room 30E No violations recorded.
Door(s)	
Instance on Ground Floor	Inspected
Condition	2 - Between Good and Fair
Deficiency	No deficiencies recorded
Floor Finish	
Instance on Ground Floor	Inspected
Condition	2 - Between Good and Fair
Deficiency	QUARRY TILE: BROKEN/MISSING TILES
Deficiency Location/Instance	Serving Area
Deficiency Quantity	10
Quantity Uom	S.F.
Potential Action	REPLACE
Urgency of Action	PRIORITY 3
Purpose of Action	LEVEL 2
Deficiency Photo1

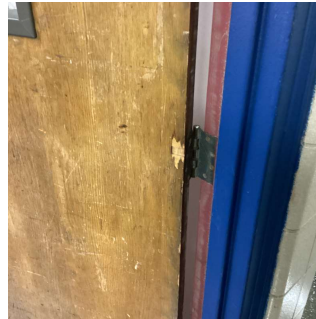
Deficiency	WOOD: DETERIORATED DOOR
------------	-------------------------

Deficiency Location/Instance	Main Entrance
------------------------------	---------------

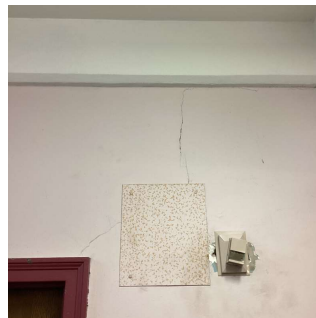
Deficiency	PLASTER: CRACKS/SPALLING
------------	--------------------------

Deficiency Location/Instance	Near Toilet Room
------------------------------	------------------

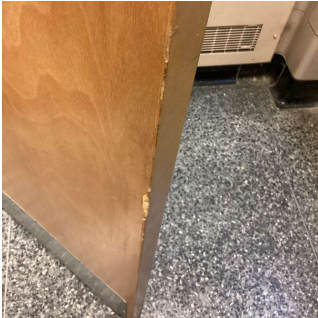
Question	Response
INTERIOR	
STAIRS/RAMPS: INTERIOR	
Ceiling	Inspected
Condition	2 - Between Good and Fair
Deficiency	No deficiencies recorded
Door(s)	Inspected
Condition	2 - Between Good and Fair
Deficiency	WOOD: DETERIORATED DOOR
Deficiency Location/Instance	Stair F/1 Vestibule
Deficiency Quantity	1
Quantity Uom	EACH
Potential Action	MAINTENANCE
Urgency of Action	PRIORITY 3
Purpose of Action	LEVEL 2
Deficiency Photo1

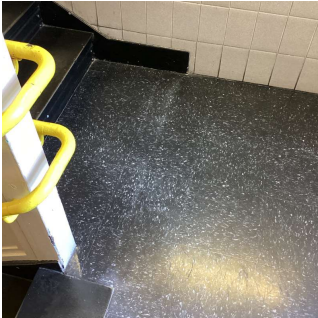
Violations	Stair F/1 Vestibule No violations recorded.
Partition	Does not Exist
Railings	Inspected
Condition	2 - Between Good and Fair
Deficiency	No deficiencies recorded
Stairs and Landings	Inspected
Condition	2 - Between Good and Fair
Deficiency	VINYL TILES: DETERIORATED SUBSTRATE
Deficiency Location/Instance	Stair E/Basement, 1
Deficiency Quantity	20
Quantity Uom	S.F.
Potential Action	REPLACE
Urgency of Action	PRIORITY 3
Purpose of Action	LEVEL 2
Deficiency Photo1

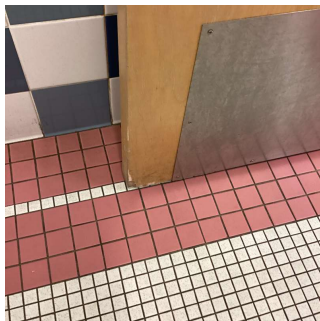
Room 108
Violations	No violations recorded.
TOILET ROOMS - STUDENTS	
Ceiling	Inspected
Condition	2 - Between Good and Fair
Deficiency	No deficiencies recorded
Door(s)	Inspected
Condition	4 - Between Fair and Poor
Deficiency	WOOD: DETERIORATED DOOR
Deficiency Location/Instance	Rooms 229, 117, 29
Deficiency Quantity	3
Quantity Uom	EACH
Potential Action	MAINTENANCE
Urgency of Action	PRIORITY 3
Purpose of Action	LEVEL 2
Deficiency Photo1

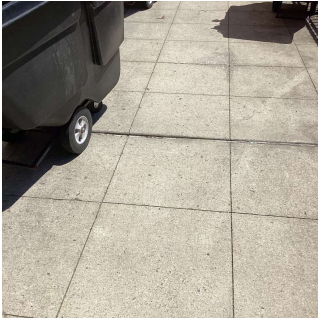
Question	Response
SITE	
PAVING	
Site Sidewalks & Walkways	
Concrete	
Deficiency Location/Instance	Exits 1, 3, 4, 13, Rear of Building
Deficiency Quantity	400
Quantity Uom	S.F.
Potential Action	REPLACE
Urgency of Action	PRIORITY 3
Purpose of Action	LEVEL 2
Deficiency Photo1

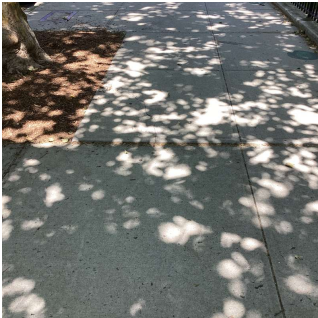
Violations	Exit 13 No violations recorded.
Pavers	Inspected
Condition	2 - Between Good and Fair
Deficiency	No deficiencies recorded
DOT Sidewalk	Inspected
Asphalt	Does not Exist
Concrete	Inspected
Condition	4 - Between Fair and Poor
Deficiency	HEAVING
Deficiency Location/Instance	113th Street
Deficiency Quantity	75
Quantity Uom	S.F.
Potential Action	REPLACE
Urgency of Action	PRIORITY 3
Purpose of Action	LEVEL 2
Deficiency Photo1

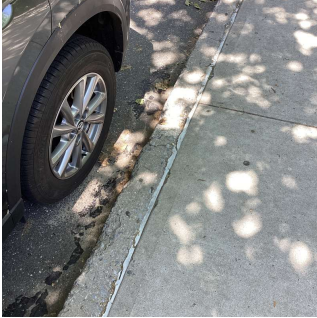
Violations	113th Street No violations recorded.
Deficiency	DAMAGED CURBS
Deficiency Location/Instance	113th Street
Deficiency Quantity	60
Quantity Uom	L.F.

Question	Response
SITE	
PAVING	
DOT Sidewalk	
Concrete	
Potential Action	REPLACE
Urgency of Action	PRIORITY 3
Purpose of Action	LEVEL 2
Deficiency Photo1

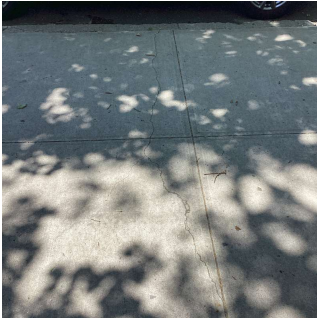
113th Street
Violations	No violations recorded.
Deficiency	DAMAGED/DETERIORATED/MISSING SECTIONS
Deficiency Location/Instance	113th Street
Deficiency Quantity	450
Quantity Uom	S.F.
Potential Action	REPLACE
Urgency of Action	PRIORITY 3
Purpose of Action	LEVEL 2
Deficiency Photo1

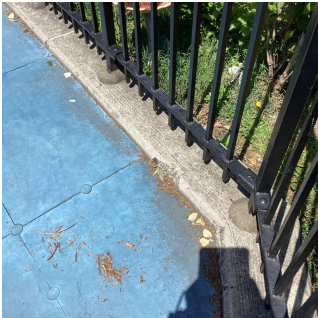
113th Street
Violations	No violations recorded.
Pavers	Does not Exist
PLAYGROUNDS	Inspected
Instance on Near Grand Central Parkway	Inspected
Instance on Near Main Entrance	Inspected
Benches	
Instance on Near Main Entrance	Inspected
Condition	2 - Between Good and Fair
Deficiency	No deficiencies recorded
Instance on Near Grand Central Parkway	Does not Exist
Fence	
Instance on Near Main Entrance	Inspected
Condition	2 - Between Good and Fair
Deficiency	CONCRETE CURB: DAMAGED/DETERIORATED

Deficiency Location/Instance	Near Entrance

Question	Response
SITE	
PLAYGROUNDS	
Fence	
Deficiency Quantity	10
Quantity Uom	S.F.
Potential Action	REPLACE
Urgency of Action	PRIORITY 3
Purpose of Action	LEVEL 2
Deficiency Photo1

Near Entrance
Violations	No violations recorded.
Pavement	
Instance on Near Main Entrance	Inspected
Condition	2 - Between Good and Fair
Deficiency	No deficiencies recorded
Instance on Near Grand Central Parkway	Inspected
Condition	1 - Good
Deficiency	No deficiencies recorded
Play Equipment	
Instance on Near Grand Central Parkway	Inspected
Condition	1 - Good
Deficiency	No deficiencies recorded
Instance on Near Main Entrance	Inspected
Condition	2 - Between Good and Fair
Deficiency	No deficiencies recorded
Safety Surfacing	
Instance on Near Grand Central Parkway	Inspected
Condition	1 - Good
Deficiency	No deficiencies recorded
Instance on Near Main Entrance	Inspected
Condition	2 - Between Good and Fair
Deficiency	No deficiencies recorded

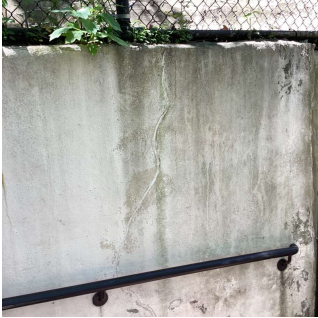
Unpaved Area	
Instance on Near Main Entrance	Does not Exist
Instance on Near Grand Central Parkway	Does not Exist
PLAYING SURFACE	Does not Exist
RETAINING WALLS	
Are there any Retaining Walls 6' OR higher facing public street/sidewalk?	Yes
Condition	3 - Fair
Deficiency	CAST IN PLACE CONCRETE: CRACKS/SPALLING - MAJOR
Deficiency Location/Instance	Near NYC Park
Deficiency Quantity	60

Question	Response
SITE	
RETAINING WALLS	
Quantity Uom	S.F.
Potential Action	REPLACE
Urgency of Action	PRIORITY 3
Purpose of Action	LEVEL 2
Deficiency Photo1

Violations	Near NYC Park No violations recorded.
Deficiency	CAST IN PLACE CONCRETE: BULGING/DISPLACED
Deficiency Location/Instance	Near NYC Park
Deficiency Quantity	40
Quantity Uom	S.F.
Potential Action	REPLACE
Urgency of Action	PRIORITY 3
Purpose of Action	LEVEL 2
Deficiency Photo1	 
Violations	Near NYC Park No violations recorded.
SEATING	Does not Exist
SITE WALLS (NOT RETAINING WALLS)	Does not Exist
STAIRS/RAMPS: EXTERIOR	Inspected
Railings	Inspected
Condition	2 - Between Good and Fair
Deficiency	No deficiencies recorded
Site Cheek/flank Walls	Inspected
Condition	2 - Between Good and Fair
Deficiency	No deficiencies recorded
Stairs/ramps	Inspected
Condition	2 - Between Good and Fair
Deficiency	No deficiencies recorded
ARTWORK	Does not Exist
