NYC Department of Education
Building Condition Assessment Survey 2023 - 2024

Architectural Inspection

Asset: P.S. 197 - QUEENS, 825 HICKSVILLE ROAD, New York, 11691

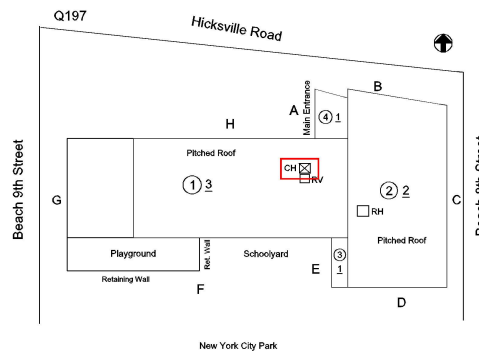
Question	Response
Architectural	
EXTERIOR	Inspected
AREAWAY	Does not Exist
AWNINGS AND CANOPIES	Inspected
Condition	2 - Between Good and Fair
Deficiency	No deficiencies recorded
CHIMNEY	Inspected
Material Type(s)	Masonry
Condition	3 - Fair
Deficiency	BRICK: DETERIORATED LADDER
Roof Plan reference

Question	Response
EXTERIOR	
CHIMNEY	
Quantity Uom	EACH
Potential Action	REPLACE
Urgency of Action	PRIORITY 3
Purpose of Action	LEVEL 2
Deficiency Photo1

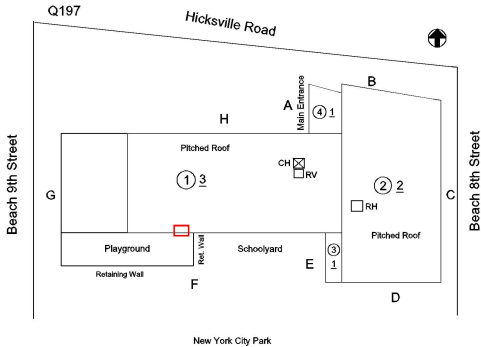
Violations	Roof 1 - Chimney No violations recorded.
COPING	Does not Exist
CORNICE	Does not Exist
DOORS	Inspected
DOORS AND FRAMES	Inspected
Condition	5 - Poor
Deficiency	METAL: DETERIORATED DOOR AND FRAME - MAJOR DETERIORATION
Roof Plan reference

Deficiency Quantity	4
Quantity Uom	EACH
Potential Action	REPLACE
Urgency of Action	PRIORITY 4
Purpose of Action	LEVEL 2
Deficiency Photo1

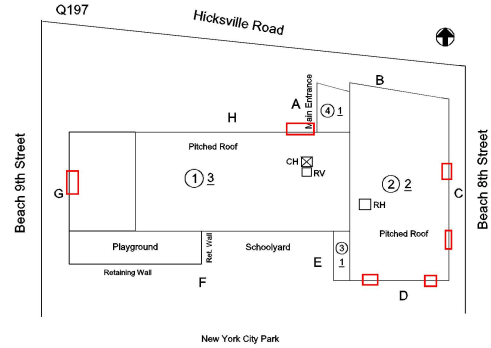
METAL CLAD: DETERIORATED DOOR AND FRAME - MAJOR DETERIORATION

REPLACE

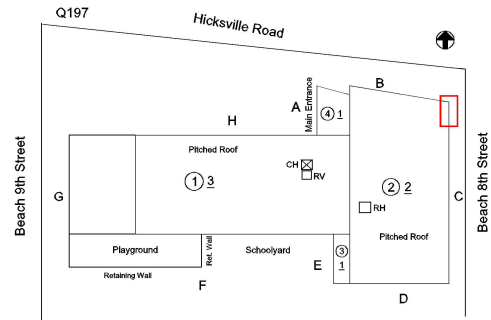
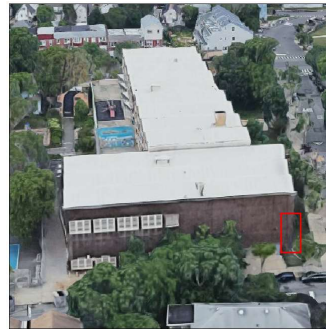
BRICK: CRACKS/DISPLACED/SPALLED BRICK AT BUILDING CORNERS

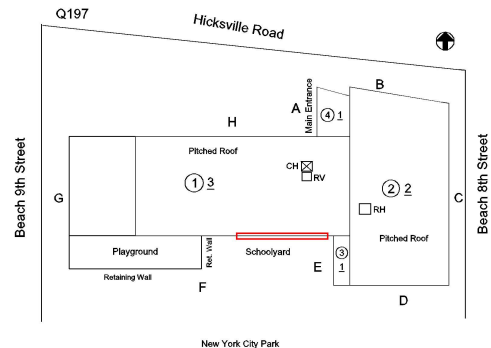
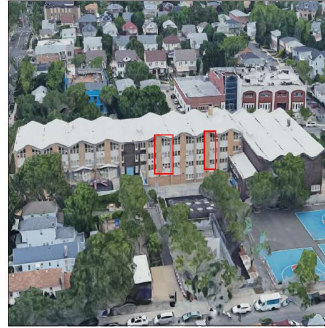
BRICK: EFFLORESCENCE

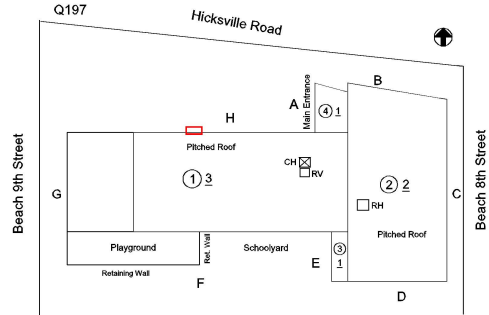
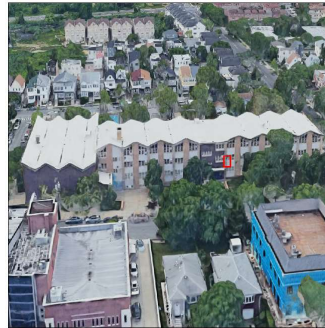
BRICK: MINOR CRACKS AND SPALLING

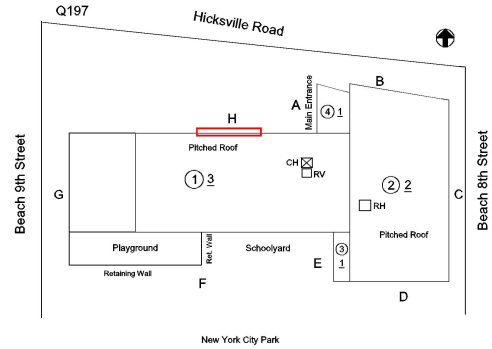
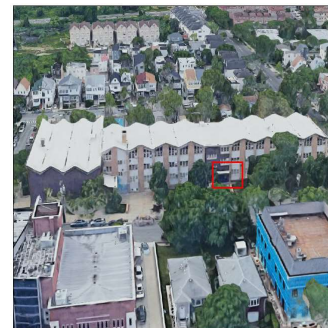
CERAMIC TILE: CHIPPED, SPALLED, BROKEN PIECES

REPLACE

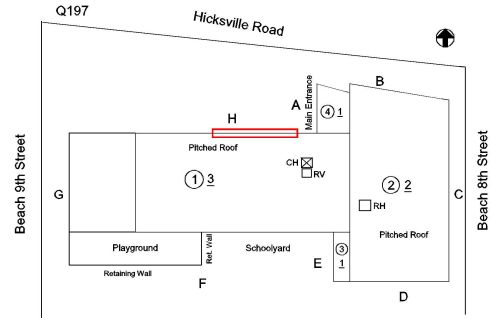
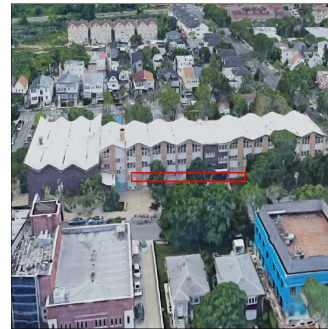
BRICK: DETERIORATED MASONRY SILLS - MAJOR

REMOVE AND REPLACE

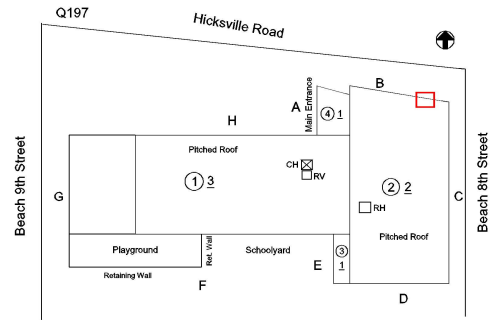
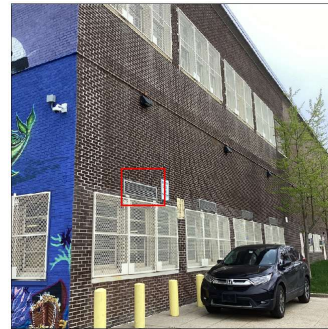
BROKEN/ DENTED BLADES

10
S.F.
REPLACE
PRIORITY 4
LEVEL 2

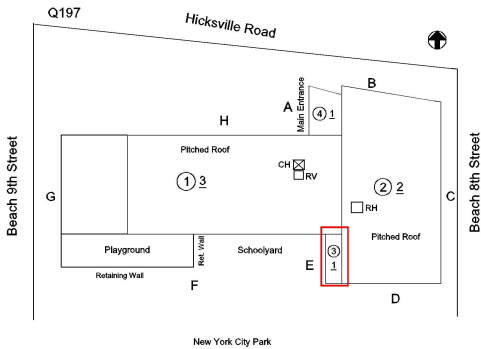
Roof 1
Instance Quantity	35,000
Instance Quantity Uom	S.F.
Does the roof have major mechanical equipment sitting on Dunnage Steel less than 18" above the Roofing?	No
Does this roof instance have a Sustainable Roof System?	Yes
Sustainable Roof Type	White Roof
Sustainable Roof Location (Roof Number)	All Roofs
Do solar panels exist on these roofs?	No
Is/Are the roof(s) suitable for Solar Panel installation?	Yes
Installation Year	2020
Source of Installation	Custodial Staff
Deficiency	MODIFIED BITUMEN: ROOFING: MAJOR ACTIVE ROOF LEAKS IN INSTRUCTIONAL SPACE
Roof Plan reference

Deficiency Quantity	200
Quantity Uom	S.F.
Potential Action	REPLACE ROOFING WITHOUT MAJOR EQUIPMENT REMOVAL
Urgency of Action	PRIORITY 5

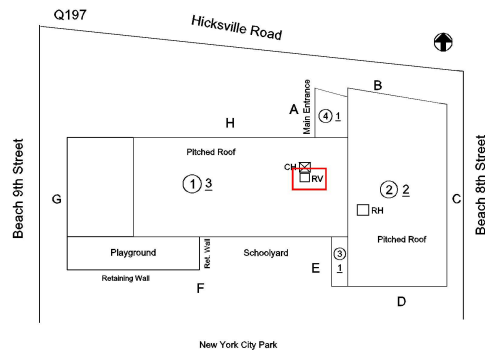
SHAFT VENTS DAMAGED

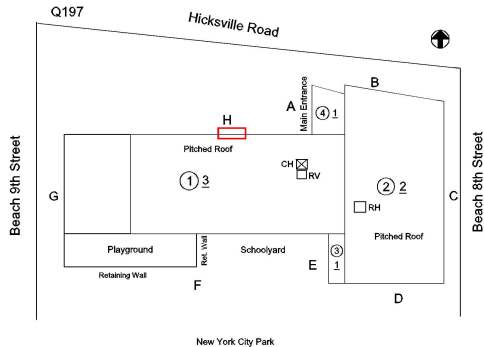
Question	Response
EXTERIOR	
ROOF	
Specialties	
SKYLIGHT/ROOF VENT	Inspected
Deficiency Photo1	 
	Roof 1
Violations	No violations recorded.
ROOF/GRAVITY TANK	Does not Exist
STAIRS/RAMPS: EXTERIOR	Inspected
BUILDING CHEEK/FLANK WALLS	Does not Exist
RAILINGS	Does not Exist
STAIRS/RAMPS	Inspected
Condition	4 - Between Fair and Poor
Deficiency	STONE: DETERIORATED SUBSTRATE
Roof Plan reference

Deficiency Quantity	10
Quantity Uom	S.F.
Potential Action	REPLACE SUBSTRATE AND RESET
Urgency of Action	PRIORITY 4
Purpose of Action	LEVEL 2
Deficiency Photo1

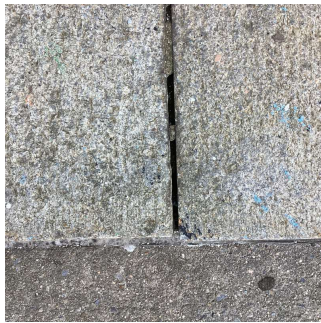
Facade H
Violations	No violations recorded.
Deficiency	STONE: DETERIORATED JOINTS

Question	Response
EXTERIOR	
STAIRS/RAMPS: EXTERIOR	
STAIRS/RAMPS	
Roof Plan reference	
Deficiency Quantity	10
Quantity Uom	L.F.
Potential Action	REPOINT
Urgency of Action	PRIORITY 4
Purpose of Action	LEVEL 2
Deficiency Photo1

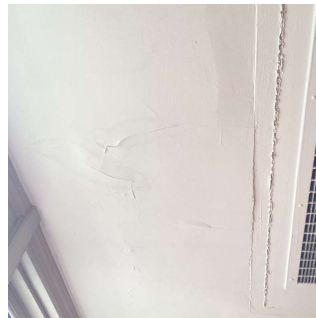
PLASTER: CRACKS/SPALLING

REPLACE

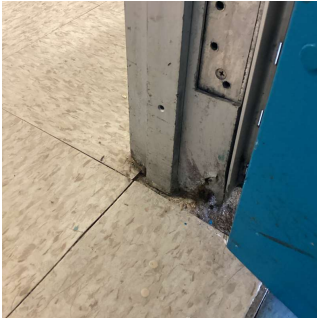
Violations	Near Serving Area No violations recorded.
Door(s)	
Instance on Basement	Inspected
Condition	4 - Between Fair and Poor
Deficiency	METAL: DETERIORATED DOOR AND FRAME
Deficiency Location/Instance	Entrance
Deficiency Quantity	2
Quantity Uom	EACH
Potential Action	MAINTENANCE
Urgency of Action	PRIORITY 3
Purpose of Action	LEVEL 2
Deficiency Photo1

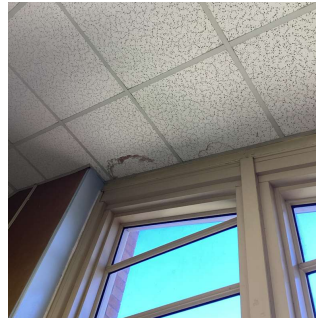
Room 307

ACOUSTIC TILES: DAMAGED/MISSING

REPLACE

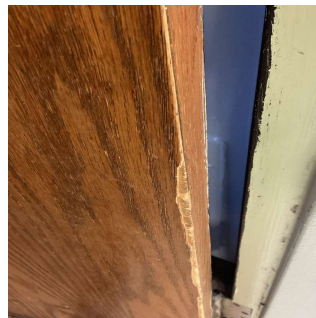
WOOD: DETERIORATED DOOR

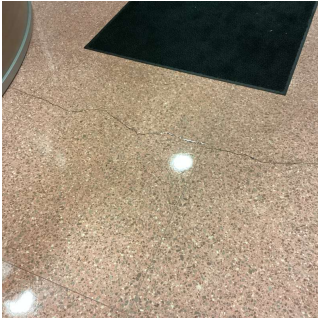
Question	Response
INTERIOR	
CLASSROOMS/CORRIDORS/ADMIN SPACES	
Door(s)	Inspected
	Room 322
Violations	No violations recorded.
Floor Finish	Inspected
Condition	3 - Fair
Deficiency	TERRAZZO: CRACKS
Deficiency Location/Instance	Main Entrance lobby
Deficiency Quantity	10
Quantity Uom	S.F.
Potential Action	REPLACE
Urgency of Action	PRIORITY 3
Purpose of Action	LEVEL 2
Deficiency Photo1

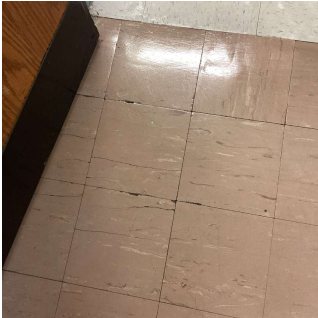
Violations	Main Entrance lobby No violations recorded.
Deficiency	VINYL TILES: BROKEN/DETERIORATED/MISSING TILES
Deficiency Location/Instance	Rooms 103, 115, 303, 304, 317, and others
Deficiency Quantity	1,300
Quantity Uom	S.F.
Potential Action	REPLACE
Urgency of Action	PRIORITY 3
Purpose of Action	LEVEL 2
Deficiency Photo1

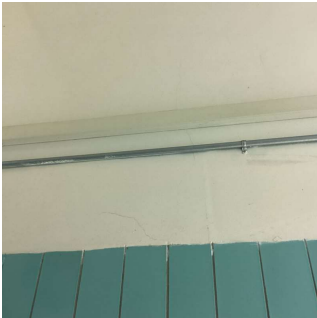
Question	Response
INTERIOR	
CLASSROOMS/CORRIDORS/ADMIN SPACES	
Walls	
Violations	Corridor near Room 215 No violations recorded.
Deficiency	PLASTER: CRACKS/SPALLING
Deficiency Location/Instance	Room 108, 306, Corridor near Rooms 306, 312, 320, and others
Deficiency Quantity	200
Quantity Uom	S.F.
Potential Action	REPLACE
Urgency of Action	PRIORITY 3
Purpose of Action	LEVEL 2
Deficiency Photo1

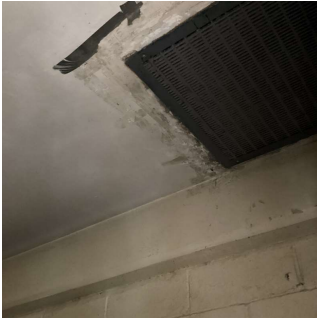
Violations	Corridor near Room 320 No violations recorded.
Specialties	Does not Exist
GYMNASIUM	
Instance on 1st Floor	Inspected
Ceiling	Inspected
Instance on 1st Floor	Inspected
Condition	2 - Between Good and Fair
Deficiency	PLASTER: CRACKS/SPALLING
Deficiency Location/Instance	Storage Room
Deficiency Quantity	10
Quantity Uom	S.F.
Potential Action	REPLACE
Urgency of Action	PRIORITY 3
Purpose of Action	LEVEL 2
Deficiency Photo1

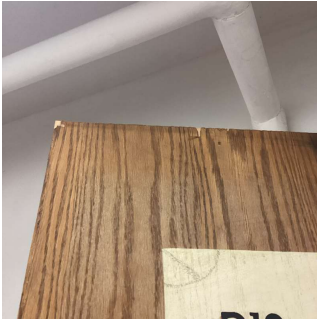
Violations	Storage Room No violations recorded.
Door(s)	
Instance on Basement	Inspected
Condition	5 - Poor
Deficiency	WOOD: DETERIORATED DOOR
Deficiency Location/Instance	Room B13
Deficiency Quantity	1
Quantity Uom	EACH
Potential Action	MAINTENANCE
Urgency of Action	PRIORITY 3
Purpose of Action	LEVEL 2
Deficiency Photo1

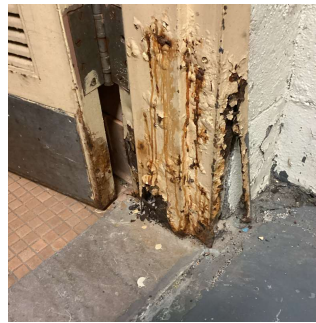
Mop Room

Violations	Room B13 No violations recorded.
Deficiency	METAL: DETERIORATED DOOR AND FRAME
Deficiency Location/Instance	Mop Room, Storage Room
Deficiency Quantity	2
Quantity Uom	EACH
Potential Action	MAINTENANCE
Urgency of Action	PRIORITY 3
Purpose of Action	LEVEL 2

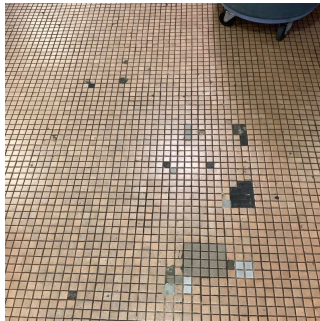
Deficiency	CERAMIC TILE: BROKEN/MISSING TILES
------------	------------------------------------

Potential Action	REPLACE
------------------	---------

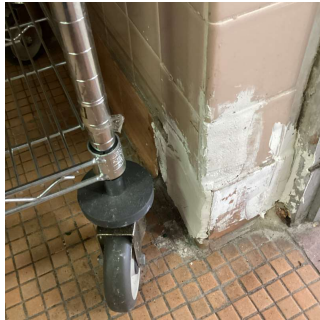
Violations	Near Serving Area No violations recorded.
Walls	
Instance on Basement	Inspected
Condition	2 - Between Good and Fair
Deficiency	CERAMIC TILE: BROKEN/ MISSING
Deficiency Location/Instance	Columns, Near Entrance, Mop Room, Sink Area
Deficiency Quantity	30
Quantity Uom	S.F.
Potential Action	REPLACE
Urgency of Action	PRIORITY 3
Purpose of Action	LEVEL 2
Deficiency Photo1

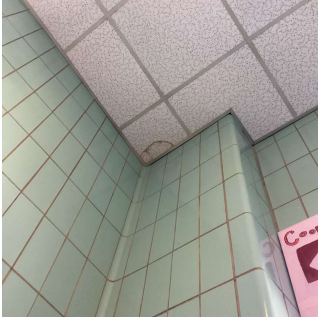
Question	Response
INTERIOR	
SCIENCE LAB	
Alternative use	No
Fixed Equipment	
Instance on Room 217	Inspected
Condition	2 - Between Good and Fair
Deficiency	No deficiencies recorded
SCIENCE PREP ROOM	
Does not Exist	
SHOWER ROOM	
Inspected	
Instance on 1st Floor	Inaccessible
STAIRS/RAMPS: INTERIOR	
Inspected	
Do Letter Stair Signs Exist?	No
Ceiling	Inspected
Condition	2 - Between Good and Fair
Deficiency	ACOUSTIC TILES: DAMAGED/MISSING
Deficiency Location/Instance	Stair EF/2
Deficiency Quantity	10
Quantity Uom	S.F.
Potential Action	REPLACE
Urgency of Action	PRIORITY 3
Purpose of Action	LEVEL 2
Deficiency Photo1

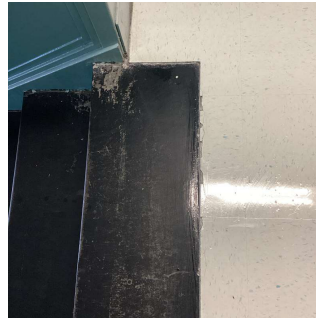
Stair D/3

VINYL TILES: BROKEN/DETERIORATED/MISSING TILES

REPLACE

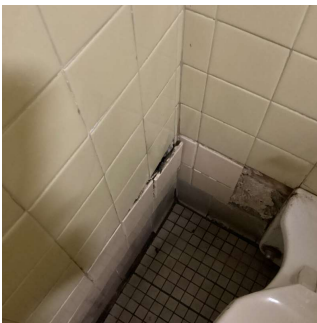
Violations	Room 223 No violations recorded.
Deficiency	CERAMIC TILE: BROKEN/ MISSING
Deficiency Location/Instance	Rooms 223, 323
Deficiency Quantity	20
Quantity Uom	S.F.
Potential Action	REPLACE
Urgency of Action	PRIORITY 3
Purpose of Action	LEVEL 2

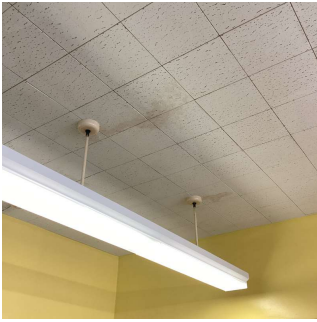
Violations	Room 106 No violations recorded.
Door(s)	
Condition	5 - Poor
Deficiency	METAL: DETERIORATED DOOR AND FRAME
Deficiency Location/Instance	Rooms B14, B16
Deficiency Quantity	2
Quantity Uom	EACH
Potential Action	MAINTENANCE
Urgency of Action	PRIORITY 3
Purpose of Action	LEVEL 2

Violations	Room 223 No violations recorded.
TOILET ROOMS - STUDENTS	
Ceiling	Inspected
Condition	2 - Between Good and Fair
Deficiency	ACOUSTIC TILES ON PLASTER: DAMAGED/MISSING
Deficiency Location/Instance	Room 106
Deficiency Quantity	10
Quantity Uom	S.F.
Potential Action	REPLACE
Urgency of Action	PRIORITY 3
Purpose of Action	LEVEL 2
Deficiency Photo1

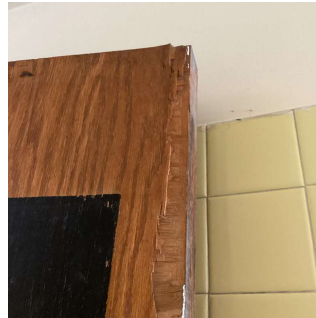
Room 314

WOOD: DETERIORATED DOOR

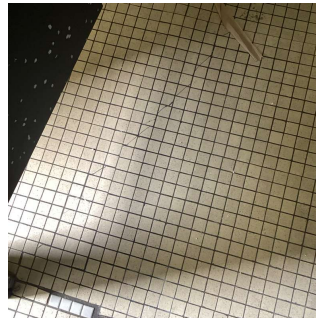
CERAMIC TILE: BROKEN/MISSING TILES

REPLACE

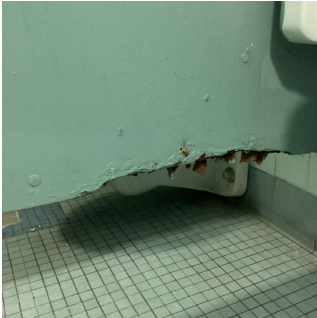
Question	Response
INTERIOR	
TOILET ROOMS - STUDENTS	
Floor Finish	Inspected
	Room 214
Violations	No violations recorded.
Stalls	Inspected
Condition	4 - Between Fair and Poor
Deficiency	RUST - MAJOR
Deficiency Location/Instance	Gymnasium - Boys and Girls
Deficiency Quantity	4
Quantity Uom	EACH
Potential Action	REPLACE
Urgency of Action	PRIORITY 3
Purpose of Action	LEVEL 2
Deficiency Photo1

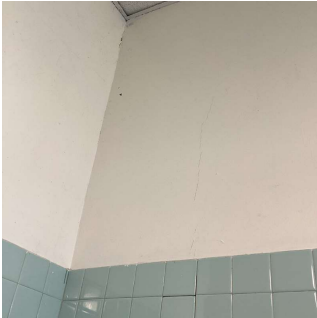
Violations	Room 310 No violations recorded.
Deficiency	CERAMIC TILE: BROKEN/ MISSING
Deficiency Location/Instance	Rooms 106, 110, 114, 310, 314, and others
Deficiency Quantity	50
Quantity Uom	S.F.
Potential Action	REPLACE

Violations	Gymnasium - Boys No violations recorded.
Walls	Inspected
Condition	2 - Between Good and Fair
Deficiency	PLASTER: CRACKS/SPALLING
Deficiency Location/Instance	Rooms 214, 310
Deficiency Quantity	20
Quantity Uom	S.F.
Potential Action	REPLACE
Urgency of Action	PRIORITY 3
Purpose of Action	LEVEL 2
Deficiency Photo1

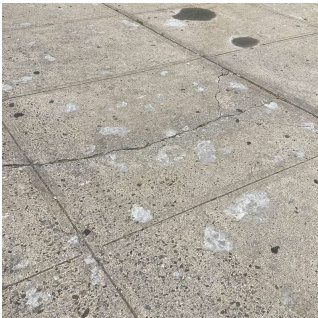
Question	Response
SITE	
PAVING	
Student Use	
Asphalt	Inspected
Violations	No violations recorded.
Concrete	Inspected
Condition	1 - Good
Deficiency	No deficiencies recorded
Pavers	Does not Exist
Site Sidewalks & Walkways	Inspected
Asphalt	Does not Exist
Concrete	Inspected
Condition	3 - Fair
Deficiency	DAMAGED/DETERIORATED/MISSING SECTIONS
Deficiency Location/Instance	Near Exits 1, 5, Playground
Deficiency Quantity	225
Quantity Uom	S.F.
Potential Action	REPLACE
Urgency of Action	PRIORITY 3
Purpose of Action	LEVEL 2
Deficiency Photo1

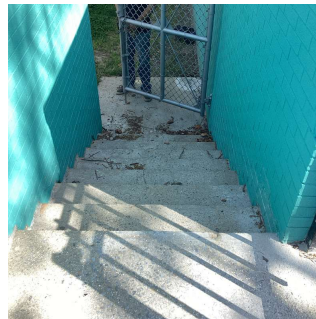
Entrance Playground

MISSING

REPLACE
