NYC Department of Education
Building Condition Assessment Survey 2023 - 2024

Architectural Inspection

Asset: I.S. 198 - QUEENS, 3-65 BEACH 56 STREET, New York, 11692

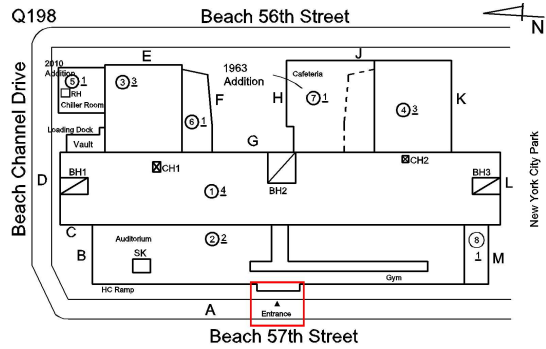
Roof Plan reference

| Question | Response |
|---|---|
| Condition | 4 - Between Fair and Poor |
| Deficiency | CONCRETE: WATER PENETRATION |

100
S.F.
REPAIR
PRIORITY 5
LEVEL 2

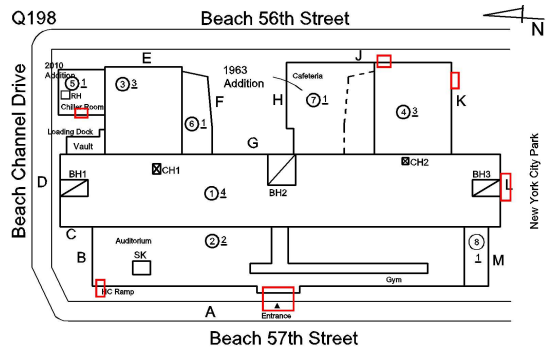
Roof Plan reference

METAL: DETERIORATED DOOR AND FRAME - MAJOR DETERIORATION

12
EACH
REPLACE
PRIORITY 4
LEVEL 2

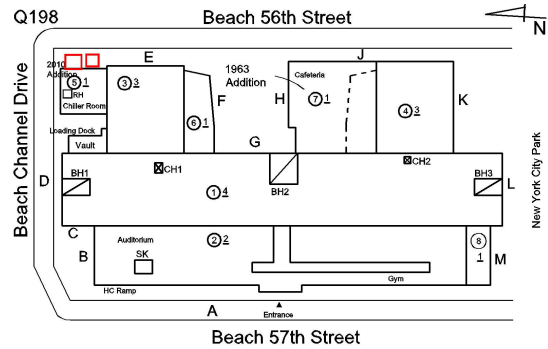
Roof Plan reference

ROLL-UP DOOR: DETERIORATED DOOR AND FRAME - MAJOR DETERIORATION

REPLACE

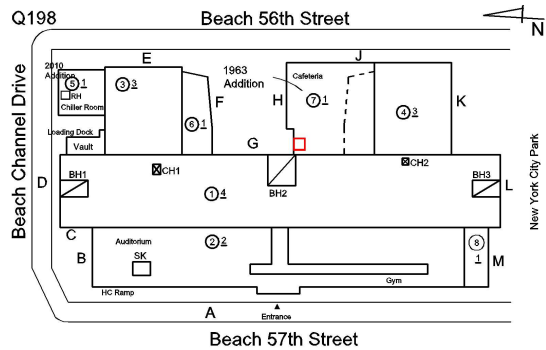
Roof Plan reference

METAL CLAD: DETERIORATED DOOR AND FRAME - MAJOR DETERIORATION

1
 EACH
 REPLACE
 PRIORITY 4
 LEVEL 2

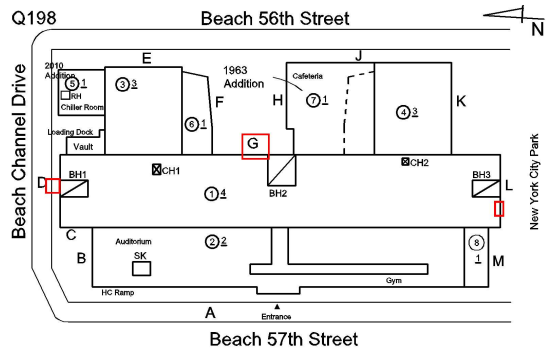
Roof Plan reference

METAL: DETERIORATED DOOR AND FRAME - MINOR DETERIORATION

7
 EACH
 MAINTENANCE
 PRIORITY 3
 LEVEL 2
 No photo recorded
 No violations recorded.

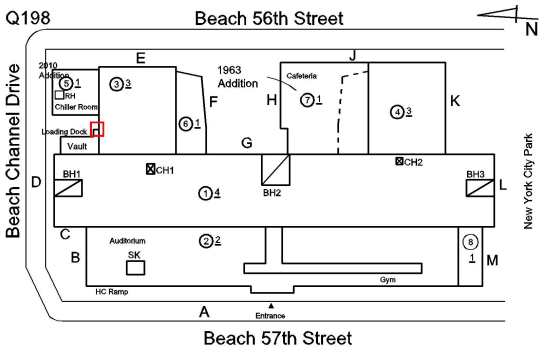
| Question | Response |
|---|--|
| Roof Plan reference | |

| Question | Response |
|---|--|
| Condition | 4 - Between Fair and Poor |
| Deficiency | METAL: DENTED, MAJOR RUSTING |

| Question | Response |
|---|--|
| Potential Action | REPLACE |

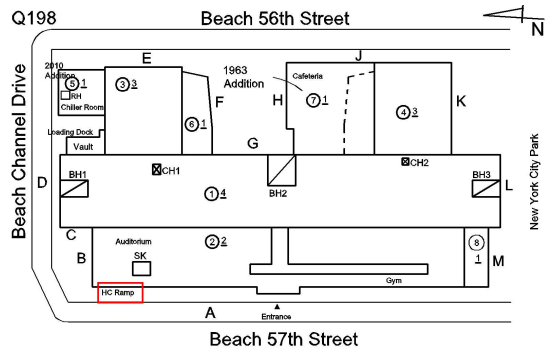
Roof Plan reference

| Question | Response |
|---|---|
| Condition | 3 - Fair |
| Deficiency | BROKEN BRACKET |

1
 EACH
 REPLACE
 PRIORITY 4
 LEVEL 2

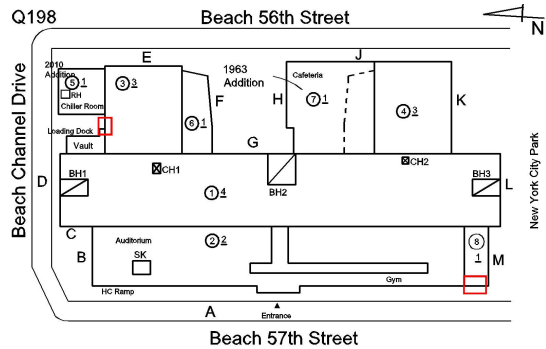
Roof Plan reference

CONCRETE: CRACKS/SPALLING - MINOR

30
 S.F.
 REPAIR
 PRIORITY 3
 LEVEL 2

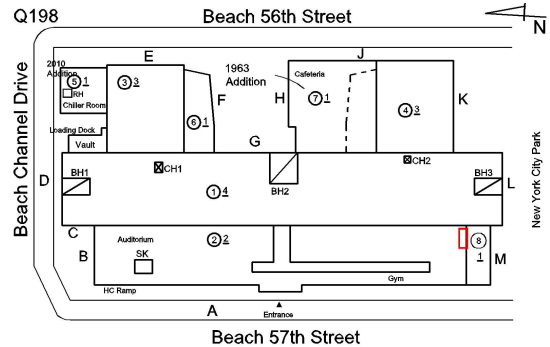
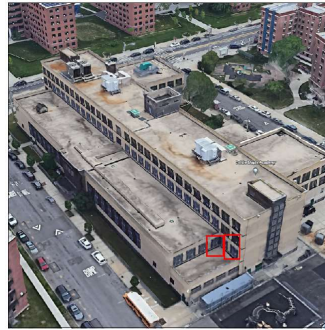
Roof Plan reference

ALUMINUM - DOUBLE HUNG: BROKEN PANE

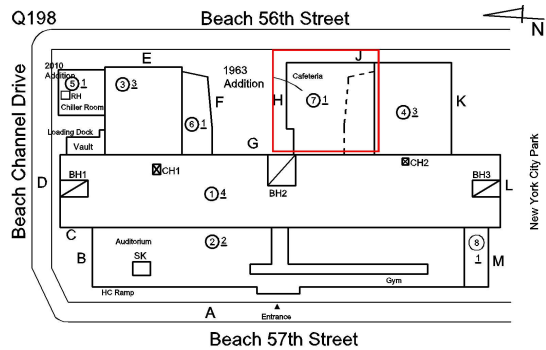
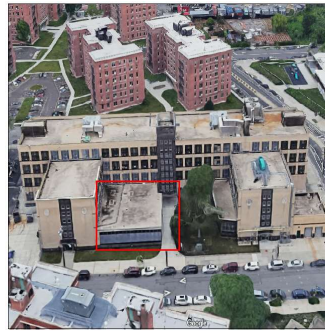
Roof Plan reference

| Deficiency | ALUMINUM - DOUBLE HUNG: INOPERABLE BALANCE |

50
EACH
REPLACE BALANCES
PRIORITY 3
LEVEL 2
No photo recorded
No violations recorded.

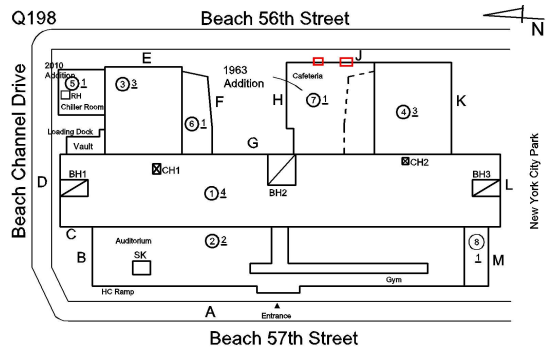
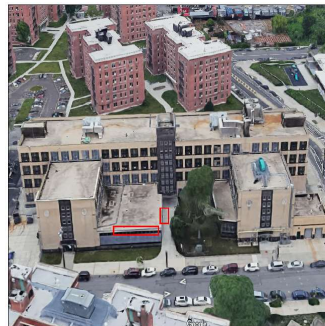
Roof Plan reference

ALUMINUM - DOUBLE HUNG: AIR/WATER INFILTRATION, DETERIORATED JOINTS WITH DAMAGED CAULKING

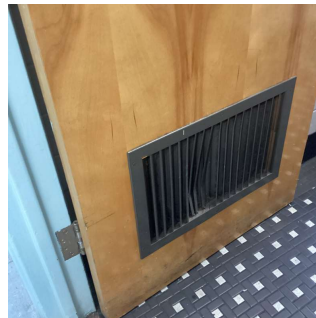
Room 414

WOOD: DAMAGED LOUVER

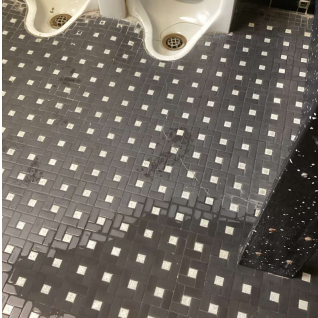
| Question | Response |
|---|--|
| Deficiency Location/Instance | Room 318 |

| Question | Response |
|---|--|
| Condition | 2 - Between Good and Fair |
| Deficiency | CERAMIC TILE: BROKEN/MISSING TILES |
| Urgency of Action | PRIORITY 3 |

| Question | Response |
|---|--|
| Potential Action | REPLACE |
