NYC Department of Education
Building Condition Assessment Survey 2023 - 2024

Architectural Inspection

Asset: P.S. 199 - QUEENS, 39-20 48 AVENUE, New York, 11104

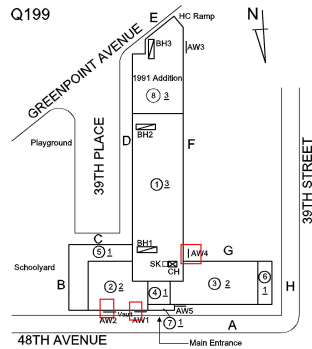
Question	Response
Architectural	
EXTERIOR	Inspected
AREAWAY	Inspected
Instance on AW1 - AW5	Inspected
Instance Condition	3 - Fair
Instance Quantity	5
Instance Quantity Uom	EACH
Deficiency	AREAWAY WALLS: CRACKS AND SPALLING
Roof Plan reference	Q199
Deficiency Quantity	20
Quantity Uom	S.F.
Potential Action	REPLACE
Urgency of Action	PRIORITY 4
Purpose of Action	LEVEL 2

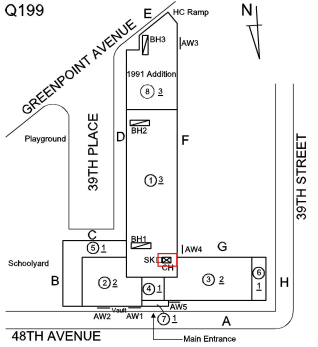
Violations	CH No violations recorded.
COPING	
Condition	Inspected
Deficiency	3 - Fair CAST STONE: CRACKED/BROKEN PIECES

30
L.F.
REPLACE-IN-KIND
PRIORITY 4
LEVEL 2

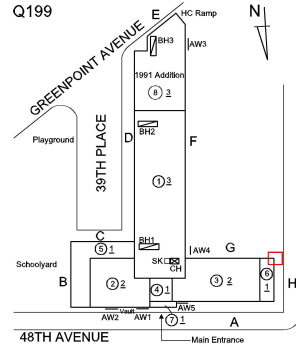
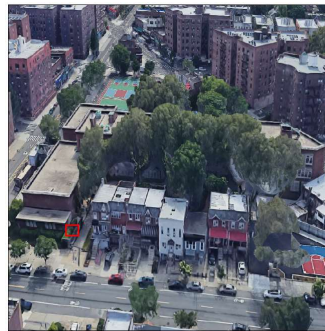
BRICK: CRACKS/DISPLACED/SPALLED BRICK AT BUILDING CORNERS

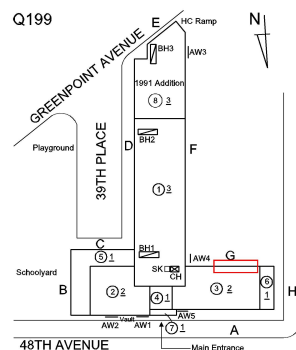
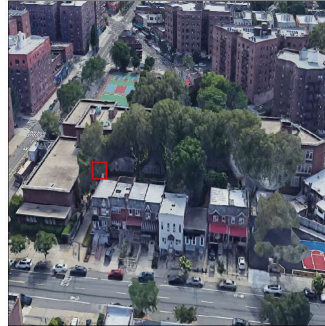
BRICK: DETERIORATED JOINTS

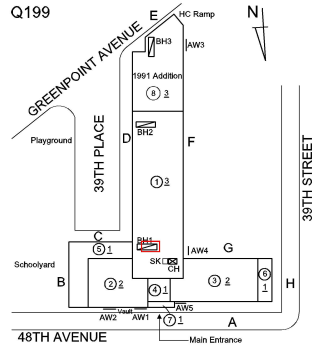
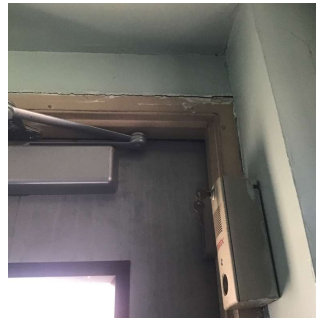
BH1

Deficiency **BULKHEAD/PENTHOUSE DOORS: AIR/WATER INFILTRATION WITH DAMAGED CAULKING**

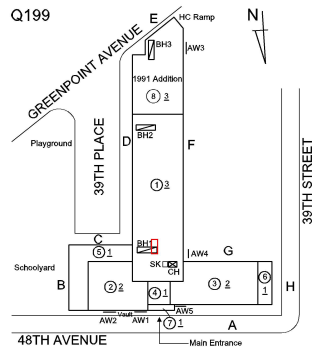
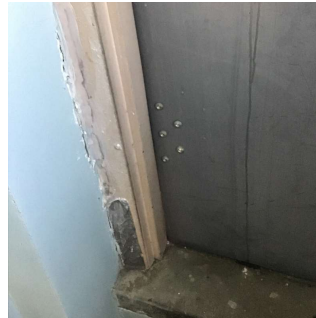
BH1

Deficiency **BULKHEAD/PENTHOUSE DOORS: DETERIORATED DOOR AND FRAME**

Potential Action REPLACE DOOR AND FRAME

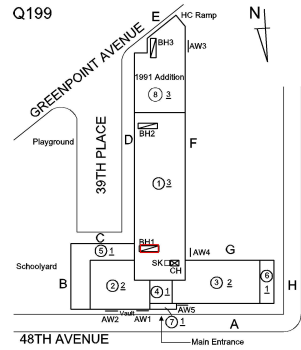
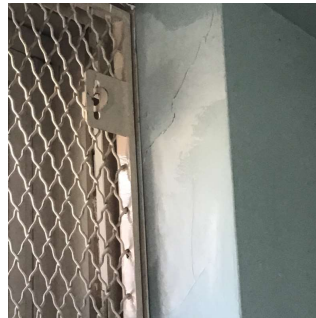
BH1

**BULKHEAD/PENTHOUSE WALLS/INTERIOR: PLASTER
CRACKS/SPALLING**

REPLACE

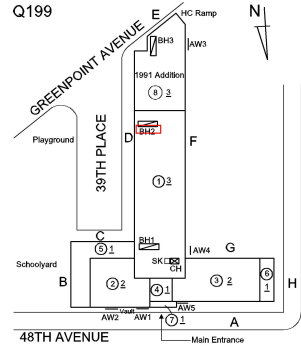
**BULKHEAD/PENTHOUSE WALLS/EXTERIOR:
CRACKS/SPALLING - MINOR**

20
S.F.
REPAIR
PRIORITY 3
LEVEL 2

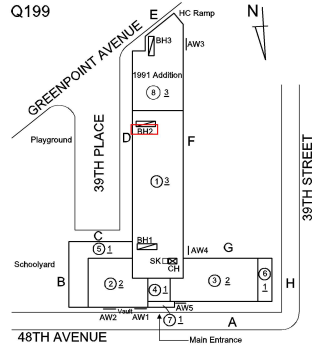
**BULKHEAD/PENTHOUSE WALLS/EXTERIOR: WATER
INFILTRATION**

100
S.F.
REPAIR
PRIORITY 5
LEVEL 2

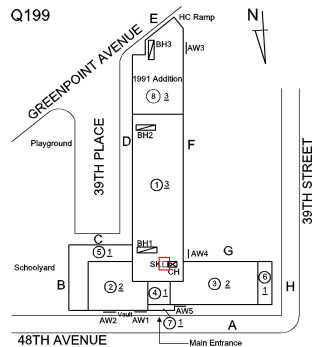
SHAFT VENTS DAMAGED

1
EACH
MAINTENANCE

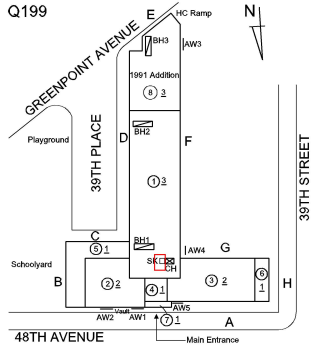
Roof 1
Violations	No violations recorded.
Deficiency	BROKEN GLASS
Roof Plan reference	Q199

Deficiency Quantity	30
Quantity Uom	S.F.
Potential Action	MAINTENANCE
Urgency of Action	PRIORITY 3
Purpose of Action	LEVEL 2
Deficiency Photo1

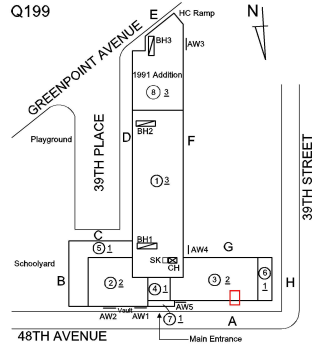
Deficiency	RUST - MAJOR
------------	--------------

Potential Action	REPLACE
------------------	---------

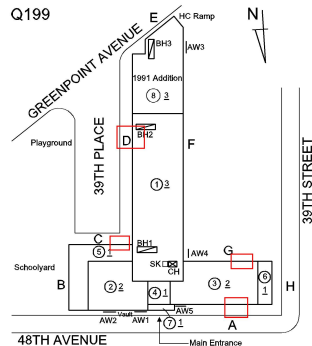
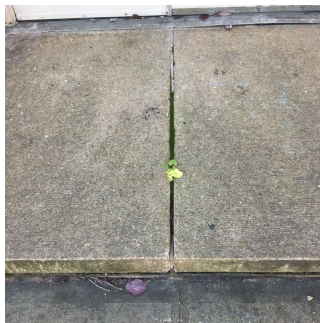
Deficiency	STONE: DETERIORATED JOINTS
------------	----------------------------

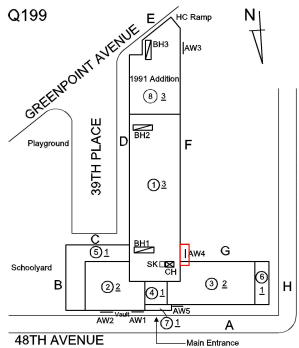
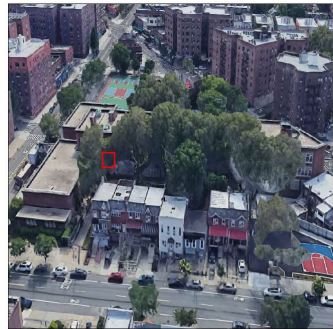
Violations	Facade A No violations recorded.
WINDOWS	Inspected
Replacement Quantity	9,000
Replacement Uom	S.F.
EXTERIOR GUARDS	Inspected
Condition	3 - Fair
Deficiency	RUST - MAJOR
Roof Plan reference

Deficiency Quantity	120
Quantity Uom	S.F.
Potential Action	REPLACE
Urgency of Action	PRIORITY 4
Purpose of Action	LEVEL 2

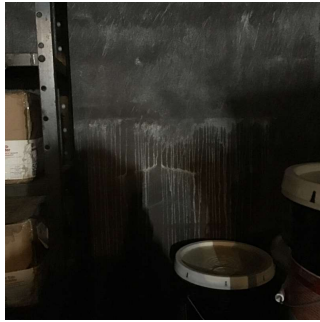
Question	Response
INTERIOR	
STRUCTURAL	
FOUNDATION WALLS	
Deficiency Photo1	 
Violations	Basement - Custodian Lounge No violations recorded.
Deficiency	CONCRETE: WATER INFILTRATION IN NON- INSTRUCTIONAL SPACE
Deficiency Location/Instance	Basement - Boiler Room, Bunker, Custodian Lounge
Deficiency Quantity	300
Quantity Uom	S.F.
Potential Action	INSTALL WATERPROOFING
Urgency of Action	PRIORITY 5
Purpose of Action	LEVEL 5
Deficiency Photo1

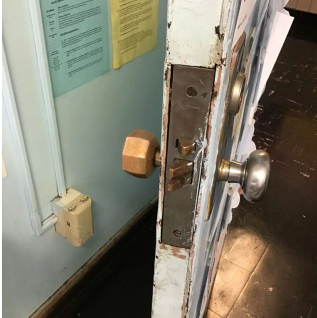
Question	Response
INTERIOR	
CLASSROOMS/CORRIDORS/ADMIN SPACES	
Door(s)	Inspected
Condition	5 - Poor
Deficiency	METAL: DETERIORATED DOOR
Deficiency Location/Instance	Room 311
Deficiency Quantity	1
Quantity Uom	EACH
Potential Action	MAINTENANCE
Urgency of Action	PRIORITY 3
Purpose of Action	LEVEL 2
Deficiency Photo1

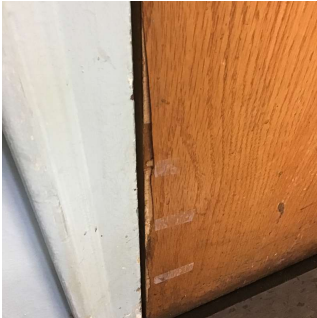
Violations	Room 311 No violations recorded.
Deficiency	WOOD: DETERIORATED DOOR
Deficiency Location/Instance	Rooms 314B, 317, 319, 205
Deficiency Quantity	4
Quantity Uom	EACH
Potential Action	MAINTENANCE
Urgency of Action	PRIORITY 3
Purpose of Action	LEVEL 2
Deficiency Photo1

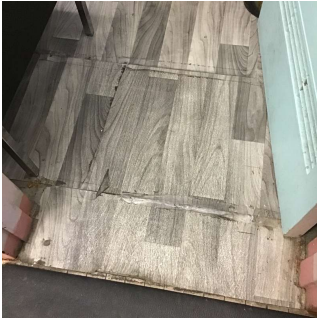
Deficiency	SHEET VINYL: BROKEN/DETERIORATED/MISSING TILES
Deficiency Location/Instance	Office

Question	Response
INTERIOR	
KITCHEN	
Floor Finish	
Deficiency Quantity	10
Quantity Uom	S.F.
Potential Action	REPLACE
Urgency of Action	PRIORITY 3
Purpose of Action	LEVEL 2
Deficiency Photo1

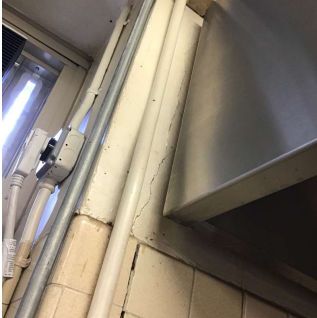
Violations	Office No violations recorded.
Walls	
Instance on 1st Floor	Inspected
Condition	2 - Between Good and Fair
Deficiency	PLASTER: CRACKS/SPALLING
Deficiency Location/Instance	Office, Near Windows
Deficiency Quantity	20
Quantity Uom	S.F.
Potential Action	REPLACE
Urgency of Action	PRIORITY 3
Purpose of Action	LEVEL 2
Deficiency Photo1

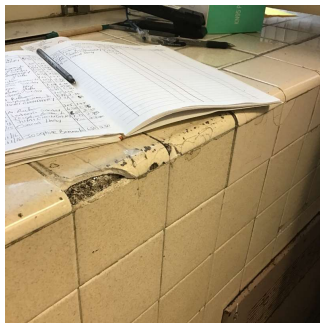
Violations	Near Windows No violations recorded.
Deficiency	CERAMIC TILE: BROKEN/ MISSING
Deficiency Location/Instance	Near Office, Storage Closet, Windows
Deficiency Quantity	20
Quantity Uom	S.F.
Potential Action	REPLACE
Urgency of Action	PRIORITY 3
Purpose of Action	LEVEL 2

Question	Response
INTERIOR	
KITCHEN	
Walls	
Deficiency Photo1

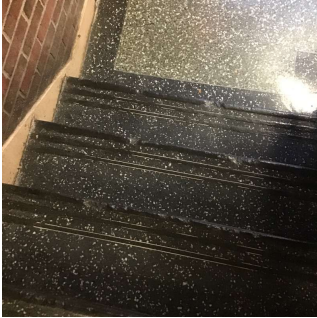
Question	Response
INTERIOR	
STAIRS/RAMPS: INTERIOR	
Stairs and Landings	Inspected
Condition	4 - Between Fair and Poor
Deficiency	TERRAZZO: CRACKS
Deficiency Location/Instance	Stair C/1, D/1, Vestibule Exit 6, Main Entrance.
Deficiency Quantity	130
Quantity Uom	S.F.
Potential Action	REPLACE
Urgency of Action	PRIORITY 3
Purpose of Action	LEVEL 2
Deficiency Photo1

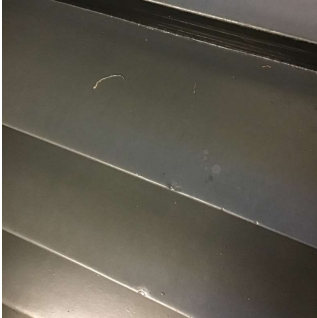
Violations	Vestibule Exit 6 No violations recorded.
Deficiency	STONE: BROKEN/MISSING
Deficiency Location/Instance	Stairs A/2, C/1
Deficiency Quantity	20
Quantity Uom	S.F.
Potential Action	REPLACE
Urgency of Action	PRIORITY 3
Purpose of Action	LEVEL 2
Deficiency Photo1

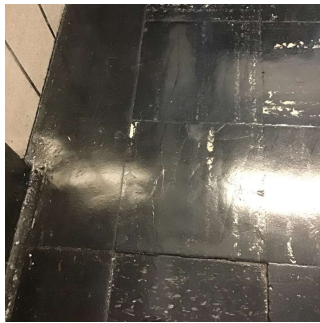
Violations	Stair C/1 No violations recorded.
Deficiency	VINYL TILES: BROKEN/DETERIORATED/MISSING TILES
Deficiency Location/Instance	Stair D/1, 2, 3
Deficiency Quantity	200
Quantity Uom	S.F.
Potential Action	REPLACE
Urgency of Action	PRIORITY 3
Purpose of Action	LEVEL 2

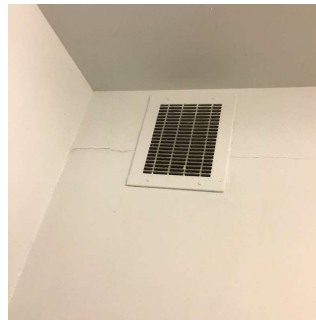
Room 159

PLASTER: CRACKS/SPALLING

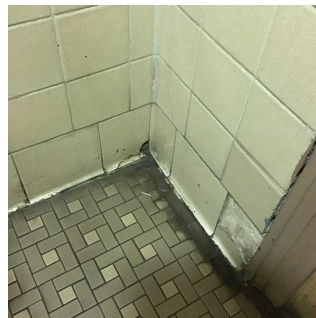
CERAMIC TILE: BROKEN/ MISSING

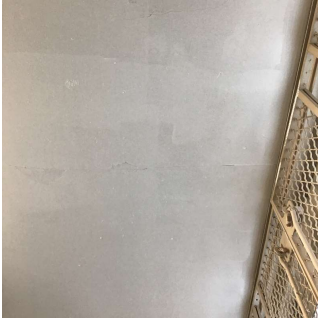
Question	Response
INTERIOR	
TOILET ROOMS - STAFF	Inspected
Walls	Inspected
	Room 304
Violations	No violations recorded.
TOILET ROOMS - STUDENTS	Inspected
Ceiling	Inspected
Condition	2 - Between Good and Fair
Deficiency	PLASTER: CRACKS/SPALLING
Deficiency Location/Instance	Room 313
Deficiency Quantity	10
Quantity Uom	S.F.
Potential Action	REPLACE
Urgency of Action	PRIORITY 3
Purpose of Action	LEVEL 2
Deficiency Photo1

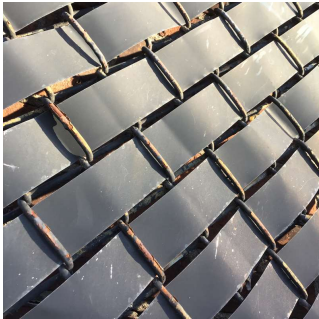
Question	Response
SITE	
Drainage System for Soil	Inspected
Catch Basins/Manhole - Surrounded by Soil	Inspected
Condition	2 - Between Good and Fair
Deficiency	No deficiencies recorded
Culverts - Soil Covering	Does not Exist
DRINKING FOUNTAINS	Inspected
Condition	2 - Between Good and Fair
Deficiency	No deficiencies recorded
FENCES	Inspected
Condition	4 - Between Fair and Poor
Deficiency	CHAIN LINK: RUST - MAJOR
Deficiency Location/Instance	Near 39th Street
Deficiency Quantity	1,000
Quantity Uom	S.F.
Potential Action	REPLACE
Urgency of Action	PRIORITY 3
Purpose of Action	LEVEL 2
Deficiency Photo1

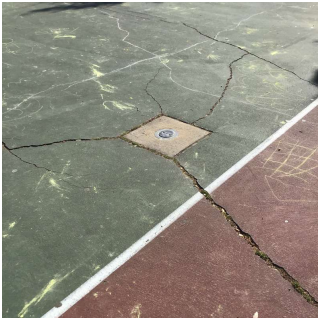
Question	Response
SITE	
PAVING	
Student Use	
Asphalt	
Deficiency	CRACKS - MAJOR
Deficiency Location/Instance	Schoolyard- Near center , Greenpoint Avenue, 48th Avenue.
Deficiency Quantity	1,200
Quantity Uom	S.F.
Potential Action	REPLACE
Urgency of Action	PRIORITY 3
Purpose of Action	LEVEL 2
Deficiency Photo1

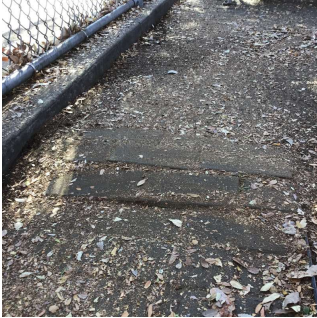
Violations	Near 40th Street No violations recorded.
Deficiency	DAMAGED/MISSING
Deficiency Location/Instance	Near 40th Street , Stair Entrance.
Deficiency Quantity	40
Quantity Uom	S.F.
Potential Action	REPLACE

Question	Response
SITE	
PAVING	
Student Use	
Pavers	
Urgency of Action	PRIORITY 3
Purpose of Action	LEVEL 2
Deficiency Photo1

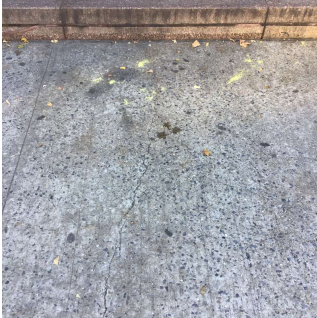
Near 40th Street
Violations	No violations recorded.
Site Sidewalks & Walkways	Inspected
Asphalt	Does not Exist
Concrete	Inspected
Condition	4 - Between Fair and Poor
Deficiency	DAMAGED/DETERIORATED/MISSING SECTIONS
Deficiency Location/Instance	Near Exit 1, 8, 9, 10, Schoolyard.
Deficiency Quantity	500
Quantity Uom	S.F.
Potential Action	REPLACE
Urgency of Action	PRIORITY 3
Purpose of Action	LEVEL 2
Deficiency Photo1

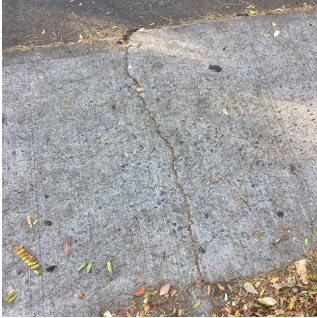
Near Exit 1
Violations	No violations recorded.
Pavers	Does not Exist
DOT Sidewalk	Inspected
Asphalt	Does not Exist
Concrete	Inspected
Condition	4 - Between Fair and Poor
Deficiency	DAMAGED/DETERIORATED/MISSING SECTIONS
Deficiency Location/Instance	39th Street, 39th Place, 40th Street, 48th Avenue, Greenpoint Avenue.
Deficiency Quantity	2,300
Quantity Uom	S.F.
Potential Action	REPLACE

Question	Response
SITE	
PAVING	
DOT Sidewalk	
Concrete	
Urgency of Action	PRIORITY 3
Purpose of Action	LEVEL 2
Deficiency Photo1

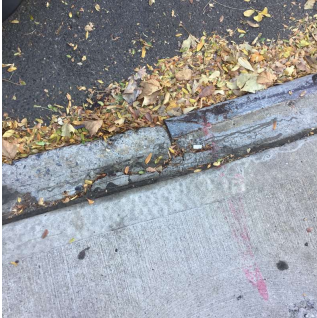
48th Avenue
Violations	No violations recorded.
Deficiency	DAMAGED CURBS
Deficiency Location/Instance	39th Street, 39th Place, 40th Street, 48th Avenue, Greenpoint Avenue.
Deficiency Quantity	200
Quantity Uom	L.F.
Potential Action	REPLACE
Urgency of Action	PRIORITY 3
Purpose of Action	LEVEL 2
Deficiency Photo1

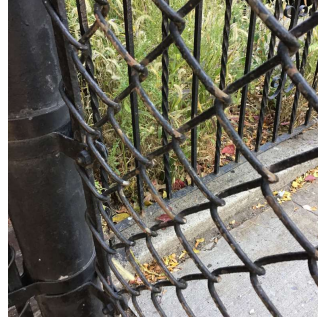
Greenpoint Avenue
No violations recorded.

48th Avenue
Violations	No violations recorded.
Pavers	Does not Exist
PLAYGROUNDS	Inspected
Instance on 39th Place	Inspected
Benches	
Instance on 39th Place	Inspected
Condition	2 - Between Good and Fair
Deficiency	No deficiencies recorded
Fence	
Instance on 39th Place	Inspected
Condition	5 - Poor
Deficiency	CHAIN LINK: RUST - MAJOR
Deficiency Location/Instance	Greenpoint Avenue
Deficiency Quantity	1,900
Quantity Uom	S.F.
Potential Action	REPLACE

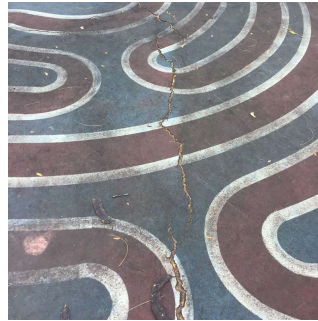
Near Entrance

ASPHALT: CRACKS - MAJOR
Near Entrance, Green Point Avenue, Play Equipment.
100
S.F.
REPLACE
PRIORITY 3
LEVEL 2

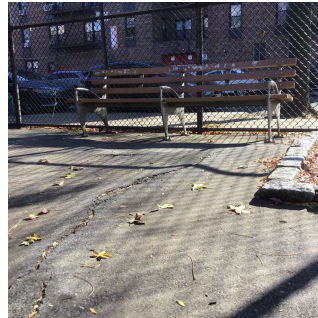
Near Greenpoint Avenue

ASPHALT: CRACKS - MAJOR

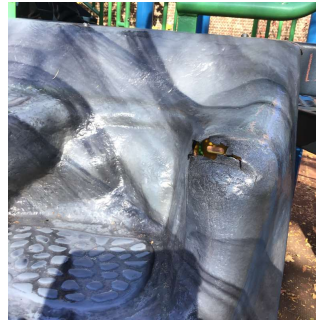
Steps Area

BROKEN/DETERIORATED/MISSING

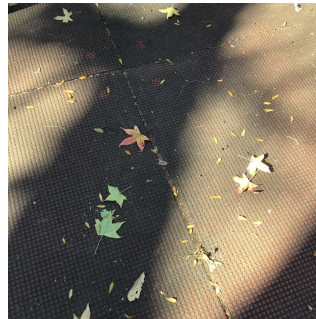
Near borders

Instance on 39th Place	Inspected
Condition	3 - Fair
Deficiency	DETERIORATED/MISSING
Deficiency Location/Instance	Near borders, Play equipment, 39th Place.
Deficiency Quantity	150
Quantity Uom	S.F.
Potential Action	MAINTENANCE
Urgency of Action	PRIORITY 3
Purpose of Action	LEVEL 2
Deficiency Photo1

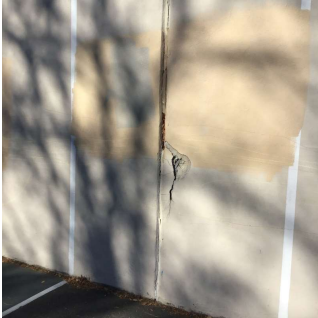
Question	Response
SITE	
PLAYGROUNDS	
Unpaved Area	
Deficiency Photo1	 
Violations	Rear No violations recorded.
PLAYING SURFACE	
	Does not Exist
RETAINING WALLS	
Are there any Retaining Walls 6' OR higher facing public street/sidewalk?	Inspected Yes
Condition	3 - Fair
Deficiency	CAST IN PLACE CONCRETE: CRACKS/SPALLING - MAJOR
Deficiency Location/Instance	Greenpoint Avenue
Deficiency Quantity	30
Quantity Uom	S.F.
Potential Action	REPLACE
Urgency of Action	PRIORITY 3
Purpose of Action	LEVEL 2
Deficiency Photo1	 
Violations	Greenpoint Avenue No violations recorded.
SEATING	
	Inspected
Benches	
	Inspected
Concrete	Does not Exist
Metal/Wood/Plastic	Inspected
Condition	2 - Between Good and Fair
Deficiency	No deficiencies recorded
Bleachers	Does not Exist
SITE WALLS (NOT RETAINING WALLS)	
	Inspected
Condition	3 - Fair
Deficiency	CAST IN PLACE CONCRETE: CRACKS/SPALLING - MAJOR
Deficiency Location/Instance	Handball wall
Deficiency Quantity	30

Question	Response
SITE	
SITE WALLS (NOT RETAINING WALLS)	
Potential Action	REPLACE
Urgency of Action	PRIORITY 3
Purpose of Action	LEVEL 2
Deficiency Photo1
