NYC Department of Education
Building Condition Assessment Survey 2023 - 2024

Architectural Inspection

Asset: P.S. 200 - QUEENS, 70-10 164 STREET, New York, 11365

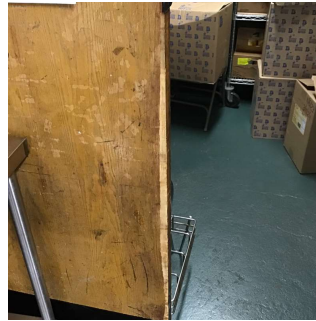
Storage Room Near Kitchen

Door(s)
