NYC Department of Education
Building Condition Assessment Survey 2023 - 2024

Architectural Inspection

Asset: P.S. 201 - QUEENS, 65-11 155 STREET, New York, 11367

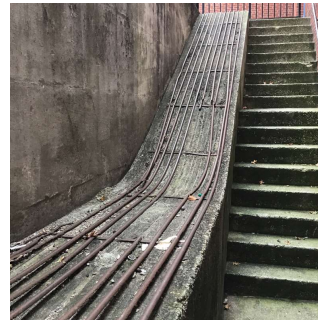
AW2
No violations recorded.

AREAWAY STAIRS: DETERIORATED MATERIAL SLIDE

25
S.F.
REPLACE
PRIORITY 3
LEVEL 2

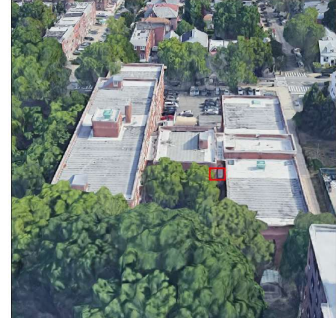
Question	Response
EXTERIOR	
DOORS	Inspected
TRANSOM/SIDE LIGHT	
Deficiency	No deficiencies recorded
EXTERIOR WALLS	Inspected
Material Type(s)	Masonry
Replacement Quantity	34,000
Replacement Uom	S.F.
Instance on All Facades	Inspected
Instance Condition	3 - Fair
Instance Quantity	34,000
Instance Quantity Uom	S.F.
Deficiency	BRICK: DETERIORATED JOINTS
Roof Plan reference

Deficiency Quantity	20
Quantity Uom	S.F.
Potential Action	REPOINT
Urgency of Action	PRIORITY 4
Purpose of Action	LEVEL 2
Deficiency Photo1

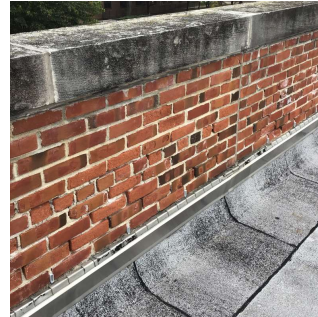
Roof 4

BRICK: DETERIORATED JOINTS

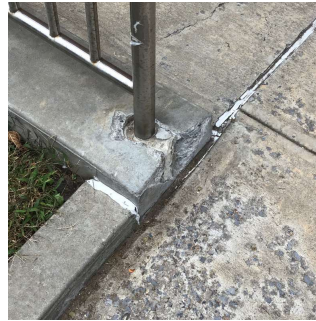
Facade H

Violations	BH3 No violations recorded.
CUPOLA/ SPIRES/ TOWERS	Does not Exist
DORMER	Does not Exist
DUNNAGE STEEL	Does not Exist
SKYLIGHT/ROOF VENT	Inspected
Material Type(s)	Glass
Condition	2 - Between Good and Fair
Deficiency	No deficiencies recorded
ROOF/GRAVITY TANK	Does not Exist
STAIRS/RAMPS: EXTERIOR	Inspected
BUILDING CHEEK/FLANK WALLS	Inspected
Condition	3 - Fair
Deficiency	CAST IN PLACE CONCRETE: CRACKS/SPALLING - MAJOR
Roof Plan reference

Deficiency Quantity	10
Quantity Uom	S.F.
Potential Action	REPLACE
Urgency of Action	PRIORITY 4
Purpose of Action	LEVEL 2

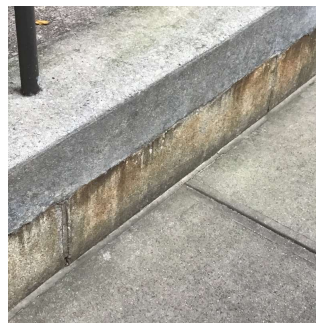
Facade C

STONE: DETERIORATED JOINTS

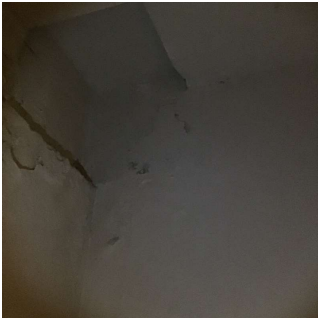
Question	Response
INTERIOR	
STRUCTURAL	
FLOOR STRUCTURE	
Potential Action	REPAIR
Urgency of Action	PRIORITY 3
Purpose of Action	LEVEL 5
Deficiency Photo1	No photo recorded
Violations	No violations recorded.
FOUNDATION WALLS	
Material Type(s)	Inspected Concrete
Condition	2 - Between Good and Fair
Deficiency	No deficiencies recorded
ROOF STRUCTURE	
Material Type(s)	Inspected
Condition	2 - Between Good and Fair
Deficiency	No deficiencies recorded
VAULTS-BUNKERS	
Foundation Walls	
Material Type(s)	Inspected
Condition	3 - Fair
Deficiency	CRACKS, SPALLING
Deficiency Location/Instance	Basement - Boiler Room
Deficiency Quantity	25
Quantity Uom	S.F.
Potential Action	REPAIR
Urgency of Action	PRIORITY 3
Purpose of Action	LEVEL 5
Deficiency Photo1

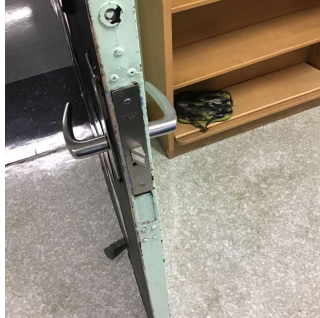
Question	Response
INTERIOR	
CLASSROOMS/CORRIDORS/ADMIN SPACES	
Door(s)	
Quantity Uom	EACH
Potential Action	MAINTENANCE
Urgency of Action	PRIORITY 3
Purpose of Action	LEVEL 2
Deficiency Photo1

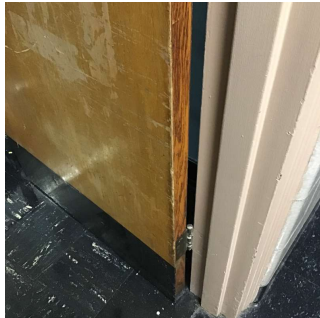
Violations	Room 200 No violations recorded.
Deficiency	WOOD: DETERIORATED DOOR
Deficiency Location/Instance	Room 113, 300, 306, 313, 316 and others
Deficiency Quantity	15
Quantity Uom	EACH
Potential Action	MAINTENANCE
Urgency of Action	PRIORITY 3
Purpose of Action	LEVEL 2
Deficiency Photo1

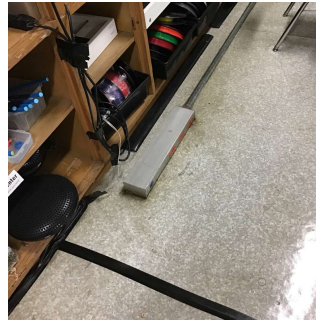
Violations	Room 113 No violations recorded.
Floor Finish	Inspected
Condition	3 - Fair
Deficiency	SHEET VINYL: TRIPPING HAZARD - ELECTRICAL OUTLET
Deficiency Location/Instance	Room 200
Deficiency Quantity	25
Quantity Uom	S.F.
Potential Action	REMOVE
Urgency of Action	PRIORITY 5
Purpose of Action	LEVEL 6

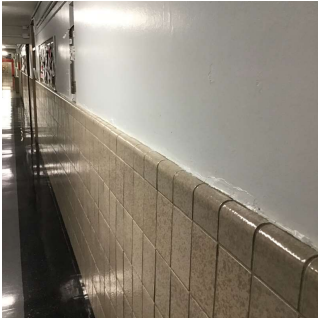
Question	Response
INTERIOR	
CLASSROOMS/CORRIDORS/ADMIN SPACES	
Walls	Inspected
Condition	2 - Between Good and Fair
Deficiency	GLAZED BLOCK: CRACKS/SPALLING
Deficiency Location/Instance	Corridor near Room 204
Deficiency Quantity	10
Quantity Uom	S.F.
Potential Action	REPLACE
Urgency of Action	PRIORITY 3
Purpose of Action	LEVEL 2
Deficiency Photo1	 
	Corridor near Room 204
Violations	No violations recorded.
Deficiency	PLASTER: CRACKS/SPALLING
Deficiency Location/Instance	Corridor near Stair BC/1, Corridor near Room 102
Deficiency Quantity	15
Quantity Uom	S.F.
Potential Action	REPLACE
Urgency of Action	PRIORITY 3
Purpose of Action	LEVEL 2
Deficiency Photo1

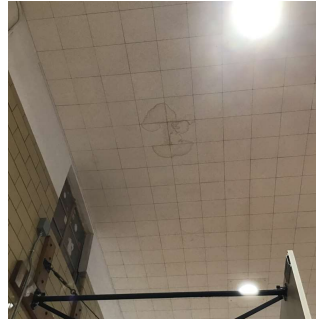
Corridor near Stair BC/1
Violations	No violations recorded.
Specialties	Does not Exist
GYMNASIUM	Inspected
Instance on 1st Floor	Inspected
Ceiling	Inspected
Instance on 1st Floor	Inspected
Condition	2 - Between Good and Fair
Deficiency	ACOUSTIC TILES ON PLASTER: DAMAGED/MISSING - ACTIVE LEAK

Deficiency Location/Instance	Near Entrance
Deficiency Quantity	25

Quantity Uom	S.F.
Potential Action	REPLACE
Urgency of Action	PRIORITY 5
Purpose of Action	LEVEL 2
Deficiency Photo1

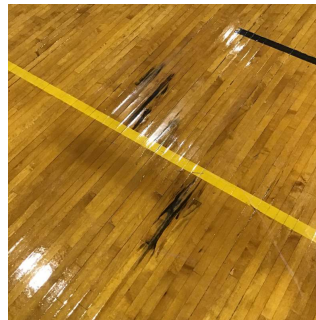
Rear

Instance on 1st Floor	Inspected
Condition	2 - Between Good and Fair
Deficiency	WOOD: DAMAGED/DETERIORATED
Deficiency Location/Instance	Rear, Near Drinking Fountain
Deficiency Quantity	50
Quantity Uom	S.F.
Potential Action	REPLACE
Urgency of Action	PRIORITY 3
Purpose of Action	LEVEL 2
Deficiency Photo1

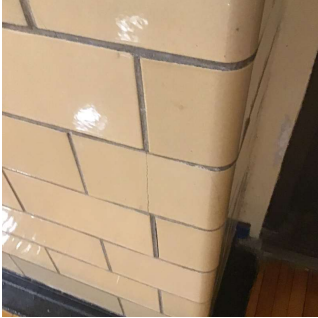
Question	Response
INTERIOR	
GYMNASIUM	
Seating	
Deficiency	No deficiencies recorded
Sliding-folding Partition	
Instance on 1st Floor	Does not Exist
Stage	
Instance on 1st Floor	Does not Exist
Walls	
Instance on 1st Floor	Inspected
Condition	2 - Between Good and Fair
Deficiency	GLAZED BLOCK: CRACKS/SPALLING
Deficiency Location/Instance	Near exit 10
Deficiency Quantity	10
Quantity Uom	S.F.
Potential Action	REPLACE
Urgency of Action	PRIORITY 3
Purpose of Action	LEVEL 2
Deficiency Photo1

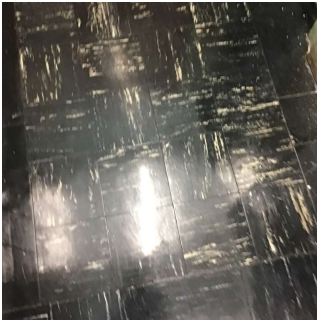
Violations	Main Entrance Vestibule No violations recorded.
Deficiency	VINYL TILES: BROKEN/DETERIORATED/MISSING TILES
Deficiency Location/Instance	Stair J/2
Deficiency Quantity	10
Quantity Uom	S.F.
Potential Action	REPLACE
Urgency of Action	PRIORITY 3
Purpose of Action	LEVEL 2
Deficiency Photo1

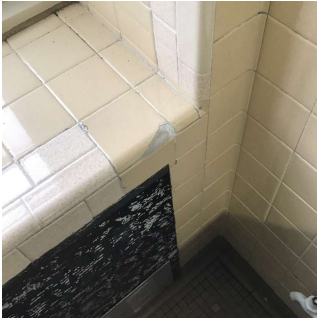
Question	Response
INTERIOR	
TOILET ROOMS - STUDENTS	
Walls	
Deficiency	CERAMIC TILE: BROKEN/ MISSING
Deficiency Location/Instance	Rooms 310, 312, 224,112, inside Room 102
Deficiency Quantity	25
Quantity Uom	S.F.
Potential Action	REPLACE
Urgency of Action	PRIORITY 3
Purpose of Action	LEVEL 2
Deficiency Photo1

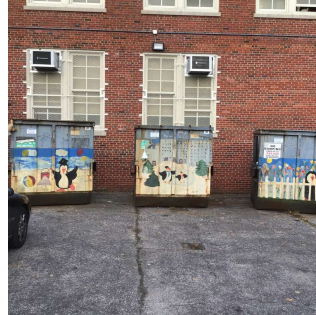
North Schoolyard
No violations recorded.

Purpose of Action	LEVEL 2
Deficiency Photo1	No photo recorded
Violations	No violations recorded.
Deficiency	CONCRETE PAD MISSING
Deficiency Location/Instance	North Schoolyard
Deficiency Quantity	300
Quantity Uom	S.F.

INSTALL NEW
PRIORITY 3
LEVEL 2

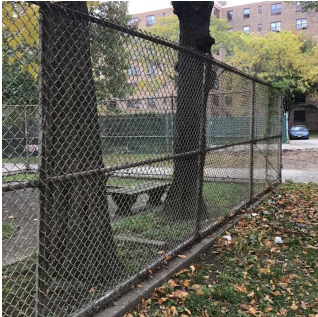
Question	Response
SITE	
DRINKING FOUNTAINS	Inspected
Violations	No violations recorded.
FENCES	
Condition	Inspected
	4 - Between Fair and Poor
Deficiency	CHAIN LINK: RUST - MAJOR
Deficiency Location/Instance	South Side, along 65th Avenue, along 156th Street
Deficiency Quantity	3,000
Quantity Uom	S.F.
Potential Action	REPLACE
Urgency of Action	PRIORITY 3
Purpose of Action	LEVEL 2
Deficiency Photo1

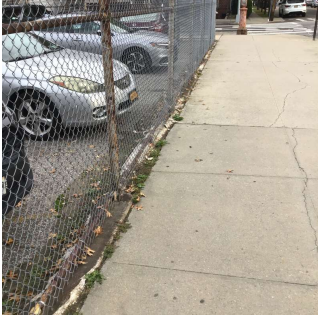
Violations	South side No violations recorded.
Deficiency	CONCRETE CURB: DAMAGED/DETERIORATED
Deficiency Location/Instance	Along 156th Street , Along 65th Avenue, South side
Deficiency Quantity	120
Quantity Uom	S.F.
Potential Action	REPLACE
Urgency of Action	PRIORITY 3
Purpose of Action	LEVEL 2
Deficiency Photo1

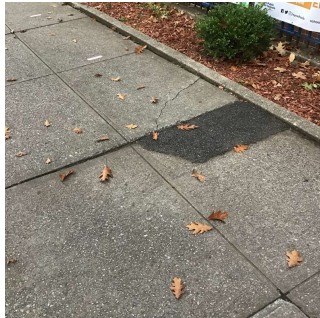
South side
Violations	No violations recorded.
Pavers	Does not Exist
DOT Sidewalk	Inspected
Asphalt	Does not Exist
Concrete	Inspected
Condition	4 - Between Fair and Poor
Deficiency	HEAVING
Deficiency Location/Instance	Near Main Entrance
Deficiency Quantity	50
Quantity Uom	S.F.
Potential Action	REPLACE
Urgency of Action	PRIORITY 3
Purpose of Action	LEVEL 2
Deficiency Photo1

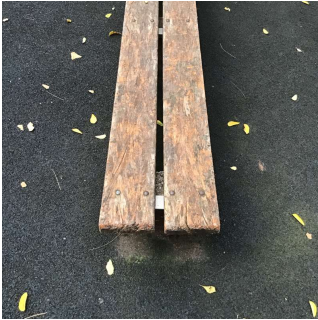
Question	Response
SITE	
PAVING	Inspected
DOT Sidewalk	
Concrete	Inspected
Violations	No violations recorded.
Pavers	Does not Exist
PLAYGROUNDS	Inspected
Instance on Rear of School	Inspected
Benches	
Instance on Rear of School	Inspected
Condition	5 - Poor
Deficiency	DAMAGED/DETERIORATED
Deficiency Location/Instance	South side
Deficiency Quantity	4
Quantity Uom	EACH
Potential Action	REPLACE
Urgency of Action	PRIORITY 3
Purpose of Action	LEVEL 2
Deficiency Photo1

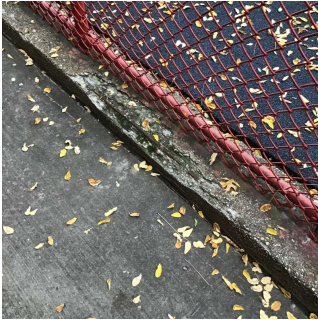
Violations	Along south side No violations recorded.
Fence	
Instance on Rear of School	Inspected
Condition	3 - Fair
Deficiency	CONCRETE CURB: DAMAGED/DETERIORATED
Deficiency Location/Instance	East side
Deficiency Quantity	10
Quantity Uom	S.F.
Potential Action	REPLACE
Urgency of Action	PRIORITY 3
Purpose of Action	LEVEL 2
Deficiency Photo1

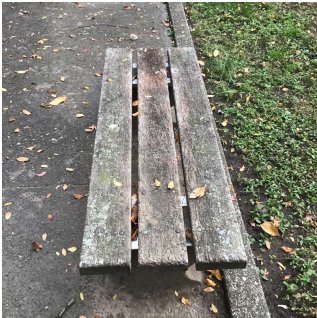
Question	Response
SITE	
PLAYGROUNDS	Inspected
Unpaved Area	
Instance on Rear of School	Does not Exist
PLAYING SURFACE	Does not Exist
RETAINING WALLS	Does not Exist
SEATING	Inspected
Benches	Inspected
Concrete	Does not Exist
Metal/Wood/Plastic	Inspected
Condition	4 - Between Fair and Poor
Deficiency	DAMAGED/DETERIORATED
Deficiency Location/Instance	South side
Deficiency Quantity	2
Quantity Uom	EACH
Potential Action	REPLACE
Urgency of Action	PRIORITY 3
Purpose of Action	LEVEL 2
Deficiency Photo1
