**NYC Department of Education**  
**Building Condition Assessment Survey 2023 - 2024**

Architectural Inspection

**Asset:** I.S. 204 - QUEENS, 36-41 28 STREET, New York, 11106

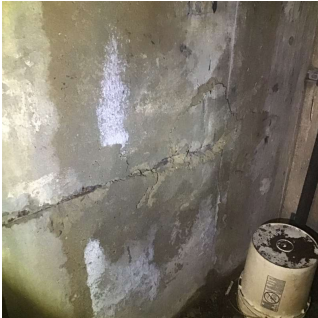
Question	Response
<b>INTERIOR</b>	
<b>STRUCTURAL</b>	
<b>ROOF STRUCTURE</b>	Inspected
Deficiency	No deficiencies recorded
<b>VAULTS-BUNKERS</b>	Inspected
<b>Foundation Walls</b>	Inspected
Condition	3 - Fair
Deficiency	CRACKS, SPALLING
Deficiency Location/Instance	Basement - Ash Hoist Vault
Deficiency Quantity	20
Quantity Uom	S.F.
Potential Action	REPAIR
Urgency of Action	PRIORITY 4
Purpose of Action	LEVEL 5
Deficiency Photo1

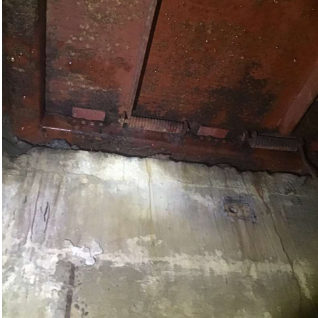
Violations	Ash Hoist Vault No violations recorded.
<b>Slab Structure</b>	Inspected
Condition	2 - Between Good and Fair
Deficiency	No deficiencies recorded
<b>Vault/Ash Hoist Doors and Framing</b>	Inspected
Condition	5 - Poor
Deficiency	WATER INFILTRATION
Deficiency Location/Instance	Basement - Ash Hoist Vault
Deficiency Quantity	10
Quantity Uom	S.F.
Potential Action	REPAIR
Urgency of Action	PRIORITY 5
Purpose of Action	LEVEL 2
Deficiency Photo1

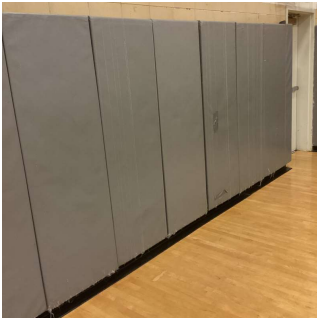
Question	Response
<b>INTERIOR</b>	
<b>GYMNASIUM</b>	
<b>Seating</b>	
Instance on 1st Floor	Inspected
Condition	2 - Between Good and Fair
Deficiency	No deficiencies recorded
<b>Sliding-folding Partition</b>	
Instance on 1st Floor	Inspected
Condition	2 - Between Good and Fair
Deficiency	No deficiencies recorded
<b>Stage</b>	
Instance on 1st Floor	Does not Exist
<b>Walls</b>	
Instance on 1st Floor	Inspected
Condition	4 - Between Fair and Poor
Deficiency	MASONRY: CRACKS/SPALLING
Deficiency Location/Instance	Storage Room
Deficiency Quantity	20
Quantity Uom	S.F.
Potential Action	REPLACE
Urgency of Action	PRIORITY 3
Purpose of Action	LEVEL 2
Deficiency Photo1	 
	Storage Room
Violations	No violations recorded.
Deficiency	WALL PADDING: DETERIORATED
Deficiency Location/Instance	Near Office
Deficiency Quantity	560
Quantity Uom	S.F.
Potential Action	REPLACE
Urgency of Action	PRIORITY 3
Purpose of Action	LEVEL 2
Deficiency Photo1

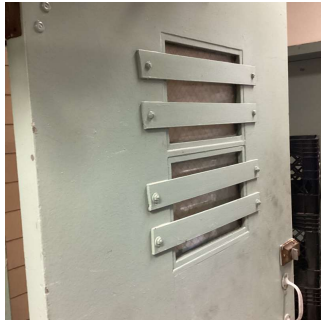
Question	Response
<b>INTERIOR</b>	
<b>GYMNASIUM</b>	Inspected
<b>Walls</b>	
Violations	No violations recorded.
<b>Window Curtains/Shades/Blinds</b>	
Instance on 1st Floor	Does not Exist
<b>INTERIOR DOOR HARDWARE</b>	Inspected
Condition	3 - Fair
Deficiency	No deficiencies recorded
<b>INTERIOR GUARDS</b>	Inspected
Condition	2 - Between Good and Fair
Deficiency	No deficiencies recorded
<b>KITCHEN</b>	Inspected
Instance on 1st Floor	Inspected
<b>Ceiling</b>	
Instance on 1st Floor	Inspected
Condition	2 - Between Good and Fair
Deficiency	No deficiencies recorded
<b>Door(s)</b>	
Instance on 1st Floor	Inspected
Condition	3 - Fair
Deficiency	METAL: DETERIORATED DOOR
Deficiency Location/Instance	Near Storage Room
Deficiency Quantity	1
Quantity Uom	EACH
Potential Action	MAINTENANCE
Urgency of Action	PRIORITY 3
Purpose of Action	LEVEL 2
Deficiency Photo1

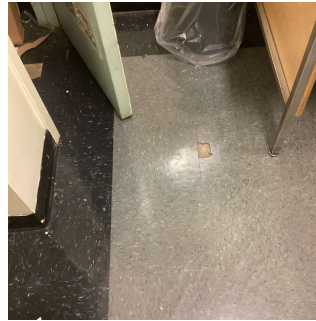
Instance on 1st Floor	Inspected
Condition	3 - Fair
Deficiency	VINYL TILES: DETERIORATED SUBSTRATE
Deficiency Location/Instance	Office
Deficiency Quantity	10
Quantity Uom	S.F.
Potential Action	REPLACE
Urgency of Action	PRIORITY 3
Purpose of Action	LEVEL 2

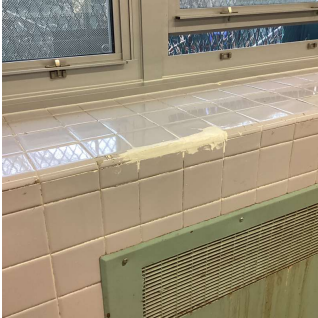
Question	Response
<b>INTERIOR</b>	
<b>KITCHEN</b>	
<b>Walls</b>	
Instance on 1st Floor	Inspected
Condition	2 - Between Good and Fair
Deficiency	CERAMIC TILE: BROKEN/ MISSING
Deficiency Location/Instance	Along Windows
Deficiency Quantity	10
Quantity Uom	S.F.
Potential Action	REPLACE
Urgency of Action	PRIORITY 3
Purpose of Action	LEVEL 2
Deficiency Photo1

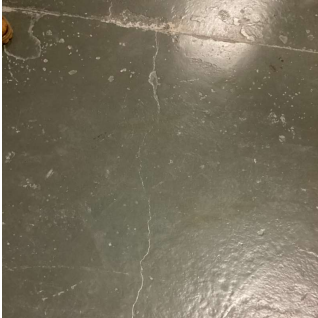
Question	Response
<b>INTERIOR</b>	
<b>LOCKER ROOM</b>	
<b>Door(s)</b>	
Condition	2 - Between Good and Fair
Deficiency	No deficiencies recorded
Instance on Basement - Girls (201 Lockers)	Inspected
Condition	2 - Between Good and Fair
Deficiency	No deficiencies recorded
<b>Floor Finish</b>	
Instance on Basement - Boys (252 Lockers)	Inspected
Condition	3 - Fair
Deficiency	CONCRETE: CRACKS
Deficiency Location/Instance	Center
Deficiency Quantity	50
Quantity Uom	S.F.
Potential Action	REPLACE
Urgency of Action	PRIORITY 3
Purpose of Action	LEVEL 2
Deficiency Photo1

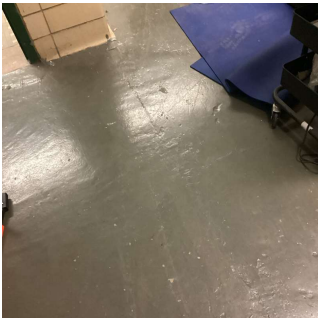
Violations	Center No violations recorded.
Instance on Basement - Girls (201 Lockers)	Inspected
Condition	2 - Between Good and Fair
Deficiency	CONCRETE: CRACKS
Deficiency Location/Instance	Near Entrance
Deficiency Quantity	10
Quantity Uom	S.F.
Potential Action	REPLACE
Urgency of Action	PRIORITY 3
Purpose of Action	LEVEL 2
Deficiency Photo1

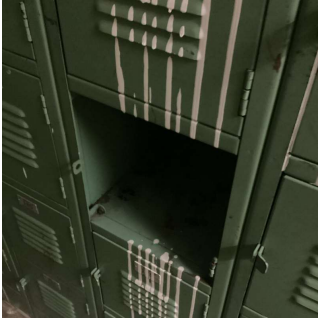
Question	Response
<b>INTERIOR</b>	
<b>LOCKER ROOM</b>	
<b>Locker Room Lockers</b>	
Instance on Basement - Boys (252 Lockers)	Inspected
Condition	2 - Between Good and Fair
Deficiency	DAMAGED UNITS
Deficiency Location/Instance	Left Side
Deficiency Quantity	1
Quantity Uom	EACH
Potential Action	REPLACE
Urgency of Action	PRIORITY 3
Purpose of Action	LEVEL 2
Deficiency Photo1

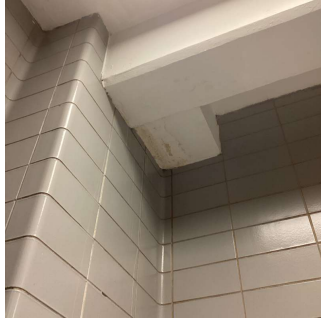
Stair B/Basement

Potential Action	REPLACE
Urgency of Action	PRIORITY 3
Purpose of Action	LEVEL 2
Deficiency Photo1

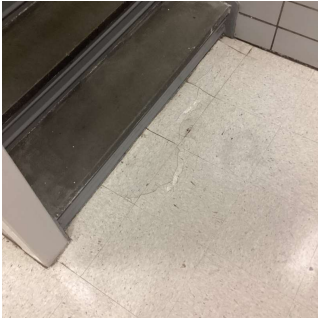
Question	Response
<b>INTERIOR</b>	
<b>STAIRS/RAMPS: INTERIOR</b>	
<b>Stairs and Landings</b>	
Deficiency	VINYL TILES: DETERIORATED SUBSTRATE
Deficiency Location/Instance	Stairs A/1,2, B/Basement, C/Basement,3
Deficiency Quantity	25
Quantity Uom	S.F.
Potential Action	REPLACE
Urgency of Action	PRIORITY 3
Purpose of Action	LEVEL 2
Deficiency Photo1

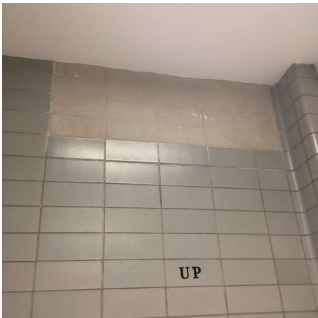
Violations	Stair B/Basement No violations recorded.
<b>Walls</b>	Inspected
Condition	2 - Between Good and Fair
Deficiency	GLAZED BLOCK: CRACKS/SPALLING
Deficiency Location/Instance	Stair C/Basement,3
Deficiency Quantity	20
Quantity Uom	S.F.
Potential Action	REPLACE
Urgency of Action	PRIORITY 3
Purpose of Action	LEVEL 2
Deficiency Photo1

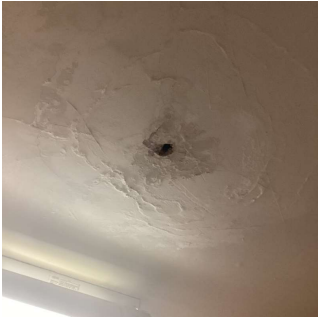
Violations	Stair C/3 No violations recorded.
<b>TOILET ROOMS - STAFF</b>	
Inspected	
<b>Ceiling</b>	
Inspected	
Condition	2 - Between Good and Fair
Deficiency	PLASTER: CRACKS/SPALLING
Deficiency Location/Instance	Kitchen Staff
Deficiency Quantity	10

Quantity Uom	S.F.
Potential Action	REPLACE
Urgency of Action	PRIORITY 3

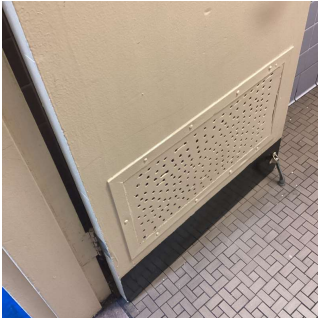
Violations	Room B20 No violations recorded.
<b>Door(s)</b>	Inspected
Condition	5 - Poor
Deficiency	WOOD: DAMAGED LOUVER
Deficiency Location/Instance	Room 320
Deficiency Quantity	1
Quantity Uom	EACH
Potential Action	MAINTENANCE
Urgency of Action	PRIORITY 3
Purpose of Action	LEVEL 2
Deficiency Photo1

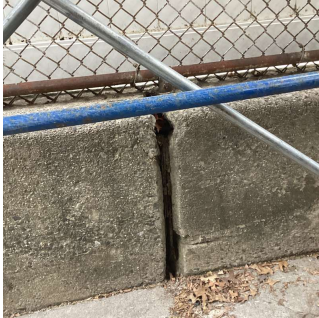
Question	Response
<b>SITE</b>	
<b>PAVING</b>	Inspected
<b>DOT Sidewalk</b>	
<b>Concrete</b>	Inspected
Violations	No violations recorded.
<b>Pavers</b>	Does not Exist
<b>PLAYGROUNDS</b>	Does not Exist
<b>PLAYING SURFACE</b>	Does not Exist
<b>RETAINING WALLS</b>	Inspected
Are there any Retaining Walls 6' OR higher facing public street/sidewalk?	No
Condition	3 - Fair
Deficiency	CAST IN PLACE CONCRETE: DETERIORATED CONTROL/EXPANSION JOINT
Deficiency Location/Instance	Near Schoolyard
Deficiency Quantity	10
Quantity Uom	L.F.
Potential Action	REPLACE
Urgency of Action	PRIORITY 3
Purpose of Action	LEVEL 2
Deficiency Photo1
