NYC Department of Education
Building Condition Assessment Survey 2023 - 2024

Architectural Inspection

Asset: P.S. 205 - QUEENS, 75-25 BELL BLVD, New York, 11364

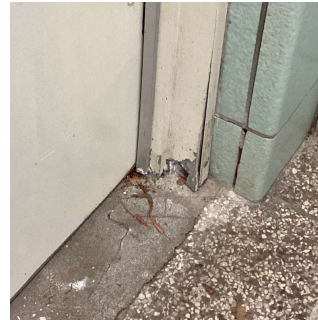
Facade G1

METAL: DETERIORATED DOOR AND FRAME - MAJOR DETERIORATION

REPLACE

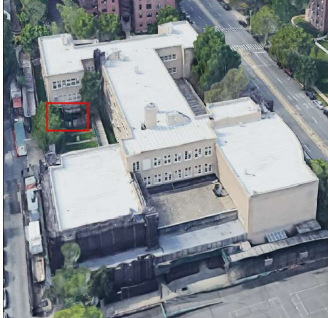
Question	Response
EXTERIOR	
EXTERIOR WALLS	Inspected
Material Type(s)	Masonry
Replacement Quantity	37,000
Replacement Uom	S.F.
Instance on All Facades	Inspected
Instance Condition	3 - Fair
Instance Quantity	37,000
Instance Quantity Uom	S.F.
Deficiency	STONE: EFFLORESCENCE
Roof Plan reference	 
Elevation

Deficiency Quantity	700
Quantity Uom	S.F.
Potential Action	MAINTENANCE
Urgency of Action	PRIORITY 1
Purpose of Action	LEVEL 1
Deficiency Photo1	 
Violations	Facade F No violations recorded.
Deficiency	BRICK: EFFLORESCENCE

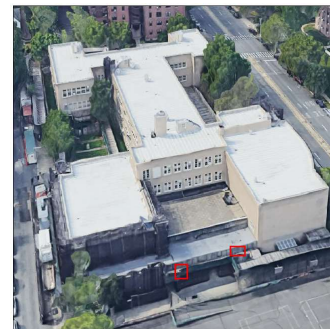
CERAMIC TILE: CHIPPED, SPALLED, BROKEN PIECES

REPLACE
PRIORITY 4
LEVEL 2

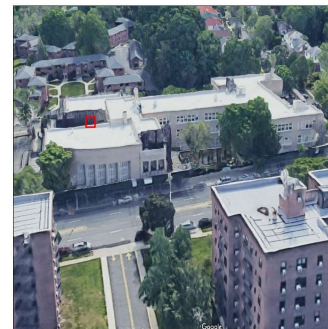
GLASS BLOCK: CHIPPED/ BROKEN PIECES

10
S.F.
REPLACE-IN-KIND
PRIORITY 4
LEVEL 2

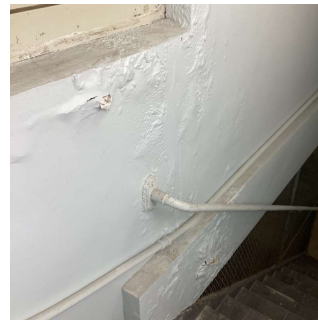
Question	Response
EXTERIOR	
ROOF	
Roofing	
ROOFING	
Deficiency Photo1	 
Violations	Roof 2 - Kitchen (shown), 1st Floor near Gymnasium No violations recorded.
ROOFING DRAINS	Inspected
Condition	2 - Between Good and Fair
Deficiency	No deficiencies recorded
Specialties	Inspected
BULKHEAD/PENTHOUSE	Inspected
Condition	4 - Between Fair and Poor
Deficiency	BULKHEAD/PENTHOUSE WALLS/EXTERIOR: WATER INFILTRATION
Roof Plan reference	 
Deficiency Quantity	150
Quantity Uom	S.F.
Potential Action	REPAIR
Urgency of Action	PRIORITY 5
Purpose of Action	LEVEL 2
Deficiency Photo1	 
Violations	BH3 No violations recorded.
Deficiency	BULKHEAD/PENTHOUSE WALLS/INTERIOR: PLASTER CRACKS/SPALLING

70
S.F.
REPLACE
PRIORITY 4
LEVEL 2

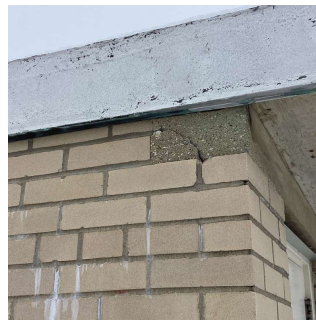
BH3

**BULKHEAD/PENTHOUSE WALLS/EXTERIOR:
CRACKS/SPALLING - MAJOR**

REPLACE

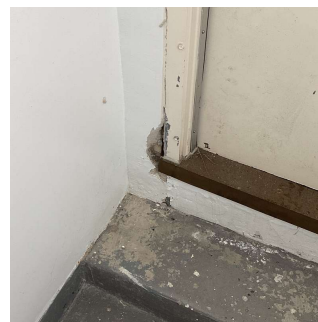
BH3
No violations recorded.

**BULKHEAD/PENTHOUSE WALLS/INTERIOR: PLASTER
CRACKS/SPALLING**

20
S.F.
REPLACE
PRIORITY 3
LEVEL 2

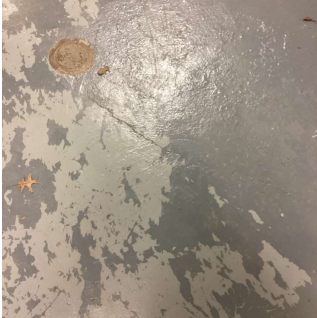
Question	Response
INTERIOR	
STRUCTURAL	Inspected
COLUMNS/BEAMS/BEARING WALLS	Inspected
Condition	2 - Between Good and Fair
Deficiency	No deficiencies recorded
FLOOR STRUCTURE	Inspected
Condition	3 - Fair
Deficiency	CONCRETE SLAB ON GRADE: THRU CRACKS
Deficiency Location/Instance	Basement - Boiler Room
Deficiency Quantity	50
Quantity Uom	S.F.
Potential Action	REPAIR
Urgency of Action	PRIORITY 3
Purpose of Action	LEVEL 5
Deficiency Photo1

Violations	Boiler Room No violations recorded.
FOUNDATION WALLS	Inspected
Material Type(s)	Concrete, Masonry
Condition	4 - Between Fair and Poor
Deficiency	CONCRETE: WATER INFILTRATION IN NON- INSTRUCTIONAL SPACE
Deficiency Location/Instance	Basement - Boiler Room near Electrical Panel Room
Deficiency Quantity	100
Quantity Uom	S.F.
Potential Action	INSTALL WATERPROOFING
Urgency of Action	PRIORITY 5
Purpose of Action	LEVEL 5
Deficiency Photo1

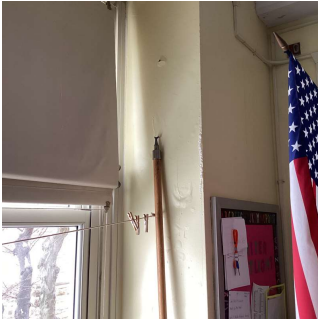
Question	Response
INTERIOR	
CLASSROOMS/CORRIDORS/ADMIN SPACES	
Floor Finish	Inspected
Violations	No violations recorded.
Walls	Inspected
Condition	2 - Between Good and Fair
Deficiency	PLASTER: CRACKS/SPALLING - ACTIVE LEAK
Deficiency Location/Instance	Room 218
Deficiency Quantity	20
Quantity Uom	S.F.
Potential Action	REPLACE
Urgency of Action	PRIORITY 5
Purpose of Action	LEVEL 2
Deficiency Photo1

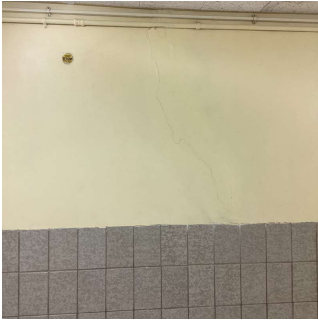
Violations	No violations recorded.
Deficiency	PLASTER: CRACKS/SPALLING
Deficiency Location/Instance	Corridor near Gymnasium, Corridor near Rooms 336, 334, 308, 213 and others
Deficiency Quantity	200
Quantity Uom	S.F.
Potential Action	REPLACE
Urgency of Action	PRIORITY 3
Purpose of Action	LEVEL 2
Deficiency Photo1

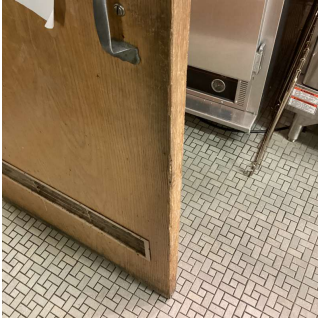
Question	Response
INTERIOR	
KITCHEN	
Door(s)	
Deficiency Location/Instance	Office
Deficiency Quantity	1
Quantity Uom	EACH
Potential Action	MAINTENANCE
Urgency of Action	PRIORITY 3
Purpose of Action	LEVEL 2
Deficiency Photo1

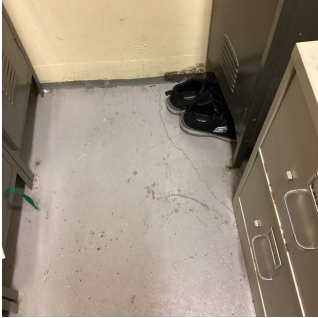
Violations	Office No violations recorded.
Floor Finish	
Instance on 1st Floor	Inspected
Condition	3 - Fair
Deficiency	CONCRETE: CRACKS
Deficiency Location/Instance	Office, Storage Room
Deficiency Quantity	50
Quantity Uom	S.F.
Potential Action	REPLACE
Urgency of Action	PRIORITY 3
Purpose of Action	LEVEL 2
Deficiency Photo1

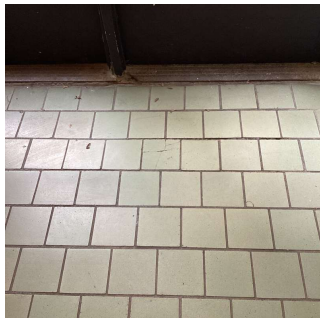
Violations	Stair AB/1 Vestibule No violations recorded.

Question	Response
INTERIOR	
LIBRARY	
Floor Finish	
Instance on Room 321/323	Inspected
Condition	1 - Good
Deficiency	No deficiencies recorded
Walls	
Instance on Room 321/323	Inspected
Condition	1 - Good
Deficiency	No deficiencies recorded
LOCKER ROOM	Does not Exist
MULTI-PURPOSE ROOM	Does not Exist
SCIENCE DEMO ROOM	Does not Exist
SCIENCE LAB	Does not Exist
SCIENCE PREP ROOM	Does not Exist
SHOWER ROOM	
Instance on 1st Floor - Boys	Inaccessible
Instance on 1st Floor - Girls	Inaccessible
STAIRS/RAMPS: INTERIOR	
Do Letter Stair Signs Exist?	Yes
Ceiling	
Condition	2 - Between Good and Fair
Deficiency	No deficiencies recorded
Door(s)	
Condition	2 - Between Good and Fair
Deficiency	No deficiencies recorded
Partition	
Condition	Does not Exist
Railings	
Condition	2 - Between Good and Fair
Deficiency	No deficiencies recorded
Stairs and Landings	
Condition	2 - Between Good and Fair
Deficiency	QUARRY TILE: BROKEN/MISSING
Deficiency Location/Instance	Stair AB/1 Vestibule

Deficiency Quantity	20
Quantity Uom	S.F.
Potential Action	REPLACE
Urgency of Action	PRIORITY 3
Purpose of Action	LEVEL 2
Deficiency Photo1

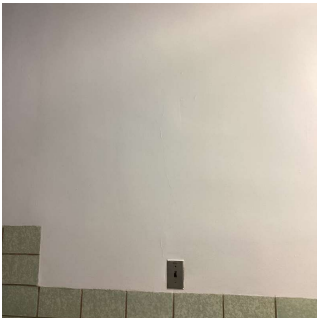
Stair E/2
Violations	No violations recorded.
Walls	Inspected
Condition	2 - Between Good and Fair
Deficiency	PLASTER: CRACKS/SPALLING
Deficiency Location/Instance	Stairs AB/1, D/3, E3, 2
Deficiency Quantity	60
Quantity Uom	S.F.
Potential Action	REPLACE
Urgency of Action	PRIORITY 3
Purpose of Action	LEVEL 2
Deficiency Photo1

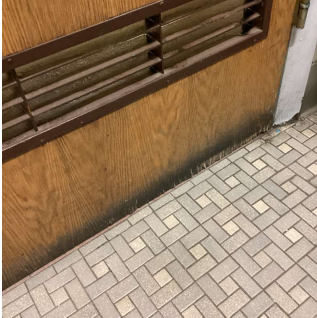
Stair D/3
Violations	No violations recorded.
TOILET ROOMS - STAFF	
	Inspected
Ceiling	Inspected
Condition	2 - Between Good and Fair
Deficiency	No deficiencies recorded
Door(s)	Inspected
Condition	5 - Poor
Deficiency	WOOD: DETERIORATED DOOR
Deficiency Location/Instance	Rooms 213A, 106, 102
Deficiency Quantity	3

Question	Response
INTERIOR	
TOILET ROOMS - STAFF	
Door(s)	
Quantity Uom	EACH
Potential Action	MAINTENANCE
Urgency of Action	PRIORITY 3
Purpose of Action	LEVEL 2
Deficiency Photo1

Room 106
Violations	No violations recorded.
Floor Finish	Inspected
Condition	2 - Between Good and Fair
Deficiency	No deficiencies recorded
Stalls	Inspected
Condition	5 - Poor
Deficiency	RUST - MAJOR
Deficiency Location/Instance	Inside Gymnasium, Rooms 308A, 213A, 105
Deficiency Quantity	4
Quantity Uom	EACH
Potential Action	REPLACE
Urgency of Action	PRIORITY 3
Purpose of Action	LEVEL 2
Deficiency Photo1

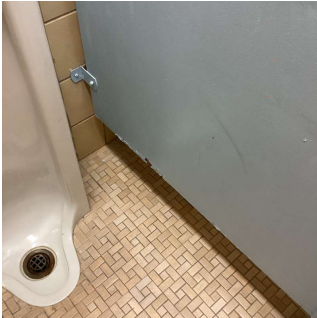
Inside Gymnasium
Violations	No violations recorded.
Walls	Inspected
Condition	2 - Between Good and Fair
Deficiency	CERAMIC TILE: BROKEN/ MISSING
Deficiency Location/Instance	Rooms 213A, 106, 102
Deficiency Quantity	30
Quantity Uom	S.F.
Potential Action	REPLACE
Urgency of Action	PRIORITY 3
Purpose of Action	LEVEL 2

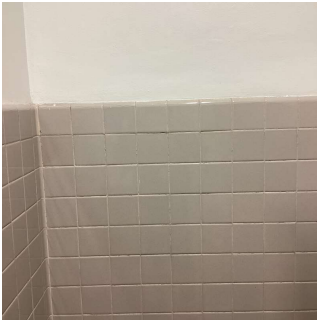
Violations	Room 106 No violations recorded.
Deficiency	PLASTER: CRACKS/SPALLING
Deficiency Location/Instance	Rooms 102, 106
Deficiency Quantity	20
Quantity Uom	S.F.
Potential Action	REPLACE
Urgency of Action	PRIORITY 3
Purpose of Action	LEVEL 2
Deficiency Photo1

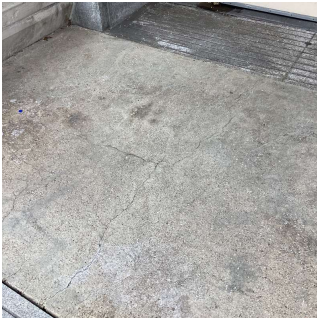
Violations	Bell Boulevard courtyard No violations recorded.
Pavers	Does not Exist
Site Sidewalks & Walkways	Inspected
Asphalt	Does not Exist
Concrete	Inspected
Condition	4 - Between Fair and Poor
Deficiency	CRACKS - MAJOR
Deficiency Location/Instance	Exits 3, 4, 5, 5A, 7 and others
Deficiency Quantity	1,200
Quantity Uom	S.F.
Potential Action	REPLACE
Urgency of Action	PRIORITY 3
Purpose of Action	LEVEL 2
Deficiency Photo1

Violations	Exit 5A No violations recorded.
Pavers	Inspected
Condition	2 - Between Good and Fair
Deficiency	No deficiencies recorded
DOT Sidewalk	Inspected
Asphalt	Does not Exist
Concrete	Inspected
Condition	4 - Between Fair and Poor
Deficiency	DAMAGED CURBS
Deficiency Location/Instance	Bell Boulevard, 77th Avenue, 217th Street
Deficiency Quantity	400
Quantity Uom	L.F.

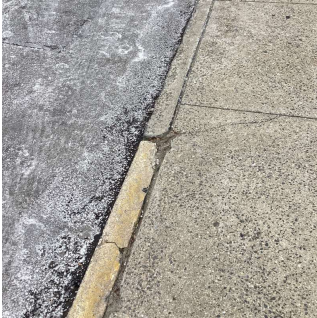
Question	Response
SITE	
PAVING	
DOT Sidewalk	
Concrete	
Potential Action	REPLACE
Urgency of Action	PRIORITY 3
Purpose of Action	LEVEL 2
Deficiency Photo1

Bell Boulevard
Violations	No violations recorded.
Deficiency	DAMAGED/DETERIORATED/MISSING SECTIONS
Deficiency Location/Instance	Bell Boulevard, 77th Avenue, 217th Street
Deficiency Quantity	2,200
Quantity Uom	S.F.
Potential Action	REPLACE
Urgency of Action	PRIORITY 3
Purpose of Action	LEVEL 2
Deficiency Photo1

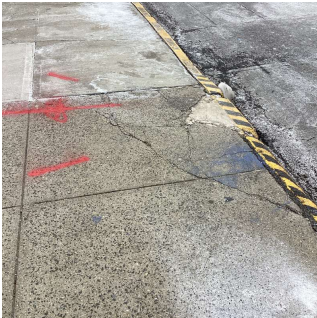
Bell Boulevard
Violations	No violations recorded.
Pavers	Does not Exist
PLAYGROUNDS	Inspected
Instance on Along 77th Avenue	Inspected
Benches	
Instance on Along 77th Avenue	Inspected
Condition	4 - Between Fair and Poor
Deficiency	DAMAGED/DETERIORATED
Deficiency Location/Instance	Rear
Deficiency Quantity	2
Quantity Uom	EACH
Potential Action	REPLACE
Urgency of Action	PRIORITY 3
Purpose of Action	LEVEL 2

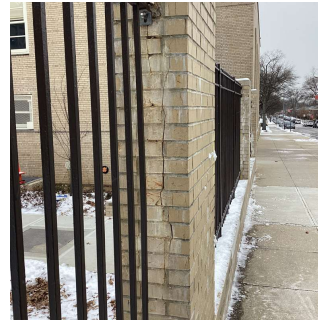
Violations	217th Street No violations recorded.
Deficiency	BRICK: BULGING/DISPLACED
Deficiency Location/Instance	217th Street
Deficiency Quantity	80
Quantity Uom	S.F.
Potential Action	REPLACE

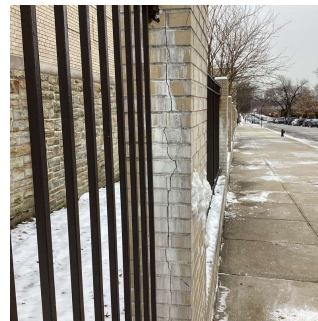
217th Street

BRICK: CRACKS/SPALLING - MAJOR

REPLACE

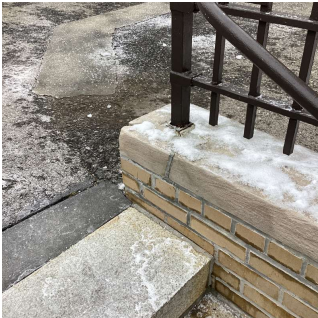
Violations	77th Avenue No violations recorded.
Site Cheek/flank Walls	Inspected
Condition	2 - Between Good and Fair
Deficiency	CAST IN PLACE CONCRETE: CRACKS/SPALLING - MAJOR
Deficiency Location/Instance	77th Avenue
Deficiency Quantity	10
Quantity Uom	S.F.
Potential Action	REPLACE
Urgency of Action	PRIORITY 3
Purpose of Action	LEVEL 2
Deficiency Photo1

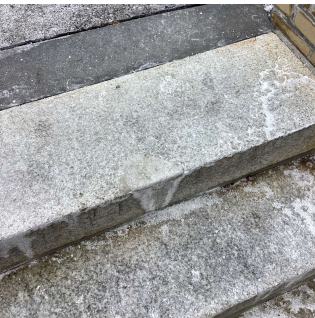
77th Avenue
Violations	No violations recorded.
ARTWORK	Does not Exist

Violations	77th Avenue No violations recorded.
Stairs/ramps	Inspected
Condition	2 - Between Good and Fair
Deficiency	CAST IN PLACE CONCRETE: CRACKS/SPALLING - MAJOR
Deficiency Location/Instance	77th Avenue
Deficiency Quantity	10
Quantity Uom	S.F.
Potential Action	REPLACE
Urgency of Action	PRIORITY 3

Question	Response
SITE	
STAIRS/RAMPS: EXTERIOR	
Stairs/ramps	
Purpose of Action	LEVEL 2
Deficiency Photo1
