**NYC Department of Education**  
**Building Condition Assessment Survey 2023 - 2024**

Architectural Inspection

Q206

**Asset:** P.S. 206 - QUEENS, 61-21 97TH PLACE, New York, 11374

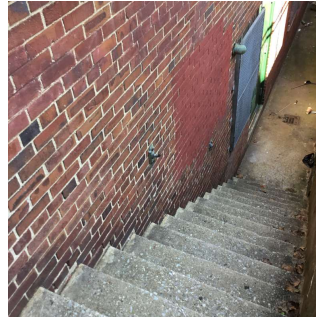
AW2

**AREAWAY STAIRS: MISSING RAILINGS**

REPLACE

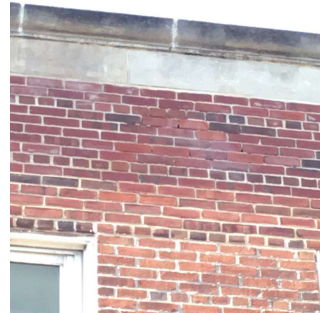
Roof 1

Deficiency	<b>BRICK: DETERIORATED JOINTS</b>
Roof Plan reference

PRIORITY 3  
LEVEL 2

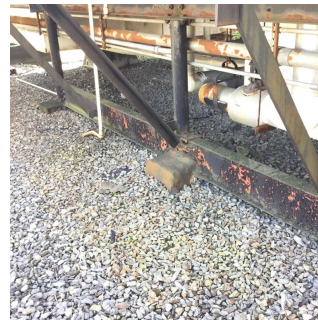
Roof 1  
 No violations recorded.

Question	Response
<b>EXTERIOR</b>	
<b>ROOF</b>	
<b>Specialties</b>	
<b>BULKHEAD/PENTHOUSE</b>	
Deficiency Photo1	 
	BH1
Violations	No violations recorded.
Deficiency	<b>BULKHEAD/PENTHOUSE WINDOWS: DAMAGED, DETERIORATED WINDOWS</b>
Roof Plan reference	 
Deficiency Quantity	60
Quantity Uom	S.F.
Potential Action	REPLACE
Urgency of Action	PRIORITY 4
Purpose of Action	LEVEL 2
Deficiency Photo1	 
	BH1
Violations	No violations recorded.
<b>CUPOLA/ SPIRES/ TOWERS</b>	Does not Exist
<b>DORMER</b>	Does not Exist
<b>DUNNAGE STEEL</b>	Inspected
Condition	3 - Fair
Deficiency	HEIGHT LESS THAN 18"

50  
 L.F.  
 REPLACE  
 PRIORITY 3  
 LEVEL 2

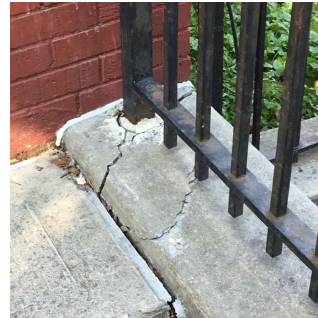
Facade K

CAST IN PLACE CONCRETE: CRACKS/SPALLING - MAJOR

10  
 S.F.  
 REPLACE  
 PRIORITY 4

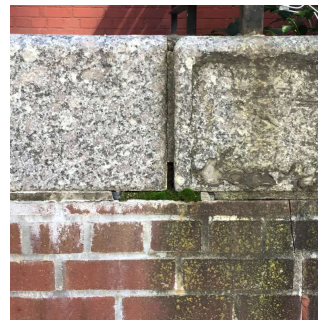
Facade J

**BRICK: DETERIORATED JOINTS AT COPING STONES**

PRIORITY 3

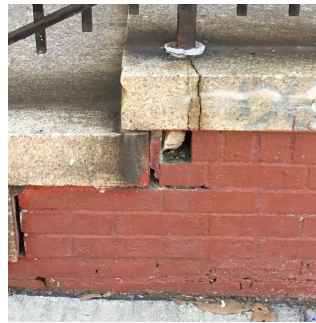
Facade N  
No violations recorded.

**BRICK: CRACKS/SPALLING - MAJOR**

30  
S.F.  
REPLACE  
PRIORITY 4  
LEVEL 2

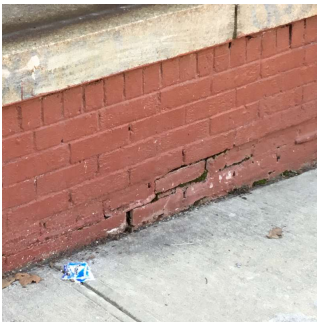
Question	Response
<b>EXTERIOR</b>	
<b>STAIRS/RAMPS: EXTERIOR</b>	
<b>BUILDING CHEEK/FLANK WALLS</b>	
Deficiency Photo1

Violations	Facade N No violations recorded.
<b>RAILINGS</b>	Inspected
Condition	2 - Between Good and Fair
Deficiency	No deficiencies recorded
<b>STAIRS/RAMPS</b>	Inspected
Condition	5 - Poor
Deficiency	<b>STONE: DETERIORATED JOINTS</b>
Roof Plan reference	<p>Q206 Long Island City</p>

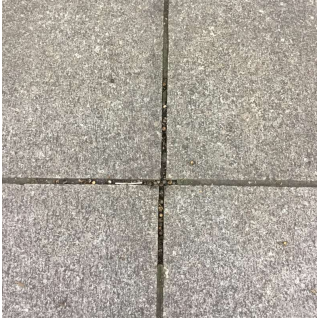
Violations	Facade J No violations recorded.
Deficiency	<b>STONE: CRACKS/SPALLING - MINOR</b>

Deficiency Quantity	10
Quantity Uom	L.F.
Potential Action	REPOINT
Urgency of Action	PRIORITY 3
Purpose of Action	LEVEL 2
Deficiency Photo1

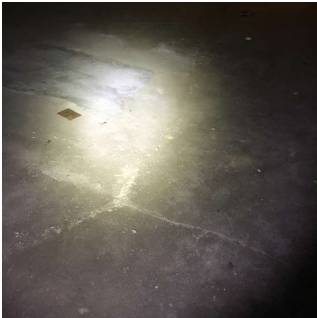
Question	Response
<b>INTERIOR</b>	
<b>STRUCTURAL</b>	
<b>FLOOR STRUCTURE</b>	
Violations	Basement Storage Area (Crawl Space, Boiler Room similar) No violations recorded.
Deficiency	CONCRETE SLAB ON GRADE: THRU CRACKS
Deficiency Location/Instance	Basement
Deficiency Quantity	350
Quantity Uom	S.F.
Potential Action	REPLACE
Urgency of Action	PRIORITY 4
Purpose of Action	LEVEL 5
Deficiency Photo1

Violations	Crawl Space (Basement Fan Area, Boiler Room similar) No violations recorded.
<b>FOUNDATION WALLS</b>	
Material Type(s)	Inspected Concrete, Masonry
Condition	4 - Between Fair and Poor
Deficiency	BRICK: WATER INFILTRATION IN ELECTRICAL PANEL ROOM
Deficiency Location/Instance	Electrical Panel Room
Deficiency Quantity	100
Quantity Uom	S.F.
Potential Action	INSTALL WATERPROOFING
Urgency of Action	PRIORITY 5
Purpose of Action	LEVEL 6
Deficiency Photo1	 
Violations	Electrical Panel Room No violations recorded.
Deficiency	CONCRETE: CRACKED/SPALLED/REINFORCEMENT EXPOSED

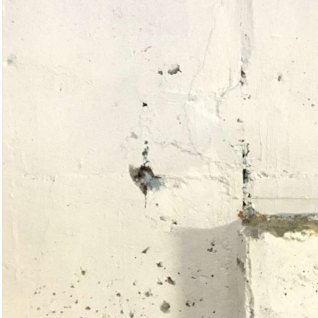
Violations	Basement Fan Area No violations recorded.
<b>ROOF STRUCTURE</b>	
Condition	Inspected
Deficiency	2 - Between Good and Fair
Deficiency	No deficiencies recorded
<b>VAULTS-BUNKERS</b>	
<b>Foundation Walls</b>	
Condition	Inspected
Deficiency	3 - Fair
Deficiency	CRACKS, SPALLING
Deficiency Location/Instance	Vault
Deficiency Quantity	35
Quantity Uom	S.F.
Potential Action	REPAIR
Urgency of Action	PRIORITY 4
Purpose of Action	LEVEL 5
Deficiency Photo1

Deficiency Location/Instance	Basement
Deficiency Quantity	10
Quantity Uom	S.F.
Potential Action	REPAIR

Question	Response
<b>INTERIOR</b>	
<b>STRUCTURAL</b>	
<b>FOUNDATION WALLS</b>	
Urgency of Action	PRIORITY 3
Purpose of Action	LEVEL 5
Deficiency Photo1

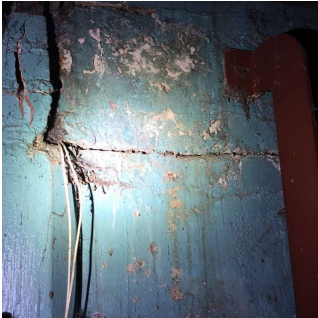
Violations	Vault No violations recorded.
<b>Slab Structure</b>	
Condition	Inspected
Deficiency	2 - Between Good and Fair
Deficiency	CONCRETE: CRACKS/SPALLED/REINFORCEMENT EXPOSED
Deficiency Location/Instance	Vault
Deficiency Quantity	10
Quantity Uom	S.F.
Potential Action	REPAIR
Urgency of Action	PRIORITY 3
Purpose of Action	LEVEL 5

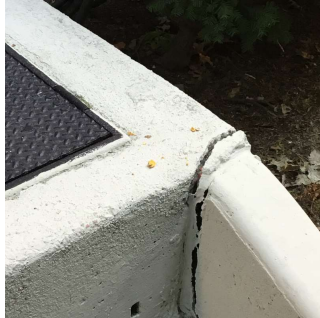
Violations	Vault No violations recorded.
<b>Vault/Ash Hoist Doors and Framing</b>	Inspected
Condition	5 - Poor
Deficiency	DETERIORATED/DAMAGED VAULT/ASH HOIST DOORS AND FRAMING
Deficiency Location/Instance	Vault
Deficiency Quantity	2
Quantity Uom	EACH
Potential Action	REPLACE
Urgency of Action	PRIORITY 4
Purpose of Action	LEVEL 2
Deficiency Photo1

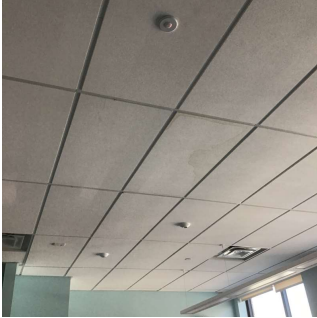
Question	Response
<b>INTERIOR</b>	
<b>CAFETERIA</b>	Inspected
<b>Window Curtains/Shades/Blinds</b>	
Instance on 1st Floor	Does not Exist
<b>CLASSROOMS/CORRIDORS/ADMIN SPACES</b>	
<b>Ceiling</b>	Inspected
Condition	2 - Between Good and Fair
Deficiency	ACOUSTIC TILES: DAMAGED/MISSING - ACTIVE LEAK
Deficiency Location/Instance	Corridor near Room 306, 307, 313
Deficiency Quantity	60
Quantity Uom	S.F.
Potential Action	REPLACE
Urgency of Action	PRIORITY 5
Purpose of Action	LEVEL 2
Deficiency Photo1	 
Violations	Corridor near Room 307 No violations recorded.
Deficiency	ACOUSTIC TILES: DAMAGED/MISSING
Deficiency Location/Instance	Rooms 329, 331, 338, Corridor near Room 203, 317, and others.
Deficiency Quantity	80
Quantity Uom	S.F.
Potential Action	REPLACE
Urgency of Action	PRIORITY 3
Purpose of Action	LEVEL 2
Deficiency Photo1

Violations	Room 329 No violations recorded.
Deficiency	ACOUSTIC TILES ON PLASTER: DAMAGED/MISSING

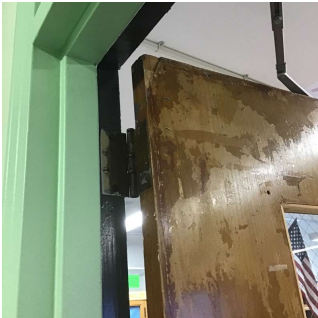
Question	Response
<b>INTERIOR</b>	
<b>CLASSROOMS/CORRIDORS/ADMIN SPACES</b>	
<b>Door(s)</b>	
Violations	Room 120 No violations recorded.
Deficiency	WOOD: DETERIORATED DOOR
Deficiency Location/Instance	Rooms 114, 200, 317, 339, Principal Office
Deficiency Quantity	5
Quantity Uom	EACH
Potential Action	MAINTENANCE
Urgency of Action	PRIORITY 3
Purpose of Action	LEVEL 2
Deficiency Photo1

Violations	Room 200 No violations recorded.
<b>Floor Finish</b>	Inspected
Condition	3 - Fair
Deficiency	CERAMIC TILE: BROKEN/MISSING TILES
Deficiency Location/Instance	Corridor near Room 128
Deficiency Quantity	10
Quantity Uom	S.F.
Potential Action	REPLACE
Urgency of Action	PRIORITY 3
Purpose of Action	LEVEL 2
Deficiency Photo1

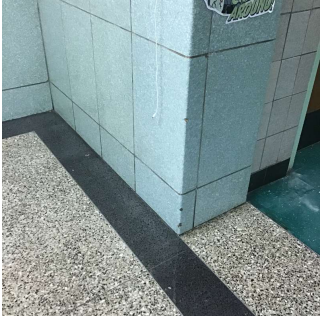
Question	Response
<b>INTERIOR</b>	
<b>CLASSROOMS/CORRIDORS/ADMIN SPACES</b>	
<b>Walls</b>	
Violations	Room (Old Building) 307 No violations recorded.
Deficiency	GLAZED BLOCK: CRACKS/SPALLING
Deficiency Location/Instance	Corridor near Room 110, Exit 1 Vestibule, Near Auditorium and old Cafeteria.
Deficiency Quantity	30
Quantity Uom	S.F.
Potential Action	REPLACE
Urgency of Action	PRIORITY 3
Purpose of Action	LEVEL 2
Deficiency Photo1

Violations	Corridor near Room 110 No violations recorded.
Deficiency	PLASTER: CRACKS/SPALLING
Deficiency Location/Instance	Rooms (Old Building) B2, B3, 102, 200, 200A, and others.
Deficiency Quantity	150
Quantity Uom	S.F.
Potential Action	REPLACE
Urgency of Action	PRIORITY 3
Purpose of Action	LEVEL 2
Deficiency Photo1

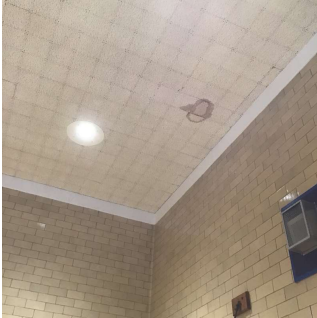
Condition	2 - Between Good and Fair
Deficiency	ACOUSTIC TILES ON PLASTER: DAMAGED/MISSING - ACTIVE LEAK

Question	Response
<b>INTERIOR</b>	
<b>GYMNASIUM</b>	
<b>Ceiling</b>	
Deficiency Location/Instance	Near back Board Opposite to entrance
Deficiency Quantity	10
Quantity Uom	S.F.
Potential Action	REPLACE
Urgency of Action	PRIORITY 5
Purpose of Action	LEVEL 2
Deficiency Photo1

Violations	Near back Board Opposite to entrance. No violations recorded.
Deficiency	ACOUSTIC TILES ON PLASTER: DAMAGED/MISSING
Deficiency Location/Instance	Near back Board Opposite to entrance
Deficiency Quantity	20
Quantity Uom	S.F.
Potential Action	REPLACE
Urgency of Action	PRIORITY 3
Purpose of Action	LEVEL 2
Deficiency Photo1

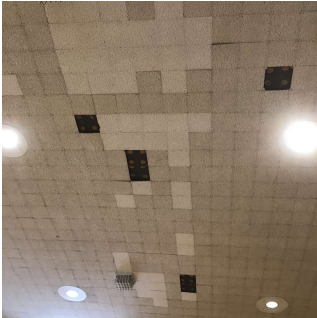
Violations	Near back Board Opposite to entrance No violations recorded.
Deficiency	ACOUSTIC TILES: DAMAGED/MISSING
Deficiency Location/Instance	Storage Room Closet
Deficiency Quantity	10
Quantity Uom	S.F.
Potential Action	REPLACE
Urgency of Action	PRIORITY 3
Purpose of Action	LEVEL 2

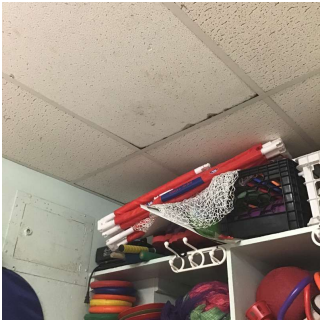
Violations	Storage Room Closet No violations recorded.
<b>Door(s)</b>	
Instance on 1st Floor	Inspected
Condition	5 - Poor
Deficiency	WOOD: DETERIORATED DOOR
Deficiency Location/Instance	Storage Room Closet
Deficiency Quantity	2
Quantity Uom	EACH
Potential Action	MAINTENANCE
Urgency of Action	PRIORITY 3
Purpose of Action	LEVEL 2
Deficiency Photo1

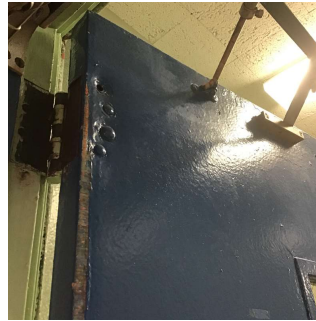
Entrance Right Side

Violations	Storage Room Closet No violations recorded.
Deficiency	METAL: DETERIORATED DOOR
Deficiency Location/Instance	Right and Left Side Entrance
Deficiency Quantity	2
Quantity Uom	EACH
Potential Action	MAINTENANCE
Urgency of Action	PRIORITY 3
Purpose of Action	LEVEL 2

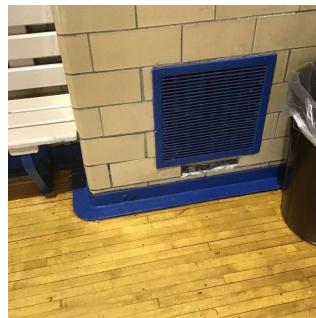
Near Drinking Fountain

GLAZED BLOCK: CRACKS/SPALLING

REPLACE

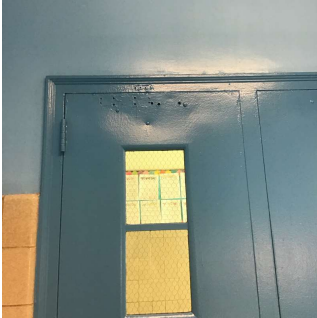
Deficiency	METAL: DETERIORATED DOOR
Deficiency Location/Instance	Stair B/3
Deficiency Quantity	1

Question	Response
<b>INTERIOR</b>	
<b>STAIRS/RAMPS: INTERIOR</b>	
<b>Door(s)</b>	
Quantity Uom	EACH
Potential Action	MAINTENANCE
Urgency of Action	PRIORITY 3
Purpose of Action	LEVEL 2
Deficiency Photo1

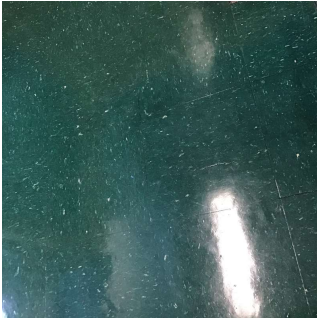
Violations	Stair B/3 No violations recorded.
<b>Partition</b>	Does not Exist
<b>Railings</b>	Inspected
Condition	2 - Between Good and Fair
Deficiency	No deficiencies recorded
<b>Stairs and Landings</b>	Inspected
Condition	2 - Between Good and Fair
Deficiency	VINYL TILES: BROKEN/DETERIORATED/MISSING TILES
Deficiency Location/Instance	Stair A/1, 2
Deficiency Quantity	20
Quantity Uom	S.F.
Potential Action	REPLACE
Urgency of Action	PRIORITY 3
Purpose of Action	LEVEL 2
Deficiency Photo1

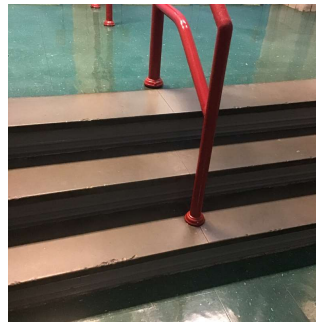
Stair B/1

Violations	Stair A/2 No violations recorded.
Deficiency	STONE: BROKEN/MISSING
Deficiency Location/Instance	Stair A/1, B/1
Deficiency Quantity	90
Quantity Uom	S.F.
Potential Action	REPLACE
Urgency of Action	PRIORITY 3
Purpose of Action	LEVEL 2

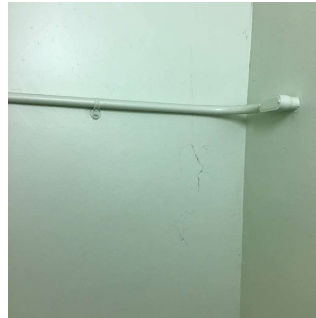
Stair Near Exit 8

PLASTER: CRACKS/SPALLING

REPLACE

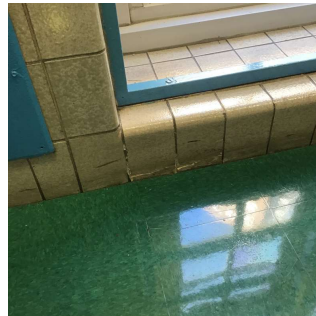
GLAZED BLOCK: CRACKS/SPALLING

REPLACE

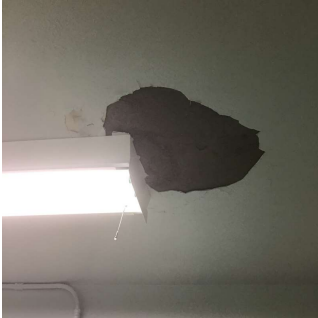
Question	Response
<b>INTERIOR</b>	
<b>STAIRS/RAMPS: INTERIOR</b>	Inspected
<b>Walls</b>	Inspected
Violations	Stair B/1 No violations recorded.
<b>TOILET ROOMS - STAFF</b>	Inspected
<b>Ceiling</b>	Inspected
Condition	2 - Between Good and Fair
Deficiency	PLASTER: CRACKS/SPALLING - ACTIVE LEAK
Deficiency Location/Instance	Room 233B
Deficiency Quantity	10
Quantity Uom	S.F.
Potential Action	REPLACE
Urgency of Action	PRIORITY 5
Purpose of Action	LEVEL 2
Deficiency Photo1

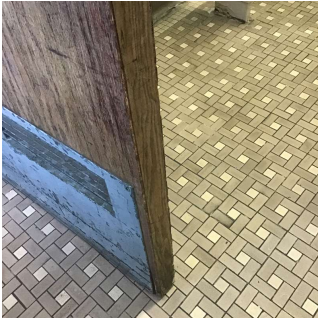
Violations	Room 223B No violations recorded.
<b>Door(s)</b>	Inspected
Condition	5 - Poor
Deficiency	WOOD: DETERIORATED DOOR
Deficiency Location/Instance	(Old Building)Rooms 208A, 233B
Deficiency Quantity	2
Quantity Uom	EACH
Potential Action	MAINTENANCE
Urgency of Action	PRIORITY 3
Purpose of Action	LEVEL 2
Deficiency Photo1

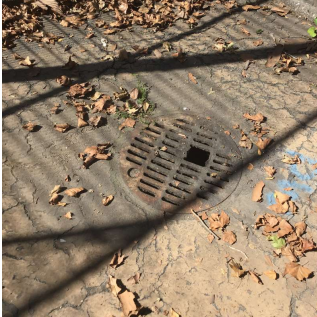
Condition	3 - Fair
Deficiency	DAMAGED COVER

Question	Response
<b>SITE</b>	
<b>Drainage System for Asphalt</b>	
<b>Catch Basins/Manhole - Surrounded by asphalt</b>	
Deficiency Location/Instance	TCU Area
Deficiency Quantity	1
Quantity Uom	EACH
Potential Action	REPLACE
Urgency of Action	PRIORITY 3
Purpose of Action	LEVEL 2
Deficiency Photo1

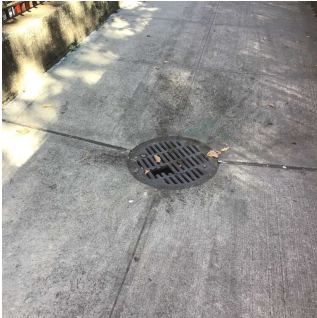
Violations	TCU Area No violations recorded.
<b>Culverts - Asphalt Covering</b>	Does not Exist
<b>Drainage System for Concrete</b>	Inspected
<b>Catch Basins/Manhole - Surrounded by concrete</b>	
Condition	3 - Fair
Deficiency	DAMAGED COVER
Deficiency Location/Instance	Near Exit 10
Deficiency Quantity	1
Quantity Uom	EACH
Potential Action	REPLACE
Urgency of Action	PRIORITY 3
Purpose of Action	LEVEL 2
Deficiency Photo1

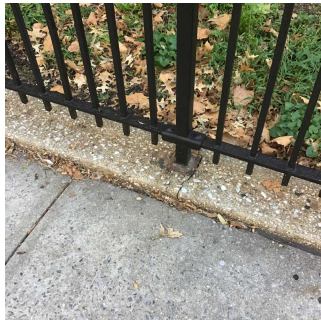
Question	Response
<b>SITE</b>	
<b>FENCES</b>	
Deficiency Photo1	 
Violations	97th place No violations recorded.
Deficiency	CONCRETE CURB: DAMAGED/DETERIORATED
Deficiency Location/Instance	97th place, 98th Place, Near TCU.
Deficiency Quantity	110
Quantity Uom	S.F.
Potential Action	REPLACE
Urgency of Action	PRIORITY 3
Purpose of Action	LEVEL 2
Deficiency Photo1

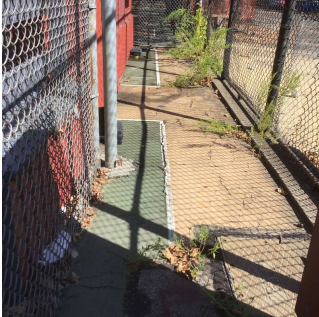
Violations	97th place No violations recorded.
<b>IRRIGATION SYSTEM</b>	Does not Exist
<b>PAVING</b>	Inspected
<b>Student Non-Use</b>	Inspected
Gravel Exists?	No
<b>Asphalt</b>	Inspected
Condition	3 - Fair
Deficiency	CRACKS - MAJOR
Deficiency Location/Instance	Back on the TCU Area
Deficiency Quantity	250
Quantity Uom	S.F.
Potential Action	REPLACE
Urgency of Action	PRIORITY 3
Purpose of Action	LEVEL 2

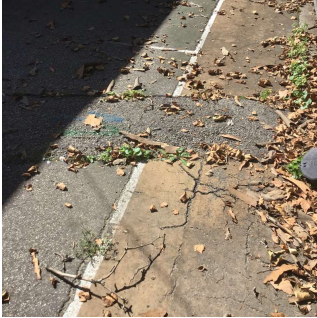
Question	Response
<b>SITE</b>	
<b>PAVING</b>	
<b>Site Sidewalks &amp; Walkways</b>	
<b>Asphalt</b>	
Deficiency Quantity	200
Quantity Uom	S.F.
Potential Action	REPLACE
Urgency of Action	PRIORITY 3
Purpose of Action	LEVEL 2
Deficiency Photo1

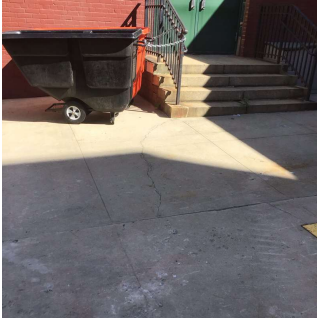
Violations	Near Fence No violations recorded.
<b>Concrete</b>	Inspected
Condition	3 - Fair
Deficiency	CRACKS - MAJOR
Deficiency Location/Instance	New area between Addition and old Building.
Deficiency Quantity	50
Quantity Uom	S.F.
Potential Action	REPLACE
Urgency of Action	PRIORITY 3
Purpose of Action	LEVEL 2
Deficiency Photo1

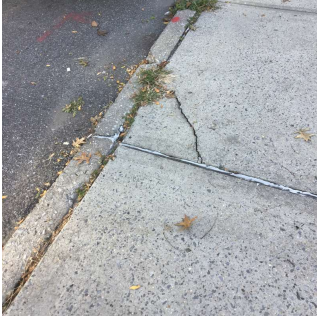
Violations	New area between Addition and old Building. No violations recorded.
<b>Pavers</b>	Inaccessible
<b>DOT Sidewalk</b>	Inspected
<b>Asphalt</b>	Does not Exist
<b>Concrete</b>	Inspected
Condition	4 - Between Fair and Poor
Deficiency	DAMAGED/DETERIORATED/MISSING SECTIONS
Deficiency Location/Instance	97th place, 98th Street, near TCU
Deficiency Quantity	750

Question	Response
<b>SITE</b>	
<b>PAVING</b>	
<b>DOT Sidewalk</b>	
<b>Concrete</b>	
Urgency of Action	PRIORITY 3
Purpose of Action	LEVEL 2
Deficiency Photo1

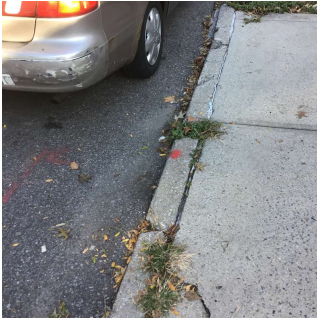
Violations	97th place No violations recorded.
Deficiency	DAMAGED CURBS
Deficiency Location/Instance	97th place, 98th Place.
Deficiency Quantity	275
Quantity Uom	L.F.
Potential Action	REPLACE
Urgency of Action	PRIORITY 3
Purpose of Action	LEVEL 2
Deficiency Photo1
