**NYC Department of Education**  
**Building Condition Assessment Survey 2023 - 2024**

Architectural Inspection

**Asset:** P.S./I.S. 208 - QUEENS, 74-30 COMMONWEALTH BLVD, New York, 11426

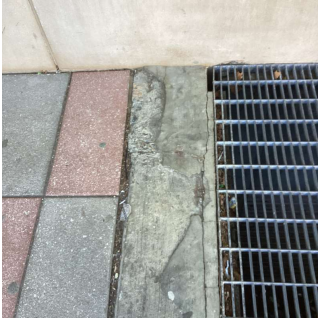
Question	Response
<b>Architectural</b>	
<b>EXTERIOR</b>	Inspected
<b>AREAWAY</b>	Inspected
Instance on AW1-AW10	Inspected
Instance Condition	2 - Between Good and Fair
Instance Quantity	10
Instance Quantity Uom	EACH
Deficiency	AREAWAY WALLS: CRACKS AND SPALLING
Roof Plan reference	Q208
Deficiency Quantity	10
Quantity Uom	S.F.
Potential Action	REPAIR
Urgency of Action	PRIORITY 3
Purpose of Action	LEVEL 2

Question	Response
<b>EXTERIOR</b>	
<b>AREAWAY</b>	
Deficiency Photo1

Violations	Facade J No violations recorded.
<b>AWNINGS AND CANOPIES</b>	
Condition	Inspected
Deficiency	2 - Between Good and Fair No deficiencies recorded
<b>CHIMNEY</b>	
Material Type(s)	Inspected Metal
Condition	2 - Between Good and Fair
Deficiency	No deficiencies recorded
<b>COPING</b>	
Condition	Inspected 3 - Fair
Deficiency	CAST STONE: DETERIORATED BED JOINT
Roof Plan reference	Q208
Deficiency Quantity	10
Quantity Uom	L.F.
Potential Action	REPOINT
Urgency of Action	PRIORITY 3
Purpose of Action	LEVEL 2
Deficiency Photo1

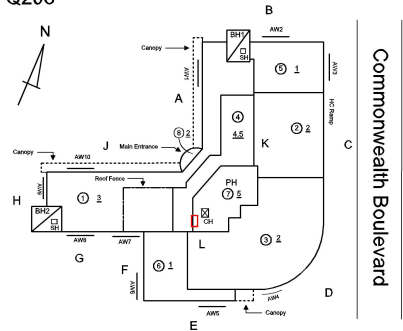
Violations	Roof 7 No violations recorded.
Deficiency	CAST STONE: DETERIORATED TRANSVERSE JOINTS

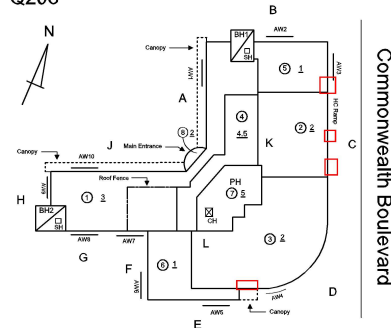
METAL: DETERIORATED DOOR AND FRAME - MAJOR DETERIORATION

REPLACE

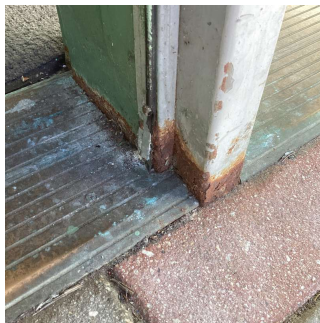
Violations	Facade C No violations recorded.
Deficiency	<b>METAL: DETERIORATED DOOR AND FRAME - MINOR DETERIORATION</b>
Roof Plan reference	<b>Q208</b>

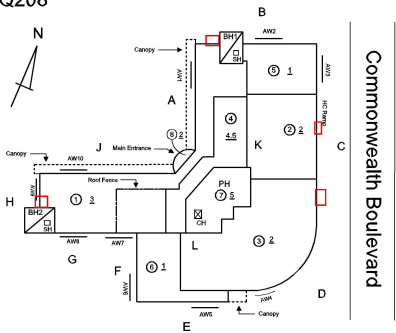
Deficiency Quantity	7
Quantity Uom	EACH
Potential Action	MAINTENANCE
Urgency of Action	PRIORITY 3
Purpose of Action	LEVEL 2
Deficiency Photo1	No photo recorded
Violations	No violations recorded.
<b>DOOR HARDWARE</b>	Inspected
Condition	3 - Fair
Deficiency	No deficiencies recorded
<b>LINTELS</b>	Inspected
Condition	2 - Between Good and Fair
Deficiency	No deficiencies recorded
<b>TRANSOM/SIDE LIGHT</b>	Inspected
Condition	2 - Between Good and Fair
Deficiency	No deficiencies recorded
<b>EXTERIOR WALLS</b>	Inspected
Material Type(s)	Masonry, Concrete
Replacement Quantity	50,000
Replacement Uom	S.F.
Instance on All Facades	Inspected
Instance Condition	3 - Fair
Instance Quantity	50,000

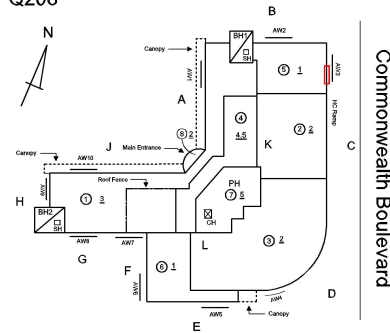
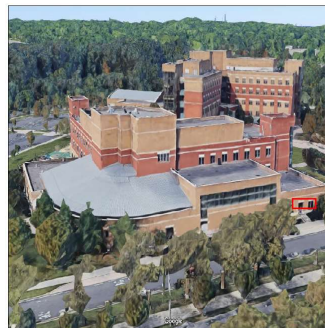
**BRICK: DETERIORATED JOINTS**

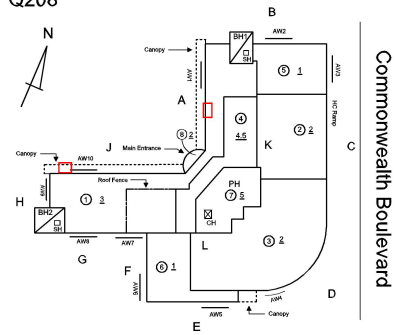
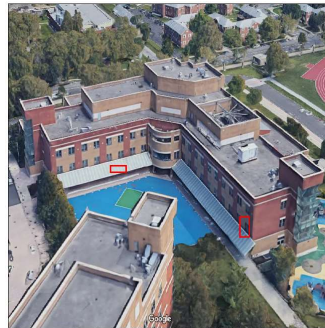
CAST IN PLACE / PRE-CAST CONCRETE: DETERIORATED JOINTS

10  
L.F.  
REPOINT  
PRIORITY 3  
LEVEL 2

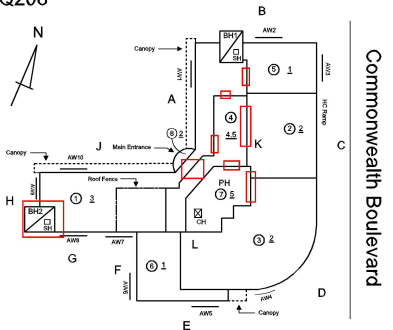
Violations	Facade A No violations recorded.
<b>EXTERIOR SOFFITS</b>	Inspected
Condition	2 - Between Good and Fair
Deficiency	No deficiencies recorded
<b>LOADING DOCK</b>	Does not Exist
<b>LOUVER</b>	Inspected
Condition	2 - Between Good and Fair
Deficiency	No deficiencies recorded
<b>PARAPETS</b>	Inspected
Material Type(s)	Masonry
Replacement Quantity	8,200
Replacement Uom	C.F.
Instance on All Facades	Inspected
Instance Condition	4 - Between Fair and Poor
Instance Quantity	8,200
Instance Quantity Uom	C.F.
Deficiency	BRICK: MINOR CRACKS, SPALLING
Roof Plan reference	Q208

Deficiency Quantity	300
Quantity Uom	S.F.
Potential Action	REPAIR
Urgency of Action	PRIORITY 3
Purpose of Action	LEVEL 2

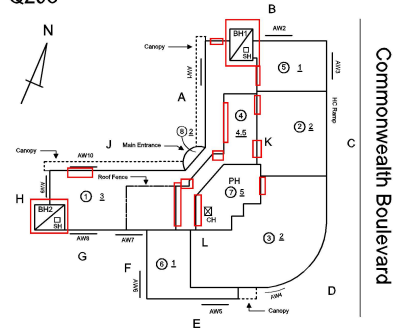
**BRICK: DETERIORATED JOINTS**

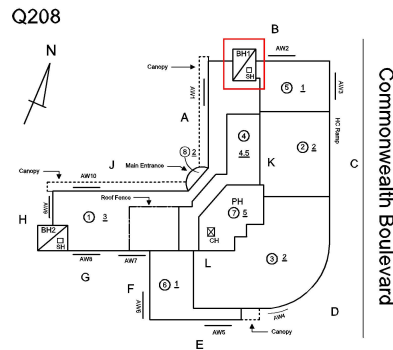
WATER INFILTRATION

1  
EACH  
REPAIR  
PRIORITY 5  
LEVEL 2

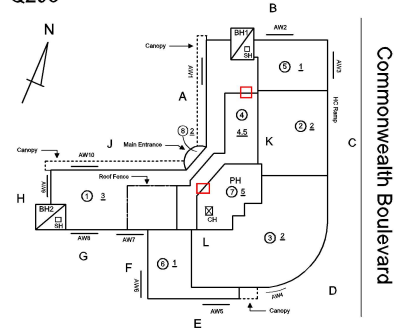
Source of Installation	Custodial Staff
Deficiency	IRMA: FLASHING: CAP FLASHING DAMAGED

20  
L.F.  
REPLACE  
PRIORITY 4  
LEVEL 4

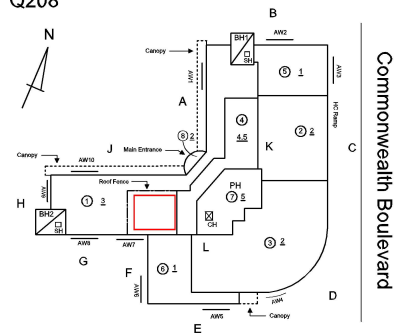
IRMA: FLASHING: PITCH POCKET DETERIORATED - MAJOR  
Q208

4  
EACH  
REPLACE  
PRIORITY 4  
LEVEL 2

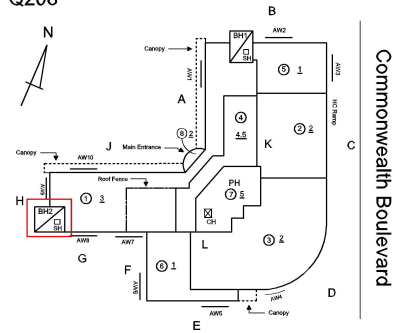
IRMA: FLASHING: CAP FLASHING MISSING

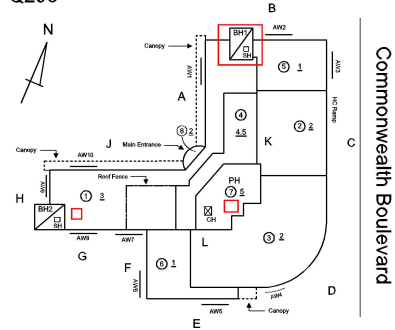
IRMA: ROOFING: DAMAGED INSULATION

50  
S.F.  
REPLACE  
PRIORITY 4  
LEVEL 2

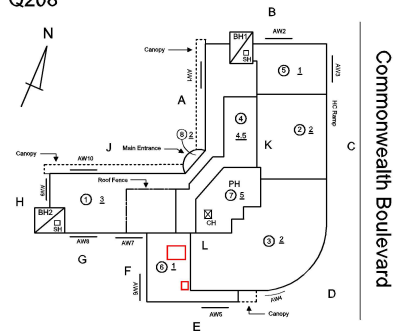
IRMA: ROOFING: MAJOR ACTIVE ROOF LEAKS IN INSTRUCTIONAL SPACE

400  
S.F.  
REPLACE ROOFING WITHOUT MAJOR EQUIPMENT  
REMOVAL  
PRIORITY 5  
LEVEL 2

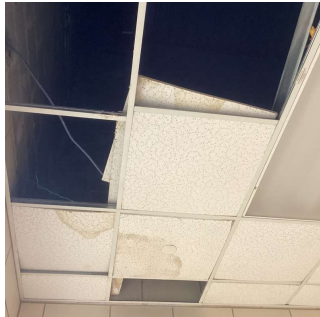
Violations	Roof 3 - Gymnasium, also Boys Locker Room near entrance, Girls Locker Room near entrance, Utility Dressing Room 151H, Sound Room 151B, Corridor near Room 151A No violations recorded.
<b>ROOFING DRAINS</b>	Inspected
Condition	5 - Poor
Deficiency	DETERIORATED
Roof Plan reference	Q208
Deficiency Quantity	12
Quantity Uom	EACH
Potential Action	REPLACE
Urgency of Action	PRIORITY 4
Purpose of Action	LEVEL 2
Deficiency Photo1

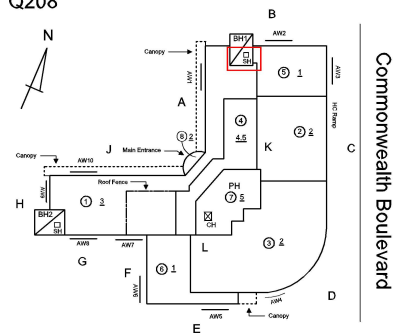
**BULKHEAD/PENTHOUSE WALLS/EXTERIOR: DETERIORATED JOINTS**

20  
S.F.  
REPOINT  
PRIORITY 3  
LEVEL 2

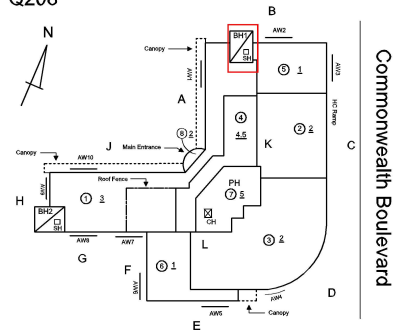
**BULKHEAD/PENTHOUSE DOORS: DETERIORATED DOOR**

REPLACE DOOR

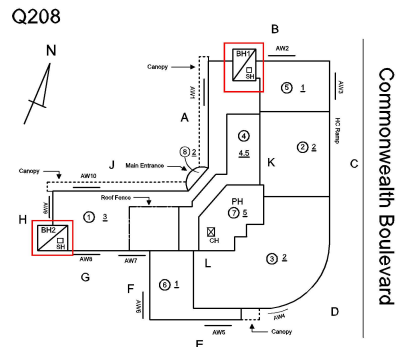
**BULKHEAD/PENTHOUSE WALLS/INTERIOR: GYPSUM BOARD DAMAGED/DETERIORATED**

50  
S.F.  
REPLACE  
PRIORITY 3  
LEVEL 2

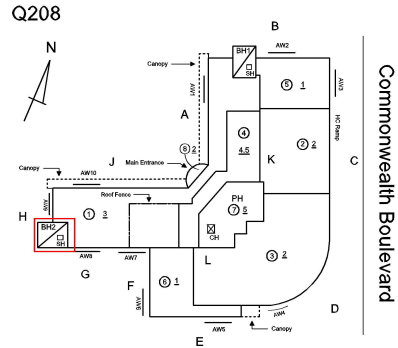
**BULKHEAD/PENTHOUSE ROOF: MAJOR LEAKAGE**

100  
S.F.  
REPLACE  
PRIORITY 5  
LEVEL 2

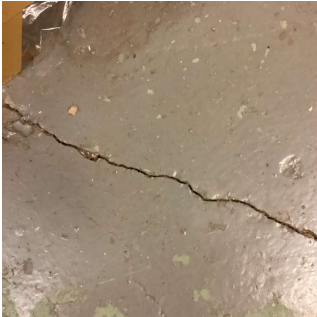
Basement - Room C2
Violations	No violations recorded.
Deficiency	CONCRETE SLAB ON GRADE: THRU CRACKS
Deficiency Location/Instance	Basement - Room C2

Deficiency Quantity	10
Quantity Uom	S.F.
Potential Action	REPAIR
Urgency of Action	PRIORITY 3

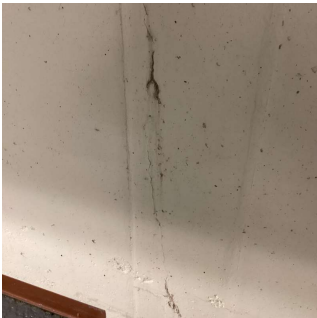
Basement - Room C2
Violations	No violations recorded.
<b>FOUNDATION WALLS</b>	
	Inspected
Material Type(s)	Concrete
Condition	3 - Fair
Deficiency	CONCRETE: CRACKED/SPALLED/REINFORCEMENT EXPOSED
Deficiency Location/Instance	Basement - Room C10, Gas Meter Room
Deficiency Quantity	30
Quantity Uom	S.F.
Potential Action	REPAIR
Urgency of Action	PRIORITY 3
Purpose of Action	LEVEL 5
Deficiency Photo1

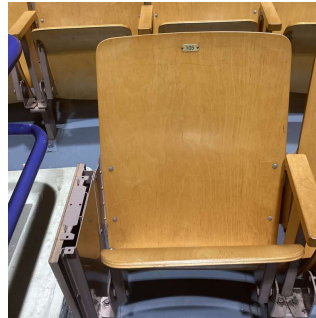
Seat A/105

DAMAGED/BROKEN/INOPERABLE

REPLACE

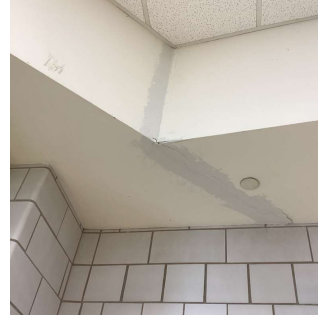
Near Serving Area

Deficiency	No deficiencies recorded
<b>CAFETERIA</b>	
Instance on 1st Floor - Staff	Inspected
Instance on 1st Floor - Students	Inspected
<b>Ceiling</b>	
Instance on 1st Floor - Students	Inspected
Condition	3 - Fair
Deficiency	GYP SUM BOARD: DAMAGED/DETERIORATED
Deficiency Location/Instance	Near Serving Area, Windows, Center
Deficiency Quantity	60
Quantity Uom	S.F.
Potential Action	REPLACE
Urgency of Action	PRIORITY 3

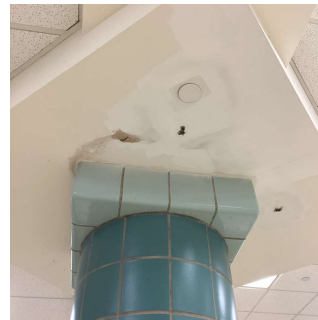
Near Room 114B

GYPSUM BOARD: DAMAGED/DETERIORATED - ACTIVE LEAK

REPLACE

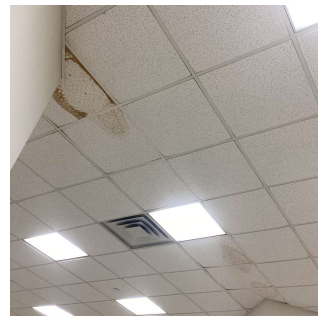
ACOUSTIC TILES: DAMAGED/MISSING - ACTIVE LEAK

REPLACE

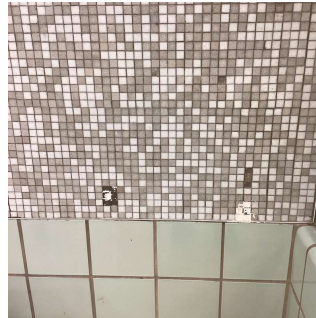
Near Windows

CERAMIC TILE: BROKEN/ MISSING

REPLACE

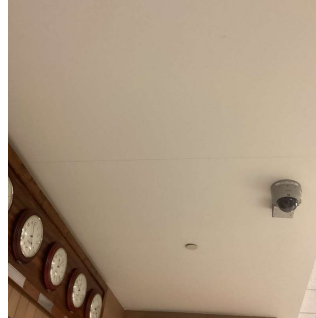
Corridor near Stair B/1

**GYPSUM BOARD: DAMAGED/DETERIORATED**

REPLACE

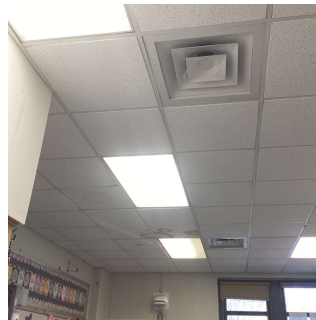
Room 143

**ACOUSTIC TILES: DAMAGED/MISSING**

REPLACE

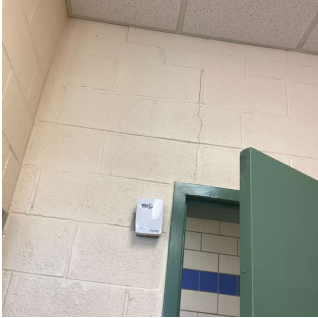
Question	Response
<b>INTERIOR</b>	
<b>CLASSROOMS/CORRIDORS/ADMIN SPACES</b>	
<b>Door(s)</b>	Inspected
Condition	2 - Between Good and Fair
Deficiency	No deficiencies recorded
<b>Floor Finish</b>	Inspected
Condition	2 - Between Good and Fair
Deficiency	No deficiencies recorded
<b>Walls</b>	Inspected
Condition	2 - Between Good and Fair
Deficiency	MASONRY: CRACKS/SPALLING
Deficiency Location/Instance	Rooms 221, 223, 313, 319, 323, and others
Deficiency Quantity	100
Quantity Uom	S.F.
Potential Action	REPLACE
Urgency of Action	PRIORITY 3
Purpose of Action	LEVEL 2
Deficiency Photo1

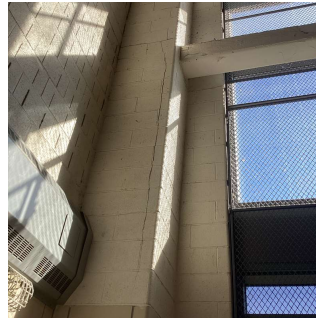
Near Exit 4

MASONRY: CRACKS/SPALLING

REPLACE

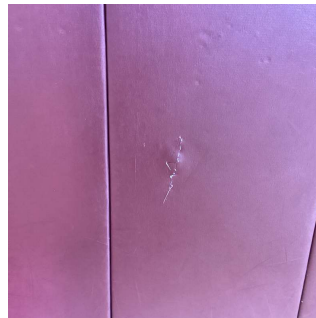
Near Room 146

WALL PADDING: DETERIORATED

REPLACE

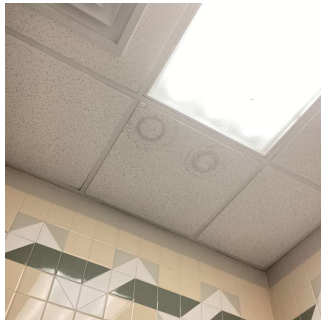
Violations	No violations recorded.
Deficiency	ACOUSTIC TILES: DAMAGED/MISSING
Deficiency Location/Instance	Room 108K
Deficiency Quantity	10
Quantity Uom	S.F.
Potential Action	REPLACE
Urgency of Action	PRIORITY 3
Purpose of Action	LEVEL 2

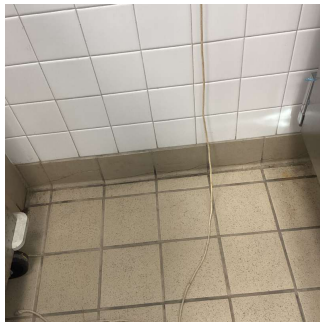
Question	Response
<b>INTERIOR</b>	
<b>KITCHEN</b>	
<b>Ceiling</b>	
Violations	No violations recorded.
<b>Door(s)</b>	
Instance on 1st Floor	Inspected
Condition	2 - Between Good and Fair
Deficiency	No deficiencies recorded
<b>Floor Finish</b>	
Instance on 1st Floor	Inspected
Condition	2 - Between Good and Fair
Deficiency	QUARRY TILE: BROKEN/MISSING TILES
Deficiency Location/Instance	Serving Area
Deficiency Quantity	20
Quantity Uom	S.F.
Potential Action	REPLACE
Urgency of Action	PRIORITY 3
Purpose of Action	LEVEL 2
Deficiency Photo1

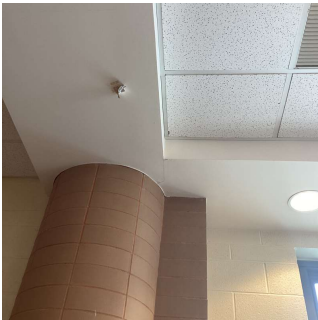
Question	Response
<b>INTERIOR</b>	
<b>LIBRARY</b>	Inspected
Instance on Room 213	Inspected
<b>Built-in Furnishing</b>	
Instance on Room 213	Does not Exist
<b>Ceiling</b>	
Instance on Room 213	Inspected
Condition	3 - Fair
Deficiency	GYPSUM BOARD: DAMAGED/DETERIORATED
Deficiency Location/Instance	Near Windows
Deficiency Quantity	10
Quantity Uom	S.F.
Potential Action	REPLACE
Urgency of Action	PRIORITY 3
Purpose of Action	LEVEL 2
Deficiency Photo1

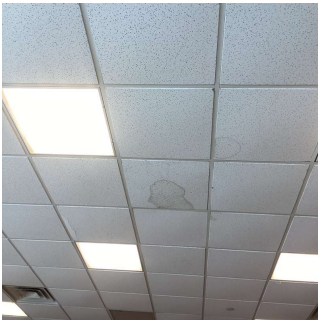
Violations	No violations recorded.
Deficiency	ACOUSTIC TILES: DAMAGED/MISSING
Deficiency Location/Instance	Near Rooms 213A, 213B, Center
Deficiency Quantity	30
Quantity Uom	S.F.
Potential Action	REPLACE
Urgency of Action	PRIORITY 3
Purpose of Action	LEVEL 2
Deficiency Photo1

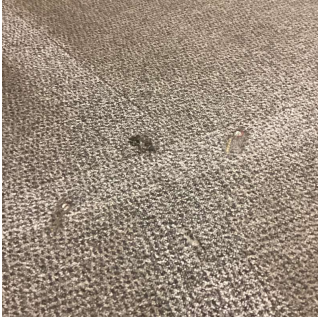
Condition	2 - Between Good and Fair
Deficiency	CARPET: WORN/DETERIORATED
Deficiency Location/Instance	Near Entrance
Deficiency Quantity	10
Quantity Uom	S.F.
Potential Action	REPLACE
Urgency of Action	PRIORITY 3
Purpose of Action	LEVEL 2
Deficiency Photo1

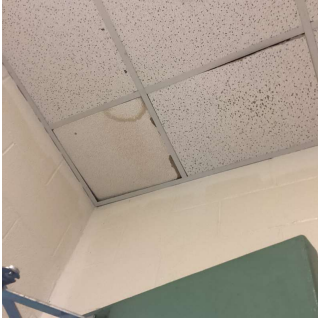
Instance on 1st Floor - Boys (252 Lockers)	Inspected
Condition	2 - Between Good and Fair
Deficiency	ACOUSTIC TILES: DAMAGED/MISSING - ACTIVE LEAK
Deficiency Location/Instance	Near Entrance
Deficiency Quantity	10
Quantity Uom	S.F.
Potential Action	REPLACE
Urgency of Action	PRIORITY 5
Purpose of Action	LEVEL 2
Deficiency Photo1

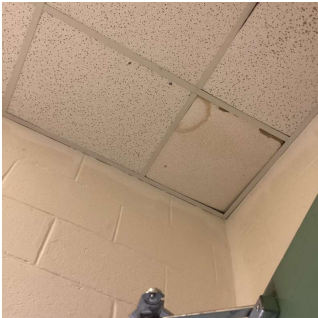
Question	Response
<b>INTERIOR</b>	
<b>LOCKER ROOM</b>	
<b>Ceiling</b>	
Violations	Near Entrance No violations recorded.
Deficiency	ACOUSTIC TILES: DAMAGED/MISSING
Deficiency Location/Instance	Near Entrance, Shower Room
Deficiency Quantity	20
Quantity Uom	S.F.
Potential Action	REPLACE
Urgency of Action	PRIORITY 3
Purpose of Action	LEVEL 2
Deficiency Photo1

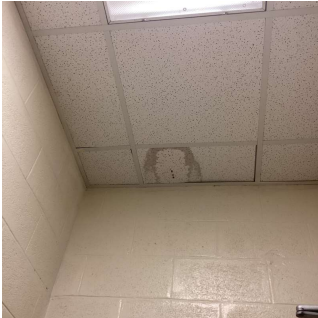
Violations	Near Entrance No violations recorded.
Instance on 1st Floor - Girls (243 Lockers)	Inspected
Condition	2 - Between Good and Fair
Deficiency	ACOUSTIC TILES: DAMAGED/MISSING - ACTIVE LEAK
Deficiency Location/Instance	Near Entrance
Deficiency Quantity	10
Quantity Uom	S.F.
Potential Action	REPLACE
Urgency of Action	PRIORITY 5
Purpose of Action	LEVEL 2
Deficiency Photo1

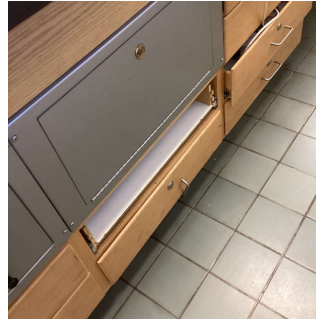
Violations	Near Locker 189 No violations recorded.
<b>MULTI-PURPOSE ROOM</b>	Does not Exist
<b>SCIENCE DEMO ROOM</b>	Does not Exist
<b>SCIENCE LAB</b>	Inspected
Instance on Rooms 315, 323	Inspected
Alternative use	No
Instance on Room 319	Inspected
Alternative use	Yes
<b>Fixed Equipment</b>	
Instance on Room 319	Inspected
Condition	3 - Fair
Deficiency	CABINETRY: MISSING/DAMAGED
Deficiency Location/Instance	Room 319
Deficiency Quantity	10

Quantity Uom	L.F.
Potential Action	REPLACE
Urgency of Action	PRIORITY 3
Purpose of Action	LEVEL 2
Deficiency Photo1

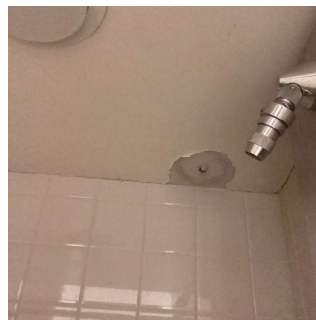
Instance on 1st Floor - Boys	Inspected
Condition	3 - Fair
Deficiency	ACOUSTIC TILES: DAMAGED/MISSING
Deficiency Location/Instance	Near center
Deficiency Quantity	10
Quantity Uom	S.F.
Potential Action	REPLACE
Urgency of Action	PRIORITY 3
Purpose of Action	LEVEL 2
Deficiency Photo1
